Technical Memorandum: UCPRC-TM-2005-9

Evaluation of New Patching Material for Open-Graded Asphalt Concrete (OGAC) Wearing Courses

Development of Improved Patching Procedures for OGAC Overlays

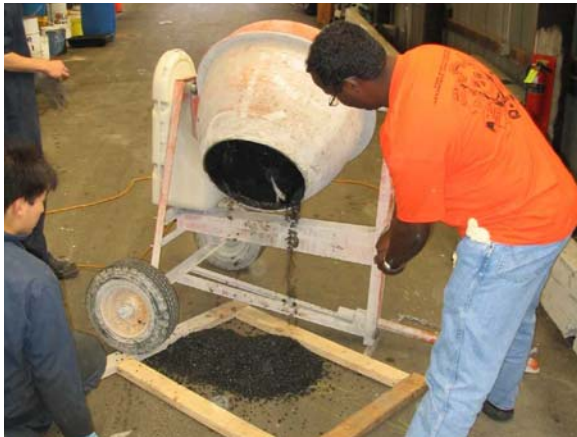
The first test site was at the Pavement Research Center, located at the University of California Berkeley Richmond Field Station in Richmond, CA. The primary objectives of the first test were to assess workability and ease of application, and to get a qualitative indication of drainage characteristics. Two potholes were filled with the material, and the material proved to be workable and easy to use. Additionally, a “lift” approximately 40 mm thick and 0.2 m² was placed over non-distressed dense-graded asphalt concrete (DGAC) with a 2-percent cross slope. To create this lift, the patch material was placed in a small wooden frame on top of the DGAC (Figure 1). After the patch material set up, the wooden frame was removed and water was poured over it (Figure 2). Twenty ounces of water was poured over the patch material over a period of approximately 60 seconds. The water seeped in relatively quickly with none of the water running off the surface of the patch material. Within a couple of minutes the water began draining from the downslope side of the patch along the interface between the patch material and the

Figure 1. Patch material being placed in wooden frame on top of DGAC pavement.

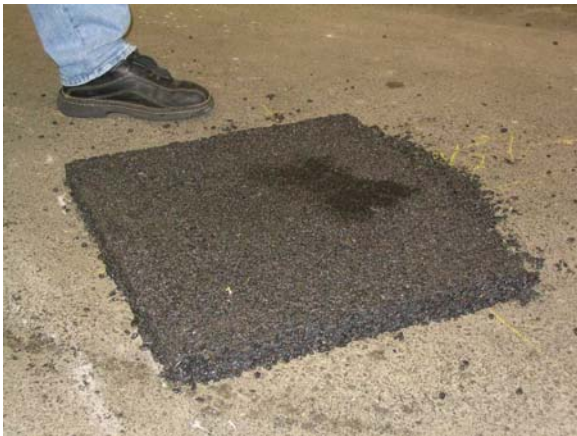
Figure 2. Water on surface of patch material.

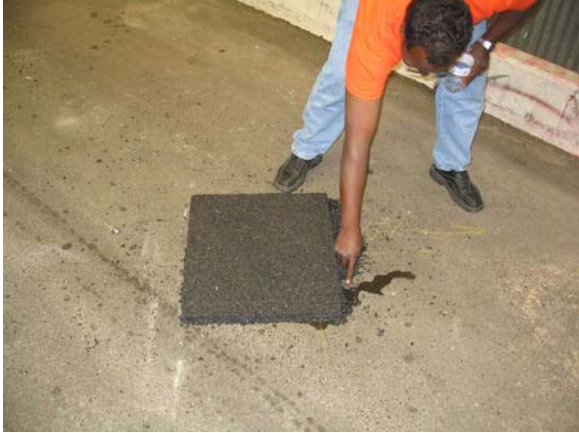
underlying DGAC (Figure 3). This trial suggested that the porosity of the modified FloMix material was high enough to provide adequate drainage characteristics.

Figure 3. Water draining from downslope side of patch material.

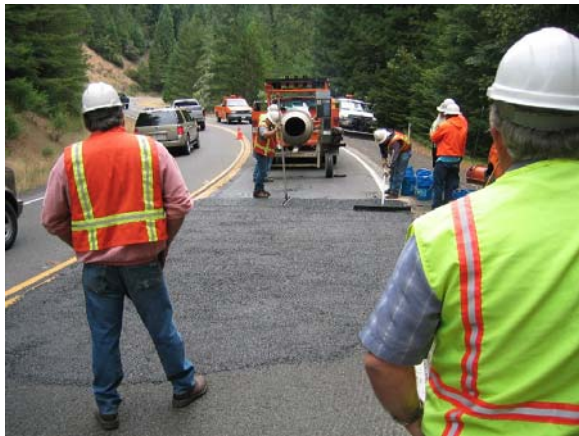
Modified FloMix was spread full lane over a length of several meters at the Highway 20 test site by a District 1 maintenance crew (Figure 4). The patch was about 1.5 cm thick and was tapered at the ends and edges. This was considered to be a severe test condition for the patch material for a couple of reasons. First, the thickness was less than desired for optimal drainage characteristics. Secondly, the patch was large in addition to being thin, and it had no confinement at the edges.

Figure 4. Placement of patch material on Highway 20 field site.

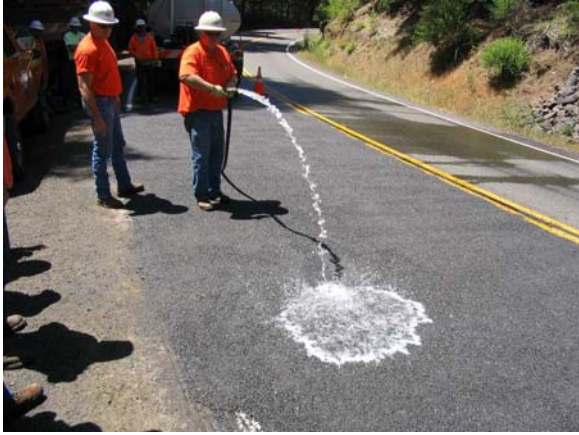
A water truck was brought in before the lane was opened to traffic. The truck made two passes, giving the patch a thorough soaking both times (Figure 5). The majority of the water drained through the patch, as anticipated, and drained out the downhill edge of the patch

Figure 5. Application of water to patched area.

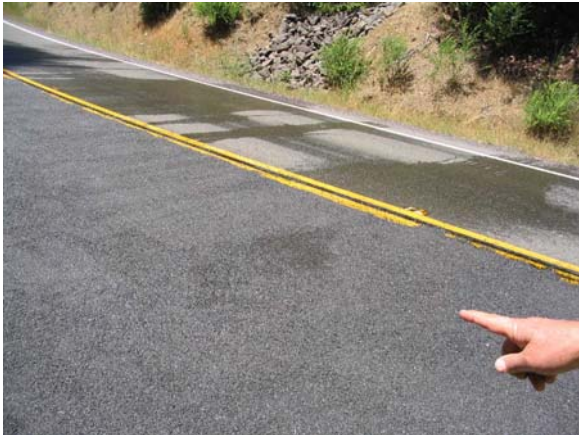
(Figure 6). The test site was then opened to traffic and the patch was monitored for durability. Unfortunately the patch was not durable and began chipping off of the underlying DGAC within a few months. Figure 7 shows the rough patch area after a year. Note the areas where the patch material has raveled completely away.

Figure 6. Water draining from downslope side of patched area.

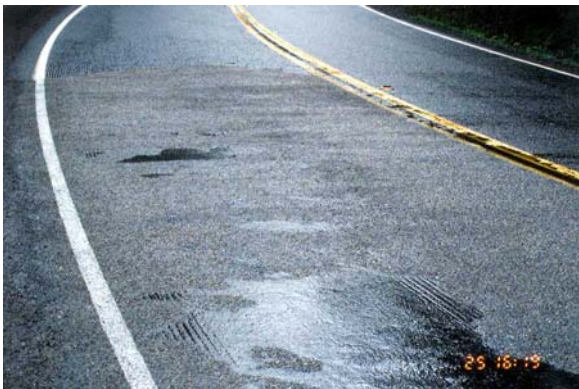
Figure 7. Deteriorated patch site showing significant raveling and roughness after one year.

Based upon the results of limited testing in this research, the use of modified FloMix for OGAC patching is not recommended. The workability and drainage characteristics of the material were good, but the material did not meet the field durability criteria. The material may have acceptable durability if applied in a less severe condition, such as filling medium-sized potholes, however this has not yet been evaluated.
