HVS Test Results on Fast-Setting Hydraulic Cement Concrete

Palmdale, California Test Sections, South Tangent

Report prepared for the California Department of Transportation

July 2002

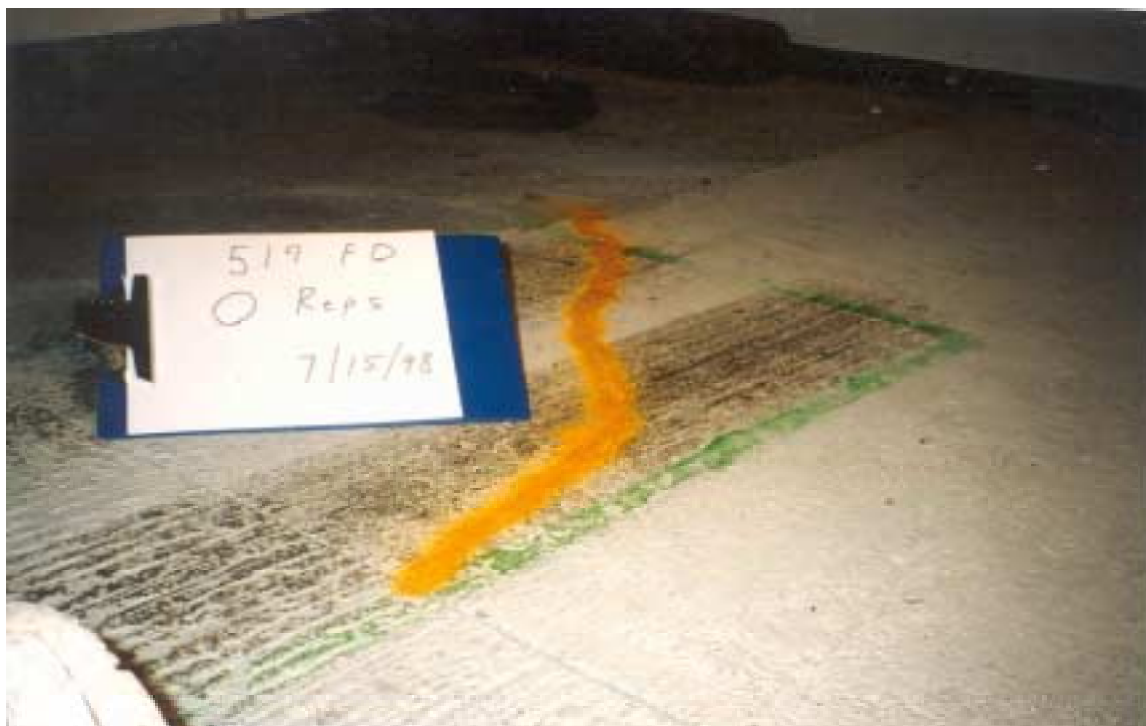
The crack pattern, as it developed with time, can be seen in Figure 4.1. Prior to the start of any loading on Section 519FD, a crack starting at joint 4 and the edge of the slab had developed, most likely from construction traffic (Photograph 4.1).

Photograph 4.1. Corner crack prior to start of test, Test Section 519FD.

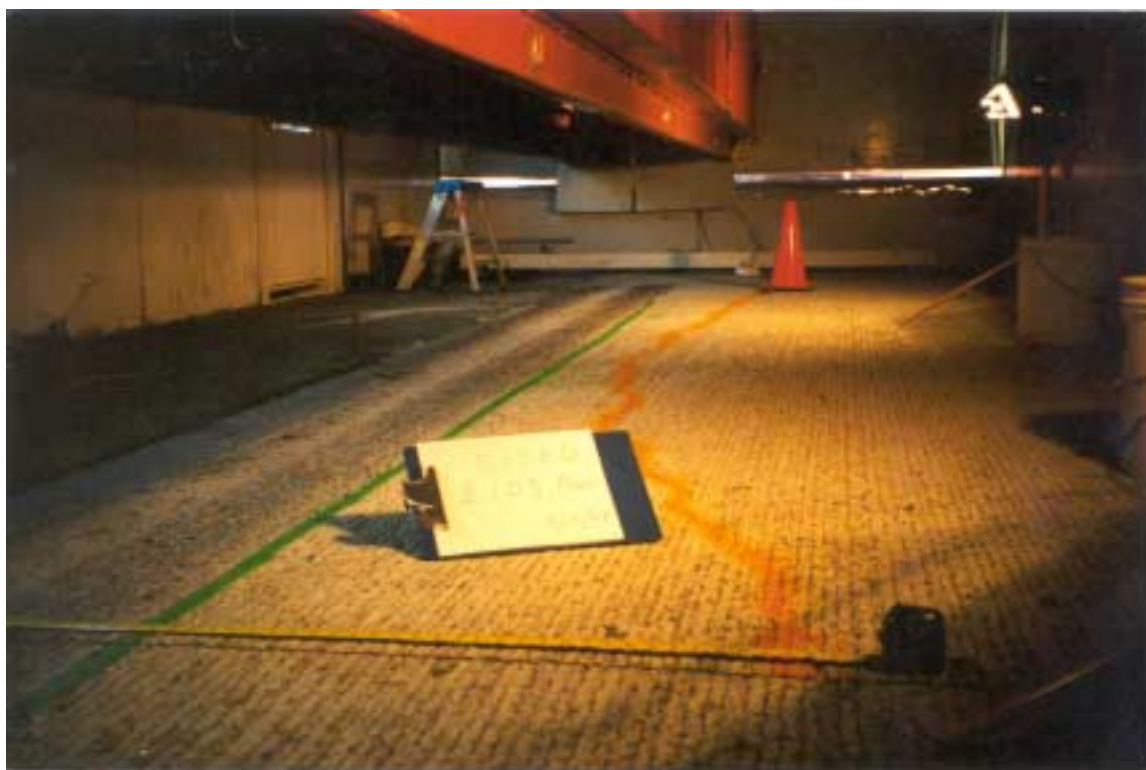
After approximately 2,000 25-kN load repetitions, a longitudinal crack developed throughout the length of the middle slab (slab 4) between both joints, about 1.4 m from the edge (Photograph 4.2). This type of crack indicates a loss of support under the slab and/or excessive slab warping causing an unsupported edge (4). This crack was followed by two corner cracks on either side of slab 4 (one in slab 3 and one in slab 5), which developed at approximately 25,000 repetitions (Photographs 4.3 and 4.4). As the test progressed, more edge and corner cracks developed. The final crack pattern is displayed in Photograph 4.5 and Figure 4.1.

Photograph 4.2. Longitudinal crack after 2,105 repetitions, Test Section 519FD.

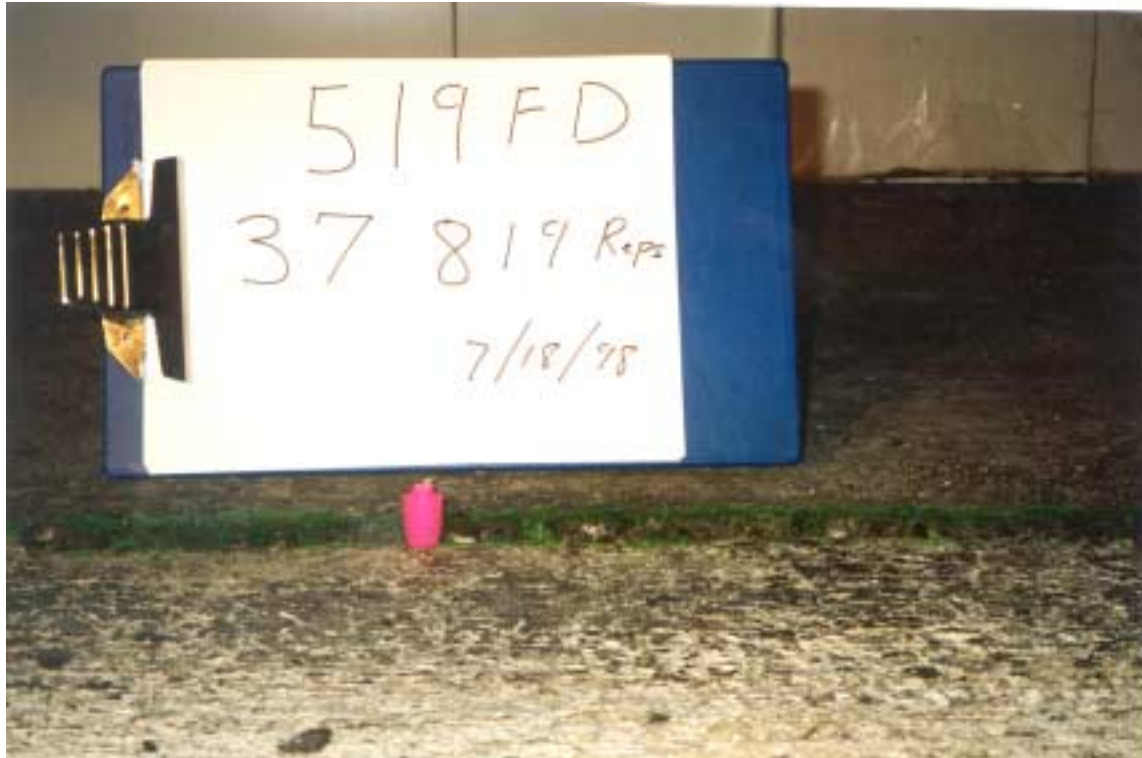
Photograph 4.6. Permanent deformation at shoulder after 37,000 repetitions, Test Section 519FD.

After 37,819 load repetitions, a maximum of approximately 20 mm of permanent deformation was recorded along the slab edge at the interface between the concrete slab and the adjacent asphalt shoulder (Photograph 4.6). This observation clearly illustrated the reason for the slab having had a longitudinal crack, i.e., the slab had to move downward to come in full contact with the base.

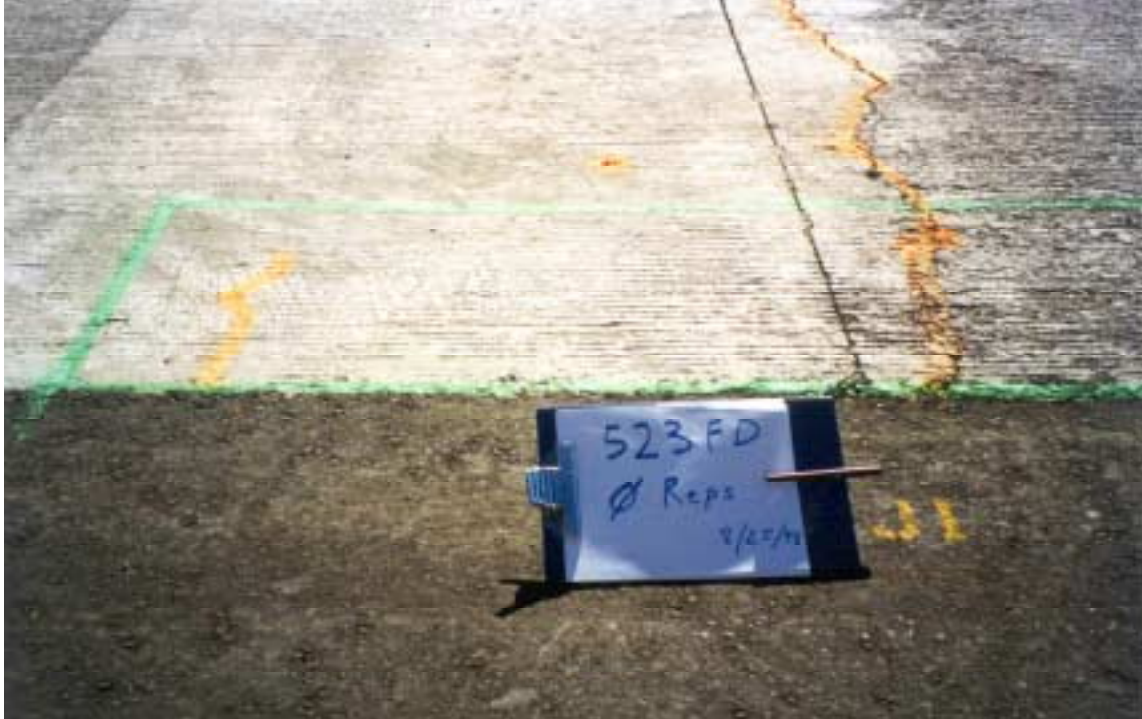
Photograph 4.22. Crack at transverse joint (joint 17) at start of test, Test Section 523FD.

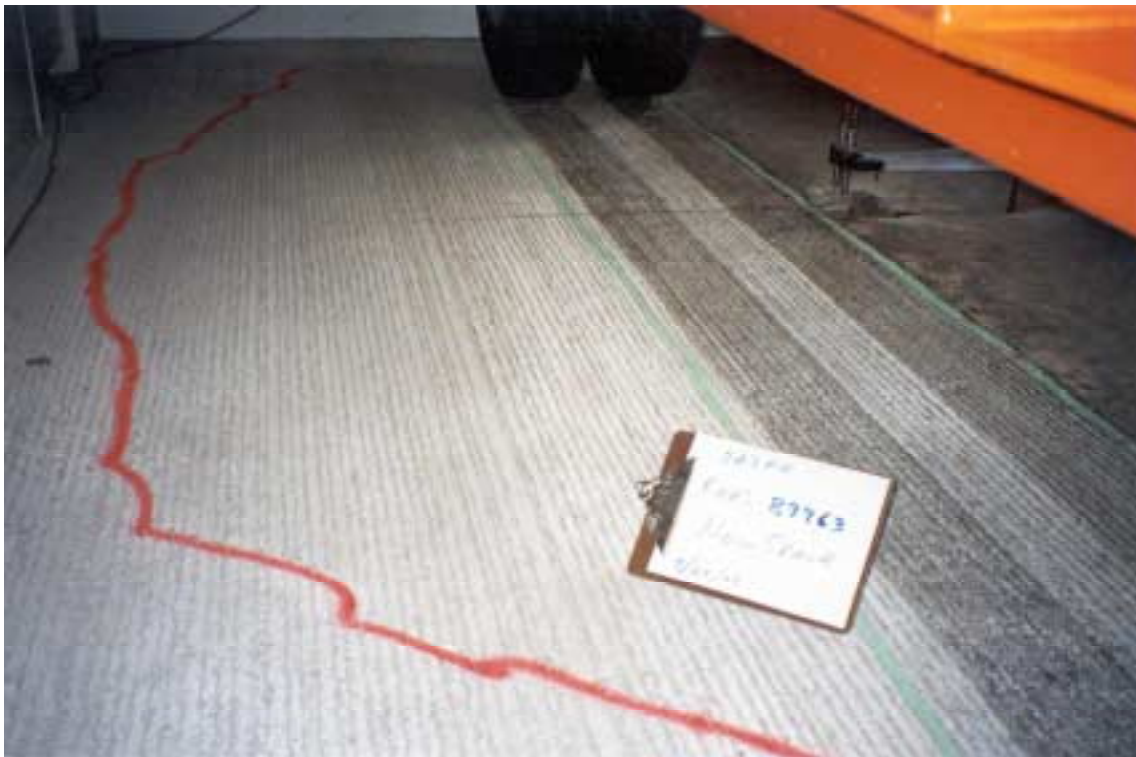
Photograph 4.21 shows an overhead view of the test section and crack pattern. Figure 4.12 shows crack development for Section 523FD. Several cracks existed before trafficking began (see Photograph 4.22). The first crack under applied loading appeared at 89,963 repetitions on slab number 17 as a corner crack and as a longitudinal crack on slab number 16 (Photograph 4.23).

Photograph 4.23. Crack pattern after 90,000 repetitions, Test Section 523FD.

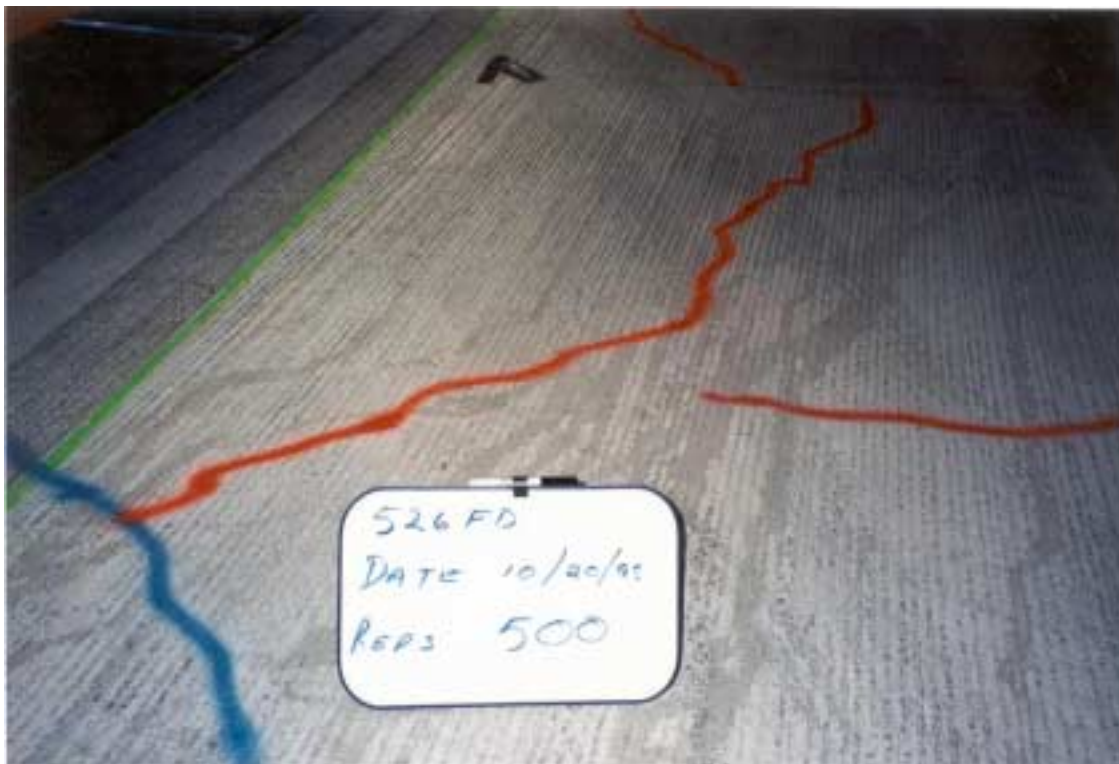
Photograph 4.29. Crack pattern after 500 repetitions, Test Section 526FD.

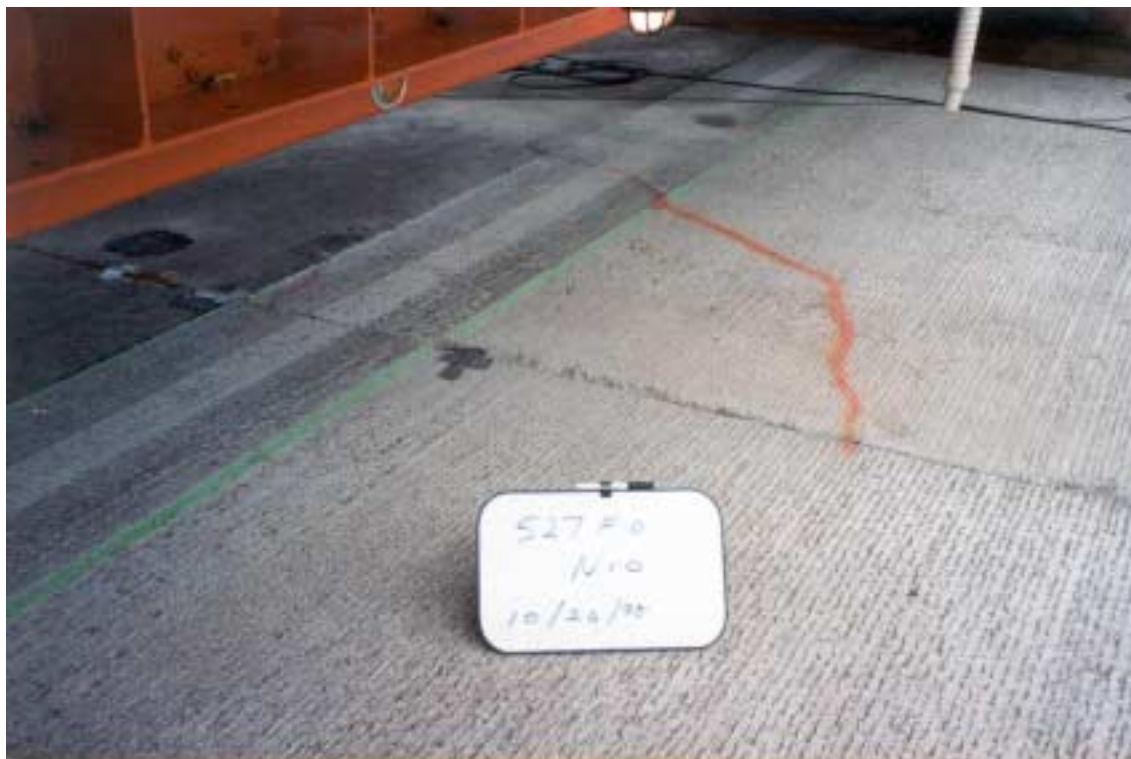
Photograph 4.32. Corner crack at start of test, Test Section 527FD.
