TM-UCB-PRC-2001-2

## **State Route 138—Test Site Evaluation**

Prepared by David Bush, P.E.  
Dynatest Consulting, Inc.

Re: State Route 138 – Test Site Evaluation

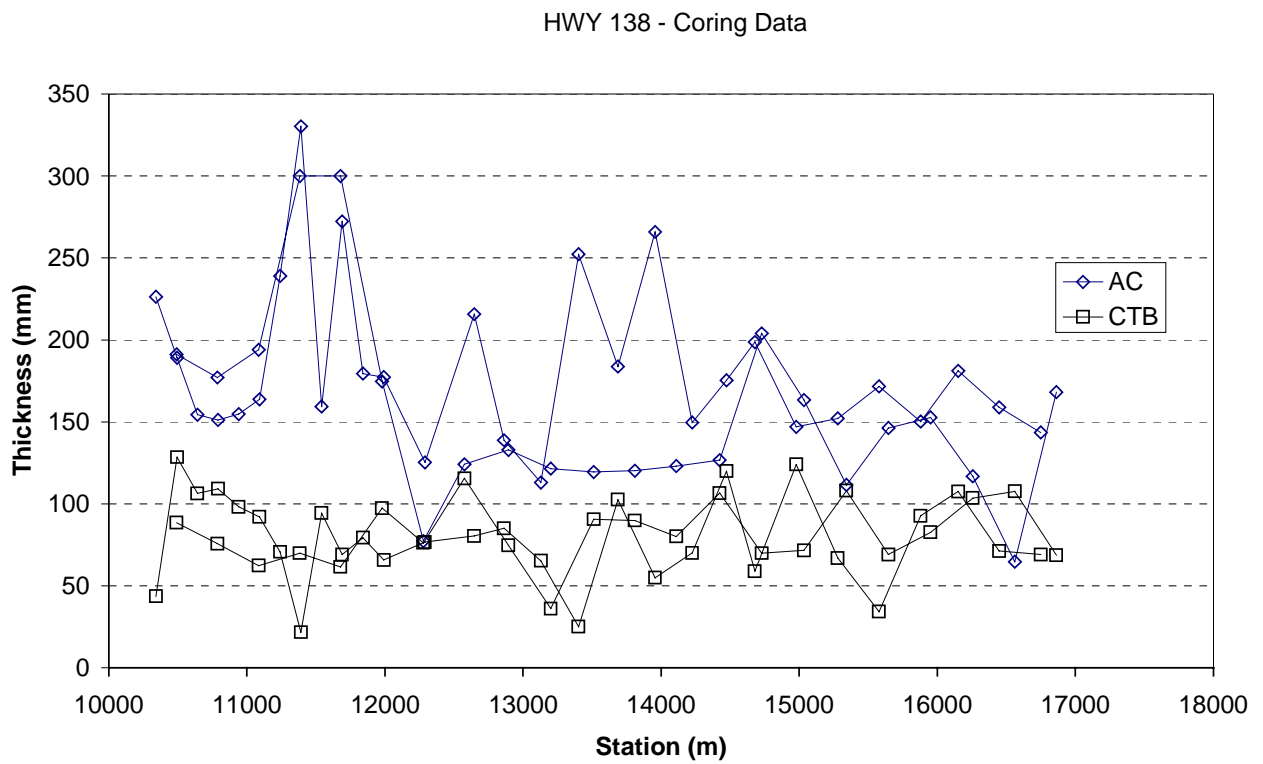
**Figure 3. Coring profile for State Route 138.**

The coring data was highly variable, as can be seen in Figure 3. The total pavement structural section varies between 150 and 325 mm. Of that total, the AC layer thickness ranges between 115 and 225 mm and the CTB layer thickness ranges between 35 and 125 mm. It is also evident from examination of the cores that there are several AC layers, i.e. “lifts.” During the coring operation, core separation was noted, which indicates a poor bond between the AC layers. However, there was little or no evidence of stripping of the AC. The number of layers varies between 3 and 6 and there is no consistency with regards to the change in thickness of each layer over the length of the project. Also, there is evidence of a fabric interlayer within the pavement. The interlayer exists between 100 to 250 mm above the subgrade. Again, there is no consistency in the AC thickness either above or below the fabric, as shown in Figures 8 and 9.

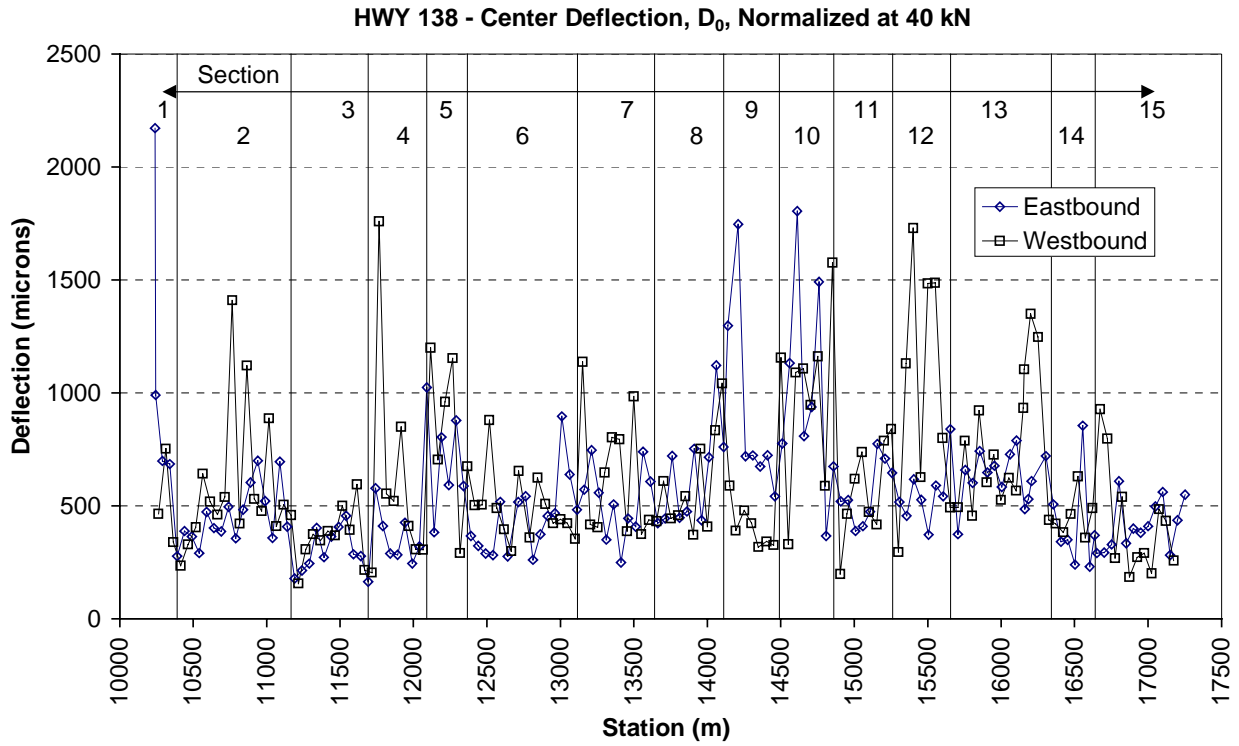
**Figure 6. Center deflection,  $D_0$ , at 40 kN for Eastbound and Westbound lanes.**

The recorded center deflection,  $D_0$ , values, shown in Figure 5, are highly variable for both eastbound and westbound lanes. This may be due to variations in the surfacing thickness, pavement materials and structural condition.

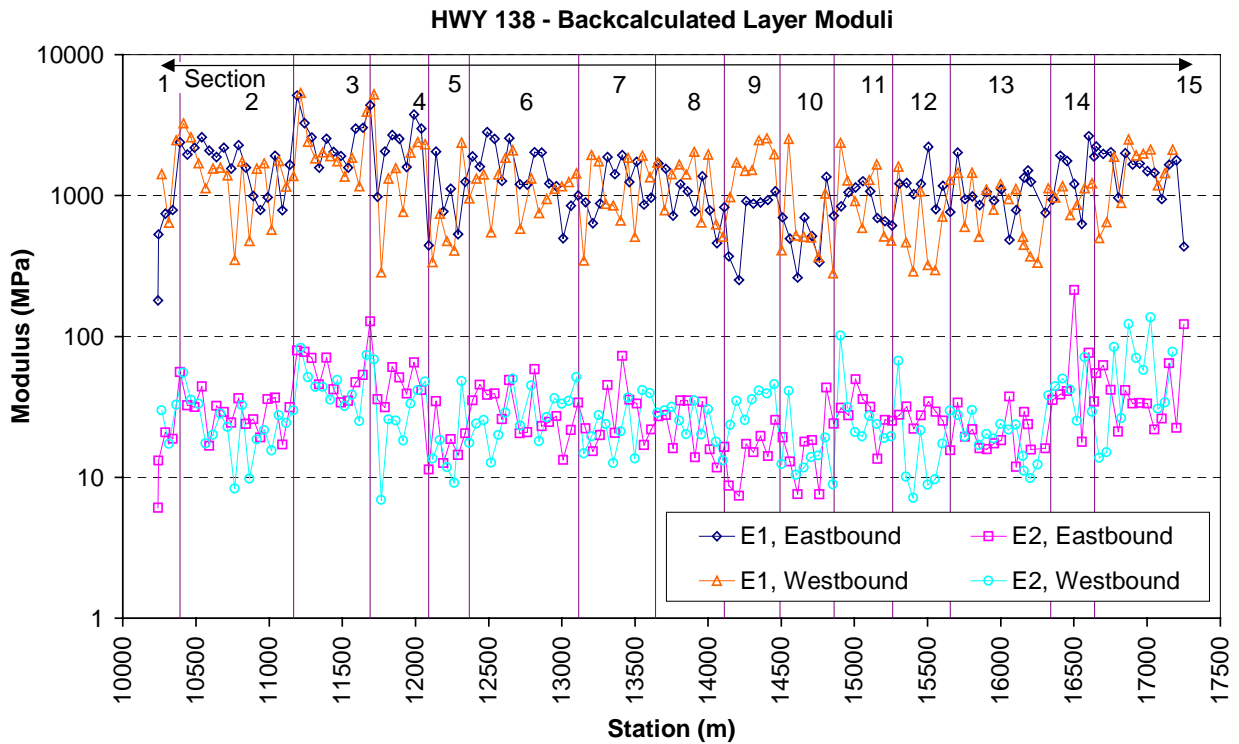
**Figure 7. Backcalculated layer moduli for East- and Westbound lanes.**

The surfacing stiffness, (i.e., AC+CTB), is generally not consistent across lanes nor along either lane, throughout the entire project. However, the subgrade stiffness is relatively consistent across lanes, but not along the lanes. Because of this consistency, it was decided to use the subgrade stiffness as the criterion for dividing the project into relatively similar sections varying from 250 to 850 meters in length. Table 4 summarizes the surfacing stiffness and subgrade stiffness for each section and the limits of each section.

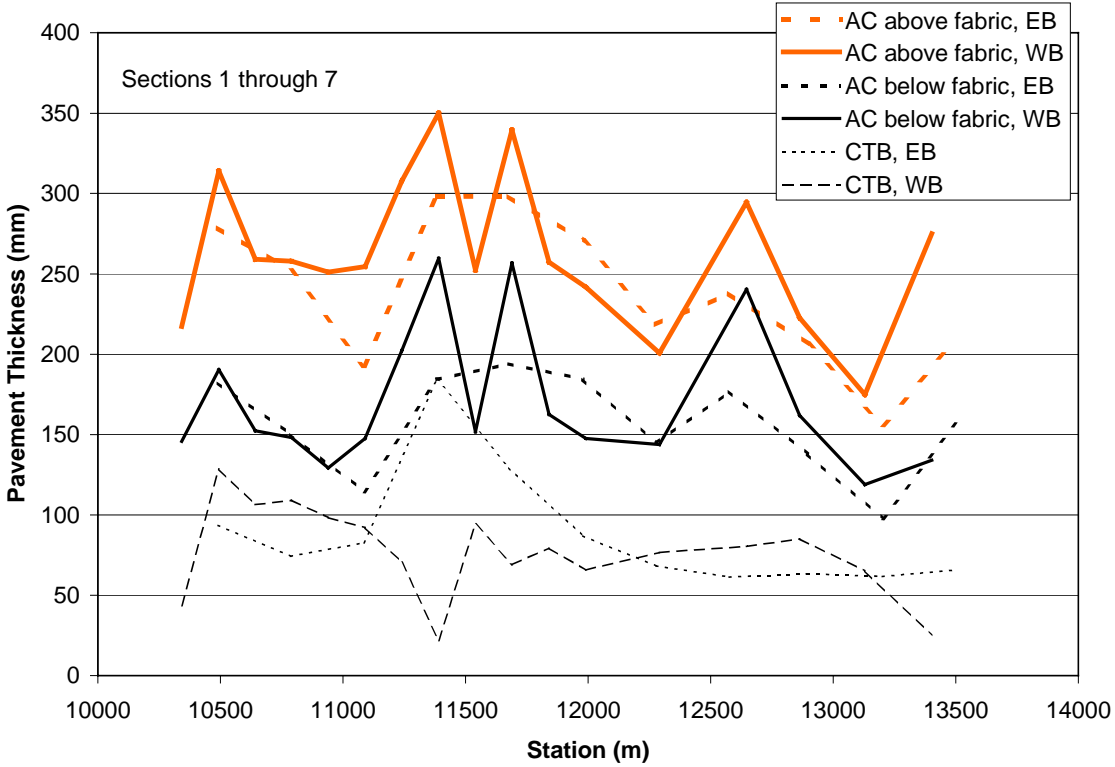
**Figure 8. Layer thickness variability, Sections 1–7, State Route 138.**

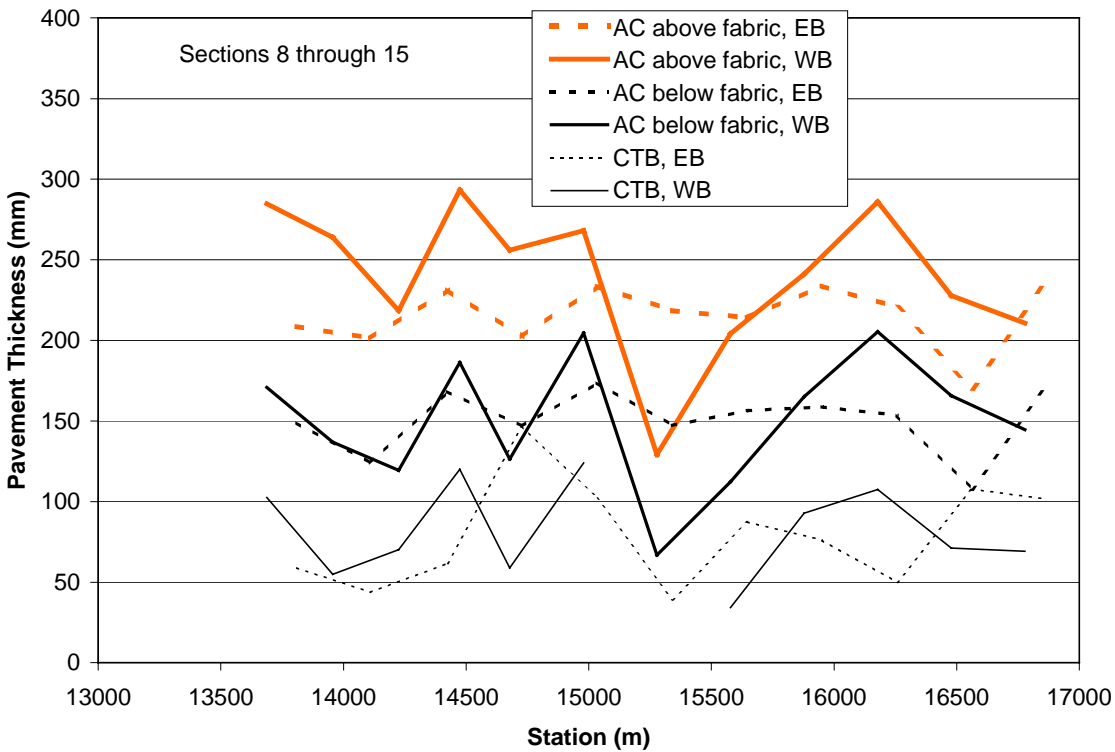
**Figure 9. Layer thickness variability, Sections 8–15, State Route 138.**

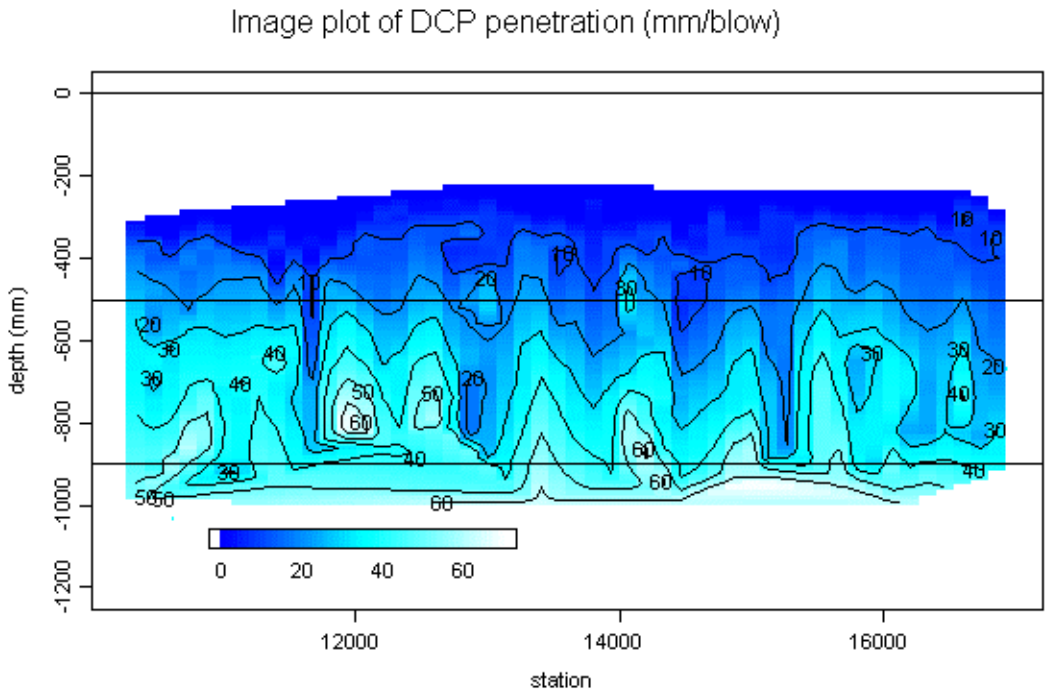
The DCP testing indicated the presence of two different in-situ materials below the AC layers. From Figure 10, it can be estimated that the first layer, Layer 1, under the AC ranges between 0 to 0.5 m, whereas the second layer, Layer 2 ranges from 0.5 to 0.9 m.

**Figure 10. Recorded DCP penetration (mm/blow) on HWY 138.**

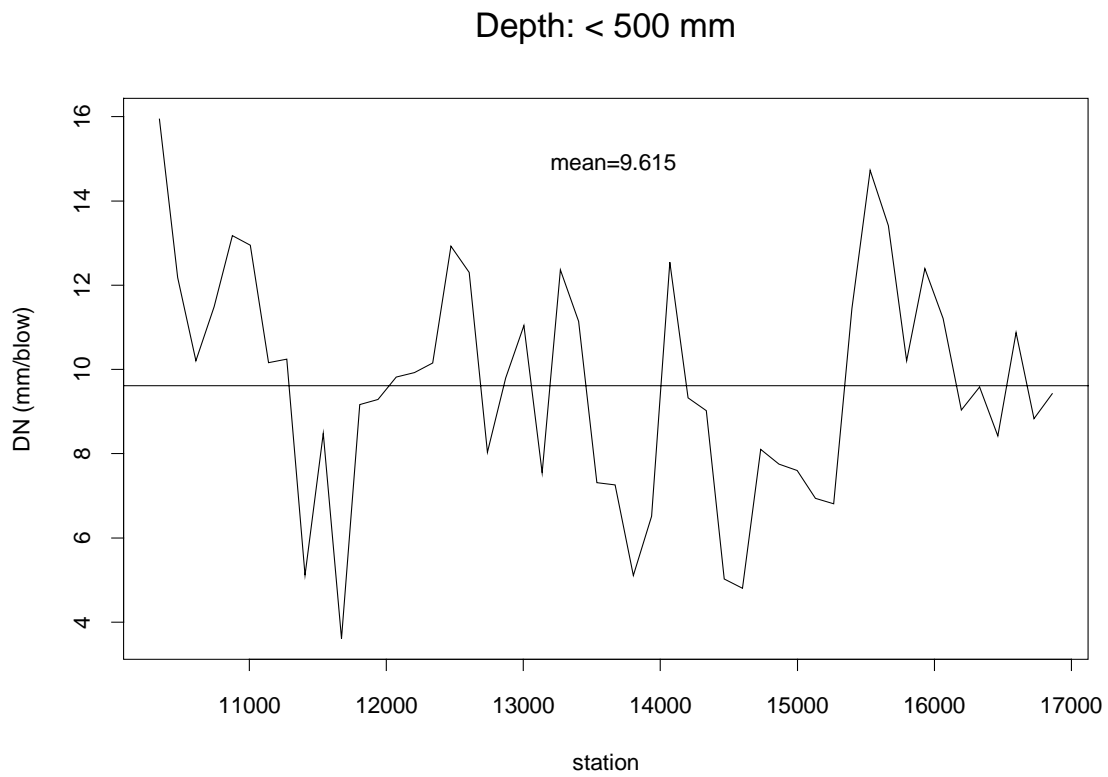
The mean DN for Layer 1 is 9.6 mm/blow and for Layer 2 it is 35.8 mm/blow. This is shown graphically in Figures 11 and 12.

The DCP results are highly variable throughout the entire project. Using the CSIR equation presented in Section 3.3, which correlates DN to effective modulus or stiffness of the material, the estimated stiffness of Layer 1 calculated from the mean DN is 101 MPa (14.6 ksi) and for Layer 2 is 25 MPa (3.6 ksi).

**Figure 11. Layer 1 plot of DN versus Station for State Route 138.**

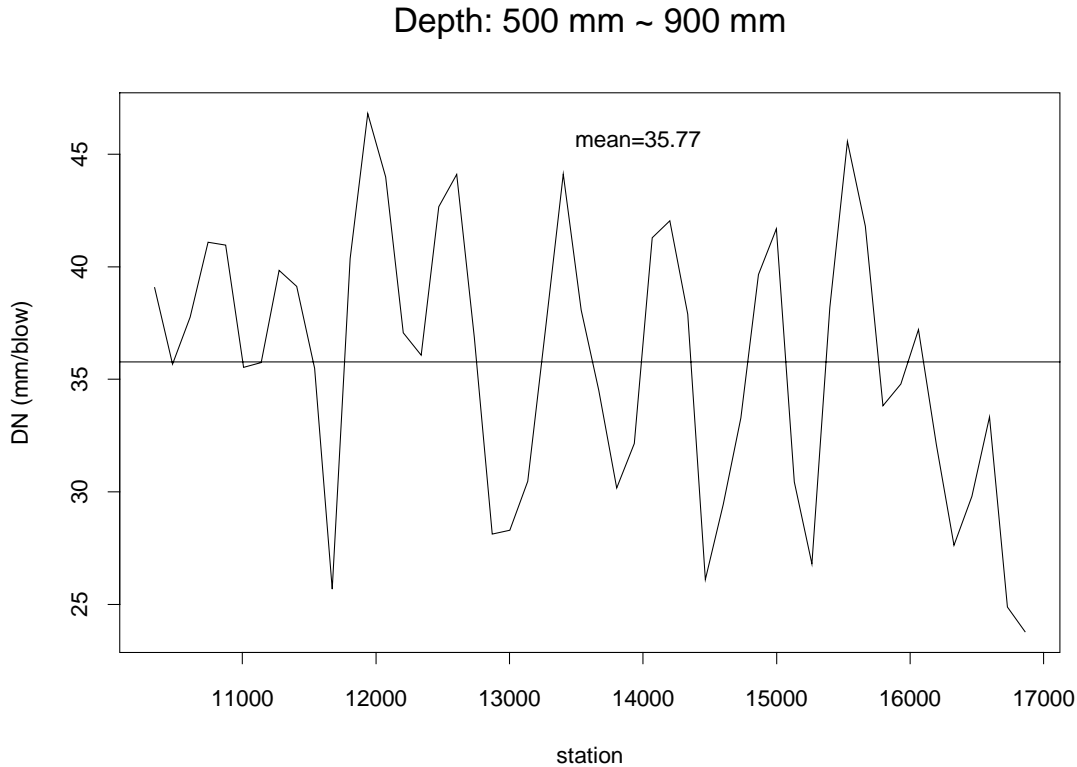
**Figure 12. Layer 2 plot of DN versus Station for State Route 138.**
