Technical Memorandum: UCPRC-TM-2005-07

Report of Field Site Visit District 3, Sacramento Interstate 5, PM 17.2-17.9 RAC-O Overlay

Work Conducted Under Partnered Pavement Research Contract

Strategic Plan Task 4.16: Investigation of Improved Open-graded Mix Designs including Quiet

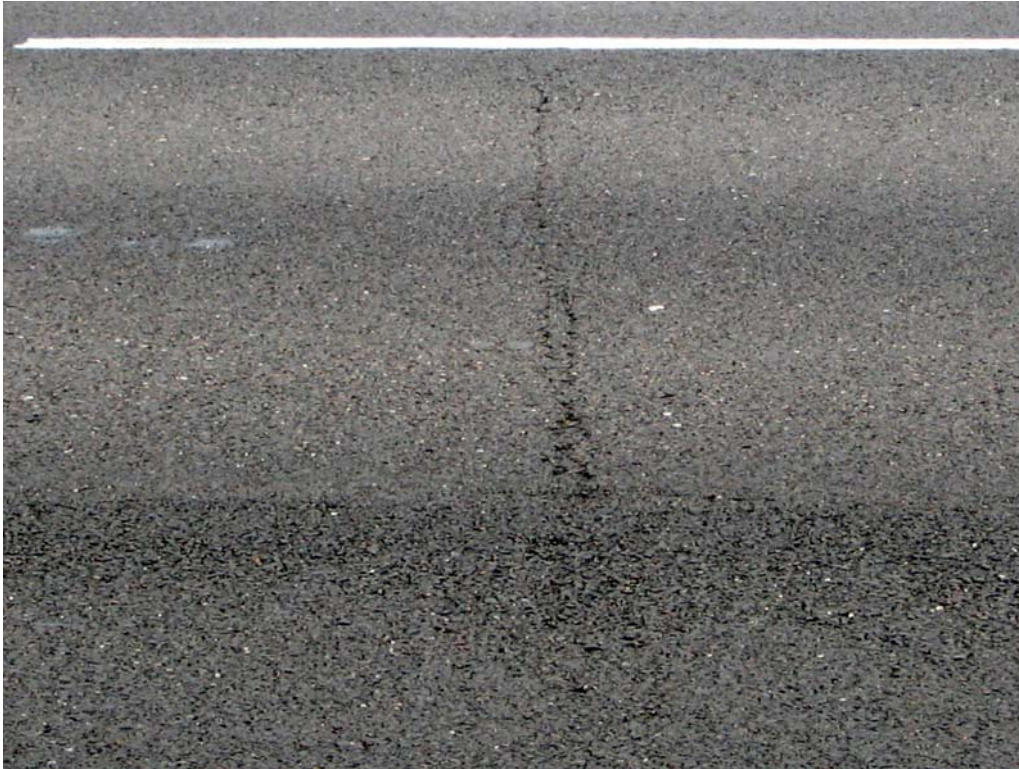
Reflection cracking was evident in the outside lanes on the south end of the southbound direction. The cracking was less frequent in the northern portion. Figures 5 and 6 show examples of the reflection cracking between Station 51+00 and Station 52+00.

Figure 5. Reflection cracking between Station 51+00 and Station 52+00(southbound lanes).

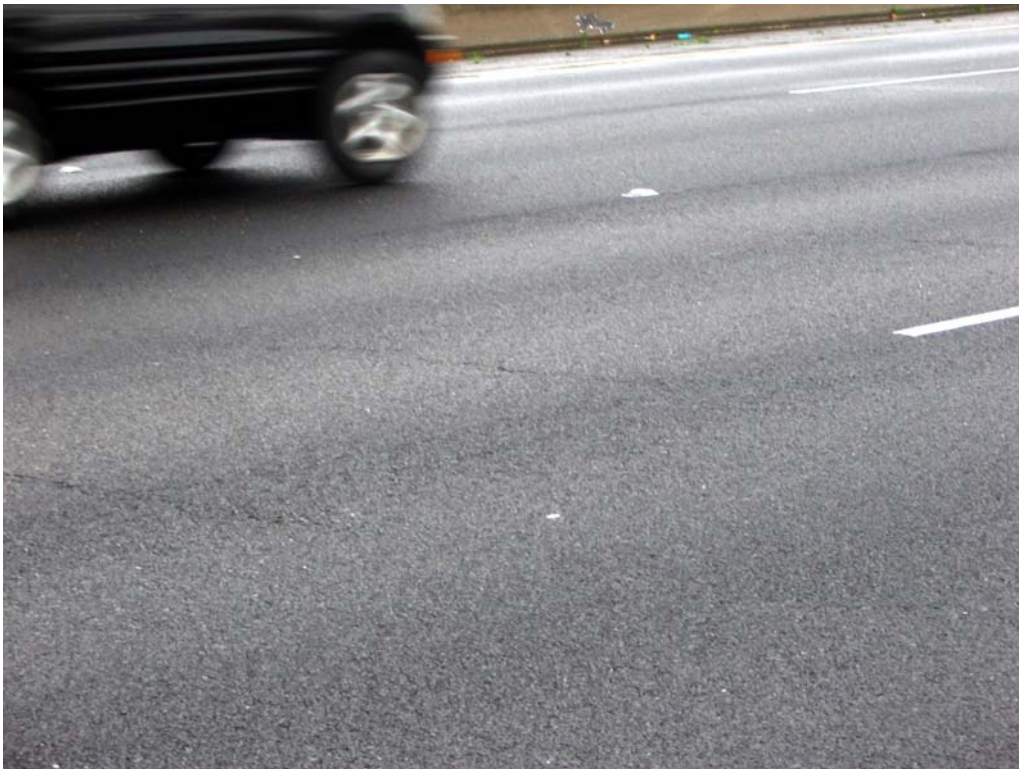
Figure 6. Reflection cracking between Station 51+00 and Station 52+00 (southbound lanes).

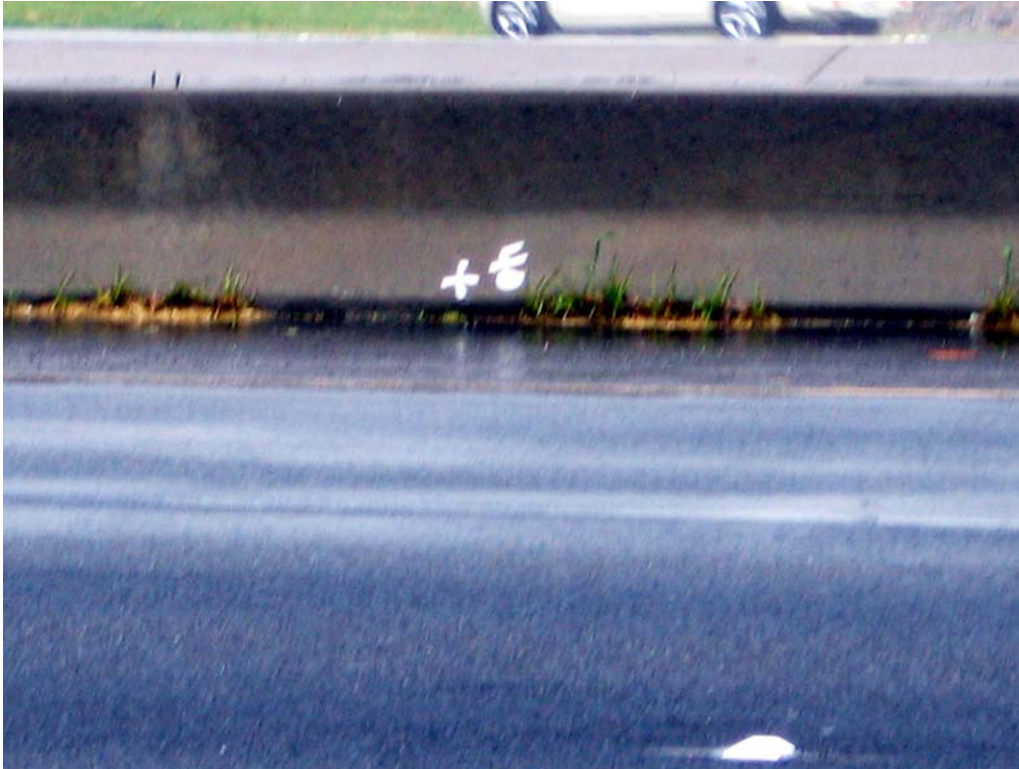
Ponding was present in the same locations as the reflection cracking. Water flowed easterly (from outside to inside lanes) on the southern portion of the project as shown in Figure 2. Moving northward against traffic in the southbound lane, the section climbs a mild hill, and then descends and the super-elevation reverses in the middle of the section, with water in the northern part of the southbound direction flowing westerly (from inside to outside lanes). Figures

Figure 7 . Ponding at Station 50+40 (inside lanes, southbound).

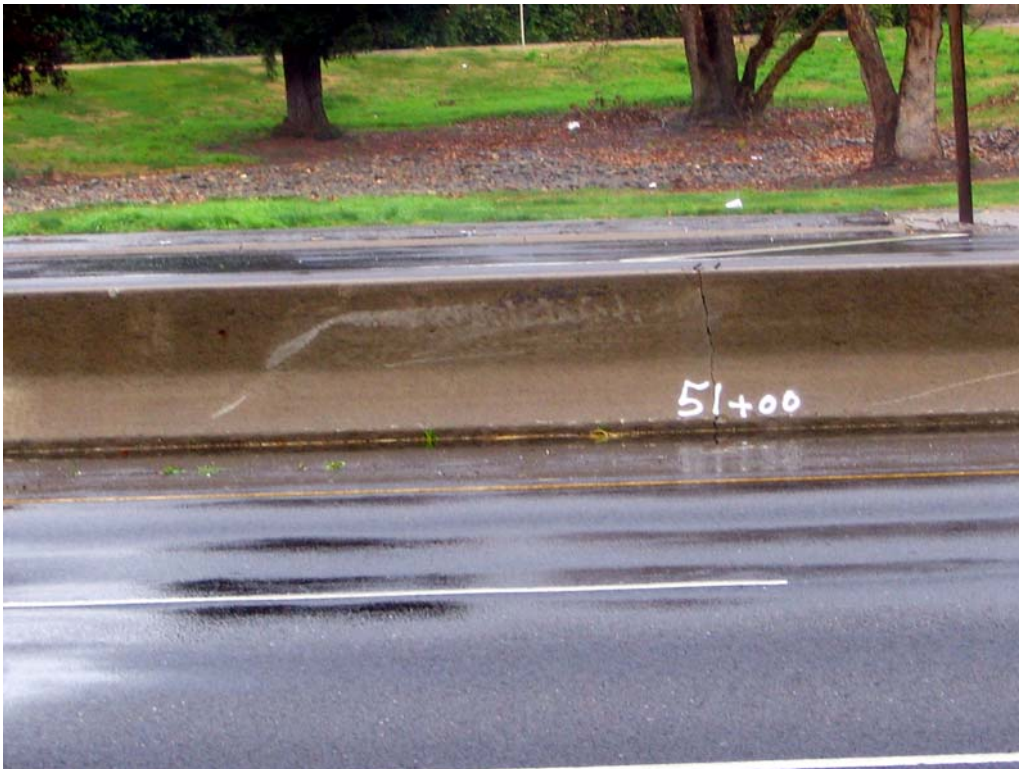
Figure 8. Ponding at Station 51+00 (inside lanes, southbound).

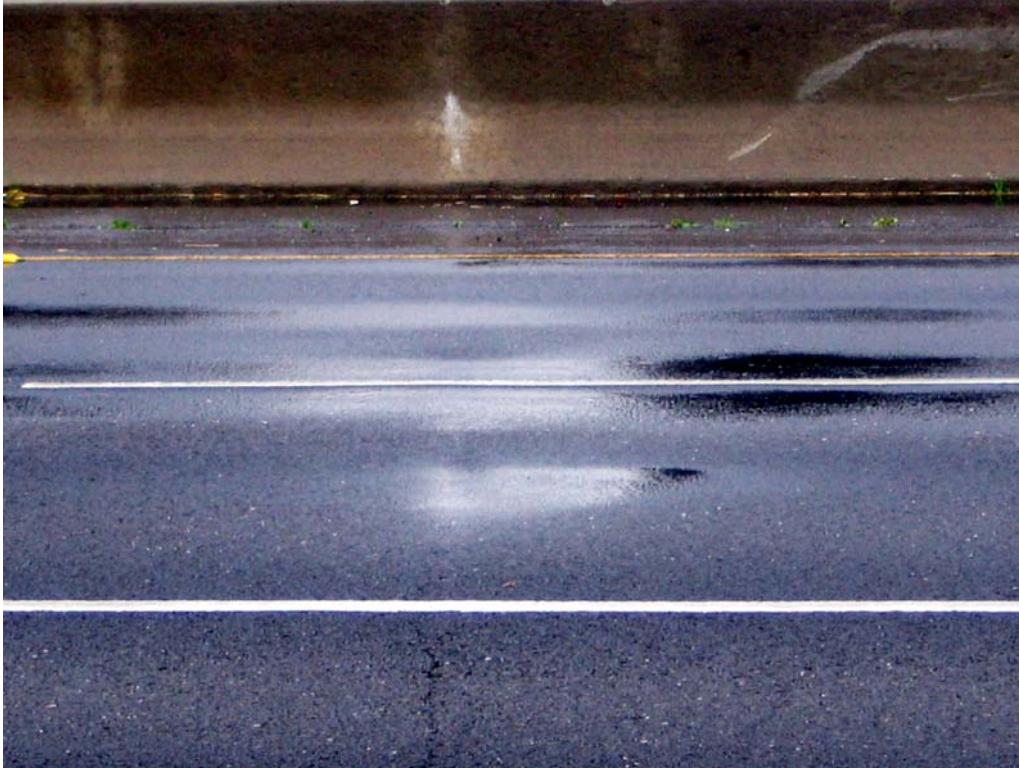
Figure 9. Ponding between Station 51+00 and Station 51+60 (inside lanes, southbound).

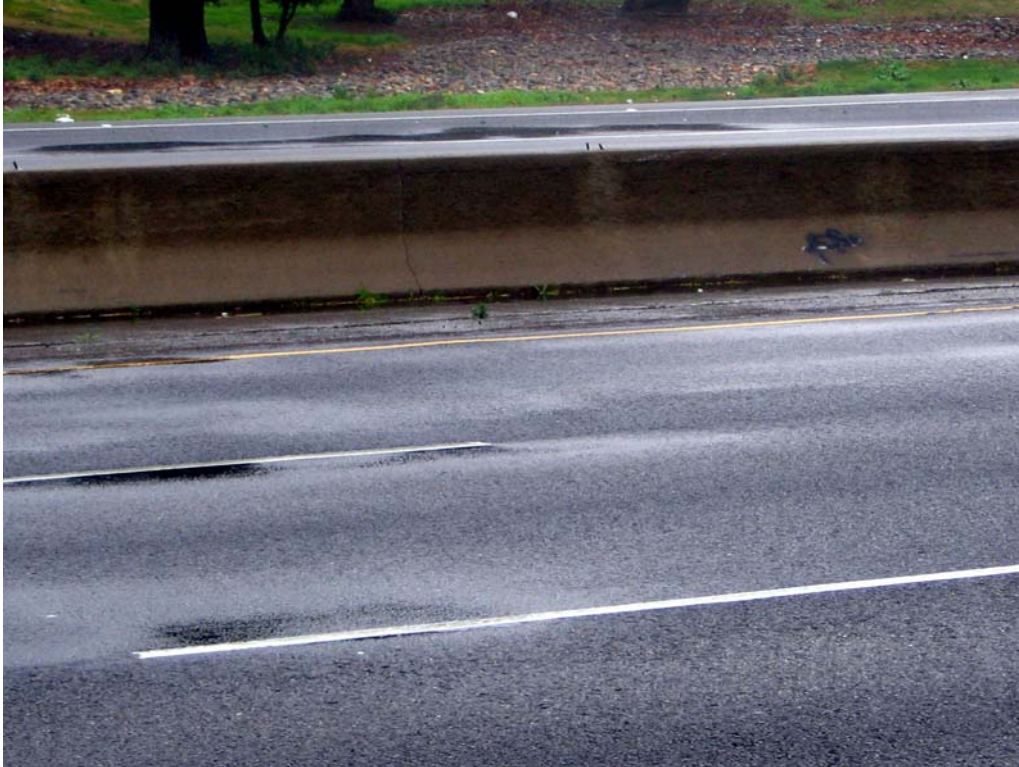
Figure 10. Ponding between Station 51+00 and Station 51+60 (inside lanes, southbound).

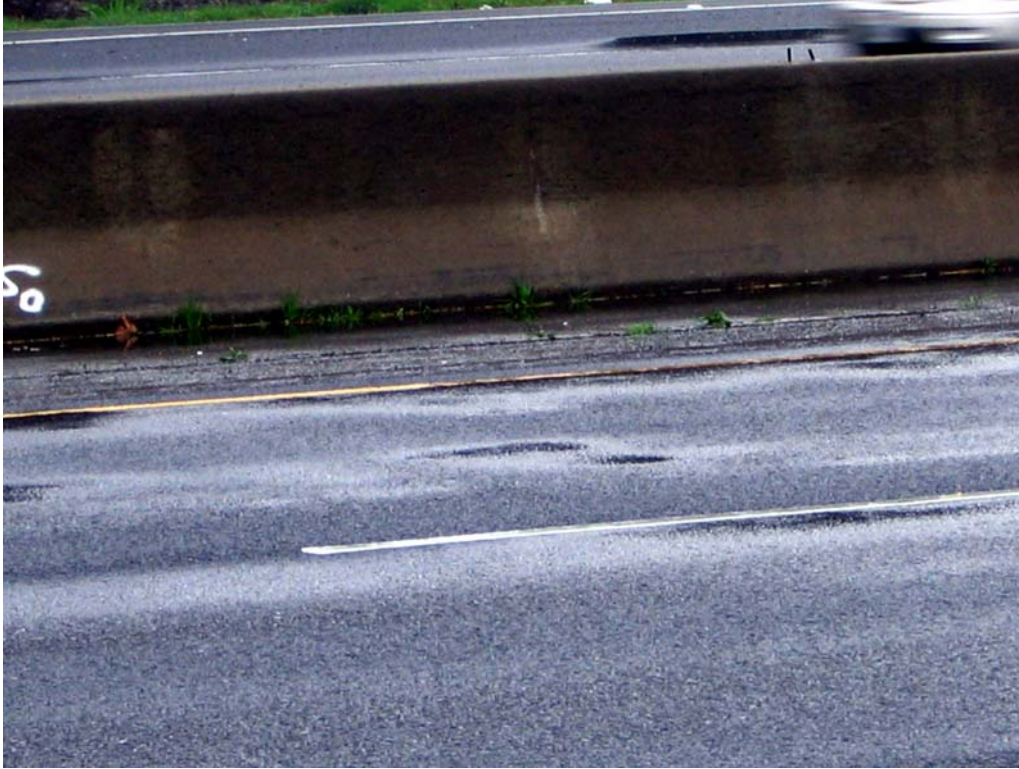
Figure 11. Ponding at Station 51+60 (inside lanes, southbound).

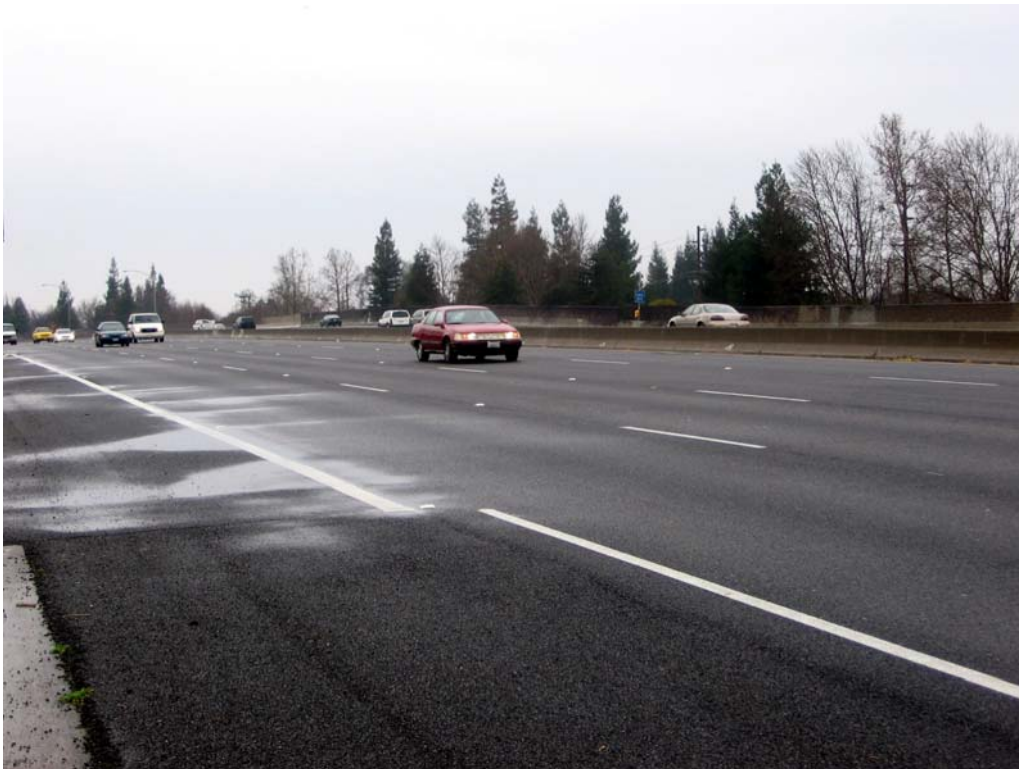
Figure 12. Ponding looking north from Station 55+00 (outside lanes, southbound).

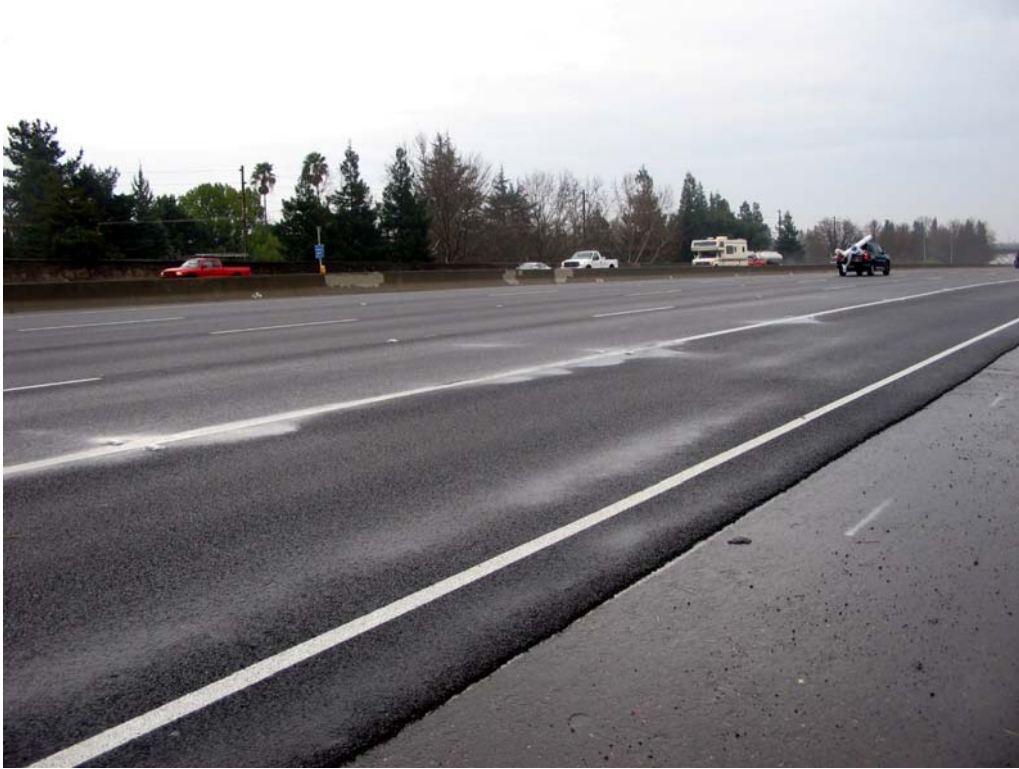
Polishing and mild rutting were observed in the truck lanes. Figure 13 shows the polishing and mild rutting on the outer lane of the southbound direction.

Figure 13. Polishing and mild rutting near Station 54+50 (outside lanes, southbound).

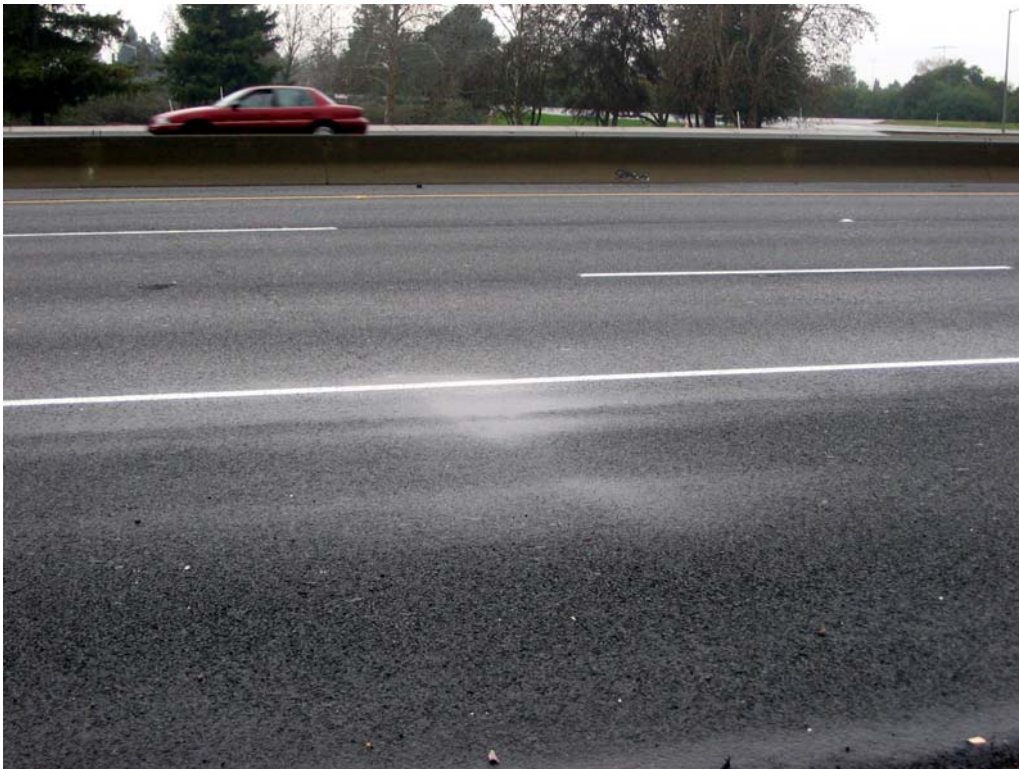
As in the southbound direction, reflection cracking was evident in the outside lanes on the south end of the northbound direction and were less frequent in the northern portion. Also, pumping of fines was evident at some transverse joints in the south end of the northbound direction. Figure 14 shows the reflection cracking while Figures 15 and 16 show reflection cracking and pumping of fines.

Figure 14. Reflection cracking between Station 51+00 and 52+00 (northbound lanes).

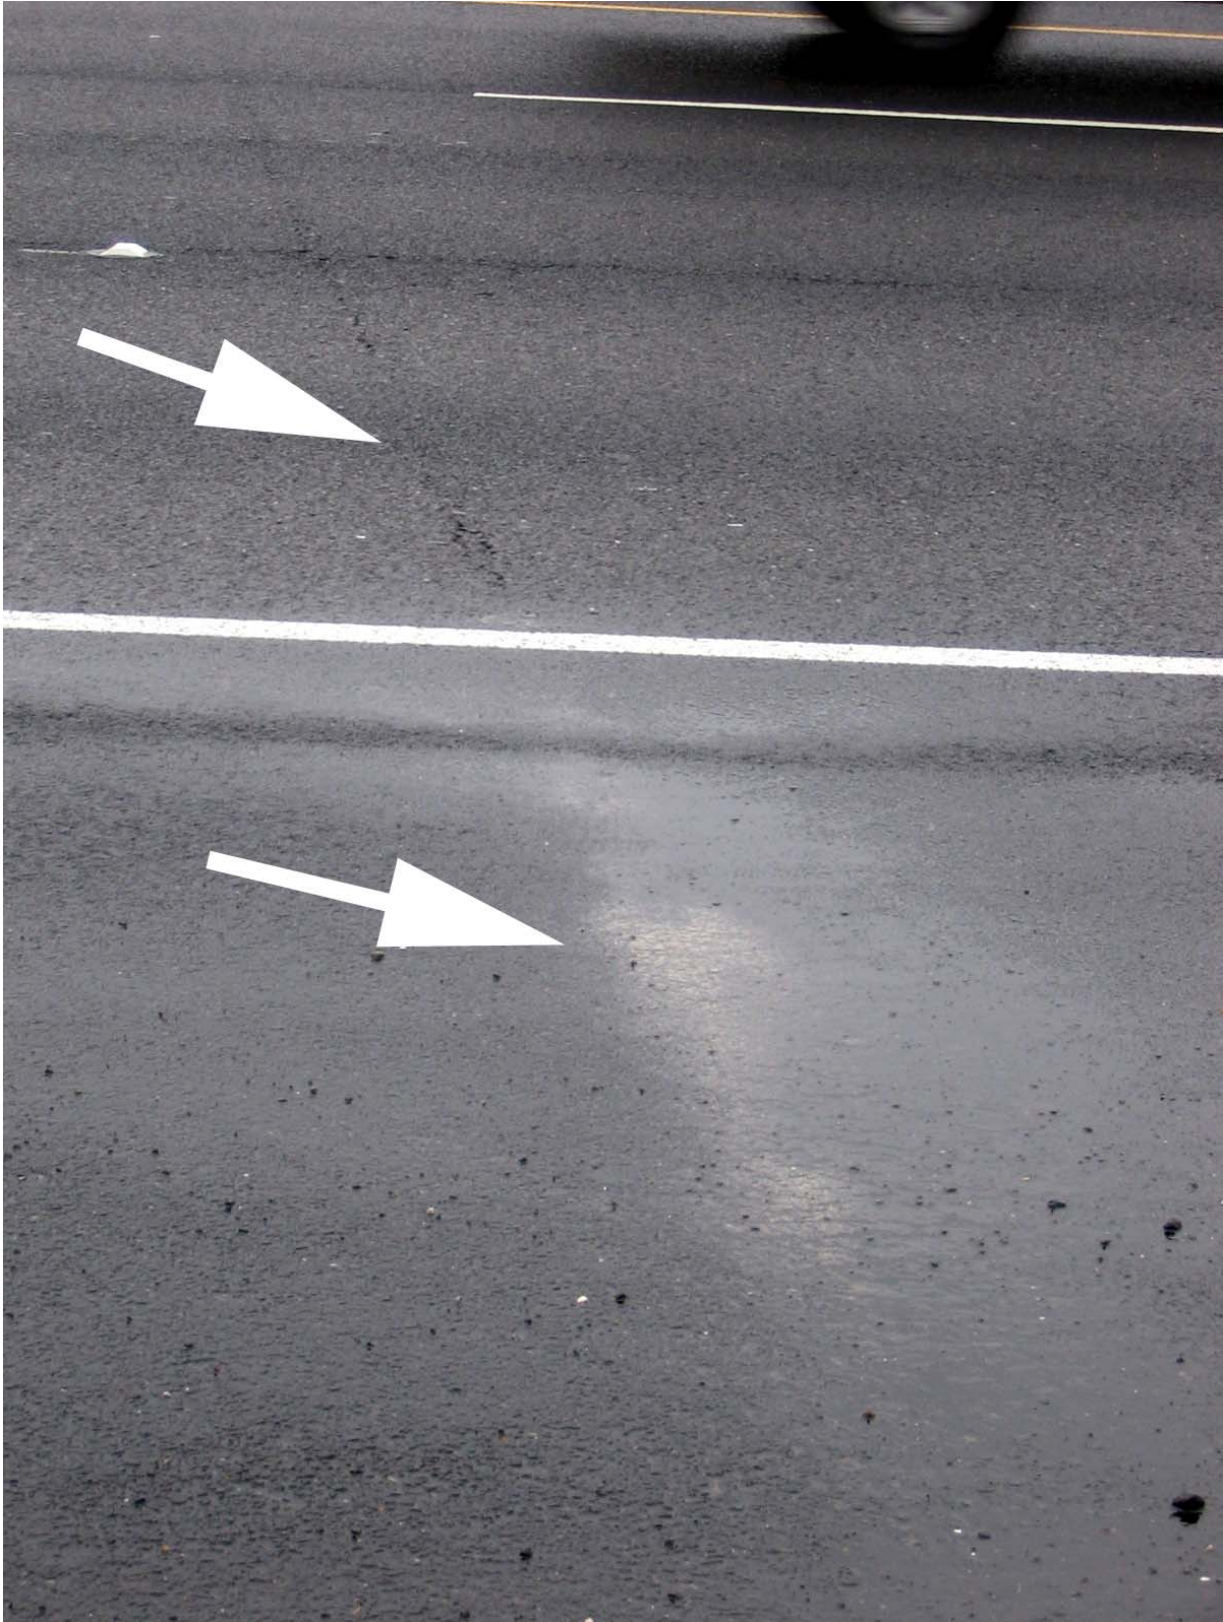
Figure 15. Reflection cracking and pumping of fines between Station 52+00 and 53+00 (northbound lanes).

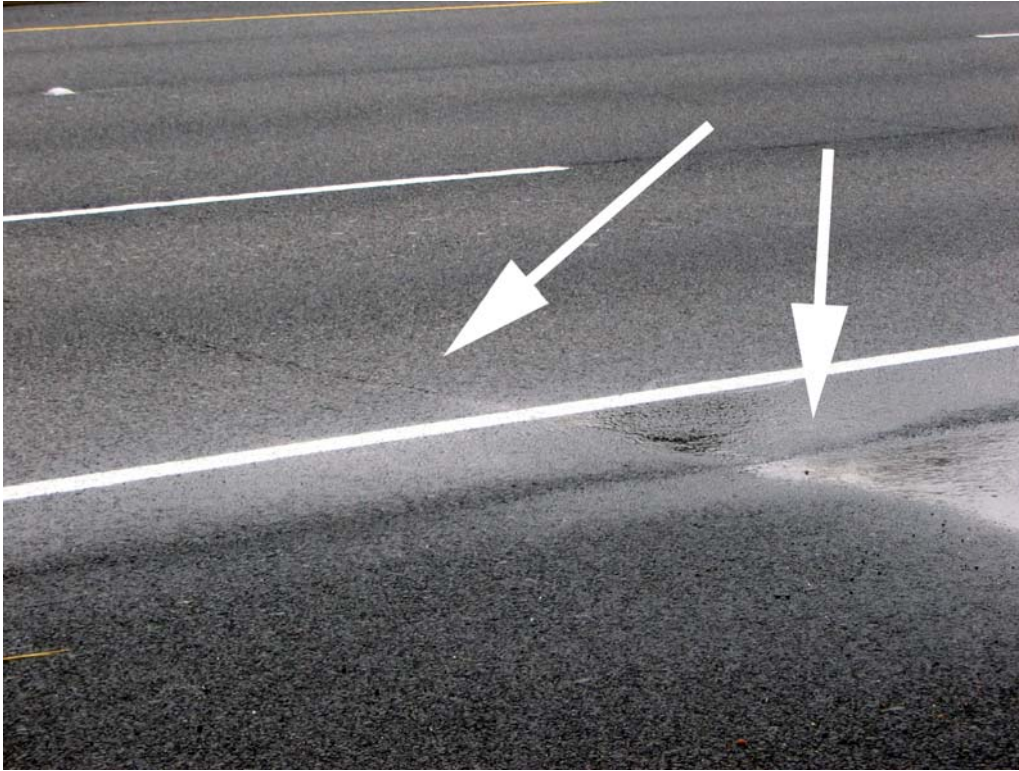
Figure 16. Reflection cracking and pumping of fines between Station 52+00 and 53+00 (northbound lanes).

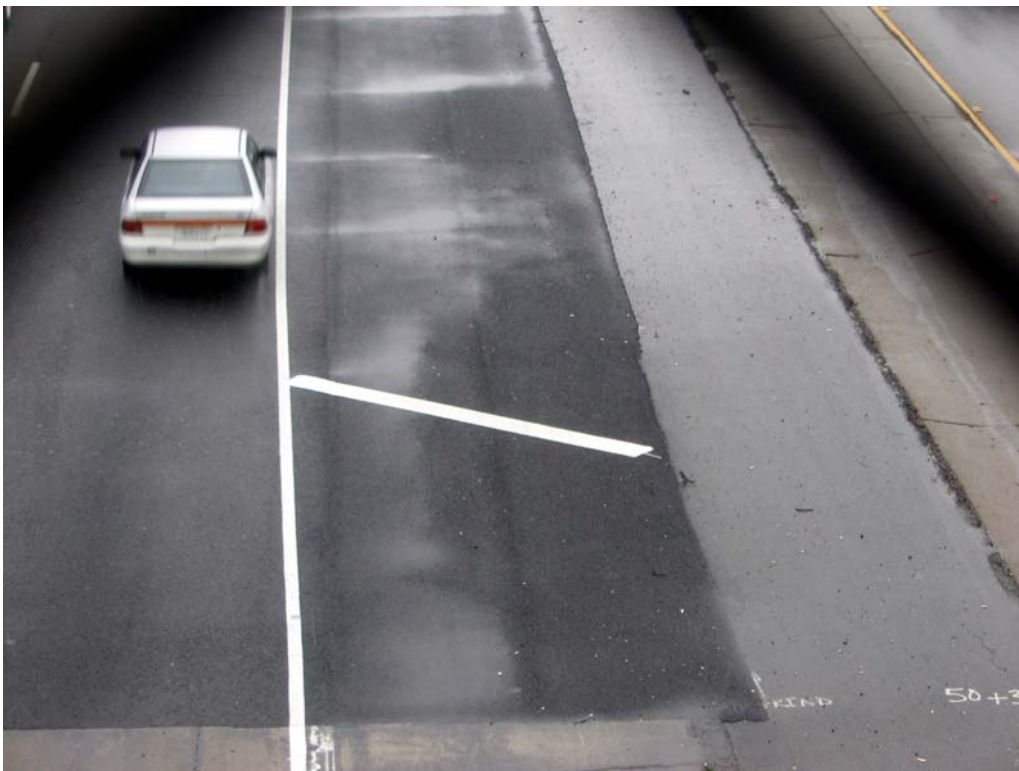
As in the southbound direction, water flow was easterly on the southern portion of the project and westerly on the northern portion of the project. Therefore, in the northbound direction, ponding occurred on the outside lanes at the southern portion and inside lanes in the northern portion. Figures 17 through 21 show the ponds on the northbound direction.

Figure 17. Ponding at Station 50+00 (outside lanes, northbound).

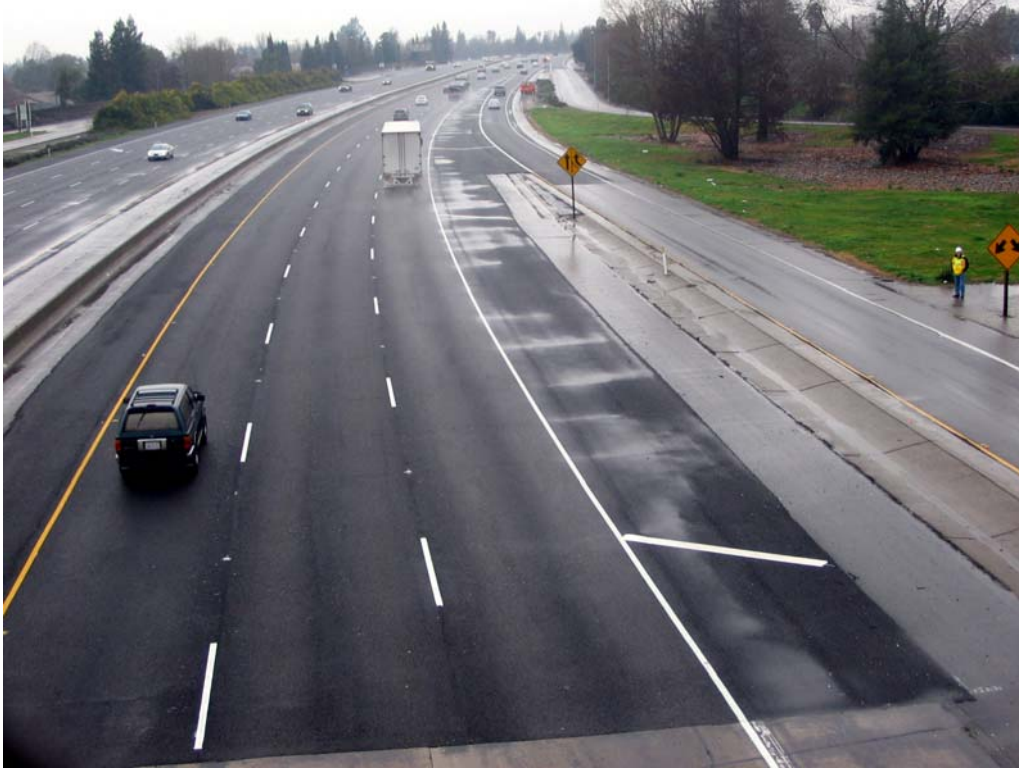
Figure 18. Ponding starting at Station 50+00 (outside lanes, northbound).

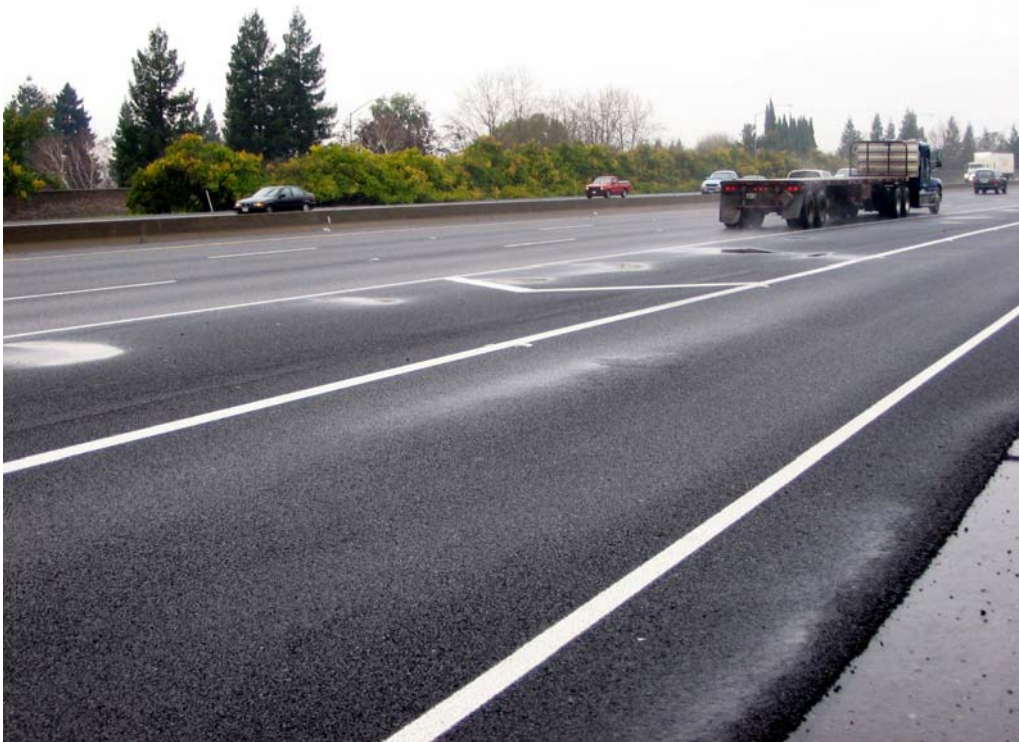
Figure 19. Ponding between Station 53+00 and Station 54+00 (outside lanes, northbound)

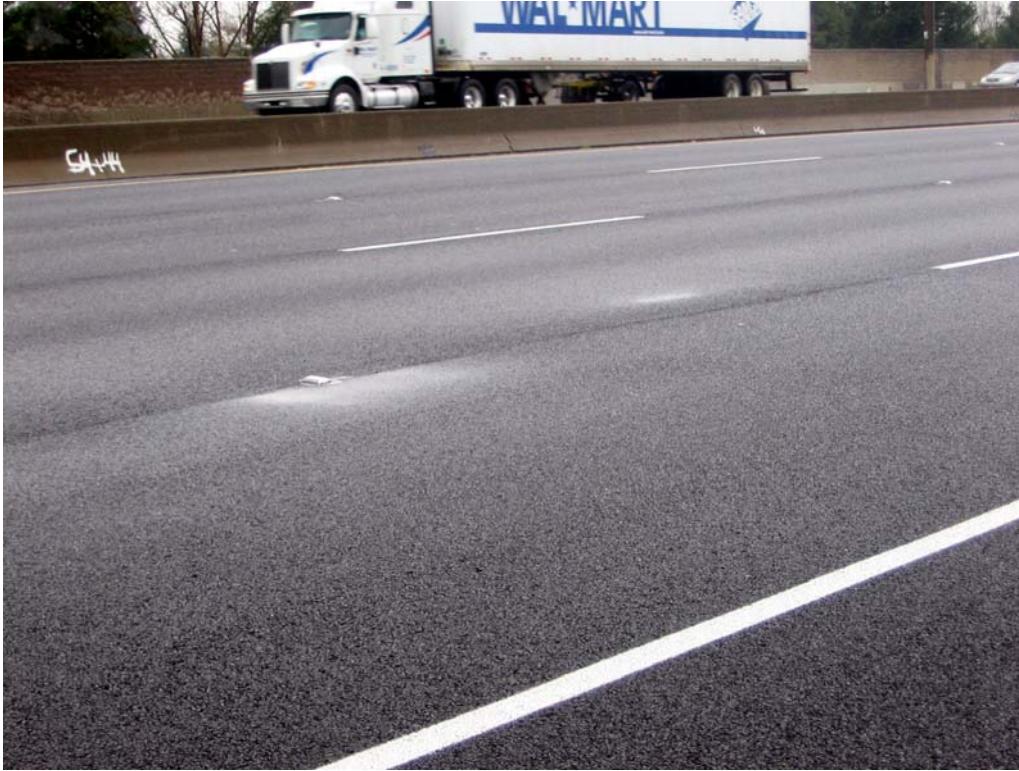
Figure 20. Ponding between at Station 54+44 (inside lanes, northbound).

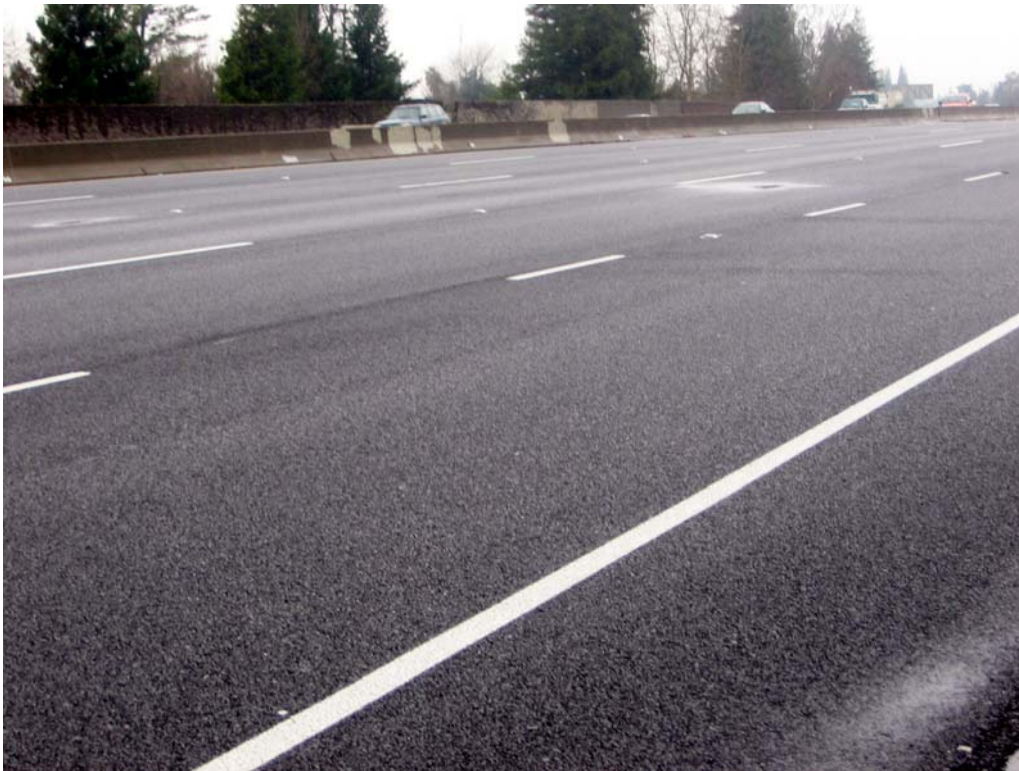
Figure 21. Ponding between between Station 54+00 and 56+00 (inside lanes, northbound).

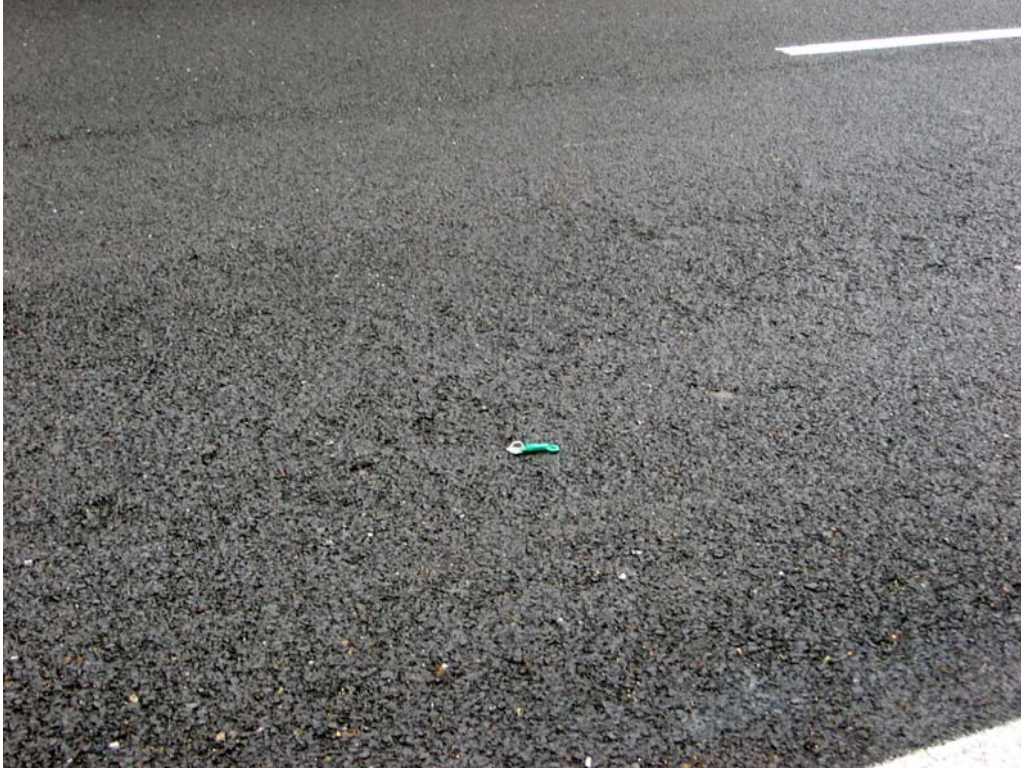
Raveling and a 1-2 inch diameter hole were observed at Station 56+80 on the northbound direction (Figures 22–24).

Figure 22. Raveling at Station 56+80 (northbound direction).

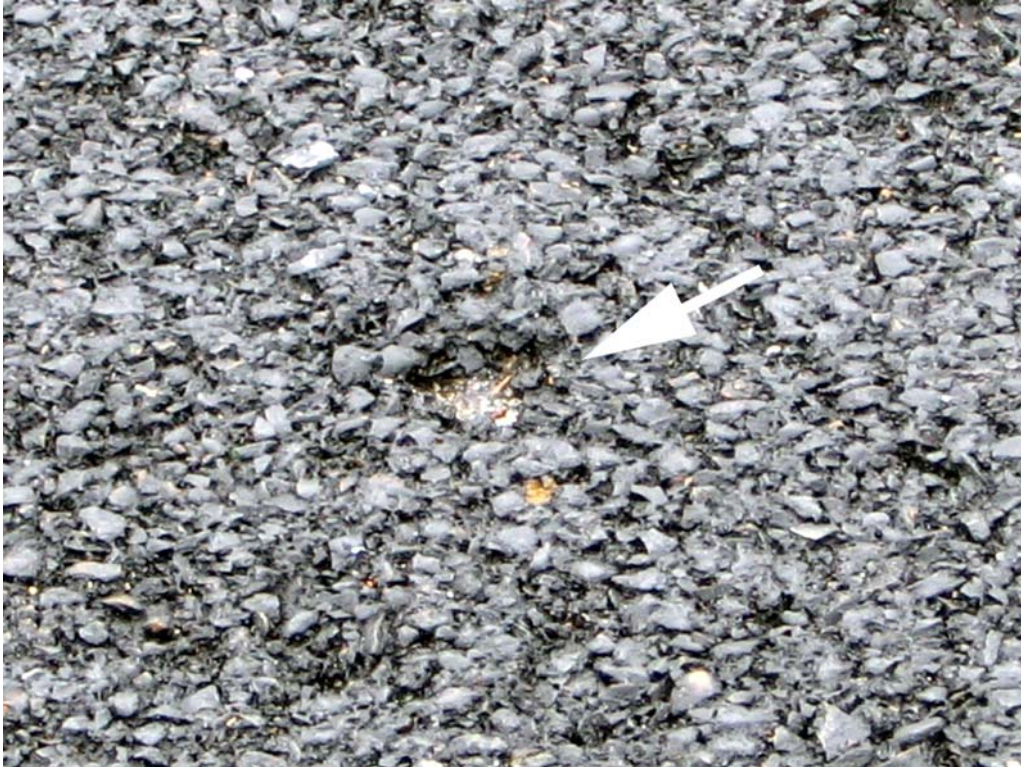
Figure 23. Hole at Station 56+80 (northbound direction).

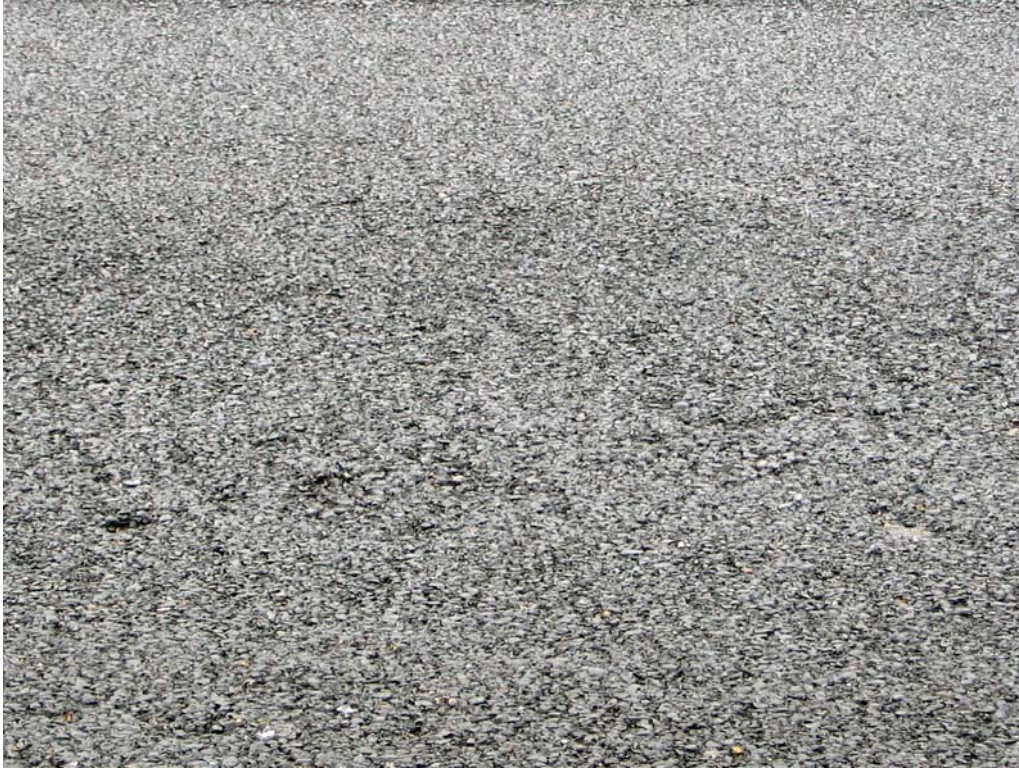
Figure 24. Raveling at Station 56+80 (northbound direction).
