**State Route 138 -Test Site Evaluation
Update of Evaluation Activities in March and October 2002**

Technical Memorandum No. TM-UC-PRC-2003-1

Pavement Research Center
Institute of Transportation Studies
University of California

April 2003

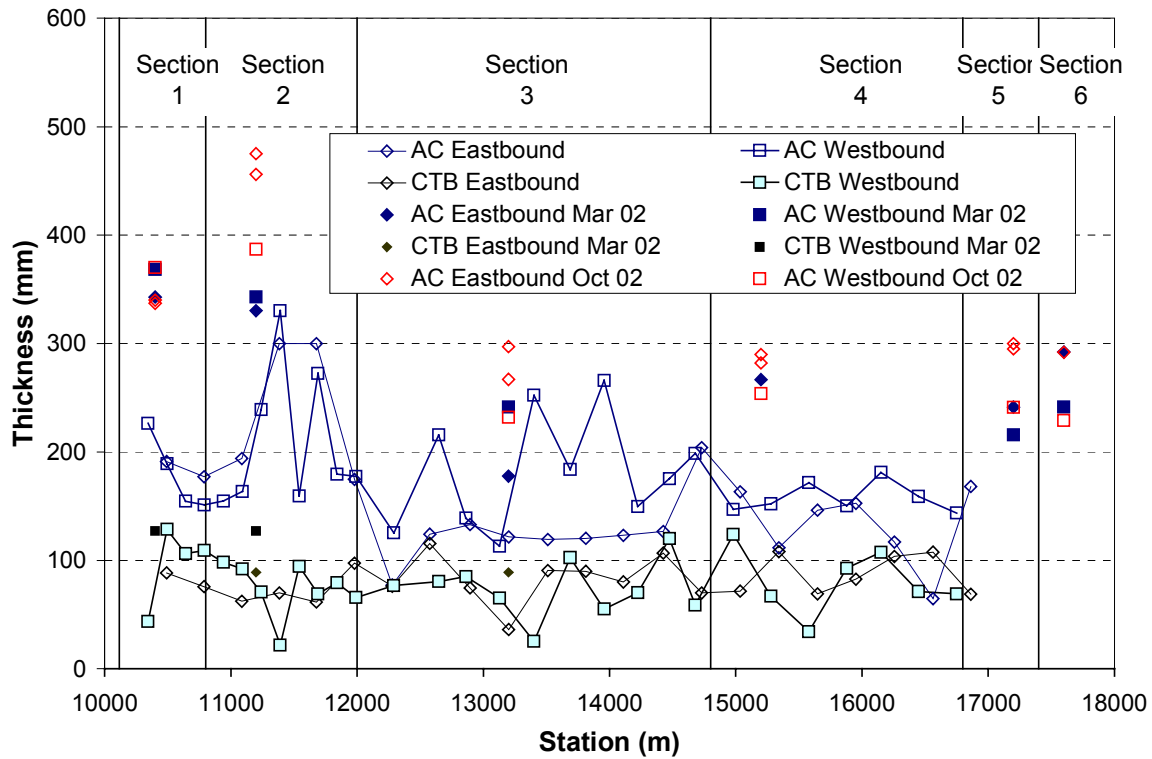
In October 2002, 11 cores were taken in the eastbound lane and 6 in the westbound lane. The total thickness of the asphalt concrete layers is shown in Figure 3, along with the total asphalt thickness from April 2001 and March 2002. The measured thicknesses of the leveling course from these cores is shown in Figure 4; the measured thicknesses of the treatments are shown in Figure 5. The results show that in addition to the highly variable thickness of the original asphalt concrete, the combined thickness of the leveling course and maintenance treatment is highly variable as well.

Figure 3. Coring profile for State Route 138 (March 2001, March 2002, and October, 2002 combined).

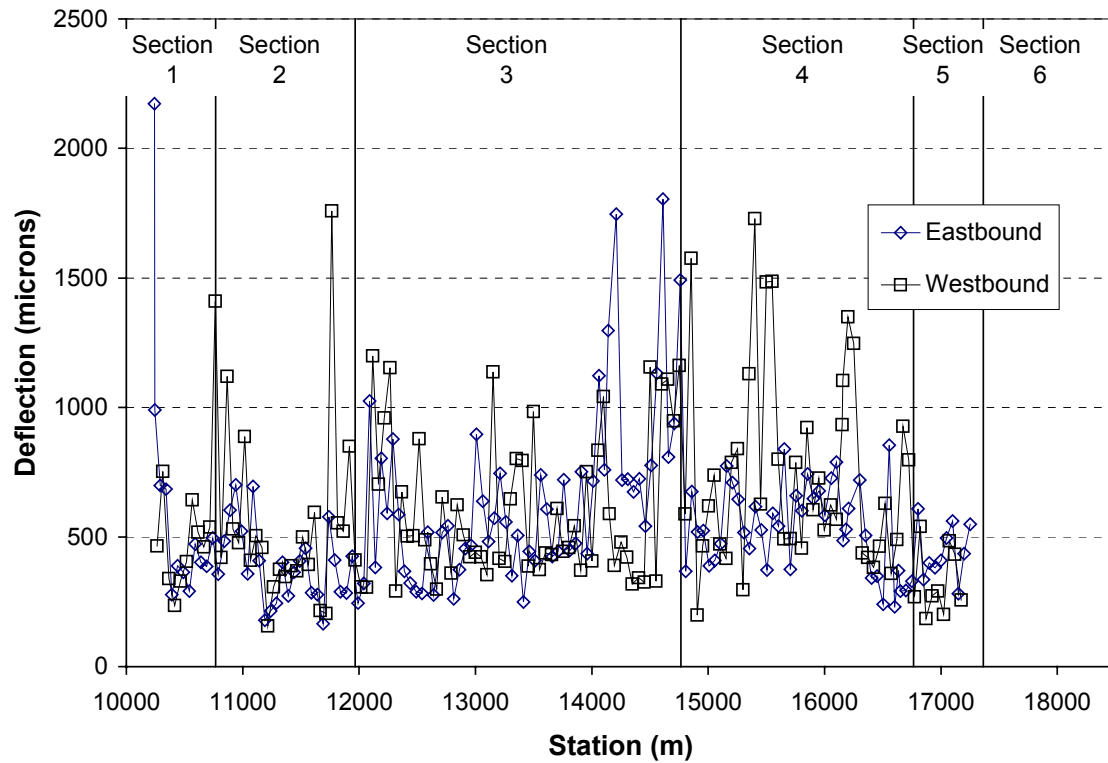
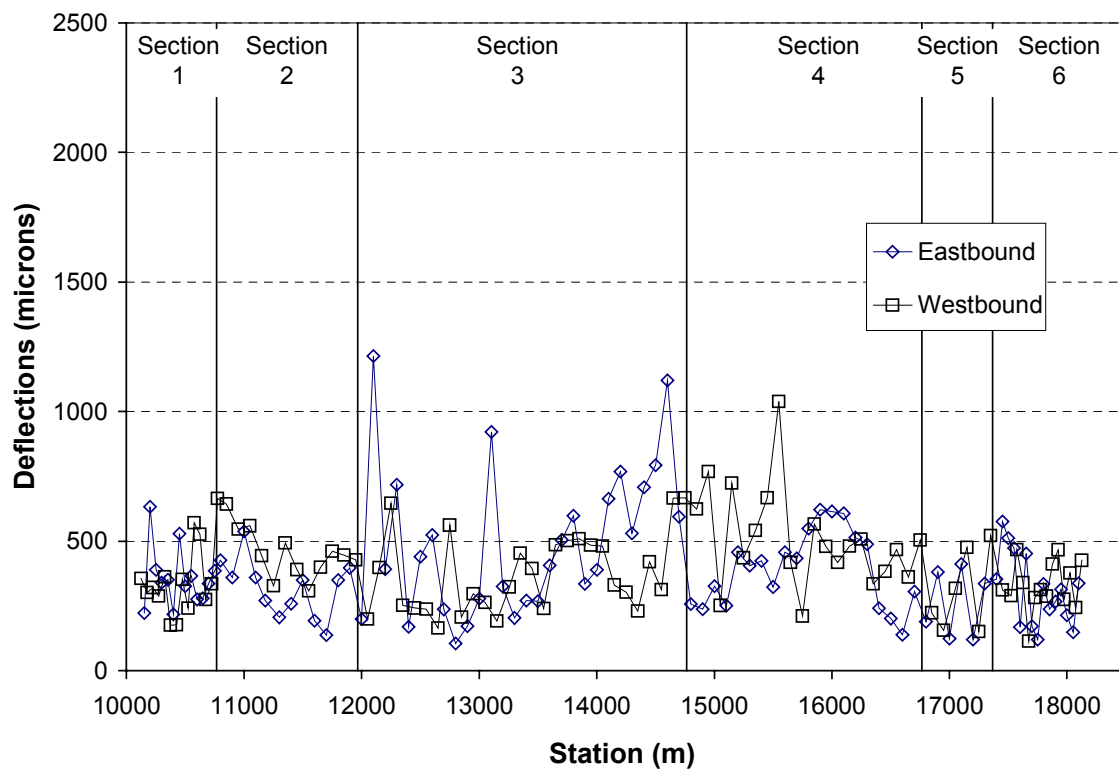
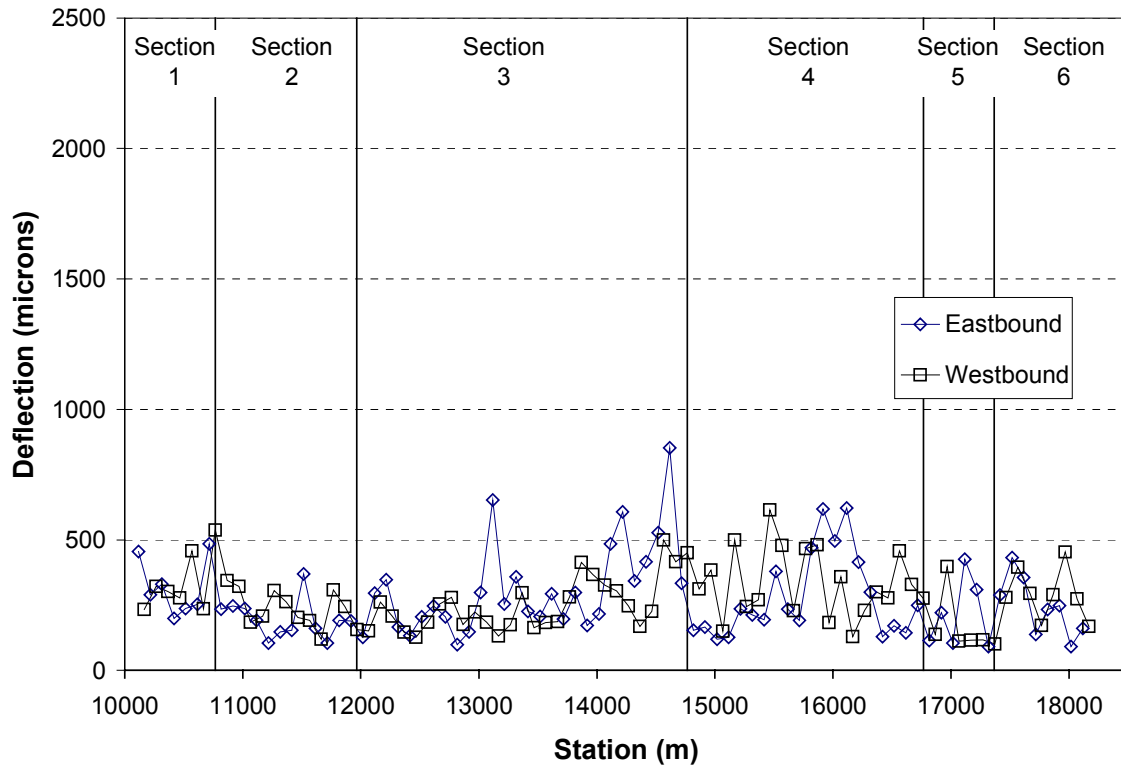
The measured deflections during 2002 are generally lower than those measured in 2001, as would be expected. Table 7 shows a comparison of the normalized center deflections for 2001 and 2002. Section 6 was not tested in 2001. Section 1 shows the most improvement, which is probably due to the significant difference between the AC overlay thicknesses of 2002. Variability in the deflections is generally similar or slightly less in 2002 than the variability in 2001, which is consistent with the placement of a thin overlay. The change in testing interval length may have had an effect on variability.

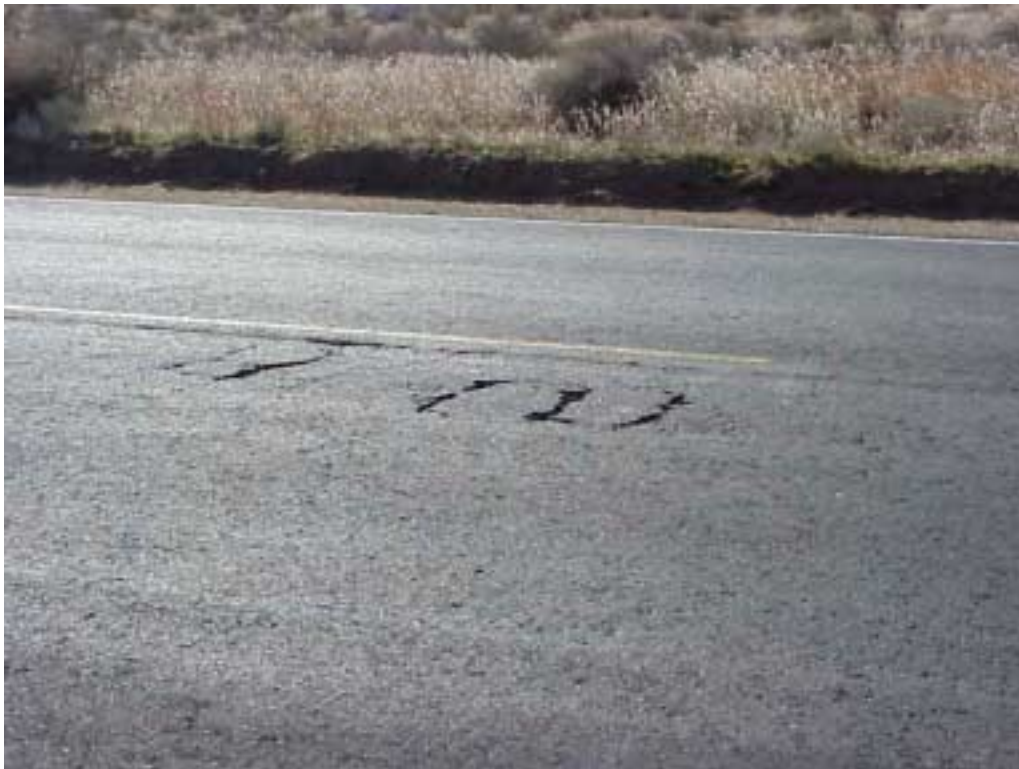
Photographs from March 2002 taken just after the overlay show that some of the distresses had already reflected up through the overlay (see Appendix B). In some of the photographs, the cracks are faintly visible in the overlay. In other areas, the areas of severe cracking to the point of loose pieces in the wheelpaths had caused the overlay to spall. The photographs also show some apparent segregation, which appears as longitudinal areas that have ravelled, and areas that appear to be over-asphalted.

Figure B2. Area of localized reflection of wheelpath fatigue cracks through levelling course overlay.

Many of these problems were noted and some additional repairs were made by the contractor prior to placement of the maintenance treatments.

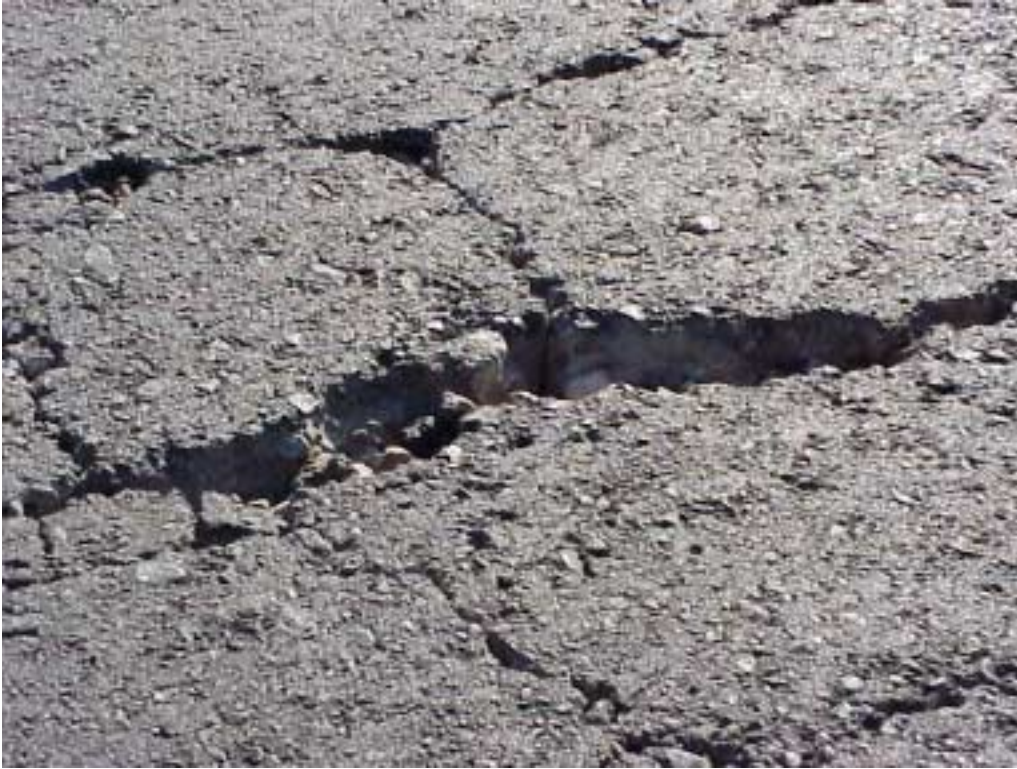
Figure B3. Close-up of localized reflection cracking showing thickness of DGAC layer.

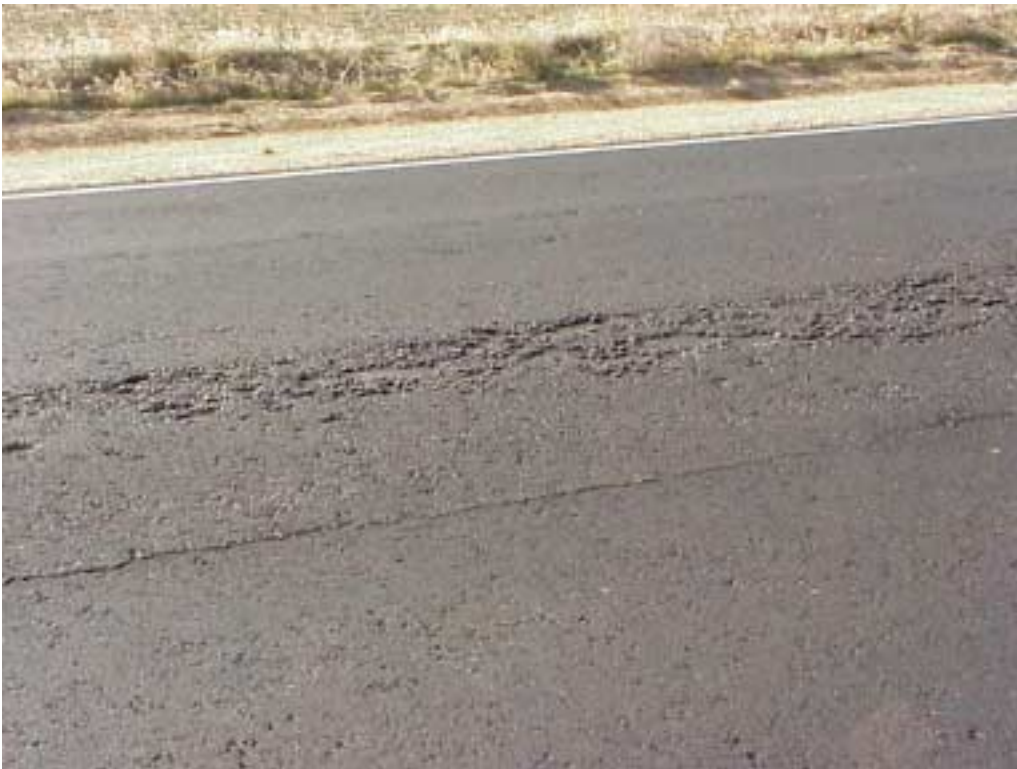
Figure B4. Area of segregation in levelling up course DGAC.

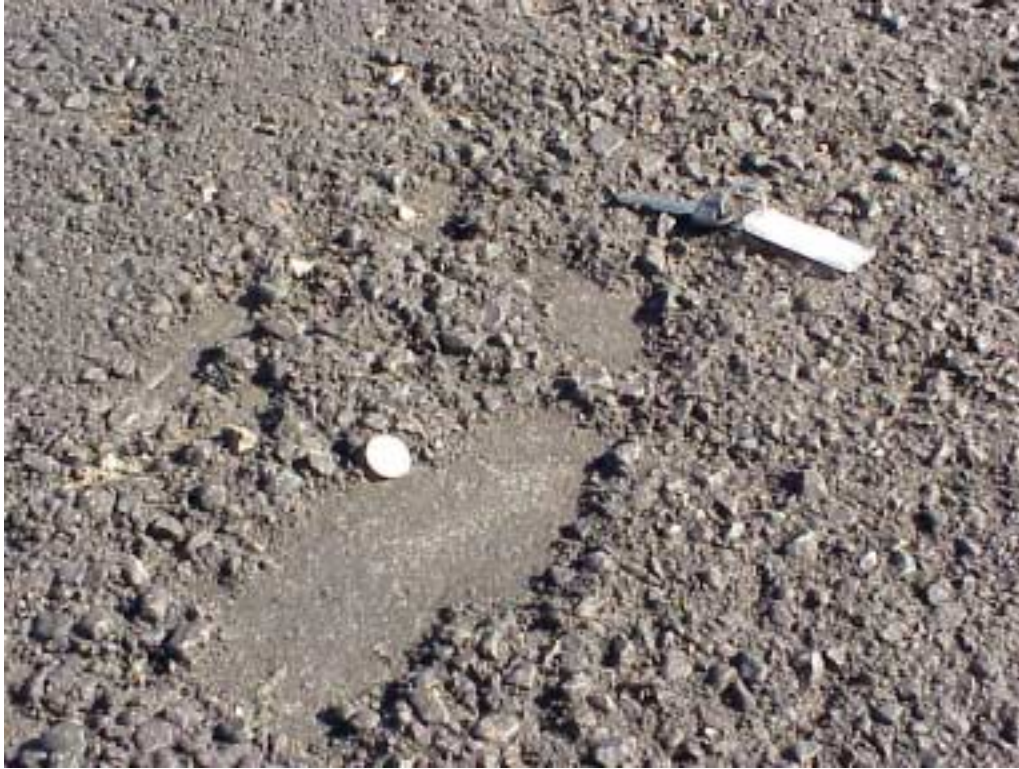
Figure B5. Close-up of segregated and ravelled area in levelling course DGAC.

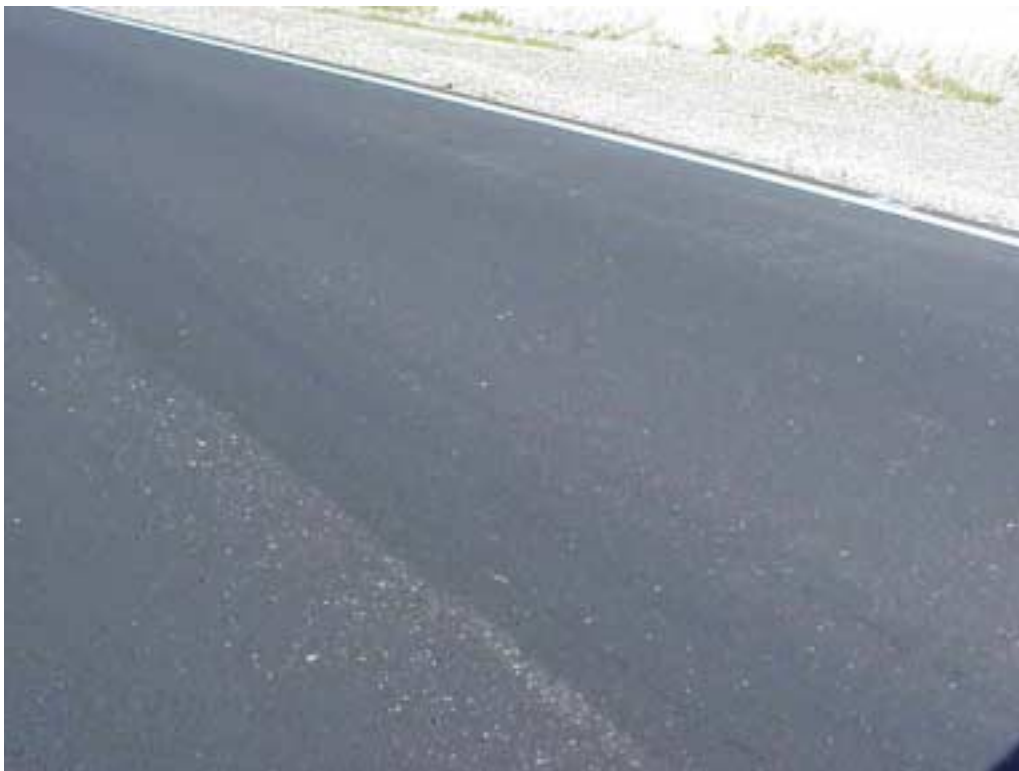
Figure B6. Area of segregation showing high and low oil contents in levelling course DGAC.

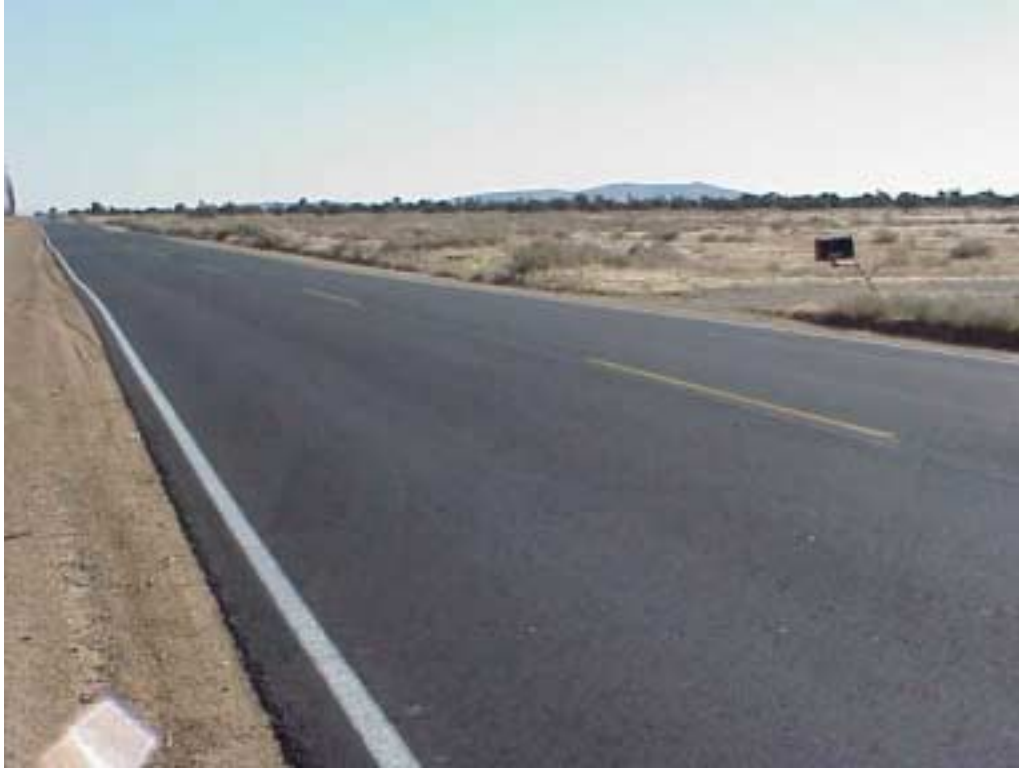
Figure B7. Area of good appearance of levelling course DGAC.

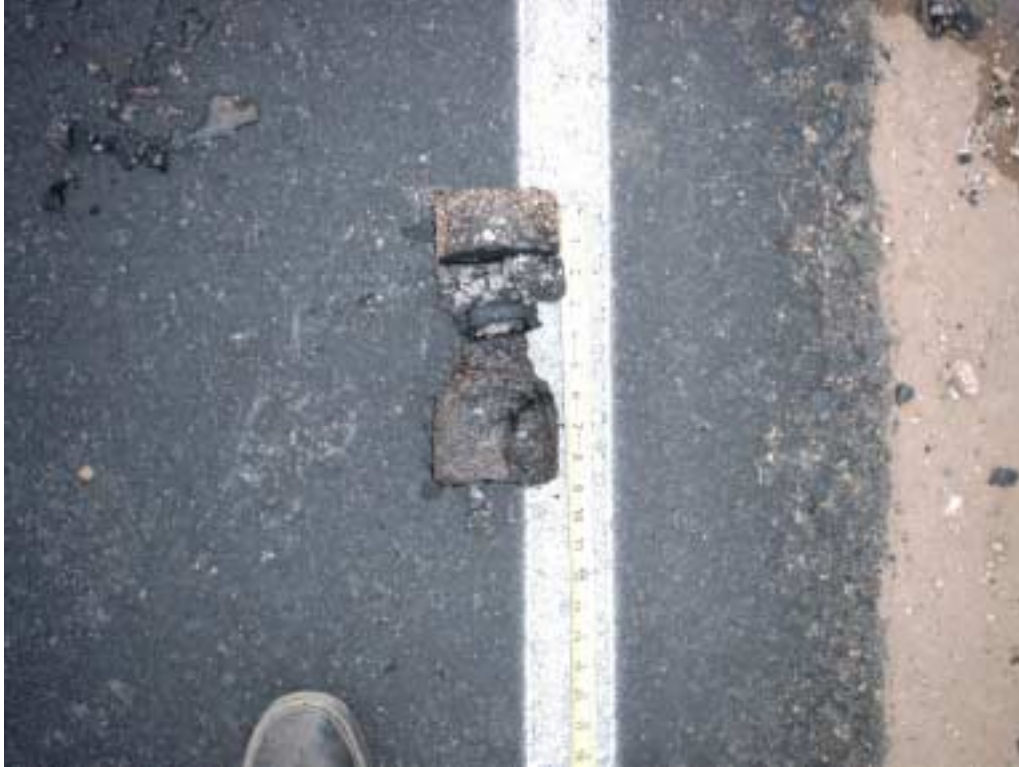
Figure C11. Core from westbound lane at station 152+00, showing evidence of stripping in middle AC layers.
