Warm-Mix Asphalt Study: Field Test Performance Evaluation

Author:
D. Jones

DOCUMENT RETRIEVAL PAGE		Technical Memorandum: UCPRC-TM-2013-08			
Title: Warm-Mix Asphalt Study: Field Test Performance Evaluation					
Authors: D. Jones					
Technical Leads: T. Joe Holland (Caltrans) and Nathan Gauff (CalRecycle)					
Prepared for: Caltrans and CalRecycle		FHWA No.: CA142385D	Work submitted: 04/05/2014		Date December 2013
Strategic Plan Element No: 4.18		Status: Final		Version No.: 1	
Abstract:					
<p>A number of warm-mix asphalt test sections were constructed in California between 2007 and 2010 to assess long-term performance under selected traffic and climate conditions. A range of pavement designs were assessed, but the six projects evaluated in this report focused on open-graded friction courses with polymer-modified (PG 58-34) and rubber-modified (PG 64-16) binders (three projects each). The main purpose of these experiments was to monitor performance under actual conditions and to quantify any benefits associated with using warm-mix asphalt under specific situations, such as with long hauls, in cool and/or damp conditions, under trafficking by large agricultural equipment, etc. F

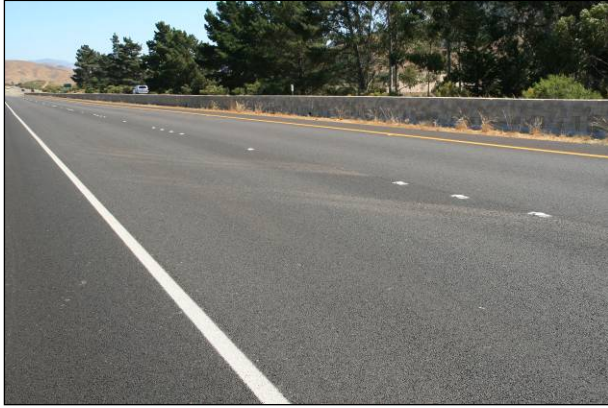
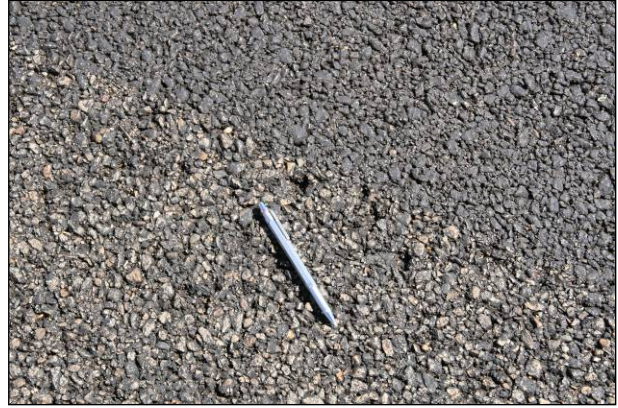
All sections resembled a typical open-graded friction course and were given an overall rating of “good.” However, evidence of trucks tracking tack coat onto the adjacent newly placed surfacing was observed in certain areas on each test section. No other problems were observed. No early stone loss was noted.

Figure 3.2: Morro Bay Control, May 2007 (0 months), track marks.

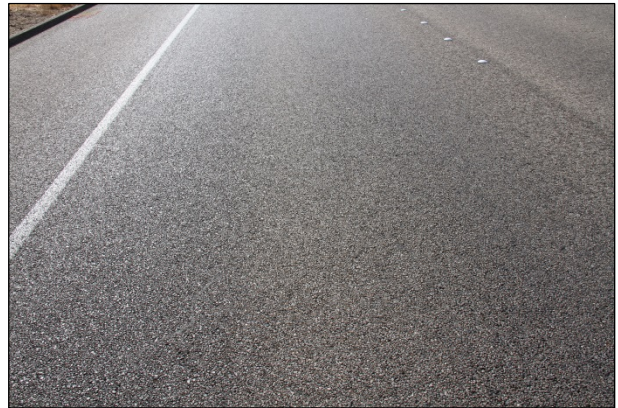
No deterioration compared to the May 2007 baseline measurements was noted on the sections after 60 months of traffic. The track marks were no longer visible on any of the sections.

Figure 3.3: Morro Bay Control, May 2012 (60 months), track marks no longer visible.

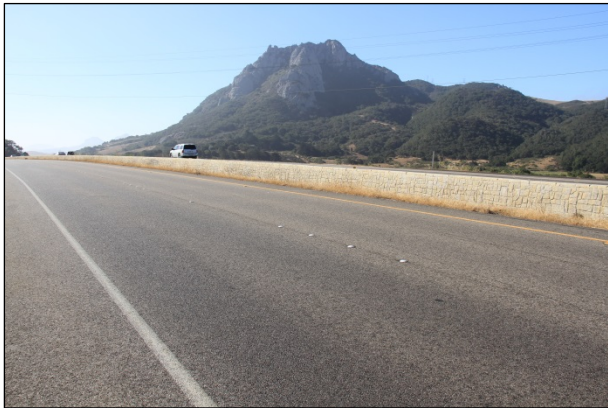
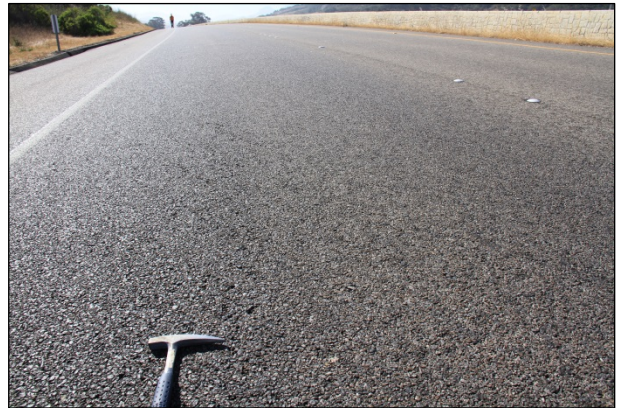
Figure 3.6: Morro Bay Advera, May 2012 (60 months), track marks no longer visible.

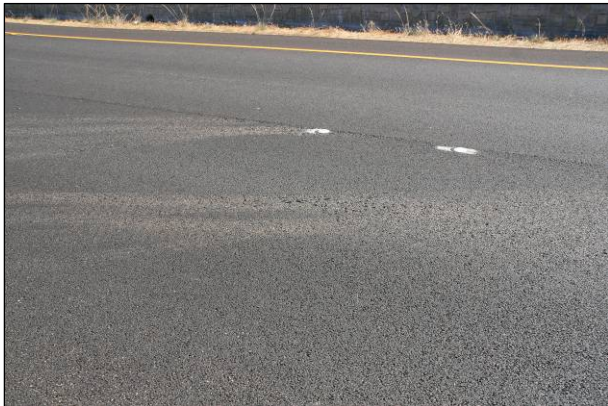
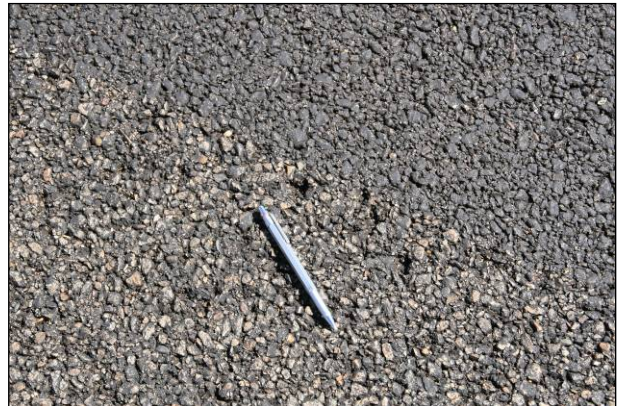
Figure 3.9: Morro Bay Evotherm, May 2007 (0 months), track marks.

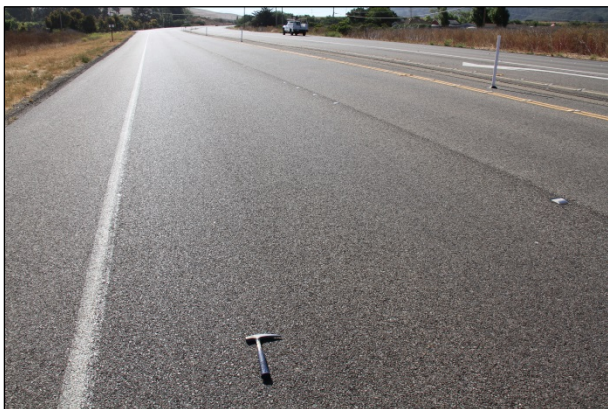
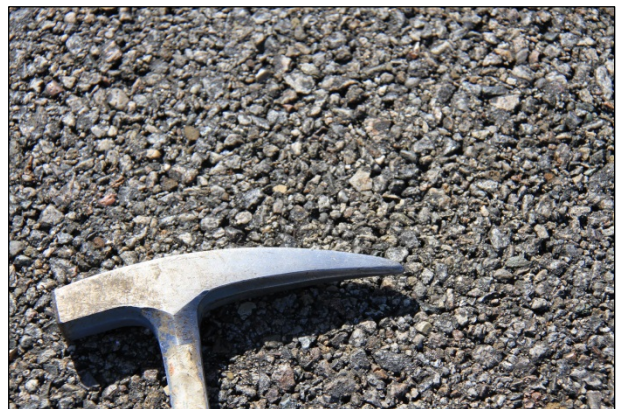
Figure 3.10: Morro Bay Evotherm, May 2012 (60 months), track marks no longer visible.

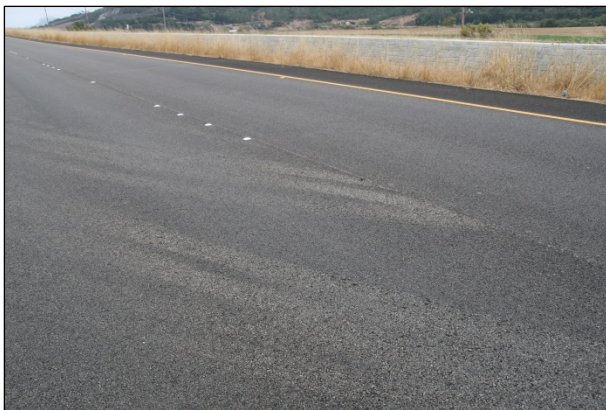
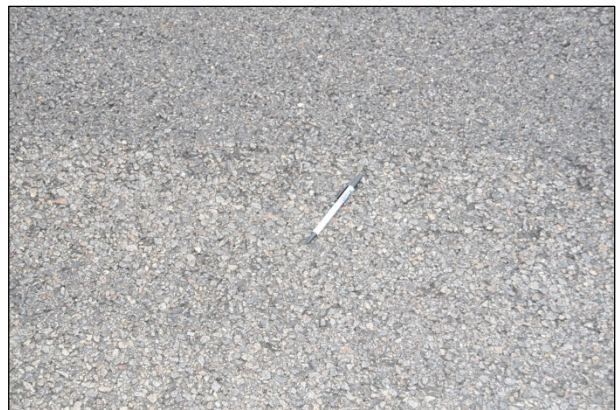
Figure 3.13: Morro Bay Sasobit, May 2007 (0 months), track marks.

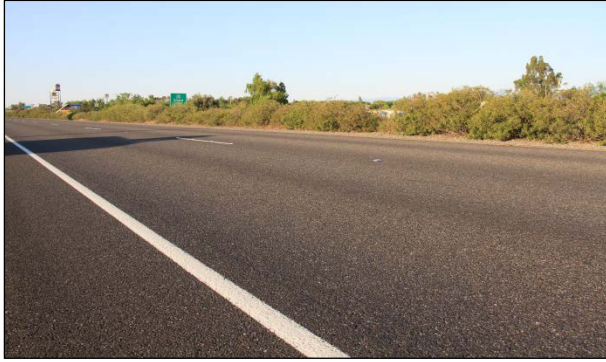
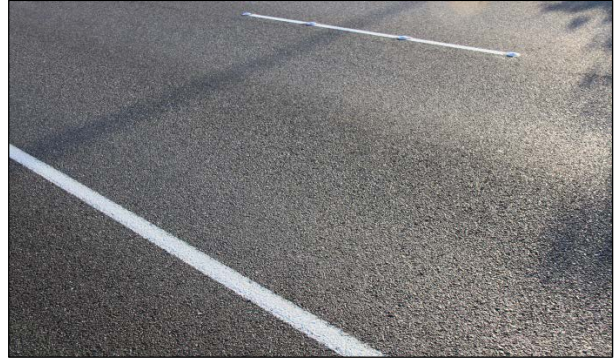
Rut depths of approximately 0.16 in. (4.0 mm) were measured on both the control and Evotherm sections. This indicated that rut performance on the hot- and warm-mix sections was similar after 12 months of trafficking and that binder oxidation rates had probably stabilized. No other deterioration compared to the June 2009 baseline measurements was noted on the sections after 12 months of traffic.

Figure 5.2: Orland Control, June 2011 (24 months). Note ruts in wheelpath.

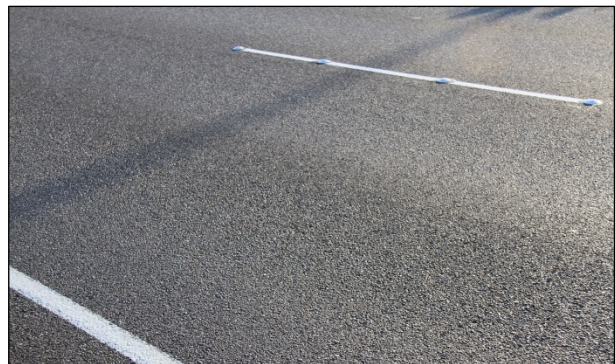
Minor rutting (average between 0.08 in. and 0.1 in. [2.0 mm and 3.0 mm]) was measured in the wheelpaths of the truck lane on the warm-mix section. No rutting was measured on the control section. The difference in rutting performance was attributed to lower oxidation of the binder in the warm-mix and consequent lower stiffness. Similar early rutting on warm-mix test sections was observed during accelerated loading tests conducted earlier in the warm-mix asphalt study (1). No other deterioration compared to the June 2009 baseline measurements was noted.

Figure 5.4: Orland Evotherm, June 2011 (24 months). Note ruts in wheelpath.

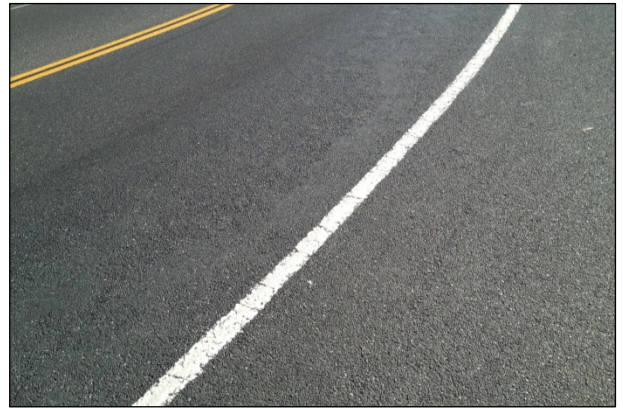
No deterioration compared to the July 2010 baseline measurements was noted on the sections after 30 months of traffic. However, minor raveling was noted on a short section of the outside wheelpath on a sharp bend on the Advera section.

No deterioration compared to the July 2010 baseline measurements was noted on the sections after 42 months of traffic. The raveling observed on the Advera section during the December 2012 visit had not deteriorated.

Figure 7.4: Mendocino Advera, December 2013 (42 months). Note raveling in outside wheel path.

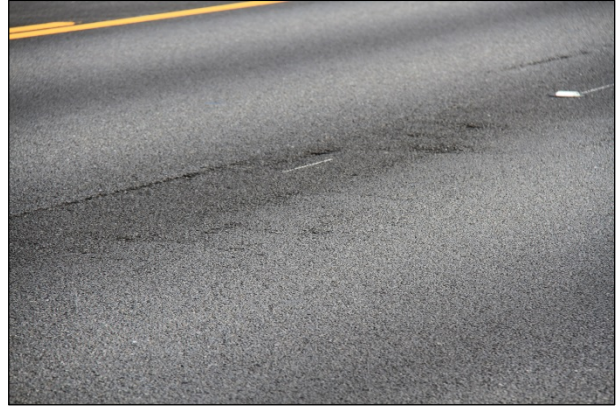
The road surface resembled a typical open-graded friction course and was given an overall rating of “good.” Some localized areas of what appeared to be segregation in the mix were noted. Some open longitudinal joints were also noted. No early stone loss was noted, and no other problems were observed. Water was effectively draining through the friction course and out through the sides of the road.

Figure 8.2: Auburn Evotherm, August 2010 (0 months). Note segregation and open joint.

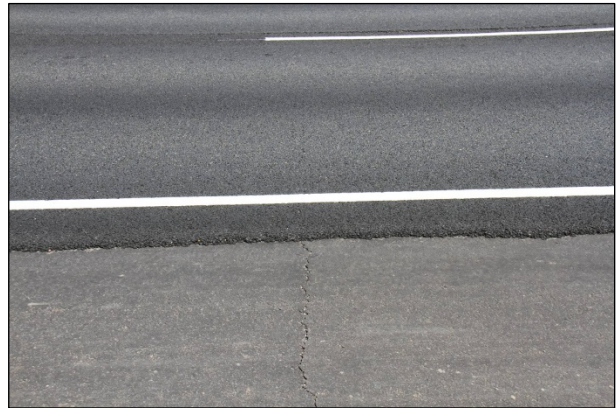
Reflected transverse cracking and some minor raveling in the outside wheelpath of the outside lanes was noted in some areas of the project. Given that no hot-mix control was available for comparison purposes, it was not clear whether these distresses were related to the warm-mix technology, to construction issues, or to other factors. No further deterioration compared to the August 2010 baseline measurements was noted.

Figure 8.3: Auburn Evotherm, July 2012 (24 months). Note deterioration and reflected crack.
