**Causes of Failure of District 11 Asphalt Rubber Chip Seal  
11-Imp-86-PM 37.3/43.3 (EA 11-241101)**

**CALIFORNIA DEPARTMENT OF TRANSPORTATION**

**Technical Memorandum TM-UCD-PRC-2005-10**

July 7, 2005

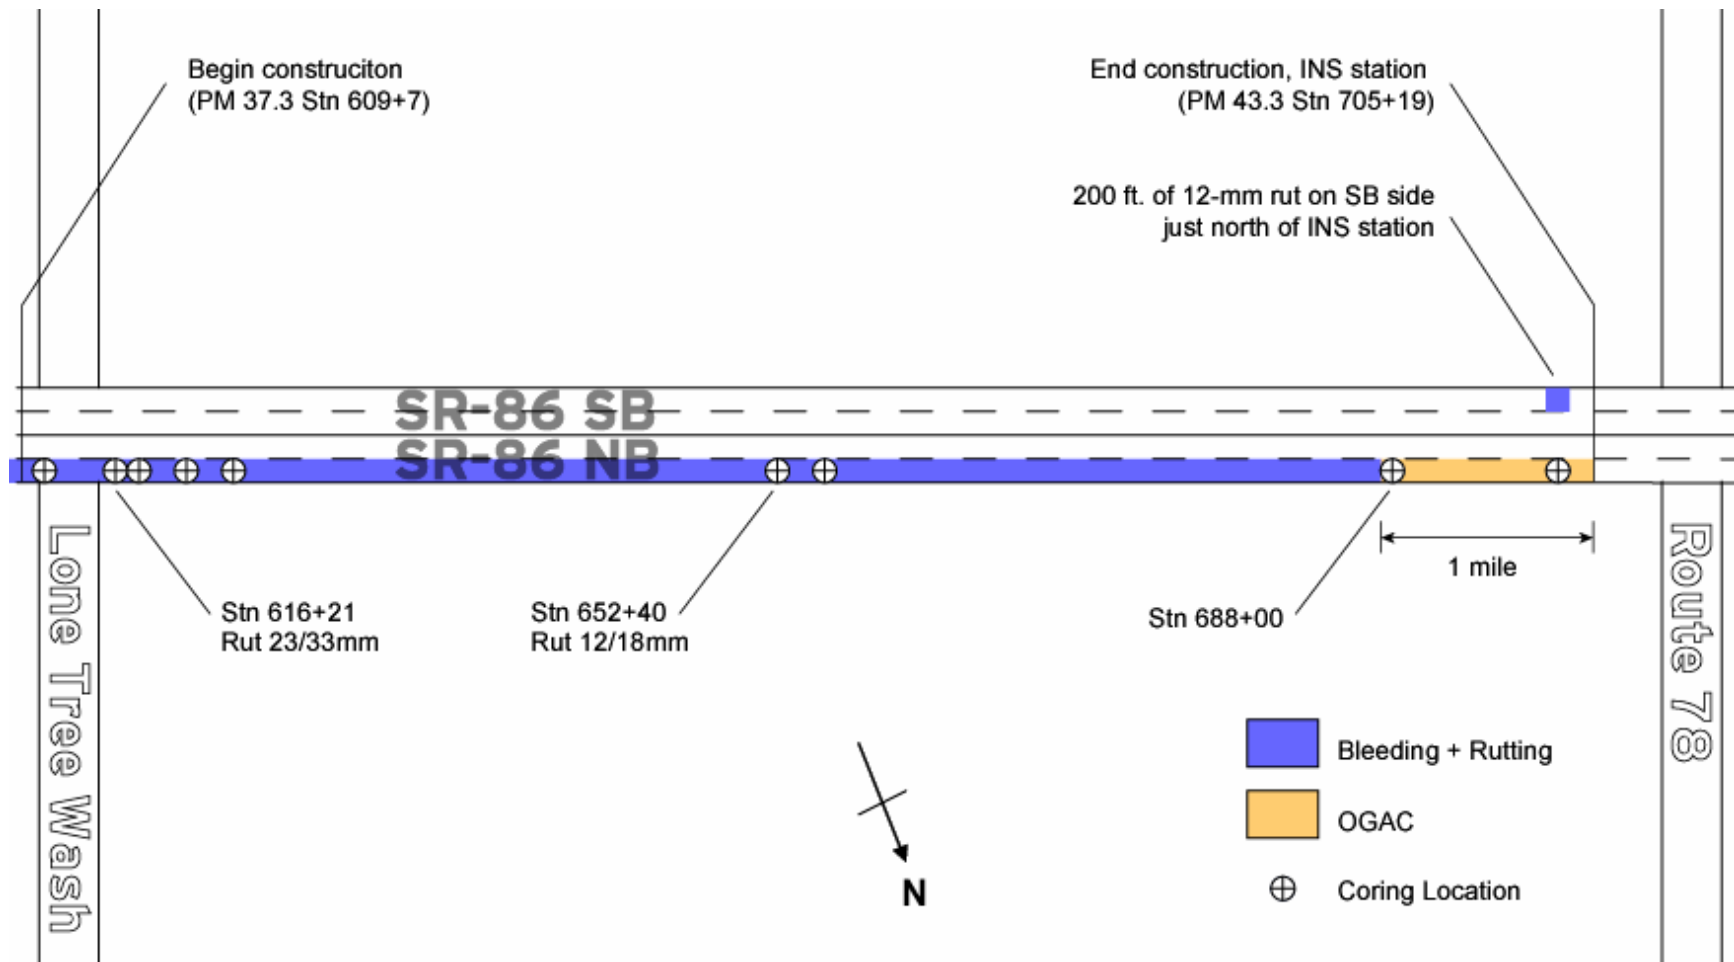
The previous Technical Memorandum contains a project map. A project schematic showing locations of coring and distress observed during the PRC field site visit of January 20, 2005 is shown in Figure 3. The condition survey revealed flushing and rutting throughout the entire pavement section in the #2 lane along the wheel paths except for the 1-mile section south of the Immigration and Naturalization Services (INS) Station. An open-graded asphalt concrete (OGAC) layer was placed previously in this area because of braking and extended durations of heavy loading near the INS Inspection Station.

Figure 3. Condition survey of 11-Imp-86-PM 37.3/43.3 during PRC field site visit in January 2005.

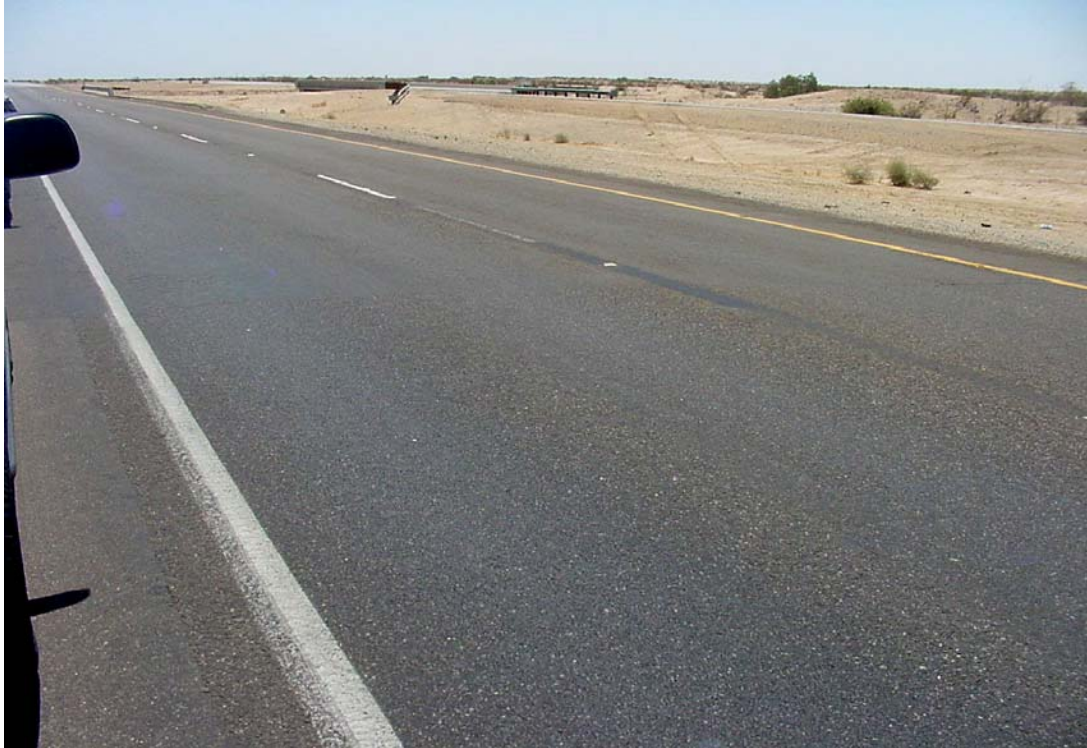
According to a Caltrans HQ Maintenance report (Ron Jones), there were no signs of distress prior to placing the asphalt rubber chip seal in September 2003. Examples of the surface condition prior to the chip seal appear in Figures 4 and 5.

**Figure 4. First pre-construction inspection with no signs of distress, July 2002 (Caltrans Maintenance – Ron Jones).**

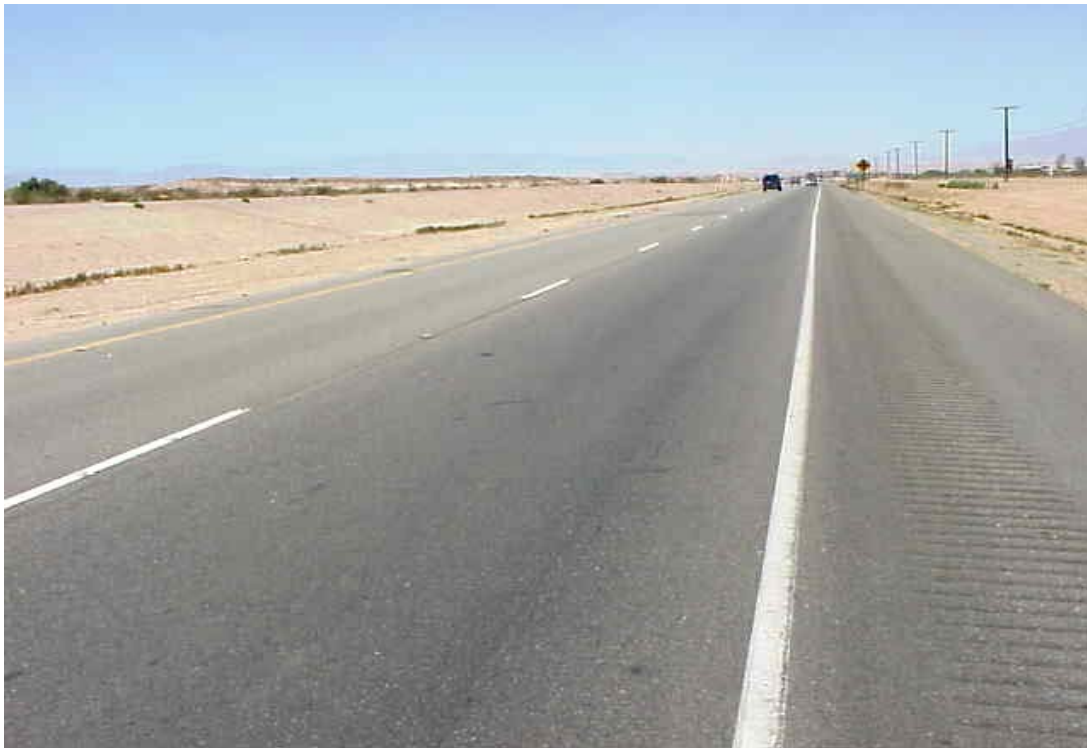
**Figure 5. Second pre-construction inspection with no signs of distress, May 2003 (Caltrans Maintenance – Ron Jones).**

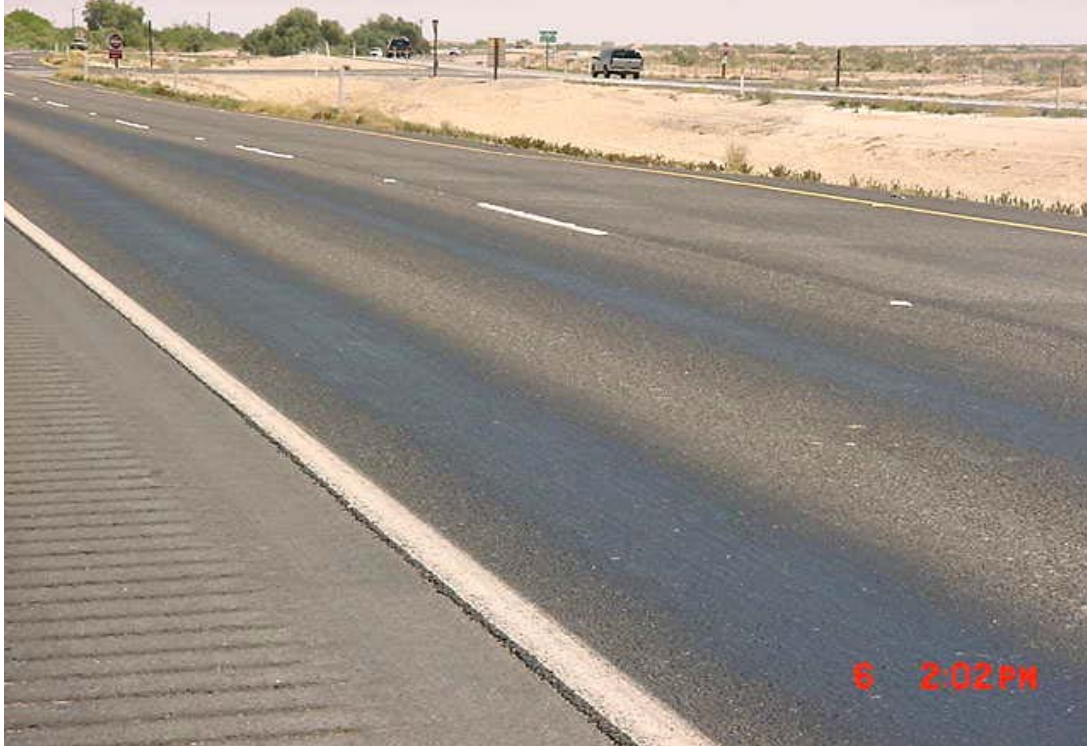
The first signs of bleeding and minor rutting were documented during the first post-construction inspection by Caltrans on March 29, 2004. By September 2004, when Caltrans conducted a second post-construction inspection, severe wheelpath rutting had developed to depths of 2 to 38 mm (see Figures 6 and 7).

**Figure 6. First post-construction inspection showing rutting in northbound #2 lane, March 2004 (Caltrans Maintenance – Ron Jones).**

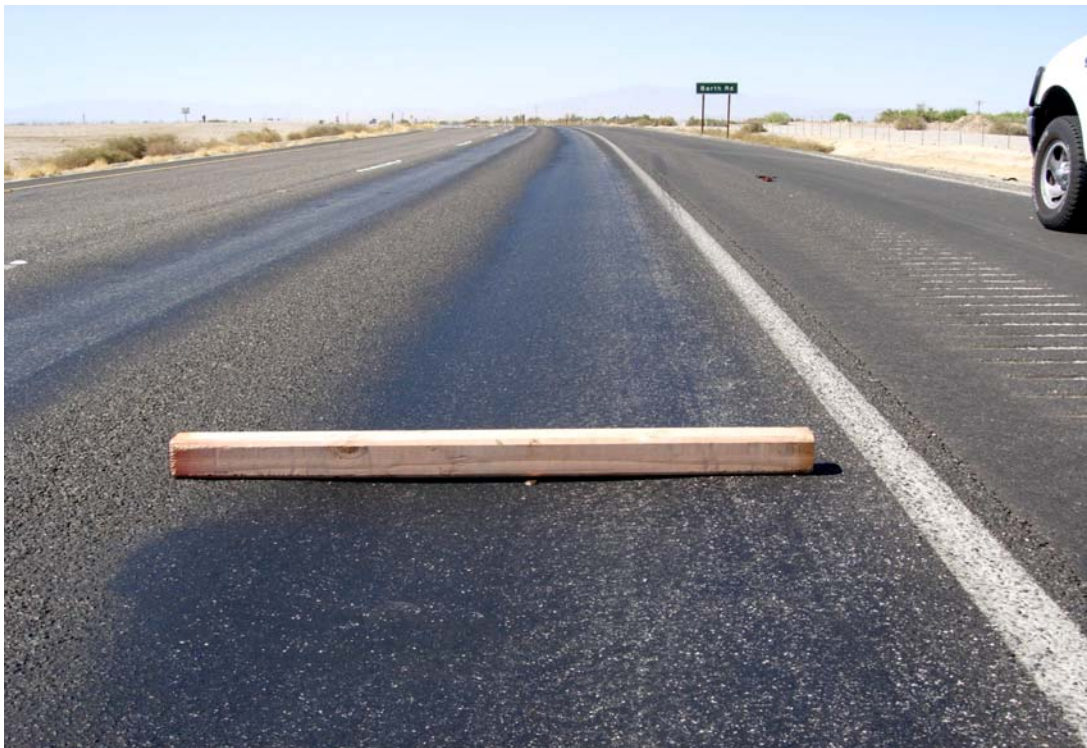
**Figure 7. Second post-construction inspection showing rutting in northbound #2 lane, September 2004 (Caltrans Maintenance – Ron Jones).**

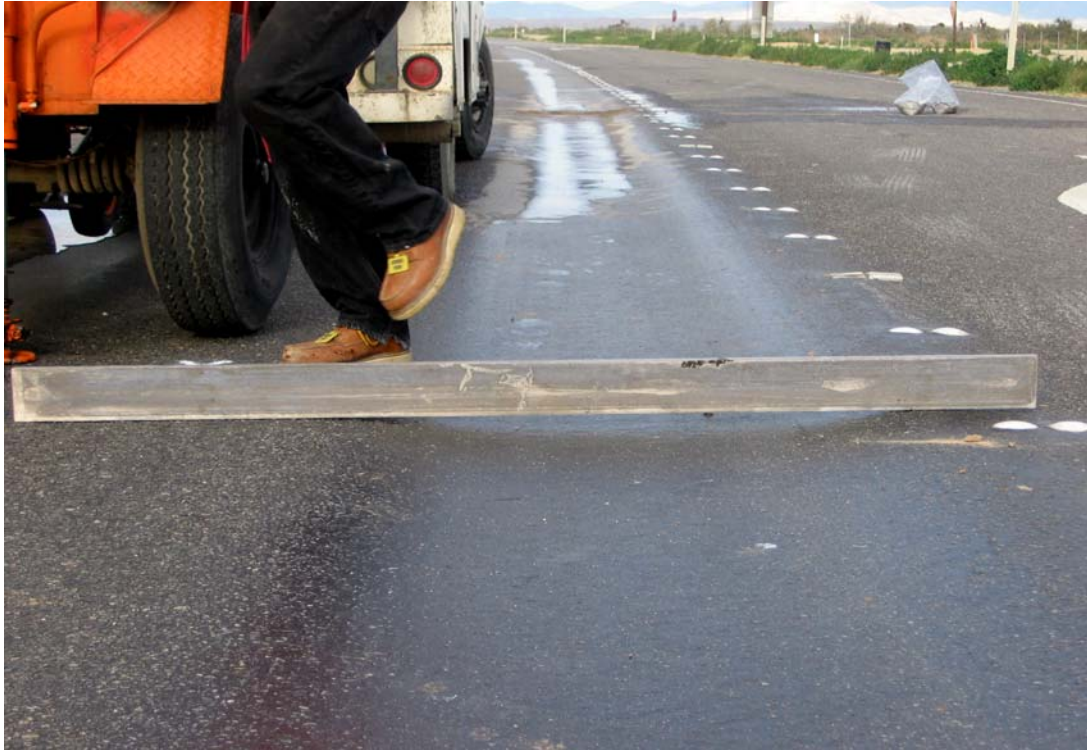
Pavement distress, both bleeding and rutting, were severe by the time of the PRC field site visit in January 2005. Figure 8 shows an example of the pavement surface condition at that time. It was evident during the site visit that bleeding and rutting were limited to the #2 (outside) lane in the northbound direction.

**Figure 8. PRC site visit showing 33-mm rut and bleeding, January 2005 (Station 616+21, northbound #2 lane).**

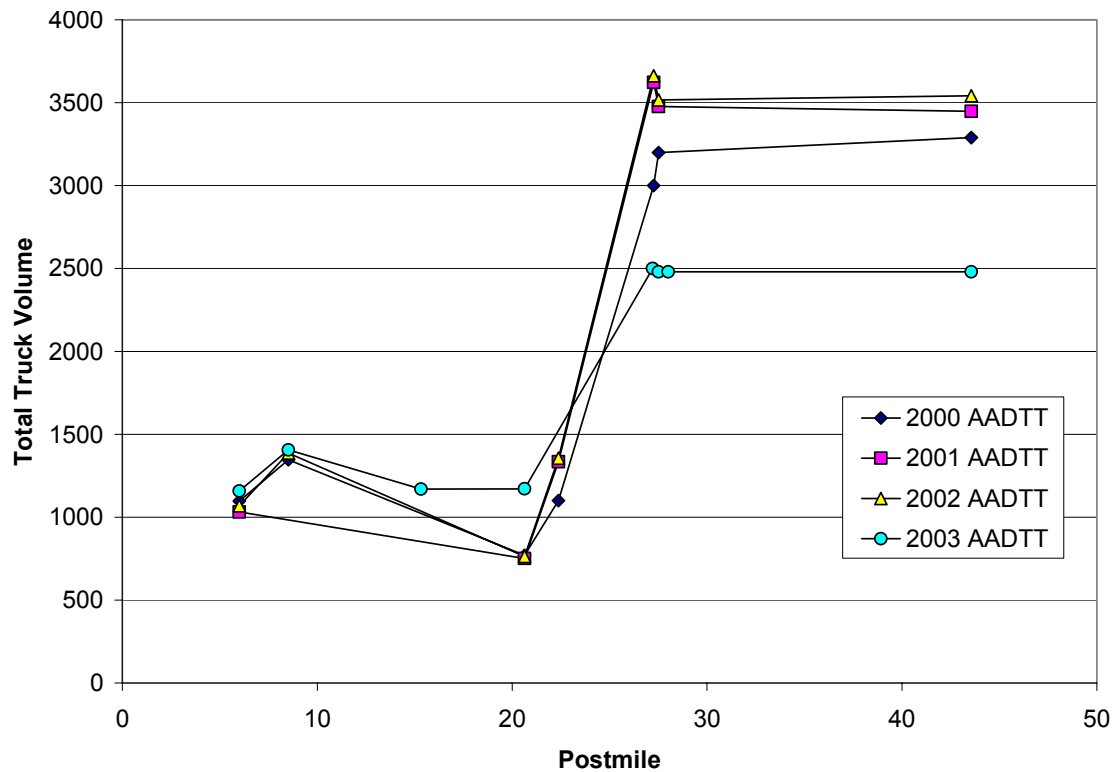
Truck count data for the project limits do not show an increase in truck volumes during the years leading up to placing the chip seal in late 2003 nor are traffic volumes in 2003 higher than in previous years. Traffic data and thus truck counts are not available for 2004 at the time of this writing.

The lack of WIM data and the inability to determine actual traffic volumes makes it difficult to identify truck traffic as a cause or contributing factor to rutting and bleeding on SR-86.

**Figure 9. Truck volume on State Route 86 over years 2000–2003.**

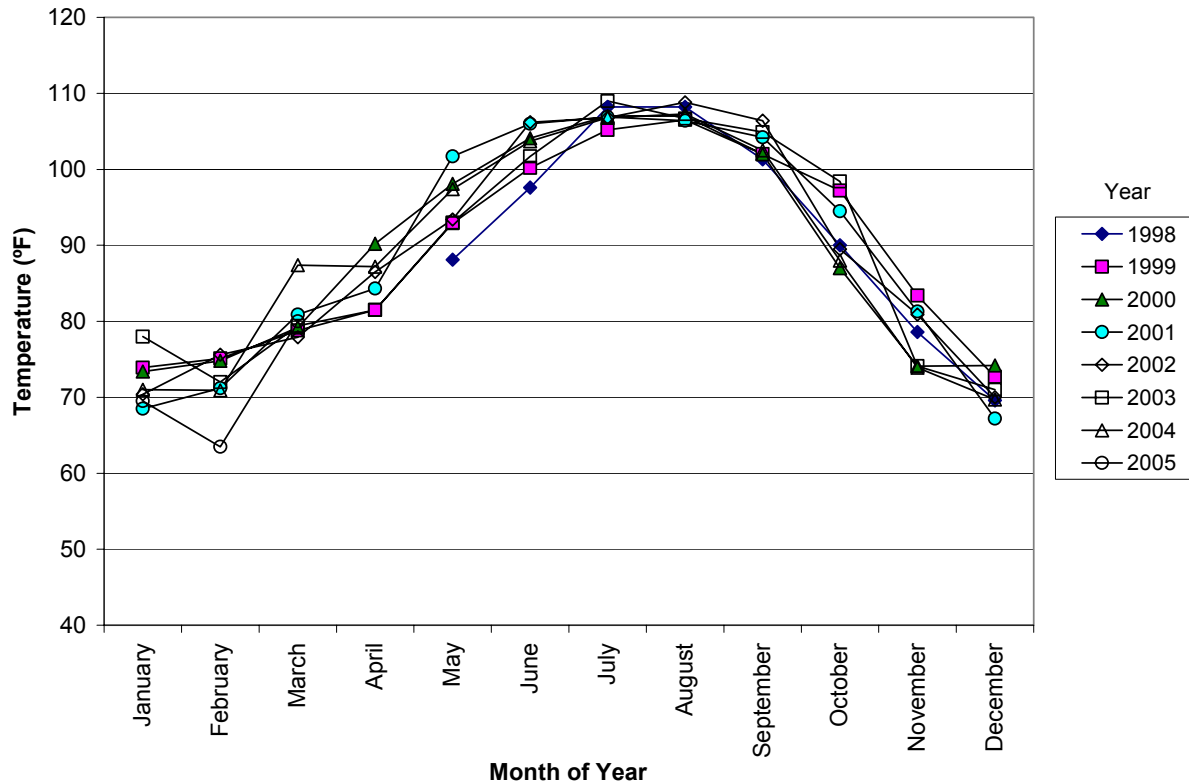
Temperature data for the time period studied do not show unusual extremes during the months preceding the first indications of distress seen in March 2004. Trends and values are consistent throughout most of the year for each year shown. Wider variation occurred early in the

**Figure 10. Average monthly maximum temperature.(6)**

year for several years including March 2004, when distress was first documented. The average monthly maximum temperature during March 2004 was nearly 88°F, about 8°F higher than typical in previous years. However, temperatures in preceding months (January and February 2004) were closer to the typical value of approximately 70°F.

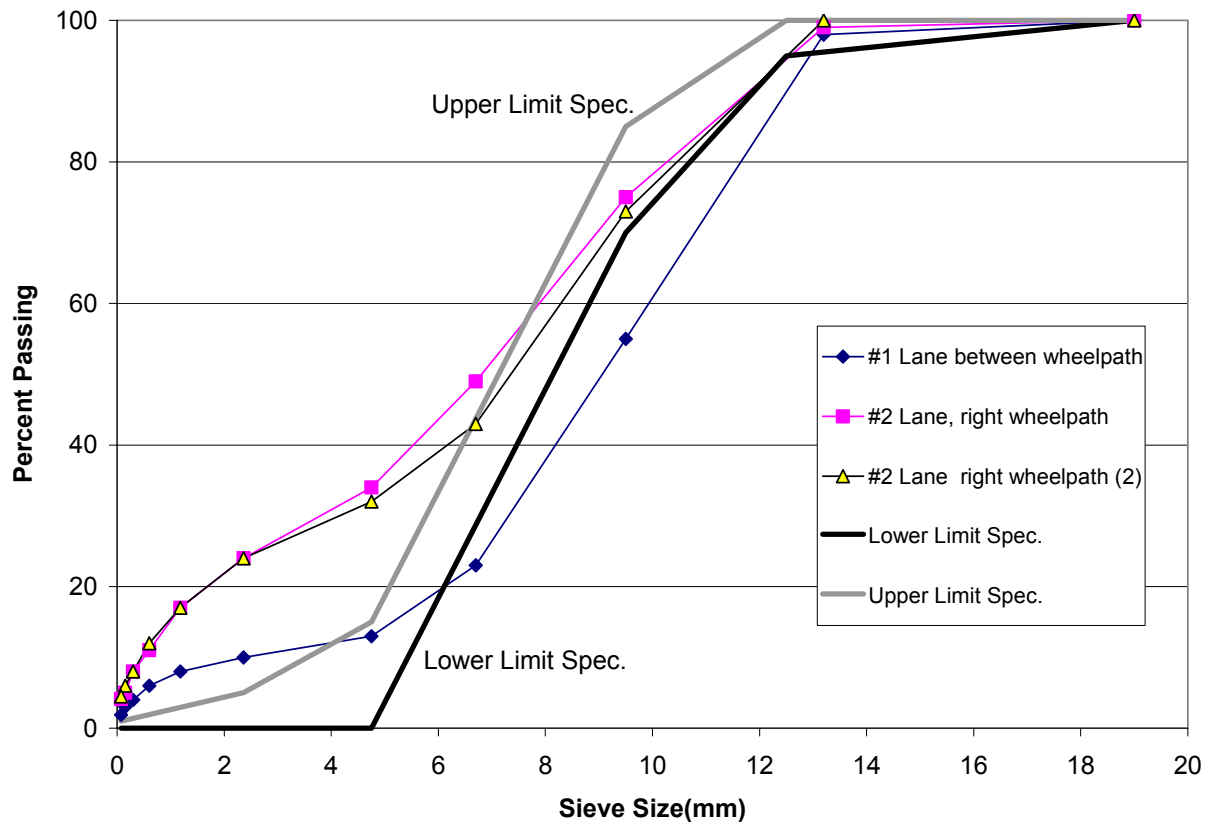
Testing by the CSIR also included determining the aggregate gradation of the chip seal based on the recovered aggregate. The resulting gradations are shown in Figure 12. Gradations from cores removed from the right wheelpath (indicated by “#2”) are comparable, though one core is from Station 610+40 and the other is from Station 654+00. A second core from Station 610+40, taken from between wheelpaths, shows a coarser gradation. This corresponds with the appearance (noted for all cores) of a rough/coarse surface for cores between wheelpaths and worn/smooth

**Figure 12. Asphalt rubber chip seal recovered aggregate gradations.**

appearance for cores within wheelpaths. It is noteworthy that many transportation agencies worldwide specify single-size chip seals. Caltrans may want to consider either using single-size chips or tightening gradation specifications.
