Research Report: UCPRC-RR-2007-04

# Reflective Cracking Study: First-Level Report on HVS Testing on Section 591RF — 45 mm MAC15TR-G Overlay

Partnered Pavement Research Program (PPRC) Contract Strategic Plan Element 4.10:  
Development of Improved Rehabilitation Designs for Reflective Cracking

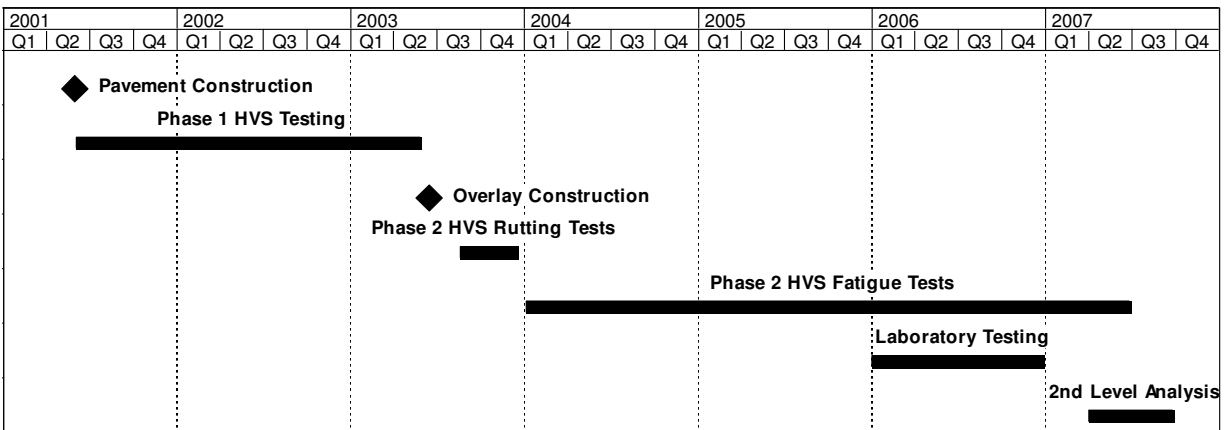
**Figure 1.1: Timeline for the Reflective Cracking Study.**

An overview of the project timeline is shown in Figure 1.1.

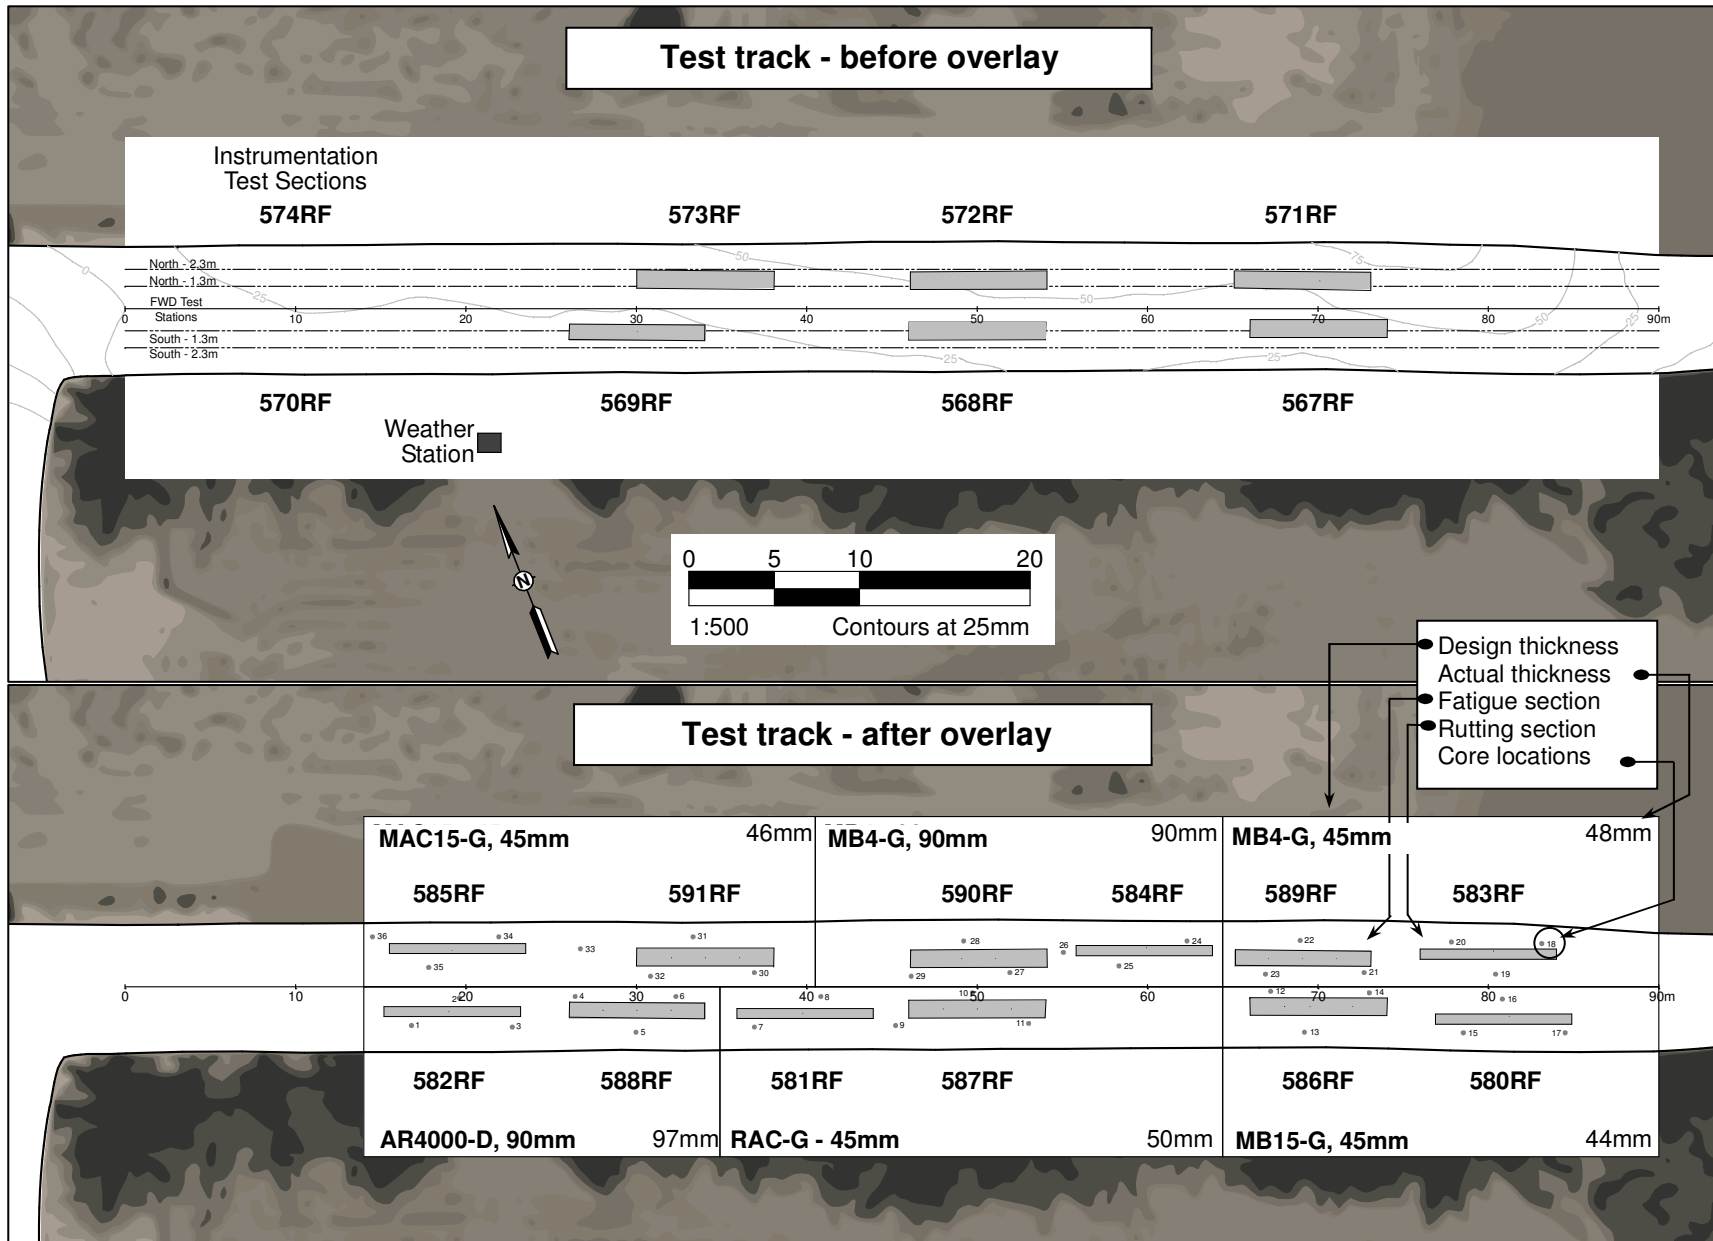
Figure 2.1: Layout of the Reflective Cracking Study project.

These sections and the corresponding Phase 1 fatigue test sections are shown in Figure 2.1. Prior to the Phase 2 reflective cracking testing, a rutting study was carried out whereby HVS loading at high temperature was applied adjacent to the reflective cracking experiments to evaluate the rutting behavior of the overlay mixes. The rutting study will be discussed in a separate report.

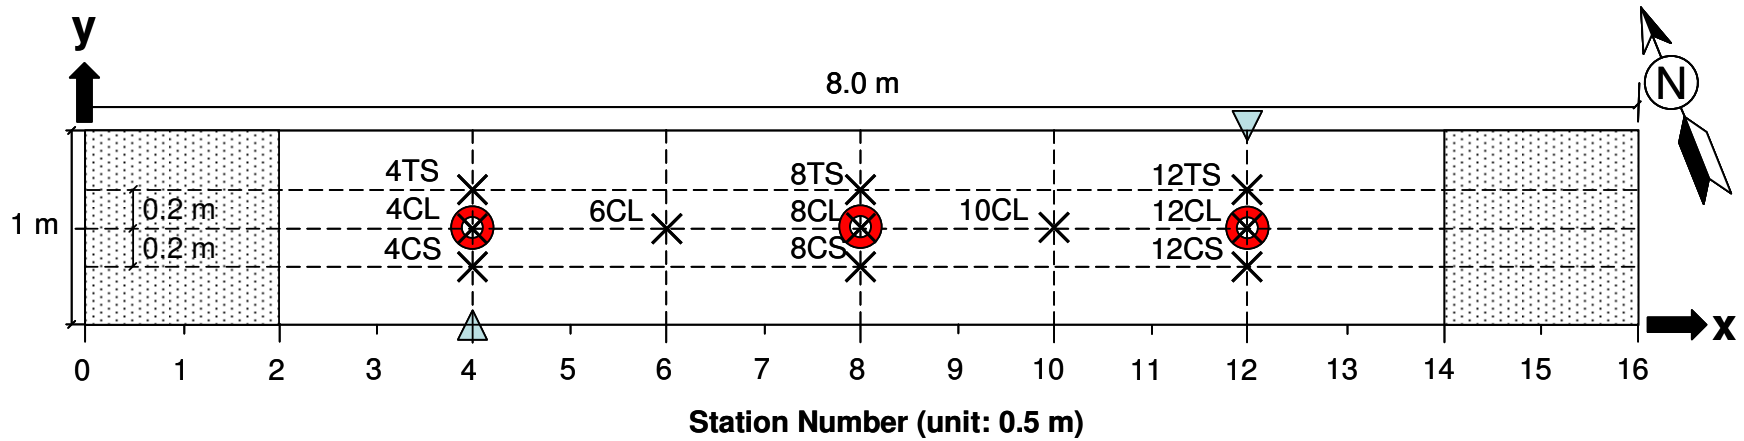
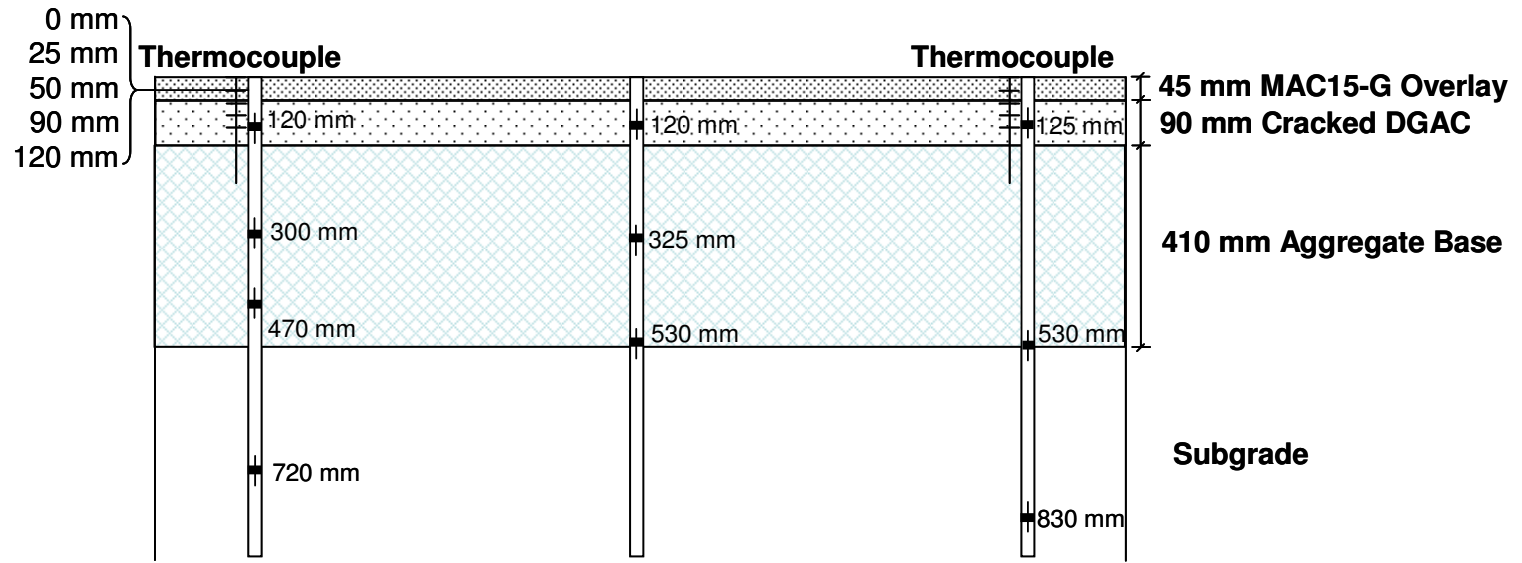
The test section layout for Section 591RF is shown in Figure 2.2. Station numbers refer to fixed points on the test section and are used for measurements and as a reference for discussing performance.

Instrument positions are shown in Figure 2.2. Detailed descriptions of the instrumentation and measuring equipment are included in Reference 4. Intervals between measurements, in terms of load repetitions, were selected to enable adequate characterization of the pavement as damage developed.

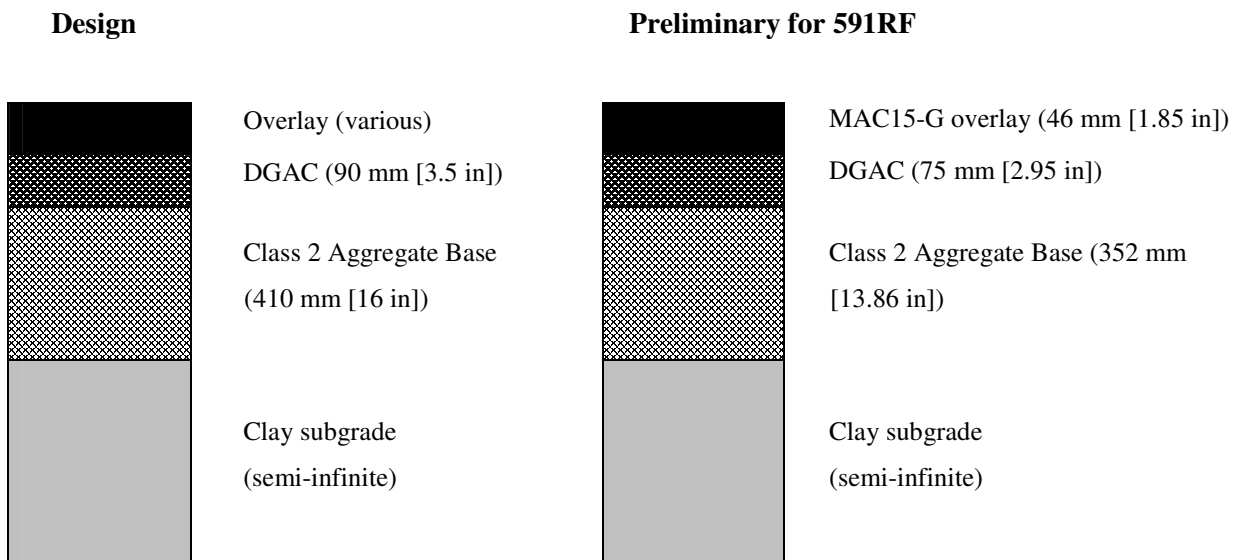
**Figure 2.3: Pavement design for the Reflective Cracking Study test track.**  
(Design and preliminary actual for 591RF)

The pavement for the first phase of HVS trafficking was designed according to the Caltrans Highway Design Manual Chapter 600 using the computer program *NEWCON90*. Design thickness was based on a tested subgrade R-value of 5 and a Traffic Index of 7 (~121,000 ESALs) (3). The pavement design for the test road and the preliminary as-built pavement structure for Section 591RF (determined from cores removed from the edge of the section) are illustrated in Figure 2.3.

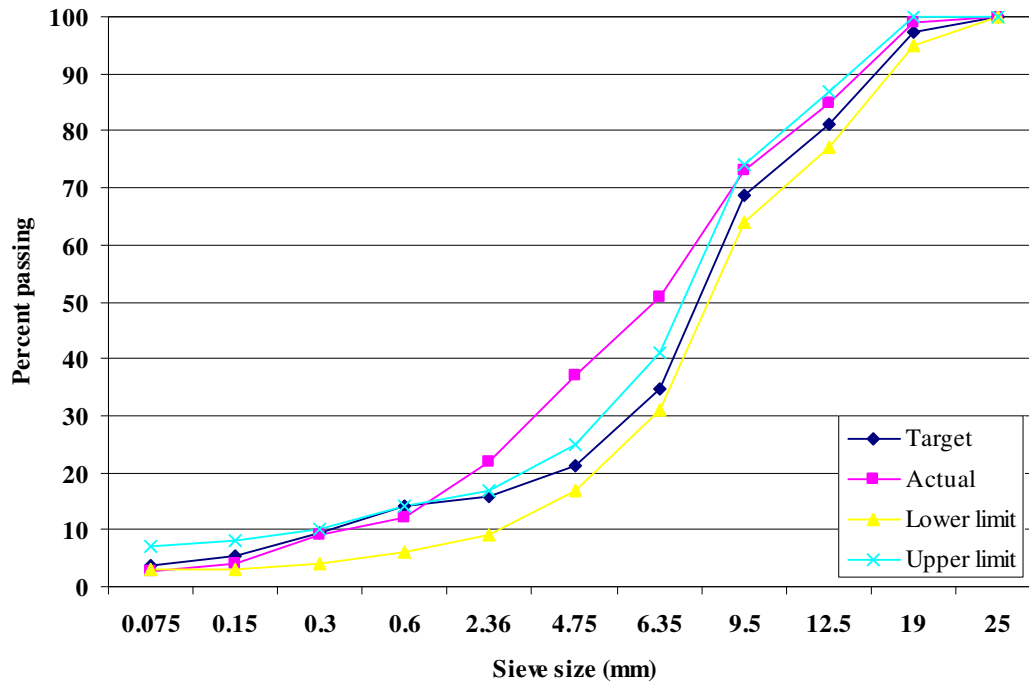
Figure 2.5: Actual vs. target gradation for MAC15-G overlay.

Laboratory testing was carried out by Caltrans and UCPRC on samples collected during construction to determine actual binder properties, binder content, aggregate gradation, and air-void content. The MAC15TR binder met the Caltrans modified binder specification, based on testing performed by Caltrans. The ignition-extracted binder content, corrected for aggregate ignition, showed an average value of 7.55 percent, somewhat higher than the design binder content of 7.4 percent. It is not clear whether this is a function of the test or contractor error. The aggregate gradation met Caltrans specifications for a 19.0 mm (3/4 in) maximum size gap gradation, with material passing the 0.6 mm (#30), 9.5 mm (3/8 in), 12.5 mm (1/2 in), and 19.0 mm (3/4 in) sieves on the upper envelope limit, while material passing the 2.36 mm (#8), 4.75 mm (#4), and 6.35 mm (1/4 in) sieves was outside the upper limit for course gradation. Gradation is illustrated in Figure 2.5. The preliminary as-built air-void content was 4.9 percent with a standard deviation of 1.0 percent, based on cores taken outside of the HVS sections. Final air-void contents will be determined from trenching and coring to be performed after trafficking of all sections.

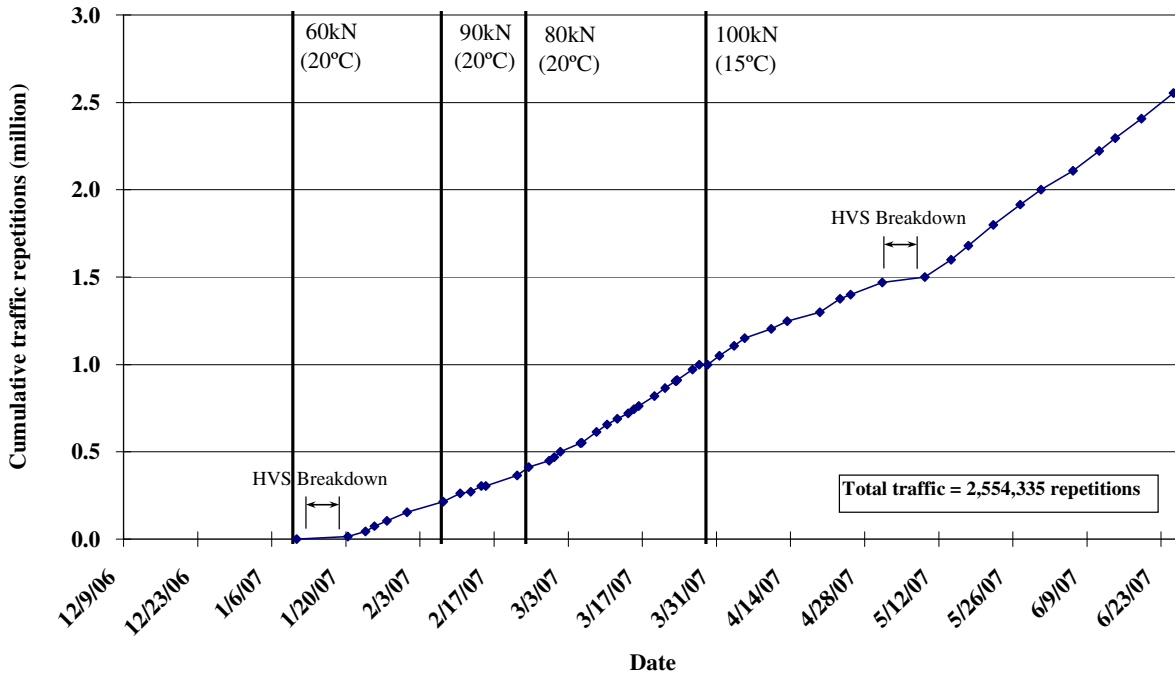
**Figure 2.6: Cumulative traffic applications and loading history.**

This loading equates to approximately 90.8 million Equivalent Standard Axle Loads (ESALs), using the Caltrans conversion of  $(\text{axle load}/18000)^{4.2}$ , which in turn equates to a Traffic Index of 15.4.

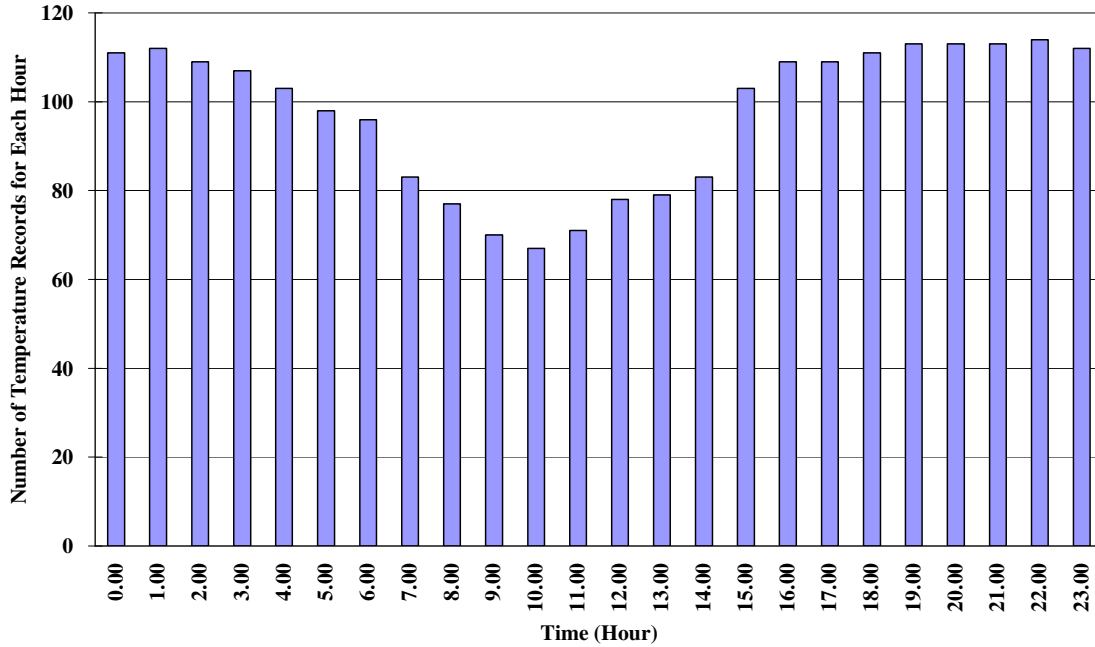
**Figure 3.1: Frequencies of recorded temperatures.**

- Zero to one million repetitions: mean of 20.4°C with a standard deviation of 2.4°C (minimum of 11.0°C, maximum of 29.0°C).
- One million to end of test: mean of 12.5°C with a standard deviation of 0.8°C (minimum of 8.8°C, maximum of 20.8°C).

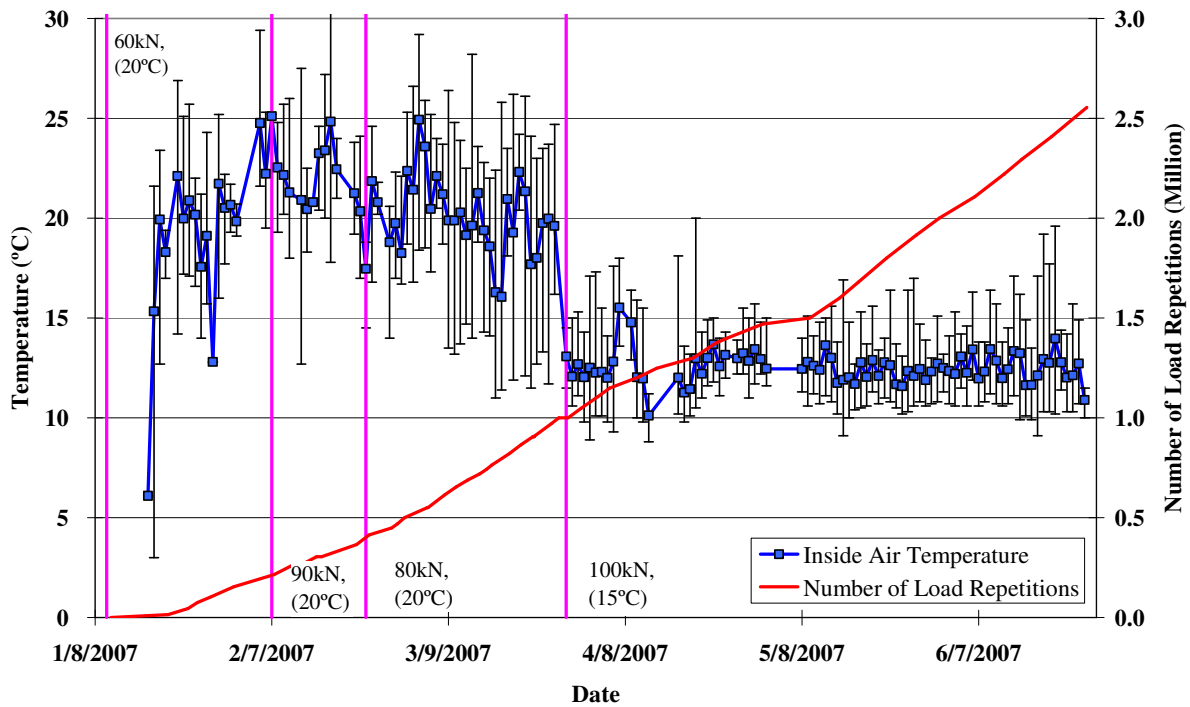
**Figure 3.2: Daily average air temperatures inside the temperature control chamber.**

The daily average air temperatures recorded in the temperature control unit, calculated from the hourly temperatures recorded during HVS operation, are shown in Figure 3.2. Vertical error bars on each point on the graph show daily temperature range.

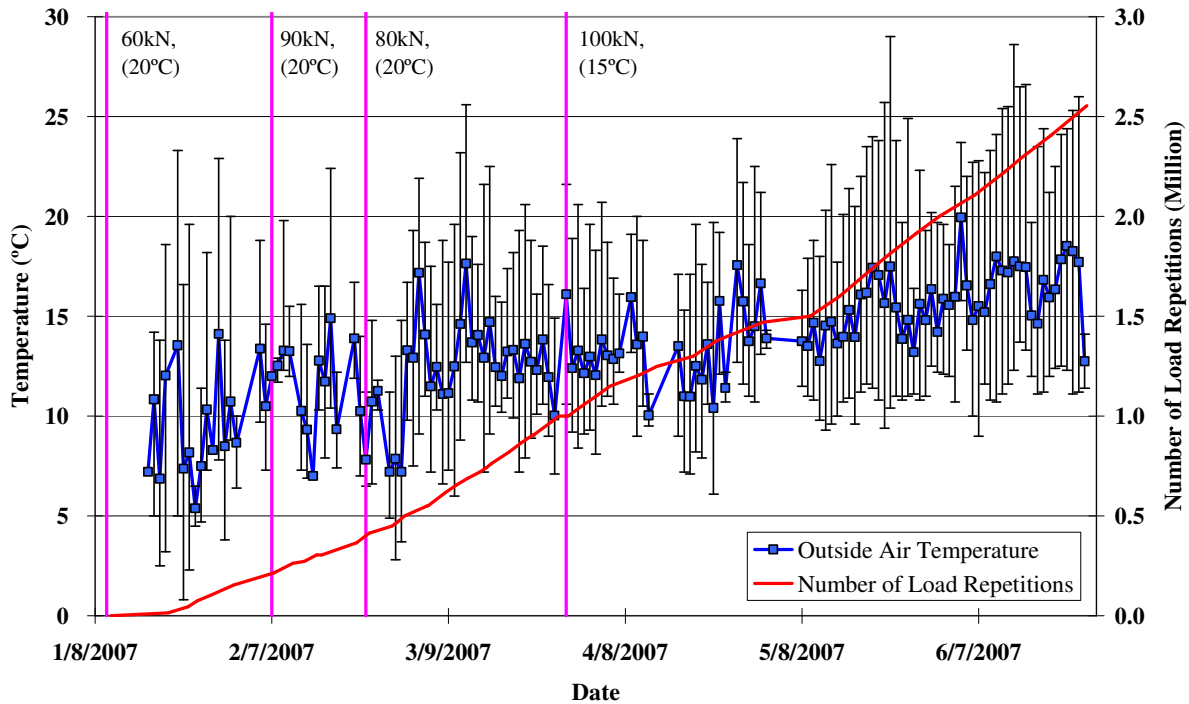
Figure 3.3: Daily average air temperatures outside the temperature control chamber.

Outside air temperatures ranged from 0.8°C to 29.0°C with an average of 13.4°C and are summarized in Figure 3.3. Vertical error bars on each point of the graph show daily temperature range.

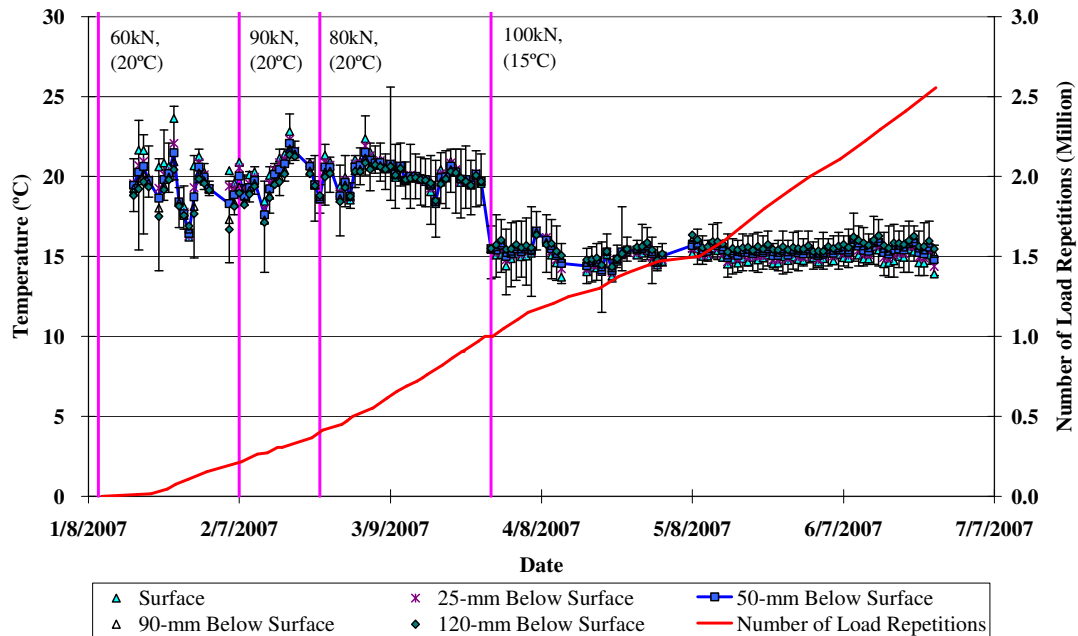
**Figure 3.4: Daily average temperatures at pavement surface and various depths.**

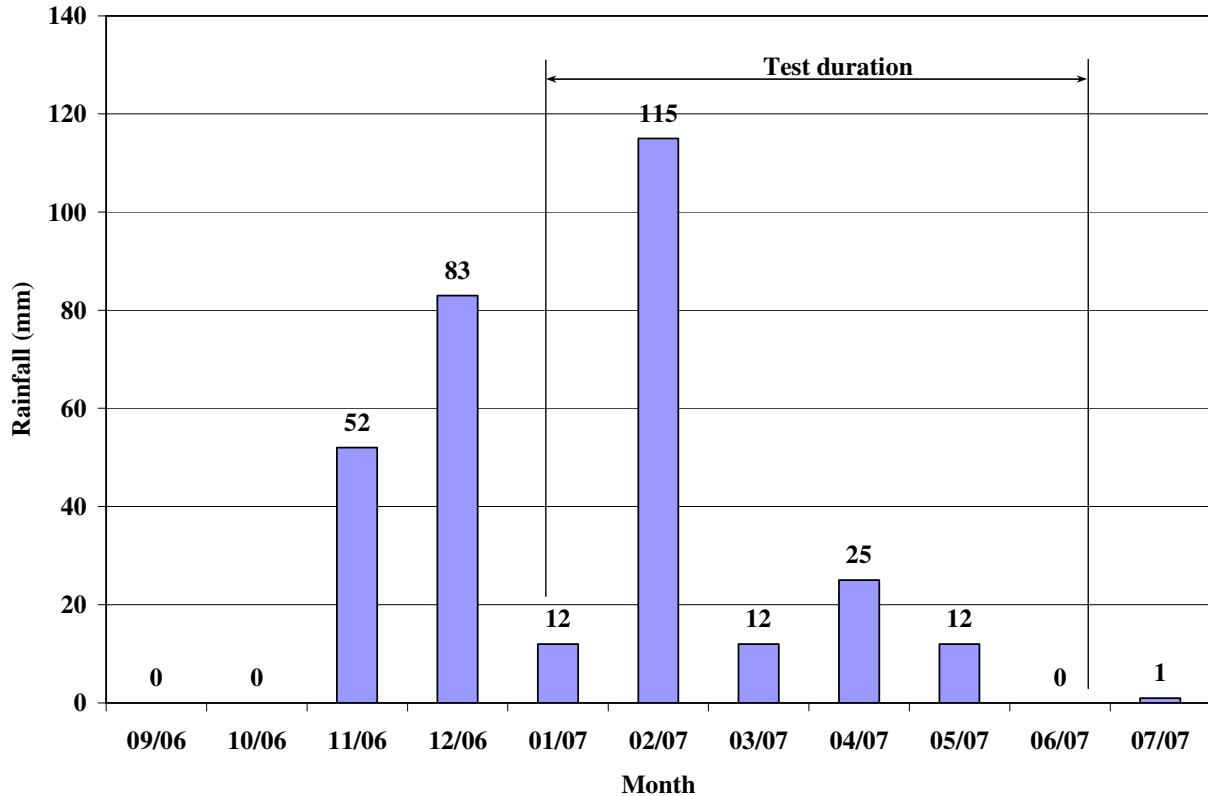
**Figure 3.5: Monthly rainfall for Richmond Field Station HVS site.**

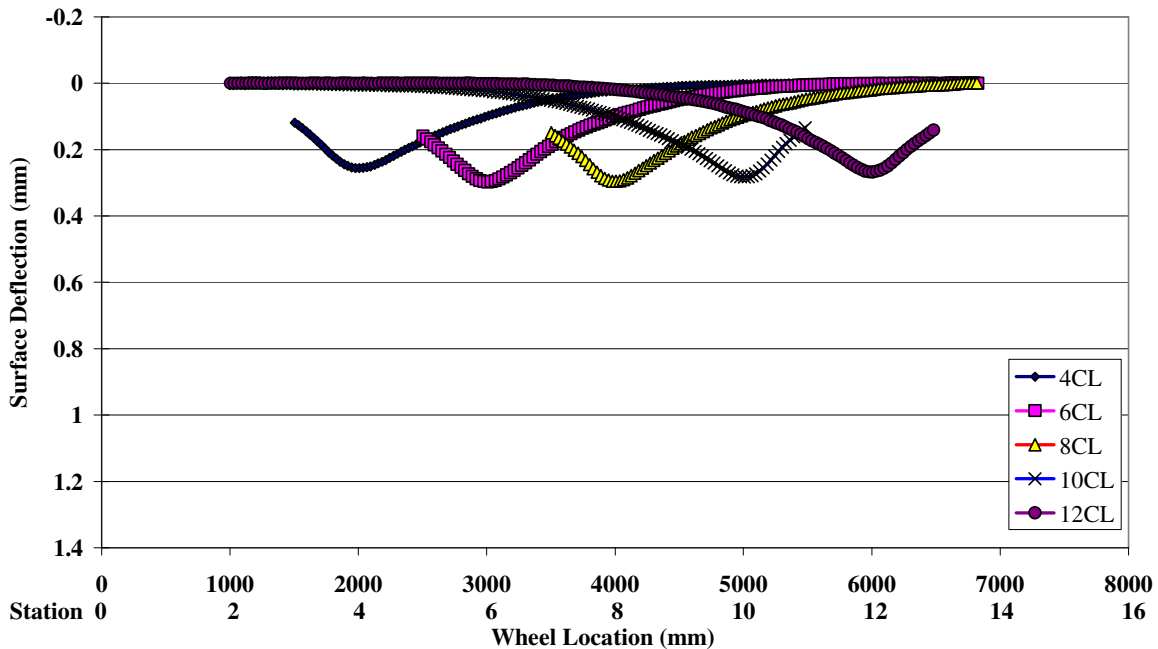
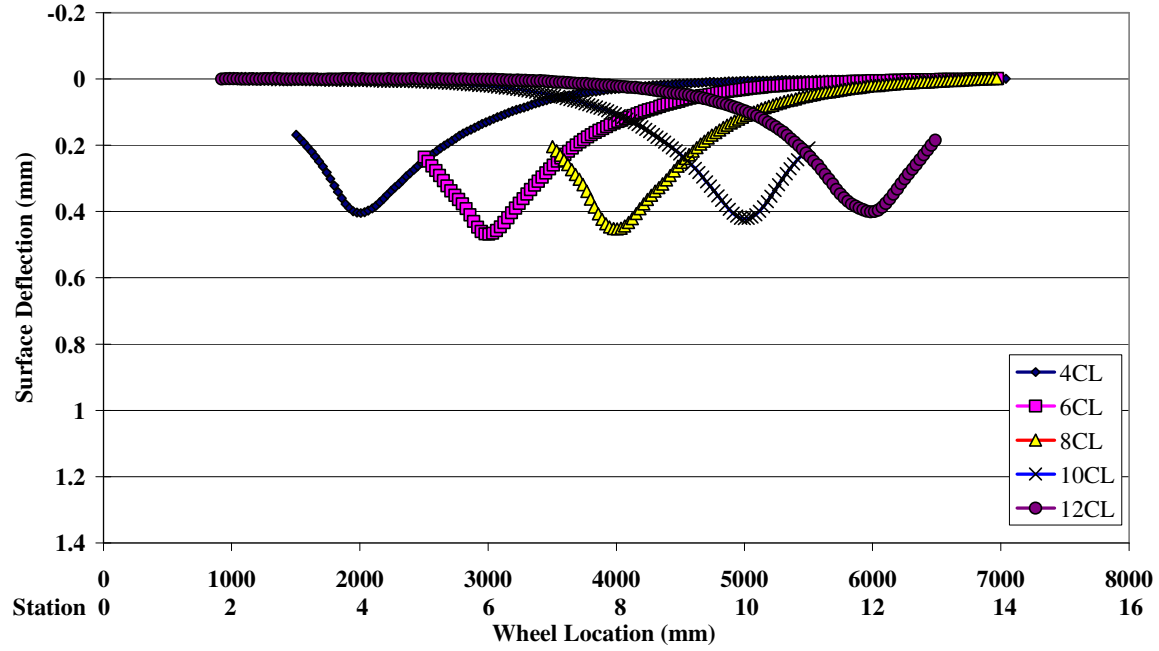
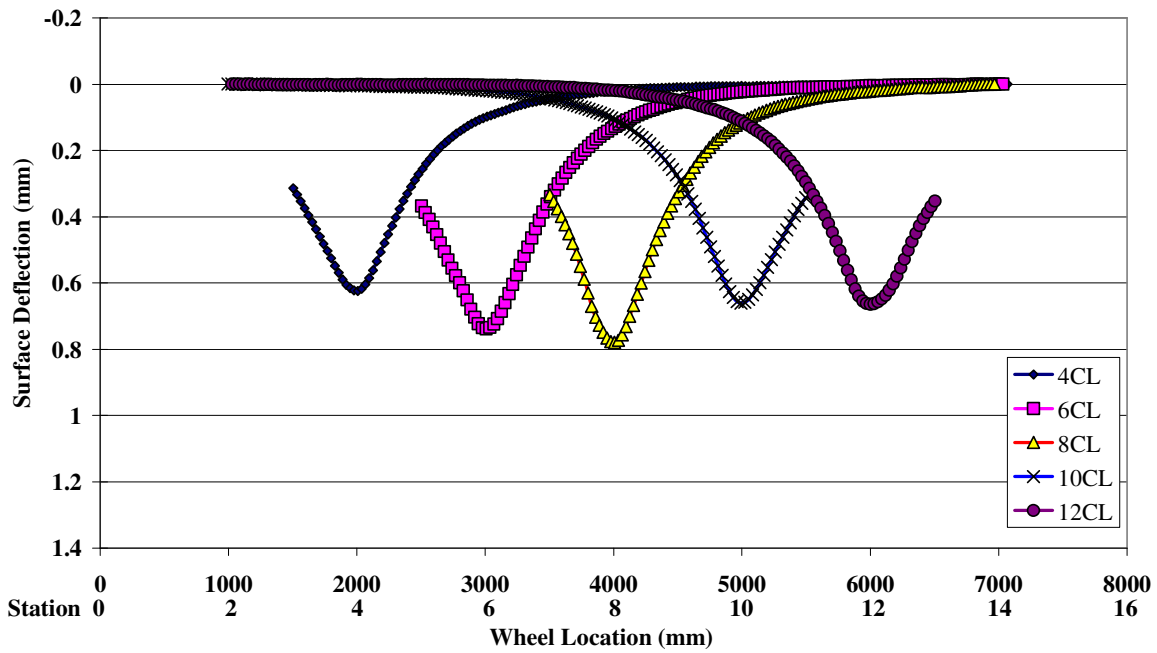
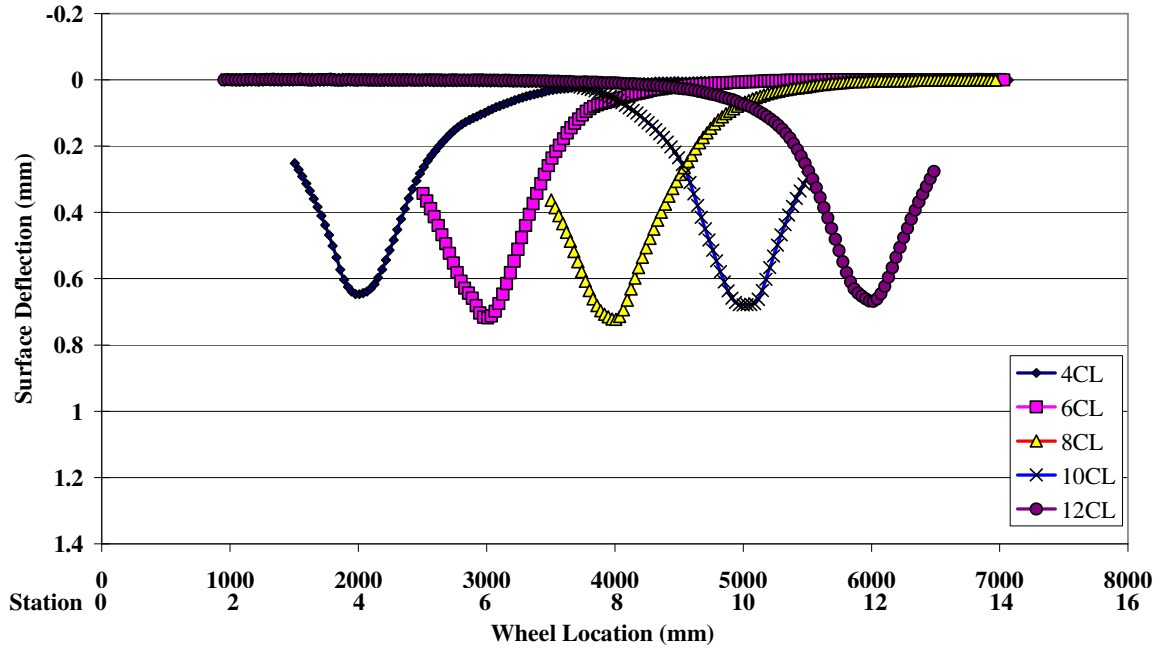
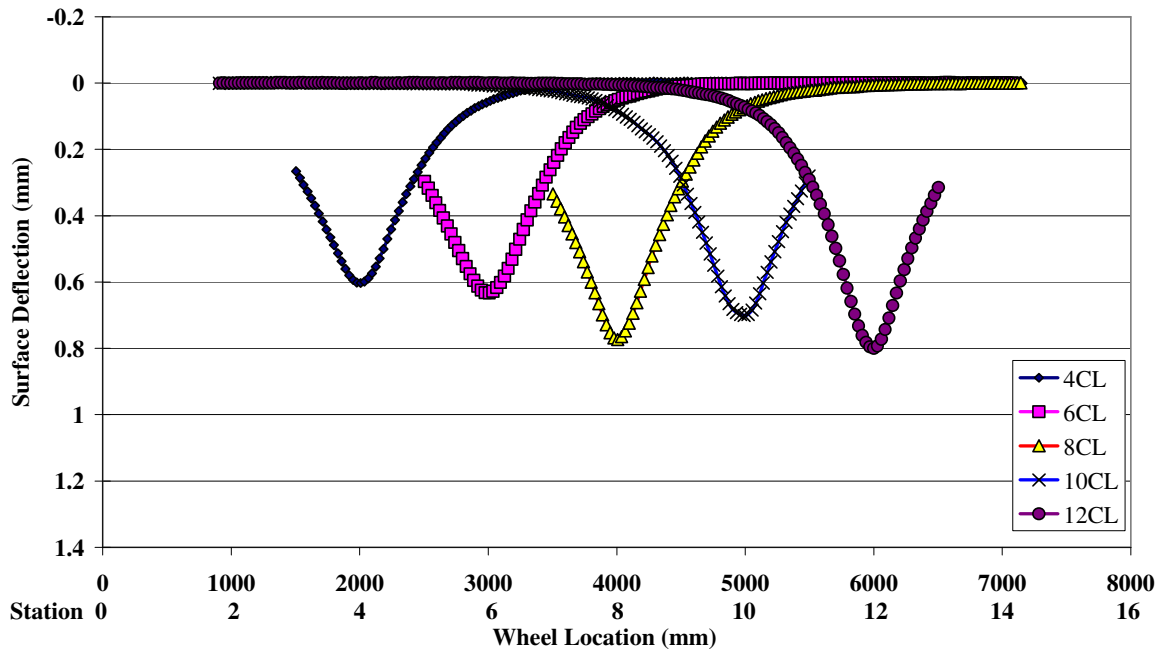
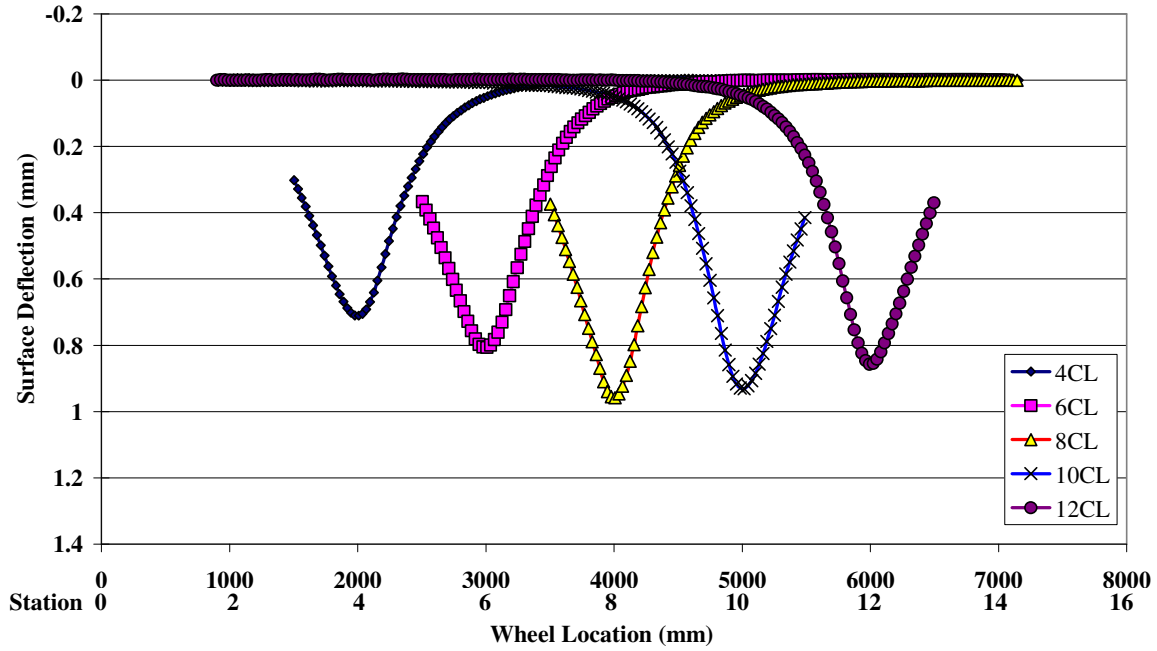
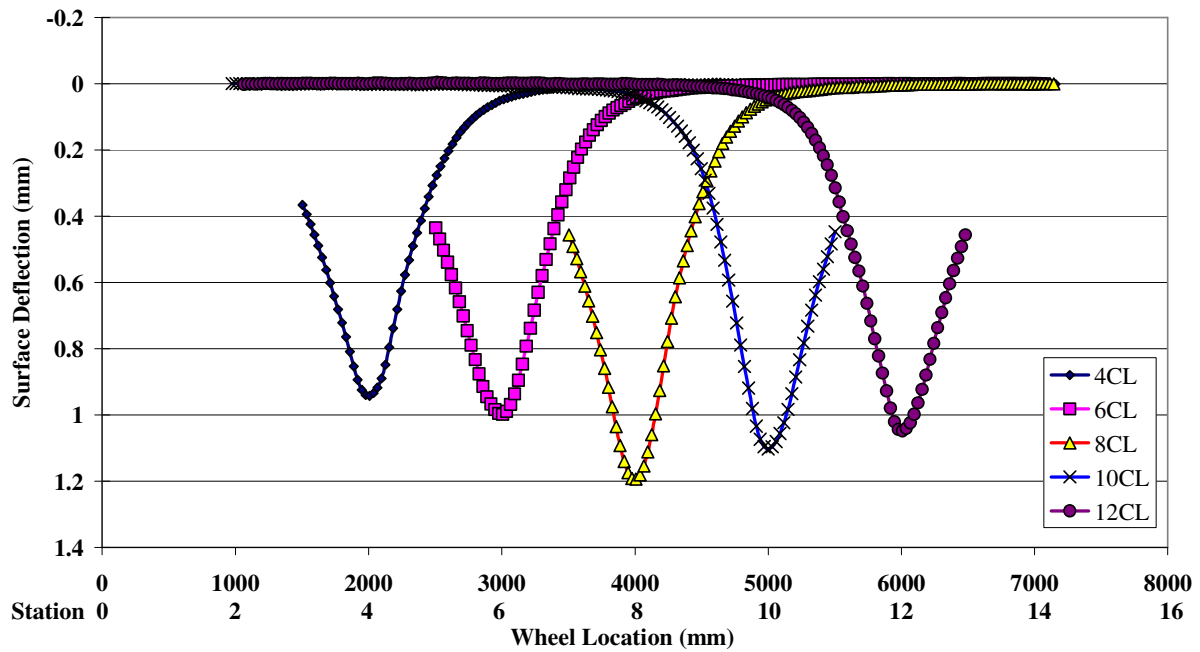
**Figure 3.6: RSD deflections at CL locations with 60 kN test load at test start.**

Figure 3.7: RSD deflections at CL locations with 60 kN test load after 215,000 repetitions. (90 kN load change)

Figure 3.8: RSD deflections at CL locations with 60 kN test load after 410,000 repetitions. (80 kN load change)

Figure 3.9: RSD deflections at CL locations with 60 kN test load after 1,000,000 repetitions. (100 kN load change)

Figure 3.10: RSD deflections at CL locations with 60 kN test load after 1,500,000 repetitions.

Figure 3.11: RSD deflections at CL locations with 60 kN test load after 2,000,000 repetitions.

Figure 3.12: RSD deflections at CL locations with 60 kN test load at test completion.

Deflections and damage rates both increased with increase in load. Figures 3.6 to 3.12 compare the deflection bowls at the same centerline locations at test start, at the three load change intervals, at 1.5 million and 2.0 million repetitions, and at test completion. The same scale is used on all the figures, and the increasing deflection in the early part of the test is clear. However, deflections did not increase when the load was increased to 100 kN (Figure 3.9). This is partly attributed to drying back of the base material. The higher deflections at Stations 8CL, 10CL, and 12CL over the more densely cracked underlying DGAC can be observed in Figures 3.10 to 3.12.

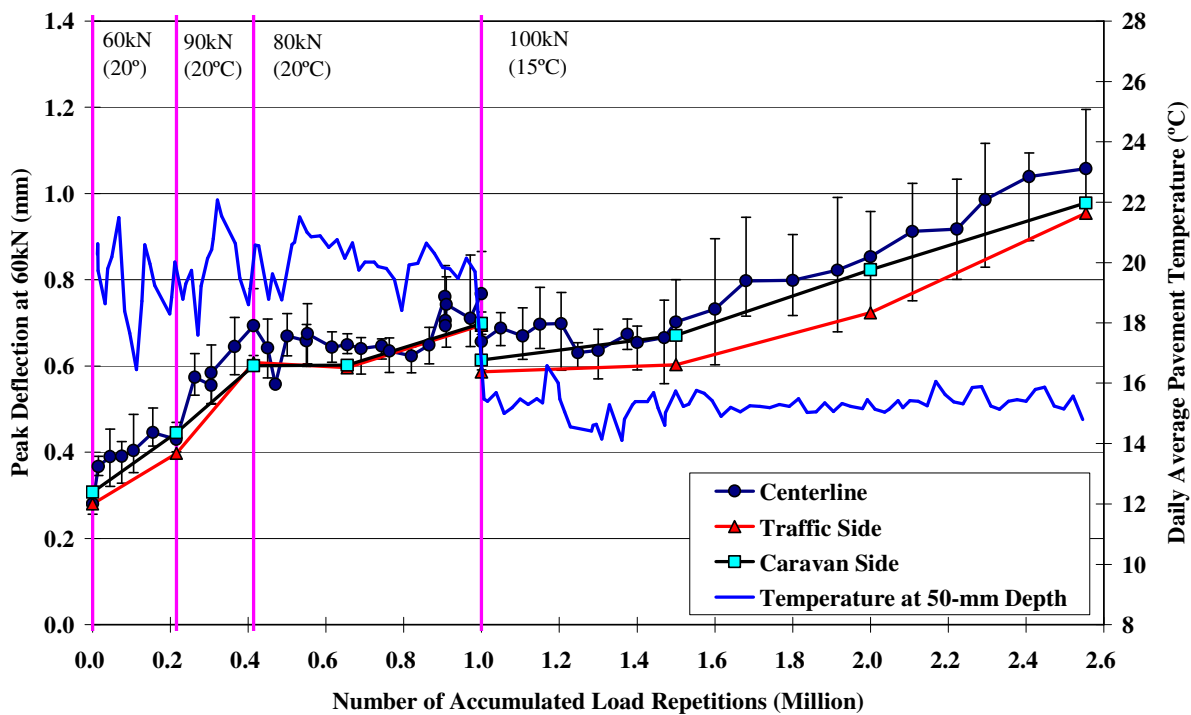
**Figure 3.13: Average RSD surface deflections with 60 kN test load (centerline and sides).**

The average 60 kN RSD deflections at centerline and side locations (200 mm from centerline within the trafficked area) are illustrated in Figure 3.13. These deflections are mostly all within 0.2 mm of each other, although as expected the side deflections are less than those of the centerline. Deflections increased sharply after the 90 kN load change, remained relatively constant during the 80 kN loading phase, and then increased marginally again after the 100 kN load change. Very little increase was recorded during the remainder of the test. The caravan side deflections are higher than the traffic side, which is attributed to the high water table on the side of the road. These results indicate that damage was generally greater in the vicinity of the centerline compared to the area away from the centerline where fewer repetitions were applied by the programmed wander of the HVS trafficking pattern.

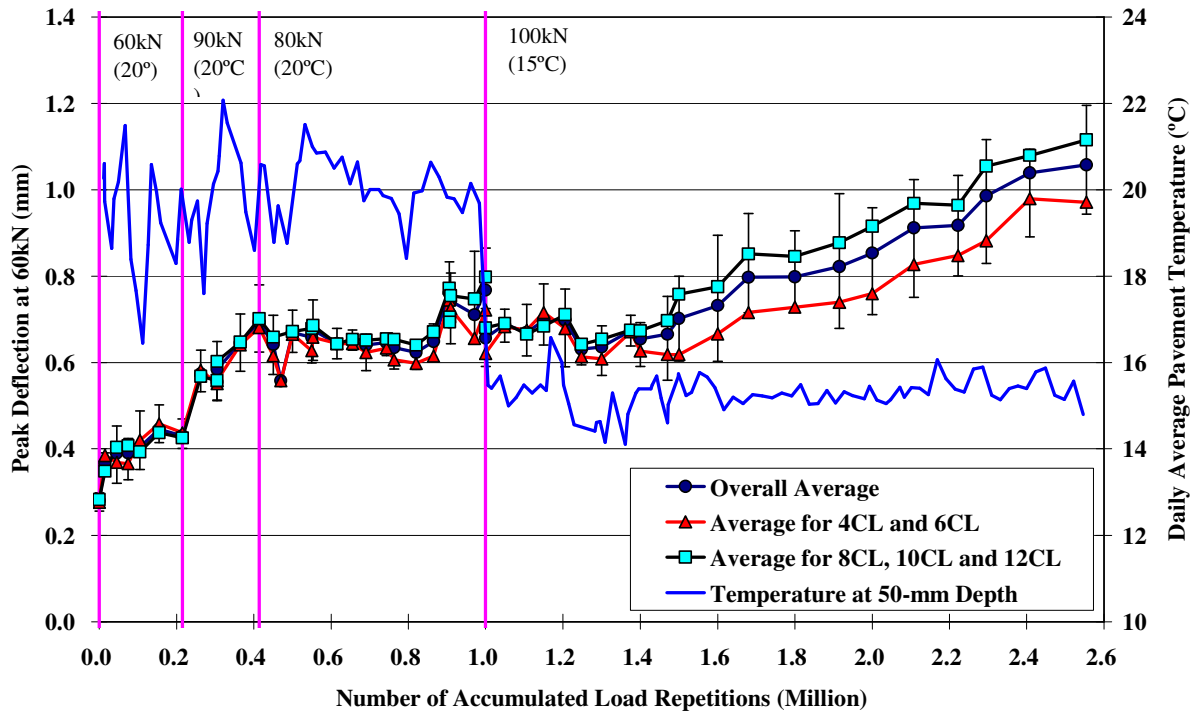
Figure 3.14: Centerline RSD surface deflections with 60 kN test load (average and subsection).

Figure 3.14 shows the average 60 kN deflection at centerline as well as the averages for measurements taken at the end of the section with more severely cracked DGAC underneath (Stations 8CL, 10CL and 12CL) and the end with less severe cracking (Stations 4CL and 6CL). The difference in deflections is evident between the two ends. In Figures 3.13 and 3.14, some sensitivity of RSD deflection to temperature is apparent, for example at the load changes at 415,000 and 1,000,000 repetitions, and at approximately 850,000 and 1,300,000 repetitions. The influence of temperature on deflection will be discussed in the second-level analysis report. The sensitivity of the RSD to a load reduction is evident in the early phase of 80 kN loading.

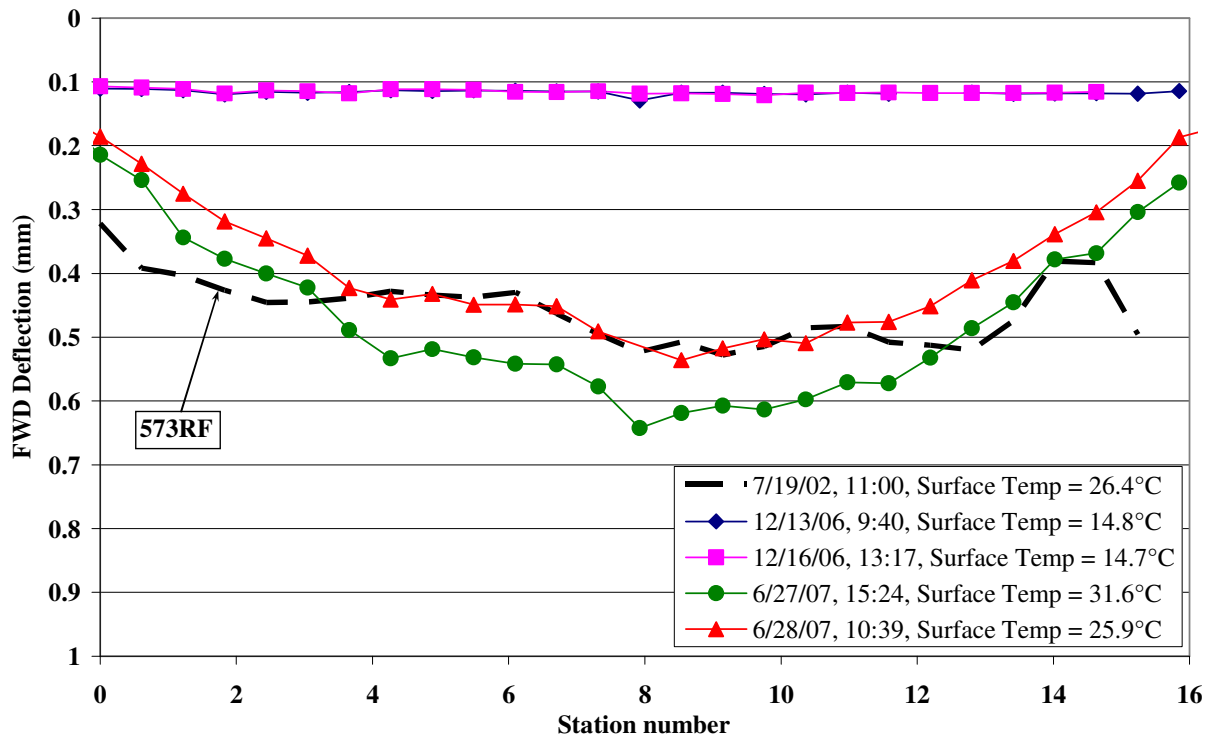
**Figure 3.15: Composite pavement stiffness (FWD Sensor 1) on section centerline.**

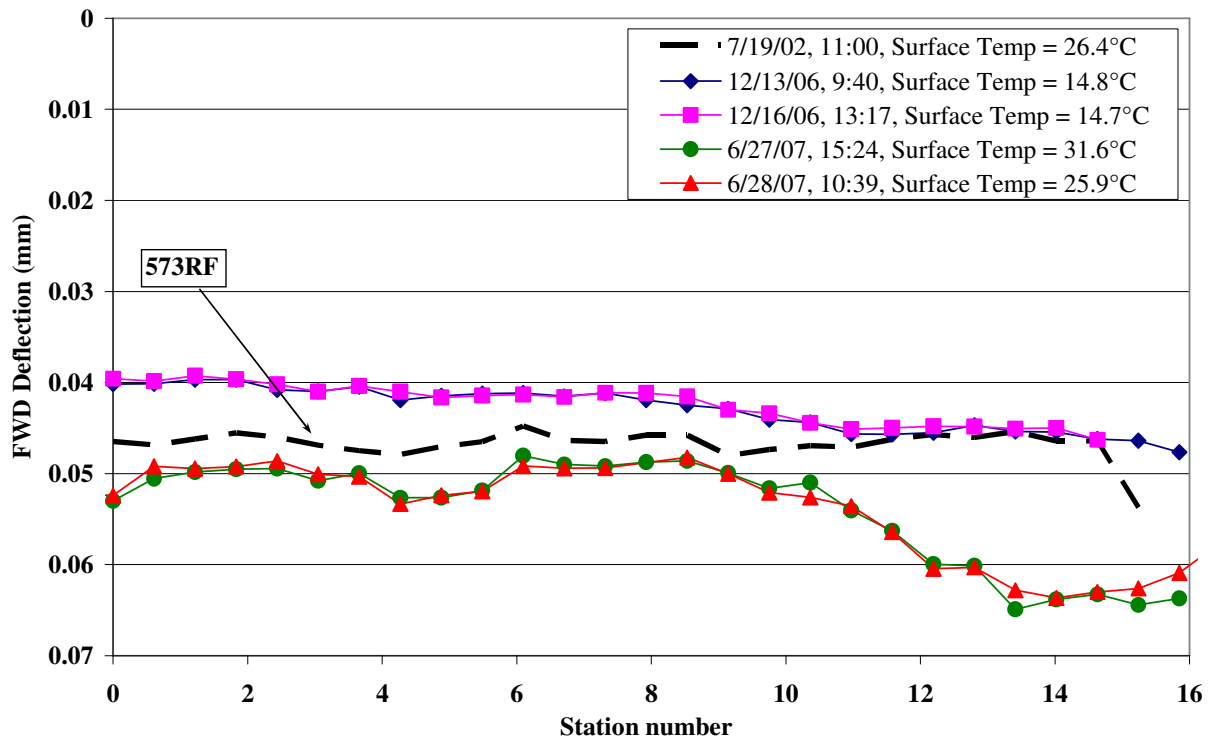
**Figure 3.16: Subgrade pavement stiffness (FWD Sensor 6) on section centerline.**

Figure 3.16 shows deflections in the subgrade before and after the test. These measurements indicate that there was no significant change (<0.02 mm) during the course of the experiment, although the subgrade

between Stations 10 and 14 appeared slightly less stiff than the remainder of the section. The overlay did not provide any significant structural improvement to the overall pavement structure in terms of protection of the subgrade. No temperature sensitivity was noted in the measurements.
