Research Report: UCPRC-RR-2007-04

# Reflective Cracking Study: First-Level Report on HVS Testing on Section 591RF — 45 mm MAC15TR-G Overlay

Partnered Pavement Research Program (PPRC) Contract Strategic Plan Element 4.10:  
Development of Improved Rehabilitation Designs for Reflective Cracking

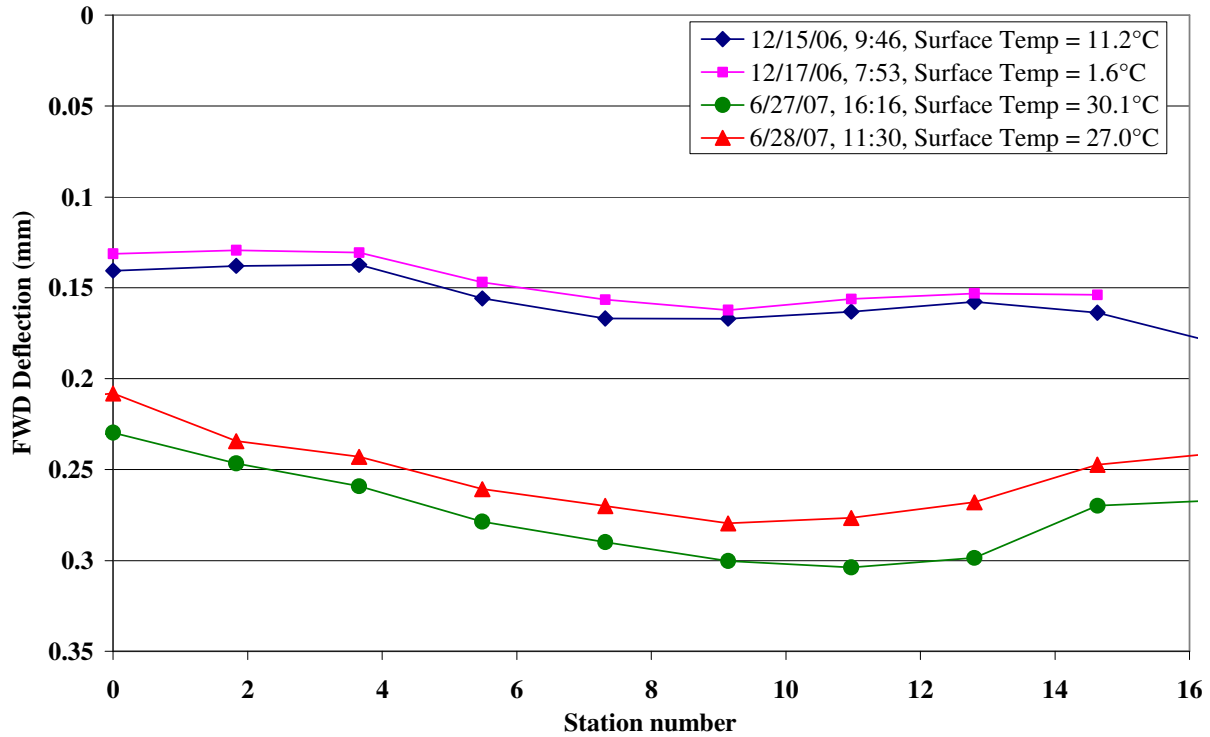
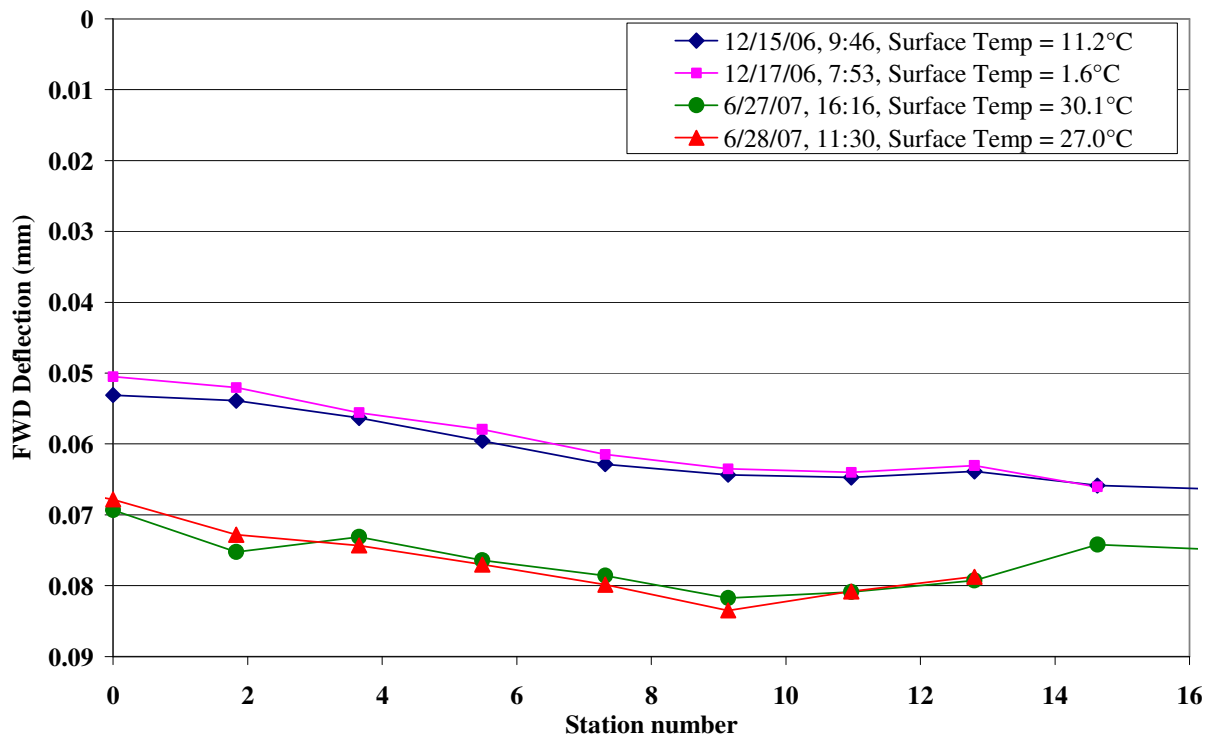
Figure 3.17: Composite pavement stiffness (FWD Sensor 1) outside trafficked area.

Figure 3.18: Subgrade pavement stiffness (FWD Sensor 6) outside trafficked area.

Figures 3.17 and 3.18 show FWD deflections taken along the side of the HVS test section but outside the trafficked area (i.e., the area tested did not have traffic damage). The figures can be used to understand the influence of environmental conditions on the performance of the section. The figures generally show slightly higher deflections after completion of testing compared to before testing. This is attributed to the effects of moisture (wetting and drying) over the course of testing. The off-section deflections did not appear to be significantly influenced by temperature.

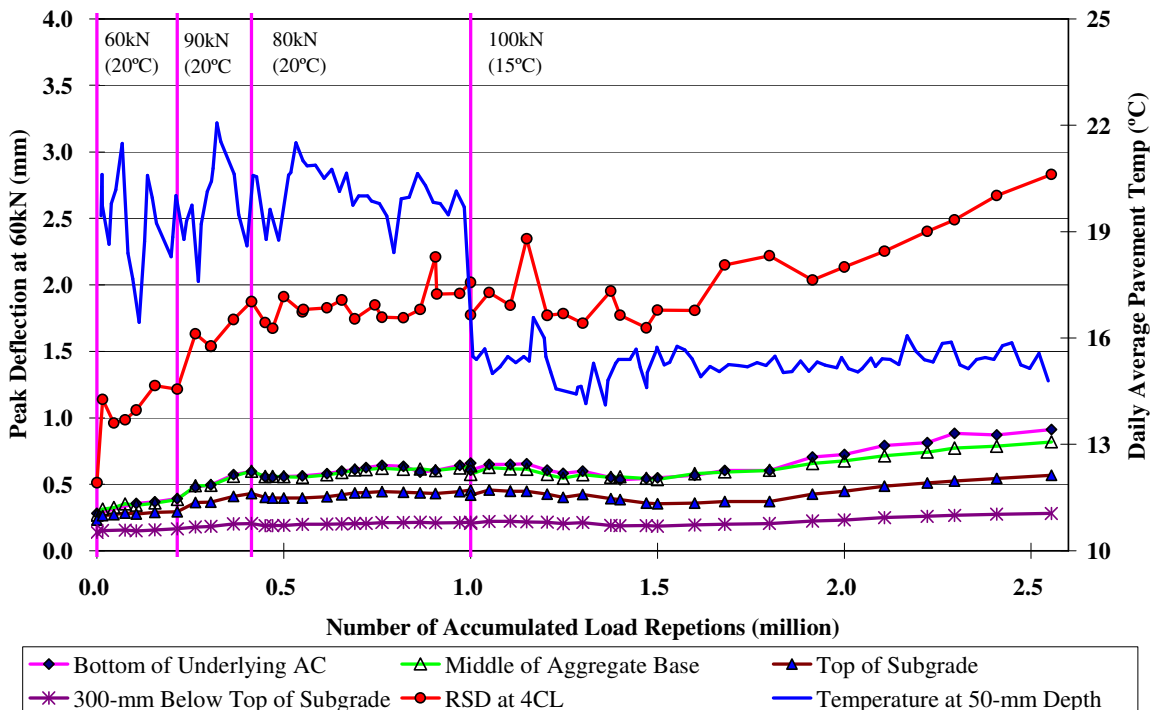
**Figure 3.19: Elastic deflections at MDD4 with 60 kN test load.**

The data indicate that most of the damage occurred in the asphalt concrete layers with similar performance recorded in the base and subgrade at both MDDs. A slightly higher damage rate was recorded at the top of the aggregate base at MDD12 compared to that recorded at MDD4, which was attributed to the higher crack density in the DGAC layer at this end of the section. Most damage occurred in the early stages of the test during the 60 kN and 90 kN loading phases. Very little increase in damage was recorded during the 80 kN and early stages of the 100 kN loading periods. The damage rate increased again after approximately 1.5 million repetitions had been applied. Some temperature sensitivity was noted at the top and middle of the aggregate base at the 100 kN load change when the pavement temperature was reduced to 15°C. Below the surfacing layers, the effect of trafficking load on elastic deflection decreased with increasing depth, as expected. Ratios of final-to-initial MDD deflections were similar for both MDDs with ratios at the bottom of the DGAC lower than at the surface. The ratios indicate that most damage occurred in the surfacing layers and top of the aggregate base. Some of the damage in the aggregate base could be attributed to recementation in the aggregate base materials (recycled construction waste) during wetting and drying cycles, and subsequent breakdown under trafficking.

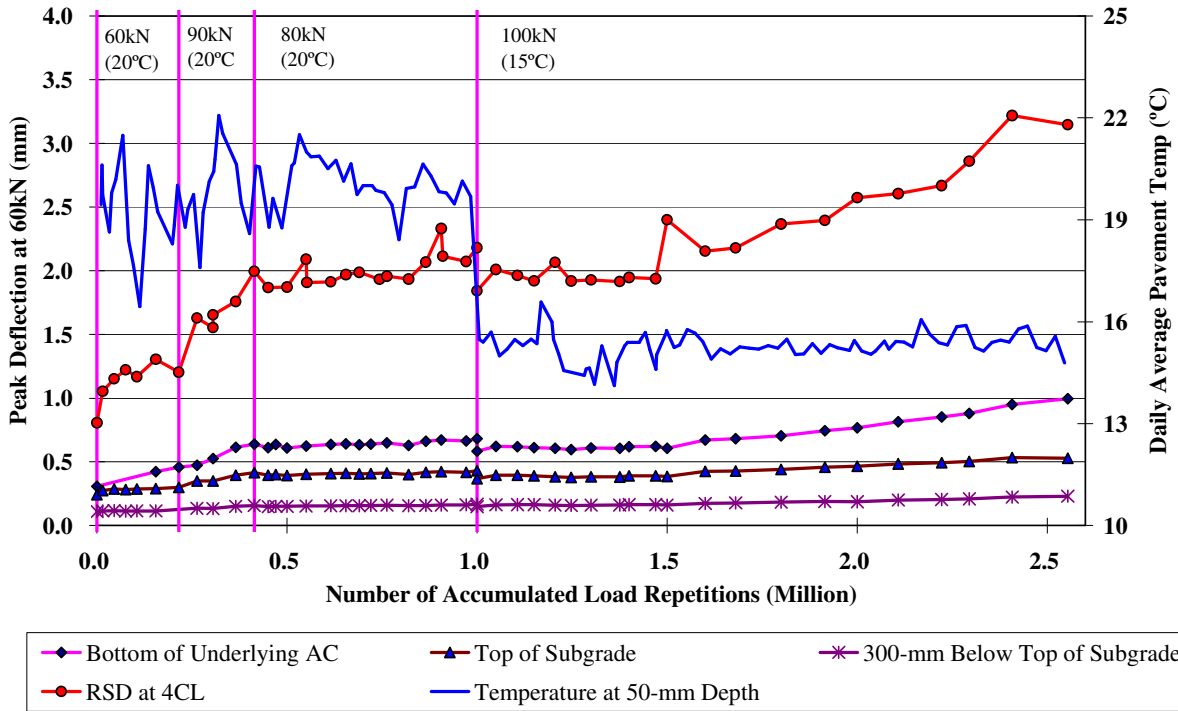
**Figure 3.20: Elastic deflections at MDD12 with 60 kN test load.**

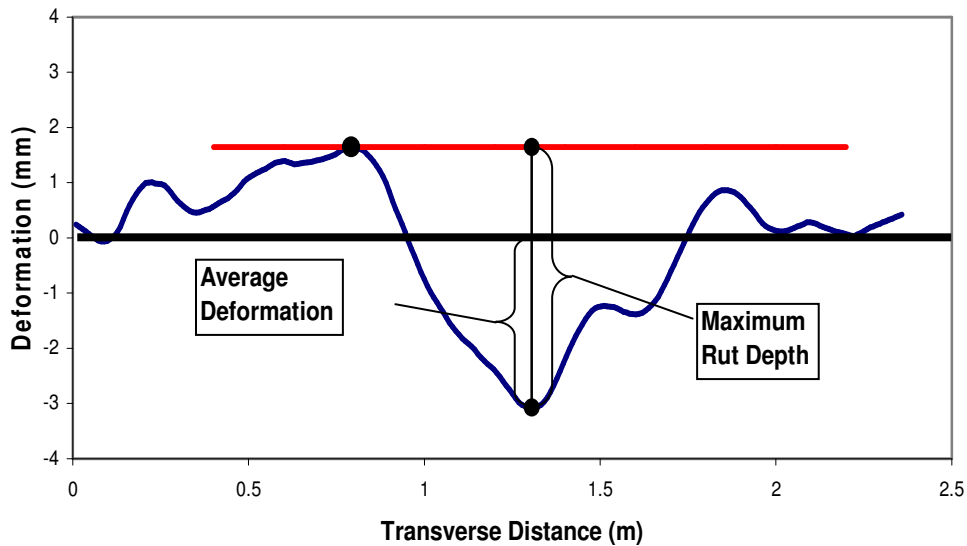
**Figure 3.21: Illustration of maximum rut depth and average deformation of a leveled profile.**

Deformation and rutting on HVS tests are usually analyzed using two definitions, namely maximum rut depth and average deformation (4), as illustrated in Figure 3.21. The Laser Profilometer is used to measure these distresses and provides sufficient information to evaluate the evolution of permanent surface deformation of the entire test section at various loading stages.

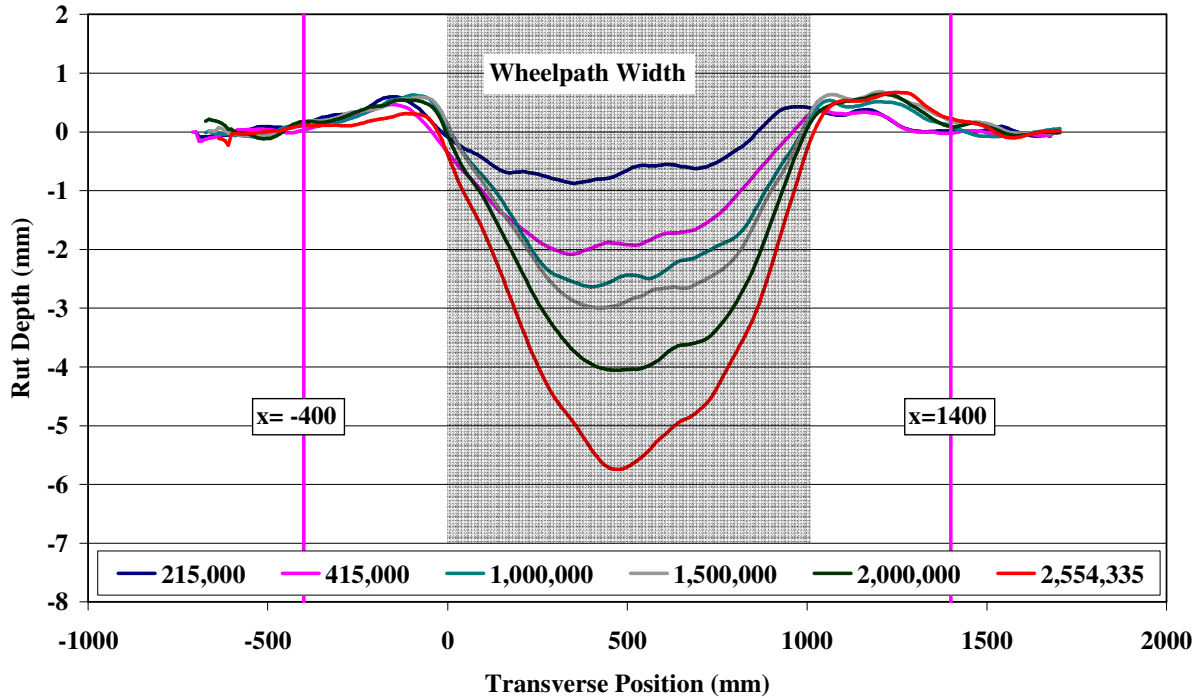
**Figure 3.22: Laser profilometer cross section at various stages of trafficking.**

Figure 3.22 shows the average transverse cross section measured with the Profilometer at various stages of the test. This plot clearly shows the increase in rutting and deformation over the duration of the test.

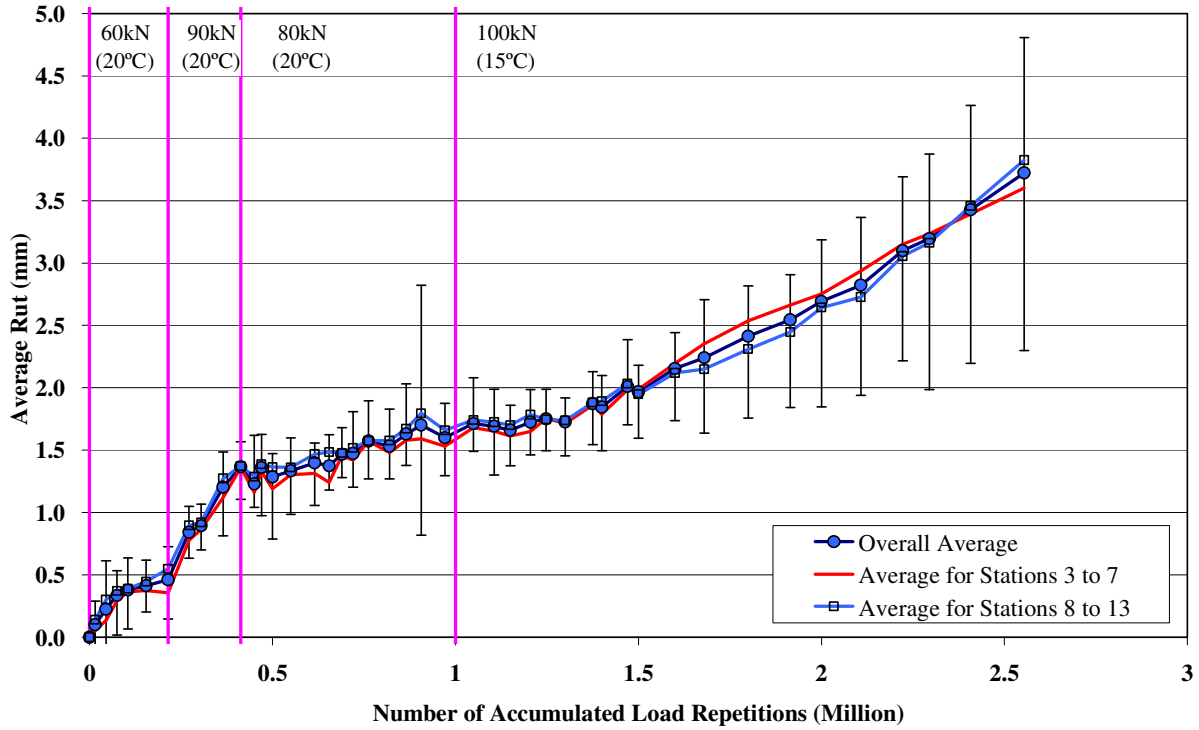
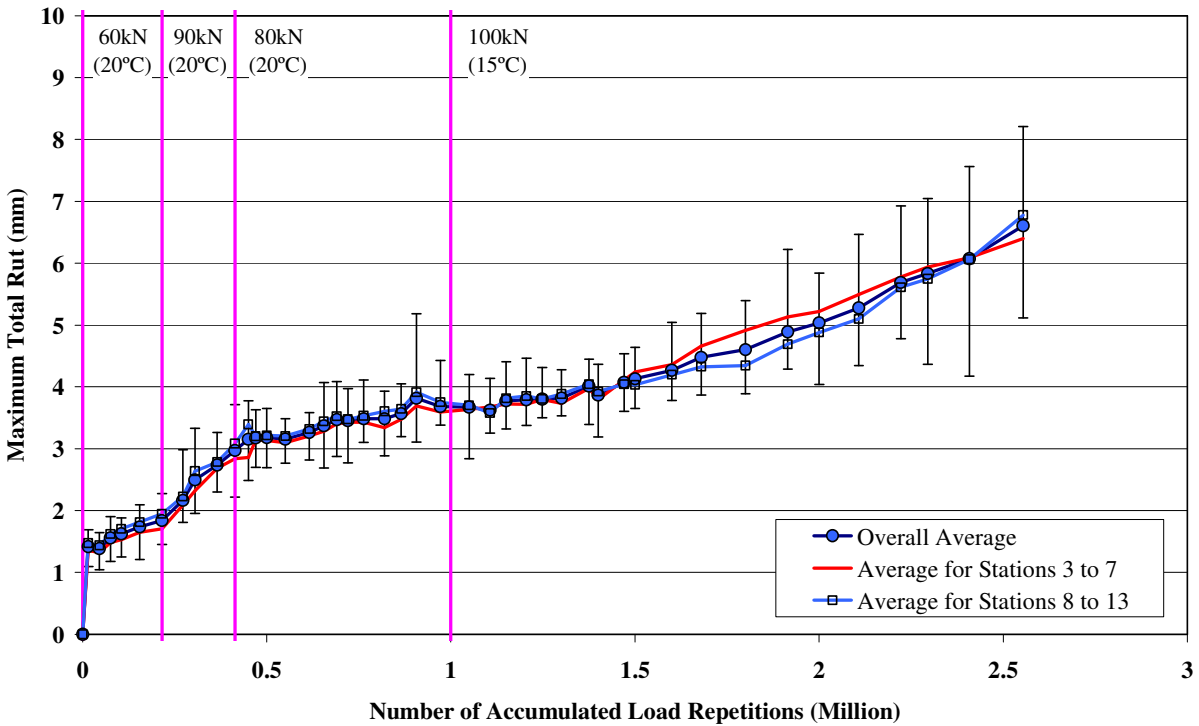
Figure 3.23: Average deformation determined from Laser Profilometer data.

Figure 3.24: Average maximum rut determined from Laser Profilometer data.

During HVS testing, rutting usually occurs at a high rate initially, then typically diminishes as trafficking progresses until reaching a steady state. If the load level is subsequently increased, the pavement will undergo another phase of rapid rutting development until a steady phase for that new load level is reached. This initial phase is referred to as the “embedment” phase. Figures 3.23 and 3.24 show the development of permanent deformation (average deformation and maximum rut, respectively) with load repetitions as determined by the Laser Profilometer for the test section. *Note that the scales in the figures are different.* Embedment phases are apparent at the beginning of the experiment and at the 90 kN load change. Error bars on the average reading indicate variation along the length of the section and show a consistently increasing difference over the section over the duration of the test (3.0 mm at the end of the test). The figures also show average deformation and average maximum rut for Stations 3 to 7 and 8 to 13. There is very little difference between the two sub-sections, indicating that the cracking in the underlying layer did not have a significant influence on rutting performance. The rate of deformation remained relatively constant throughout the test indicating that the temperature change at the 100 kN load change did not influence rutting behavior.

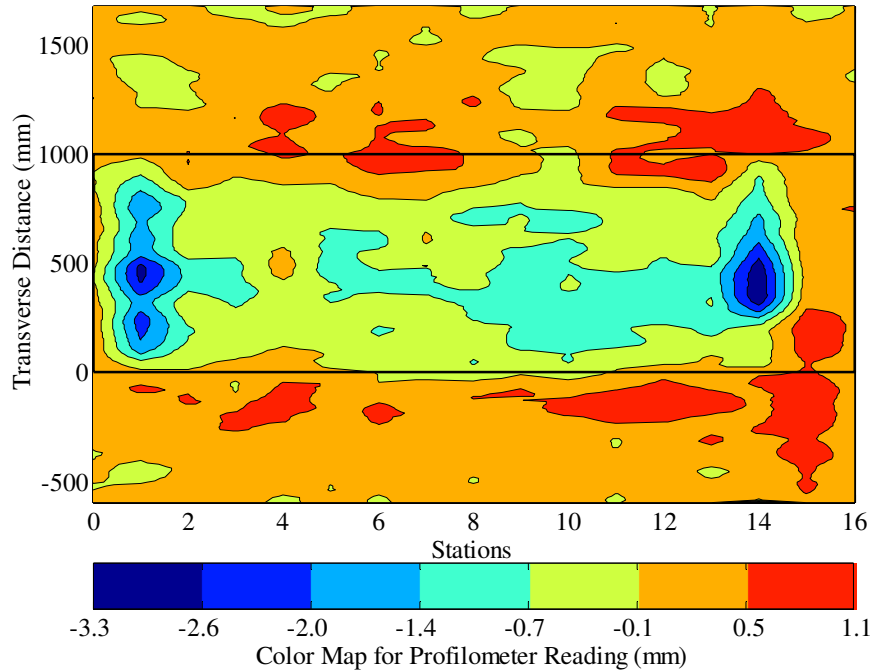
**Figure 3.25: Contour plot of permanent deformation after 215,000 repetitions.**

Figure 3.25 shows a contour plot of the pavement surface at the 90 kN load change (215,000 repetitions), when a noticeable rut had started to appear at each end of the section.

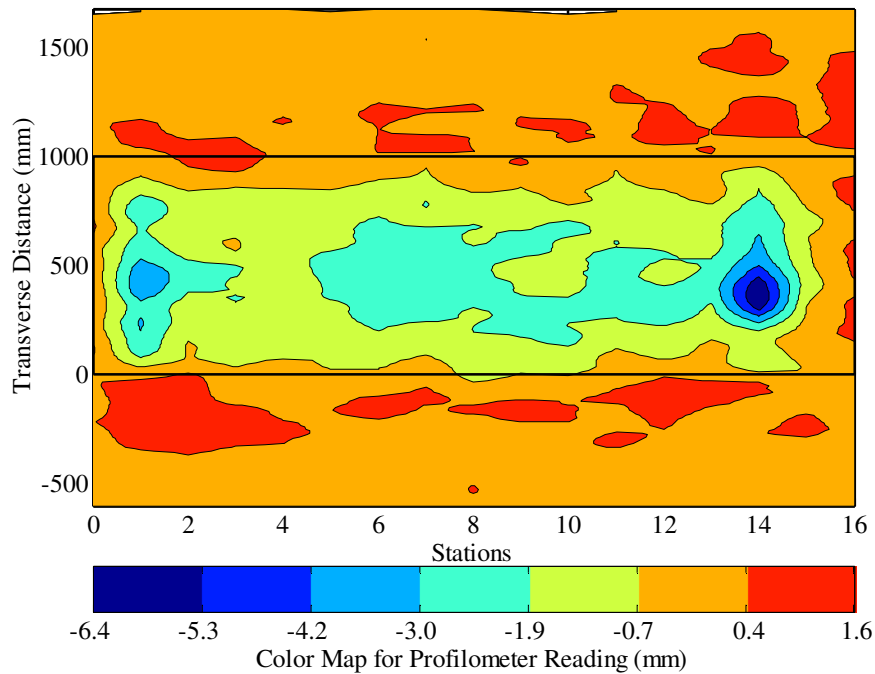
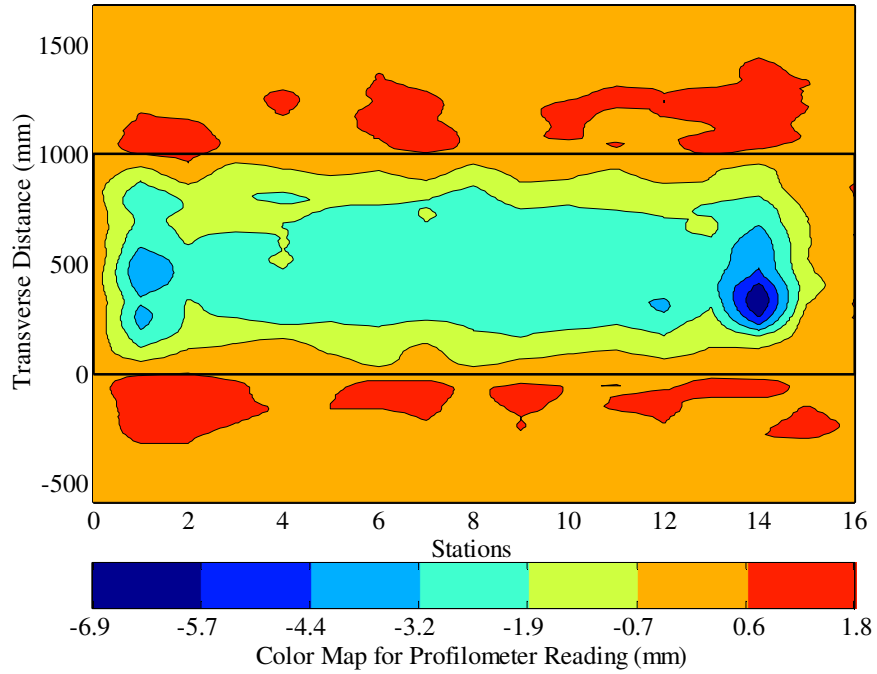
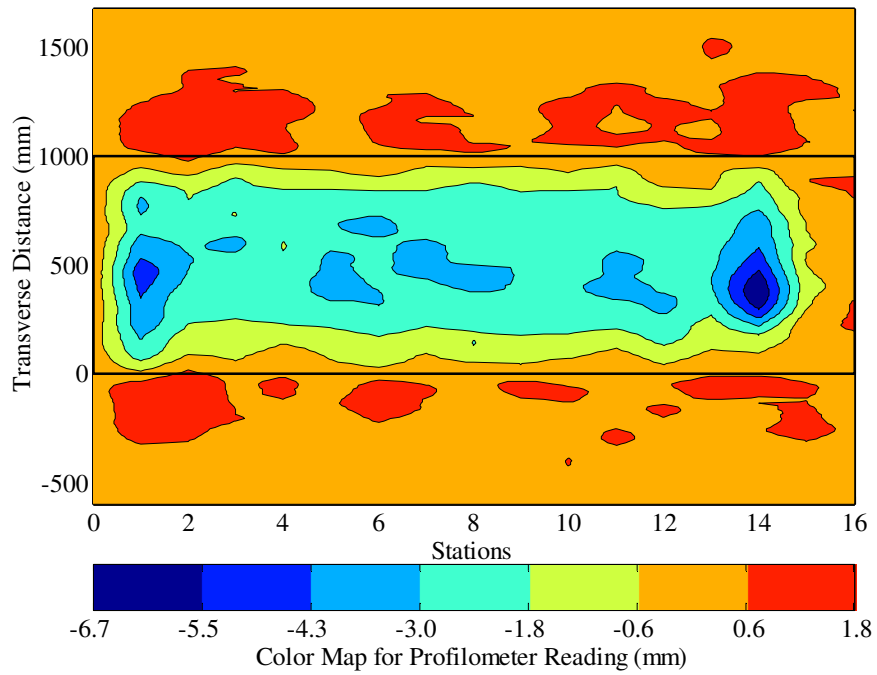
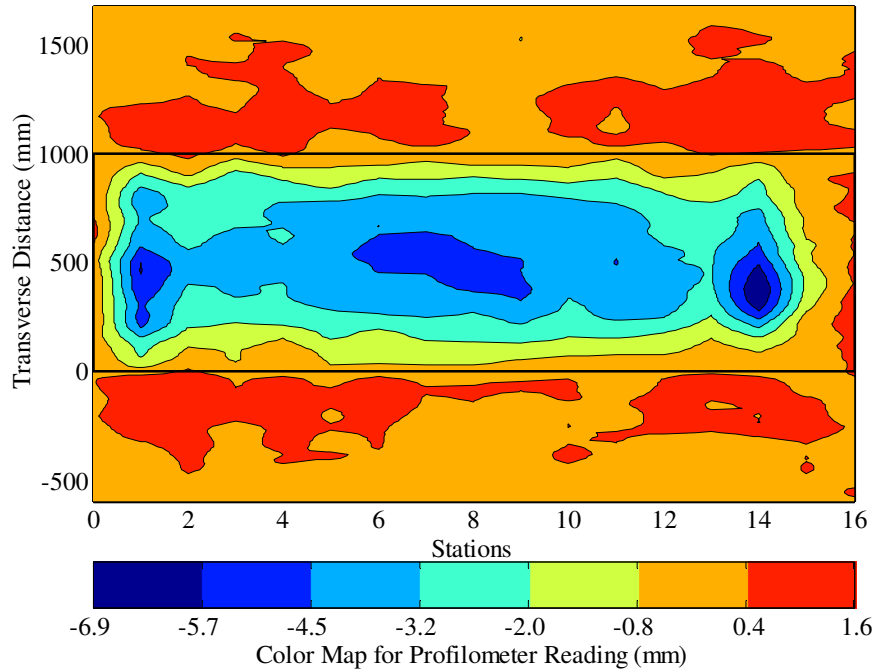
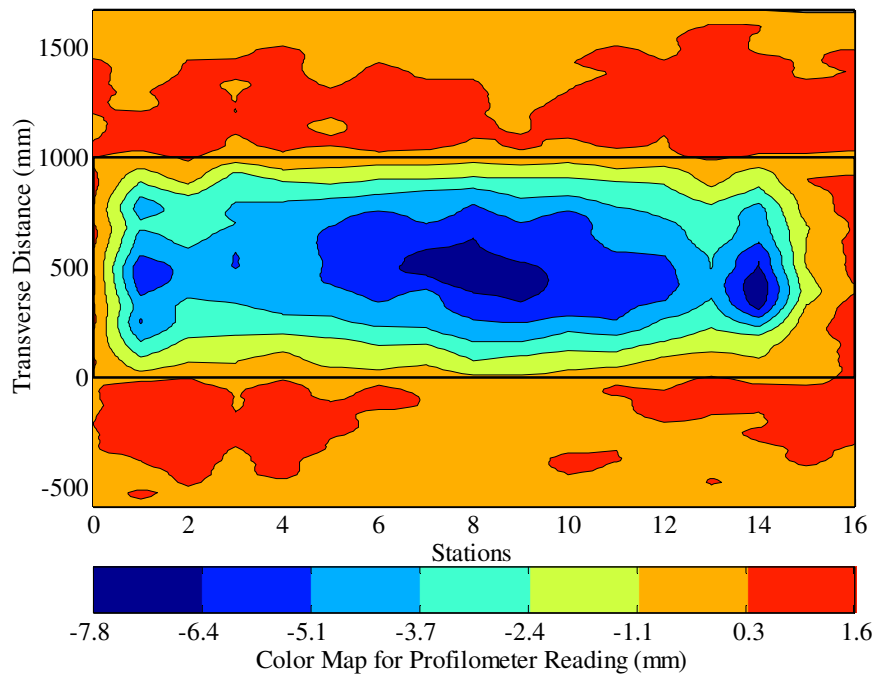
**Figure 3.26: Contour plot of permanent deformation after 410,000 repetitions.**

**Figure 3.27: Contour plot of permanent deformation after 1,000,000 repetitions.**

**Figure 3.28: Contour plot of permanent deformation after 1,500,000 repetitions.**

**Figure 3.29: Contour plot of permanent deformation after 2,000,000 repetitions.**

**Figure 3.30: Contour plot of permanent deformation at end of test (2.55 million repetitions).**

Figures 3.26 through 3.30 show contour plots of the rutting progression at the 80 kN (410,000 repetitions) and 100 kN (one million repetitions) load changes, at 1.5 and 2.0 million repetitions, and at the end of the test (2.55 million repetitions). The increase in rutting throughout the test is evident in the figures.

After completion of trafficking, the average deformation and the average maximum rut depth were just 1.7 mm and 4.6 mm respectively. The maximum rut depth measured on the section was 8.2 mm, at Station 8, which was in the vicinity of the most densely cracked area in the underlying DGAC. The

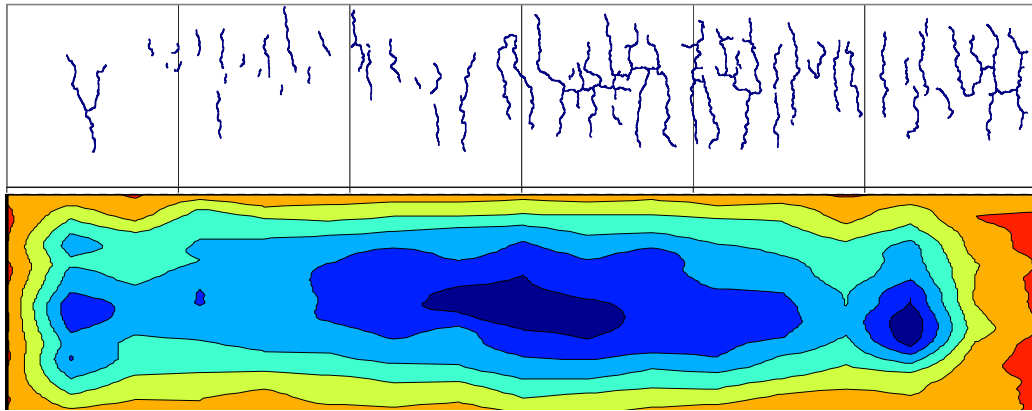
**Figure 3.31: Comparison of cracking pattern from Phase 1 and rutting in Phase 2.**

average maximum rut depth at the end of the test was significantly less than the failure criterion of 12.5 mm. However, in the interest of completing the reflective cracking study trafficking was stopped after discussion with Caltrans (6). The final surface rutting pattern of the overlay generally corresponds with the fatigue cracking pattern of the cracked DGAC layer, as shown in Figure 3.31, with the deepest rut occurring in the area with the most severe cracking in the underlying layer.

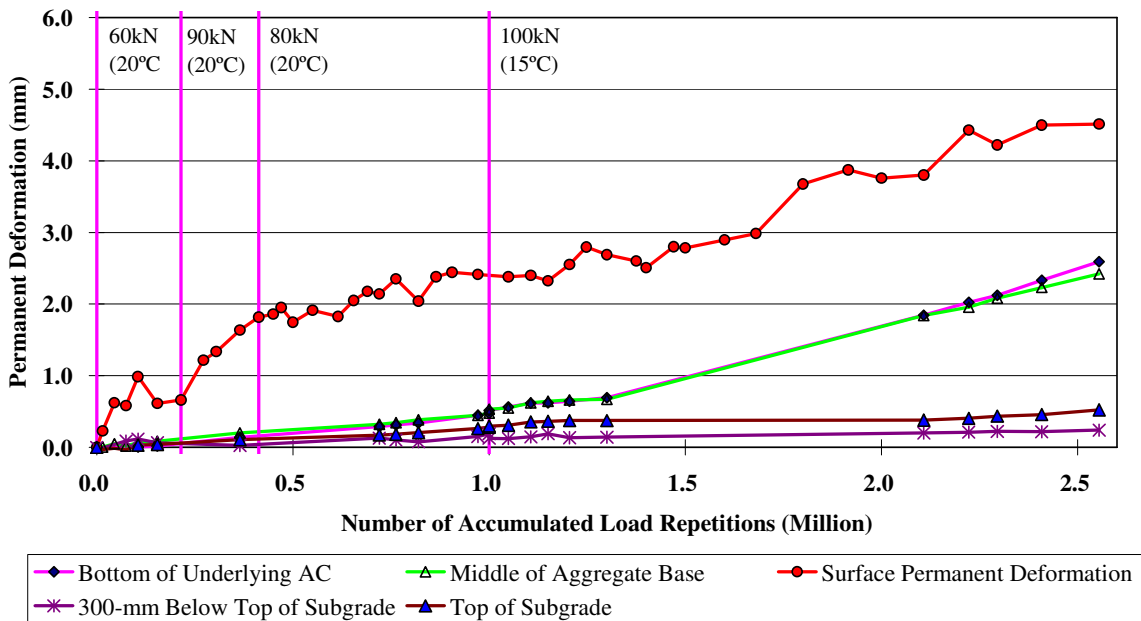
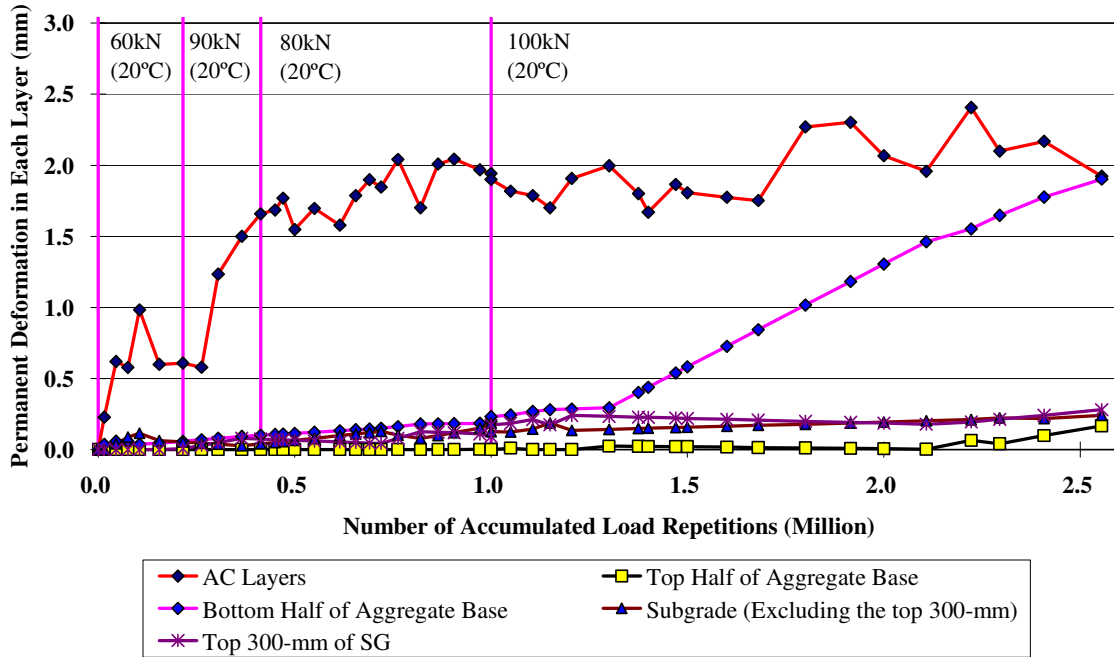
**Figure 3.32: In-depth permanent deformation at MDD4.**

Figure 3.33: In-depth differential permanent deformation of various layers at MDD4.

Relatively little permanent deformation was recorded on this experiment. For the first one million repetitions, most of the permanent deformation recorded occurred in the overlay and cracked DGAC layers (between 80 and 90 percent), followed by the aggregate base (between 10 and 14 percent), and then the subgrade (between zero and 6 percent). At the end of the test, the deformation recorded in the base (between 30 and 40 percent) and subgrade (between 6 and 9 percent) was higher than that recorded in the earlier part of the test. Permanent deformation in the surface layers at the end of the test was consequently lower (between 55 and 60 percent). The highest permanent deformation occurred in the area with more cracking in the underlying DGAC (MDD12).

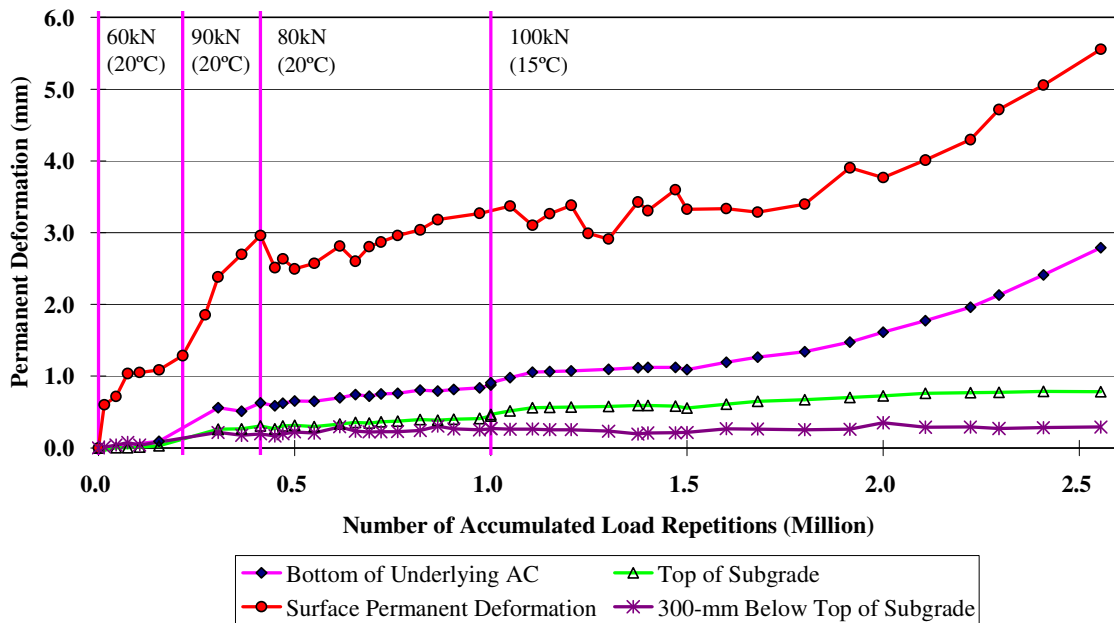
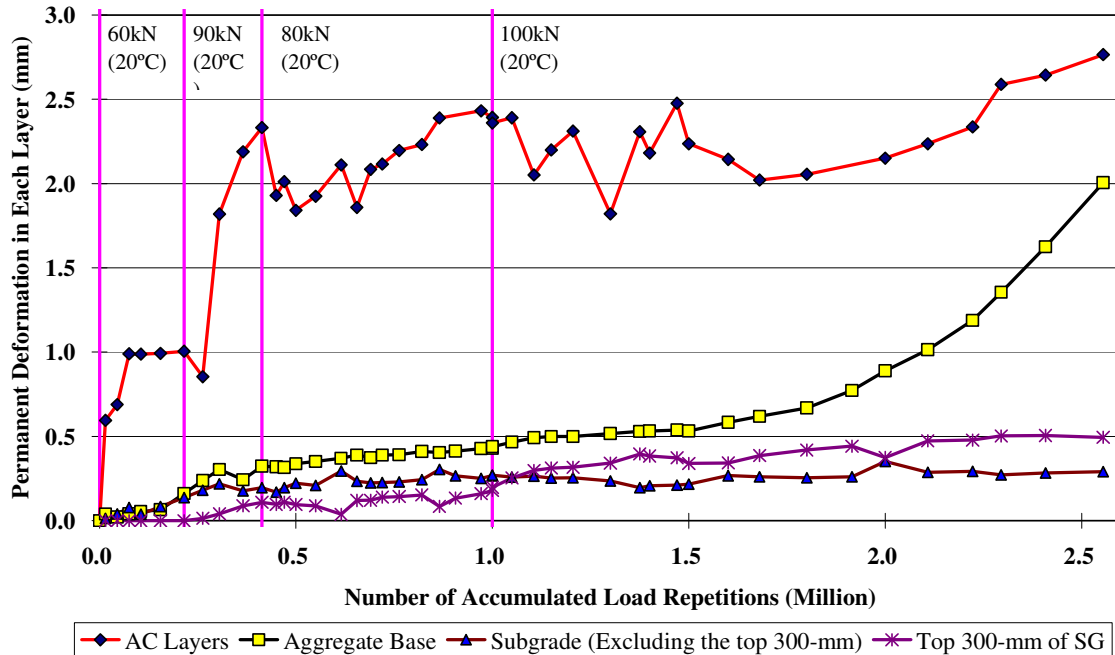
Figure 3.34: In-depth permanent deformation at MDD12.

**Figure 3.35: In-depth differential permanent deformation of various layers at MDD12.**

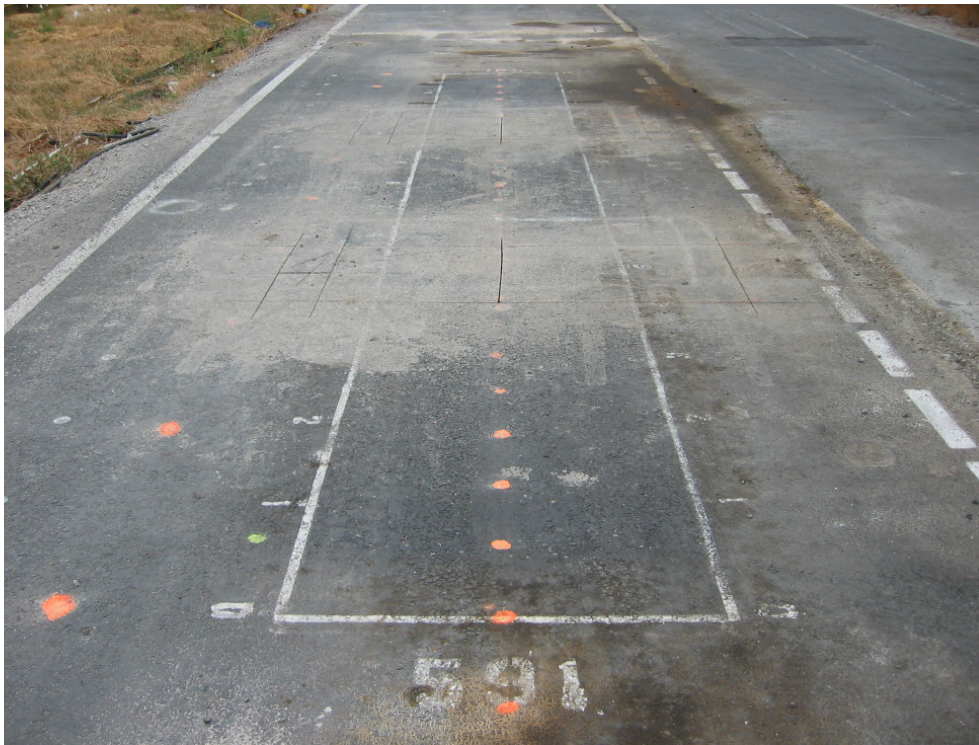
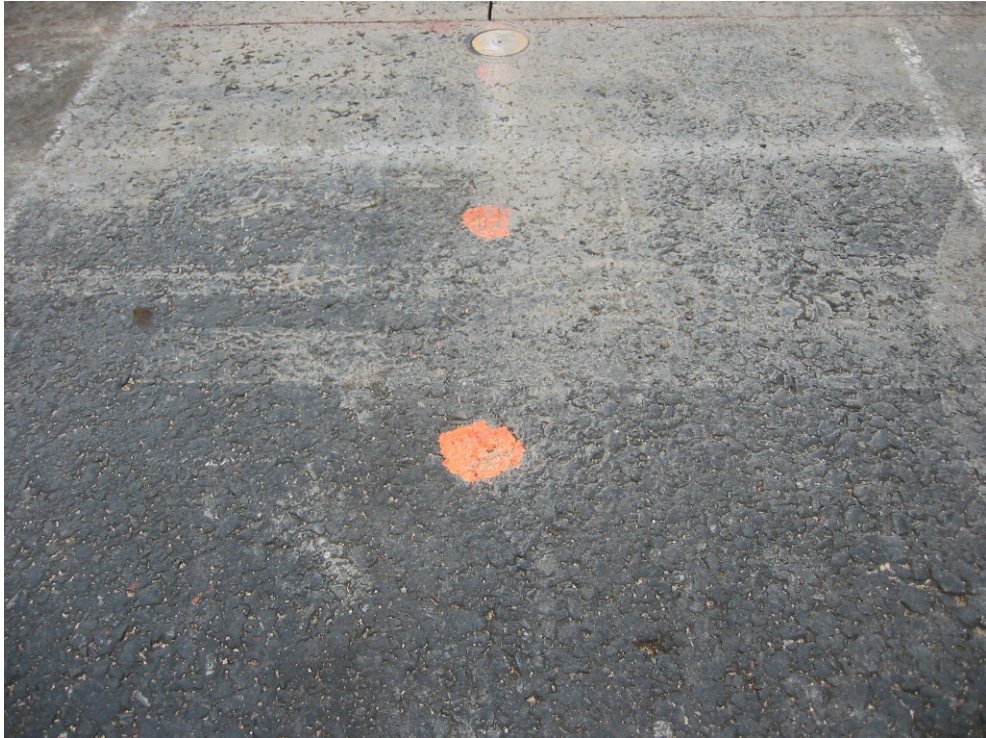
**Figure 3.36: Section surface viewed from Station 0.**

**Figure 3.37: Close-up of section surface between Stations 12 and 14.**

After 2,554,335 repetitions with increasing wheel loads (from 60 kN to 100 kN) under controlled pavement temperatures (20°C for the first one million repetitions and 15°C thereafter), no surface cracking was observed. The MAC15-G overlay thus appeared to successfully prevent any reflective cracking from the underlying layer from appearing on the surface, despite calculated ratios of final-to-initial deflections indicating that damage had occurred in the asphalt layers during the course of trafficking. Photographs of the section after trafficking are shown in Figures 3.36 and 3.37.
