Performance of Drained and Undrained Flexible Pavement

Structures under Wet Conditions

Accelerated Test Data

Test Section 544–Undrained

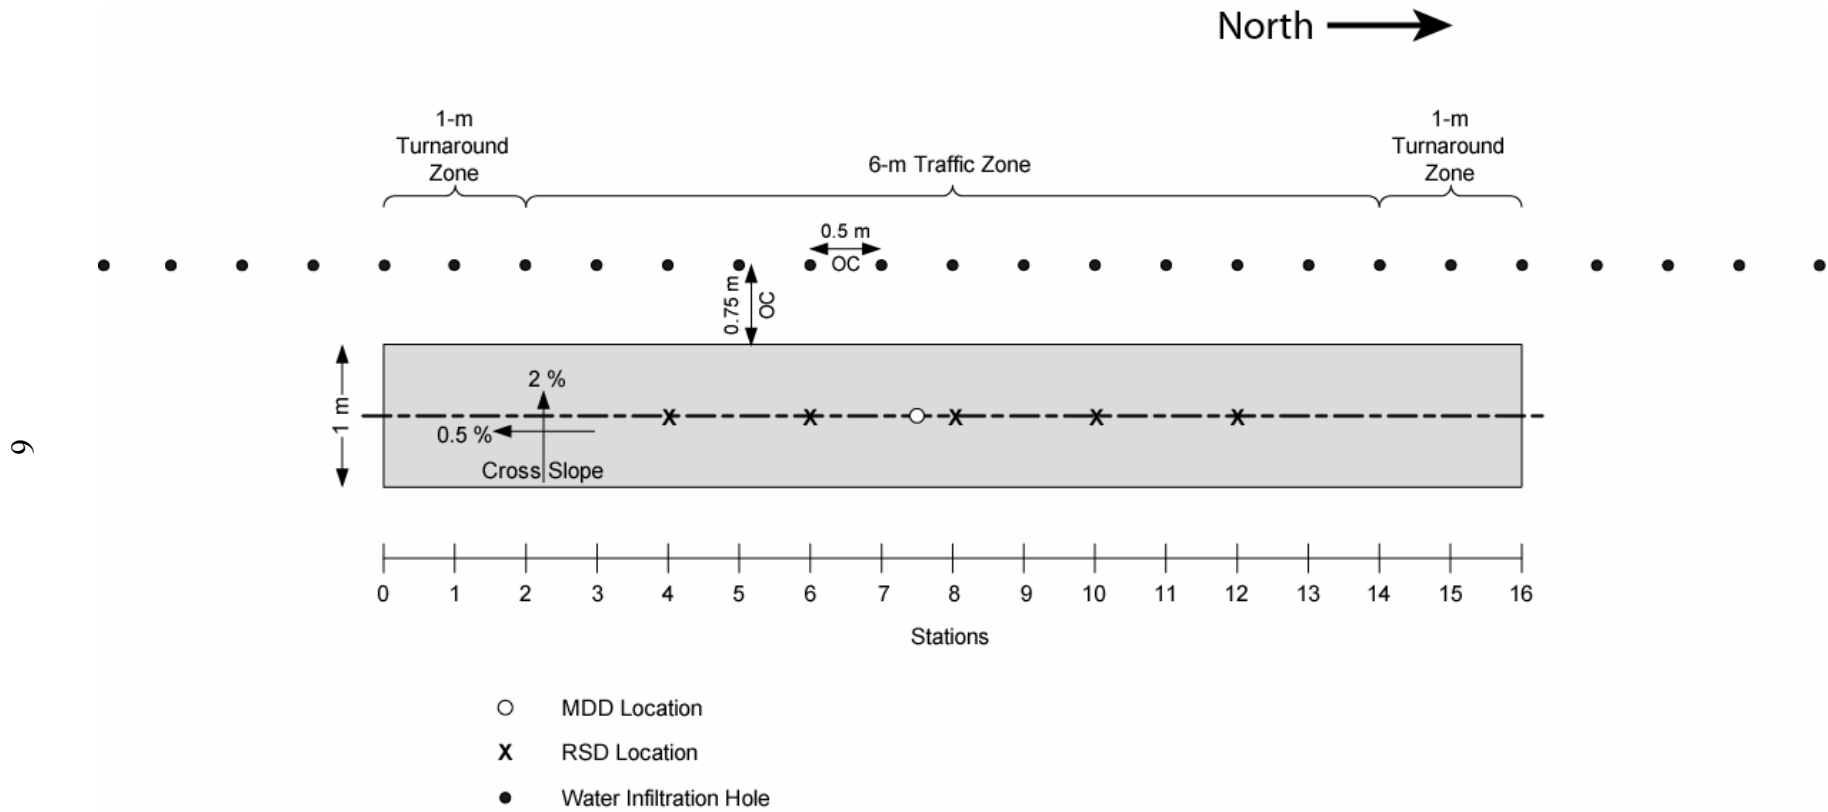
Figure 1. Test section layout and instrumentation.

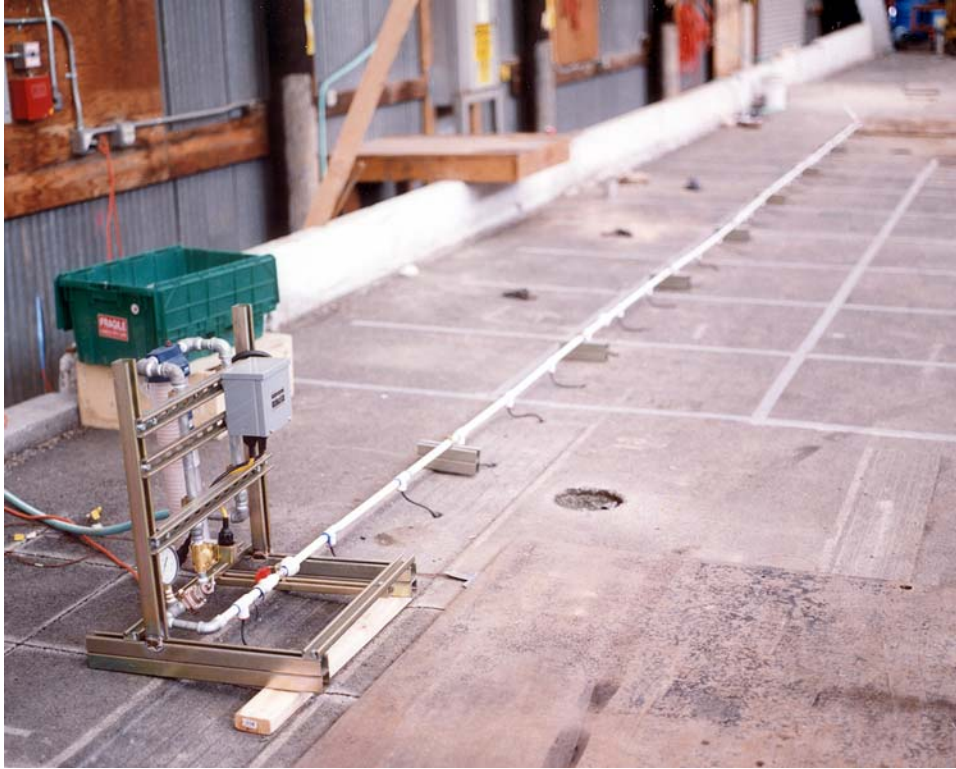
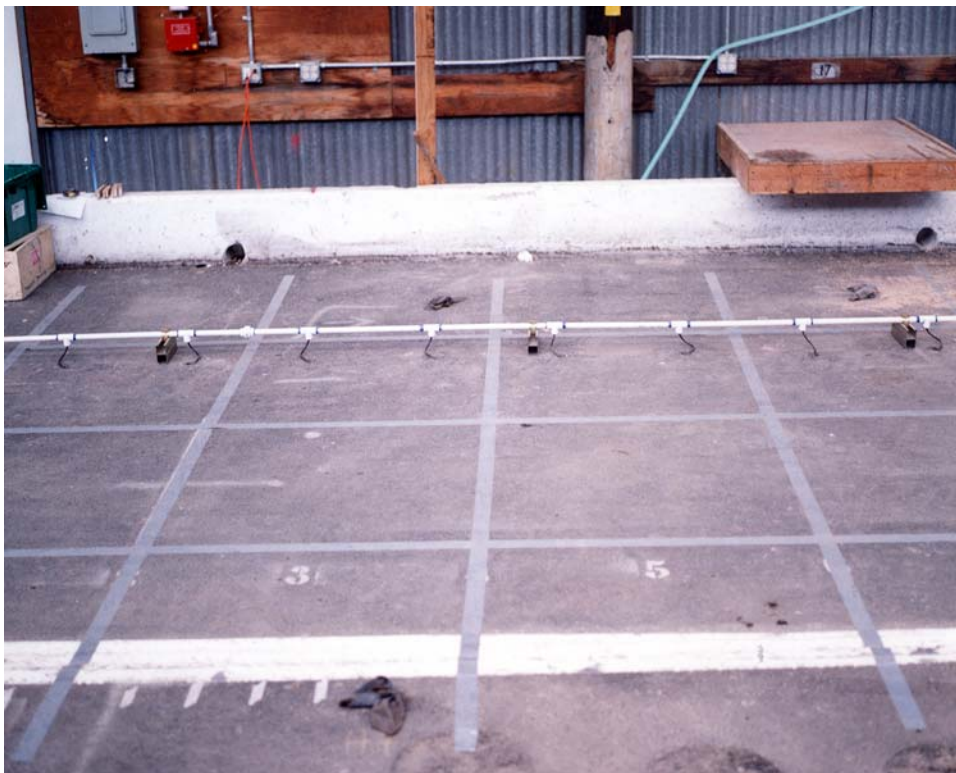
Figure 2. Water infiltration system on Section 544..

The accelerated pavement test was conducted under wet conditions at moderate pavement temperatures. Wet conditions were simulated by introducing water into the aggregate layers by means of a drip infiltration system. The infiltration system consisted of a series of 2.5-cm holes drilled through the asphalt concrete at 0.5-m intervals along a 12-m length just outside the trafficked area of the pavement (Figure 1). Drip hoses were inserted in each hole and attached to a main pump and timing system. At the end of each drip hose was a nozzle which regulated the flow. Figure 2 is a photograph of the system in place.

The design rate of water infiltration into the aggregate base was 9.7 liters per hour over an area 7.4 m wide by 12 m long. This flow was calculated to simulate precipitation for an average peak week in Eureka of 51.3 mm rainfall.(2) However, because the rate at which the aggregate base would accept water infiltration was lower than the design rate, the flow was reduced to the maximum possible (approximately 0.4 liters per hour).

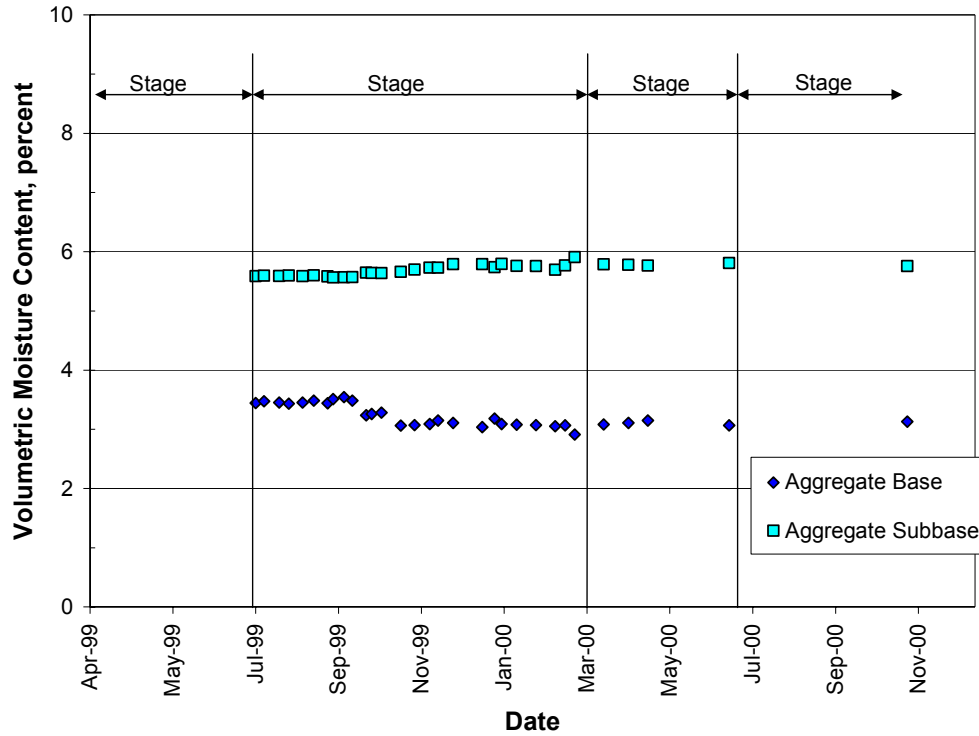
Figure 8. Volumetric moisture content in the aggregate base and subbase.

Average volumetric moisture contents for the aggregate base, subbase, and subgrade materials obtained using a hydroprobe device are shown in Figures 8 and 9. Measurements for the aggregate base and subbase were obtained at depths of 320 and 586 mm from the pavement surface, respectively, while hydroprobe readings for the subgrade were obtained at pavement depths of 859, 1159, and 1735 mm.

Volumetric moisture contents of the base and subbase were averaged across measurements taken for those layers. Figure 8 shows that the moisture content of the untreated bases remained relatively constant through all stages of testing. Moisture contents were expected to increase at least in the aggregate base due to water infiltration.

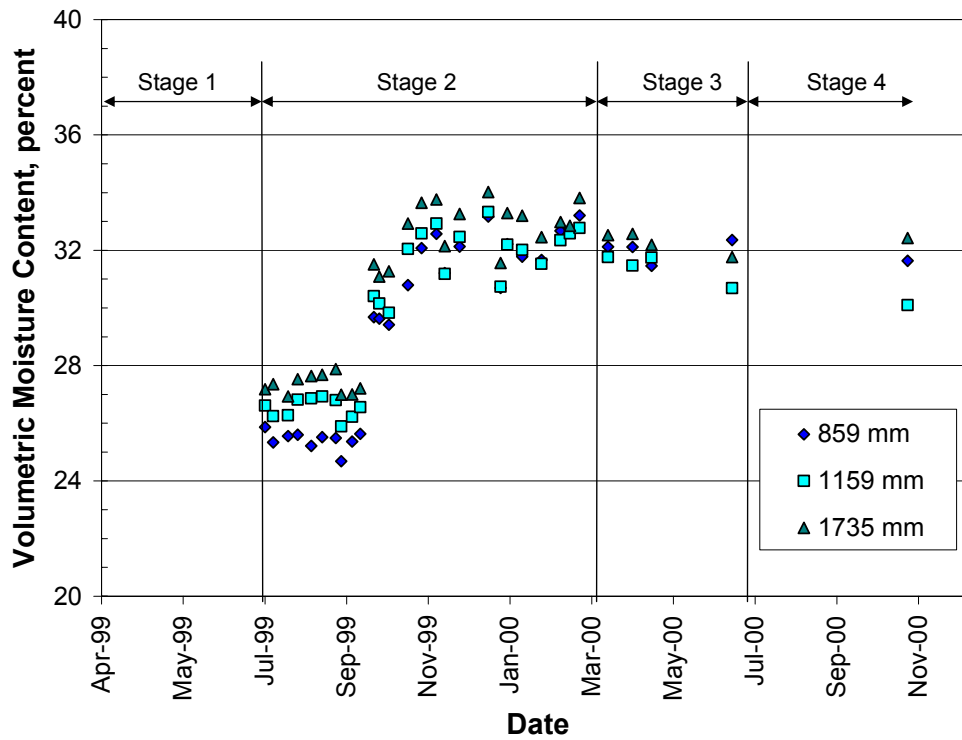
Figure 9. Volumetric moisture content in the subgrade.

Moisture contents for the subgrade (Figure 9) exhibit changes in line with precipitation trends (Figure 7). This was expected since the subgrade at the test site was not isolated from the surrounding soil; therefore it was subjected to the seasonal moisture variations at the site.

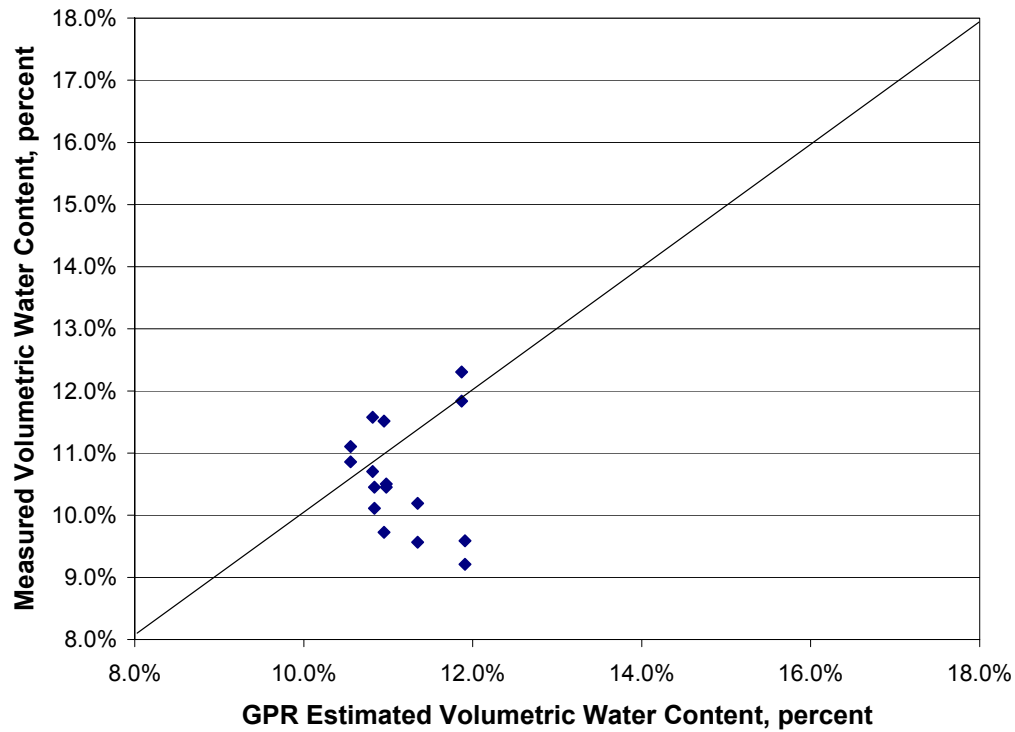
Figure 11. Comparison of GPR and gravimetric estimated volumetric aggregate base moisture contents for Section 544.

After HVS testing (Stage 3), a GPR survey was performed and the asphalt concrete was cored immediately afterwards at several locations to obtain gravimetric moisture contents in the untreated base materials (see Section 3.6 for a description of the coring activities). Gravimetric measurements were taken every 2-3 cm in the aggregate base and subbase layers, and were converted to volumetric moisture contents using the density of the layers. These measurements were then averaged across the thickness of each layer for comparison to the GPR-derived volumetric moisture content estimates from the final survey. Figure 10 shows the gravimetric moisture contents for the eight locations. Comparison of GPR and volumetric moisture contents estimated from gravimetric moisture contents for the aggregate base and subbase are shown in Figures 11 and 12, respectively.

In general, GPR-derived estimates of volumetric water contents in the aggregate base were in the range of expected values. The average absolute error was less than 0.8 percent. The estimates for the aggregate subbase had an average absolute error of 0.9 percent. The inaccuracy of the GPR-derived estimates may be caused by varying thicknesses in the aggregate base and subbase or by uneven boundaries between the layers. Test pit data indicate that the aggregate subbase had varying thickness across the section.

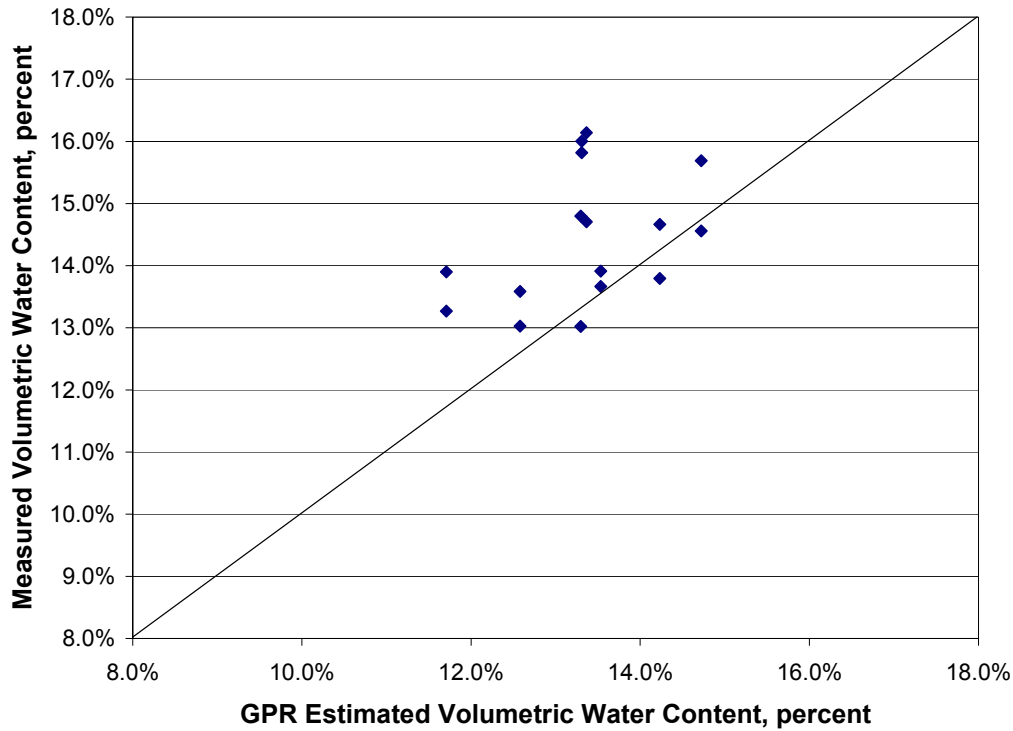
Figure 12. Comparison of GPR and volumetric subbase moisture contents estimated from gravimetric moisture contents for Section 544.

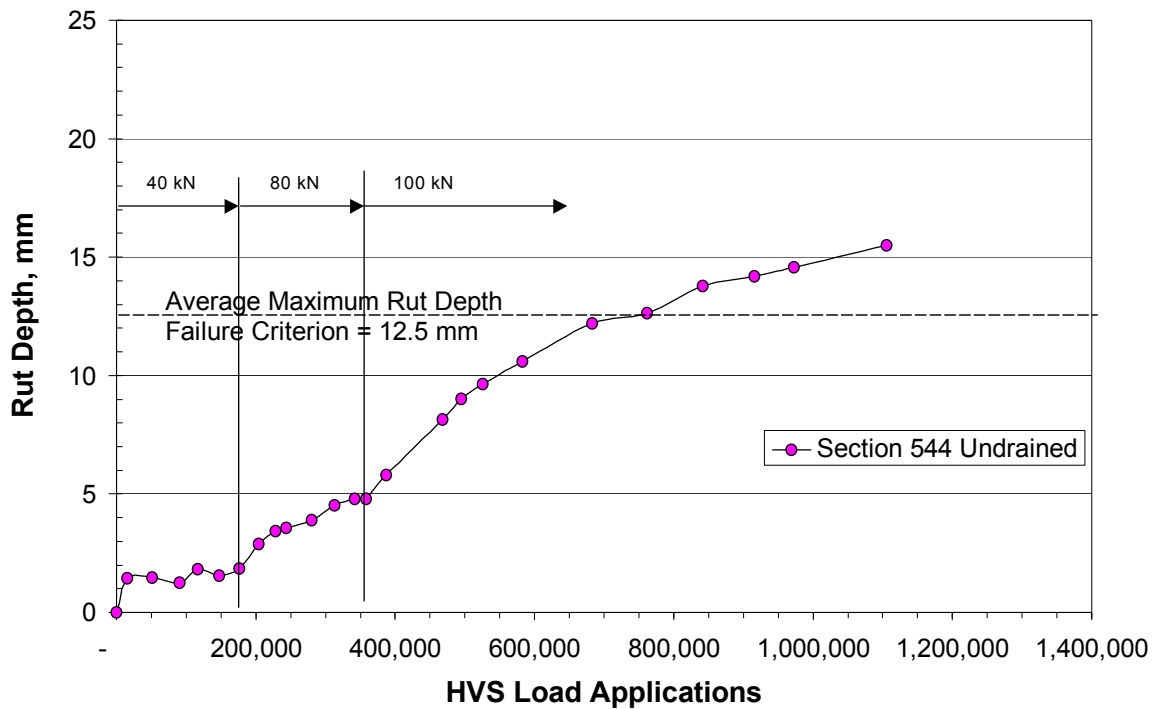
Figure 13. Average maximum rut depth versus HVS load applications for Section 544.

Figure 13 shows accumulated average maximum rut depth for Section 544. A rapid rate of surface rutting was observed under the 40-kN trafficking load during the first load applications. Thereafter, no significant accumulation of surface rutting occurs under the 40-kN load. Surface rutting again increases under the 80- and 100-kN trafficking loads, with the rate of rutting decreasing with increasing load applications. Table 4 summarizes average rates of rutting for each of the three levels of traffic loading.

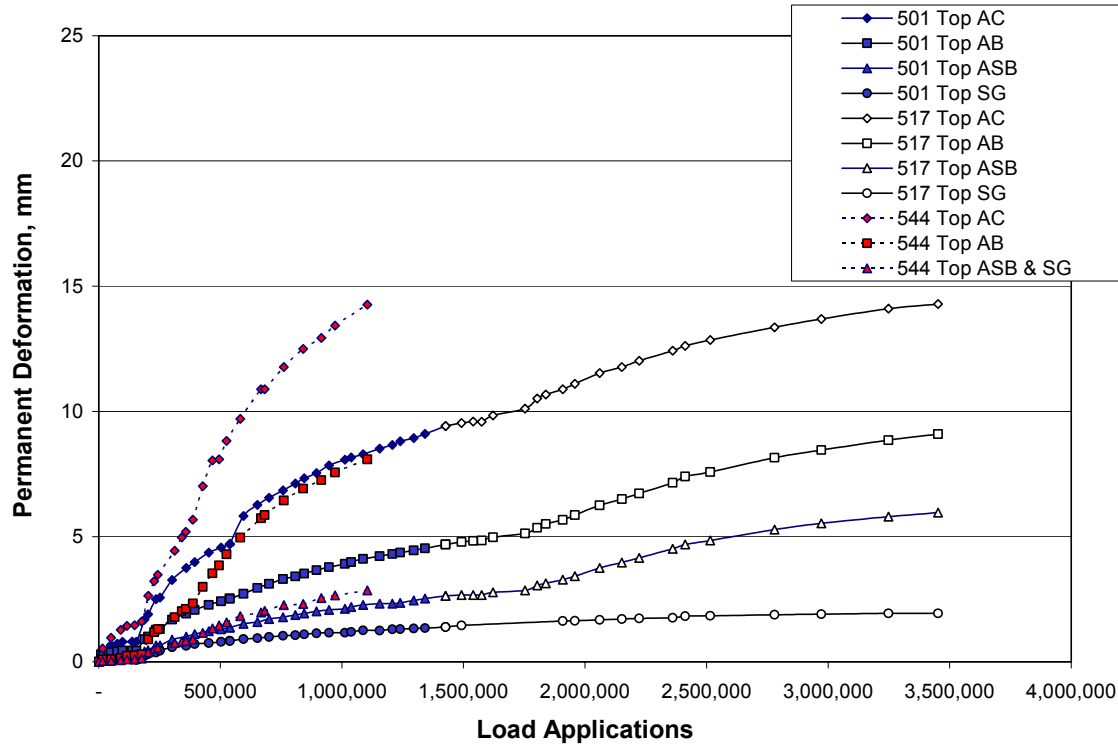
Figure 17. Comparison of in-depth permanent deformations for dry and wet sections.

Figure 17 shows in-depth permanent deformation data obtained with the MDDs for Sections 501/517. Included in dashed lines are in-depth data for Section 544. The locations of the MDDs in Sections 501/517 are similar to those for Section 544. MDDs were located near the

surface of the pavement and at the top surface of the aggregate base, aggregate subbase, and subgrade. Differences in the rutting performance of the test sections are shown in this figure. The rate of permanent deformation with number of load applications was larger for Section 544 than for Section 501 at all in-depth modules, particularly for those near the surface and at the surface of the aggregate base. At the completion of HVS testing, surface permanent deformation was about 14 mm after 1.1 million load applications in Section 544 versus 9 mm after 1.4 million load applications in Section 501. In addition, permanent deformation on top of the aggregate base was about 8 mm in Section 544 versus less than 5 mm in Section 501. In Section 501/517 (Goal 3 HVS program), additional permanent deformation accumulated on the surface and top of the aggregate base similar to those of Section 544. However, the number of load applications during both Goal 1 and Goal 3 were more than twice those applied to Section 544. The results

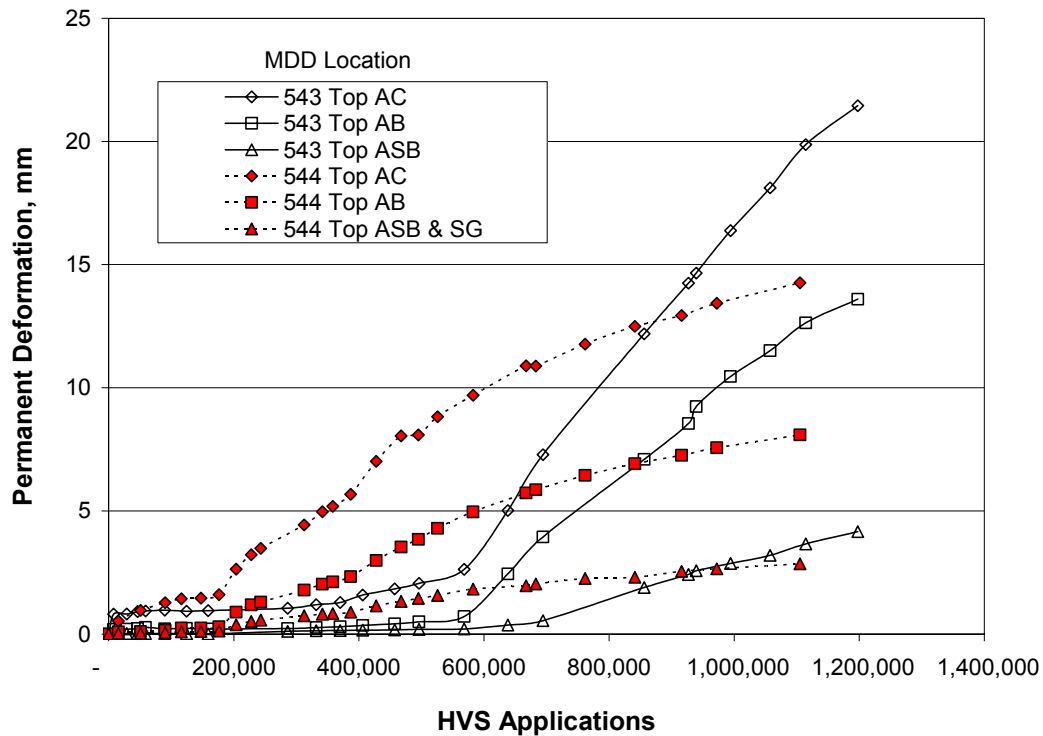
Figure 18. Comparison of in-depth permanent deformations for drained and undrained sections under wet conditions.

Section 543 was tested in the Goal 5 program with moisture conditions similar to those of Section 544. Section 543 differed from Section 544 in that it contained an ATPB layer between the asphalt concrete and the aggregate base. Results of testing Section 543 are presented in Reference (6). In-depth permanent deformations for Sections 543 and 544 are shown in Figure 18. MDD locations were similar for Sections 543 and 544.

Differences in permanent deformation performance are evident in the two sections. Under the 40- and 80-kN loads, the permanent deformations in the asphalt bound (including ATPB) and aggregate base layers in Section 543 were lower than in Section 544. This suggests that for these load levels, the ATPB layer in Section 543 performed as a relatively intact layer and that water remained in the ATPB rather than migrating into the base. Under the 100-kN load, however, the ATPB failed due to stripping and fine particle contamination producing increasing rates of permanent deformation with the number of load applications.

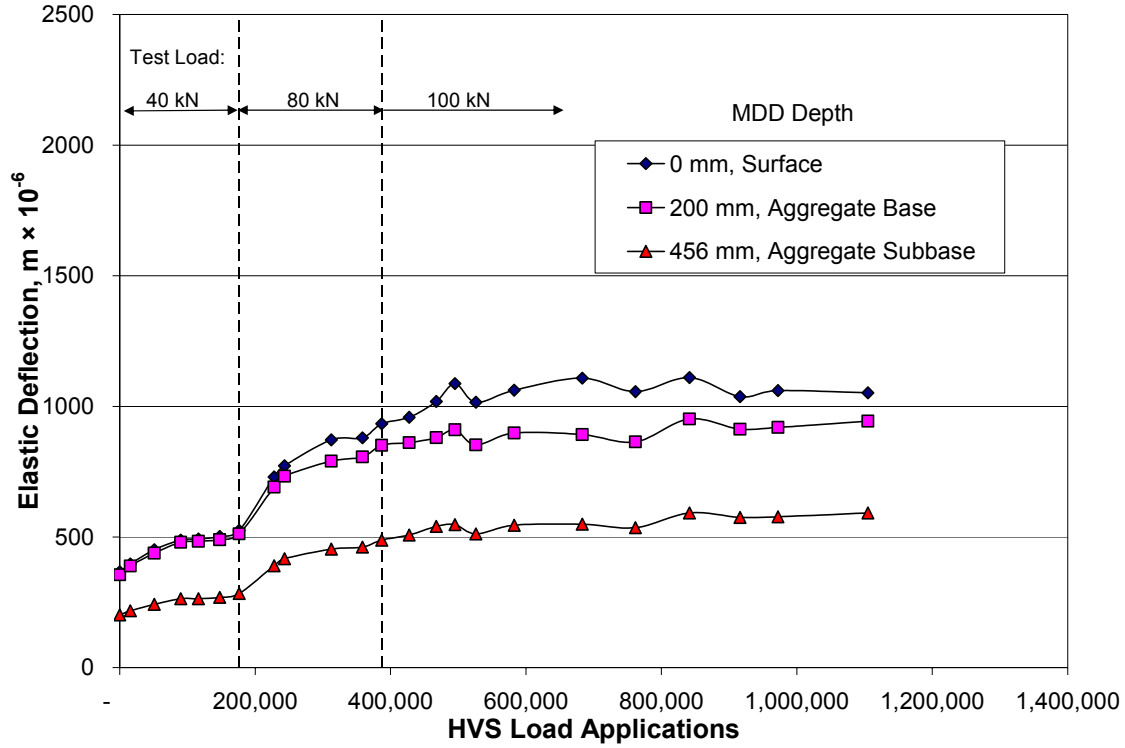
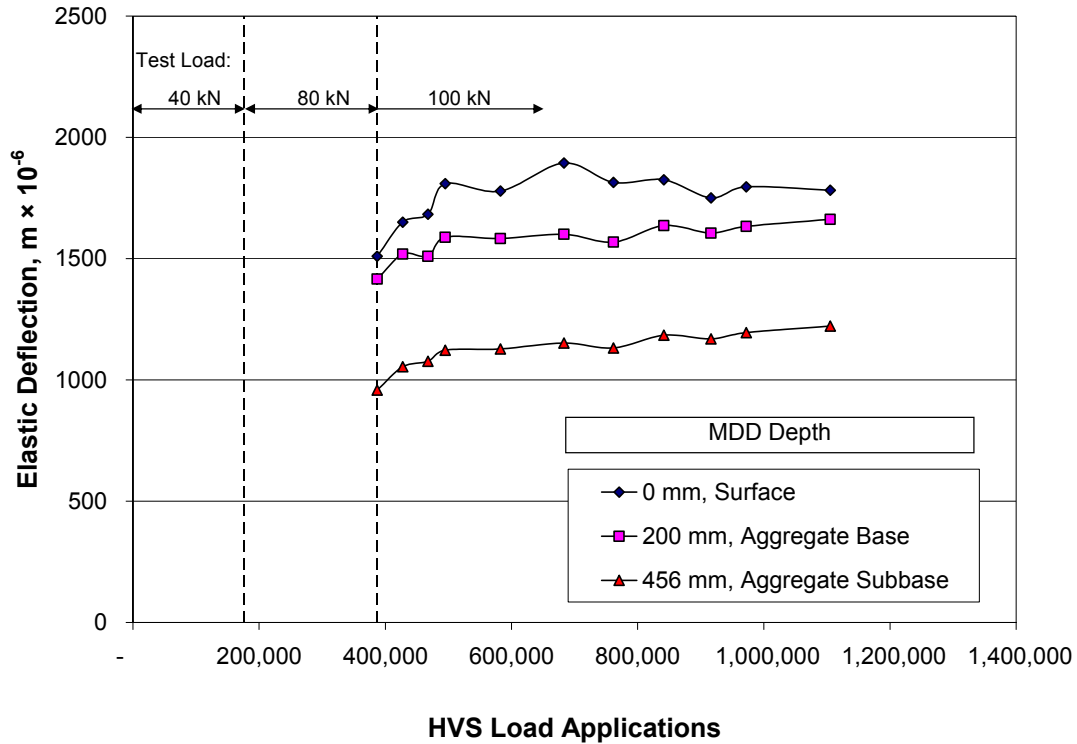
Figure 21. In-depth elastic deflections under 40-kN test load, MDD 7.

Figure 22. In-depth elastic deflections under 80-kN test load, MDD 7.

Figure 23. In-depth elastic deflections under 100-kN test load, MDD 7.

In-depth elastic deflection data for the 40-, 80-, and 100-kN test loads are presented in Figures 21, 22, and 23. Increases in elastic deflections in all layers were observed with increased

HVS trafficking under all test loads. The data indicate that the unbound layers yielded the highest elastic deflections. Deflections reached approximately constant values at about 470,000 HVS load applications for all test loads. Discussion included in the previous section for the RSD values apply to the in-depth deflections as well.

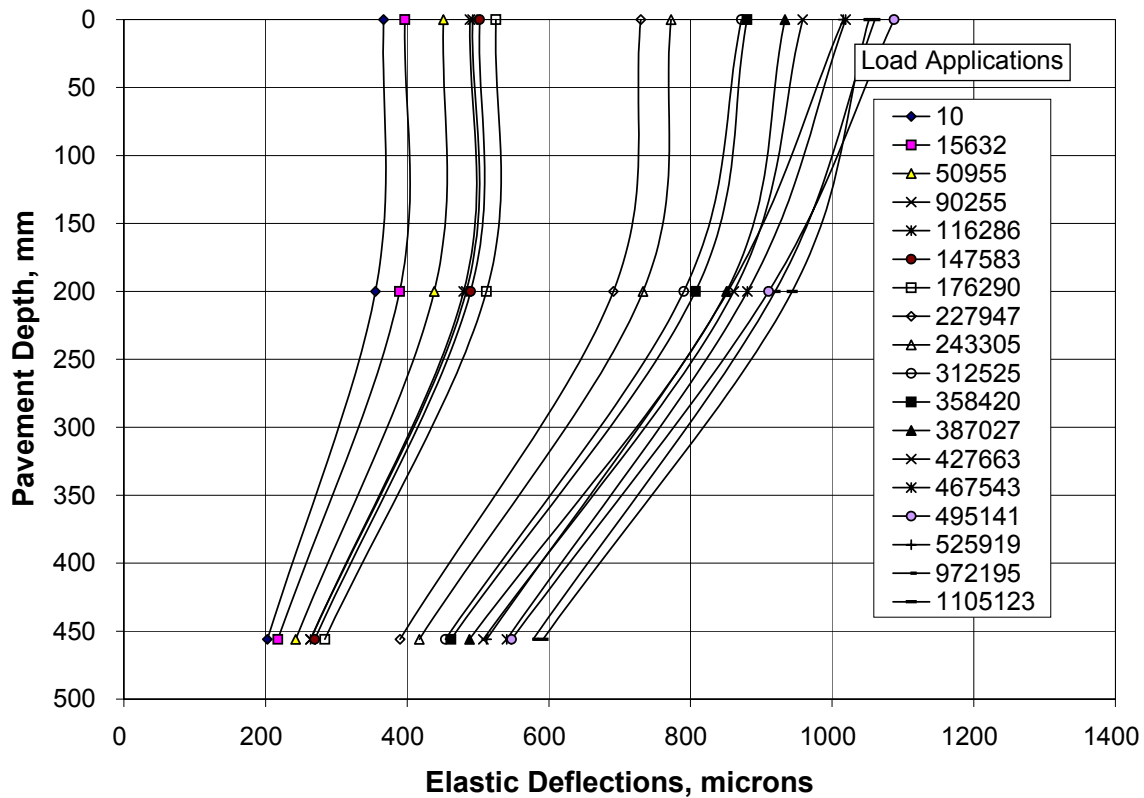
Figure 27. Profile of elastic deflections with respect to pavement depth for the 40-kN test load.

Deflection data as profiles of deflections with respect to pavement depth are shown in Figure 27. The reduction in slope of the deflection profile in the upper portion of the pavement structure results from fatigue cracking in the asphalt-bound layers due to HVS trafficking and to a change in the state of stress as well as increased moisture content in the aggregate base.

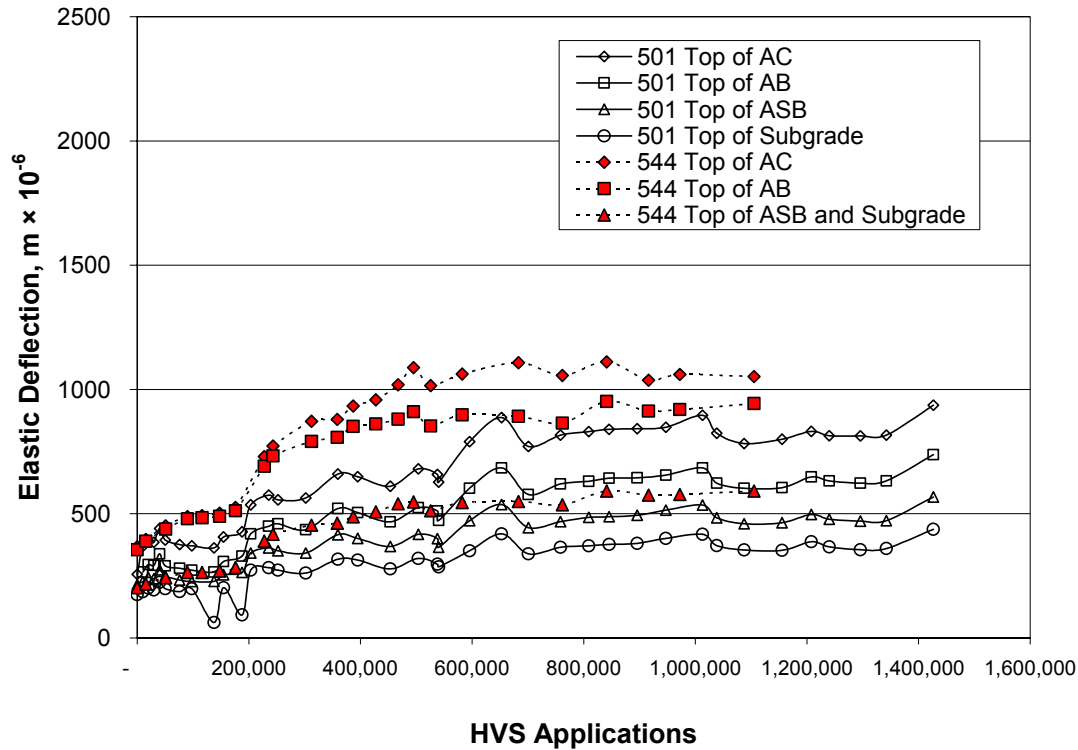
Figure 28. Comparative performance of Sections 501 and 544, elastic deflections versus HVS load applications; 40-kN test load.

Pavement Section 501, similar to Section 544, was tested earlier in the dry condition with the HVS. Comparative information for the two sections was presented in Section 3.2.3. Figure 28 shows in-depth MDD elastic deflections for the 40-kN test load for Section 501. Included in dashed lines are in-depth data for Section 544.

Elastic deflections at the beginning of the test were similar for both sections indicating similar pavement responses. However, as the number of load applications increased, elastic deflections increased faster in Section 544 than in Section 501. Elastic deflections in Section 544 leveled off at about 1065 microns for elastic deflections measured close to the surface, and at about 905 microns for the top of the aggregate base. In Section 501, elastic deflections rapidly leveled off during the three trafficking loads. Surface and top of the aggregate base deflections leveled off at about 825 microns and 634 microns, respectively. The elastic deflections at the surface of the AC and top of the aggregate base in Section 544 were about 29 and 42 percent higher, respectively, than those in Section 501. Elastic deflections on top of the subbase were about 15 percent higher in Section 544 than in Section 501. Based on the results for both sections, the largest increase in layer deflection was in the aggregate base mainly due to an

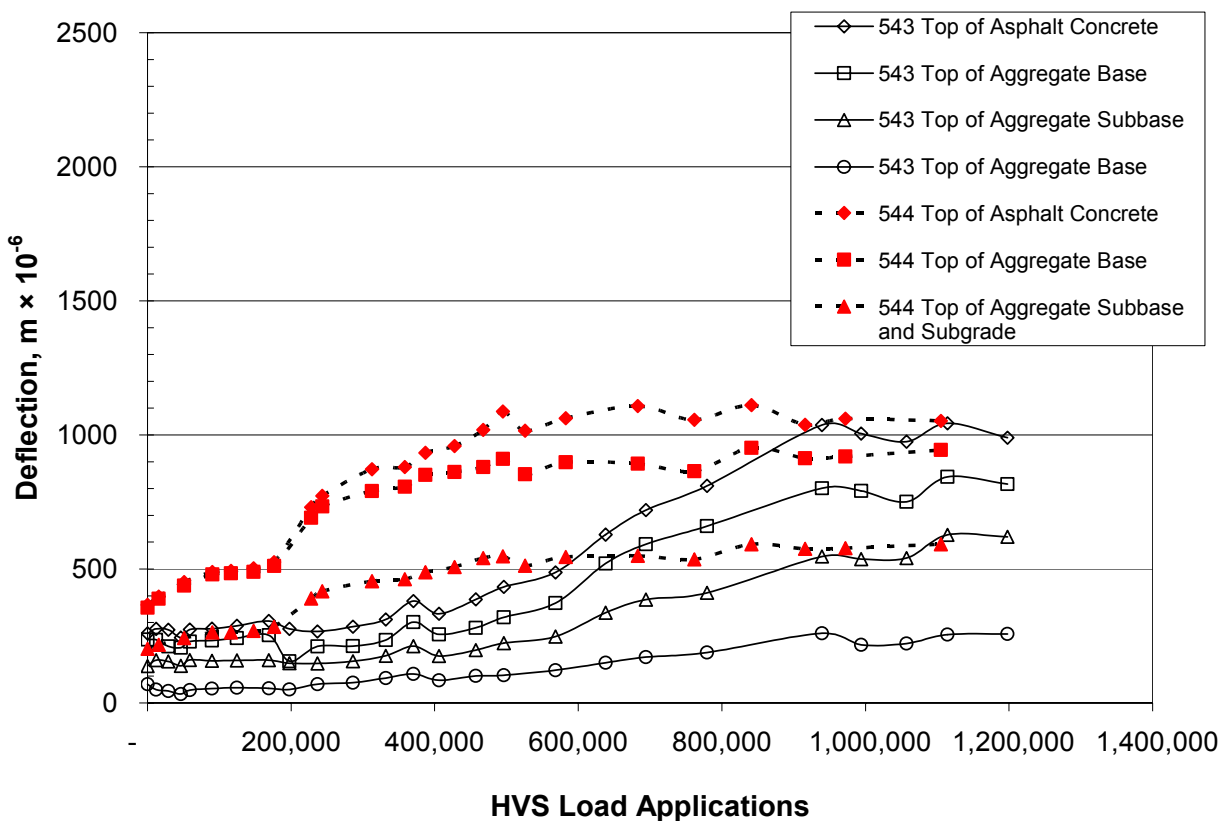
Figure 29. Comparison of elastic deflections from Sections 543 and 544, 40 kN load.

In depth elastic deflections obtained under the 40-kN test load for Section 543 are shown in Figure 29. Included as dashed lines are in-depth data for Section 544. In-depth elastic deflections at the beginning were higher for Section 544 than for Section 543. Thereafter, deflections in Section 544 increased faster with the number of load applications. During the 40- and 80-kN trafficking loads, surface deflections were significantly lower in Section 543, indicating that the structural integrity of the ATPB was maintained. However, under the 100-kN

load, elastic deflections in Section 543 increased significantly as a result of stripping in the ATPB and reached levels similar to those of Section 544. Once the ATPB stripped, it exhibited behavior similar to that of an aggregate base. Elastic deflections on top of the aggregate base were about 12 percent lower in Section 543 at the end of HVS testing because of the lower vertical stresses resulting from the added 75 mm of stripped ATPB.

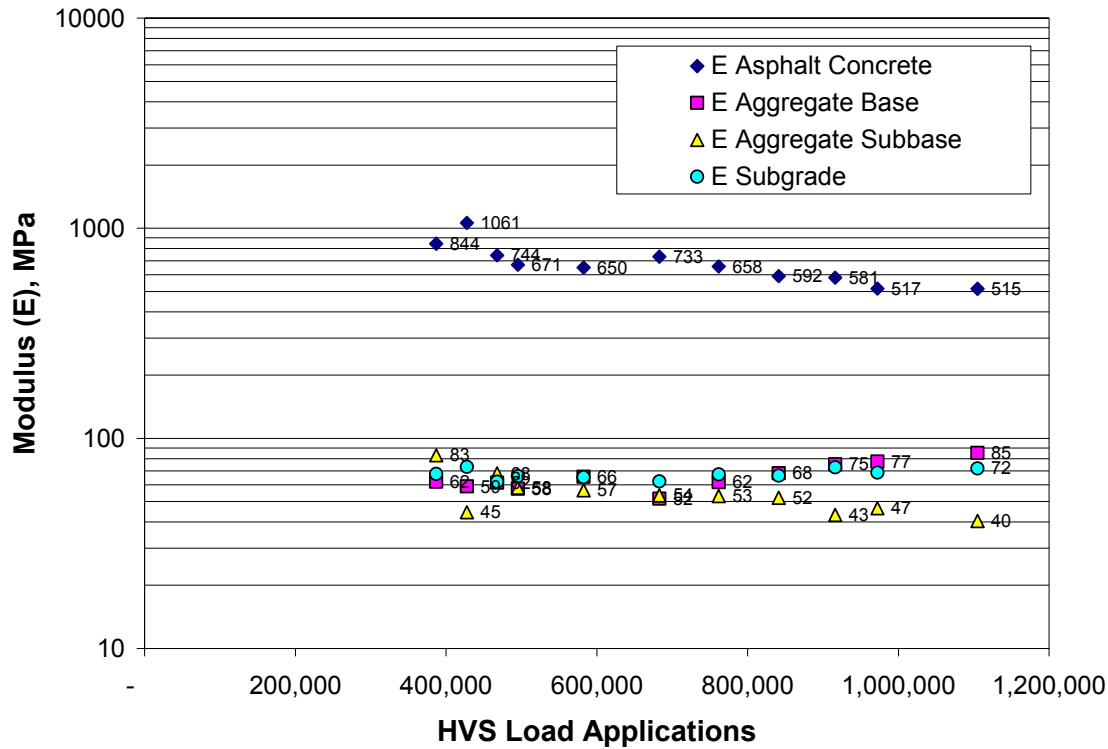
Figure 30. Layer moduli backcalculated from MDD deflections for Section 544.

Figure 30 summarizes the backcalculated moduli from the MDD data obtained for the 100-kN test load. Backcalculated moduli for the 40- and 80-kN test loads yielded spurious results and are not included in Figure 30. It will be observed that a decrease in the modulus of the asphalt bound layers with HVS load applications was obtained. This reduction is likely due to the observed cracking in the pavement. Reduction in the modulus of the asphalt concrete layer during the 100-kN loading was about 40 percent (from 844 MPa down to 515 MPa) since much of the damage occurred under the 80-kN test load, as noted earlier. For the untreated layers, the backcalculated moduli of the aggregate base were similar to those for the aggregate subbase and subgrade. The low moduli in the untreated aggregate base are likely the result of an increase in the moisture content and change in stress state due to cracking of the asphalt concrete. Backcalculated moduli for the subgrade show little variation during the 100-kN loading. It will be noted that the moduli of the aggregate base and subgrade are similar and the subbase moduli are, on average, slightly less than those of the subgrade. These values are undoubtedly a

function of the complex stress states and the non-linear response characteristics of these untreated materials.

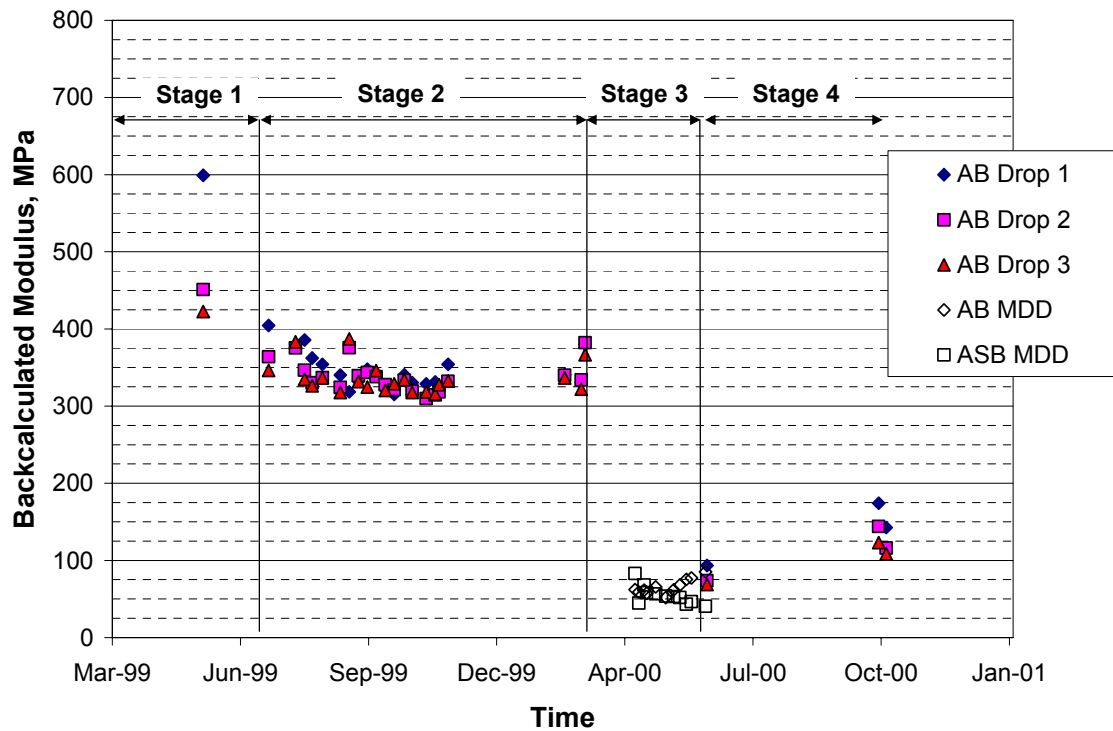
Figure 37. Moduli of aggregate base.

Moduli of the aggregate base layers are shown in Figure 37. During Stage 2, moduli ranged from 300 to 400 MPa for the three load levels. Higher moduli were obtained for the lighter load during the dry period and during the first weeks of water infiltration (July-August 1999). Thereafter, all three load levels yielded similar aggregate base moduli. Aggregate base moduli after HVS trafficking dropped to values between 60 and 100 MPa. This reduction is likely due to an increase in moisture content from infiltrated water, and by a change in stress state resulting from asphalt concrete damage. Moduli of the aggregate base recover somewhat, likely due to reduction in moisture content since water infiltration was stopped after HVS trafficking, as noted earlier.
