**Construction, Instrumentation, and Testing of Fast-Setting
Hydraulic Cement Concrete in Palmdale, California**

CALIFORNIA DEPARTMENT OF TRANSPORTATION

Pavement Research Center
Institute of Transportation Studies
University of California Berkeley

Technical Report Documentation Page

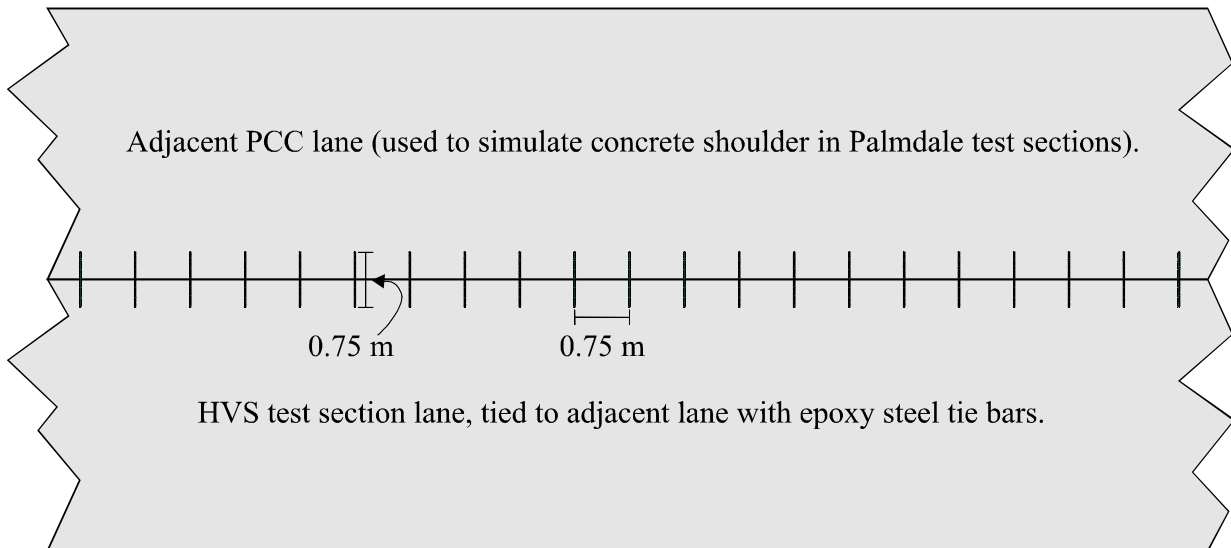
Figure 4.2. Layout and Dimensions of Dowels Used to Simulate a Tied Concrete Shoulder.

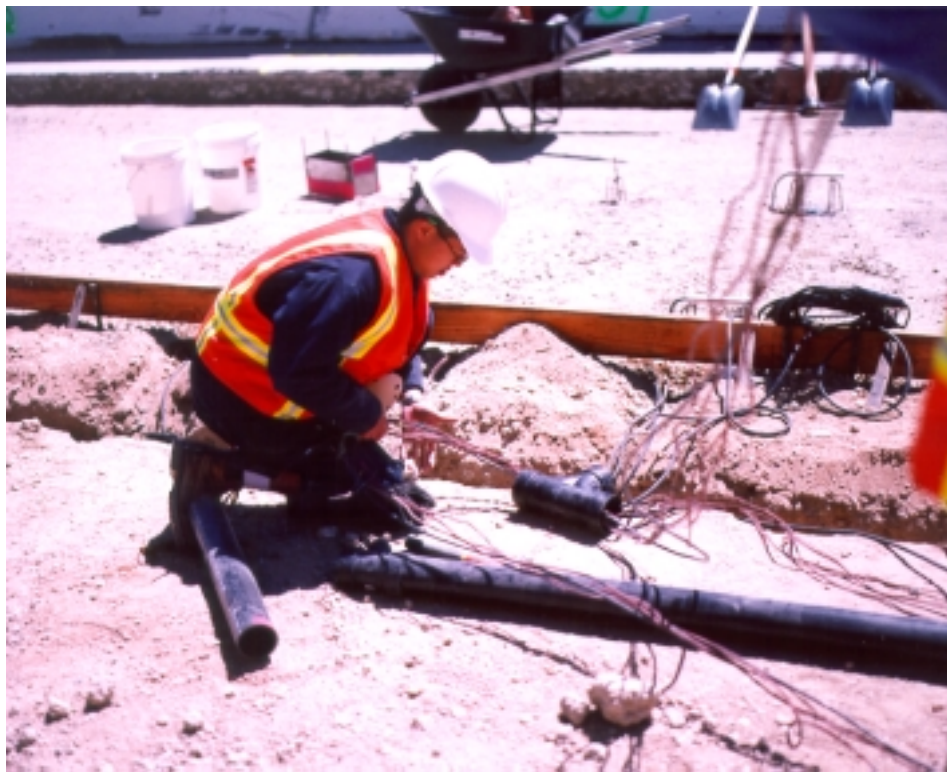
Figure 6.1. South Tangent Instrument Wiring and Piping Laid in Aggregate Base.

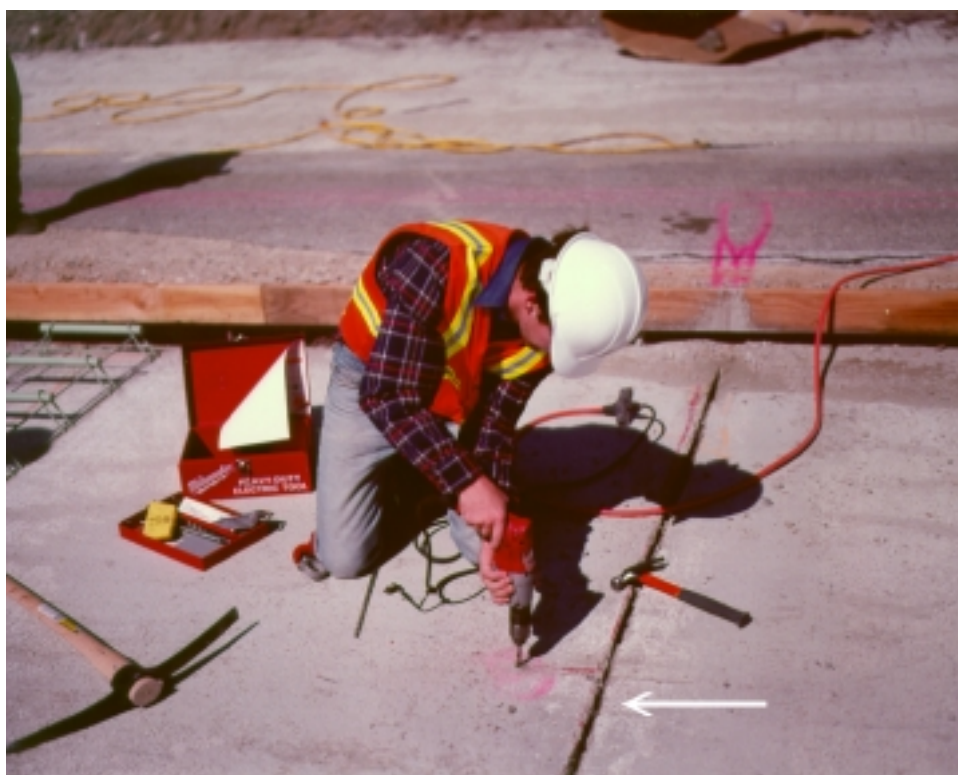
Figure 6.2. Grooves cut in North Tangent CTB for Instrument Leads.

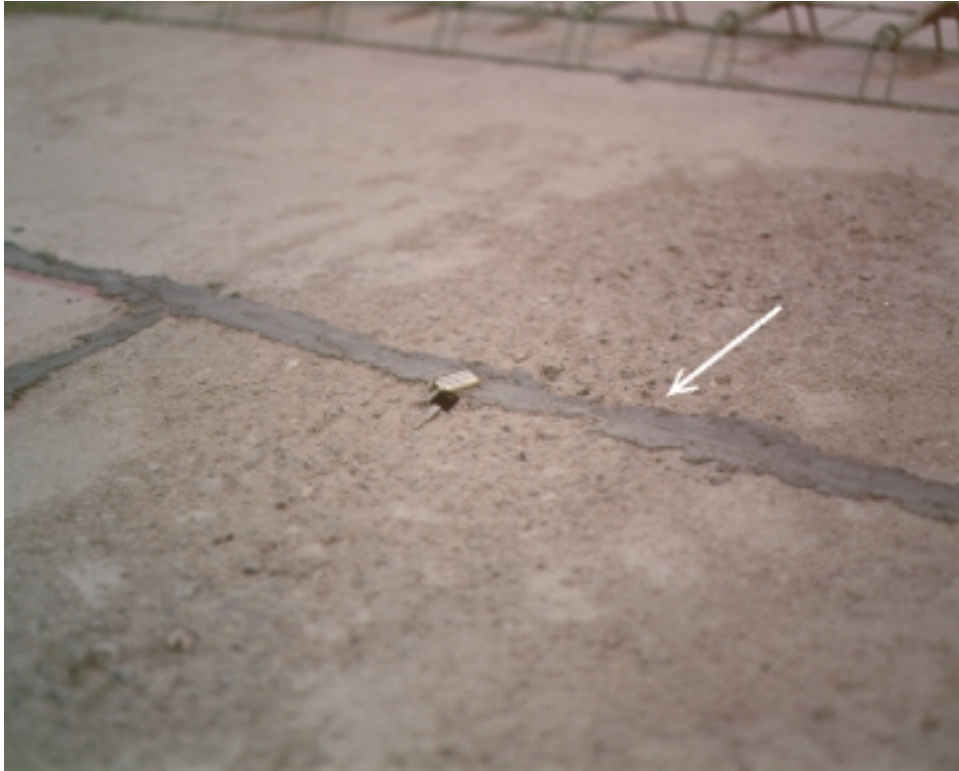
Figure 6.3. Backfilled Instrumentation Lead Channel on North Tangent CTB.

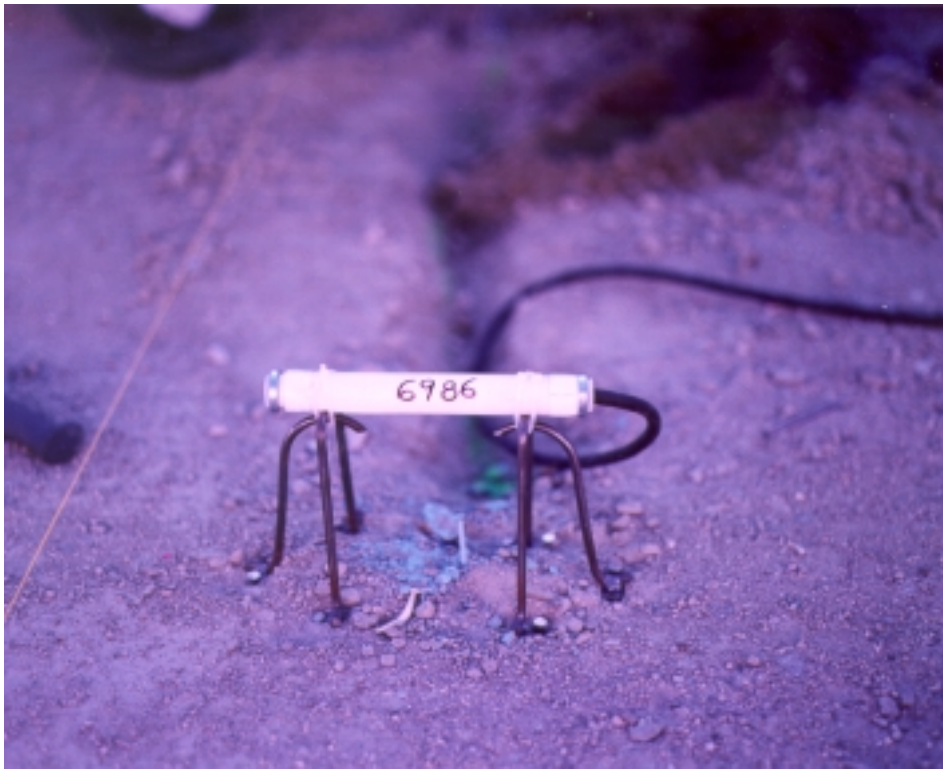
Figure 6.4. Steel Frame with Carlson A-8 Strain Meter Installed on South Tangent.

All strain gages were placed and properly oriented on the base material with small steel frames, as shown in Figures 6.4 and 6.5. Each instrument was attached to its steel frame using a plastic zip tie. Each instrument was attached firmly enough so that it wouldn't become dislodged

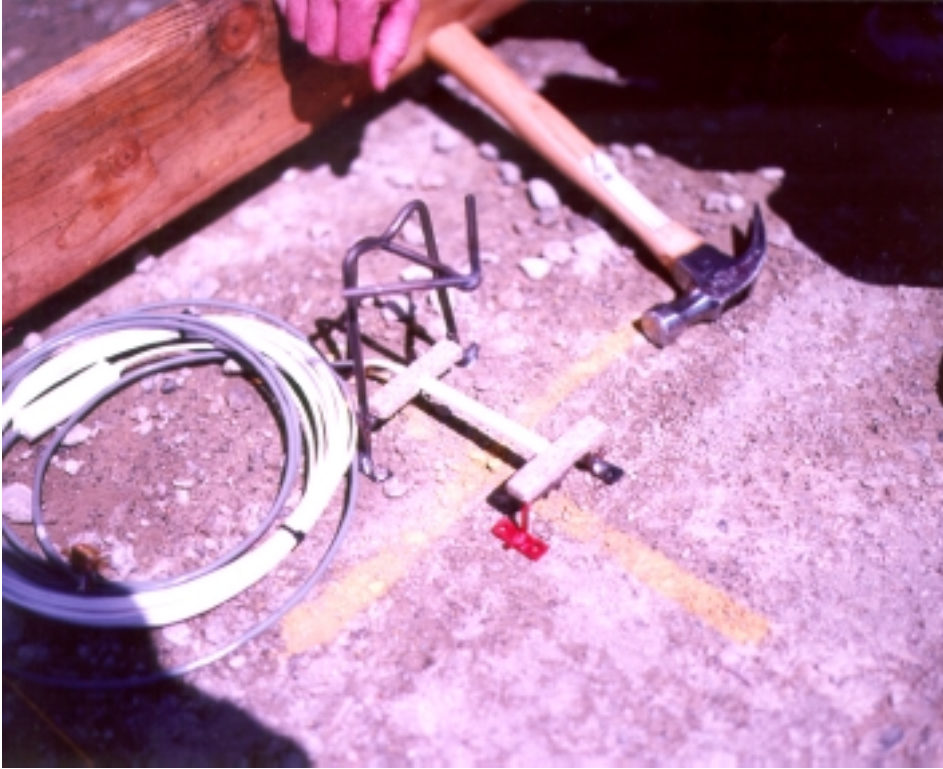
Figure 6.5. Steel Frames for Collocation of Dynatest PAST-2PCC (shown) and Tokyo-Sokki PMR-60-6L (not shown).

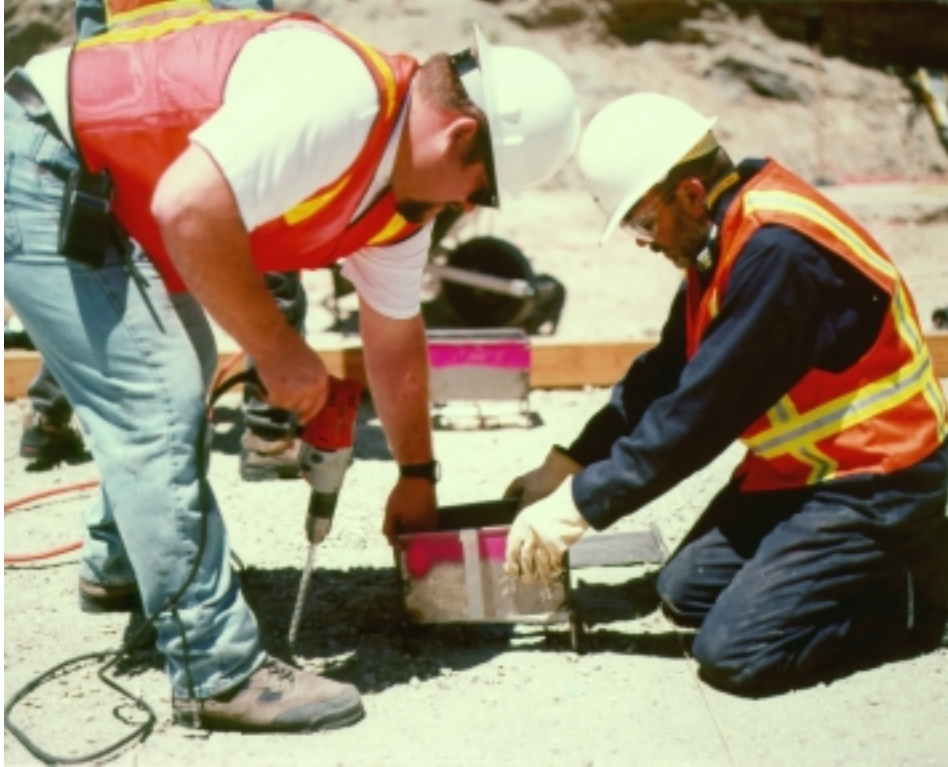
Figure 6.6. Steel Instrument Box Being Installed on South Tangent.

As shown in Figures 6.6 and 6.7, four-part sheet metal boxes with five-centimeter spikes at each corner were placed around all gages except for thermocouples. The sheet metal boxes prevented the flow of concrete from pushing any gages out of their intended location and orientation during paving. The spikes were driven into the base material to further stabilize the boxes. These boxes were then marked with “turkey tails” or wire flags affixed with duct tape so that they would be easily visible to the paving crew, as shown in Figure 6.8.

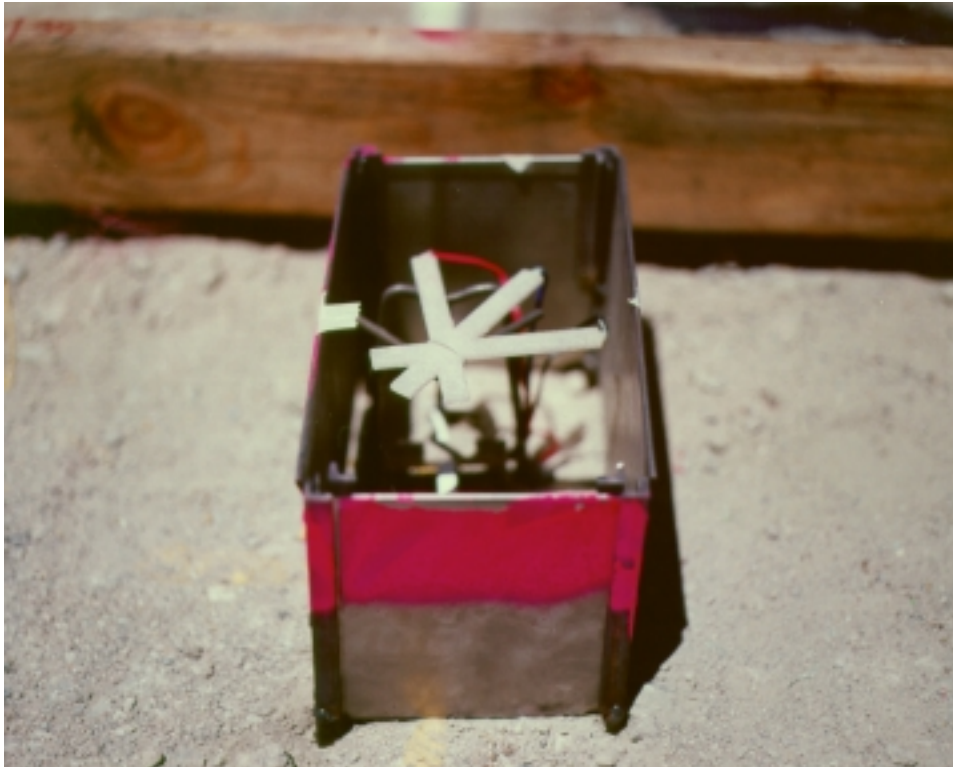
Figure 6.7. Steel Instrument Box Protecting Strain Gages on South Tangent.

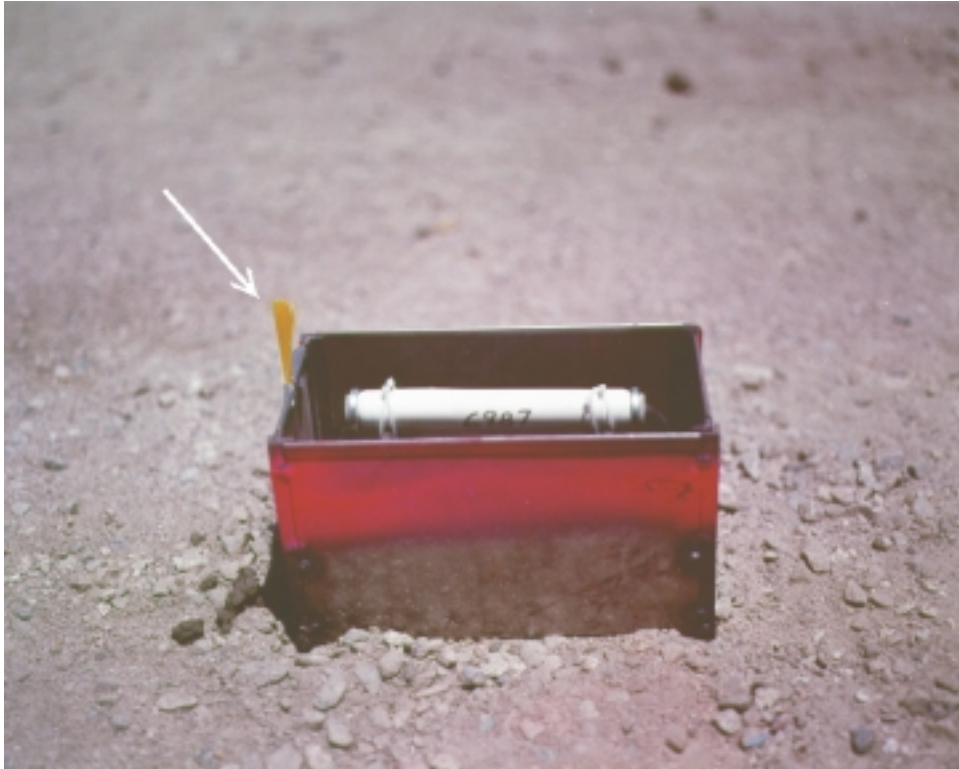
Figure 6.8. Instrument Box with Turkey Tail Attached.

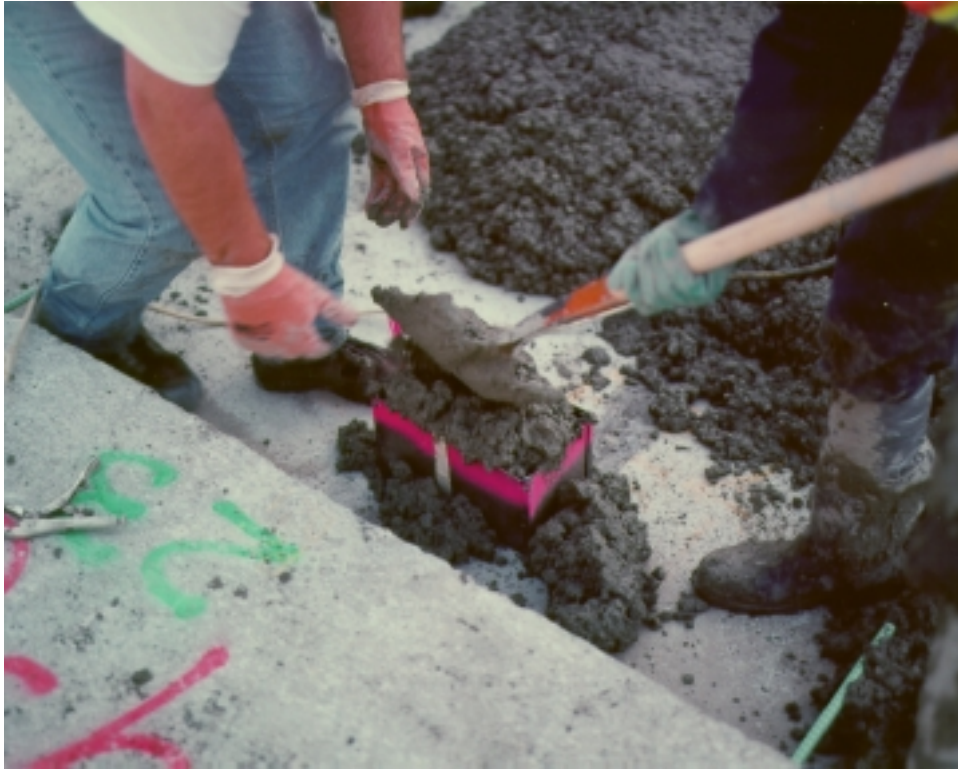
Figure 6.9. Instrument Box Being Filled by Shovel, North Tangent.

When the concrete neared one of the instruments in its box, UCB personnel shoveled concrete into the box, as shown in Figure 6.9. Coffman Specialties personnel consolidated the mix inside the sheet metal box by vibrating all four sides of the box, as shown in Figure 6.10. The Coffman Specialties crew then ran a screed over the concrete surface. Both the wire flags

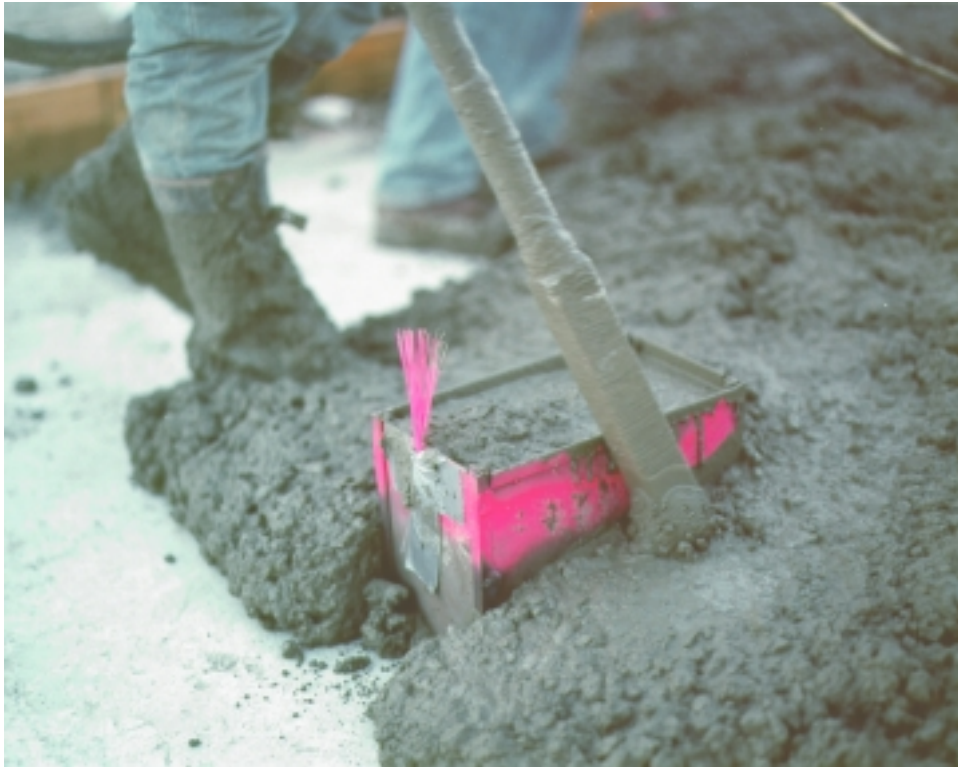
Figure 6.10. Vibrator Being Applied to Instrument Box to Consolidate Concrete.

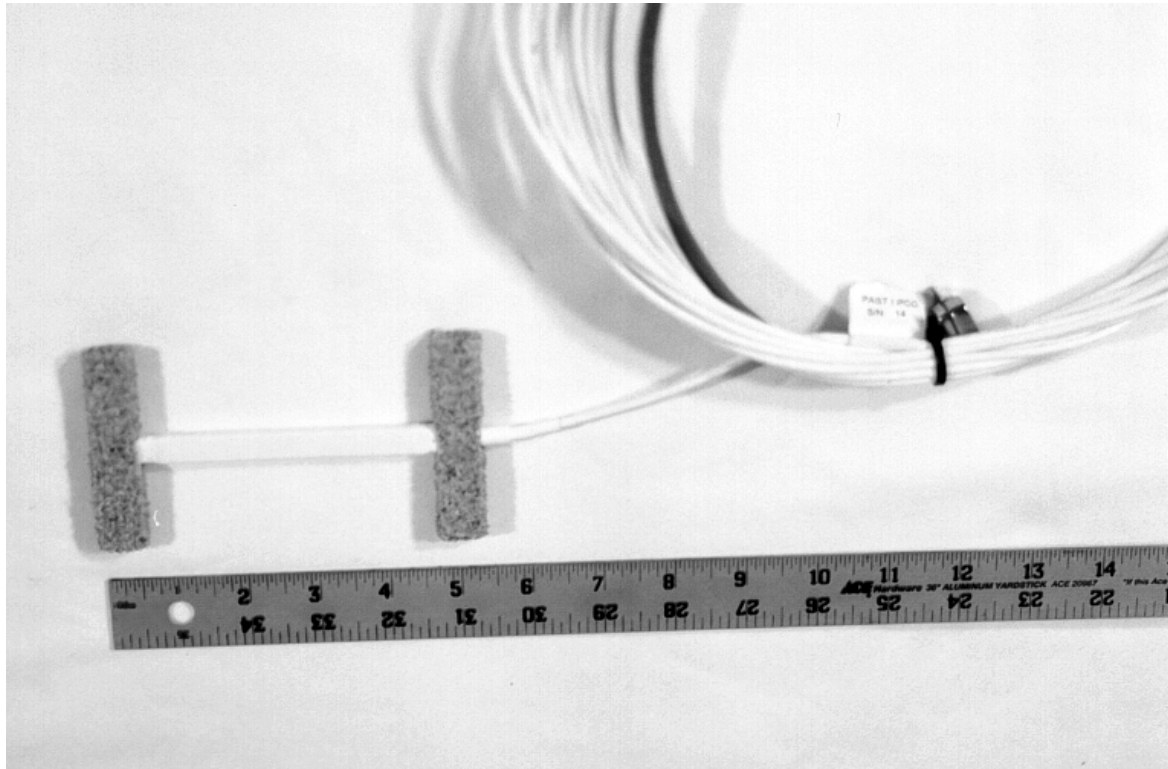
Figure 6.16. Dynatest PAST-2PCC Strain Gauge.

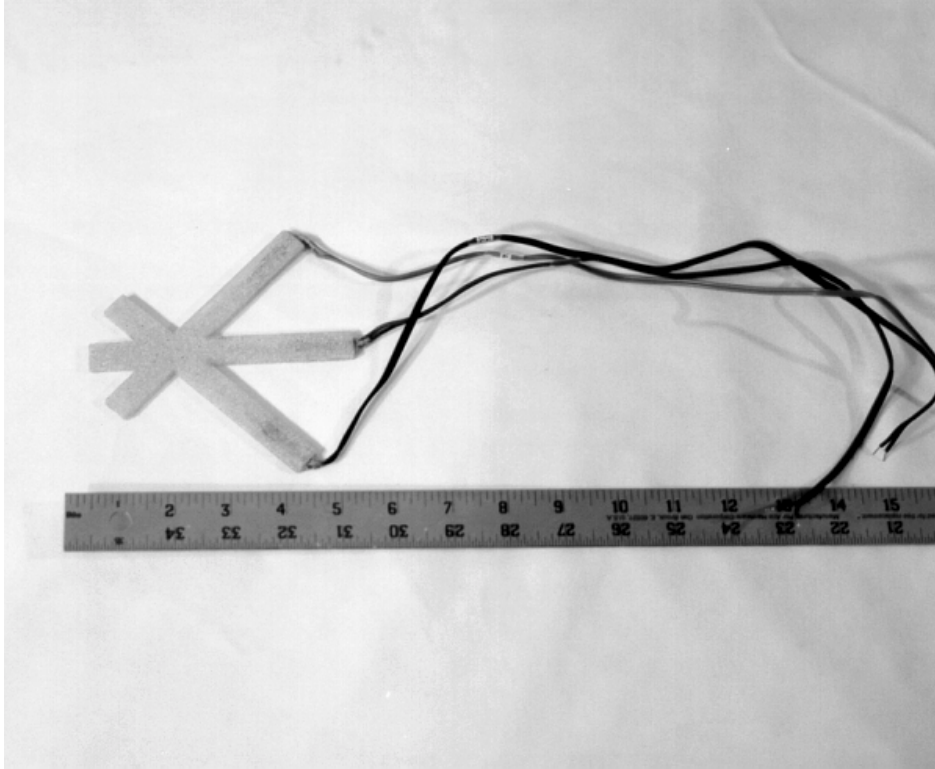
Figure 6.17. Tokyo-Sokki PMR-60-6L Strain Gage.

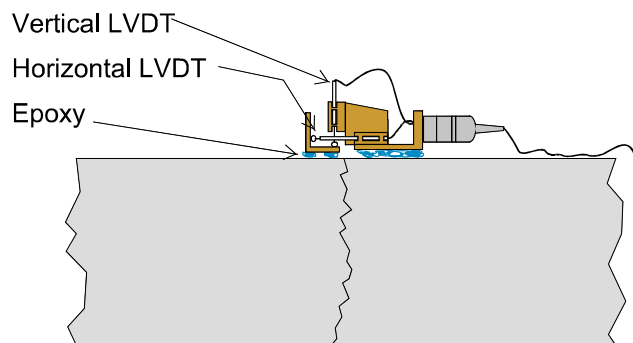
Figure 6.19. Diagram of Crack Activity Meter (CAM) on Cross-section of Pavement.

The Crack Activity Meter, manufactured by the Council for Scientific and Industrial Research (CSIR), is used to measure the horizontal and vertical displacement of cracks during dynamic loading. The device consists of two Linear Variable Differential Transformers (LVDT), one oriented horizontally and one oriented vertically, as illustrated in Figures 6.19 and 6.20. CAMs will be placed over joints on HVS loaded sections to measure the relative displacement between two adjacent slabs. The CAM data will be used for determination of the load transfer capacity between two slabs.

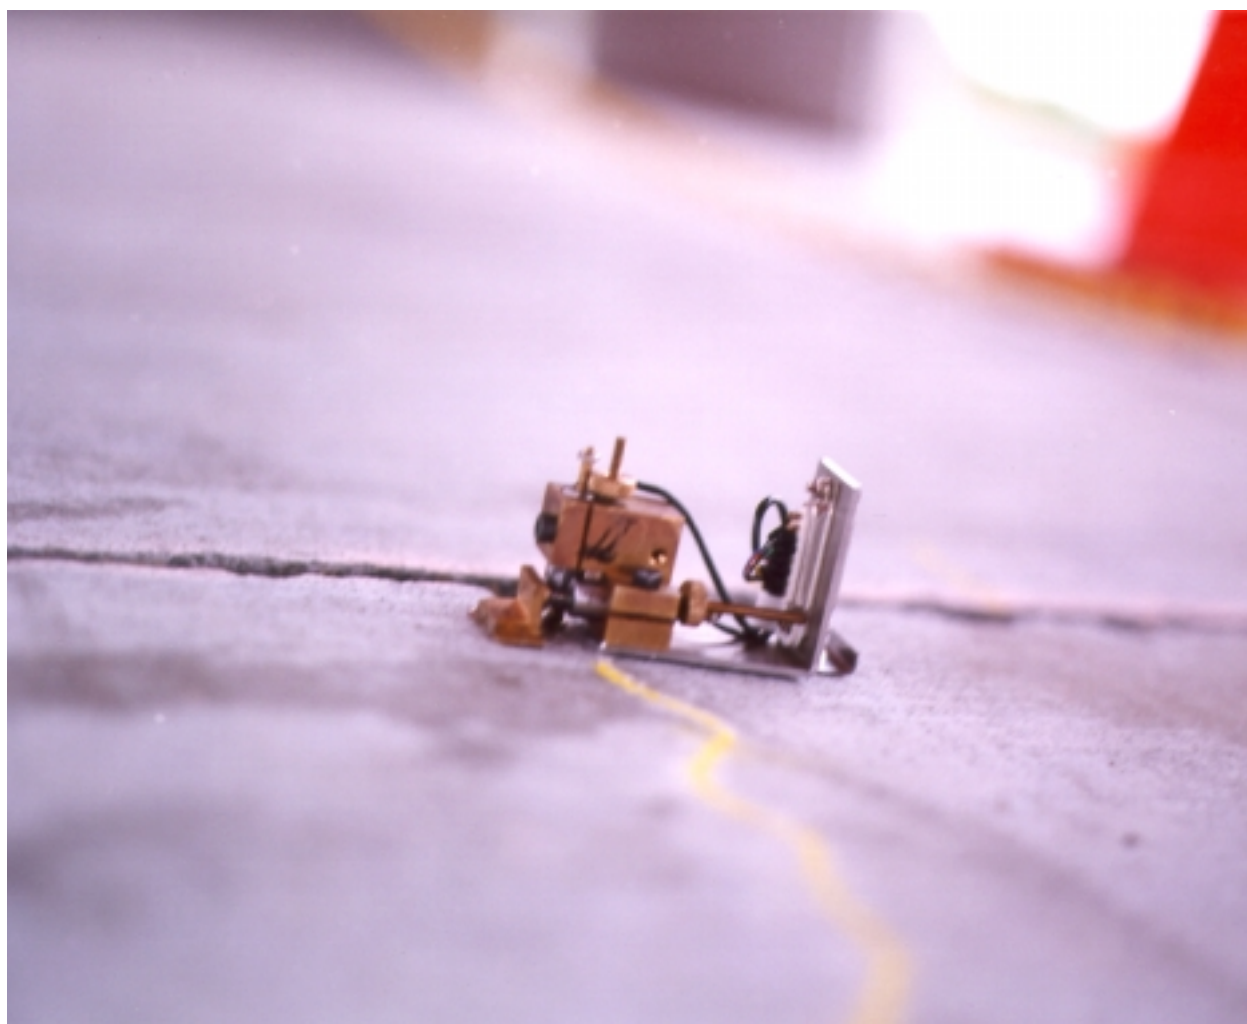
Figure 6.20. Crack Activity Meter (CAM) in Typical Position over a Crack.

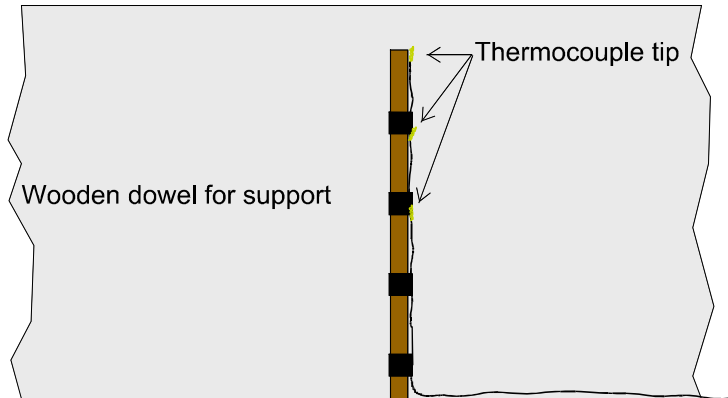
Figure 6.21. Diagram of Thermocouple as Oriented in Cross-section of Pavement.

The thermocouples used were assembled by the UCB Pavement Research Center. Type K (nickel-chromium and nickel-aluminum leads) and Number 24 American Wire Gage thermocouple wires were used. The thermocouple wires are manufactured by Omega

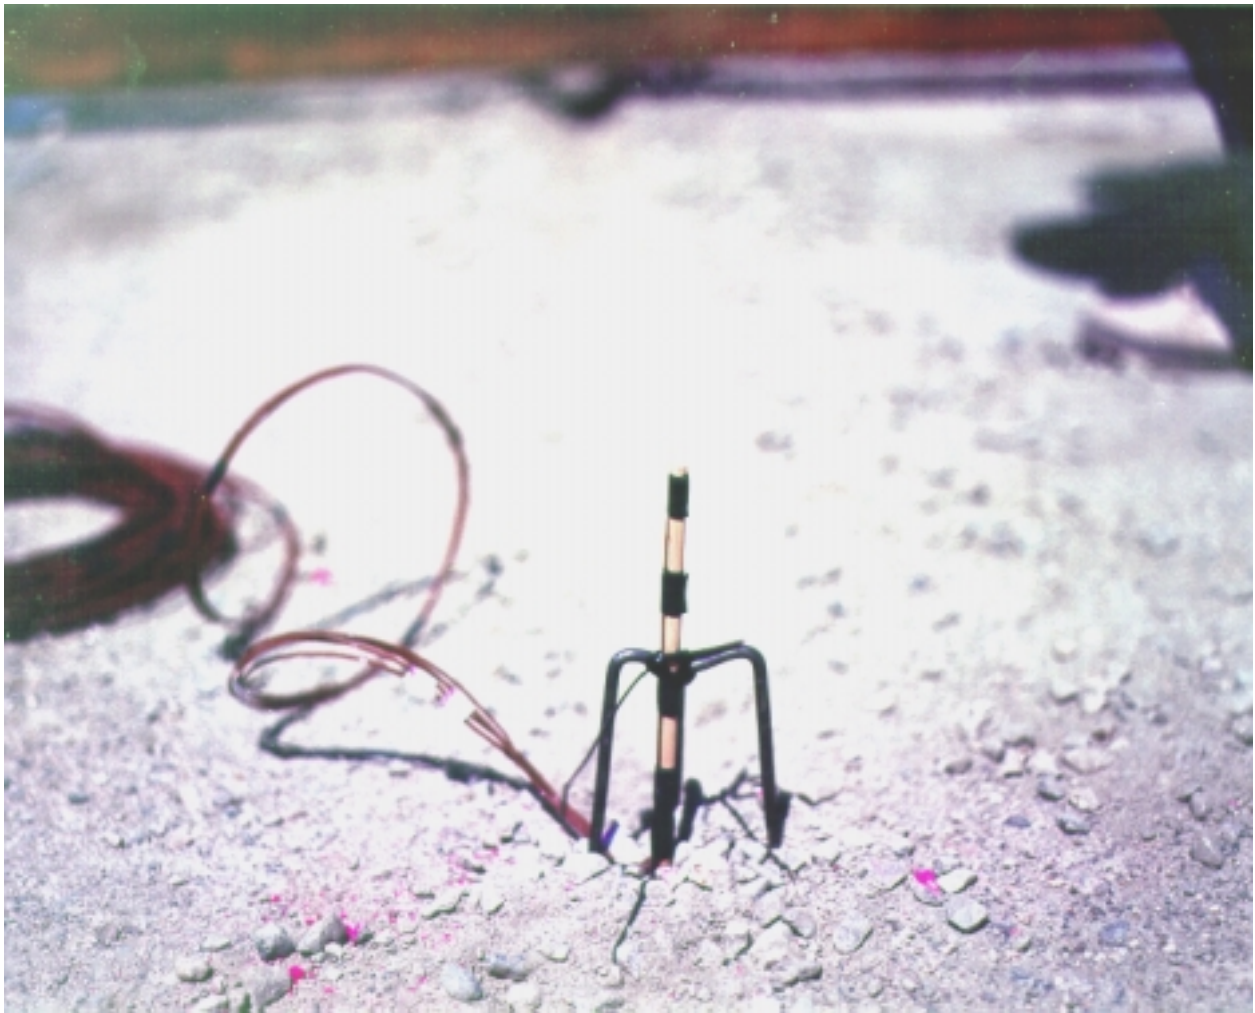
Figure 6.22. Thermocouple prior to Placement of Concrete, South Tangent.

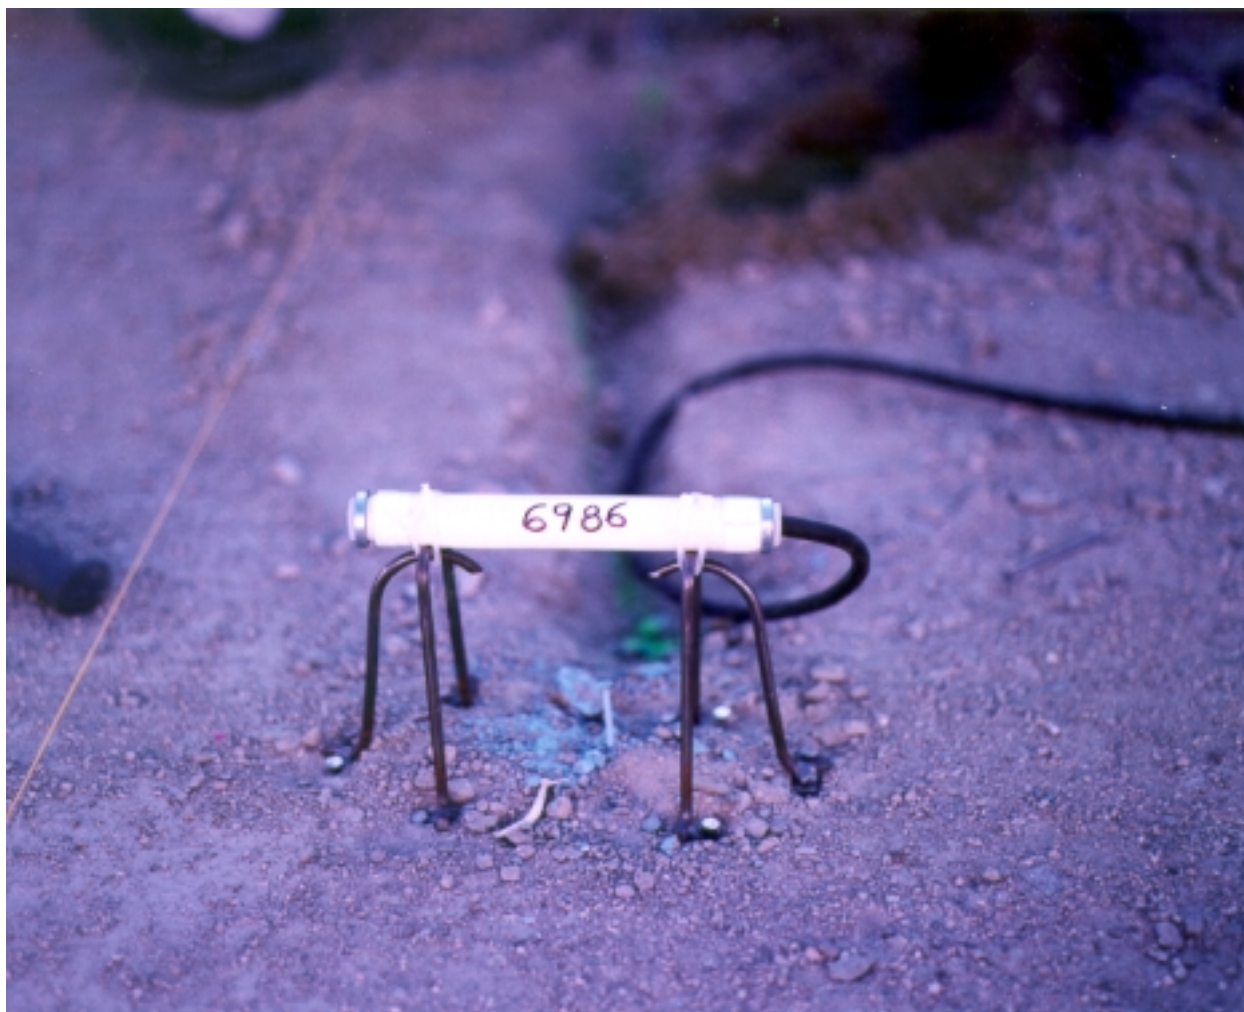
Figure 6.23. Carlson A-8 Strain Meter prior to Placement of Concrete, South Tangent.

The environmental strain gages used were the Carlson A-8 strain meter, manufactured by RST Instruments, Inc. Shown in Figures 6.15 and 6.23, the instrument is tubular in construction and contains two coils of highly elastic steel wire. One coil increases in length and electrical resistance when strained, while the other decreases in length when unloaded or compressed. The gages were placed in the concrete pavement at various critical locations near the surface and bottom of the pavement to measure strains caused by length changes in the pavement due to thermal changes and curing. The Carlson A-8 gages are monitored continuously by the online data acquisition system. A total of 24 Carlson A-8 gages have been embedded in the Palmdale test sections. Appendix A shows the locations of the Carlson A-8 gages on the Palmdale test sections.

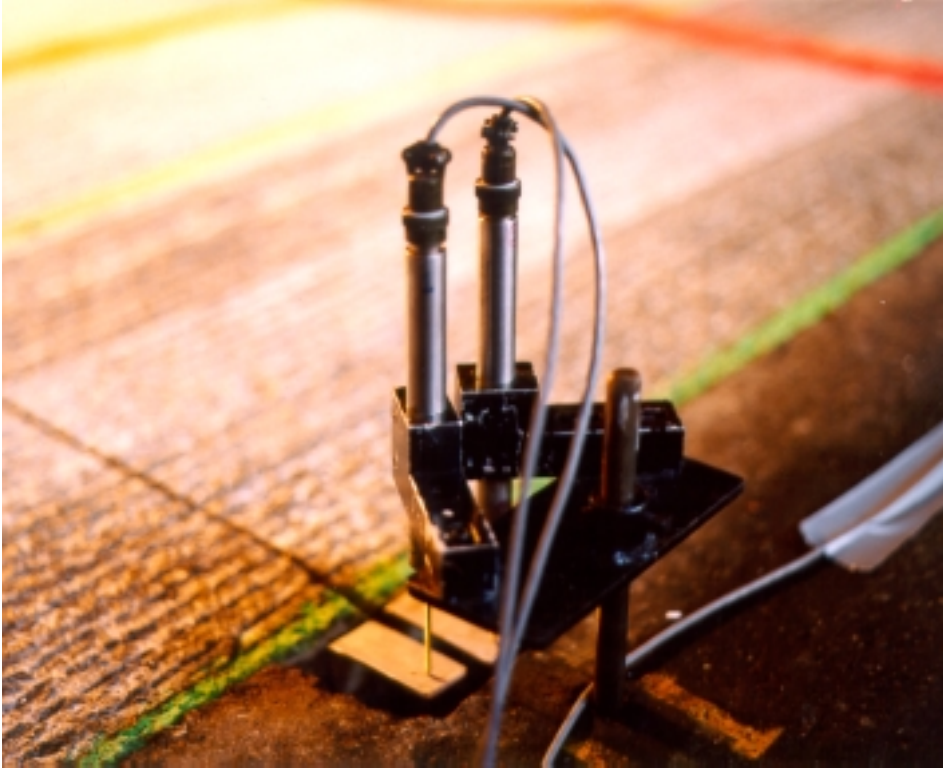
Figure 6.24. Joint Displacement Measuring Device (JDMD) on South Tangent. (*Edge Displacement Measuring Device is essentially identical except that it is placed in the middle of the slab instead of at the joint.*)

The JDMDs, manufactured by the UCB Pavement Research Center, are used to measure vertical and horizontal joint displacement under dynamic loads and temperature changes. For environmental changes, the JDMDs can be used in two separate configurations. The first device can measure the relative vertical and horizontal displacement across a joint. Each device consists of one Linear Variable Displacement Transducer (LVDT) for vertical displacement and one LVDT for horizontal displacement, as shown in Figure 6.24. Section 7C on the North Tangent

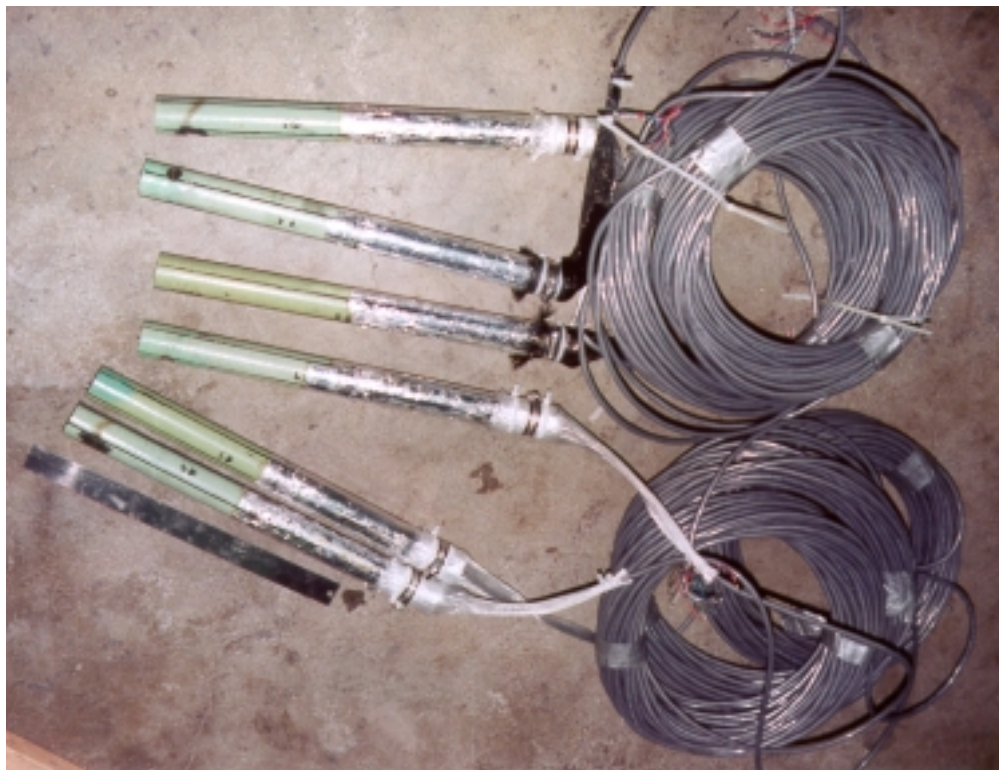
Figure 6.25. Individual Instrumented Dowel Bars Prior to being Welded to Dowel Bar Cage.

The instrumented dowels are 38 mm diameter by 450 mm long steel bars, spot welded to a frame to ensure the dowels were oriented properly in the slab. The dowels were spaced 300 mm center to center and 150 mm from the slab edge. Each instrumented dowel had two axial strain gages to measure bending strain and one strain gage rosette to measure bending and shear strain. Figure 6.25 shows the placement of the strain gages on the individual dowels prior to welding them into the dowel frame. Figures 6.26 and 6.27 show which dowels have strain gages

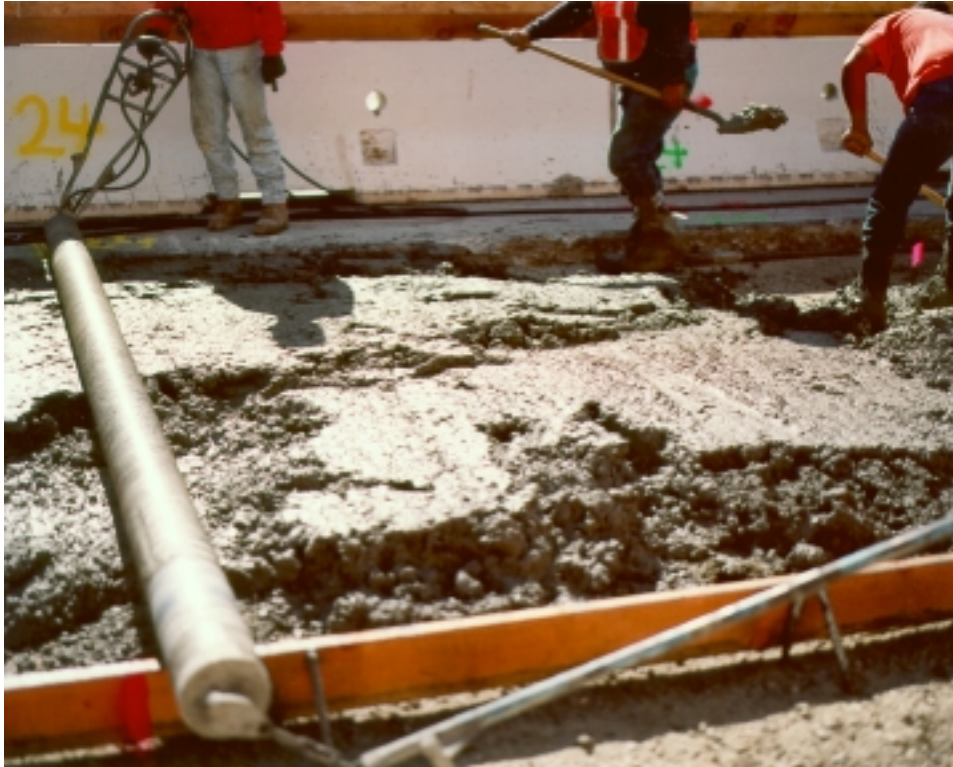
Figure 8.2. Unworkable Mix on South Tangent.

The rate of slump loss was also very high. It was frequently observed that a good consistency mix would be coming out of the chute and then within a couple of minutes it began to become difficult to offload from the truck. When this condition occurred, the contractor would add water to the drum to increase workability and help remove the FSHCC from the drum. This resulted in mixes with higher than targeted water-to-cement ratios, as seen in Tables 4.3 and 4.4 in Section 4.3.

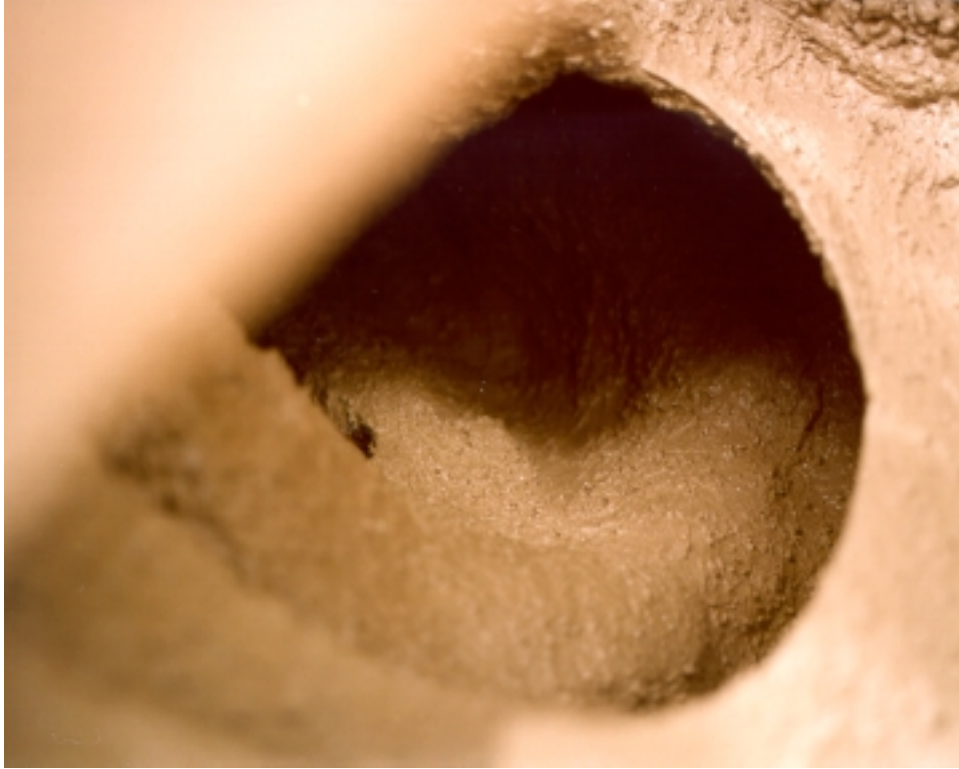
Figure 8.3. Clogged Fins inside Ready Mix Truck, North Tangent.

It was also observed that almost every night after paving, the contractor crew spent time chipping hardened concrete out of the ready mix truck drums.

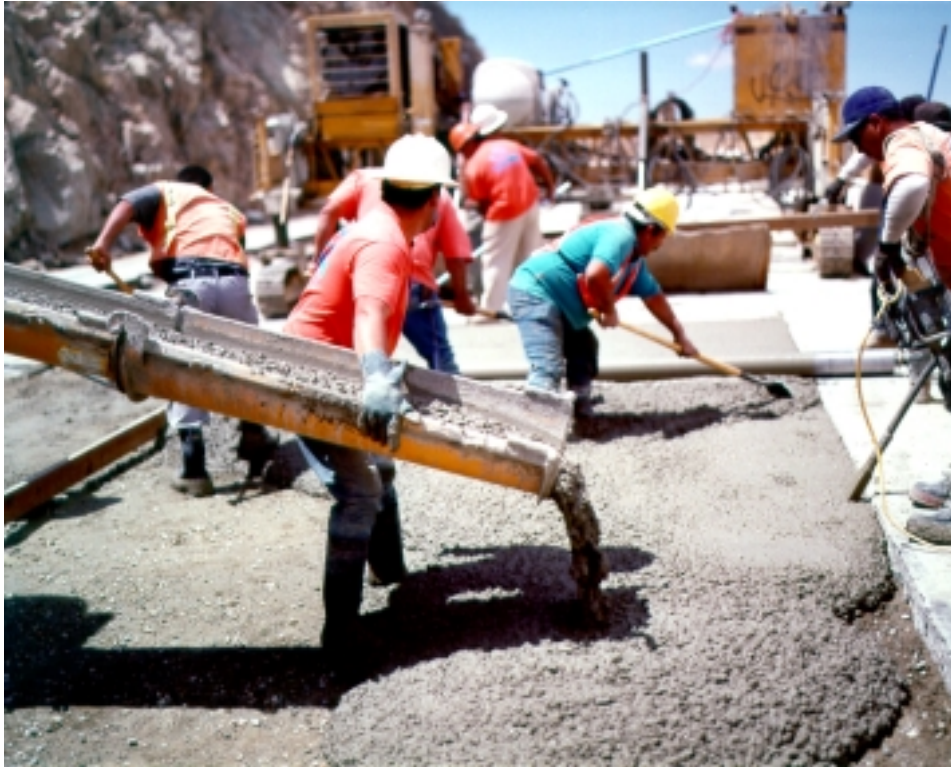
Figure 8.4. Good Mix Quality and Finish, South Tangent.

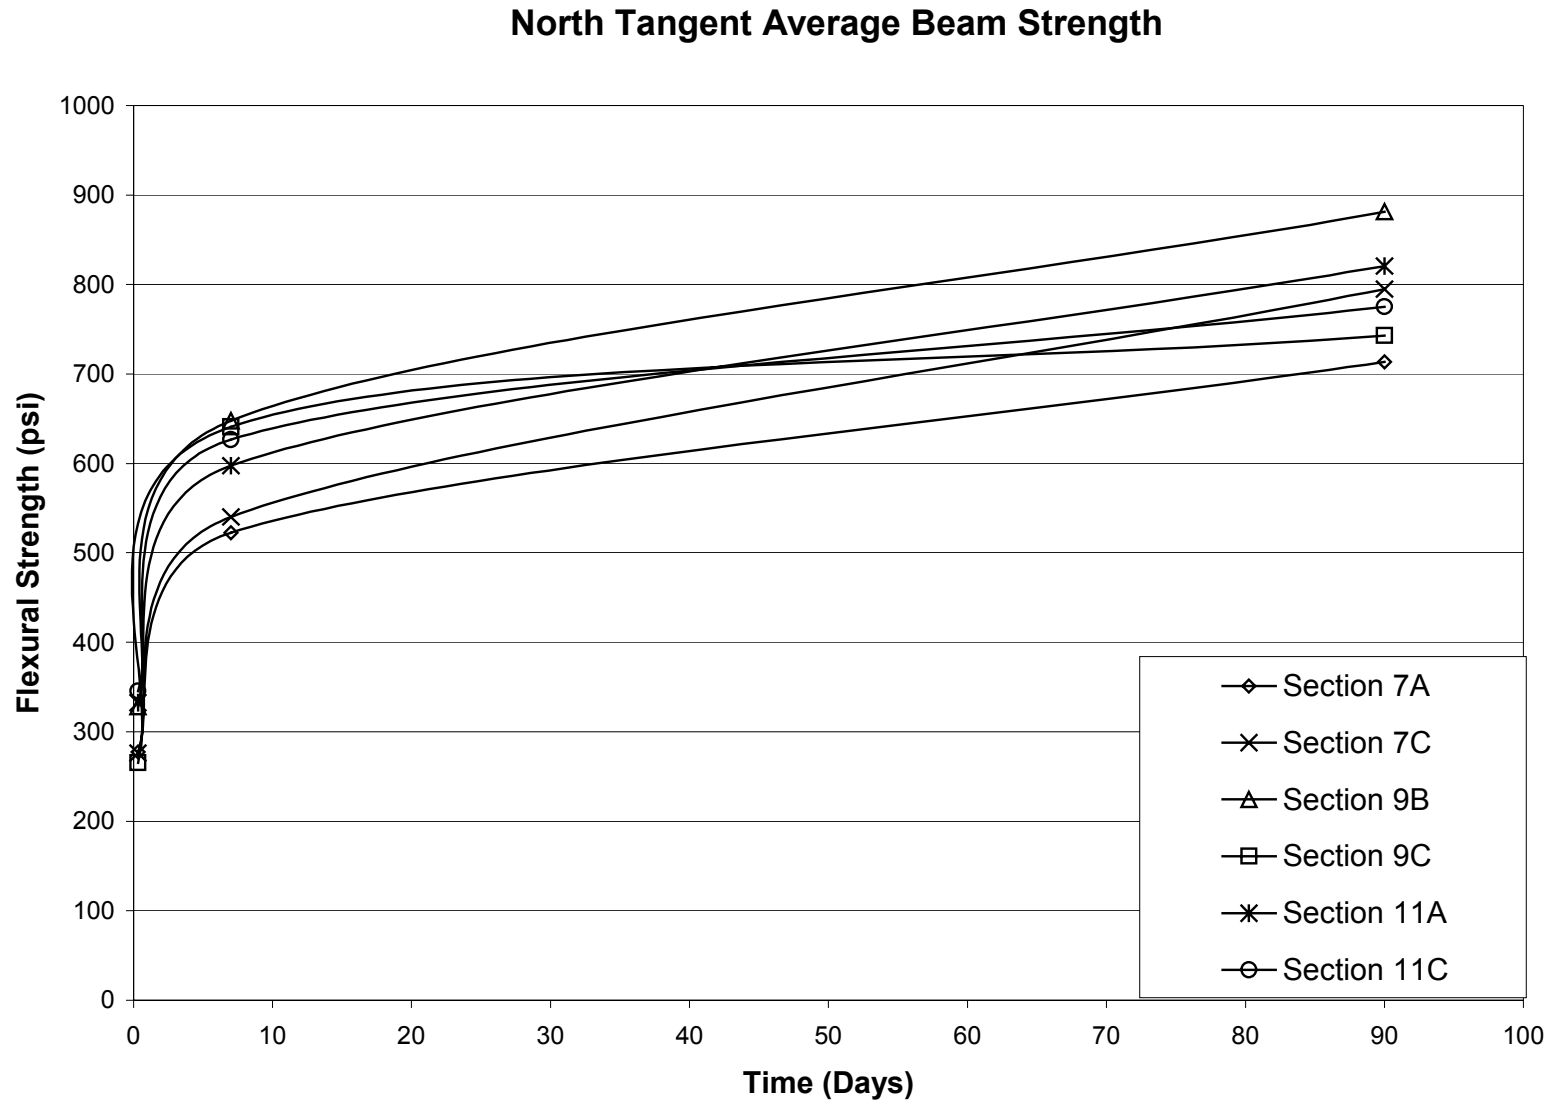
Figure 9.1. Average Beam Flexural Strength, North Tangent

Tables 9.6, 9.1, and 9.2 demonstrate that no section met the 8-hour specification of 400 psi (2.76 MPa) flexural strength and only half of the sections met the 7-day specification of 600 psi (4.14 MPa) flexural strength. This is assuming Caltrans center-point testing and ASTM third-

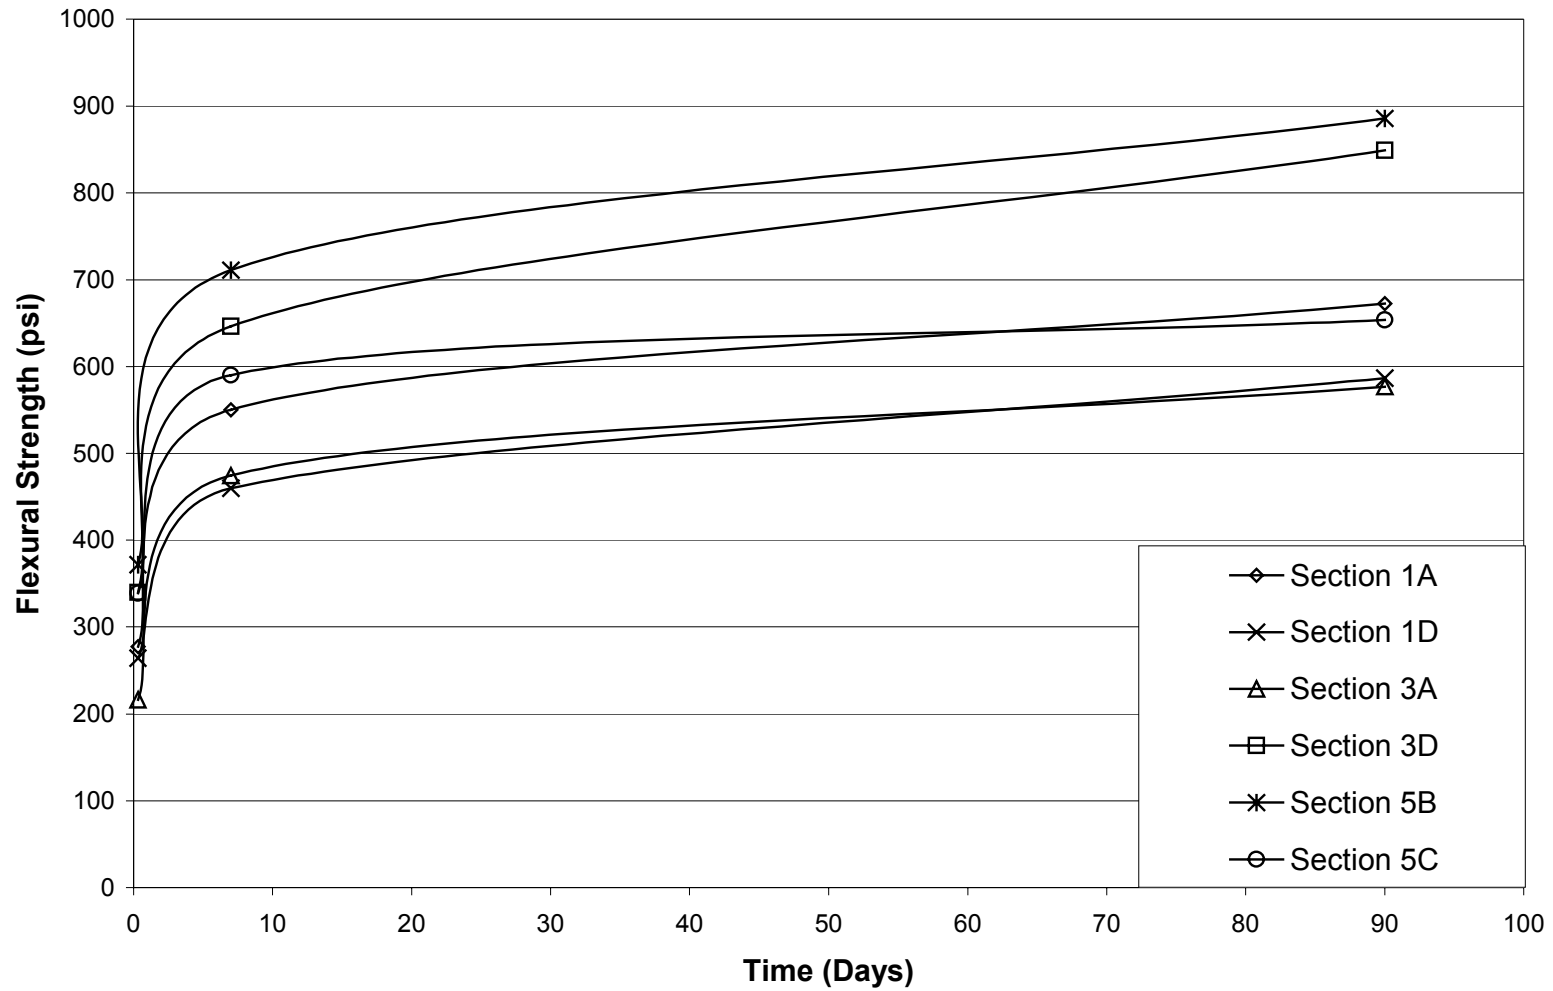
Figure 9.2. Average Beam Flexural Strength, South Tangent.
