**Construction, Instrumentation, and Testing of Fast-Setting
Hydraulic Cement Concrete in Palmdale, California**

CALIFORNIA DEPARTMENT OF TRANSPORTATION

Pavement Research Center
Institute of Transportation Studies
University of California Berkeley

Technical Report Documentation Page

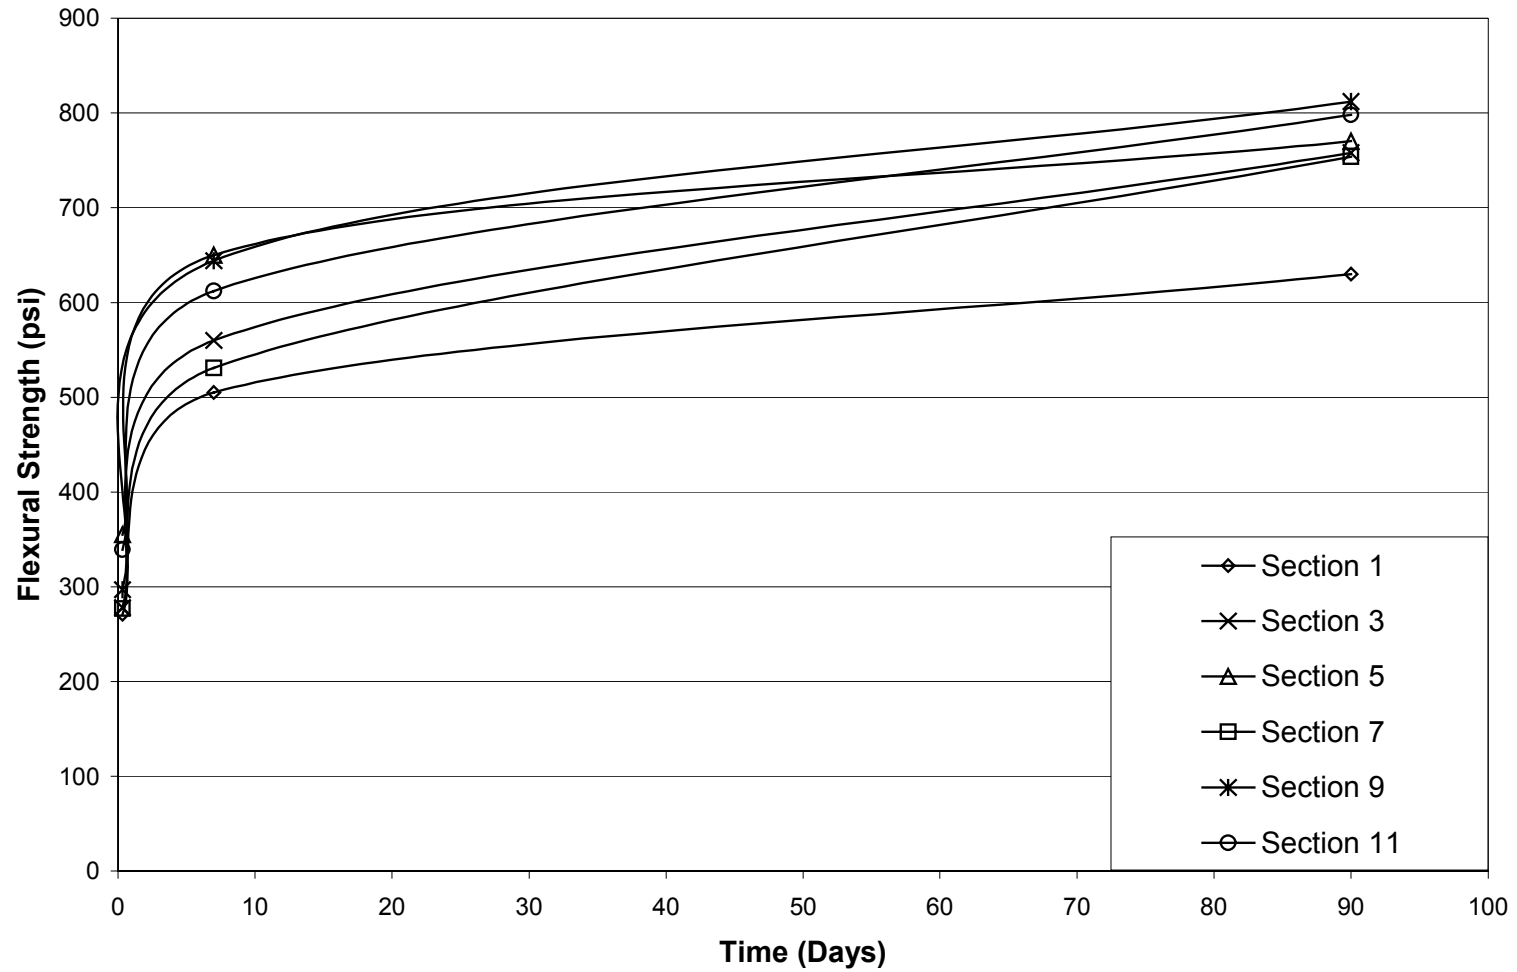
Figure 9.3. Average Beam Strength Gain for Palmdale Test Sections.

Figure 9.3 shows the average beam strength gain for each Palmdale test section. This plot demonstrates again the variability in strength found between test sections. It also shows that the strength gain rate after 7 days is similar for all mixes.

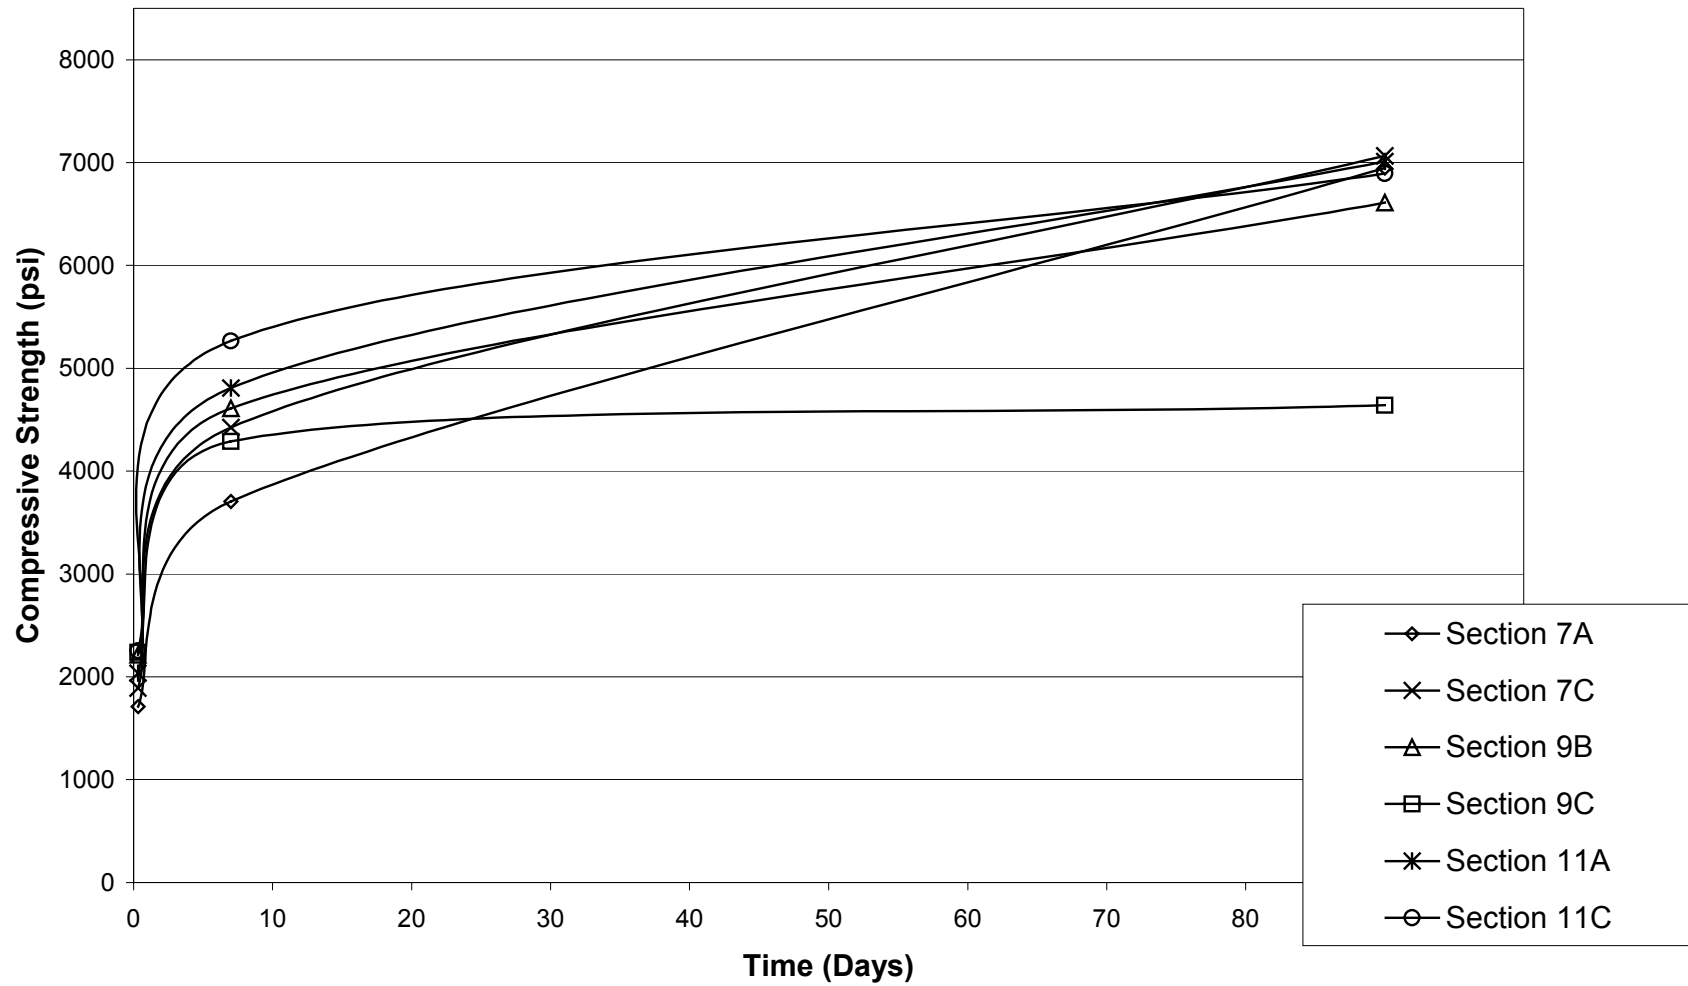
Figure 9.5. Average Cylinder Compressive Strength versus Time (North Tangent).

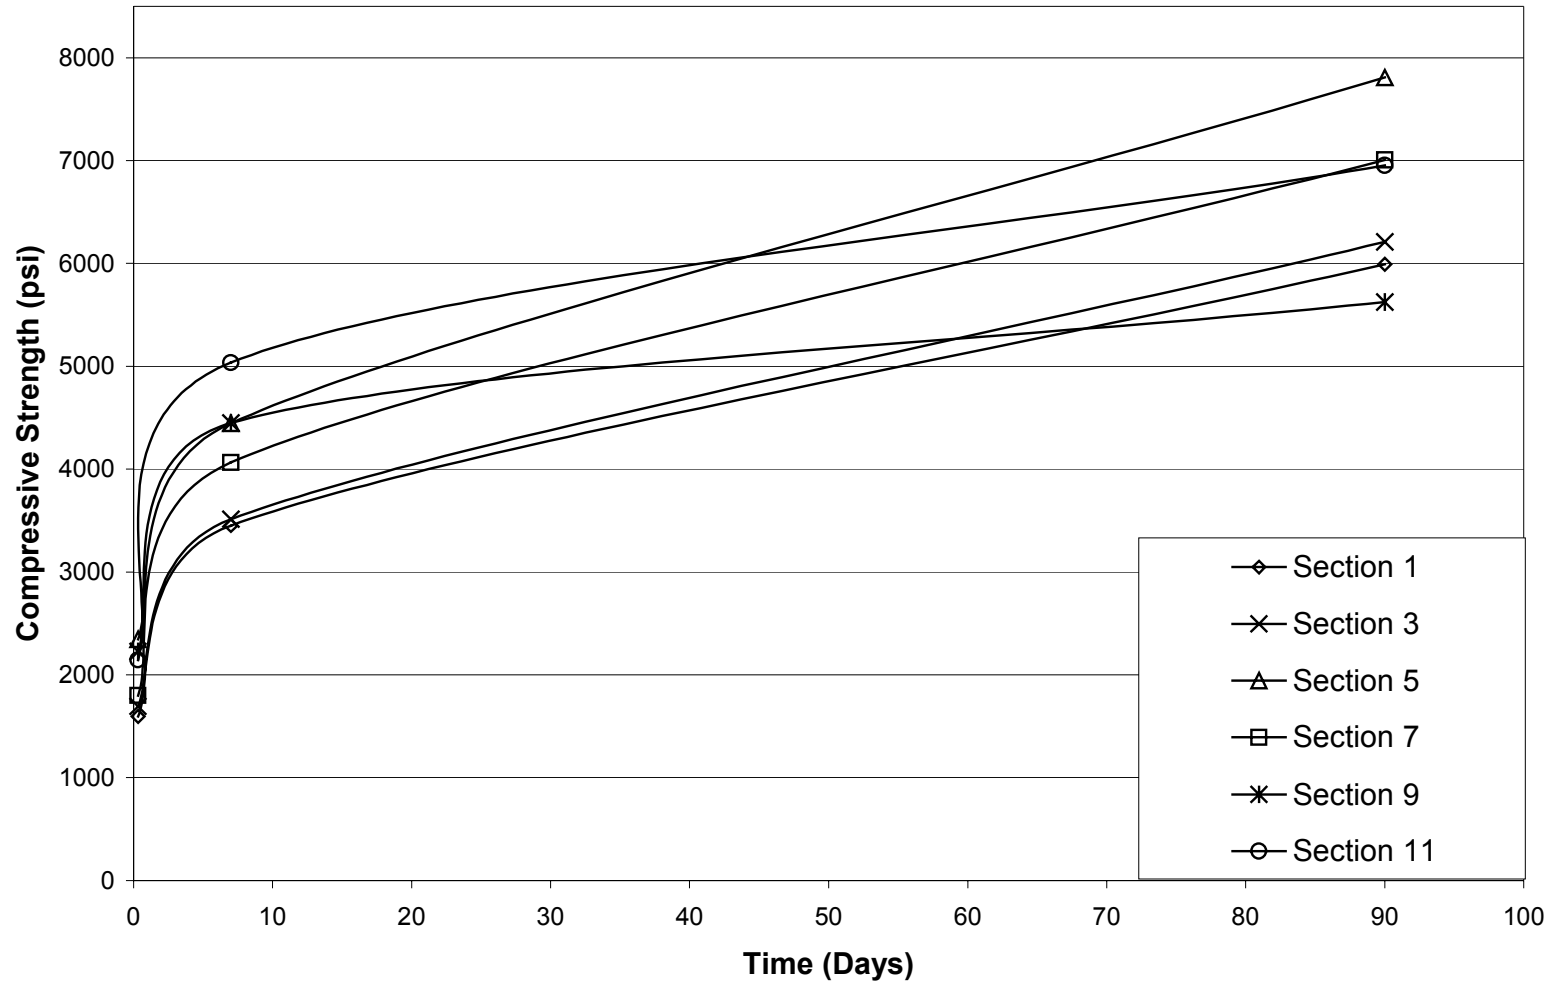
Figure 9.6. Average Cylinder Compressive Strength versus Time (North and South Tangents).

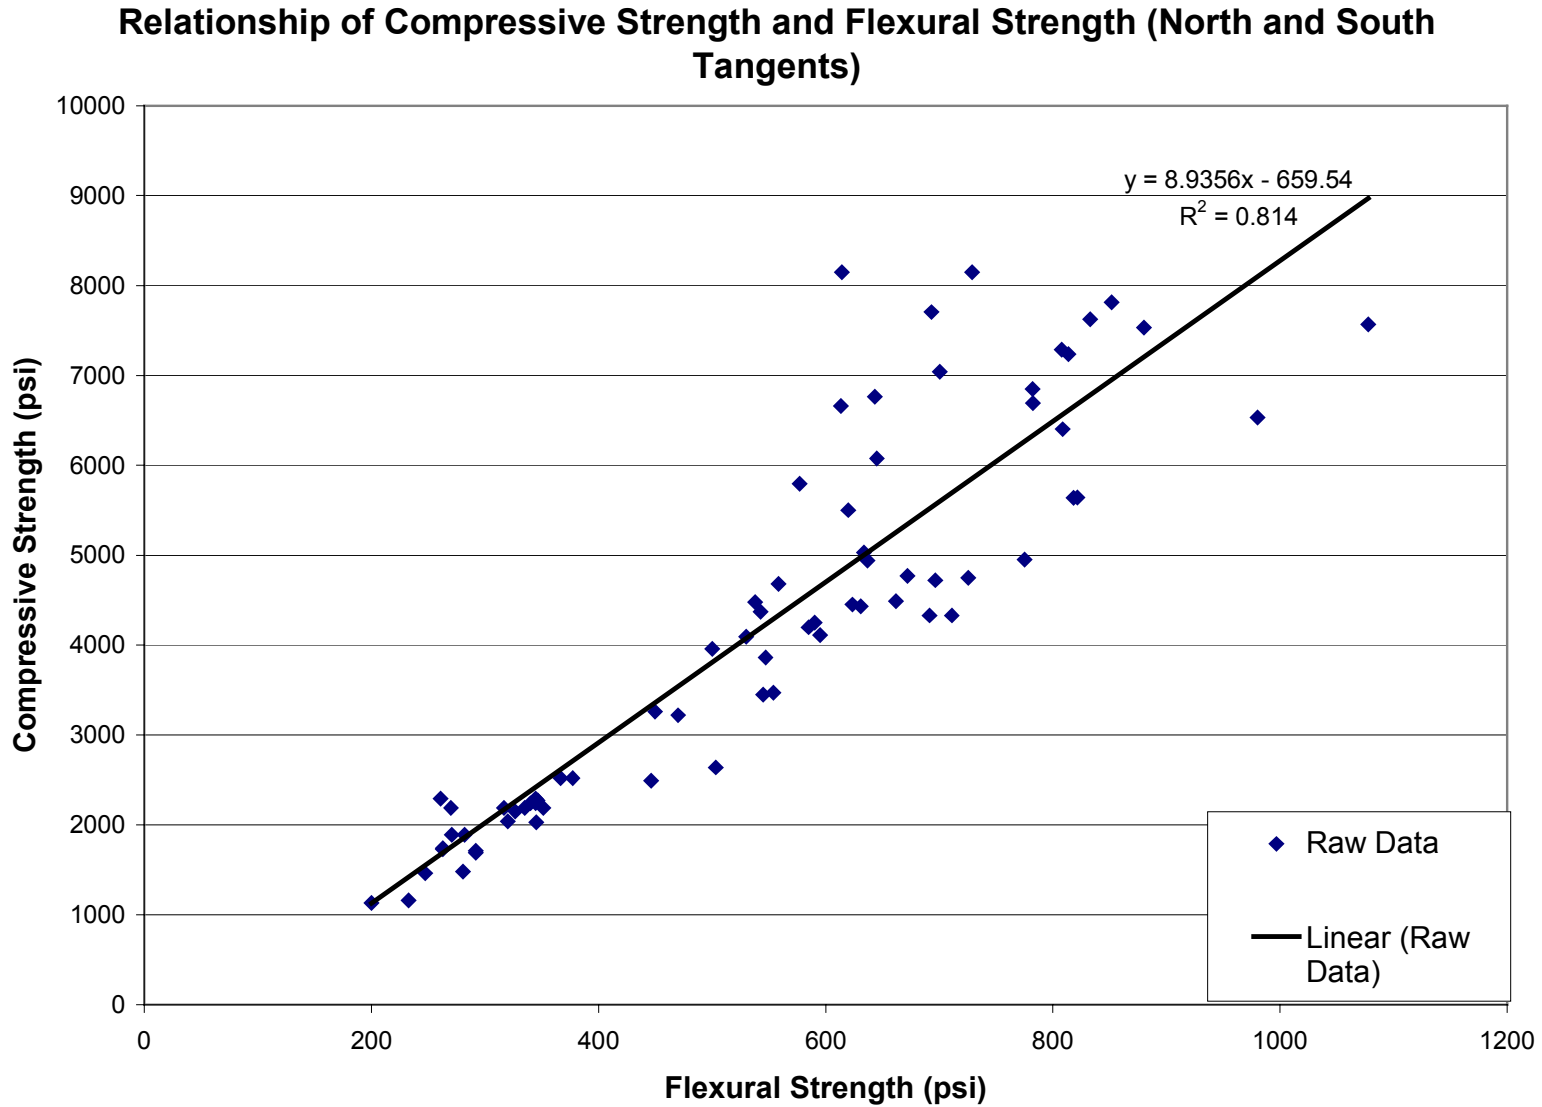
Figure 9.7. Relationship of Compressive Strength and Flexural Strength for Palmdale Test Sections.

The relationship shown in Figure 9.7 can be used to relate beam (flexural) and cylinder (compressive) strength data as long as the data is not extrapolated beyond the original data points. Furthermore, the curve shown in Figure 9.7 is only valid for the exact mix used at Palmdale, including the aggregate and cement type.

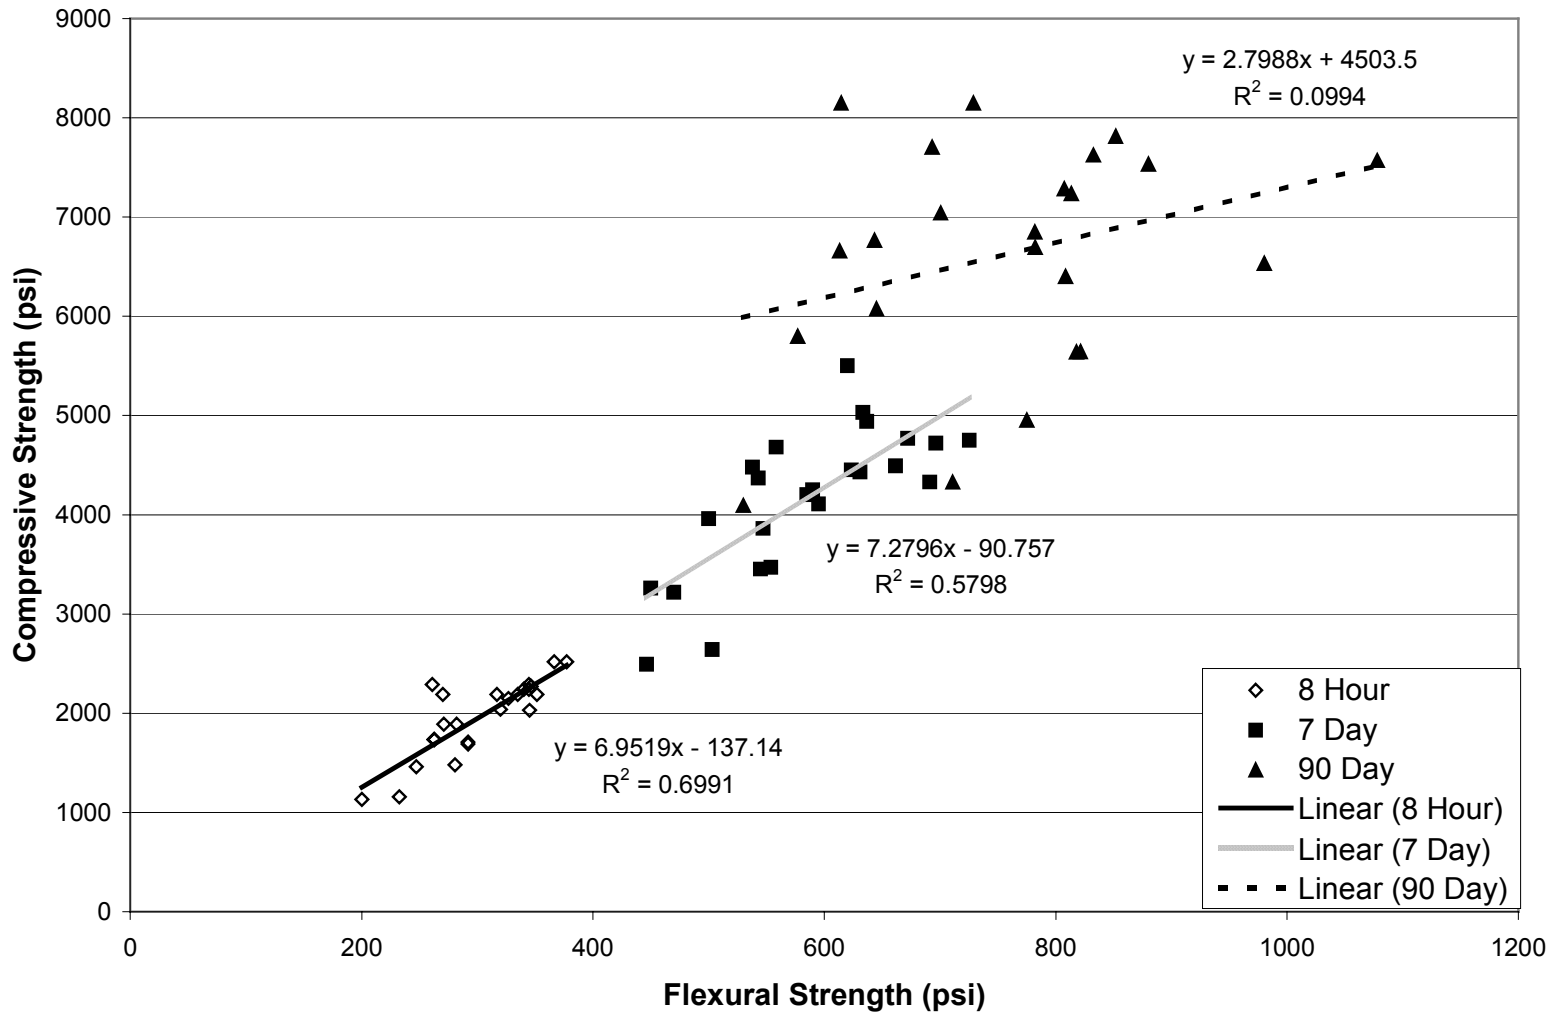
Figure 9.8. Relationship of Compressive Strength and Flexural Strength at Different Specimen Ages.

In order to identify where the most scatter exists in the data, a plot of beam (flexural) and cylinder (compressive) strength at each specimen age was made. Figure 9.8 shows that the scatter for the tests at 8 hours and 7 days is much less than for the tests at 90 days. At 90 days, there appears to be little correlation between flexural and compressive strength. Further laboratory testing needs to be completed to verify or dismiss the trend observed for the tests at 90 days.

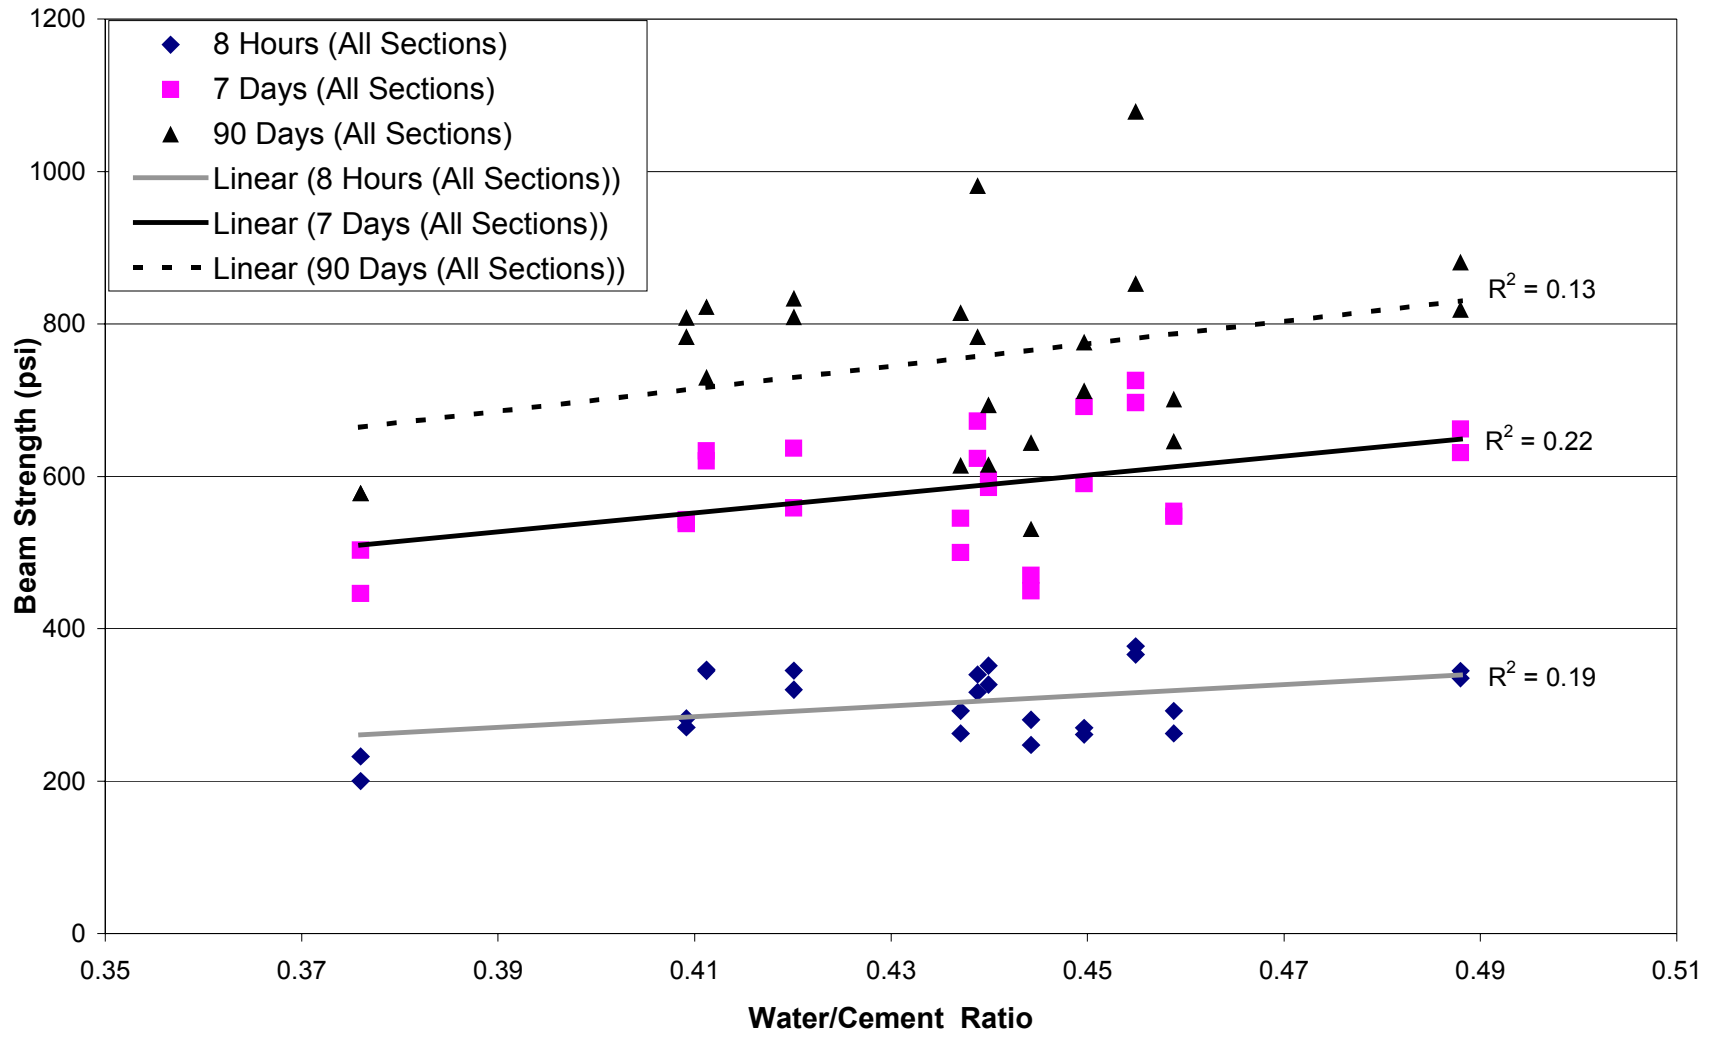
Figure 9.9. Water-to-Cement Ratio versus Beam Strength at 8 hours, 7 days, and 90 days.

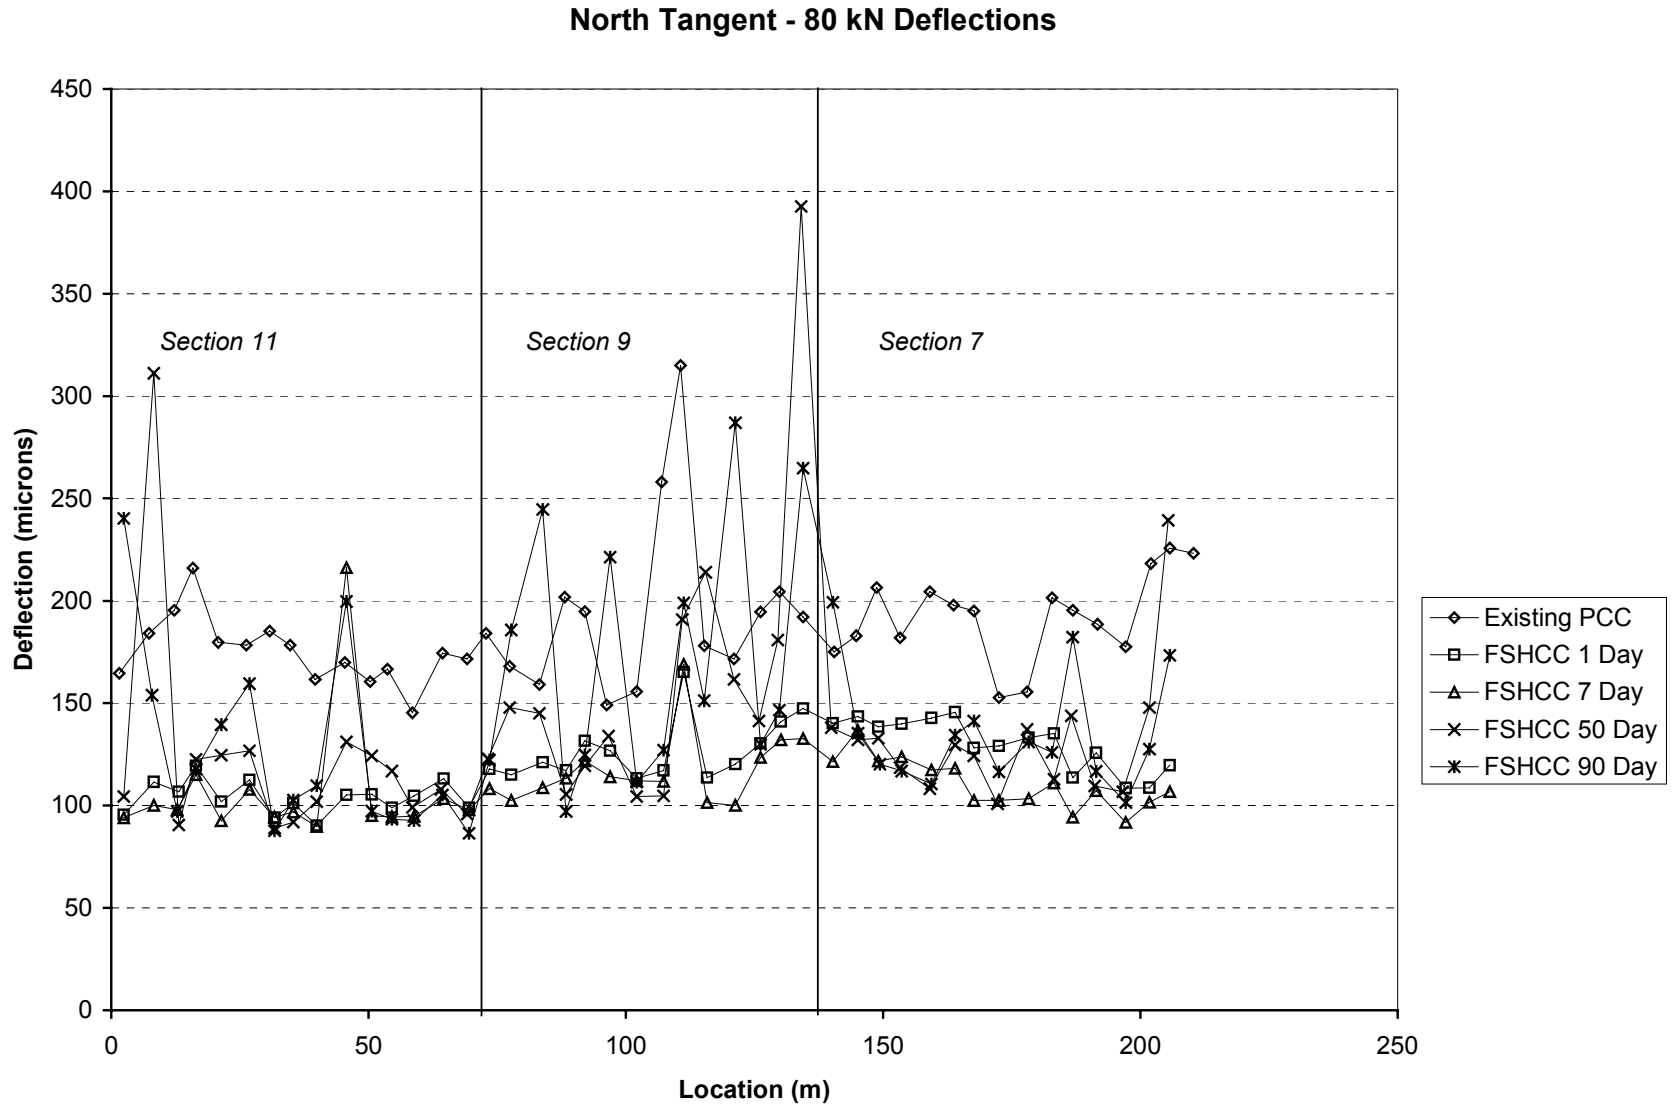
Figure 9.12. HWD Deflections, 80kN Load, North Tangent.

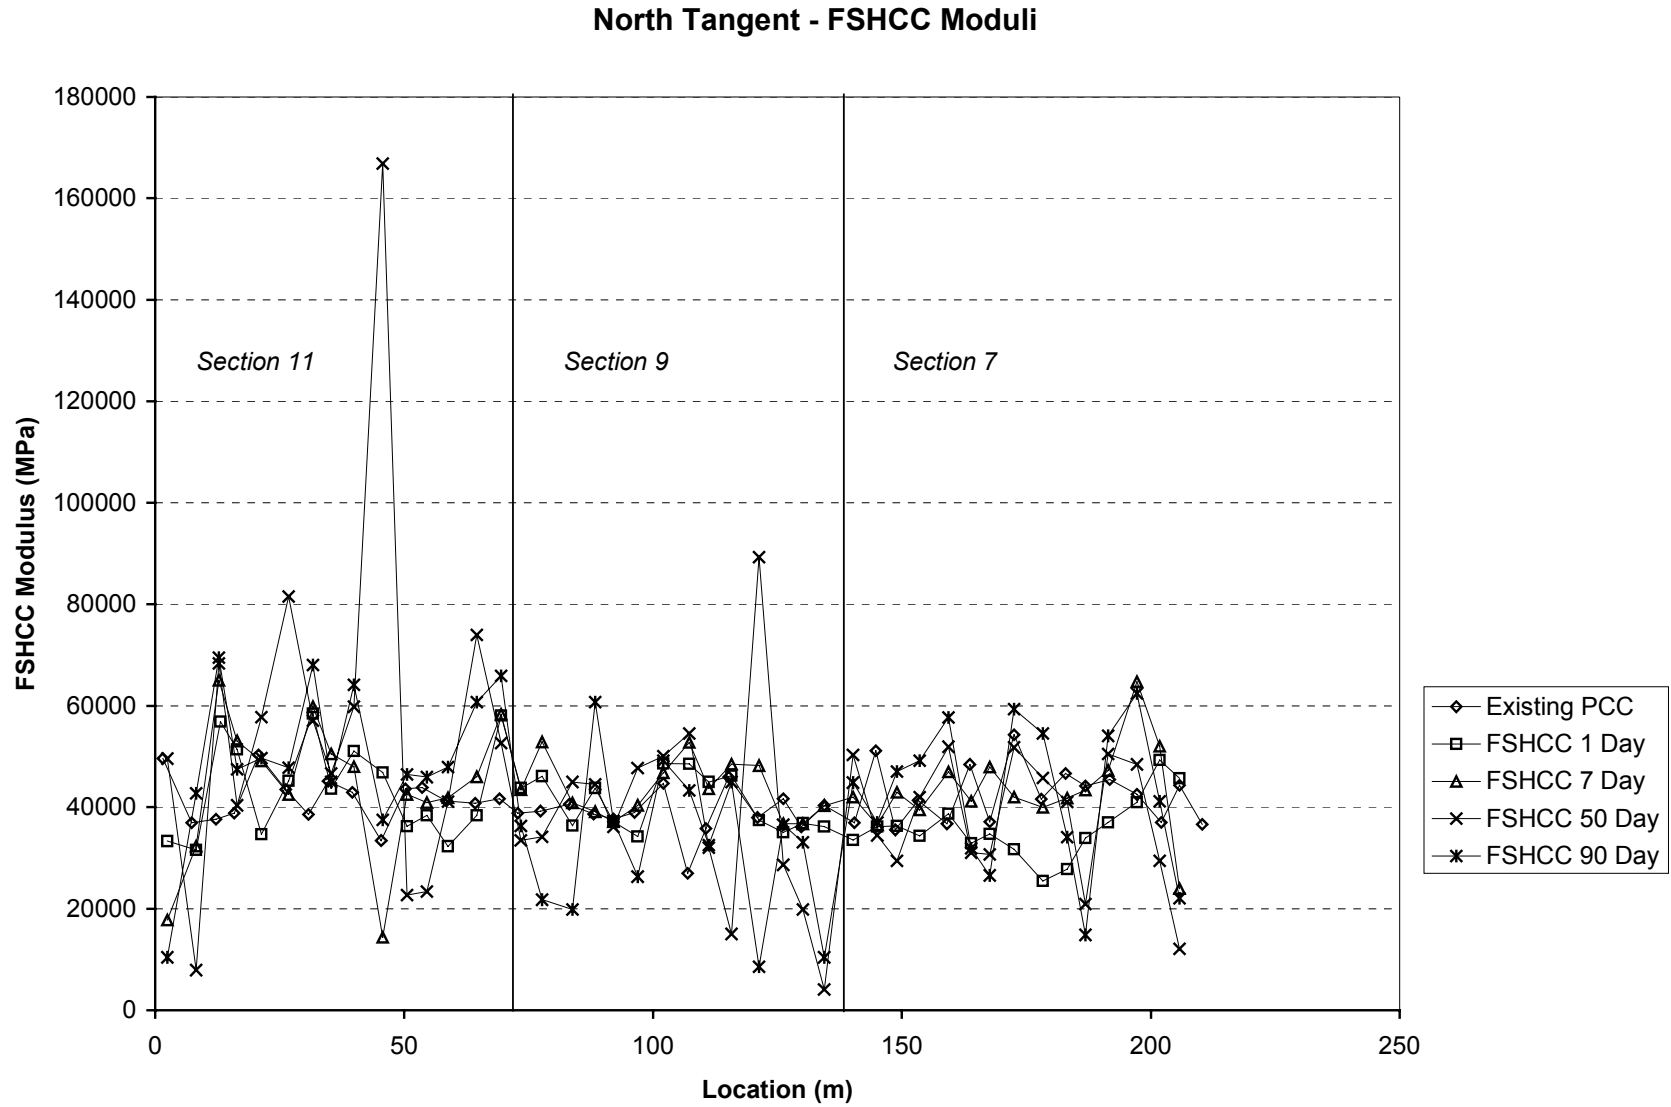
Figure 9.13. Surface Moduli (Backcalculated) for North Tangent.

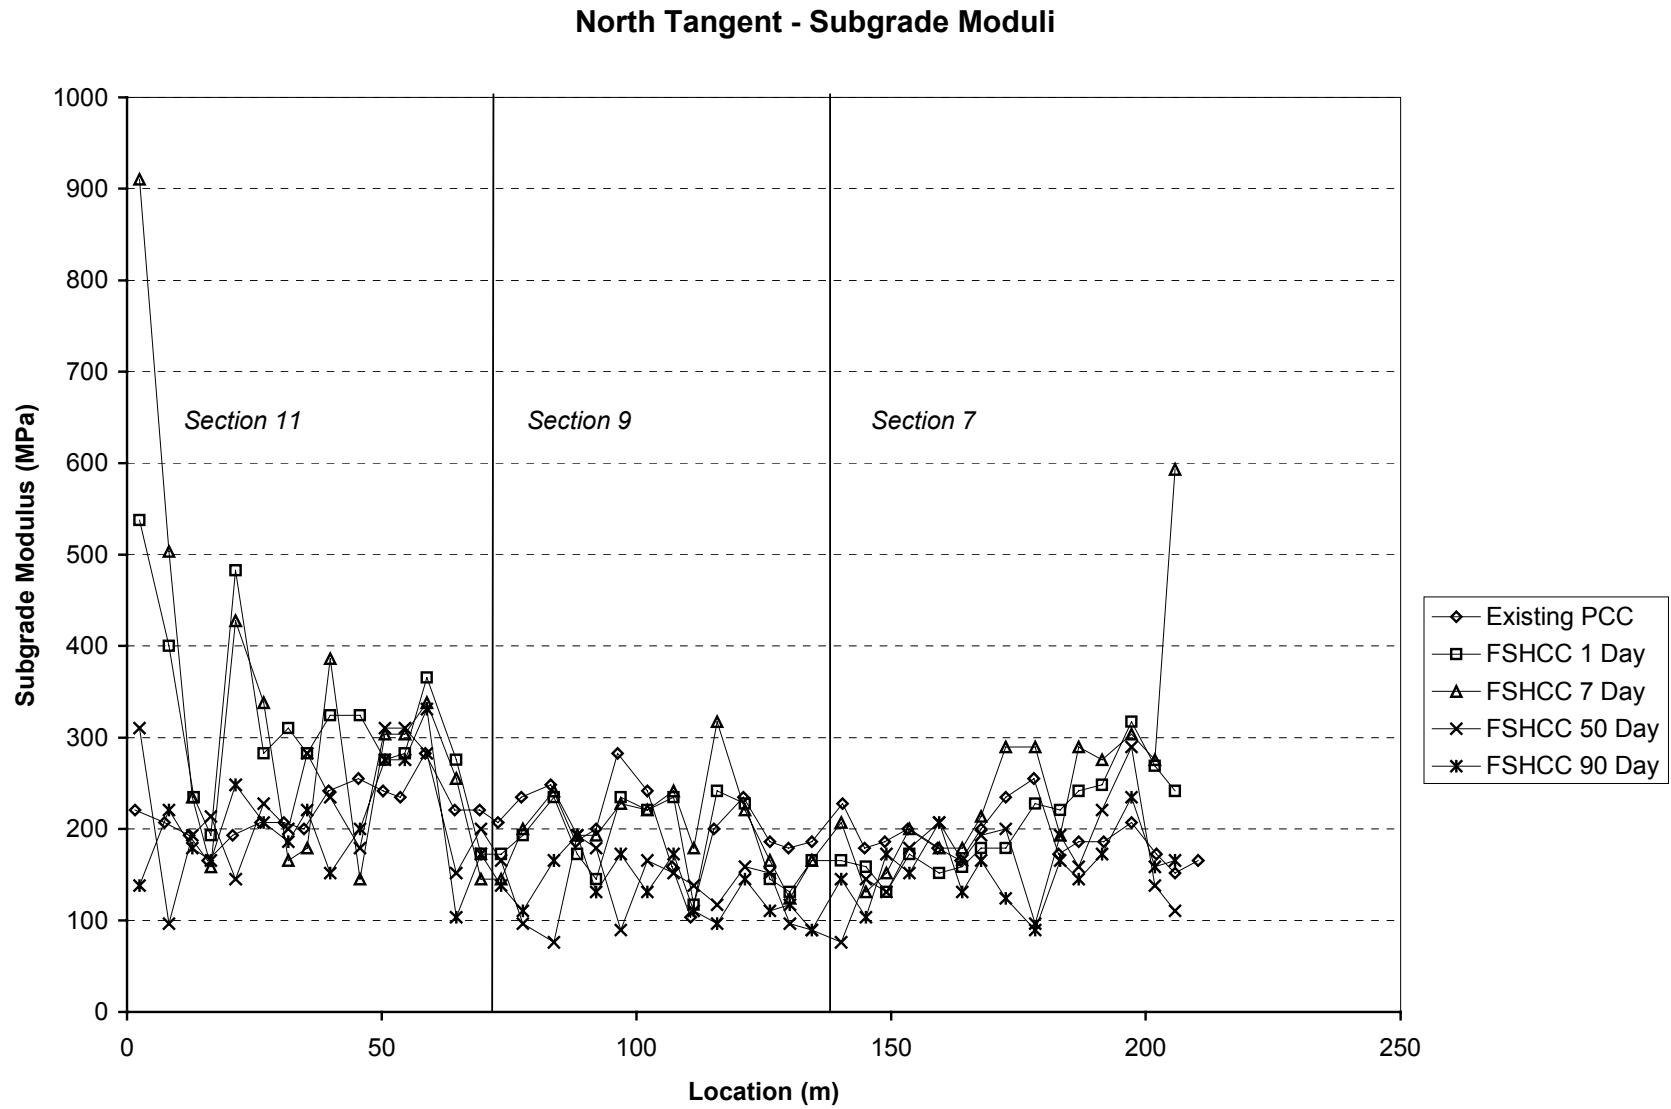
Figure 9.14. Subgrade Moduli (Backcalculated), North Tangent.

Estimated subgrade moduli do not appear to reflect the trend of increasing variability with time shown by deflections, which is consistent with the expected response. However, there does generally appear to be a trend of decreased subgrade modulus over time, which would explain the increasing deflection observed with time. The most common cause of subgrade modulus variation with time is considered to be variation in moisture content. The observed trend would typically be expected to result from increasing moisture content, which does not appear reasonable for the time period over which the deflections were measured. Another possibility involves stress sensitivity of the subgrade, which would be expected to correlate with any trends observed in the surface (FSHCC) modulus, (i.e. as FSHCC modulus increased, stress

induced on subgrade decreased for a given HWD load). Finally, the decrease in subgrade moduli could be an indication of micro- or macro-cracks occurring in the concrete surface layer.

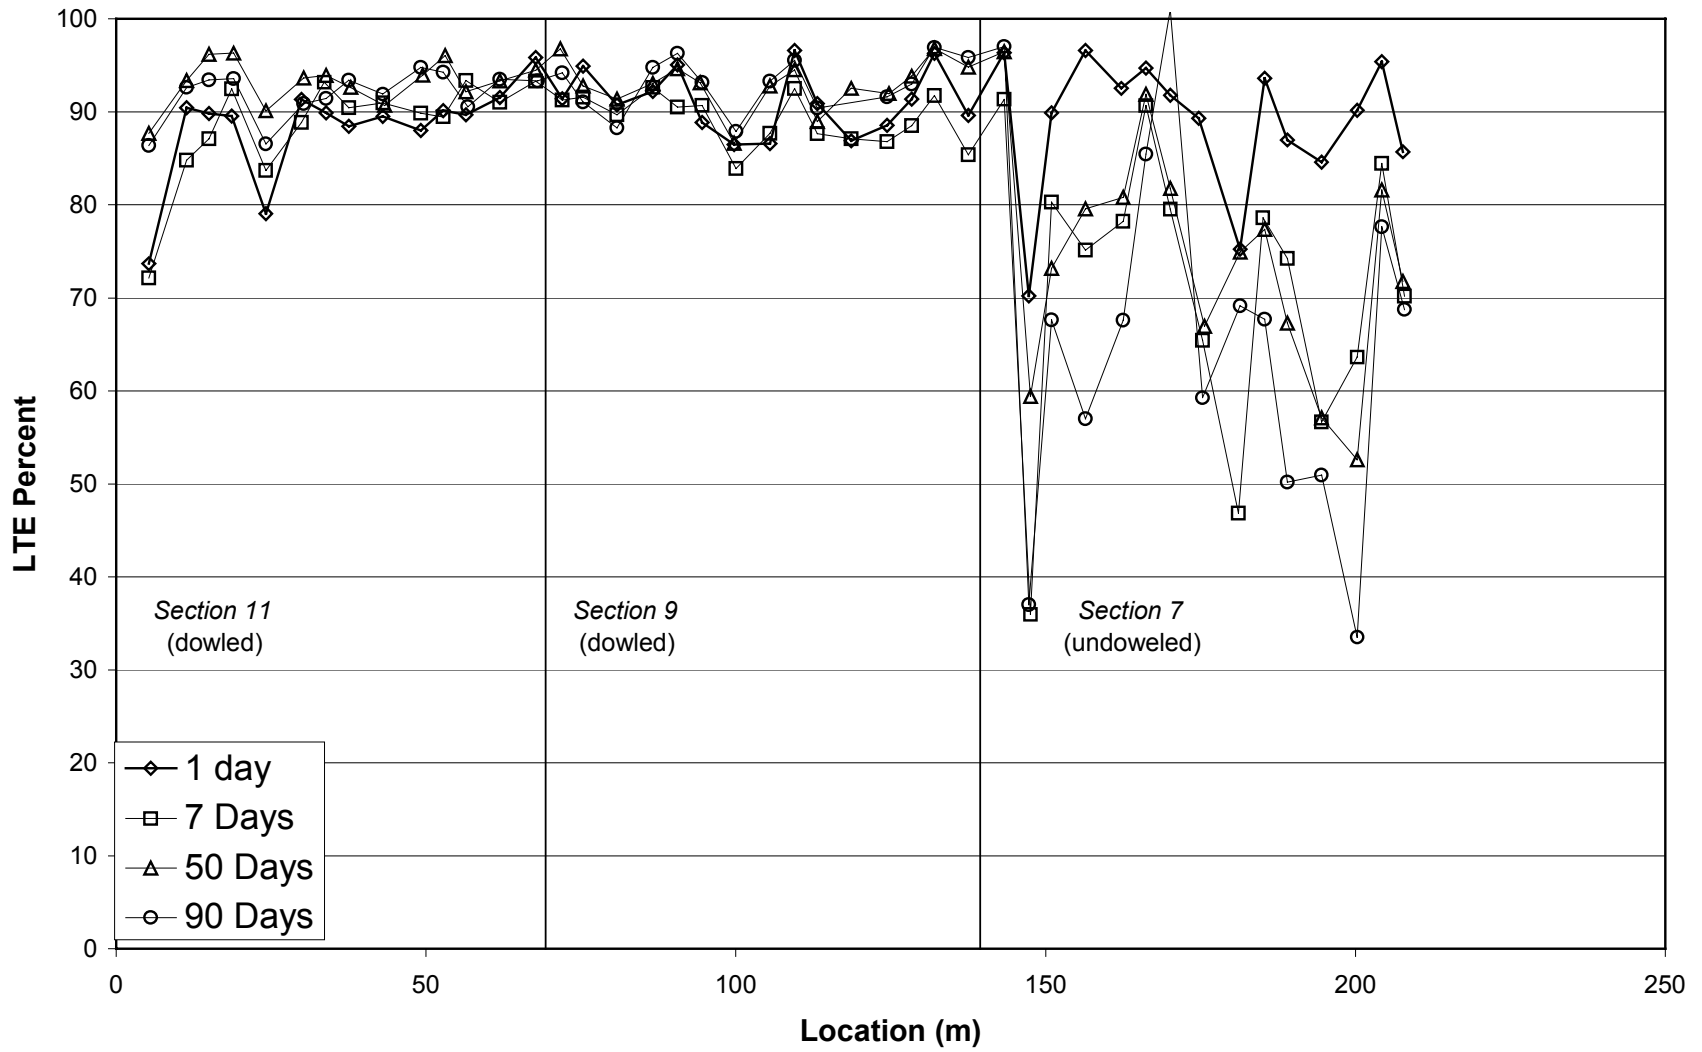
Figure 9.16. Transverse Joint Load Transfer Efficiency, North Tangent.

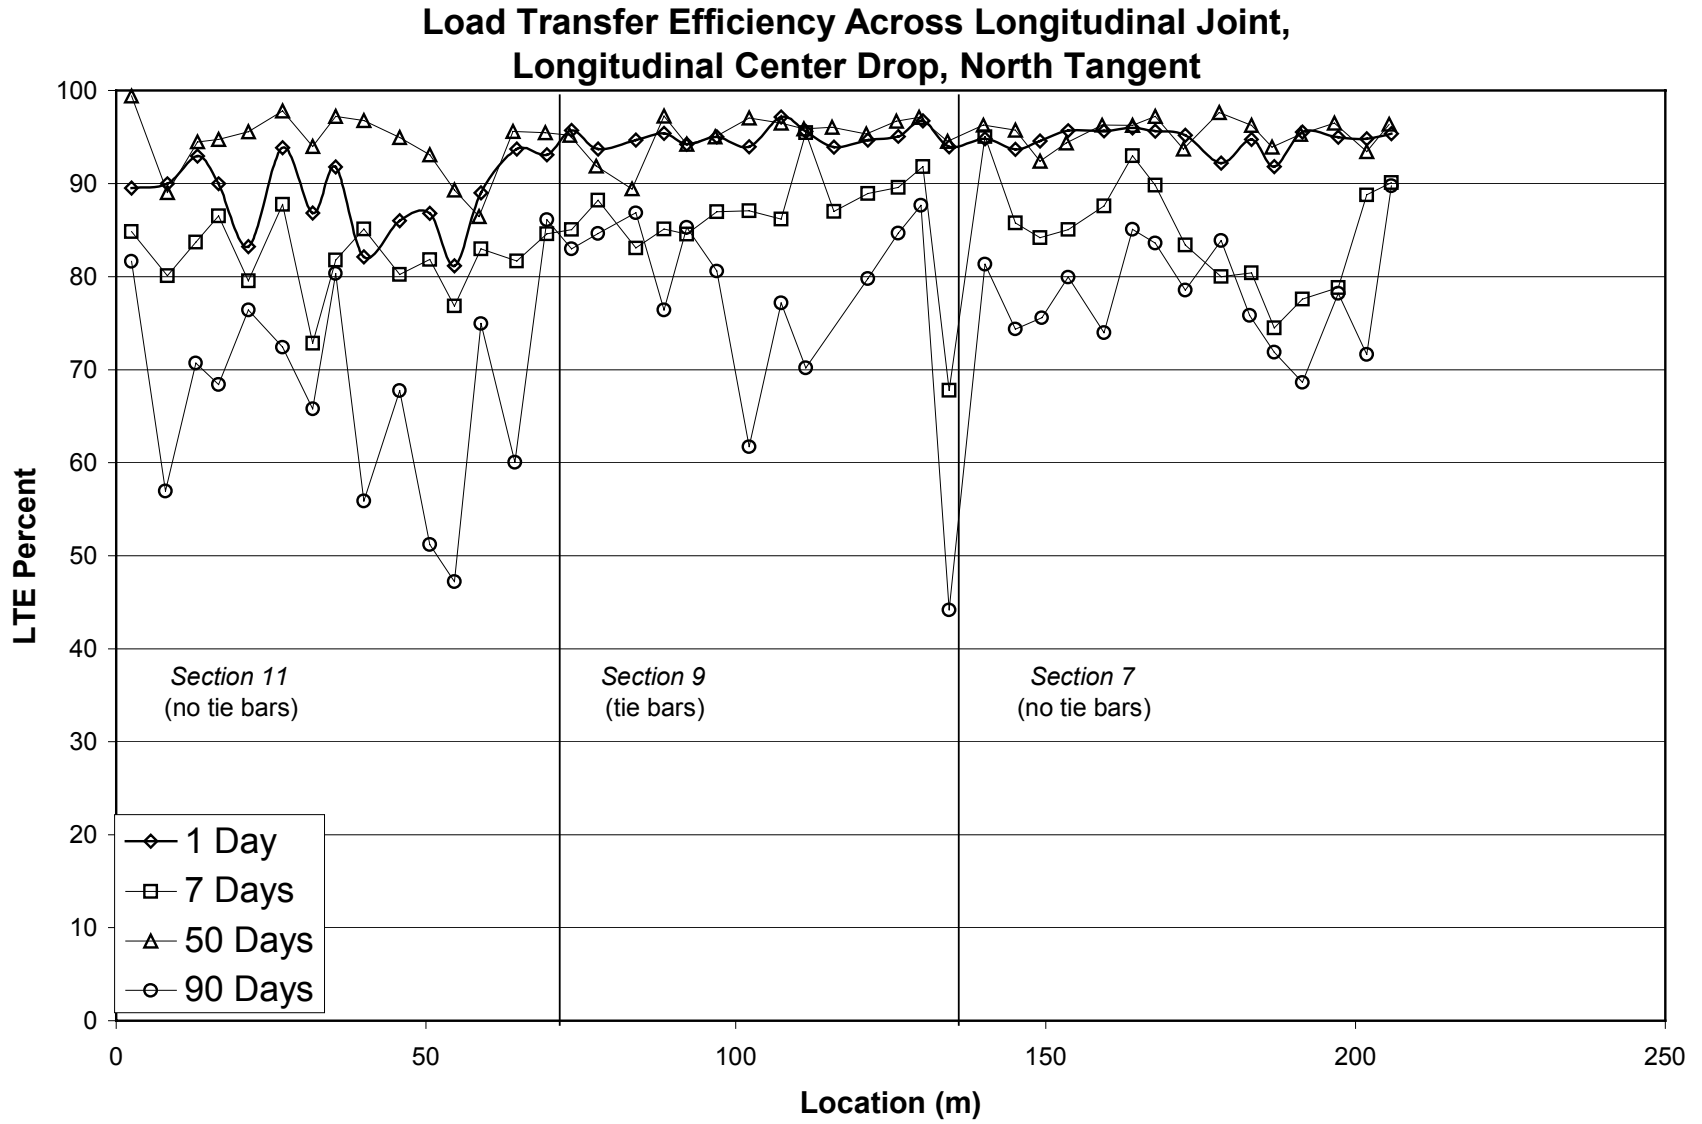
Figure 9.17. Longitudinal Joint Load Transfer Efficiency, Longitudinal Center Drop, North Tangent.

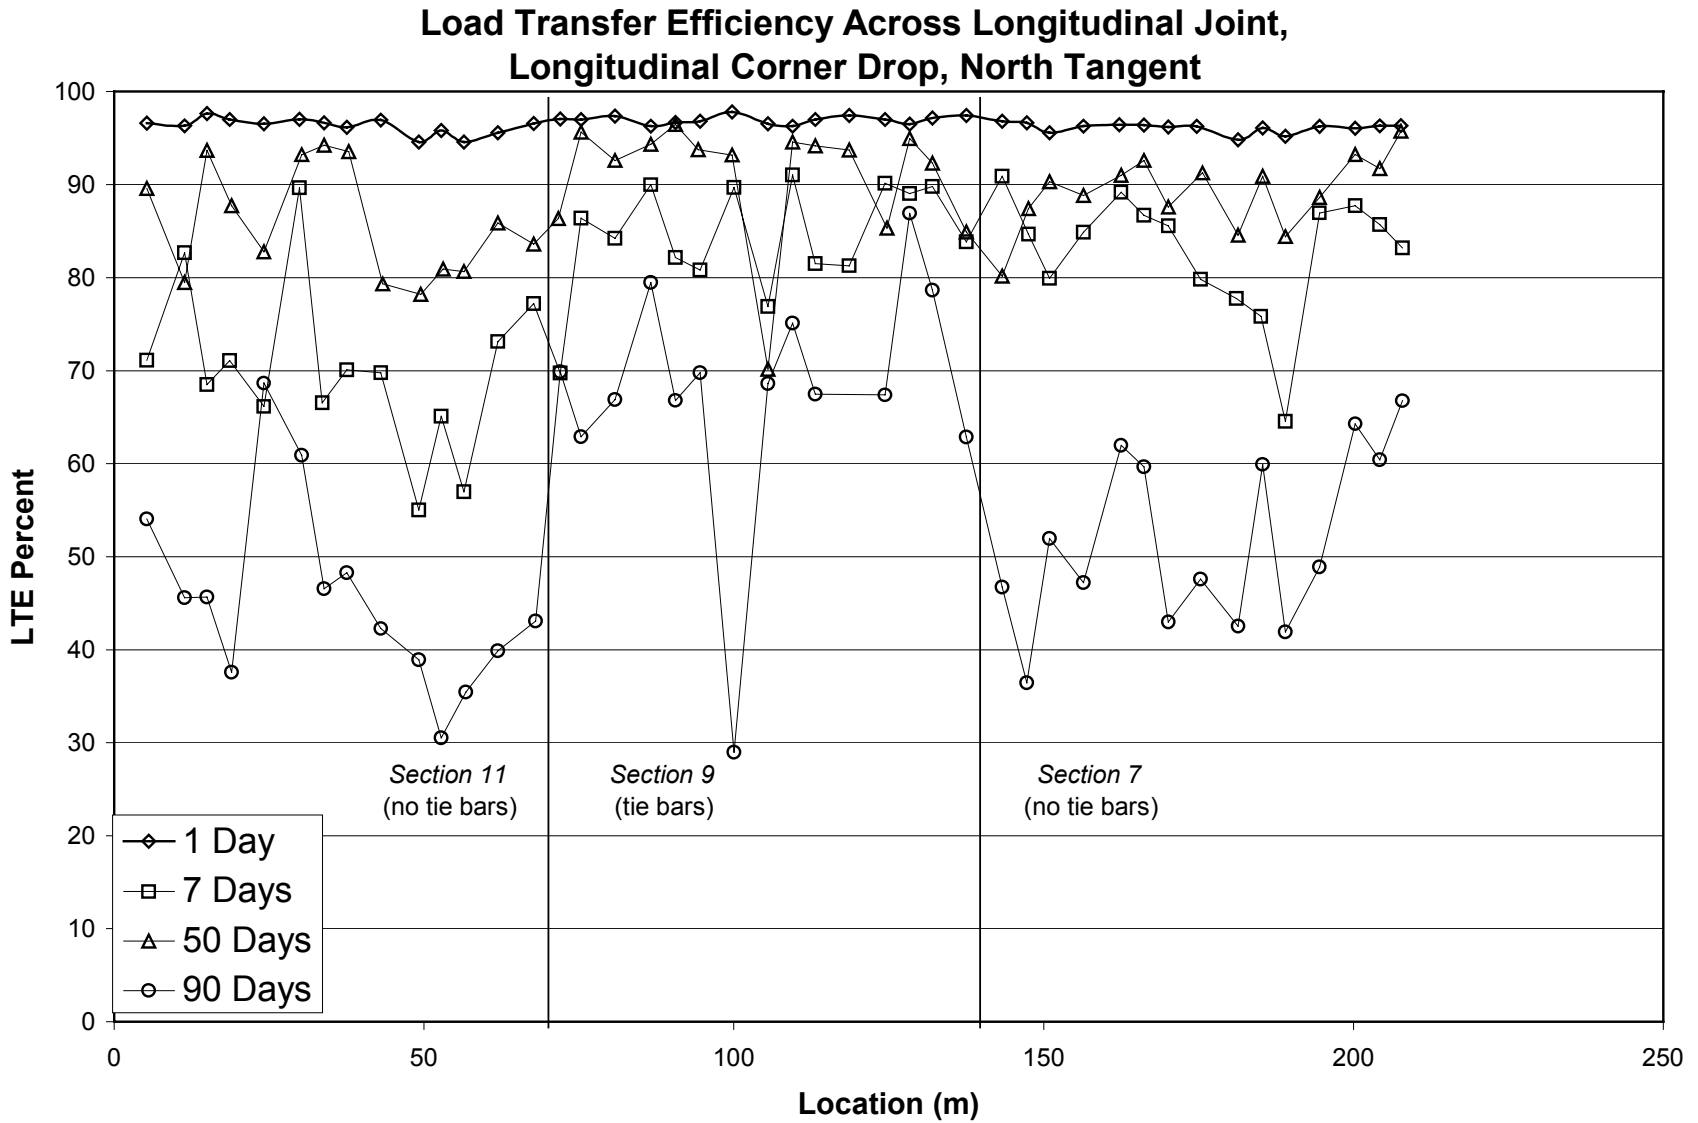
Figure 9.18. Longitudinal Joint Load Transfer Efficiency, Longitudinal Corner Drop, North Tangent.

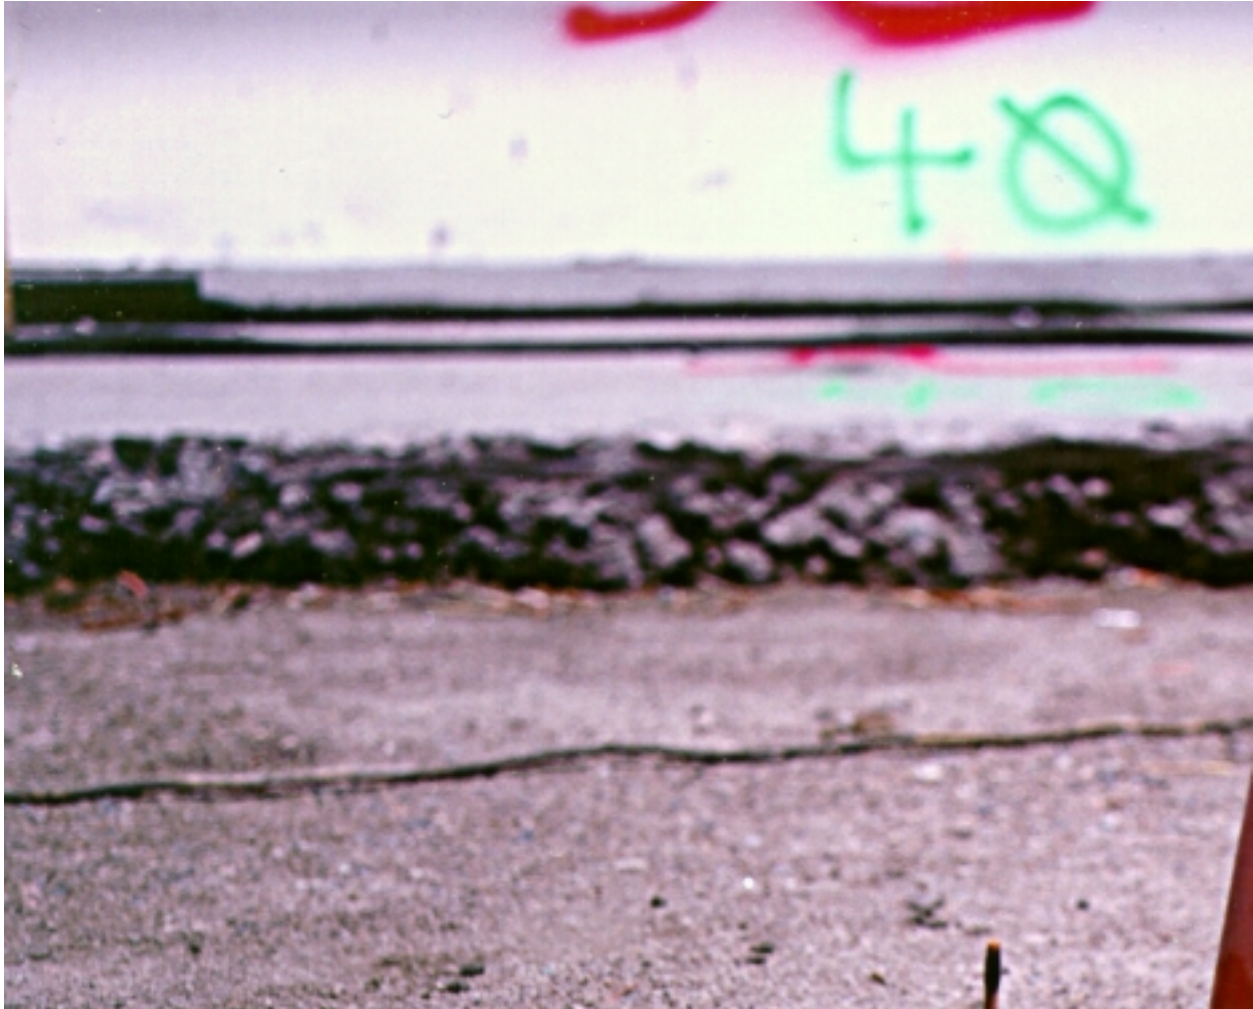
Figure 9.19. Detail photo of Rough Longitudinal Surface of Existing PCC Slabs, South Tangent.
