**Construction, Instrumentation, and Testing of Fast-Setting
Hydraulic Cement Concrete in Palmdale, California**

CALIFORNIA DEPARTMENT OF TRANSPORTATION

Pavement Research Center
Institute of Transportation Studies
University of California Berkeley

Technical Report Documentation Page

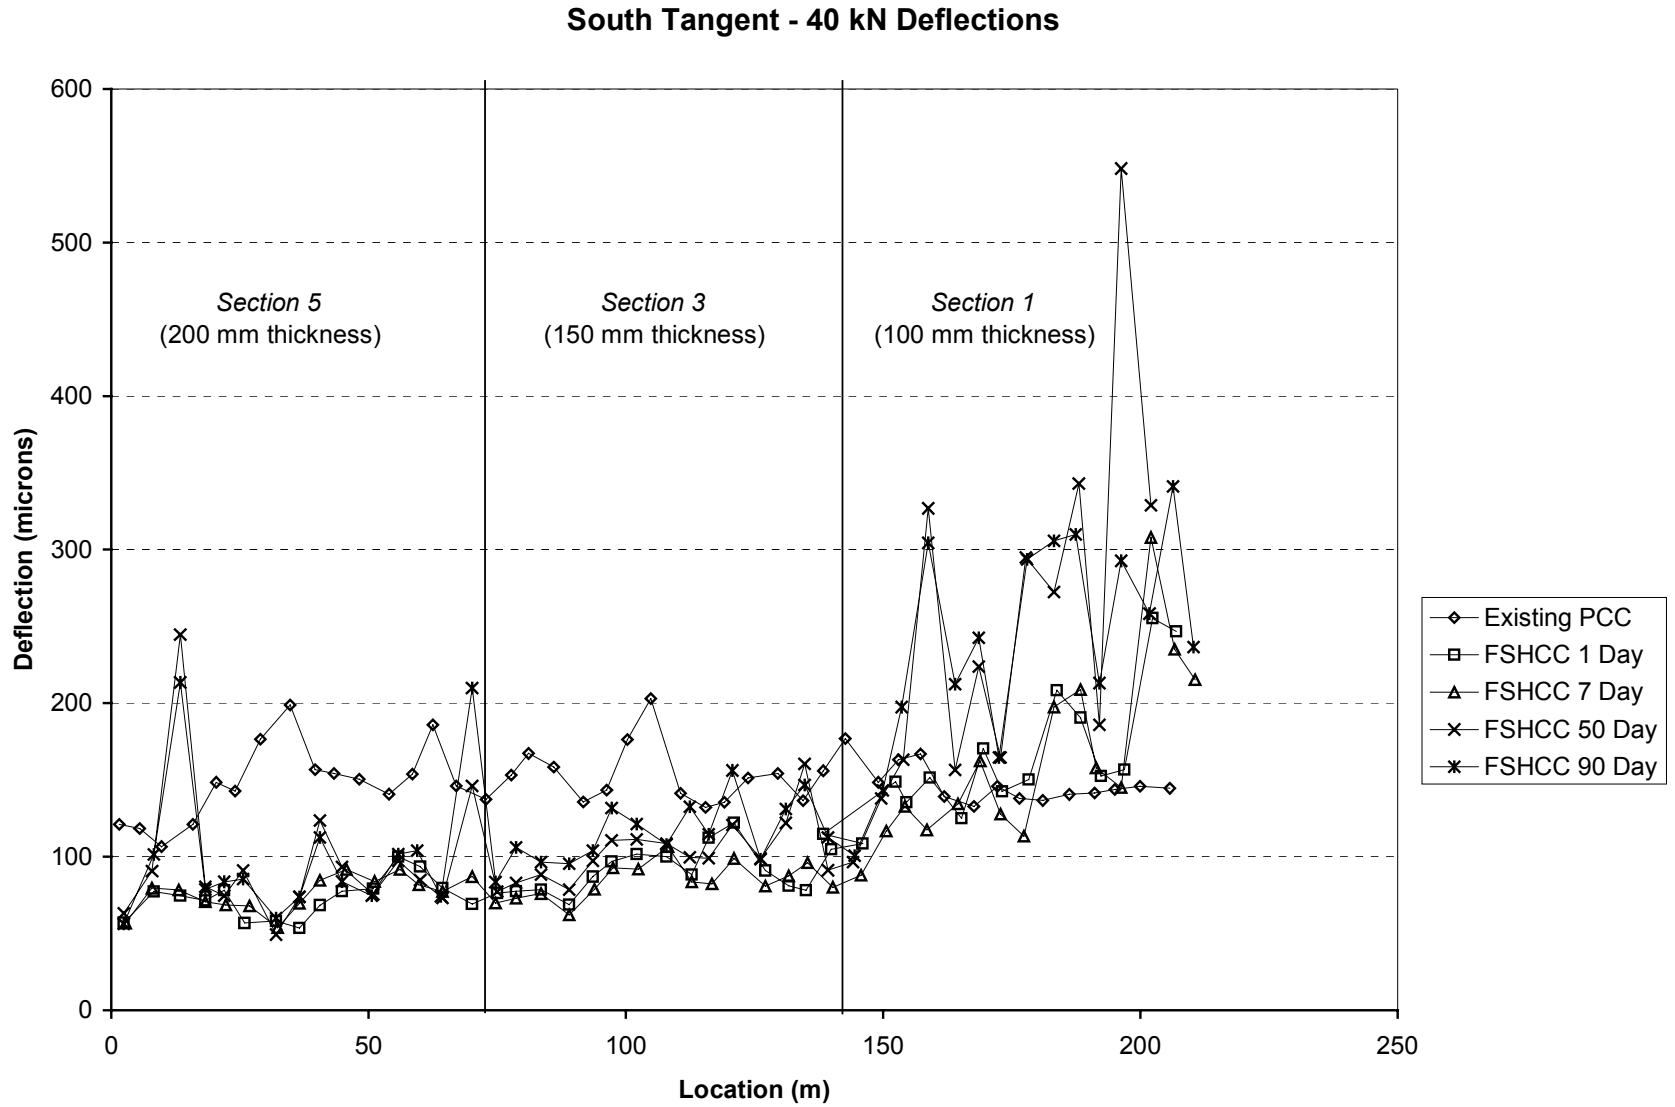
Figure 9.20. HWD Deflections, 40kN Load, South Tangent.

Inspection of Figures 9.20-9.21 and Tables 9.24-9.25 shows that the measured deflections for all days are somewhat variable, and are consistent with measured deflections of typical Portland cement concrete (PCC) slabs, including the existing PCC slabs near the Palmdale test sections. Longitudinal variations in deflection response appear to be fairly consistent for Section 5, but are increasingly variable for Sections 1 and 3. This may be due to the change in surface

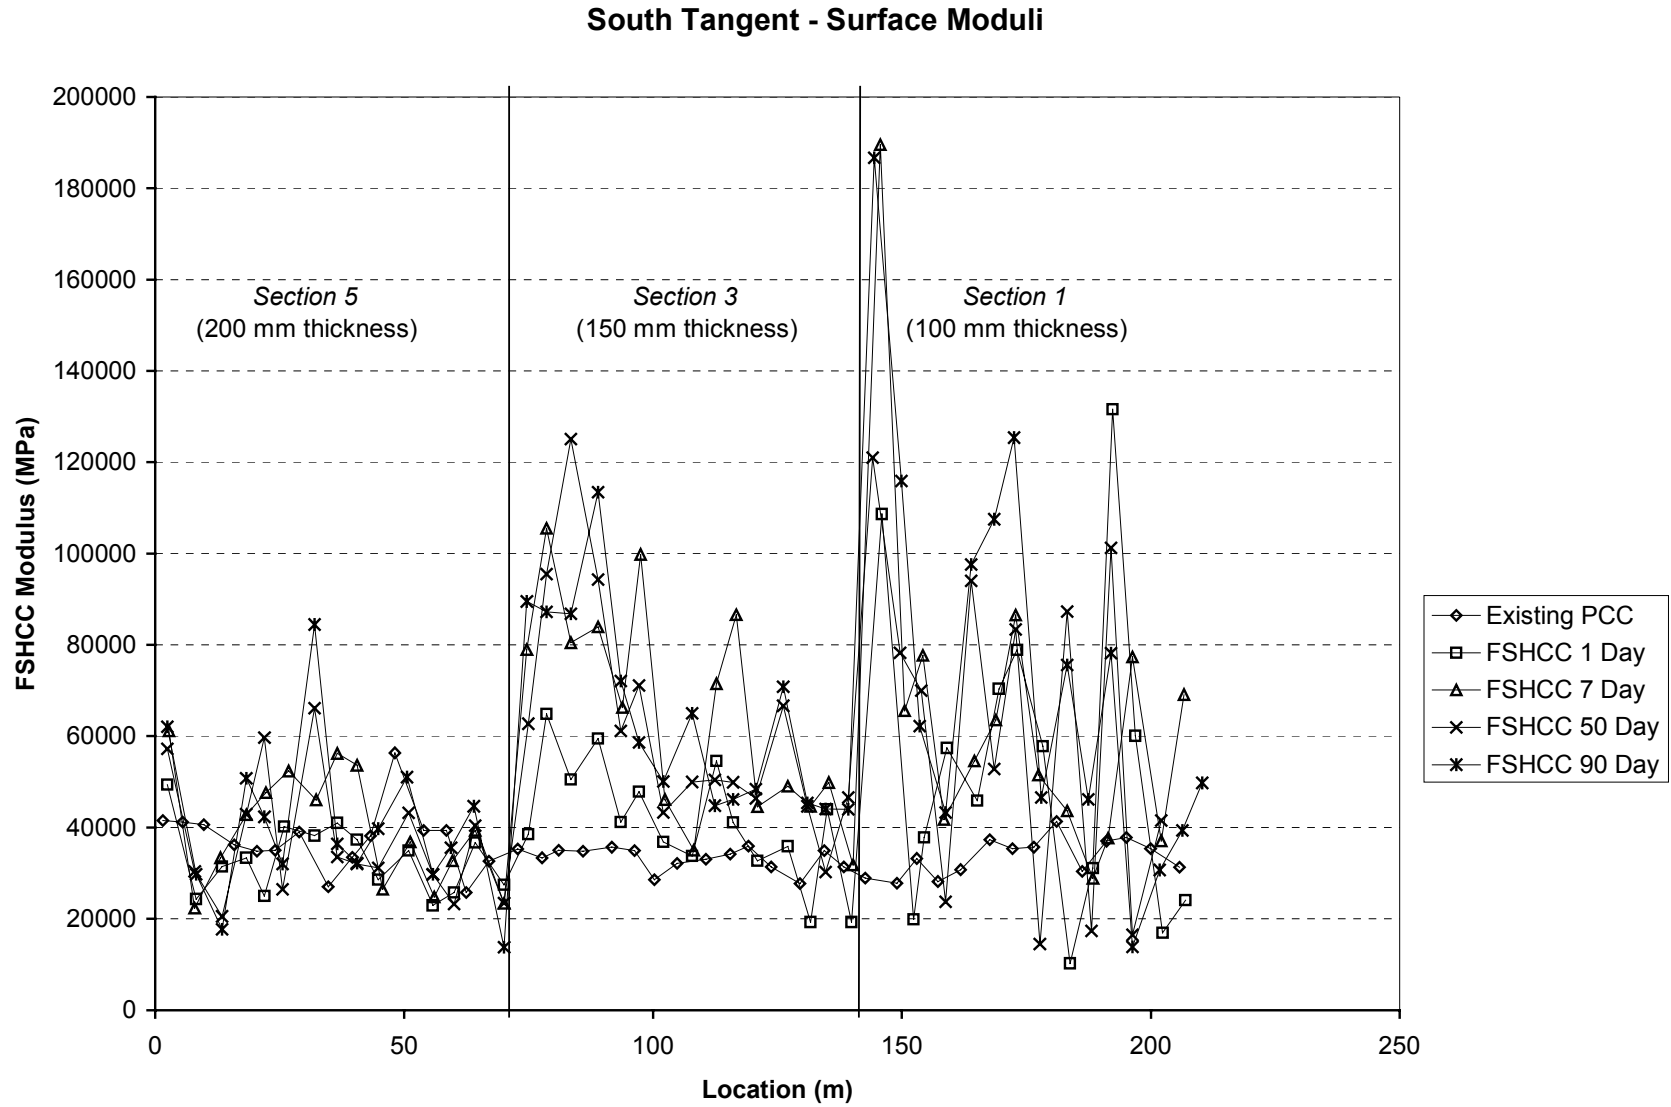
Figure 9.22. Surface Moduli (Backcalculated) for South Tangent.

A comparison of PCC and FSHCC calculated surface moduli for the South Tangent shows a good relationship between the measured values. However, comparing PCC and FSHCC calculated subgrade moduli for the South Tangent suggests a poor relationship between the two values. Variability in the South Tangent subgrade moduli is similar to that of the North Tangent subgrade moduli presented in Table 9.22.

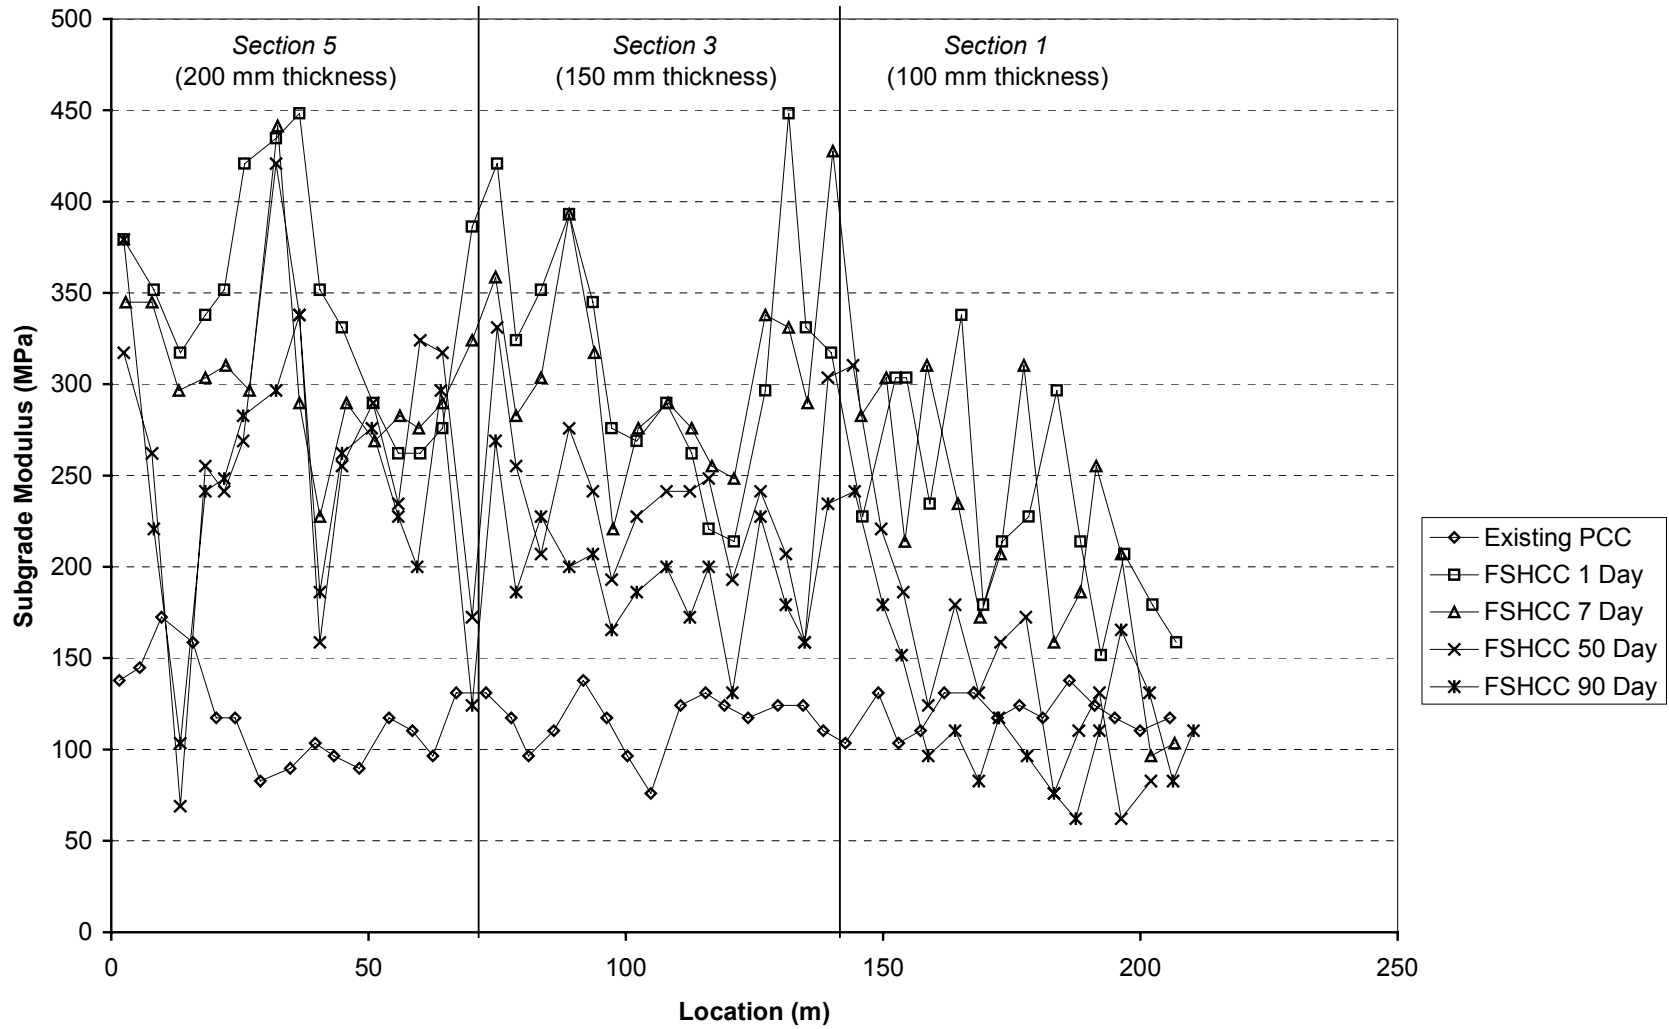
Figure 9.23. Subgrade Moduli (Backcalculated), South Tangent.

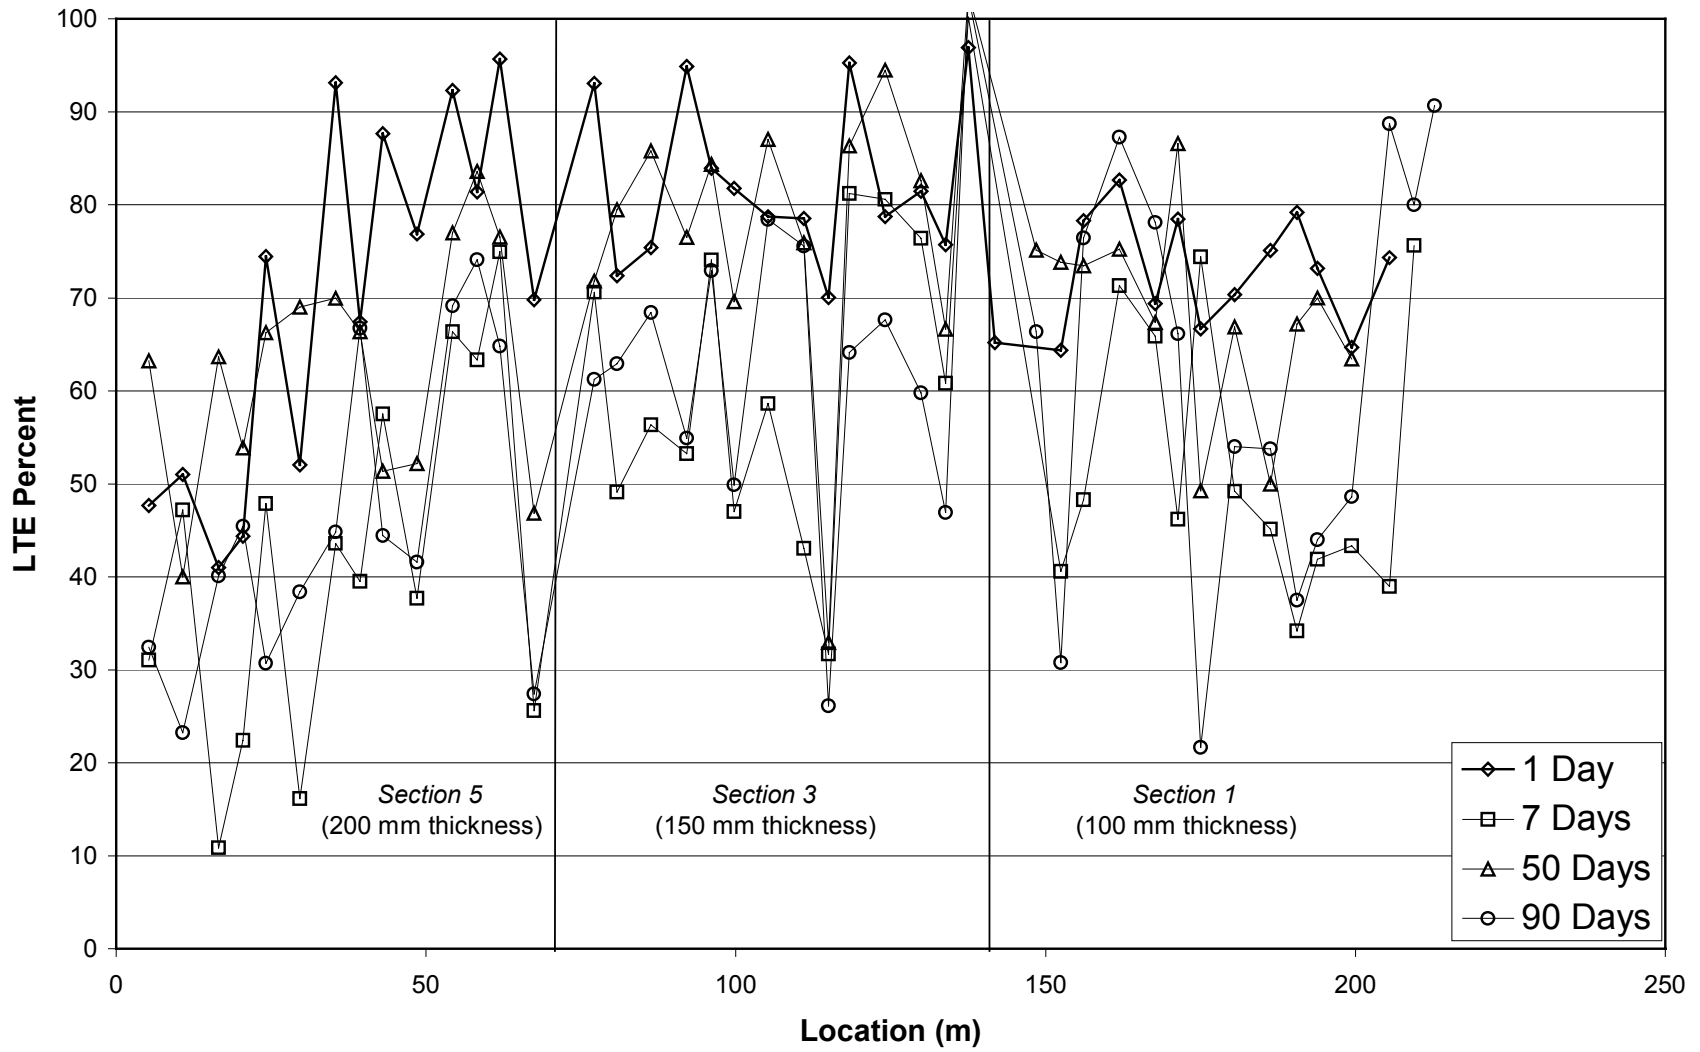
Figure 9.25. South Tangent Transverse Joint Load Transfer Efficiency.
