**Performance of Drained and Undrained Flexible Pavement  
Structures in Accelerated Loading under Wet Conditions**

**Summary Report – Goal 5**

**Partnered Pavement Performance Program**

**March 2003**

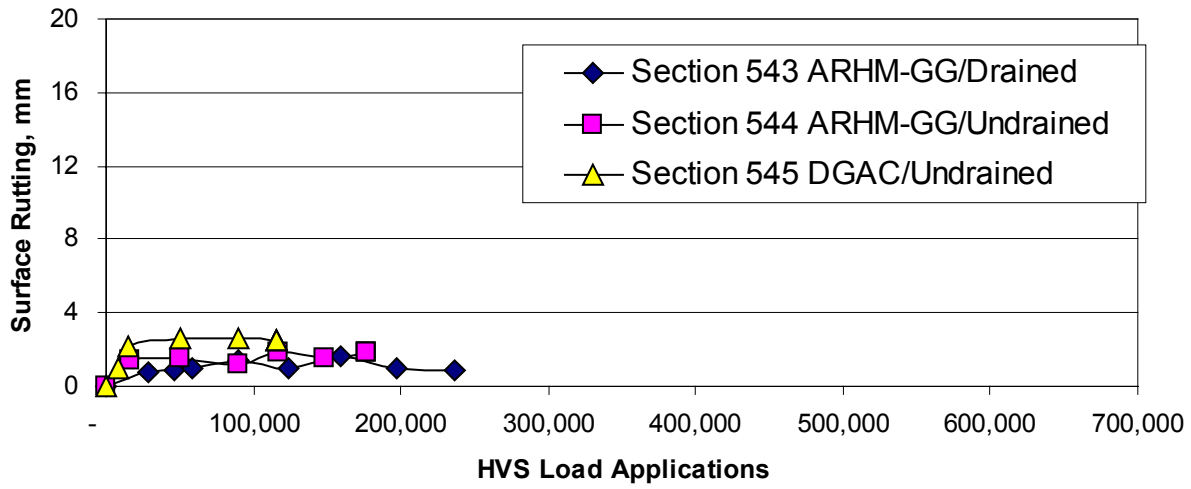
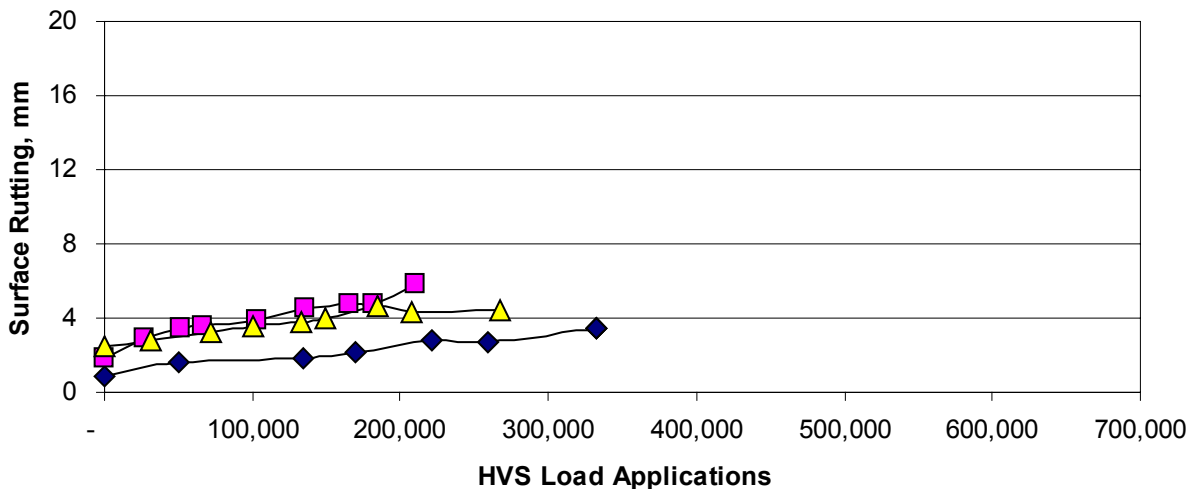
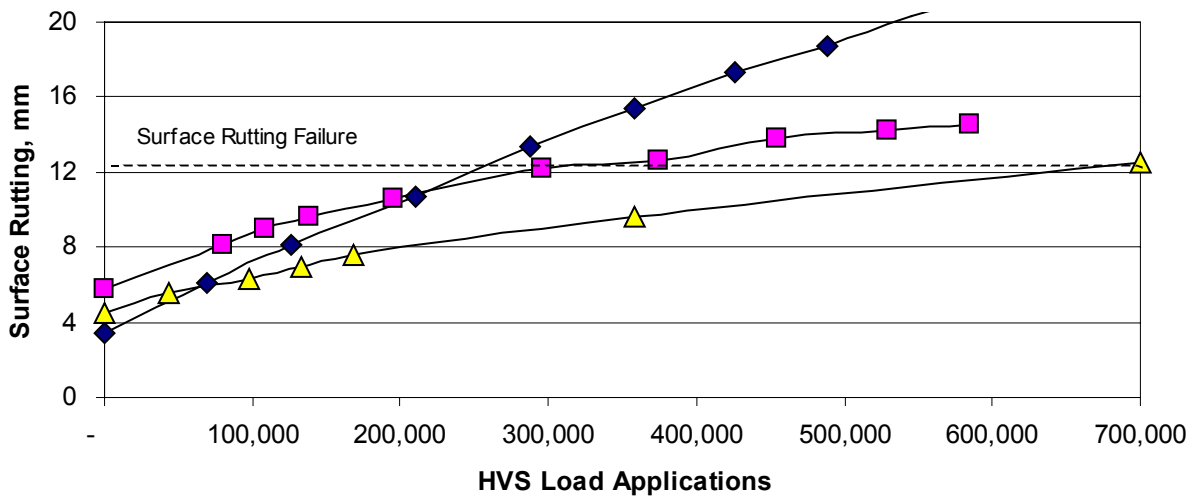
The data show that under the 40-kN load, the initial bedding-in phase of pavement rutting is slightly higher in the section with the DGAC wearing course than the rutting in the sections with the ARHM wearing course. For the 80-kN load, surface rutting is slightly higher (about 2

Figure 5. Summary of accumulated average maximum rut depths.

mm) for the undrained sections than for the drained section. For the 100-kN trafficking load, rates of surface rutting accumulation are different for the drained and undrained sections.

The rutting rates for both undrained sections are similar, gradually decreasing with the number of load applications. Section 545 (DGAC wearing course) showed less rutting than Section 544 (ARHM wearing course). This difference results from the difference in the thicknesses of the wearing courses—90 mm for Section 545 versus 38 mm for Section 544. The surface rutting rate of the drained section is about 1.5 times that of the undrained sections. This rapid increase of surface deformation with load applications under the 100-kN load attributed from the weakening of the ATPB layer is due to the presence of water.

Based on the failure criterion of 12.5 mm for limiting maximum surface rutting, the drained section (Section 543) failed at about 850,000 HVS load repetitions, as shown in Figure 5. The undrained section with the ARHM-GG wearing course (Section 544) also failed at about this same number of repetitions. At this number of HVS load repetitions, the undrained section with the DGAC (Section 545) had developed a rut depth of 8 mm.

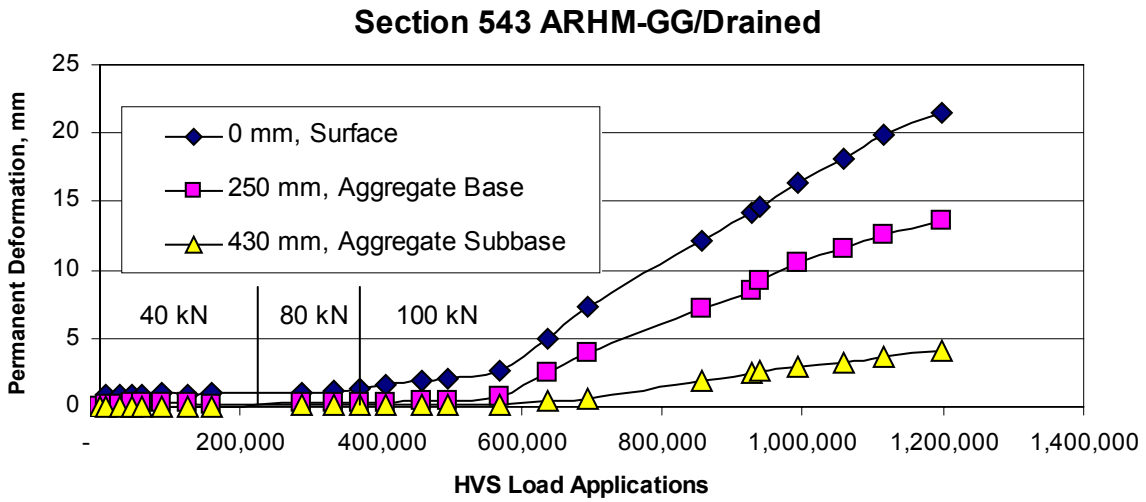
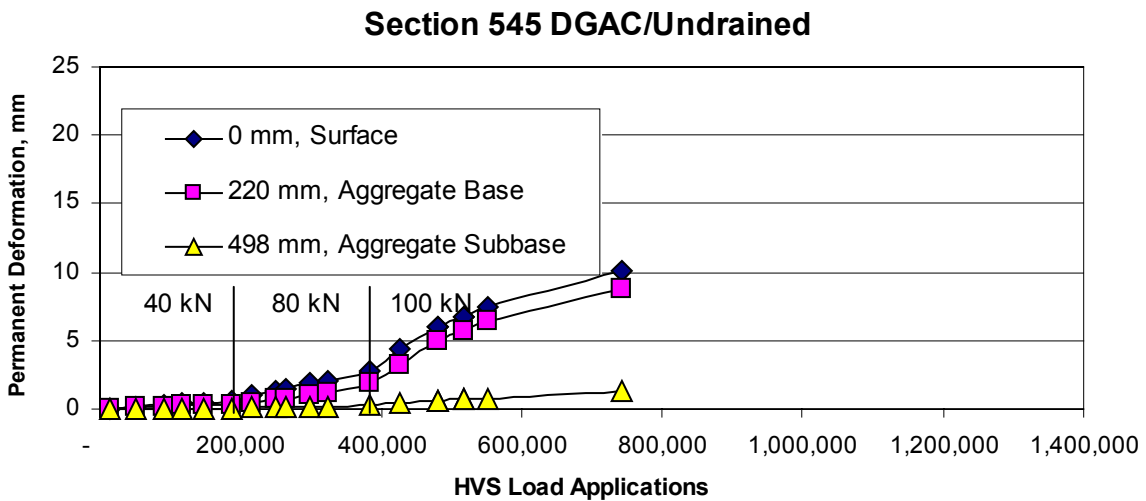
Figure 6 shows the development of in-depth permanent deformations with HVS load applications as measured with the MDDs. Contributions of each pavement layer to surface deformation is slightly different among the sections. In Sections 543 and 544, both the bound layers and the aggregate base contributed significantly to the total surface deformation. In Section 545, on the other hand, the major contributor to surface deformation was the aggregate base. Rutting at the surface of the aggregate subbase was less than 5 mm for each of the three sections. Permanent deformation at the subgrade could not be recorded because the MDD at that depth in each of the three sections was inoperable at the time of testing. Based on these measurements, the contribution of the subbase and subgrade layers was estimated to be less than 20 percent of the total rut depth measured at the pavement surface. Table 5 summarizes the approximate contributions of each pavement layer to surface rutting with the MDDs for each level of traffic.

Figure 6. Summary of in-depth permanent deformations.

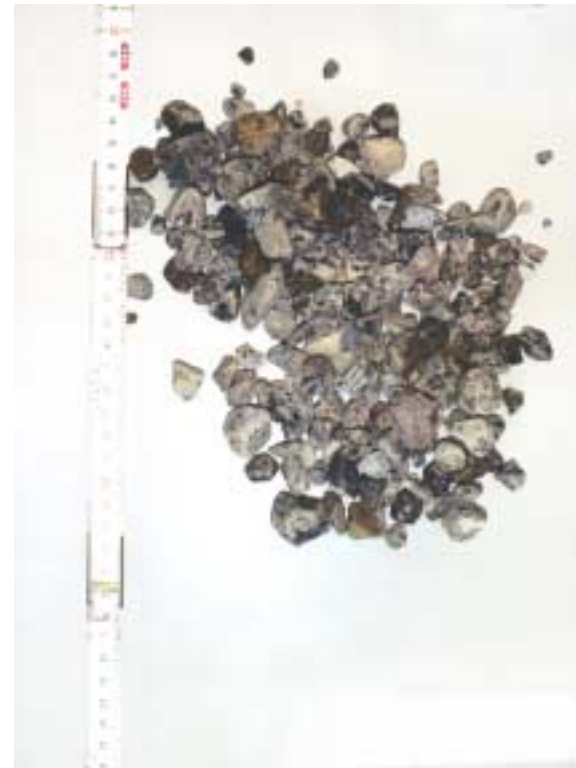
Cores obtained from the centerline and outside of the trafficked area in Section 543 show that the ATPB stripped. Those extracted from the center of the trafficked area showed that the ATPB layer could not be extracted as a solid core because the asphalt binder was completely stripped from the aggregate, as illustrated in Figure 7. On the other hand, cores extracted from outside of the trafficked area showed that the ATPB layer was intact with no stripping problems, as shown in Figure 8. Stripping in the ATPB likely resulted from water in the voids being forced through the asphalt films to the aggregate surface by the excess pore water pressure resulting from the HVS loading.

Cores and slabs also showed significant contamination by fines from the aggregate base in the interfaces of the asphalt concrete lifts as well as in the ATPB. A significant number of the cores from the trafficked areas showed no bonding between the asphalt layers. This was

**Figure 7. Core from Section 543, station 13 along the centerline (trafficked area) showing stripped ATPB separated from core.**

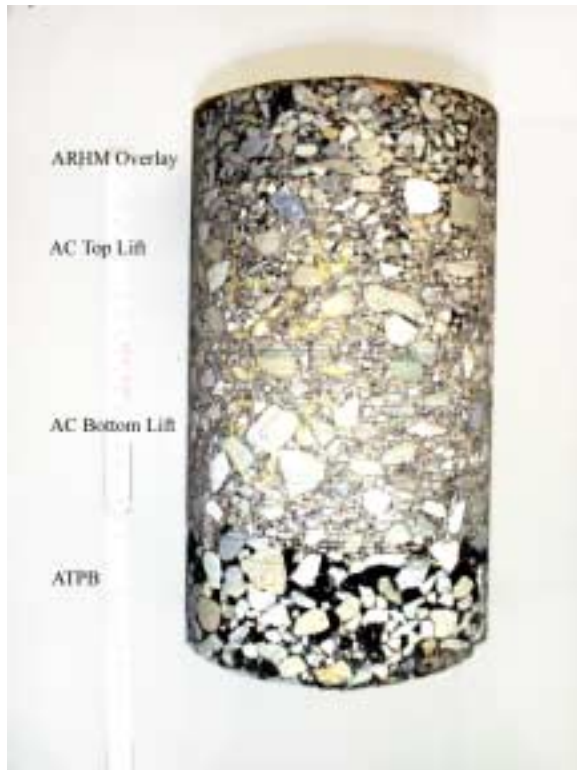
**Figure 8. Core from Section 543, station 13 outside the trafficked area showing ATPB still intact.**

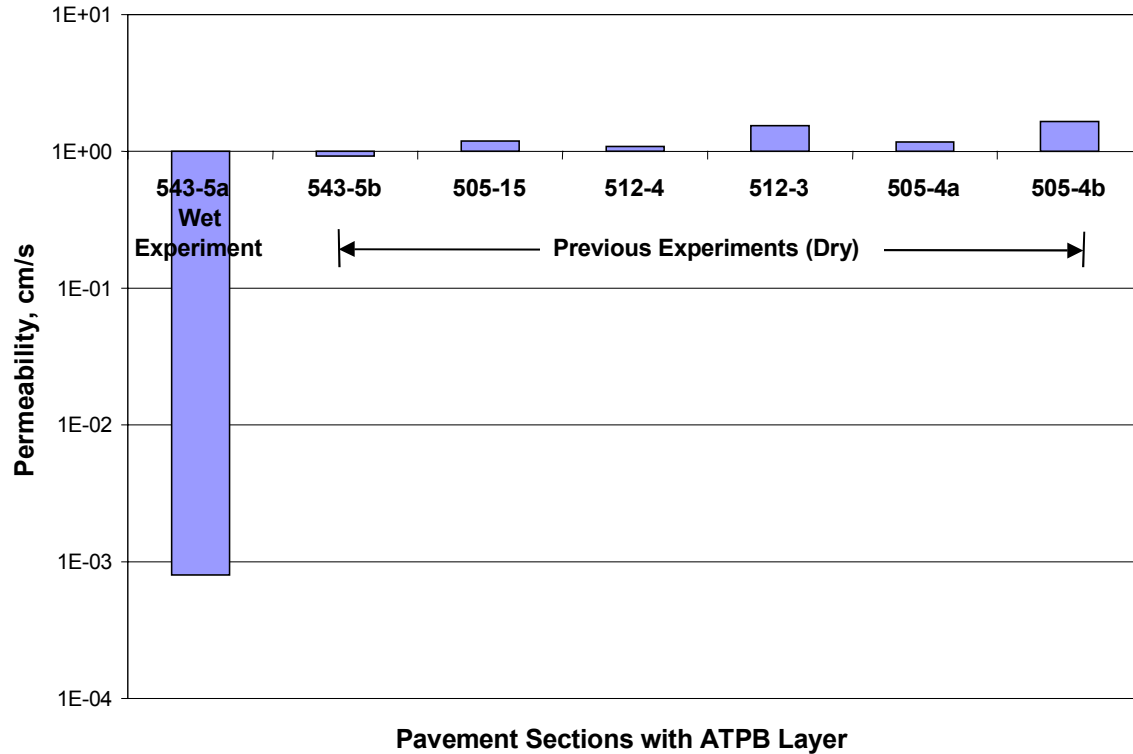
To further study the failure of the ATPB layer, a series of percolation tests were conducted on drained pavement sections previously tested under the HVS at various locations [Reference (17) contains a detailed description of the tests and their locations]. These percolation tests are summarized in Figure 9.

Percolation tests on the ATPB in the untrafficked condition had a permeability of about 1 cm/sec. Tests conducted in the trafficked portion showed a significant reduction in the

**Figure 9. Summary of percolation tests.**

permeability the ATPB to about 0.001 cm/sec. These data are supported by the observations from the test pit reported in the previous section, which clearly showed the intrusion of fines. The associated significant reduction in permeability of the ATPB contributed to the buildup of pore water pressure and subsequent stripping leading to the reduced structural capacity of the pavement section, e.g., as shown by the increase in deflection for Section 543.

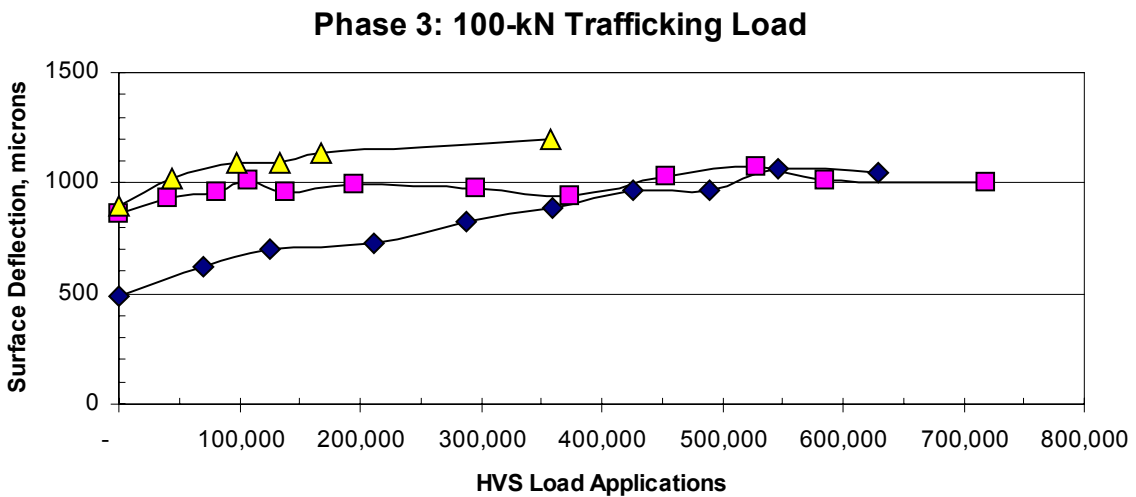
Average surface elastic deflections measured along the centerline with the RSD under a 40-kN test load are presented in Figure 10. The data show that the RSD elastic deflections of the drained section (Section 543) are 60 to 70 percent lower than those of the undrained sections (Sections 544 and 545) during the 40-kN trafficking stage. During the 80-kN trafficking stage,

**Figure 10. Summary of road surface deflections measured with the RSD under a 40-kN load.**

the surface deflections of both undrained sections are similar to one another while the surface deflections of the drained section was approximately 50 percent less than those of the undrained sections. During the 100-kN trafficking stage, the elastic deflections of the drained section rapidly increased with the number of load applications, with the level of elastic deflections on the drained section approaching a similar value to that of the elastic deflections measured on the undrained sections. Stripping of the ATPB likely accounted for the this significant increase.

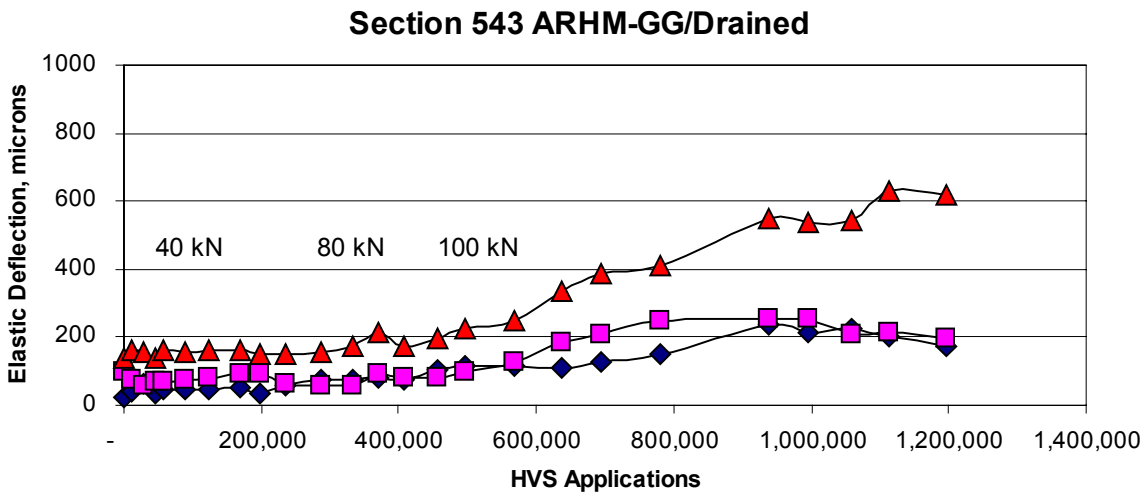
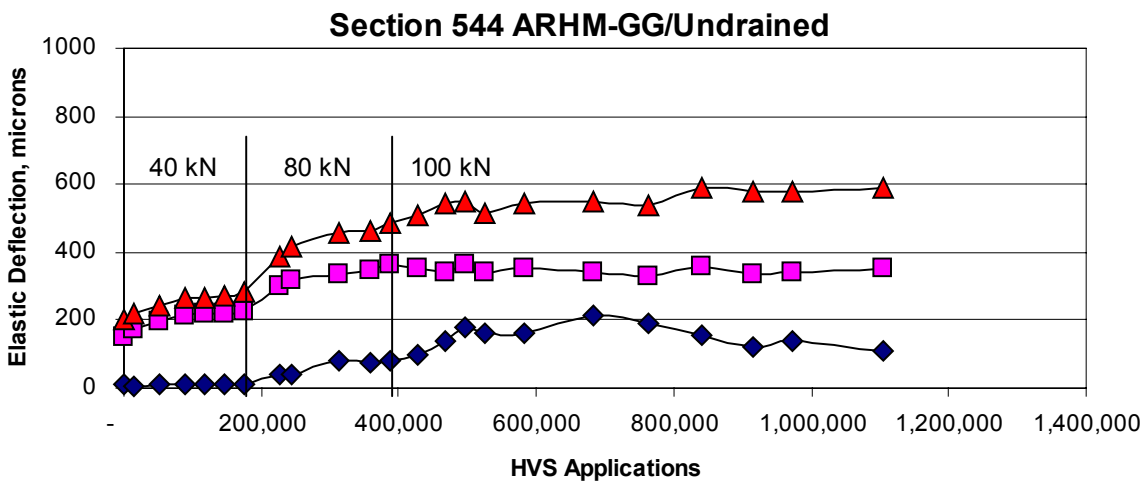
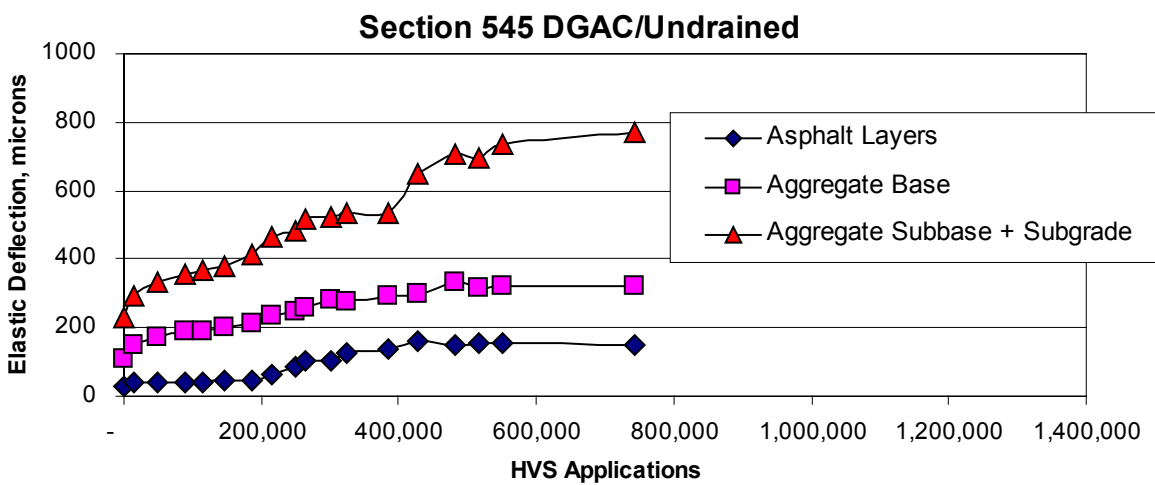
Figure 11 illustrates calculated values for elastic deflections of the pavement layers determined from in-depth elastic deflections measured with the MDD. This figure shows that the elastic deflections in the drained section remained lower than those of the undrained sections for the 40-and 80-kN trafficking loads. The progressive failure of the ATPB caused an increase in the elastic deflections of the lower unbound layers (subbase and subgrade). However, elastic deflections in the bound and aggregate base layers do not seem to change significantly during the 80- and 100-kN trafficking stages

**Figure 11. Summary of estimated elastic deflection in pavement layers based on a 40-kN HVS load.**

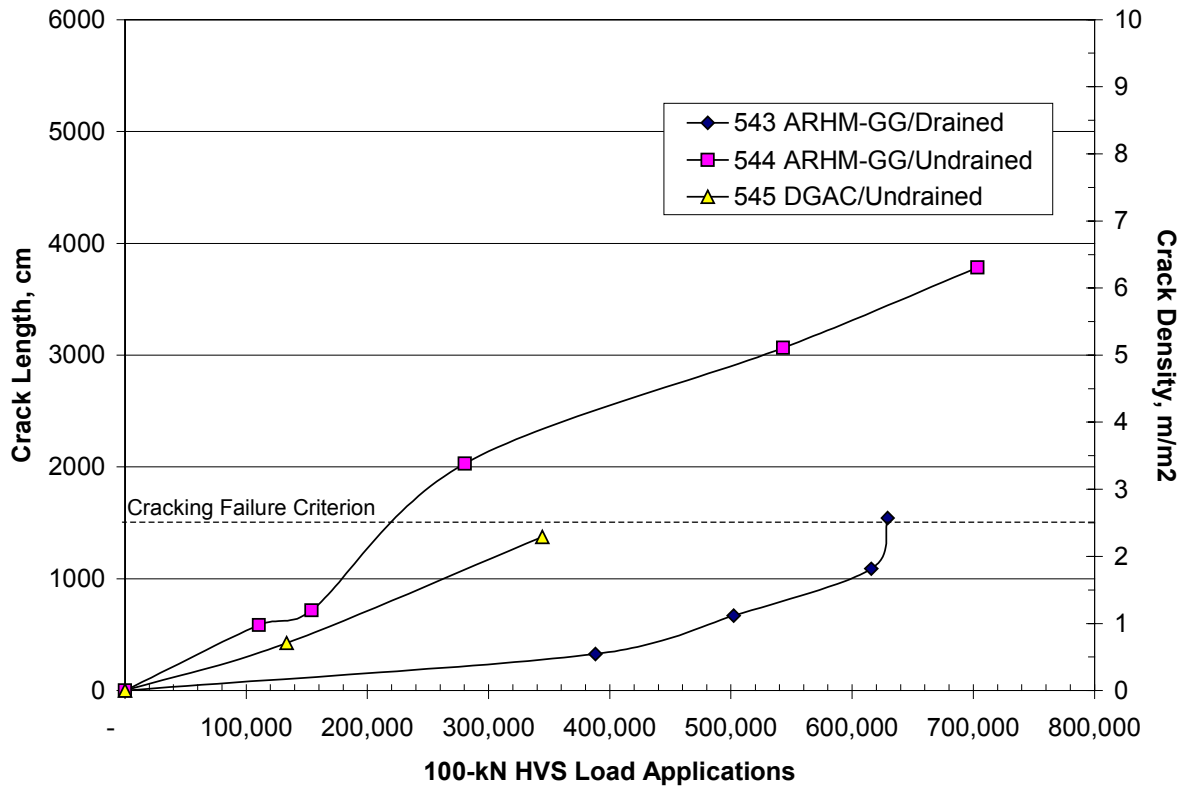
Figure 12 shows surface crack lengths measured during the 100-kN load trafficking phase. No surface cracks were observed during the 40- and 80-kN load phases. The observed cracks under the 100-kN trafficking load were predominantly transverse hairline cracks and were sometimes difficult to detect visually. Typical widest crack widths were approximately 0.2 mm. These hairline cracks did not spall or increase significantly in width during HVS trafficking.

**Figure 12. Summary of crack length accumulation.**

Figure 12 shows that surface cracks developed faster in the undrained sections than in the drained section. Using the failure criterion of  $2.5 \text{ m/m}^2$  of surface cracks, the drained section sustained about 300,000 to 450,000 more load applications of the 100-kN trafficking load than both undrained sections. This is in spite of the stripping in the ATPB. (It should be noted however as seen in Figure 4 that the limiting rut depth was reached at about 250,000 HVS load applications.
