Warm-Mix Asphalt Study: Test Track Construction and First- Level Analysis of Phase 3b HVS and Laboratory Testing (Rubberized Asphalt, Mix Design #2)

D. Jones, R. Wu, B.-W. Tsai, and J.T. Harvey

Partnered Pavement Research Center (PPRC) Contract Strategic Plan Element 4.18:
Warm-Mix Asphalt

California Department of Transportation
Division of Research and Innovation
Office of Roadway Research

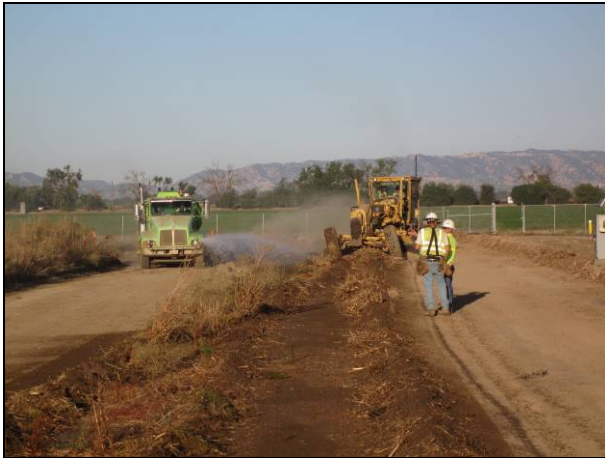
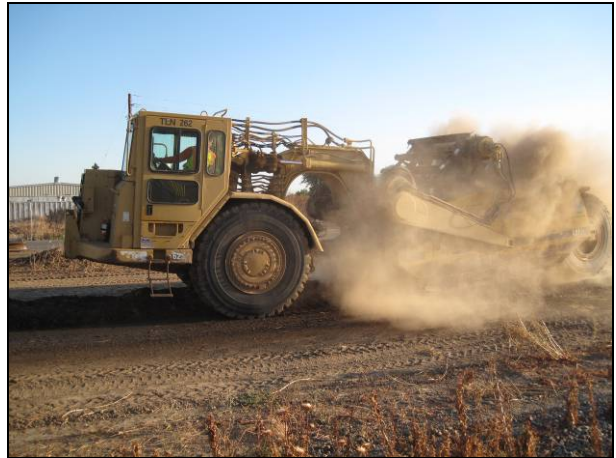
Figure 2.5: Vegetation removal.

- Removing vegetation with a grader, windrowing the deleterious material toward the center of the track, collecting this material with a scraper and dumping it in a temporary stockpile for removal (Figure 2.5).

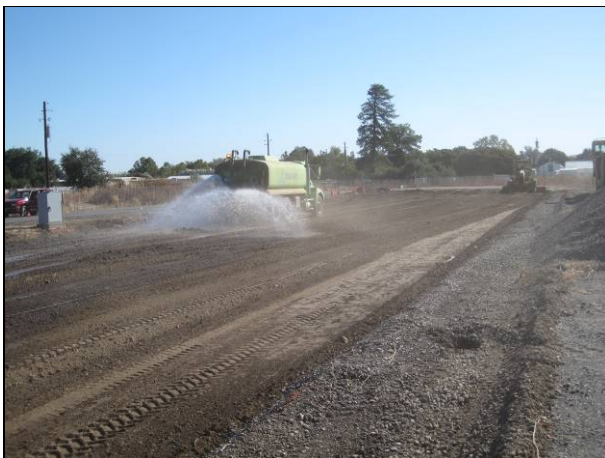
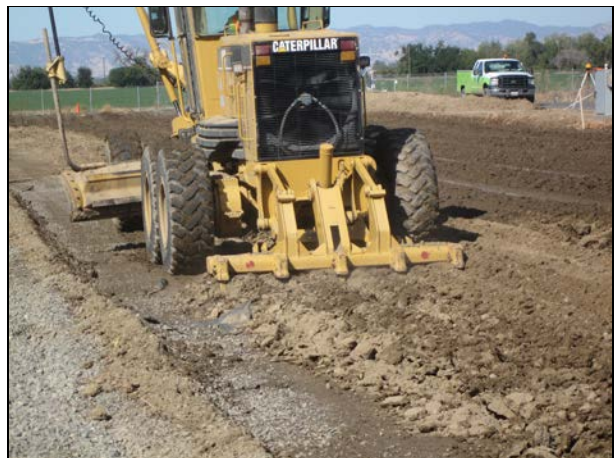
Figure 2.6: Preliminary leveling.

- Preliminary leveling with a grader followed by watering (Figure 2.6).
- Ripping to a depth of 12 in. (300 mm) (Figure 2.7).
- Watering and mixing using both the scraper and grader (Figure 2.8). Pockets of high clay content soils were observed during this process, which required additional working with the grader and scraper to break up the clods (Figure 2.9).

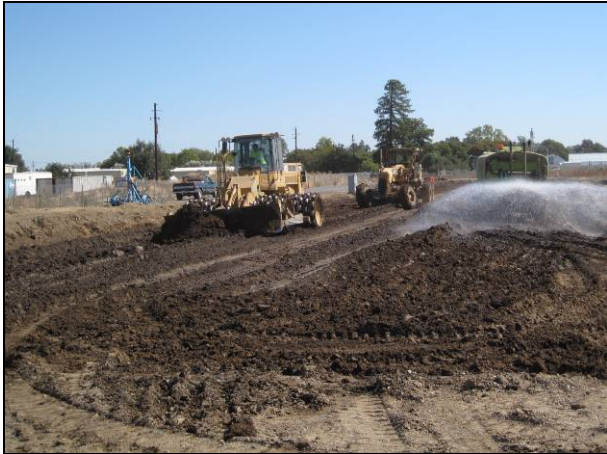
Figure 2.10: Initial compaction.

- Initial compaction with a padfoot roller (Figure 2.10). Despite extensive mixing, some clay pockets were still observed after completion of the initial compaction, with padfoot impressions clearly visible (Figure 2.11). Clay pockets appeared to predominate on the eastern half of the track.

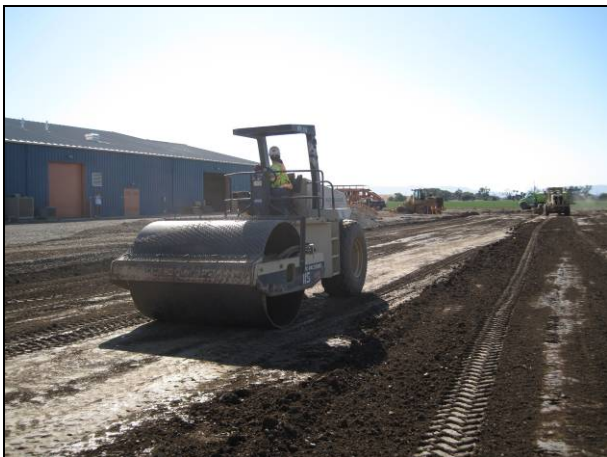
Figure 2.12: Final compaction.

- Final compaction with a vibrating smooth drum roller (Figure 2.12).
- Final leveling with a grader.
- Density checks on the finished surface (Figure 2.13) with a nuclear density gauge.

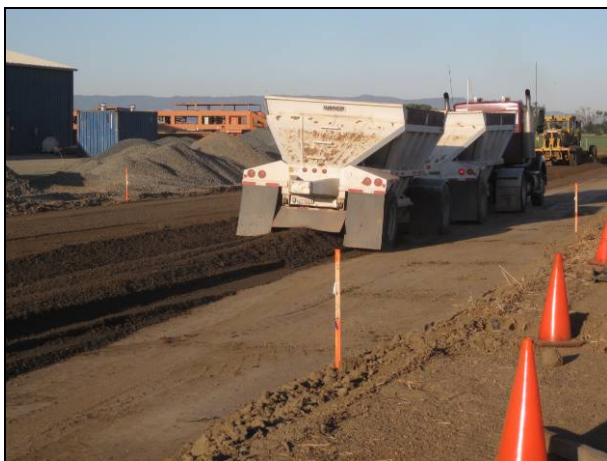
Figure 2.15: Dumping material in windrows.

- Dumping the aggregate in windrows (Figure 2.15).
- Spreading the aggregate with a grader (Figure 2.16) to a thickness of approximately 4.0 in. (100 mm).

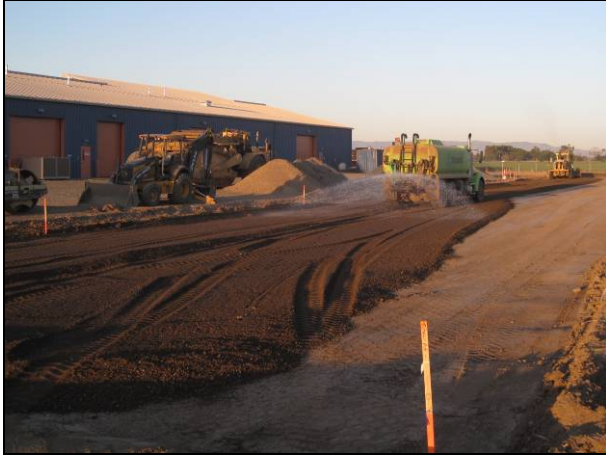
Figure 2.17: Watering.

- Adding water to bring the aggregate to the optimum moisture content and re-mixing with the grader to ensure even distribution of the moisture throughout the material (Figure 2.17).

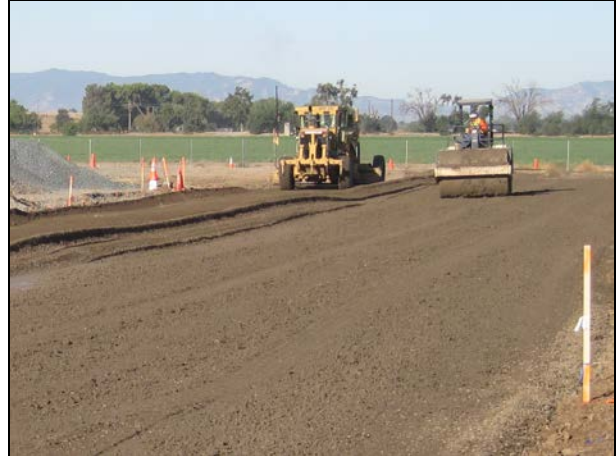
Figure 2.18: Initial compaction.

- Initial compaction of the spread material with a vibrating steel wheel roller (Figure 2.18).
- Repeating the process until the design thickness of 1.5 ft. (450 mm) was achieved.

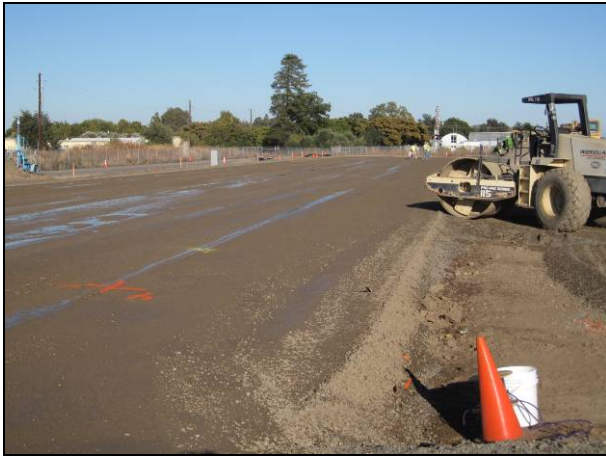
Figure 2.19: Heavy watering prior to pre-final compaction.

- Applying a generous application of water (Figure 2.19) followed by compaction to pump fines to the surface to provide good aggregate interlock (slushing).

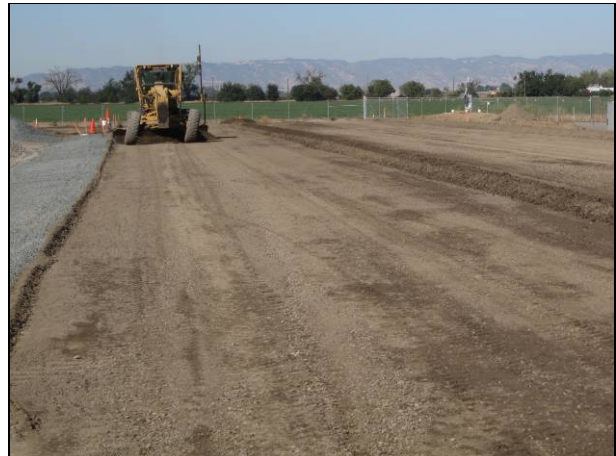
Figure 2.20: Final leveling with a grader.

- Final leveling with a grader (Figure 2.20). Final levels were checked with a total station to ensure that a consistent base-course thickness had been achieved.

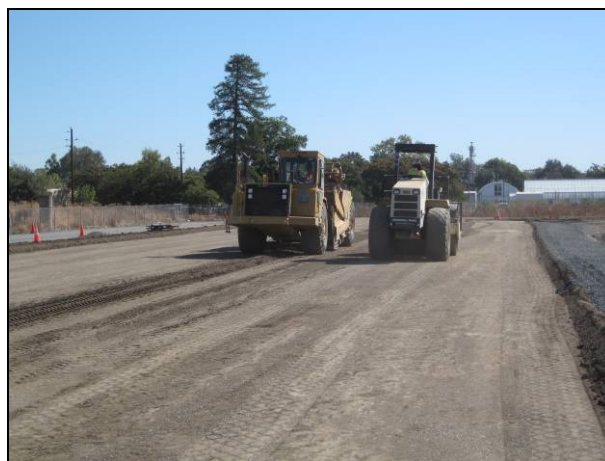
Figure 2.21: Removing excess material and final compaction.

- Removal of excess material with a scraper followed by final compaction (Figure 2.21).
- Density checks on the finished surface with a nuclear density gauge.

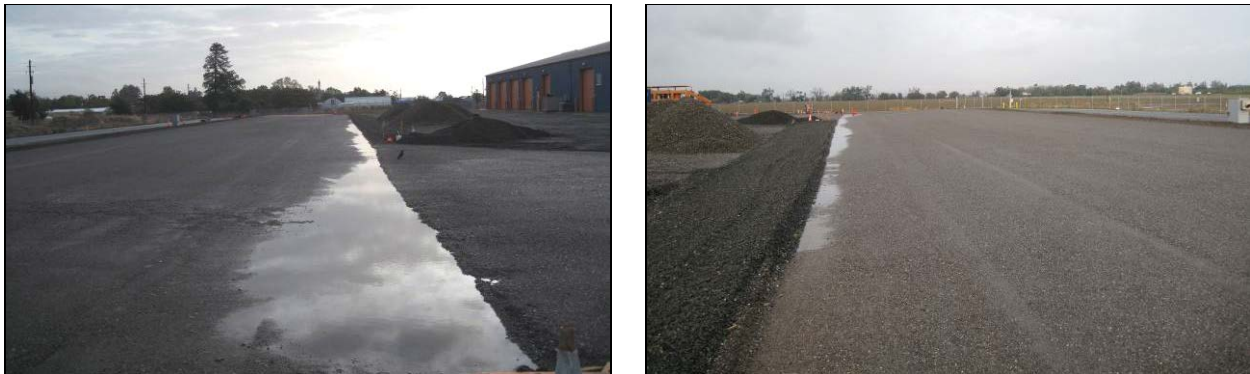
Paving of the first lift of asphalt concrete was scheduled for October 7, 2009. However, contractor scheduling and then rainfall on four days (October 13, 14, 15, and 19) delayed priming of the surface until October 23, 2009, and paving until October 30, 2009. Rainfall measured over the four days totaled 3.1 in. (78 mm). Some ponding of water in Cells #1 and #2 on the western end of the test track was observed during these rainfall events (Figure 2.23).

Figure 2.23: Ponding of water on base.

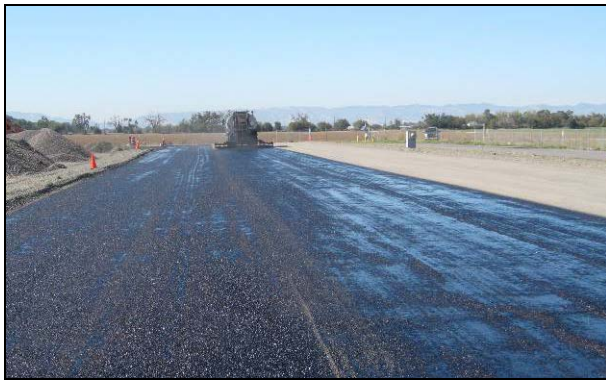
Figure 2.24: Prime coat application.

On the day before the prime coat application (October 22, 2009), the test track was compacted with a twin-drum steel roller to consolidate the base layer and accelerate movement of infiltrated water to the surface. An SS-1 asphalt emulsion prime coat was applied to the surface at a rate of 0.25 gal./yd² (1.0 L/m²). The time of application was 1:00 p.m., ambient temperature was 88°F (35°C) and relative humidity was 28 percent. A consistent application was achieved (Figure 2.24); however, differential penetration was observed, which was attributed to patches of near-surface moisture (Figure 2.25).

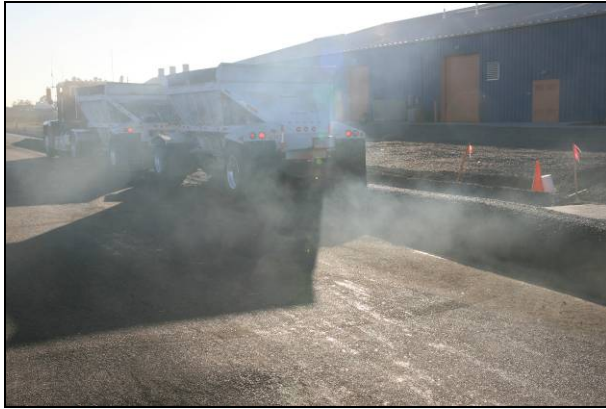
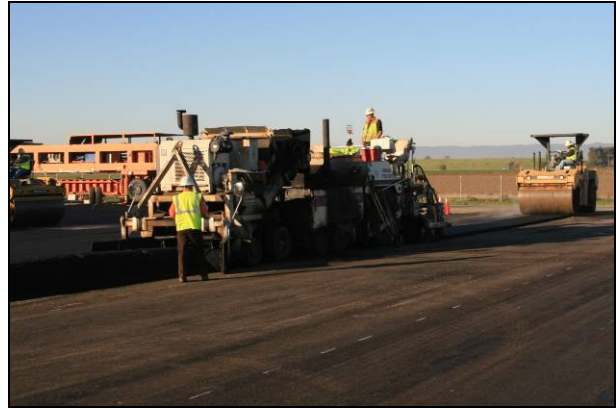
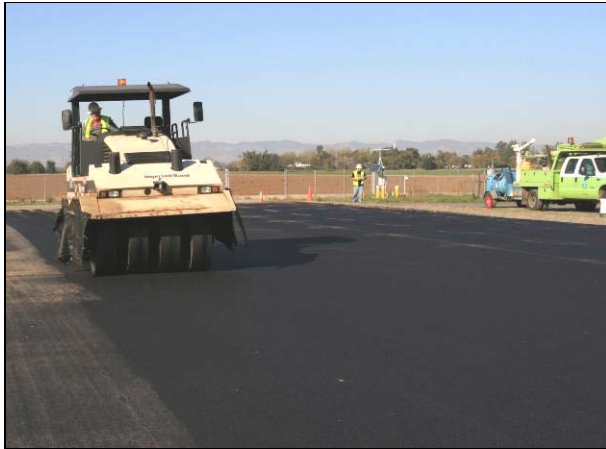
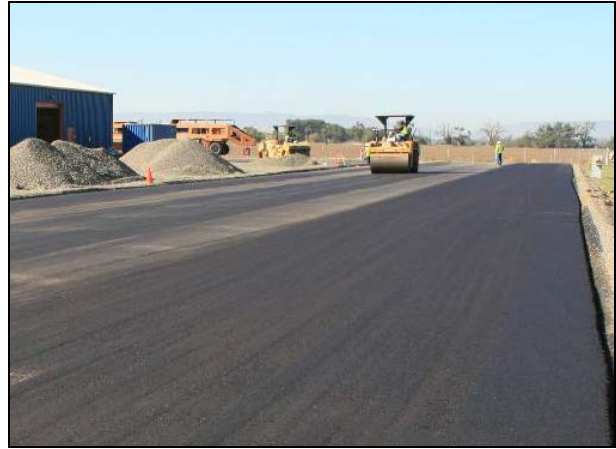
Figure 2.26: Construction of bottom lift asphalt concrete layer.

Mix was transported using bottom-dump trucks and placed in a windrow on the surface. Paving started in Lane #1, followed by Lanes #2 and #3, and was carried out in a west–east direction. A pickup machine connected to the paver collected the material and fed it into the paver hopper. Paving followed conventional procedures. The breakdown roller closely followed the paver applying about four passes. A

single pass was made with the intermediate rubber-tired roller, followed by another four passes with the finish roller. The construction process is summarized in Figure 2.26.

Placing asphalt in windrow

Paving and breakdown rolling

Intermediate rolling

Final rolling

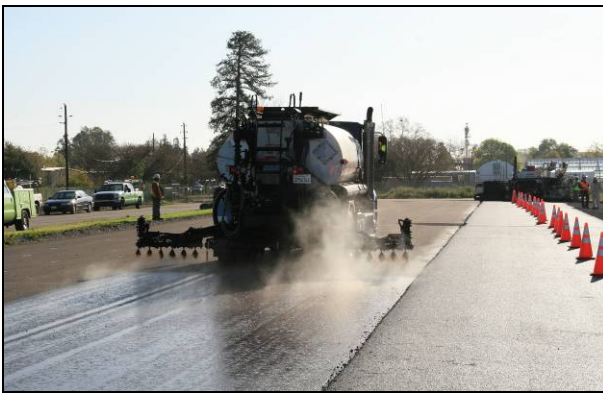
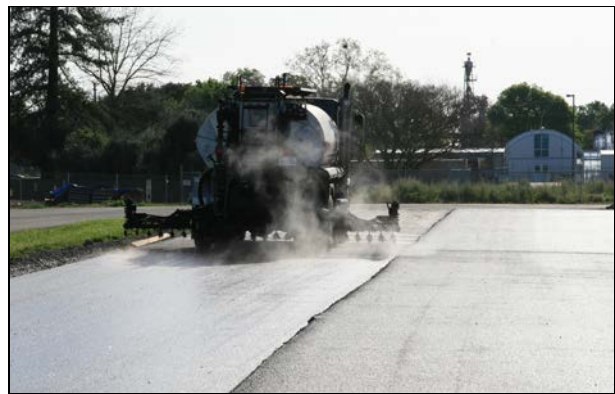
Figure 2.27: Tack coat application.

The test track was broomed to remove dust and organic matter from the surface prior to any work. Tack coat was applied to Cells #5 and #6 in Lane #2 and to Cell #7 in Lane #3 in single passes just prior to the start of paving on the first day of construction, and to the remaining cells and second Control section just prior to the start of paving on the second day of construction (Figure 2.27). A diluted SS-1 emulsion (70:30) was applied with a distributor at an application rate of approximately 0.08 gal./yd² (0.36 L/m²). Some steam was observed during application. Weather conditions at the time of tack coat application were as follows:

Lane #2, Cells #5 and #6

Lane #3

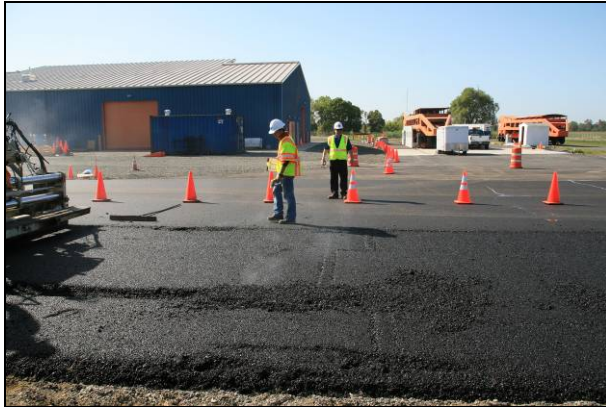
Figure 2.28: Control #1: Chunks in mix.

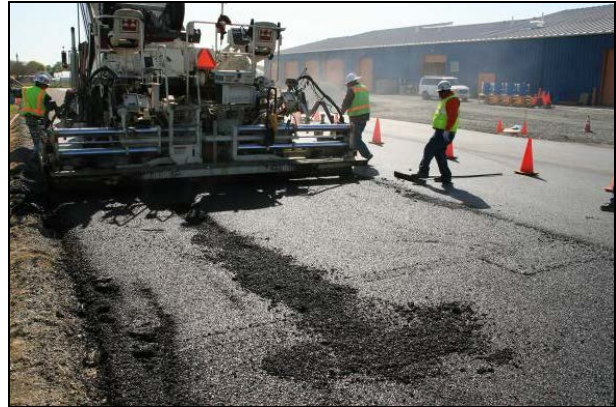
Placement of the asphalt concrete on the first Control section started at 10:10 a.m. with the positioning of the paver at the start of the section. Three loads were used. Some chunks were noted in the trucks, paver hopper, and behind the paver (Figure 2.28) and were attributed to cooling during transport. Chunks were removed and replaced with new mix. The paver reached the end of the section about 12 minutes after starting. Considerable smoke was observed from the trucks during tipping and from the paver (Figure 2.29). A pungent odor, typical of rubberized asphalt construction projects, was also noted. The paving crew wore respirators to limit the effects of these odors (Figure 2.30). Breakdown rolling started as soon as the paver was moved off of the section. Density and temperature measurements were taken

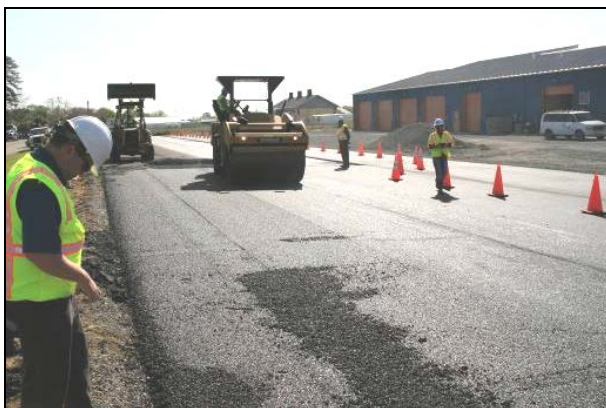
throughout (see Section 2.7.6). Seven passes were made with the breakdown roller with vibration over a period of approximately 15 minutes (Figure 2.31). Some cooling was allowed before final rolling, which consisted of five passes with no vibration (Figure 2.32). No significant tenderness was observed and the roller operator considered the exercise typical of normal rubberized asphalt projects. Paver spillage was removed from the end of the section to ensure a clean and regular surface and join for the Astec section.

Figure 2.31: Control #1: Breakdown rolling.

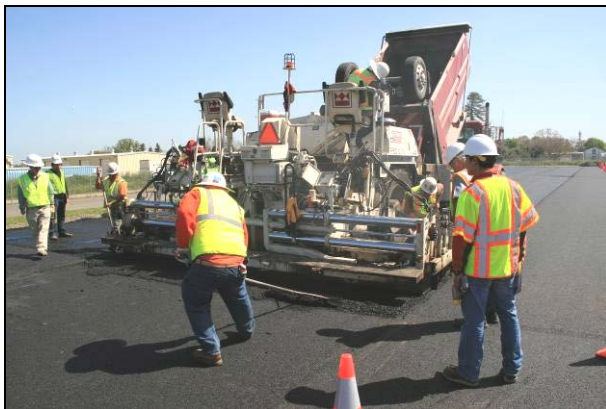
The same process described above was followed for the placement of the Sasobit mix, which started at 11:30 a.m. No smoke was observed or odors noted (Figure 2.33). Breakdown rolling was achieved with eight passes, followed by a further five passes after a short period of cooling (Figure 2.34). Final rolling was completed in ten passes. No problems were observed during any of the compaction phases and a tightly bound surface was achieved. When interviewed, the roller operator noted that the mat was a little stiffer and responded a little differently than typical rubberized asphalt projects in that the response of the roller did not relate to the density measurements taken with the nuclear gauge. The operator had considered compaction to be complete; however, the density gauge indicated that compaction levels were not the same as those measured on the previous day's Control section and consequently the additional roller passes were applied. The paving crew noted that workability of this mix in terms of raking and shoveling was much better than the Control, which was stiff and had adhered to tools. Workability was considered to be comparable to, if not better than, non-rubberized mixes. Given the absence of smoke and odors, the crew also removed their respirators during paving of this and the remaining warm-mix sections.

Figure 2.33: Sasobit: Absence of smoke from truck and paver.

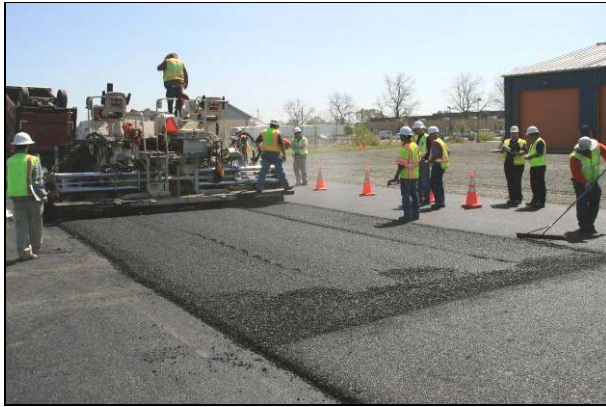
Figure 2.35: Advera: No smoke from truck or paver.

The same process followed for the previous two sections was also followed for the Advera mix. Construction started at 12:25 p.m. No smoke or odors were observed/noted (Figure 2.35); however some chunks were observed in the hopper and behind the screed. Paving was temporarily halted while these were removed (Figure 2.36). Eight passes were made with the breakdown roller, followed by a further four passes after a period of cooling (Figure 2.37). Ten passes were applied during final rolling. Some tenderness was observed during breakdown rolling and the roller operator noted similar “discrepancies” between roller response and the density gauge readings as discussed above, when compared to typical

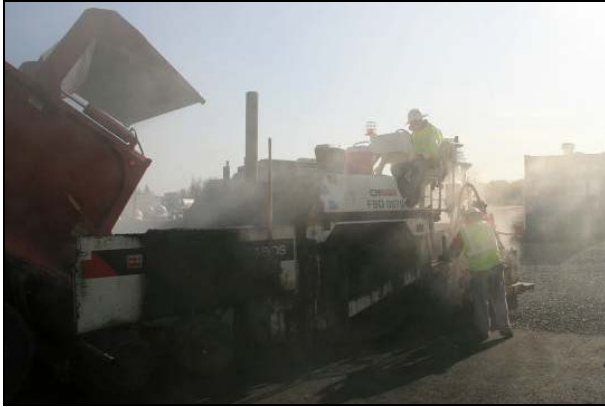
Figure 2.38: Control #2: Smoke from truck and paver.

The same process followed during the earlier construction was also followed on this section. Construction started at 9:00 a.m. Severe smoke and odors were noted (Figure 2.38) requiring the paving crew to wear respirators. Some chunks were observed (Figure 2.39) and workability of the mix was similar to the previous day's Control section. Breakdown rolling started as soon as the paver was moved off the section. Seven passes were made with the breakdown roller with vibration (Figure 2.40) followed by phased finish

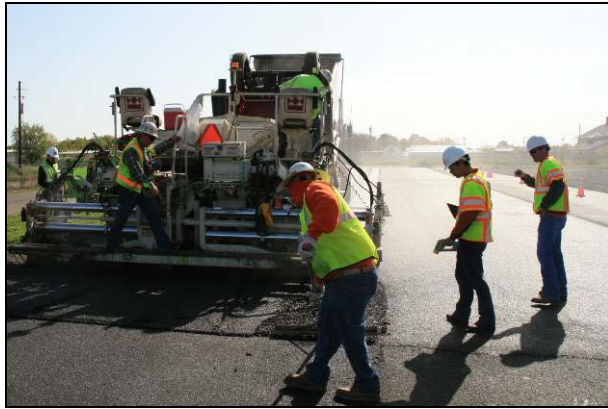
The same process followed for the previous four sections was also followed for the Astec mix. Construction started at 9:40 a.m. Some smoke was observed and odors noted, but the intensity was considerably less than that observed/noted on the Control section (Figure 2.41). Some chunks were observed in the paver hopper, but were removed before paving started. Breakdown rolling was achieved with eight passes, followed by a further four passes after a short period of cooling (Figure 2.42). Final rolling was completed in ten passes.

Figure 2.41: Astec: Some smoke from truck and paver.

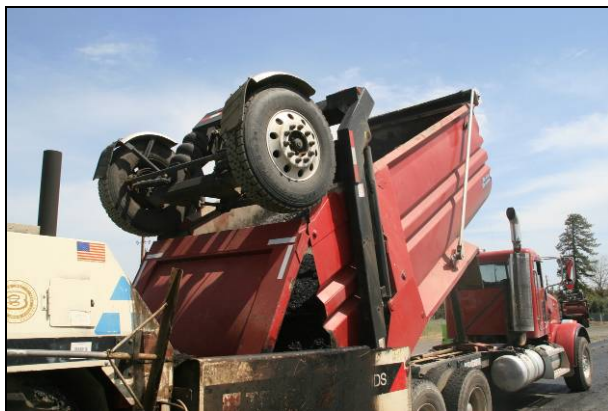
The same process followed for the other sections was also followed for the Rediset mix. Construction started at 10:25 a.m., but an immediate problem with the paver (broken feed chain) delayed the start until 12:15 p.m. Mix in the paver was removed with a loader, returned to the truck, and covered while the paver was repaired. Temperatures were monitored throughout this delay. No smoke was observed and no odors noted (Figure 2.43). Some chunks were noted and attributed to cooling of the mix on the sides of the truck during the delay. These were removed from the truck and paver hopper and did not influence actual paving. Breakdown rolling was achieved with eight passes, followed by a further four passes after a short period of cooling (Figure 2.44). Final rolling was completed in ten passes. The paving crew reported similar good workability to that noted on the other warm-mixes, despite the lower than planned placement and compaction temperatures.

Figure 2.43: Rediset: No smoke from truck or paver.

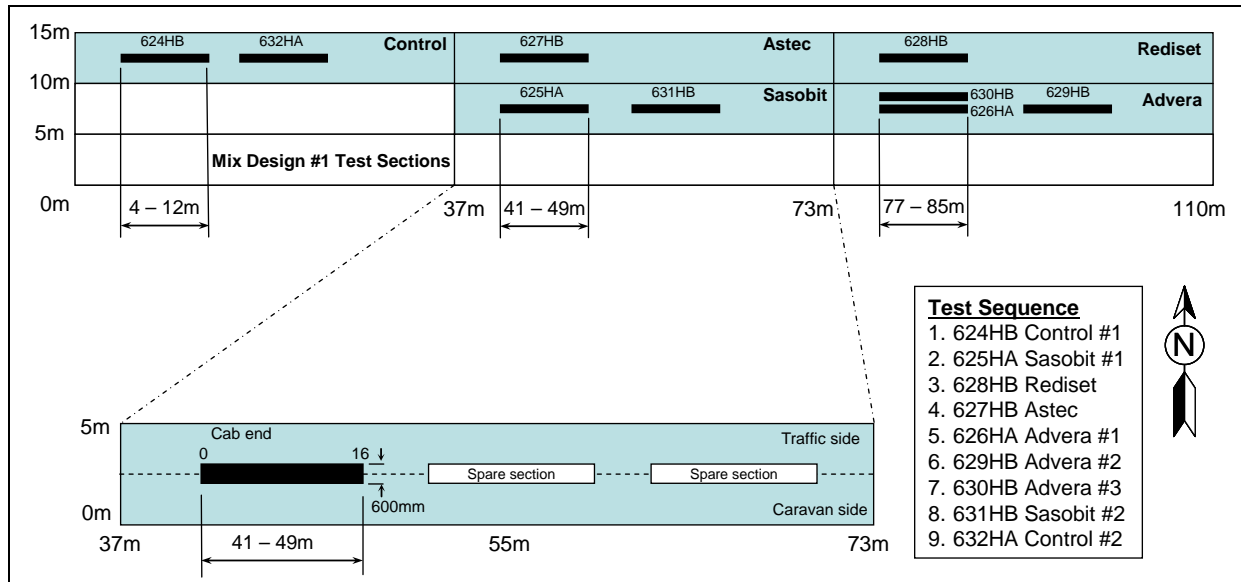
Figure 3.1: Layout of Phase 3 test track and Phase 3b HVS test sections.

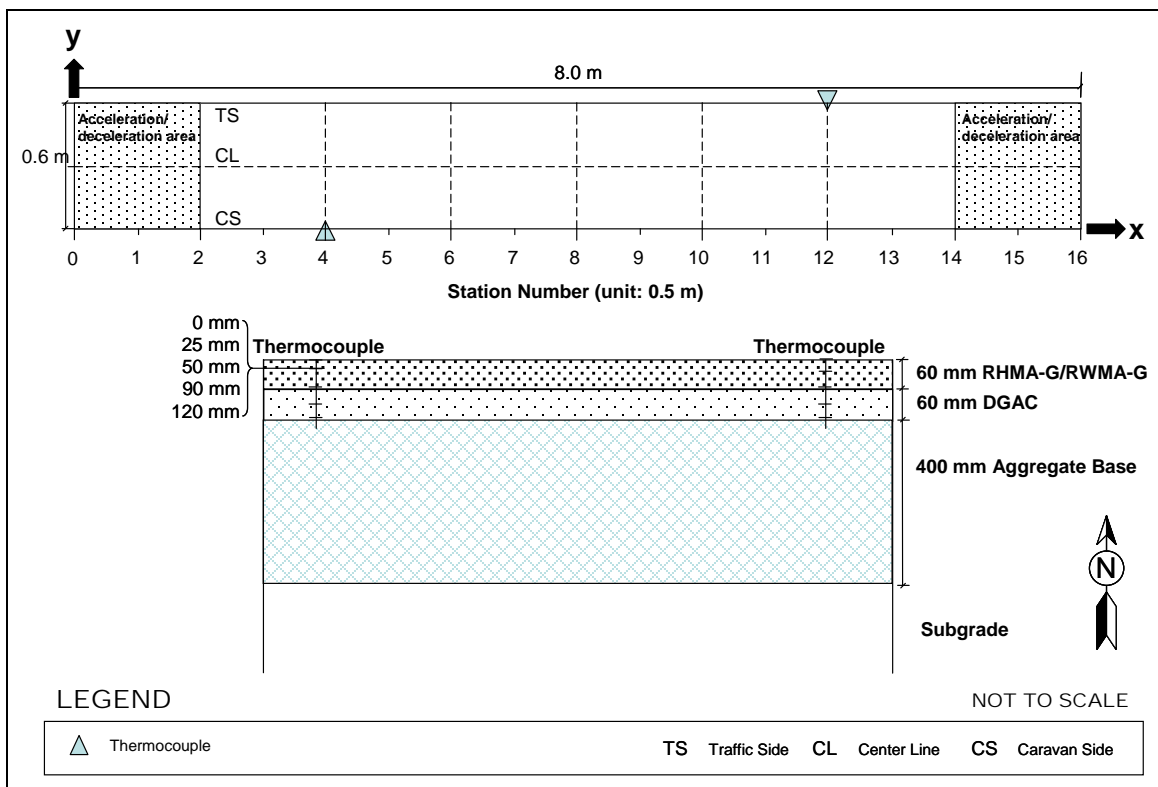
The general test section layout for each of the rutting sections is shown in Figure 3.2. Station numbers (0 to 16) refer to fixed points on the test section and are used for measurements and as a reference for discussing performance.

Figure 3.2: Location of thermocouples.

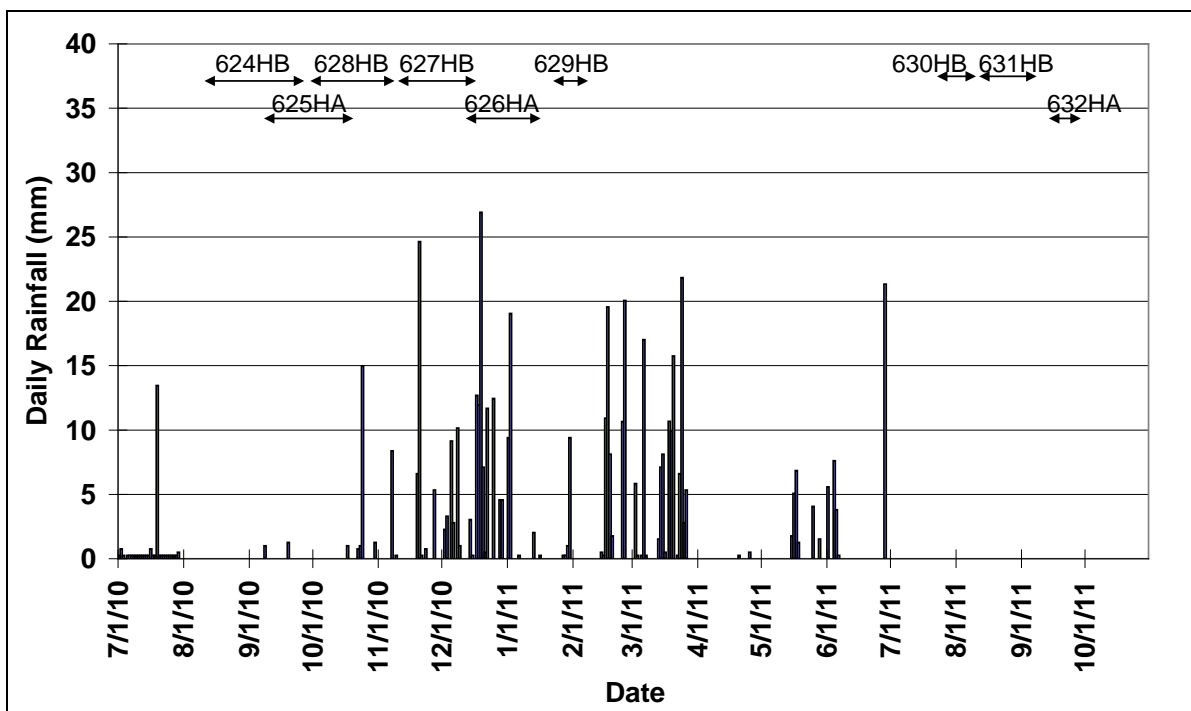
Figure 4.2 shows the monthly rainfall data from July 2010 through October 2011 as measured at the weather station next to the test track. Rainfall was measured during the first six HVS tests (five sections plus first repeat on the Advera section). No rainfall was measured during the second round of tests on the Control, Advera, and Sasobit sections. There were a number of relatively high 24 hour rainfall events (i.e., more than 20 mm (0.75 in.) in the latter stages of the first round of testing.

Figure 4.2: Measured rainfall during Phase 3b HVS testing.

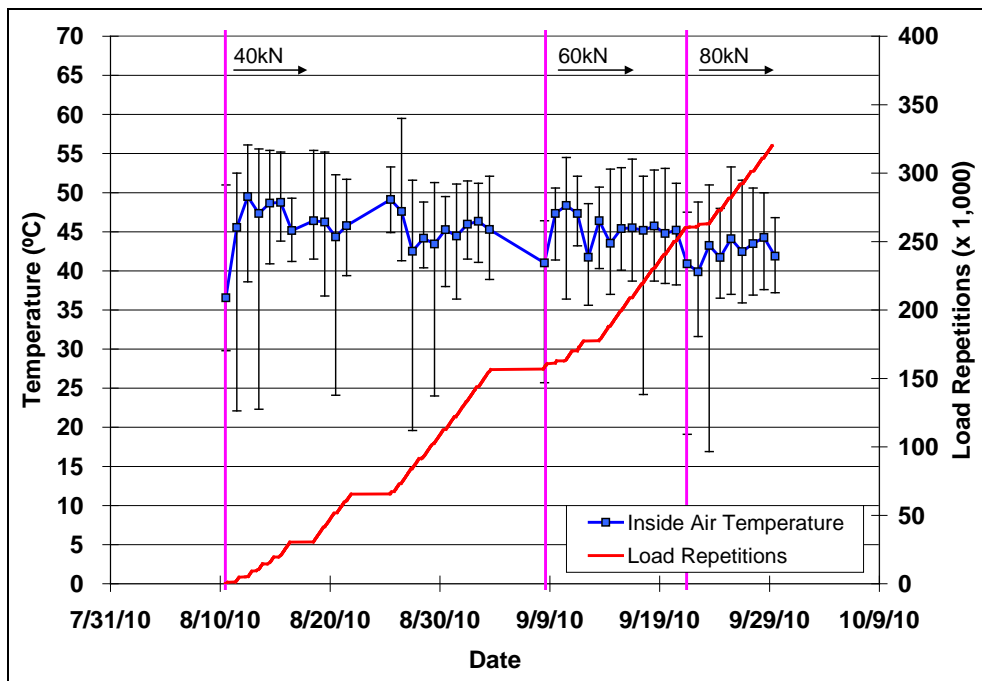
average air temperatures recorded in the temperature control unit, calculated from the hourly temperatures recorded during HVS operation, are shown in Figure 4.5. Vertical error bars on each point on the graph show daily temperature range.

Figure 4.5: 624HB: Daily average inside air temperatures.

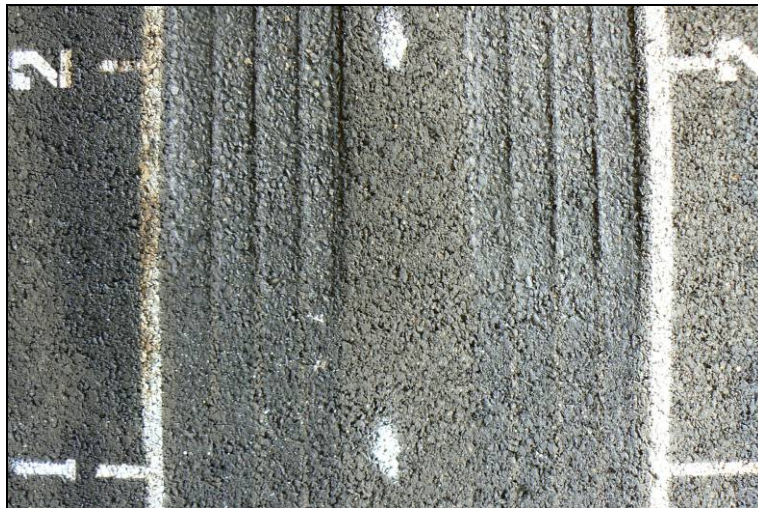
Figure 4.11: 624HB: Section photograph at test completion.

Apart from rutting, no other distress was recorded on the section. Figure 4.11 is a photograph taken of the surface at the end of the test.

Apart from rutting, no other distress was recorded on the section, which was similar in appearance to the Control (Figure 4.11) at the end of testing. Figure 4.20 shows a photograph taken of the surface at the end of the test.

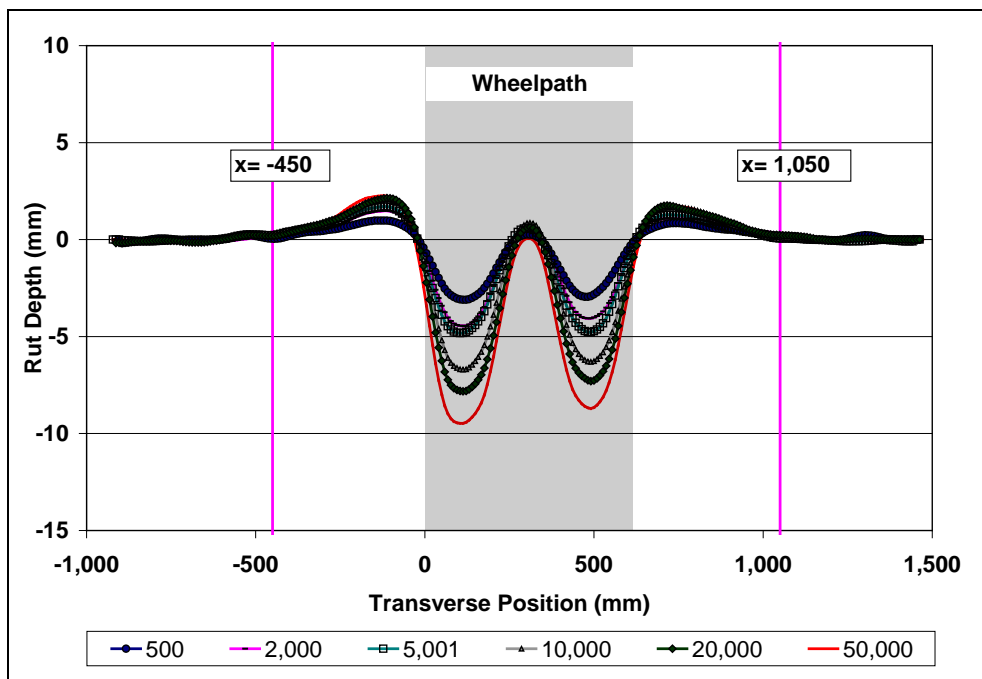
Figure 4.25 shows the average transverse cross section measured with the laser profilometer at various stages of the test and shows the increase in rutting and deformation over time.

Figure 4.25: 626HA: Profilometer cross section at various load repetitions.

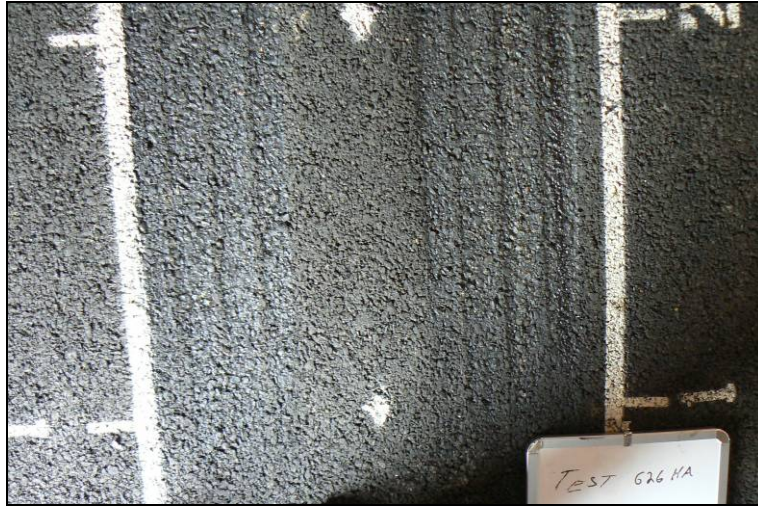
Figure 4.29: 626HA: Section photograph at test completion.

Apart from rutting, no other distress was recorded on the section. Figure 4.29 shows a photograph taken of the surface at the end of the test.

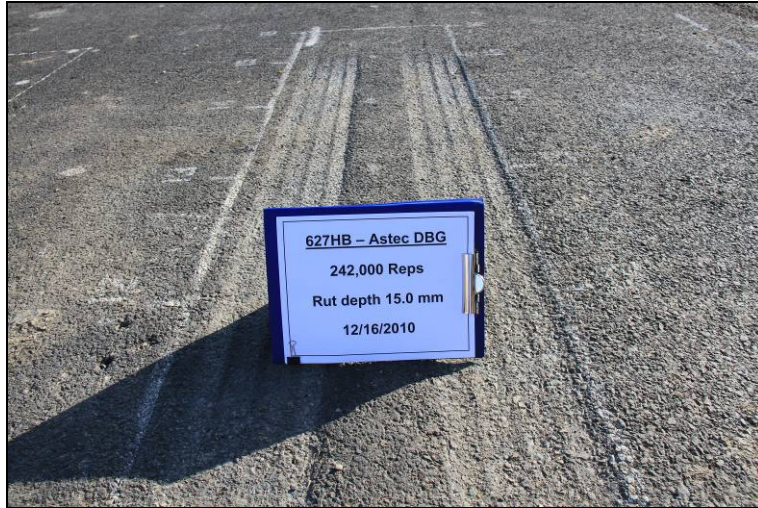
Figure 4.38: 627HB: Section photograph at test completion.

Apart from rutting, no other distress was recorded on the section. Its appearance was similar to that of the other sections. Figure 4.38 shows a photograph taken of the surface at the end of the test.

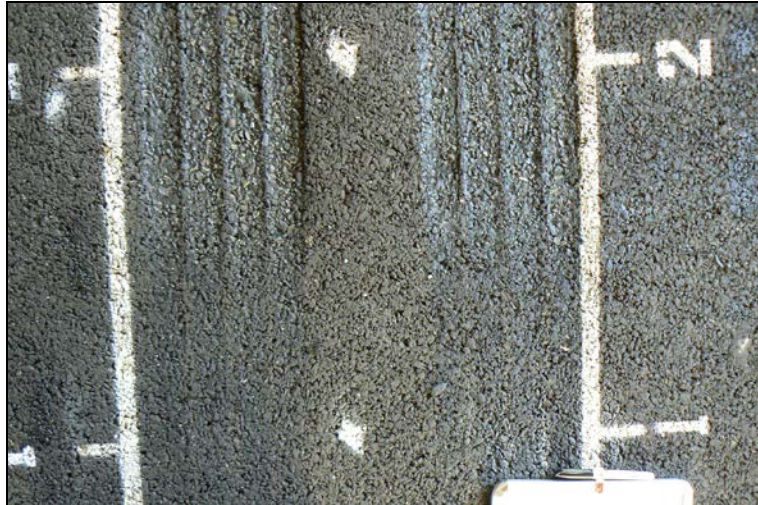
Figure 4.47: 628HB: Section photograph at test completion.

Apart from rutting, no other distress was recorded on the section. Its appearance was similar to that of the other sections. Figure 4.47 shows a photograph taken of the surface at the end of the test.

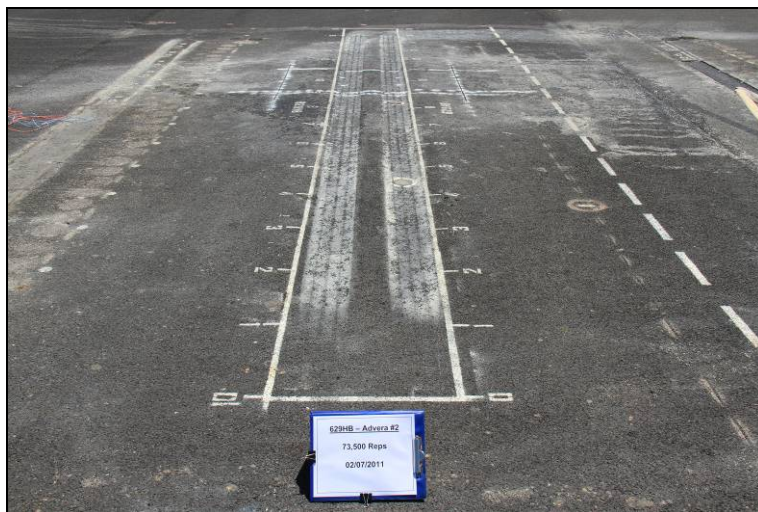
Figure 4.55: 629HB: Section photograph at test completion.

Apart from rutting, no other distress was recorded on the section. Its appearance was similar to that of the other sections. Figure 4.55 shows a photograph taken of the surface at the end of the test.

The plots clearly show that performance on this test was worse than that on the earlier test, indicating a pavement structure problem and not an equipment or testing protocol-related problem. The later forensic investigation (see Section 5.7.3) indicated that high subgrade moisture contents as well as thinner combined asphalt concrete layers on this section were probably the main contributory causes of the poor performance.

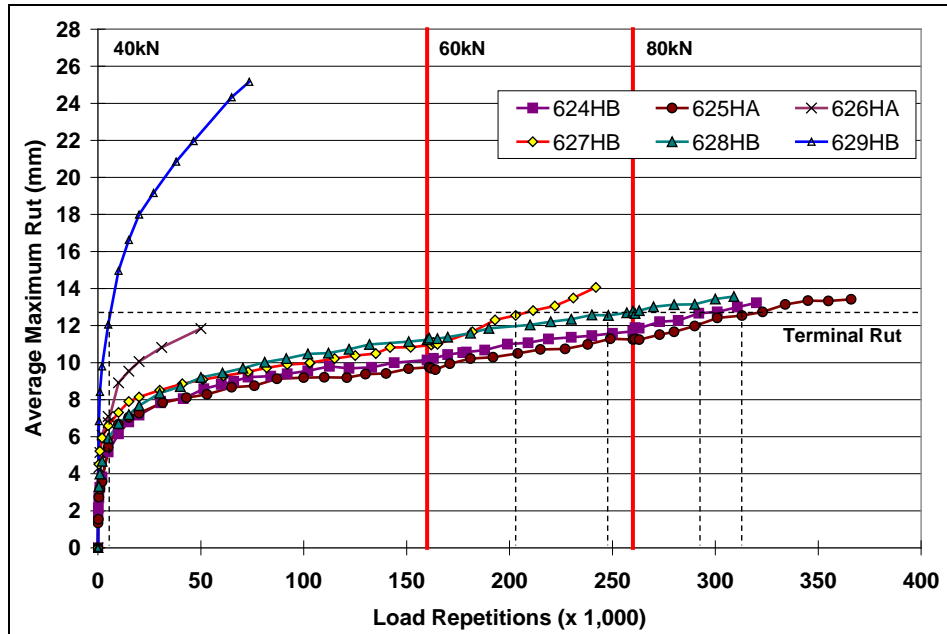
binder content. On the Astec and Rediset sections, the rut rate was slightly higher and was attributed to some moisture in the asphalt layer and in the subgrade in the Astec section (determined during the forensic investigation) and to the higher binder content on the Rediset section. Although lower production and paving temperatures typically result in less oxidation of the binder, which can influence early rutting performance, differences in production and placement temperatures did not appear to influence performance in this set of tests.

Figure 4.74: Comparison of average maximum rut.
