# Preliminary Results: Measurement of Macrotexture on Surface Treatments and Survey of Bicyclist Ride Quality on Mon-198 and SLO-1 Test Sections

Part of Partnered Pavement Research Program (PPRC) Strategic Plan Element 4.47:  
Impact of Chip Seal on Bicyclists

University of California  
Pavement Research Center  
UC Davis, UC Berkeley

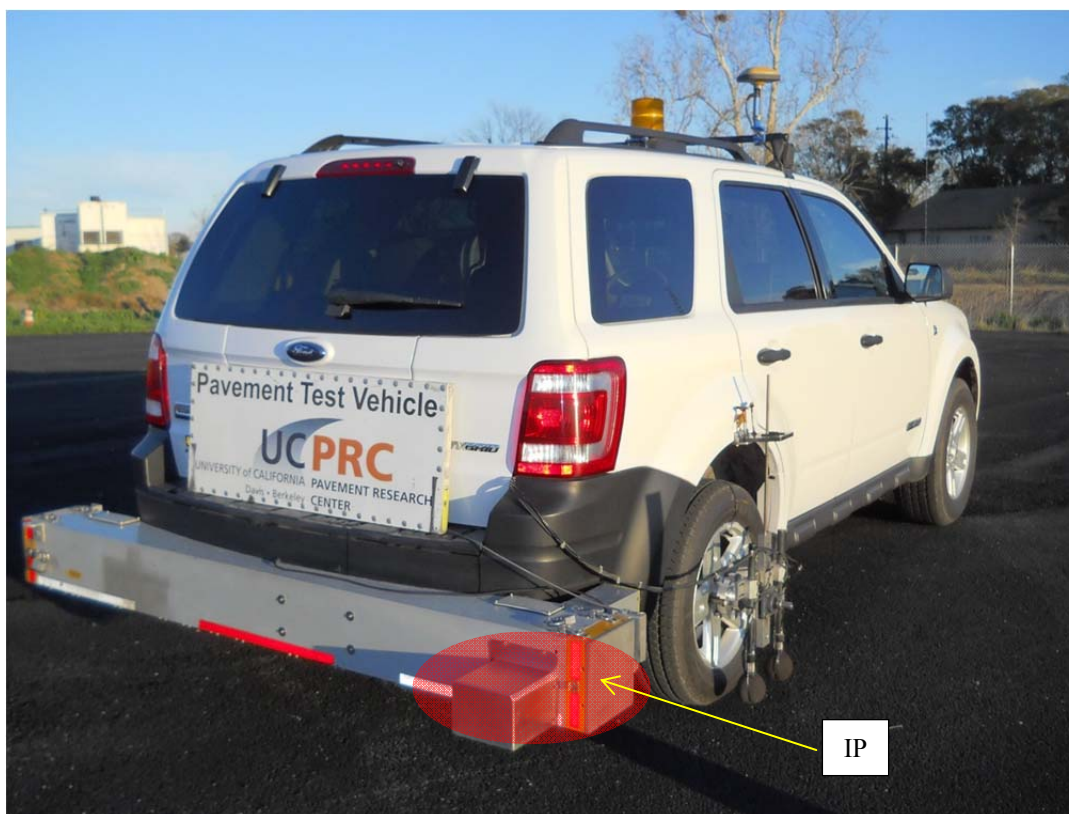
**Figure 4.7: Instrumented vehicle with an inertial profiler (IP).**

When analyzing the first results from the IP, it was discovered that the macrotexture of some of the pavement surface treatments, in terms of MPD, was greater than the 2 mm MPD default range of the sensor, and this resulted in erroneous values. Afterward, the IP's sensor range was increased to 5 mm and those sections were measured again several weeks later. Although increasing the sensor range resulted in lower resolution measurements, the resolution was sufficient for the purposes of this study.
