August 2009
Technical Memorandum: UCPRC-TM-2008-01

Rehabilitation Design for 02-PLU-36, PM 6.3/13.9 Using Caltrans ME Design Tools: Findings and Recommendations

Partnered Pavement Research Program (PPRC) Contract Strategic Plan Element 3.4:
Development of Improved Rehabilitation Designs for Reflective Cracking

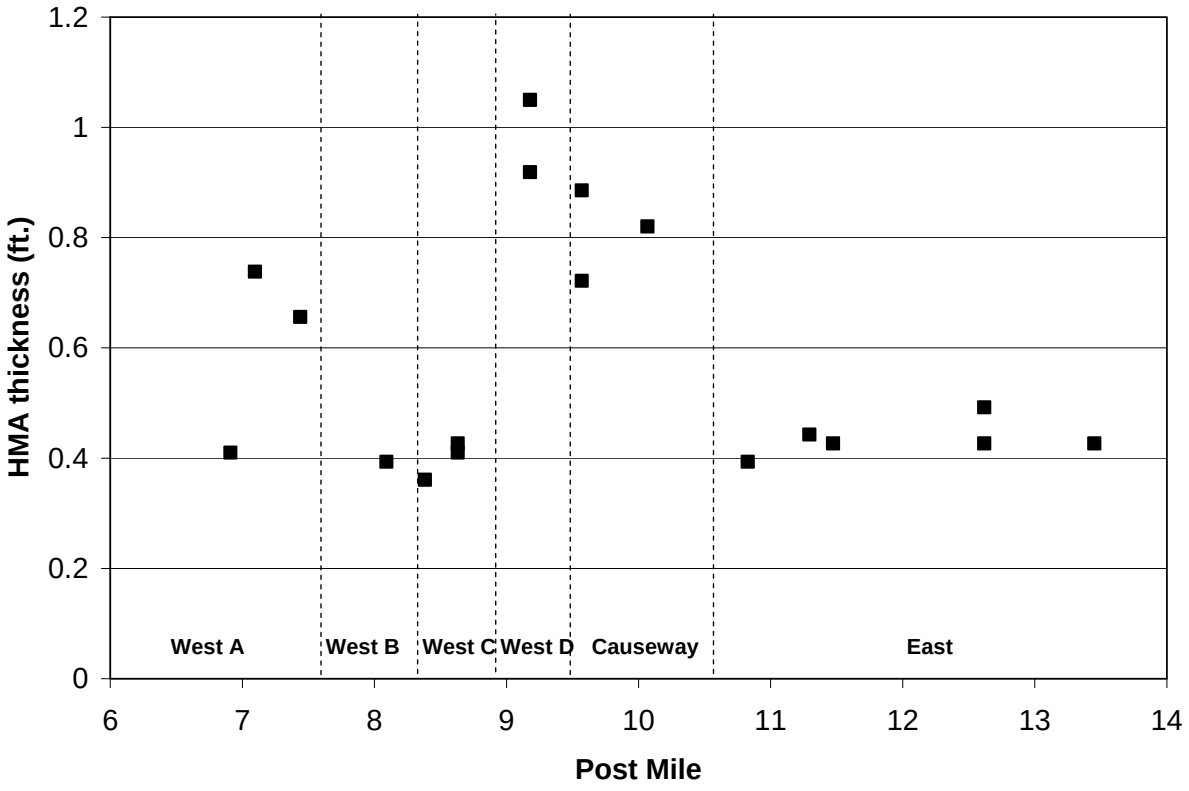
Figure 6: HMA core thicknesses by section and post mile (see Figure 2).

Results from the coring operations showed a consistent HMA layer with a thickness of 0.37 ft (115 mm) in sections West B, West C, and West D. Section West A had a thickness of 0.41 ft (125 mm) at STA 32+83 (1,000 m) and an average thickness of 0.69 ft (212 mm) at STA 42+68 ft (1,300 m) and 60+74 ft (1,850 m). The extent of the thicker section of HMA material in Section West A was unknown. (Note: A ground penetrating radar investigation would be able to show the extent of the thicker section of HMA and also the variability in the thickness of the HMA layer.) The thickness of the HMA layer on the Causeway section varied from 0.80 ft to 0.98 ft (245 mm to 300 mm), with an average thickness of 0.87 ft (265 mm) based on three cores. It was determined from five cores that the East section had an average thickness of 0.43 ft (130 mm) in the HMA layer and that this layer showed low variability. All of the cores from the East section showed a consistent pattern: an initial HMA layer (about 0.23 ft [70 mm]) and then a series of overlays approximately 0.08 ft (25 mm) thick. A diagram of the core thicknesses along the project is shown in Figure 6.

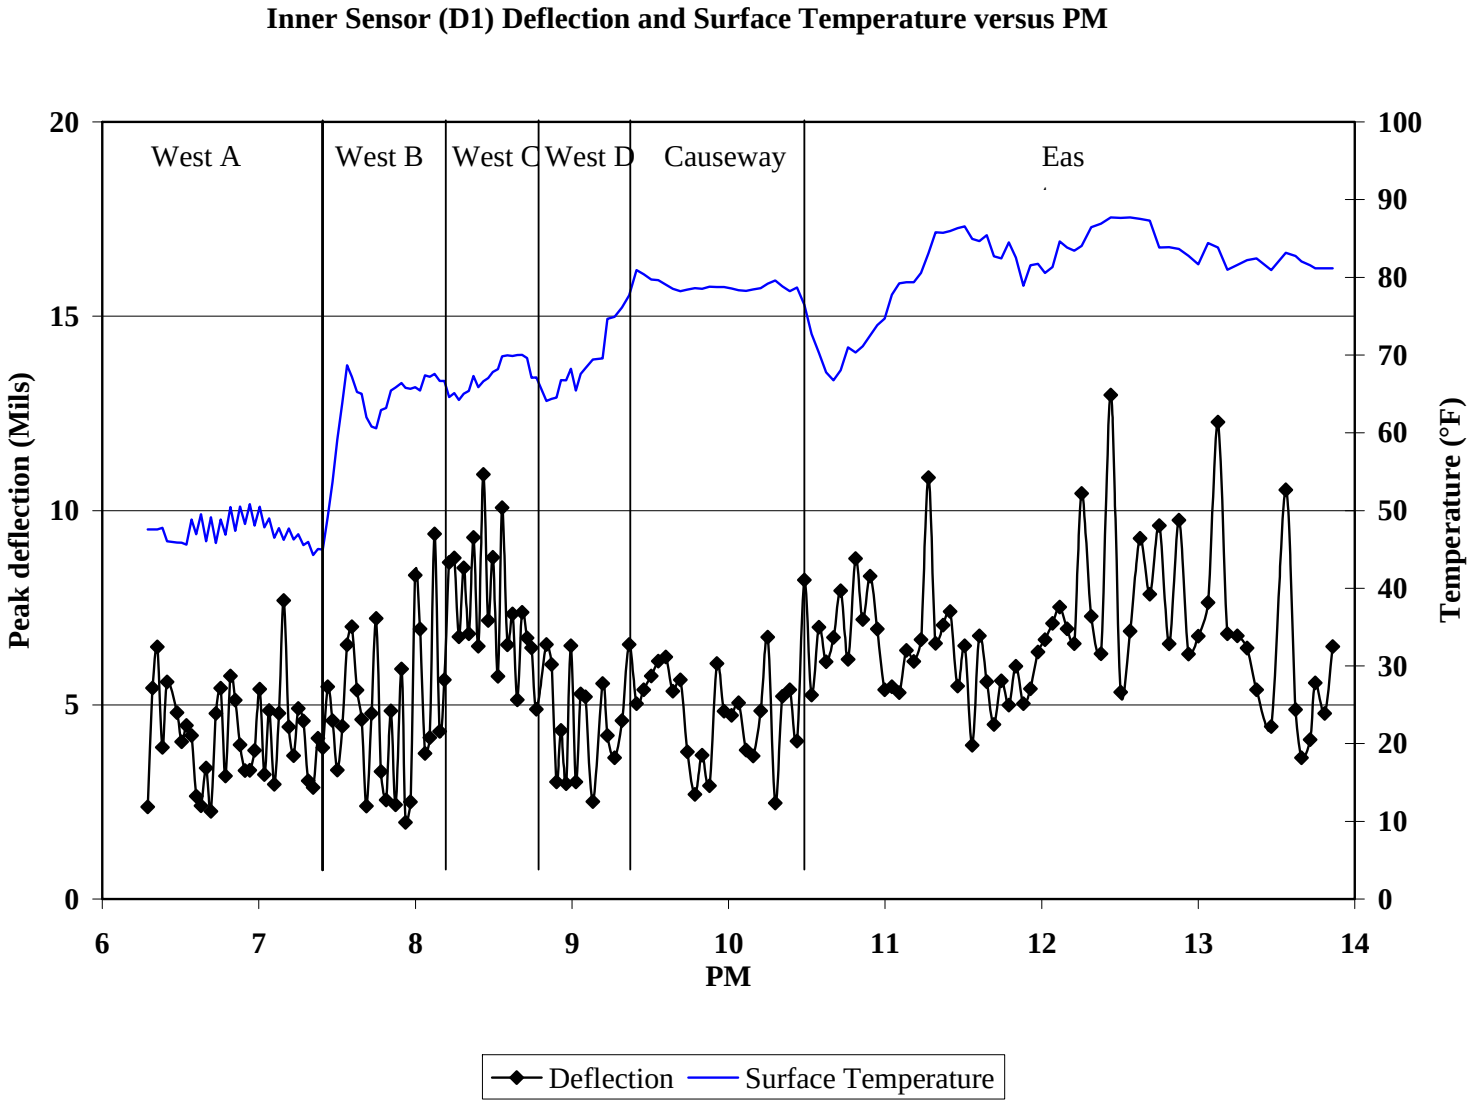
Figure 10: FWD inner sensor (D1) peak deflection and surface temperature versus post mile.

Figure 10 shows the Falling Weight Deflectometer deflection data for inner sensor (D1) and HMA surface temperature versus post mile. Figure 11 shows the Falling Weight Deflectometer deflection data for the outer sensor (D8) and HMA surface temperature versus post mile. Deflection testing started in the morning at Section West A, and proceeded generally eastbound as indicated by increasing surface temperatures with post mile. Figure 12 shows the temperature-adjusted layer moduli from *CalBack* for the entire project. Reference stiffnesses for SC, SM, and Clay were comparable in this project since *CalME* did not contain sufficient calibrated soil materials at the time of analysis. Table 7 through Table 10 present the raw westbound and eastbound FWD data. Figure 13 shows the deflection bowl from Station 1850.
