HVS Test Results on Fast-Setting Hydraulic Cement Concrete

Palmdale, California Test Sections, South Tangent

Report prepared for the California Department of Transportation

July 2002

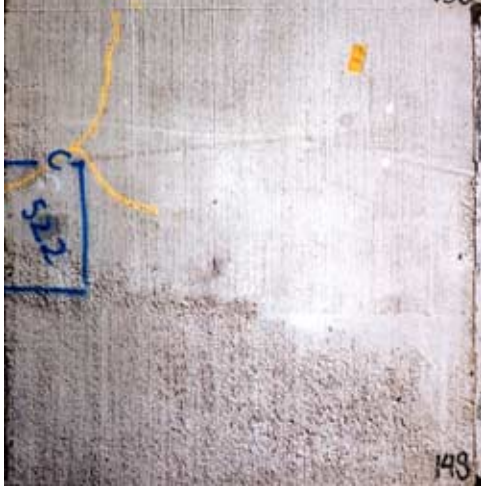
Photograph 4.18. Photograph of final crack pattern, Test Section 522FD.

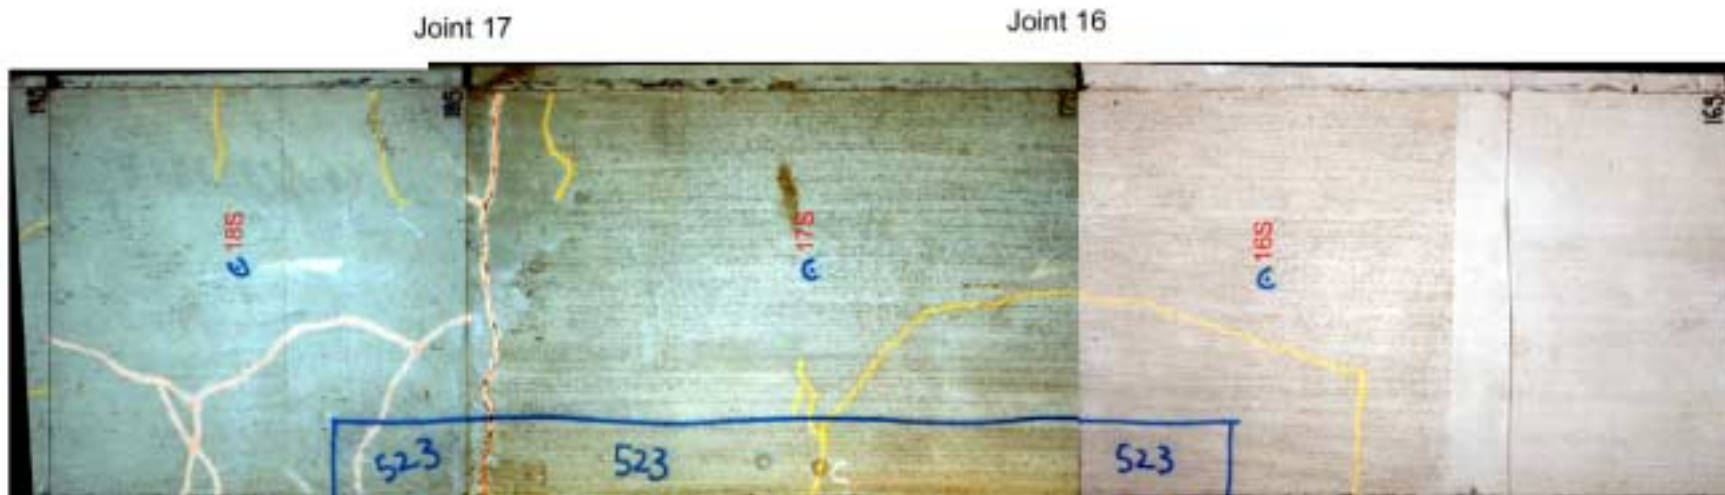
Photograph 4.21 shows an overhead view of the test section and crack pattern. Figure 4.12 shows crack development for Section 523FD. Several cracks existed before trafficking began (see Photograph 4.22). The first crack under applied loading appeared at 89,963 repetitions on slab number 17 as a corner crack and as a longitudinal crack on slab number 16 (Photograph 4.23).

Photograph 4.21. Composite photograph of final crack pattern, Test Section 523FD.

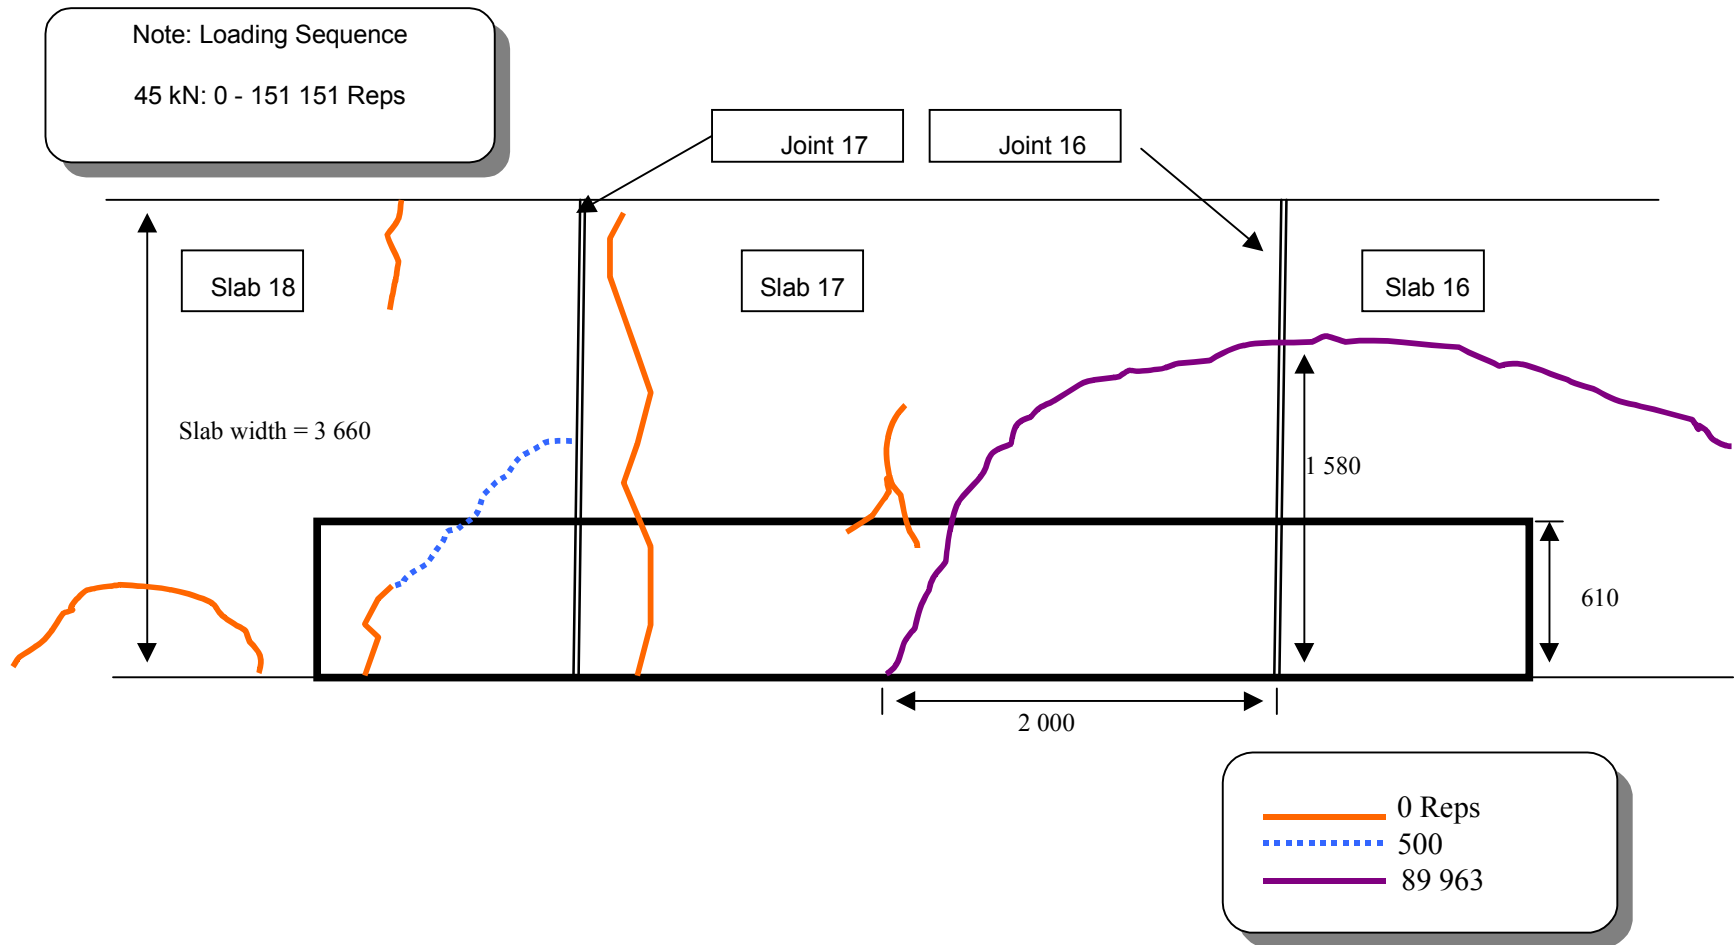
Figure 4.12. Schematic of crack development, Test Section 523FD (not to scale).

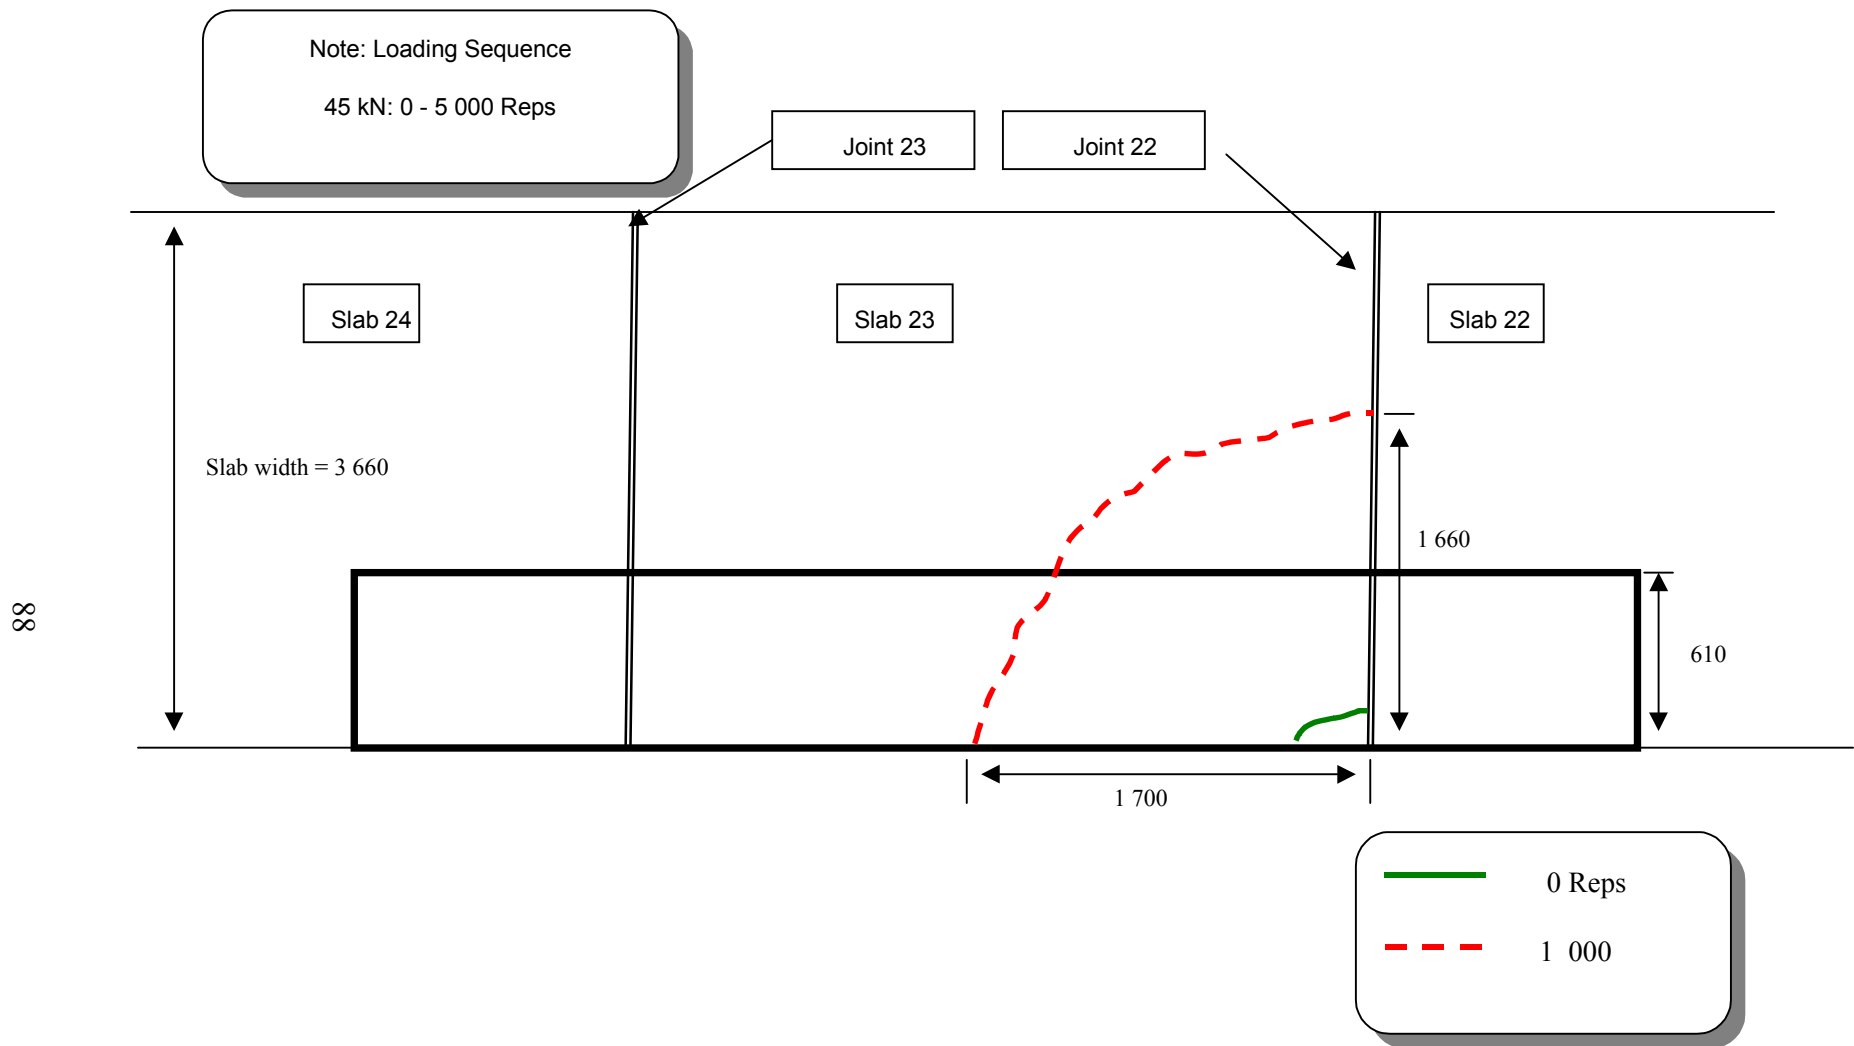
Figure 4.21. Schematic of crack development, Test Section 525FD (not to scale).

The first crack appeared on the middle slab (slab 23) by 1,000 repetitions. As seen in Photograph 4.26, the HVS produced a corner crack at joint 22 that was approximately symmetrical (1.7 by 1.66 m). This crack was similar to failure modes experienced on the other

The maximum permanent deformation (5 mm) occurred on the slab 23 side of joint 22 (refer to Figure 4.21 and Photograph 4.26 for the location). At the right side of the joint (slab 22), the permanent deformation was 1 mm. The 4-mm differential permanent vertical displacement between slabs at joint 22 shows that a significant faulting effect occurred. As can

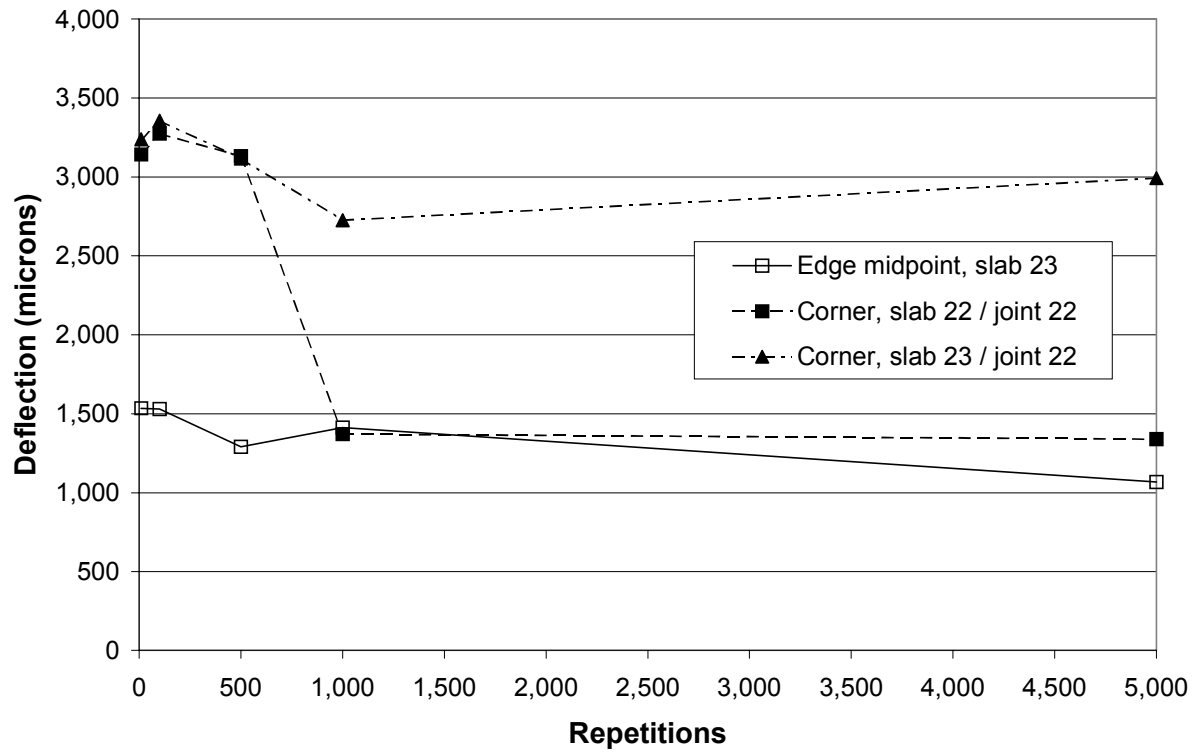
Figure 4.22. JDMD and EDMD deflections, Test Section 525FD.

Figure 4.22 shows the average measured deflections (from Table 4.33) and Figure 4.23 shows the permanent deformations (from Table 4.34). The plot of the elastic corner deflections shows the drop in response after slab 23 cracked at approximately 1,000 repetitions. The corner deflection measured on slab 23 dropped more markedly than the corner deflection measured on slab 22. This is due to the corner crack forming on slab 23, which caused the slab to come into full contact with the base again. The midpoint edge deflection did not decrease appreciably after the corner crack had formed, even though the final crack appeared only 100 mm from the gauge.

After 1,000 repetitions, the development of the corner crack induced a steep increase in the permanent deformation (about 63 percent) and a sudden decrease of deflection (about 56 percent). These observations lead again to the assumption that the slab was curled upward prior to the start of the test and until the corner crack developed. The unsupported condition at the corner caused the formation of a corner crack and consequent slab failure.

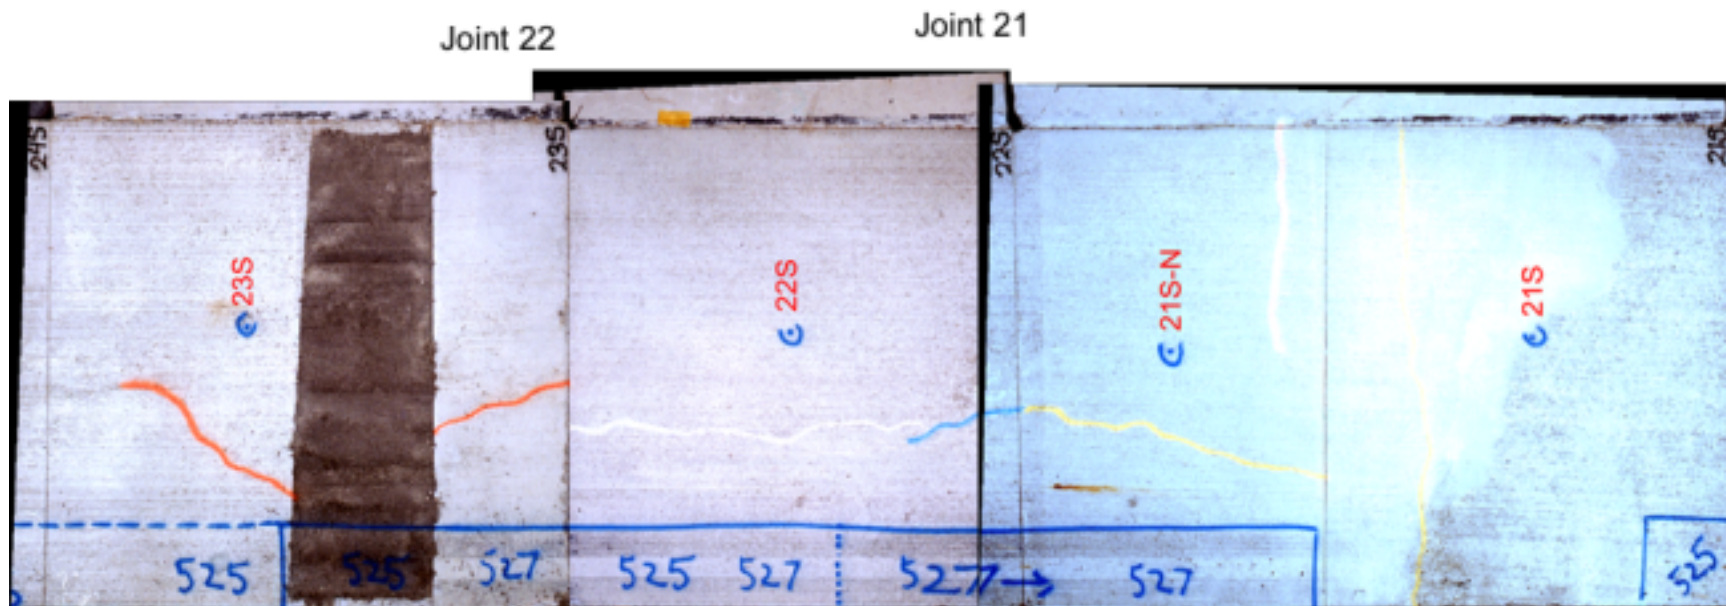
Photograph 4.31. Composite photograph of final crack pattern, Test Section 527FD.

As seen in Photograph 4.31, slab 23 had a corner crack from the outset, about 1.7 m from the edge. After 129,805 repetitions, a new longitudinal crack at about 1.5 m from the edge of the tested slab (slab 22) formed. Shortly after the load was increased to 40 kN (after 890,000 repetitions), a longitudinal crack formed on slab 21. This new crack developed through the entire width of the slab, also about 1.5 m from the edge.

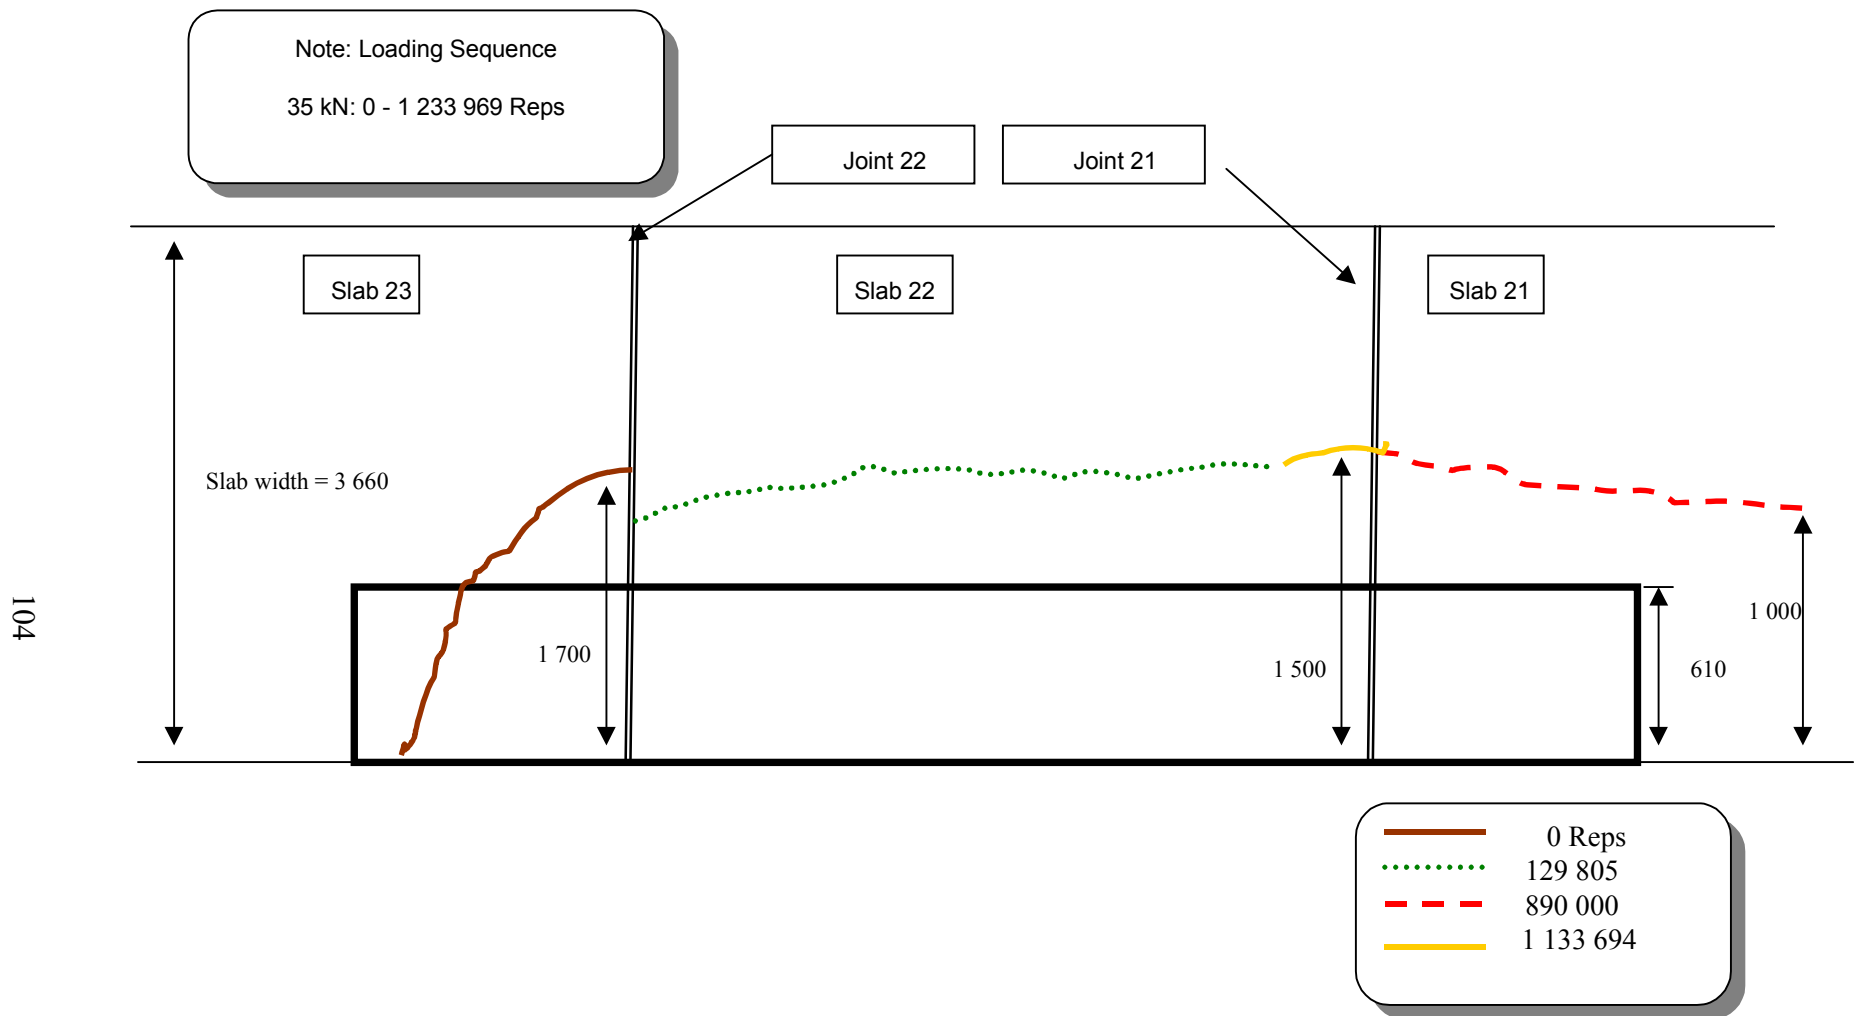
Figure 4.27. Schematic of crack development, Test Section 527FD (not to scale).

Test Section 527FD included slabs 21, 22, and 23. A photograph of the full test section with cracks at the end of HVS trafficking is presented in Photograph 4.31; crack development is presented in Figure 4.27.

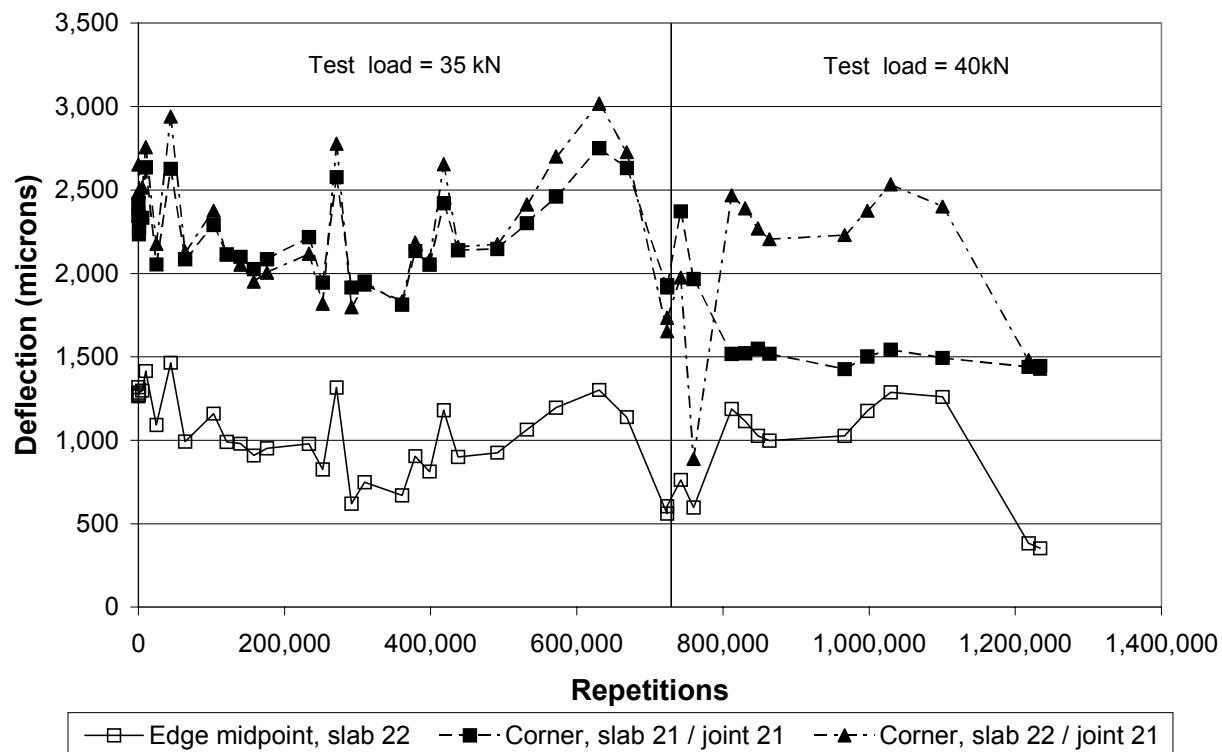
Figure 4.28. EDMD and JDMD deflections, test load = 35 and 40 kN, Test Section 527FD.

Deflections on both sides of joint 21 were broadly similar for the first part of the test (wheel load of 35 kN up to 723,438 repetitions) and in the order of 1,000 microns on the edge and 2,000 to 2,500 microns at the joint (Figure 4.28). This suggests that there was no significant deterioration under the trafficking load, with good slab support and aggregate interlock at the joint being maintained.

When the wheel load was increased to 40 kN, however, the joint deflections dropped noticeably (see Figure 4.28). In addition, deflections measured on each side of the joint differed until the end of the test: those on the slab 22 side (main trafficked slab) were generally higher than those on the slab 21 side.

At the end of the test, deflections on each side of the joint were approximately 1,500 microns. Deflection at the midpoint edge of slab 21 dropped to 350 microns. This may have been due to the cracks that formed on slab 21 at 890,000 repetitions and on slab 22 at 1,133,694 repetitions, which caused the slab to seat and come into full contact with the base layers similar to conditions observed in other tests.

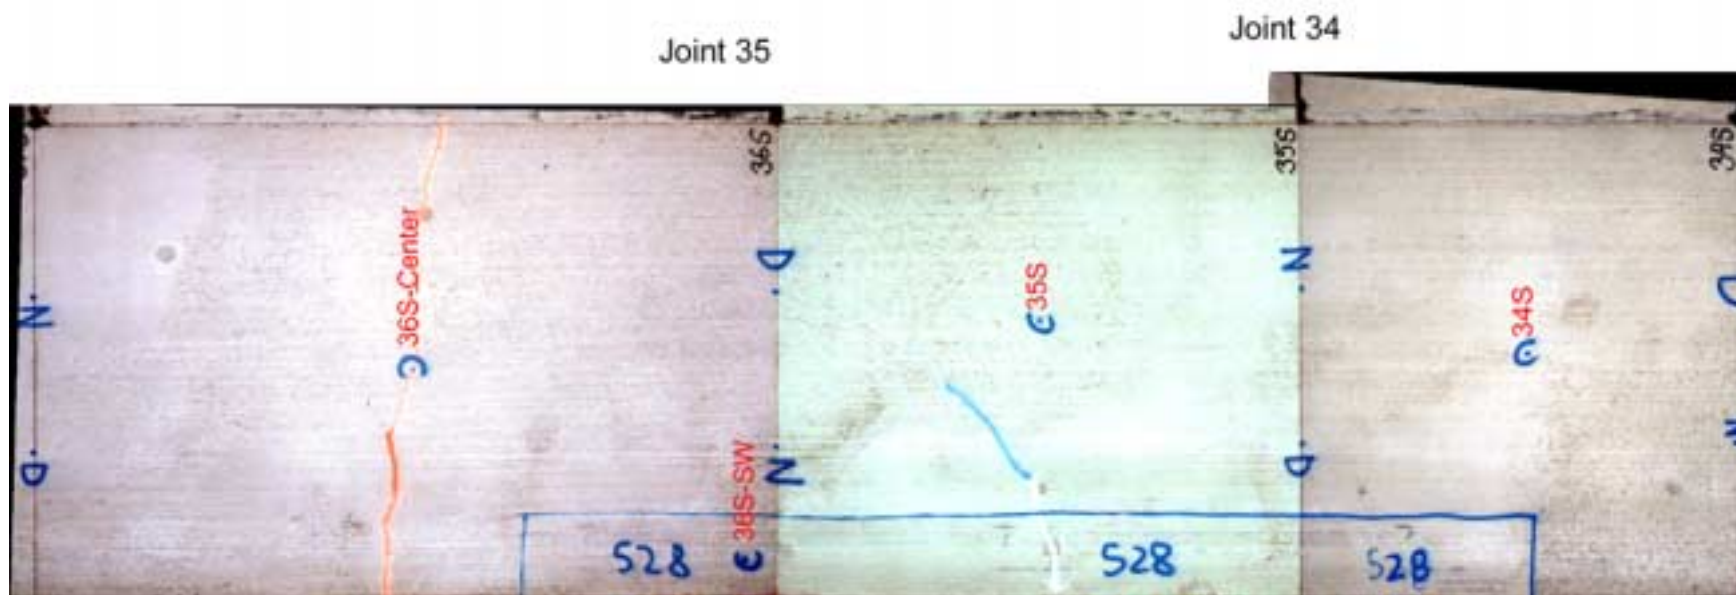
Photograph 4.33. Composite photograph of final crack pattern, Test Section 528FD.

A 40-kN dual wheel load was used for the entire duration of the test to a total of 83,045 repetitions. An overhead photograph of the test section after HVS trafficking is presented in Photograph 4.33.

break. This crack extended with time and the final crack pattern can be seen in Figure 4.30 and Photograph 4.35.

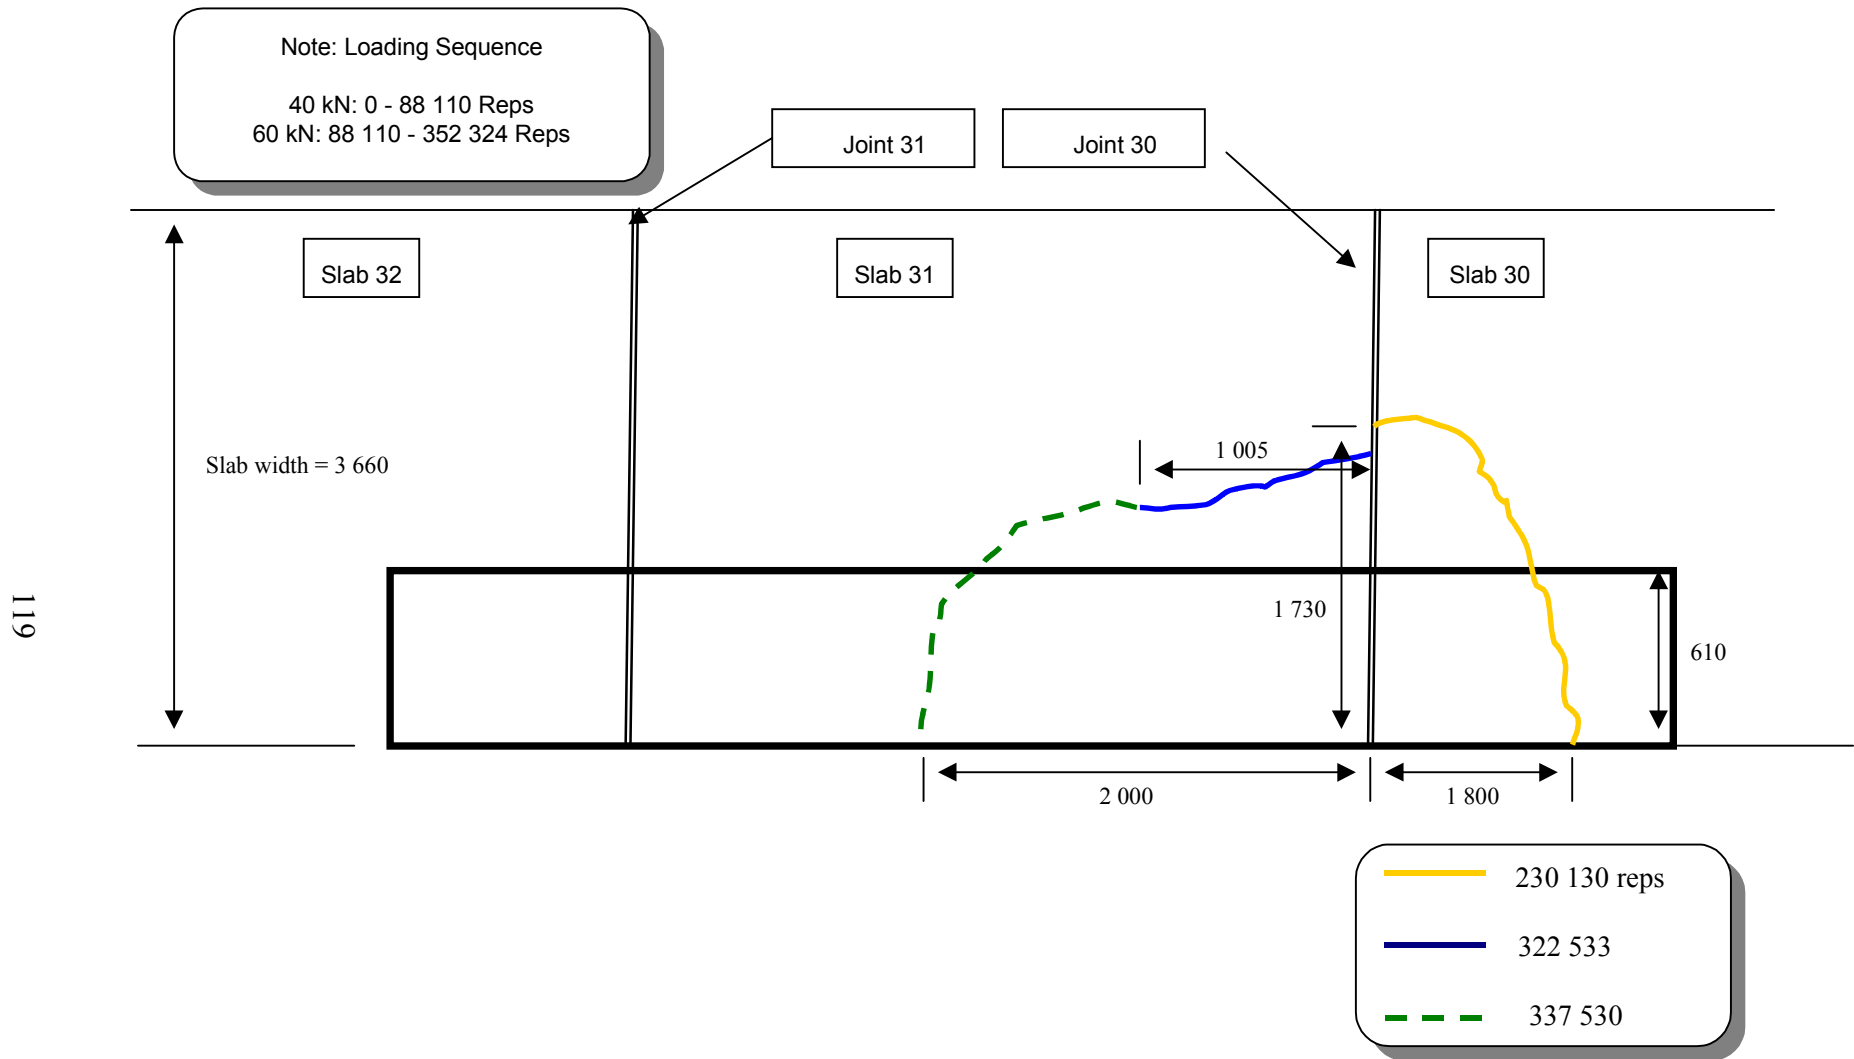
Figure 4.32. Schematic of crack development, Test Section 529FD (not to scale).

HVS Test Section 529FD was completed on slabs 30, 31 and 32 on the South Tangent, with the 8 ×1 m HVS test section located so that slab 31 was tested along its entire edge. The test started with a 40-kN dual wheel load, which was kept constant to 88,110 repetitions, after which it was increased to 60 kN for an additional 264,214 repetitions. The test was stopped at 352,324 load repetitions. The crack pattern, as it developed with time, can be seen in Figure 4.32. A composite photograph of Test Section 529FD can be seen in Photograph 4.36.

It is conjectured that the sawed joint did not propagate straight down to the base. It appears that the crack propagated down toward slab 32, which is directly to the left of the mid-slab (slab 31).

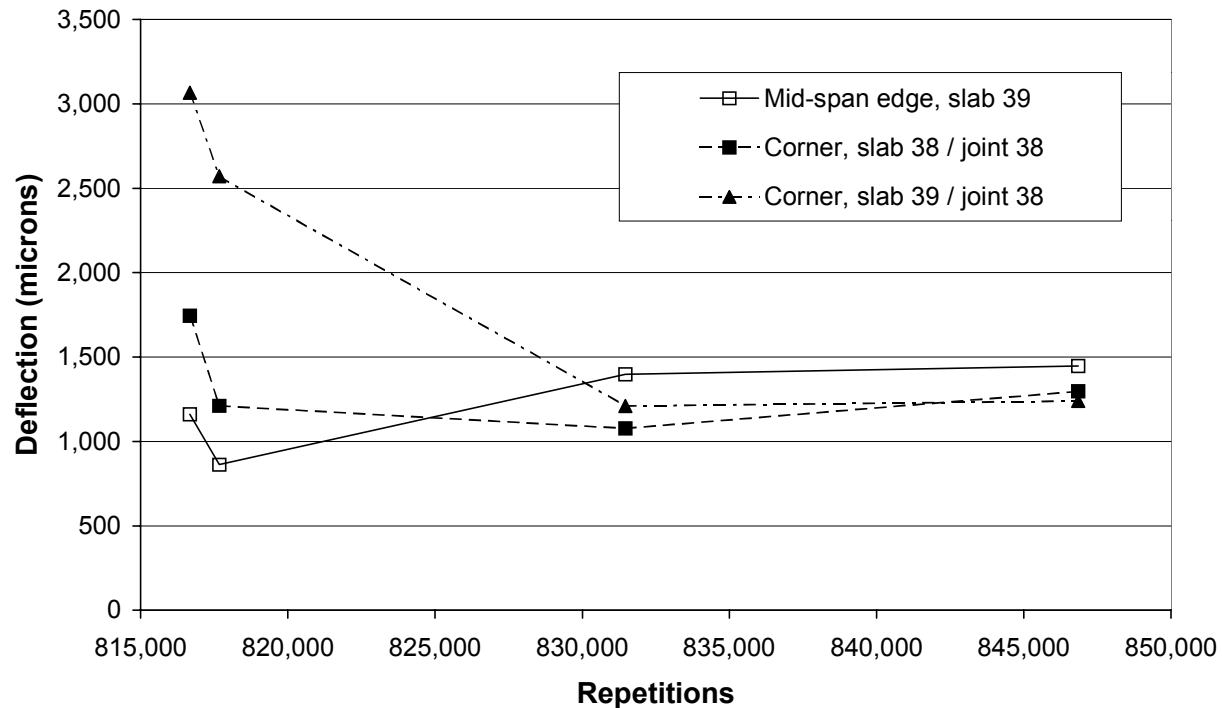
Figure 4.38. Elastic surface deflections, test load = 90 kN, Test Section 530FD.

While the test load was 40 kN (to 64,227 repetitions), the deflections stayed relatively constant, in the order of 0.6 mm at the edge midpoint and 1.6 to 2 mm on either side of joint 38. After 227,457 repetitions at 60 kN (291,684 total repetitions), a corner crack developed on slab 38. This is shown in Figure 4.37, where the deflection reading of the JDMD on the slab 38 side of the joint decreases significantly. When the load was raised to 90 kN, a corner crack developed on slab 39 at approximately 5,000 90kN load repetitions (830,463 total repetitions), which is shown by the drop in deflection for the slab 39 side of the joint in Figure 4.38.

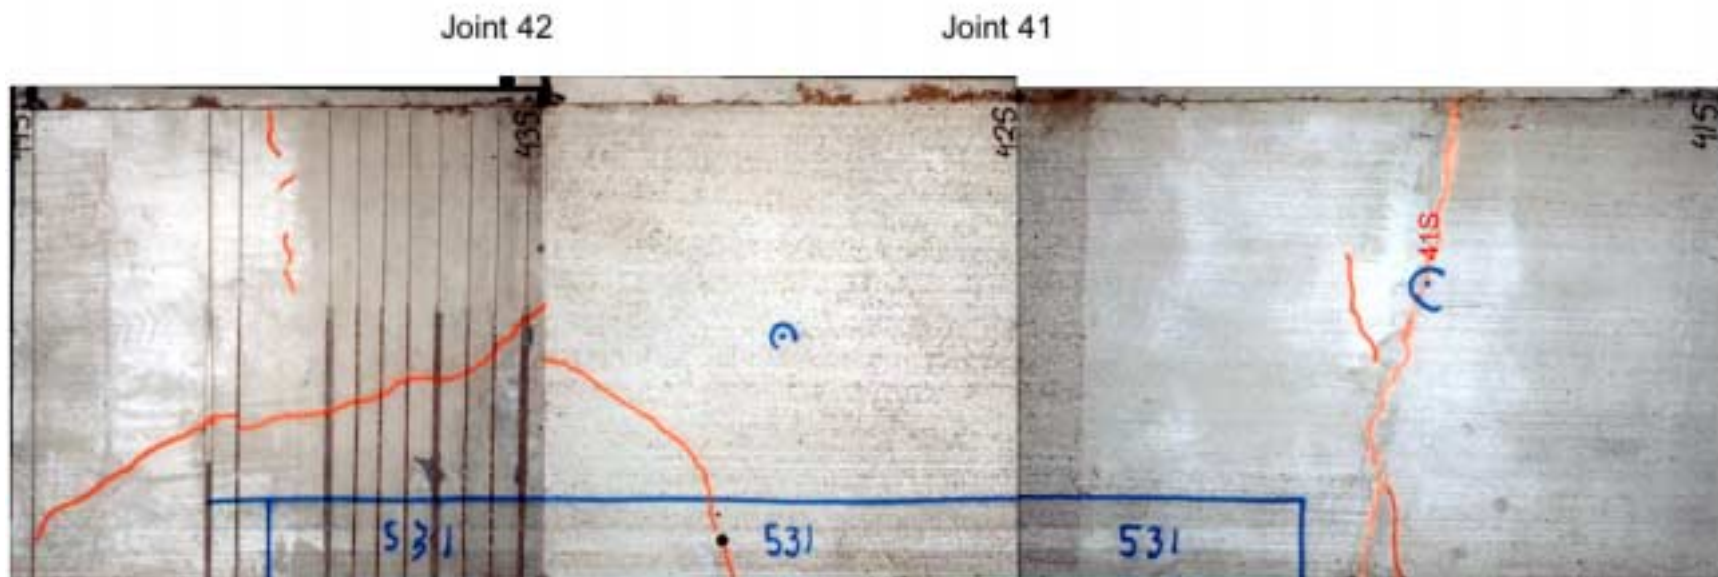
Photograph 4.41. Composite photograph of final crack pattern, Test Section 531FD.

Test Section 531FD was conducted on slabs 41, 42 and 43 and was the last HVS test performed on the South Tangent. The test was conducted with temperature control. As shown in Figure 4.41, slab 42 (total length of 4.7 m) was fully tested, together with some area on either side of joints 41 and 42. The test started with a 40-kN dual wheel load, which was kept constant up to 31,318 repetitions, after which it was increased to 70 kN for an additional 33,997 repetitions. The test was stopped at 65,315 total load repetitions. The crack pattern, as it developed with time, can be seen in Figure 4.41. A photo composite of the test section with cracks after HVS trafficking is presented in Photograph 4.41.

Prior to the start of HVS testing, no cracks were visible on the Section 531FD. After 31,318 40-kN load repetitions and 31,495 70-kN load repetitions (a total of 62,813 load repetitions), a transverse crack developed in the middle slab (slab 42) and a longitudinal crack developed across the WIM instrumentation in slab 43. This crack pattern suggests that the slab failed due to fatigue and if time permitted, the crack may have appeared to be a corner break (see Photograph 4.42).

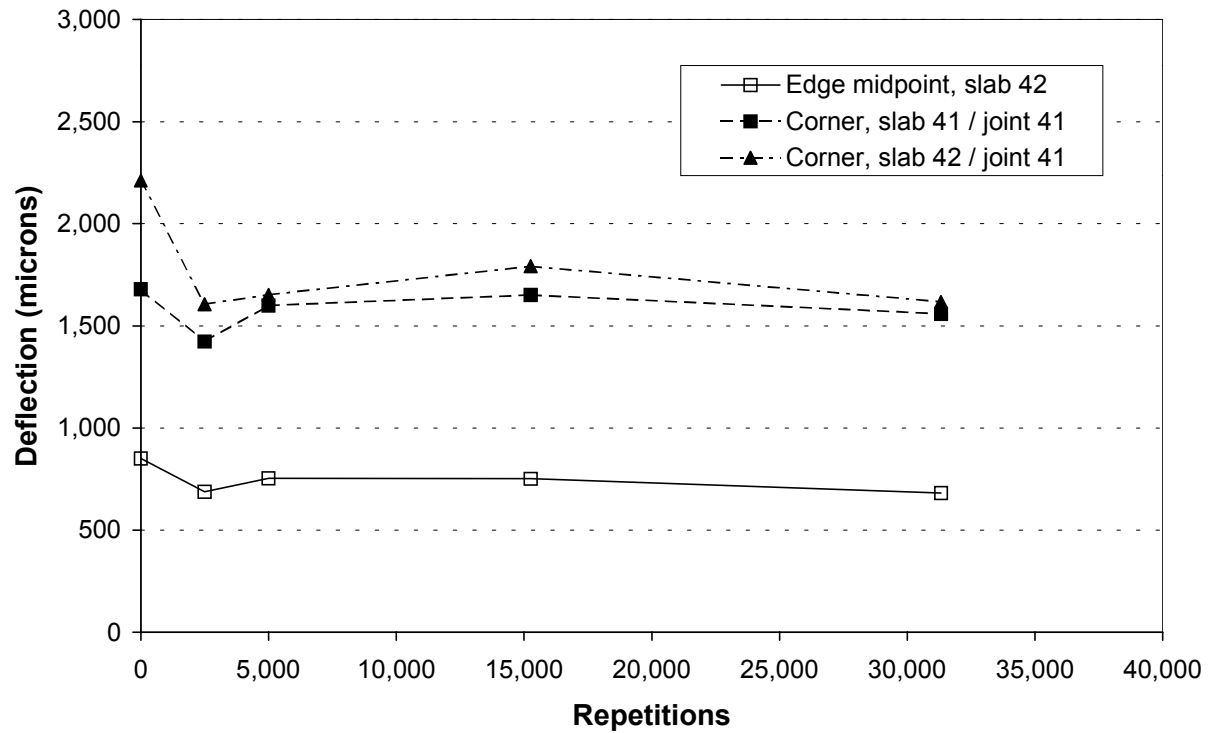
Figure 4.42. Elastic surface deflections, test load = 40 kN, Test Section 531FD.

Two Joint Displacement Monitoring Devices (JDMDs) were placed on either side of joint 41 (between slabs 41 and 42) and one Edge Displacement Monitoring Device (EDMD) was placed on the edge of slab 42 at its edge midpoint (midway between the two joints). The maximum deflection at the midpoint edge of the middle slab, and the corner edge deflections on either side of joint 41, are summarized in Table 4.54 for the 40-kN loading and Table 4.55 for the 70-kN loading. The data are also shown in Figures 4.42 and 4.43 for the 40- and 70-kN load cases, respectively.

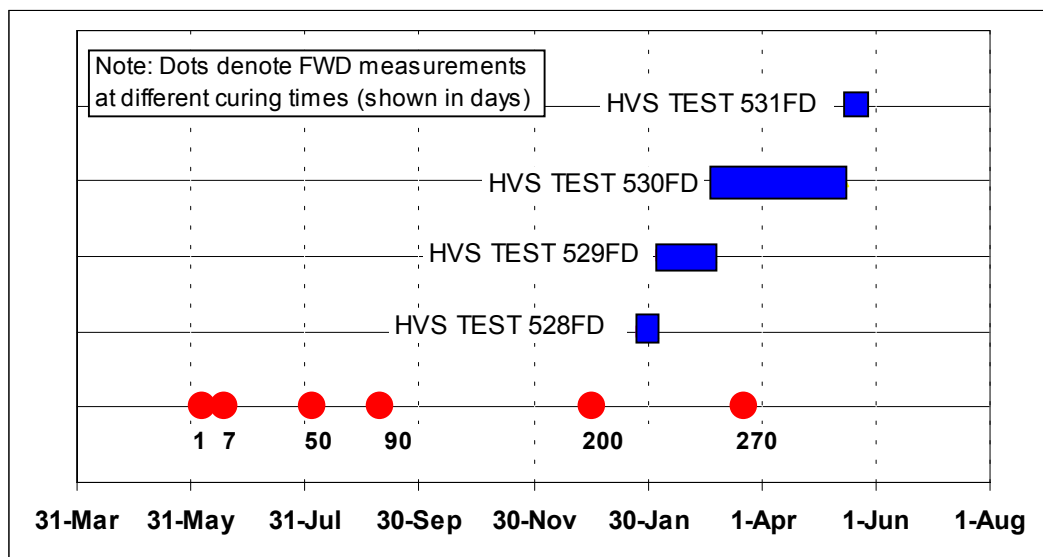
Figure 6.1. Timeline showing time of FWD testing and start and duration of HVS testing on 200-mm thick slabs.

FWD measurements were taken at 1, 7, 50, 90, 200, and 270 days after construction of the concrete pavement. The sequence of these six test groups relative to the HVS testing is shown in Figure 6.1. It should be noted that the FWD testing was performed only on the concrete sections with a thickness of 200 mm or greater, thus only these HVS test sections are shown in Figure 6.1.

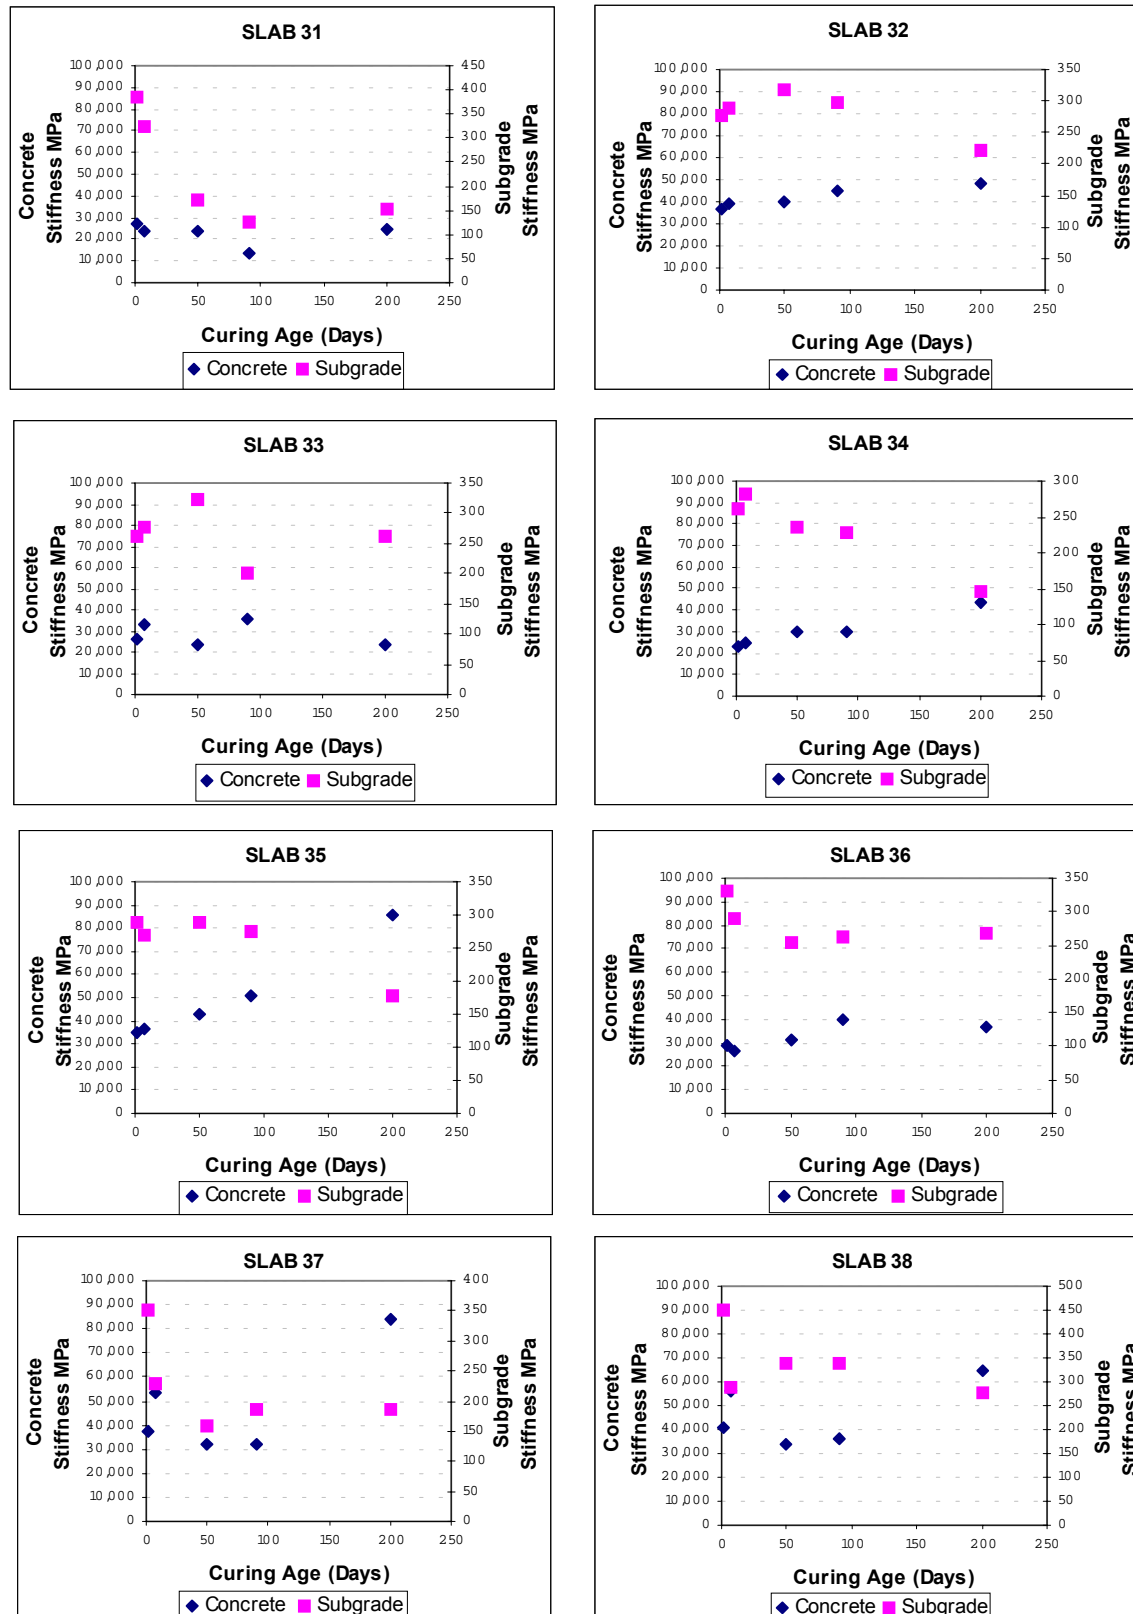
Figure 6.2. Curing age versus stiffness of the concrete and subgrade for different slabs (based on deflections measured at slab center).

Concrete slab and subgrade stiffnesses were backcalculated using the ELMOD software. A two-layer model was assumed with the first layer being the concrete slab, and the second layer (referred to as the subgrade) consisting of the aggregate base and subgrade. Backcalculated stiffnesses for the concrete slabs and subgrade at different curing times are listed in Table 6.1. The change in concrete and subgrade stiffness with increasing curing time is shown in Figure 6.2. The trends observed from these figures are decreasing subgrade stiffness and a tendency for decreased stiffness versus curing age for the concrete. These trends are also reflected in the raw deflection data for the different HVS tests (see Appendix A).

The tendency for the deflections to increase with increased curing age may be attributable to curling effects, which cause less consistent seating of the concrete slab on the subgrade, rather than weakening of the concrete slabs. Care should therefore be taken in the interpretation of the backcalculated stiffnesses. For second level analysis, it is recommended that a more rigorous backcalculation study be undertaken for the slabs situated within the HVS sections, particularly with respect to temperature. It can particularly be seen that backcalculated concrete stiffness is lowest at 90 days during the hottest time of the year, and highest at 200 days in mid-winter.

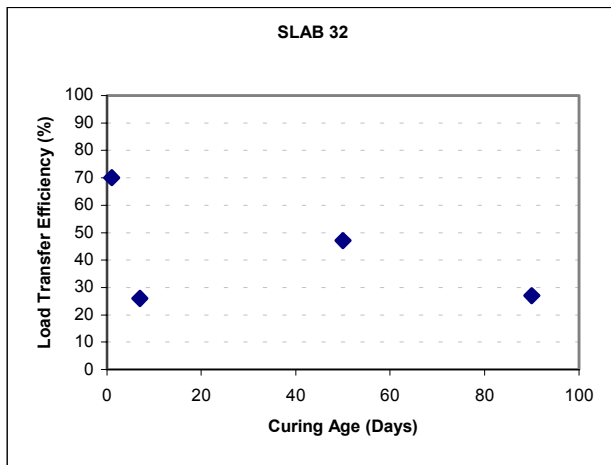
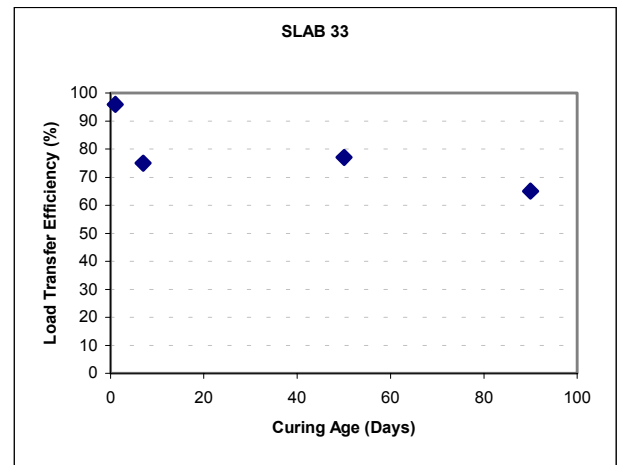
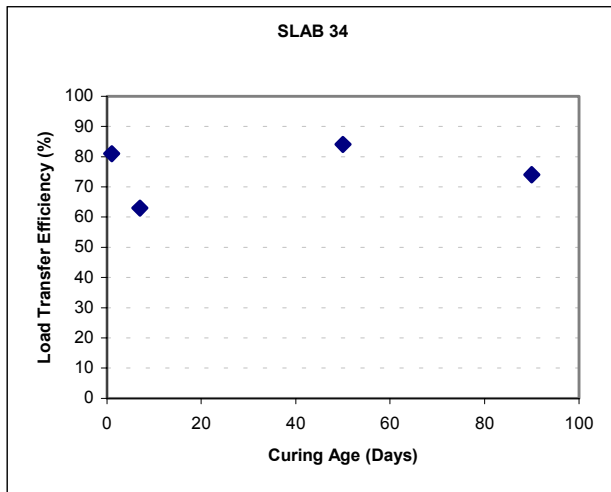
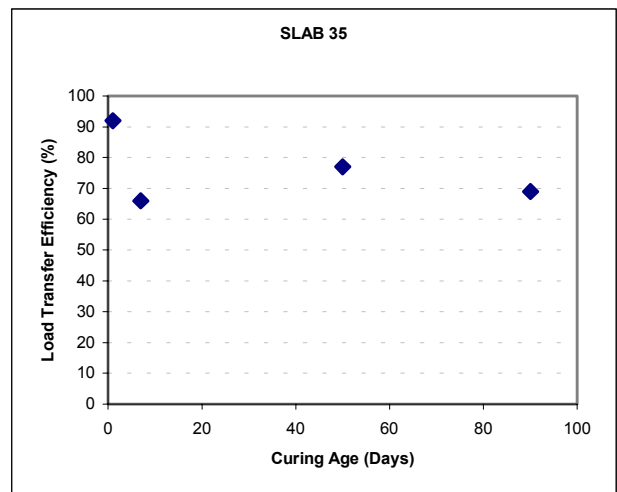
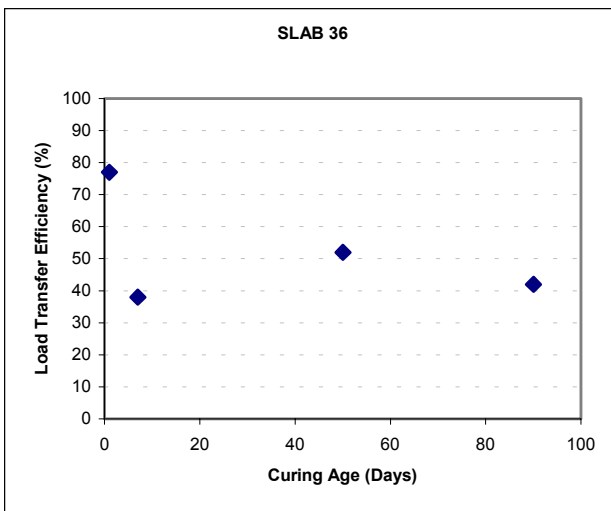
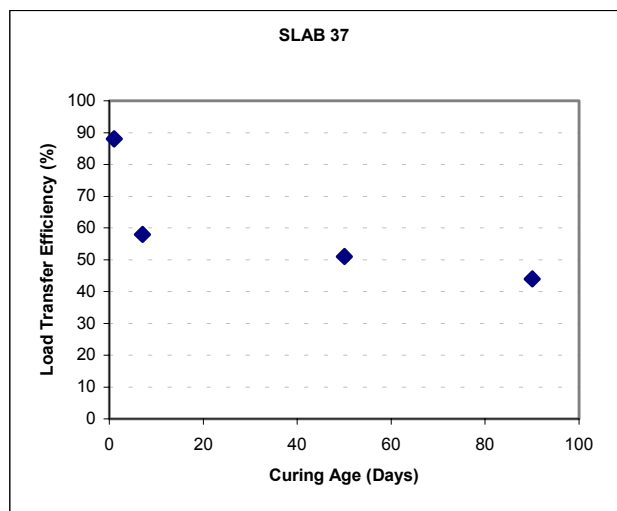
Figure 6.3. Load transfer efficiency versus curing age

The Load Transfer Efficiency (LTE) between different slabs at different curing ages is summarized in Table 6.2. No apparent relationship exists between the LTE and the curing age. It should be noted that temperature variations are not accounted for in these plots. The LTE percentages at different curing ages are shown in Figure 6.3.
