Technical Memorandum: UCPRC-TM-2005-07

Report of Field Site Visit District 3, Sacramento Interstate 5, PM 17.2-17.9 RAC-O Overlay

Work Conducted Under Partnered Pavement Research Contract

Strategic Plan Task 4.16: Investigation of Improved Open-graded Mix Designs including Quiet

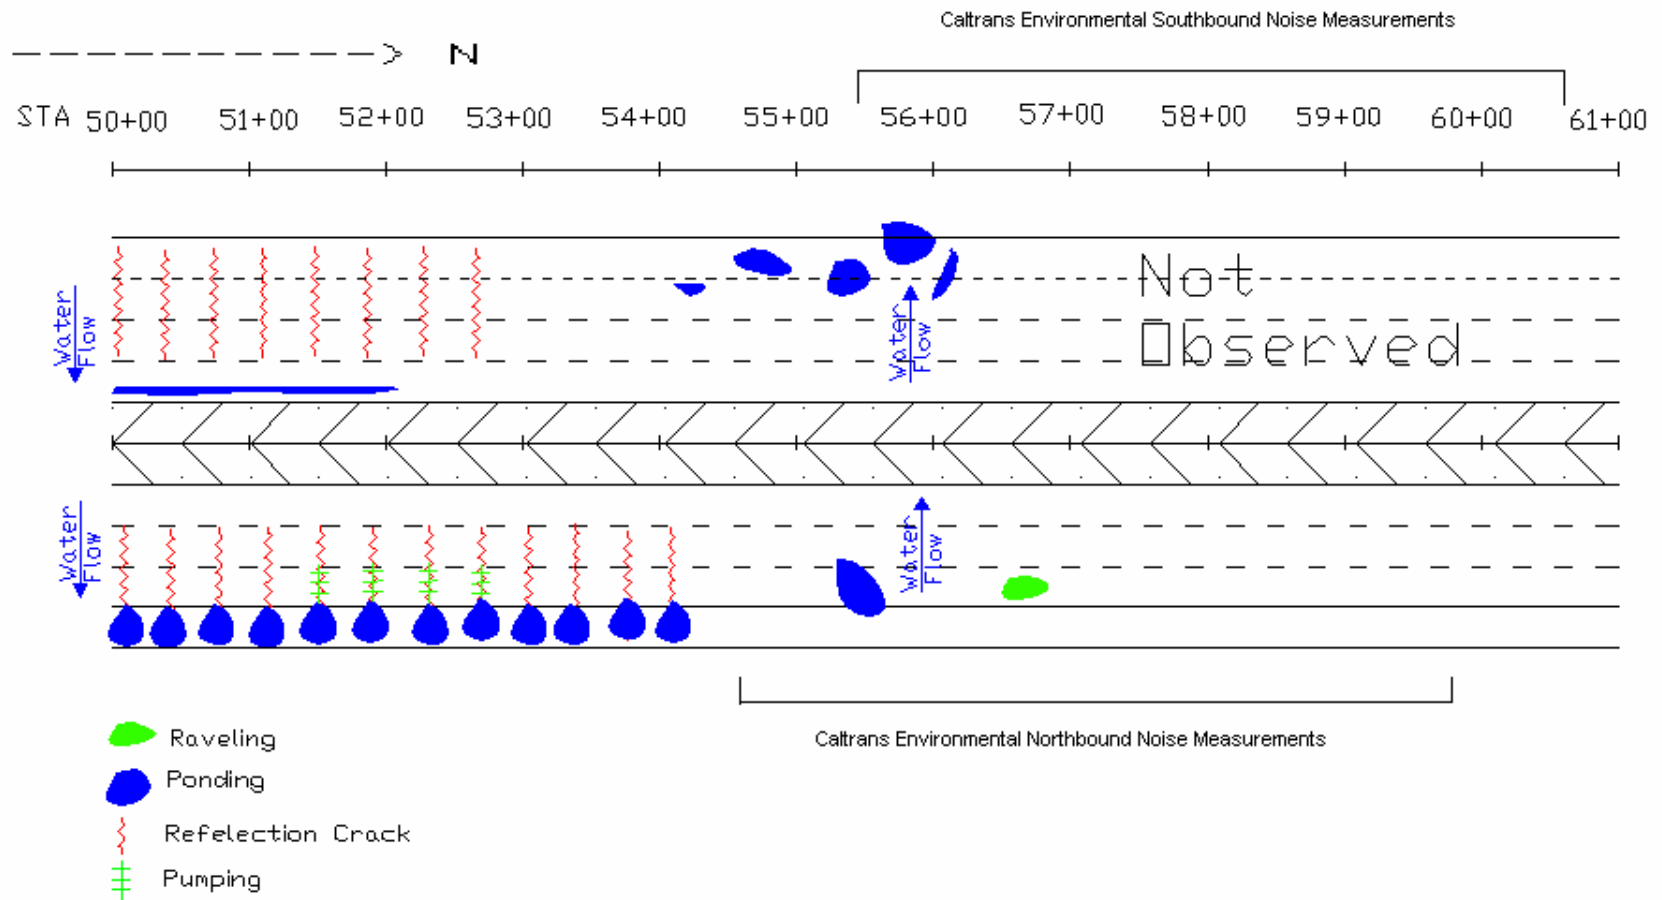
Ponding was present in the same locations as the reflection cracking. Water flowed easterly (from outside to inside lanes) on the southern portion of the project as shown in Figure 2. Moving northward against traffic in the southbound lane, the section climbs a mild hill, and then descends and the super-elevation reverses in the middle of the section, with water in the northern part of the southbound direction flowing westerly (from inside to outside lanes). Figures

Figure 2. Plan of the section and the distresses (from Caltrans Environmental).

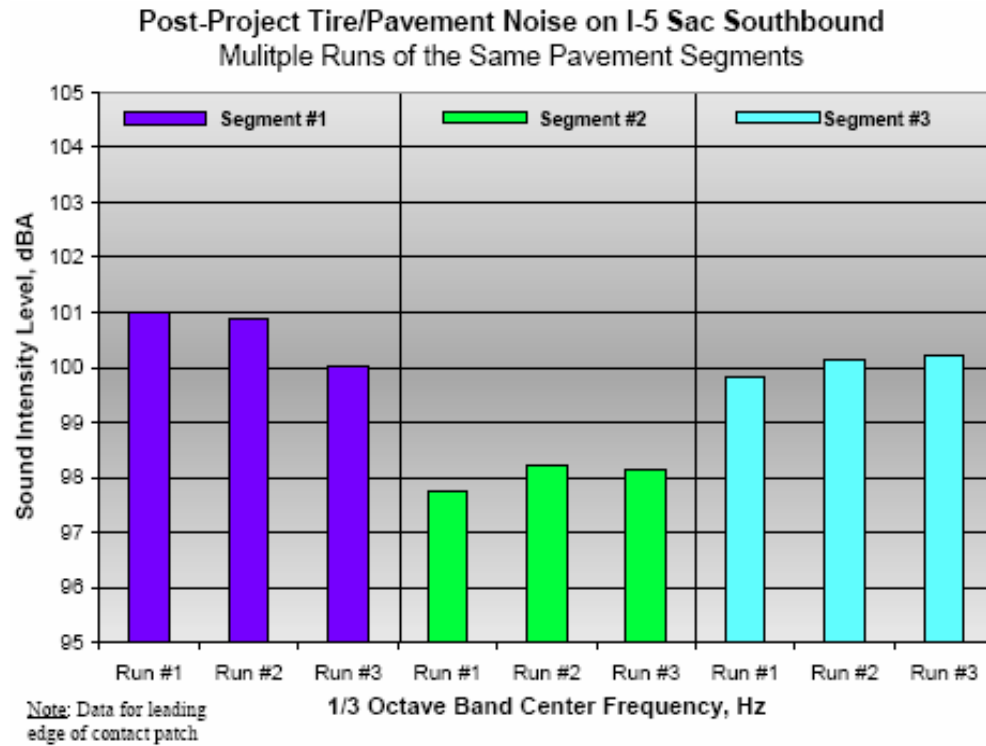
PRC evaluation of the results presented in the Caltrans Environmental presentation (Figures 3 and 4) indicate that the maximum difference within the southbound direction is about 3.5 dB, and the difference between the average north and southbound directions is less than 1.5 dB. Verbal communication with Caltrans Environmental indicated that all sound intensity measurements were taken in the outside lane.

Figure 3. Tire pavement noise on I-5 Sacramento southbound (from Caltrans Environmental presentation).

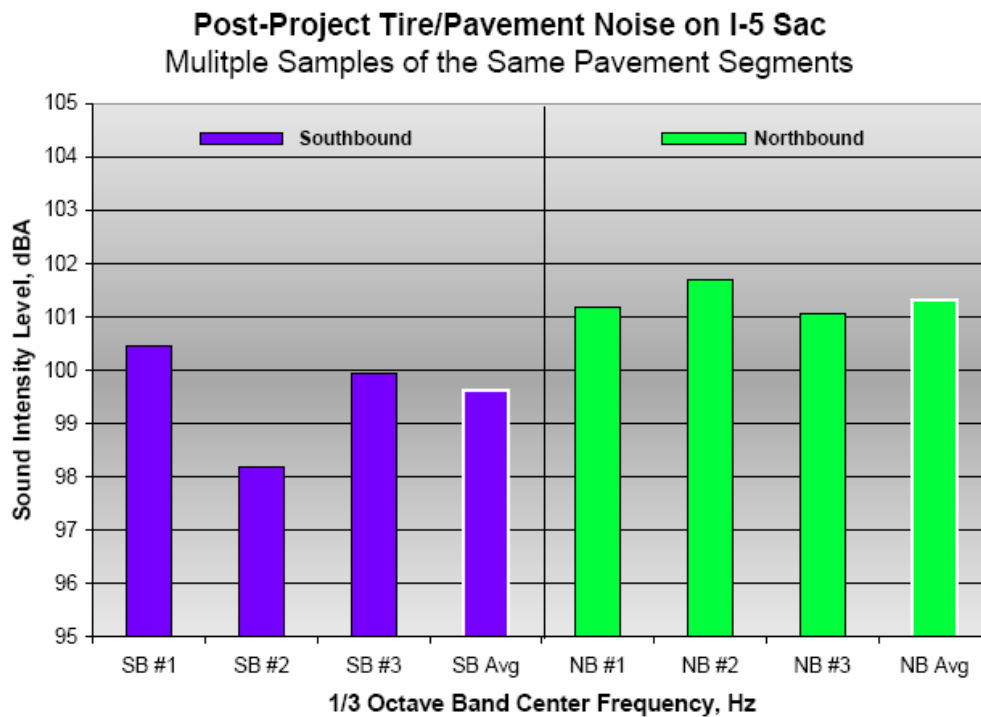
Figure 4. Tire pavement noise on I-5 Sacramento southbound and northbound (from Caltrans Environment presentation).

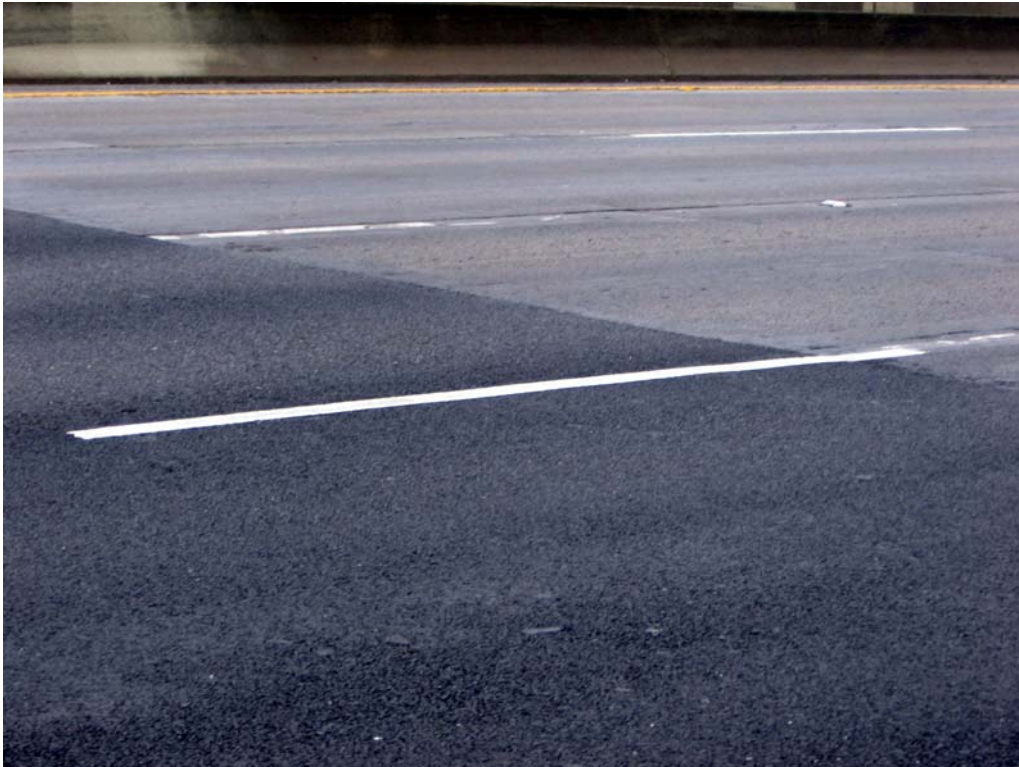
The end point of the condition survey was Station 61+00 northbound, where the open graded section ends. Figure 25 shows the end of the open graded section and the start of PCC section.

Figure 25. End of open graded section (northbound direction)
