**State Route 138 -Test Site Evaluation
Update of Evaluation Activities in March and October 2002**

Technical Memorandum No. TM-UC-PRC-2003-1

Pavement Research Center
Institute of Transportation Studies
University of California

April 2003

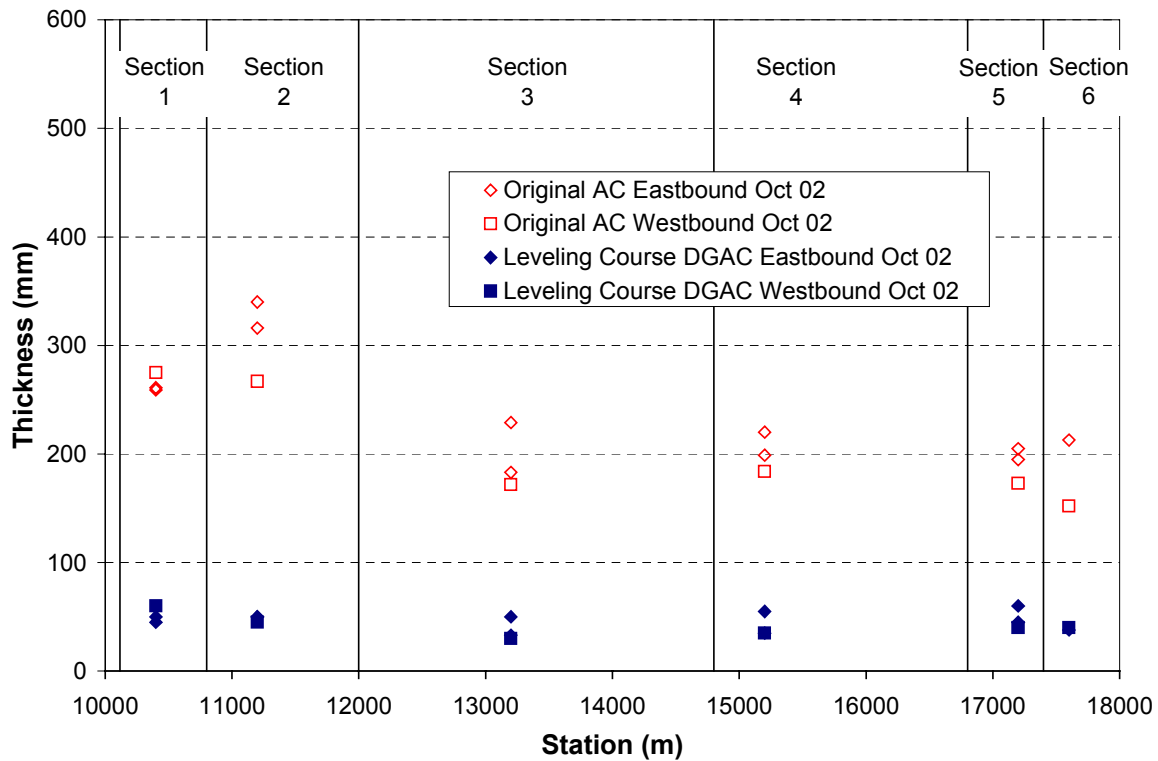
Figure 4. Thicknesses of asphalt concrete leveling course from October 2002 cores.

In October 2002, 11 cores were taken in the eastbound lane and 6 in the westbound lane. The total thickness of the asphalt concrete layers is shown in Figure 3, along with the total asphalt thickness from April 2001 and March 2002. The measured thicknesses of the leveling course from these cores is shown in Figure 4; the measured thicknesses of the treatments are shown in Figure 5. The results show that in addition to the highly variable thickness of the original asphalt concrete, the combined thickness of the leveling course and maintenance treatment is highly variable as well.

Photographs of the cores taken in October 2002 are shown in Appendix E. In addition to the variable thickness of the original asphalt concrete, the cores show that the leveling course had some variability in thickness and that the treatments were constructed at the design thickness or slightly thicker. All of the cores taken over the past year show that there is a pavement reinforcing fabric in some of the cores, approximately 150 mm below the surface of the original asphalt concrete. This fabric has typically broken the bond of the asphalt concrete layers between which it was laid.

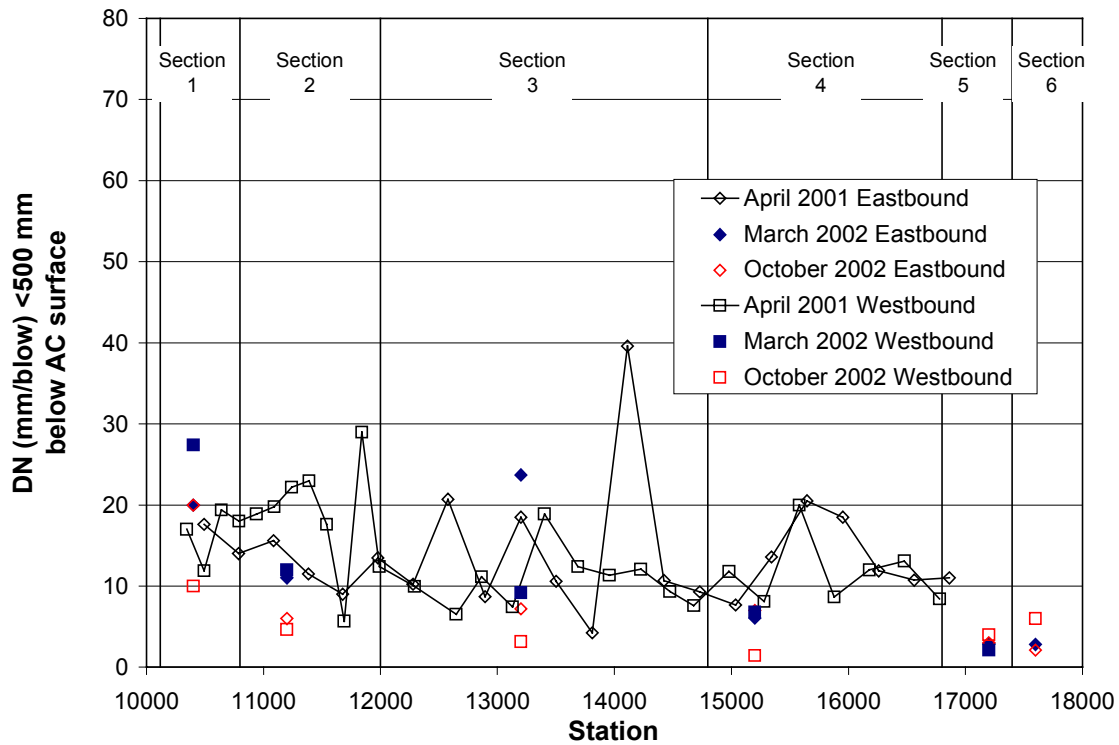
Figure 6. Layer 1 plot of DN versus station (all data from 2001 and 2002).

The DN (DCP number, or mm/blow) values are shown in Figures 6 and 7. The DN values are similar between March 2002 and April 2001, which is the end of the wet season at the project location. The DN values in Layer 2 from March, 2002 are somewhat less than those of April 2001, which is likely due to the smaller amount of rainfall in the spring of 2002. The DN values are lower (fewer mm/blow) in October, 2002 at the end of the dry season, which seems reasonable.

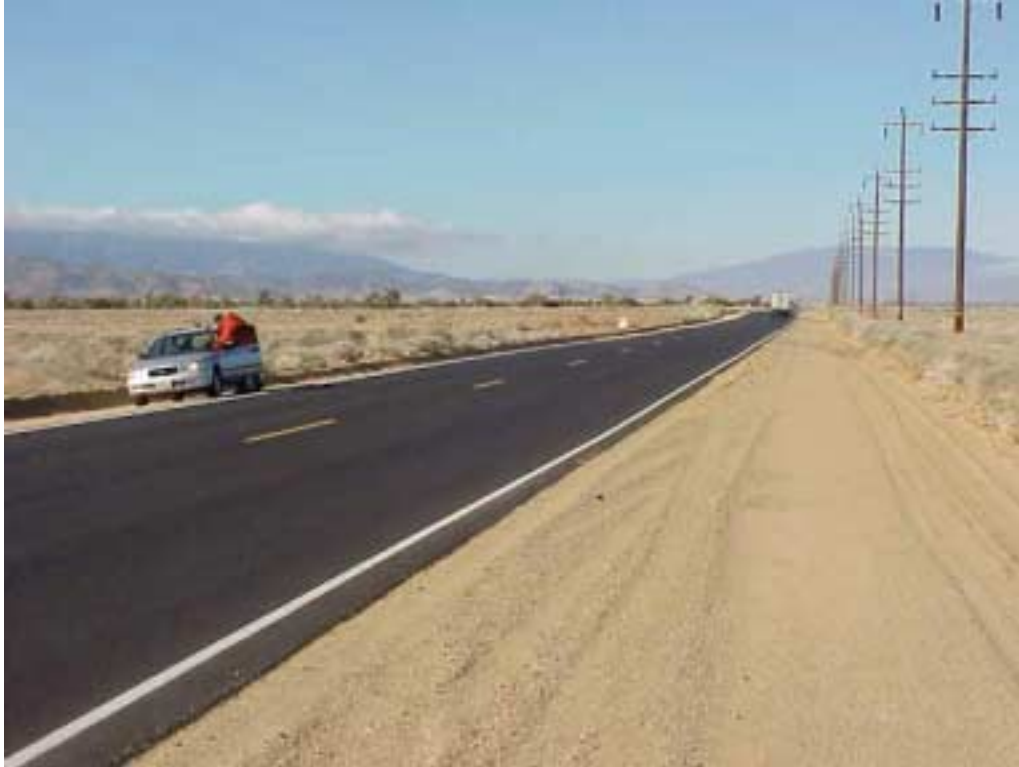
Figure B1. View eastward from about station 104+00

Photographs from March 2002 taken just after the overlay show that some of the distresses had already reflected up through the overlay (see Appendix B). In some of the photographs, the cracks are faintly visible in the overlay. In other areas, the areas of severe cracking to the point of loose pieces in the wheelpaths had caused the overlay to spall. The photographs also show some apparent segregation, which appears as longitudinal areas that have ravelled, and areas that appear to be over-asphalted.
