Warm-Mix Asphalt Study: Field Test Performance Evaluation

Author:
D. Jones

DOCUMENT RETRIEVAL PAGE		Technical Memorandum: UCPRC-TM-2013-08			
Title: Warm-Mix Asphalt Study: Field Test Performance Evaluation					
Authors: D. Jones					
Technical Leads: T. Joe Holland (Caltrans) and Nathan Gauff (CalRecycle)					
Prepared for: Caltrans and CalRecycle		FHWA No.: CA142385D	Work submitted: 04/05/2014		Date December 2013
Strategic Plan Element No: 4.18		Status: Final		Version No.: 1	
Abstract:					
<p>A number of warm-mix asphalt test sections were constructed in California between 2007 and 2010 to assess long-term performance under selected traffic and climate conditions. A range of pavement designs were assessed, but the six projects evaluated in this report focused on open-graded friction courses with polymer-modified (PG 58-34) and rubber-modified (PG 64-16) binders (three projects each). The main purpose of these experiments was to monitor performance under actual conditions and to quantify any benefits associated with using warm-mix asphalt under specific situations, such as with long hauls, in cool and/or damp conditions, under trafficking by large agricultural equipment, etc. F

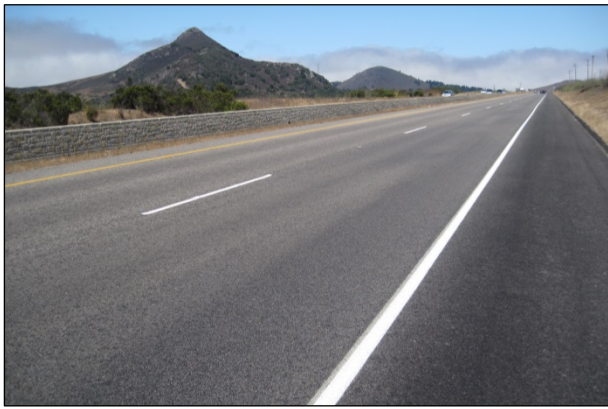
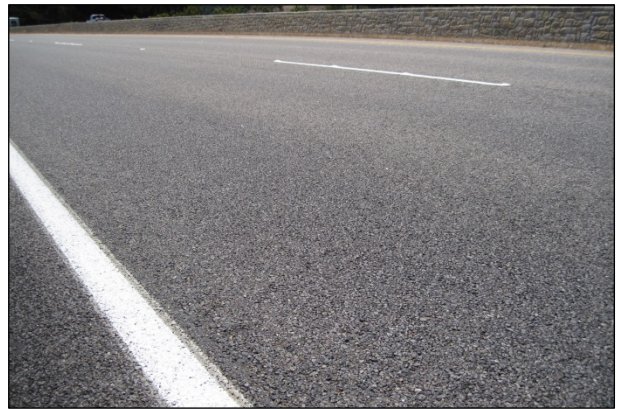
Figure 3.4: Morro Bay Control, June 2013 (73 months).

No deterioration compared to the May 2007 baseline measurements was noted on the sections after 73 months of traffic. Although the surface color of all sections was considerably lighter compared to new asphalt, the surface was still in very good condition and only minor stone loss, consistent with the age of the surface, was observed. Permeability through the open-graded friction course also remained effective on all sections (Figure 3.16).

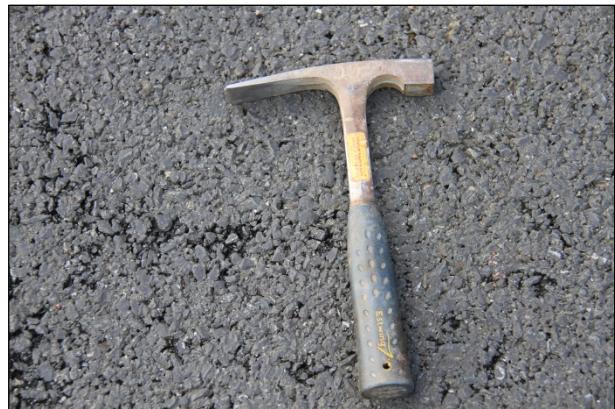
Figure 4.1: Point Arena Evotherm, December 2008 (3 months).

The Evotherm section resembled a typical open-graded friction course and was given an overall rating of “good.” No early stone loss was noted. Water was effectively draining through the friction course and out through the sides of the road. No other problems were observed.

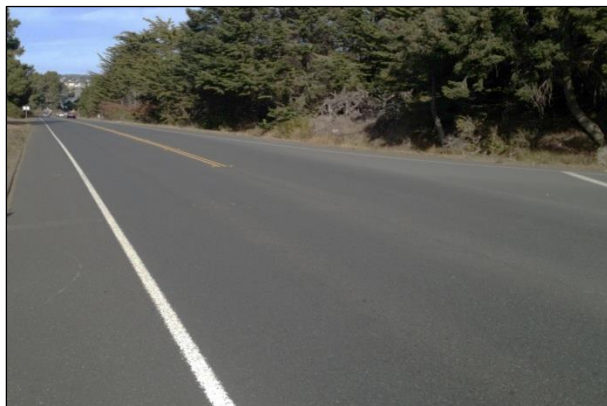
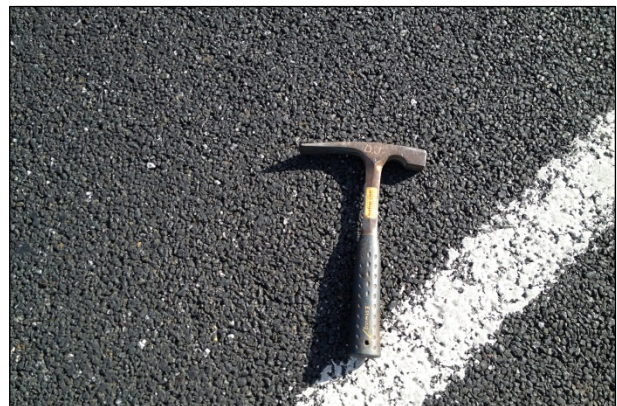
Figure 7.2: Mendocino Control, December 2013 (42 months).

No deterioration compared to the July 2010 baseline measurements was noted on the sections after 42 months of traffic. The raveling observed on the Advera section during the December 2012 visit had not deteriorated.
