**Causes of Failure of District 11 Asphalt Rubber Chip Seal  
11-Imp-86-PM 37.3/43.3 (EA 11-241101)**

**CALIFORNIA DEPARTMENT OF TRANSPORTATION**

**Technical Memorandum TM-UCD-PRC-2005-10**

July 7, 2005

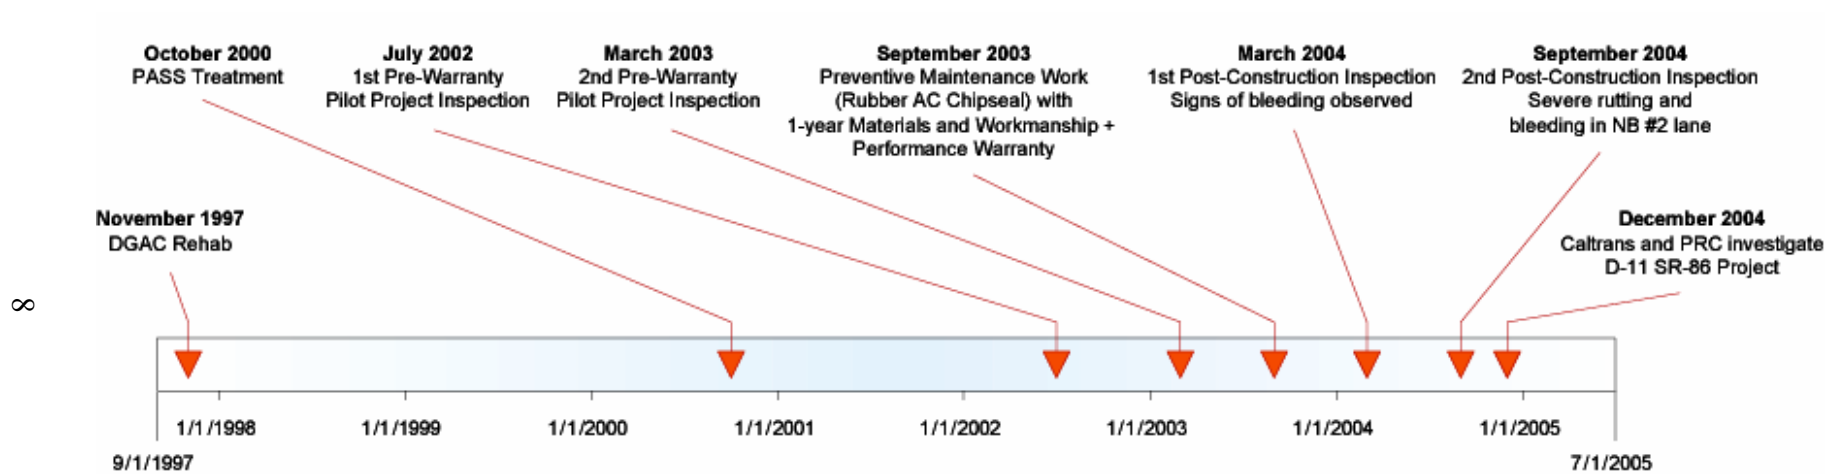
Figure 2. Timeline of project events for 11-Imp-86-PM 37.3/43.3

The project timeline begins in November 1997 with widening of the previously 2-lane SR-86 into a 4-lane divided highway. This project was part of a series of expansion projects on SR-86 to accommodate increases in freight and agricultural goods movement.(1-3) Two new southbound lanes throughout the project limits were constructed using portland cement concrete (PCC), which is typical for much of SR-86 in both directions south of the project limits. The original 2-lane highway became the two northbound lanes of SR-86 and a DGAC overlay was placed. No distress was noted prior to placing the overlay. A maintenance surface treatment (emulsion rejuvenator referred to as a PASS treatment) was applied in October 2000. Details about the PASS treatment were not available for assessment.

A chip seal was placed in September 2003 for preventive maintenance. There were no signs of distress during two chip seal pre-warranty pilot project inspections in mid-2002 and March 2003, though the surface was noted as appearing “dry” during the second inspection. Bleeding and minor rutting were first noticed and documented in the northbound #2 lane during

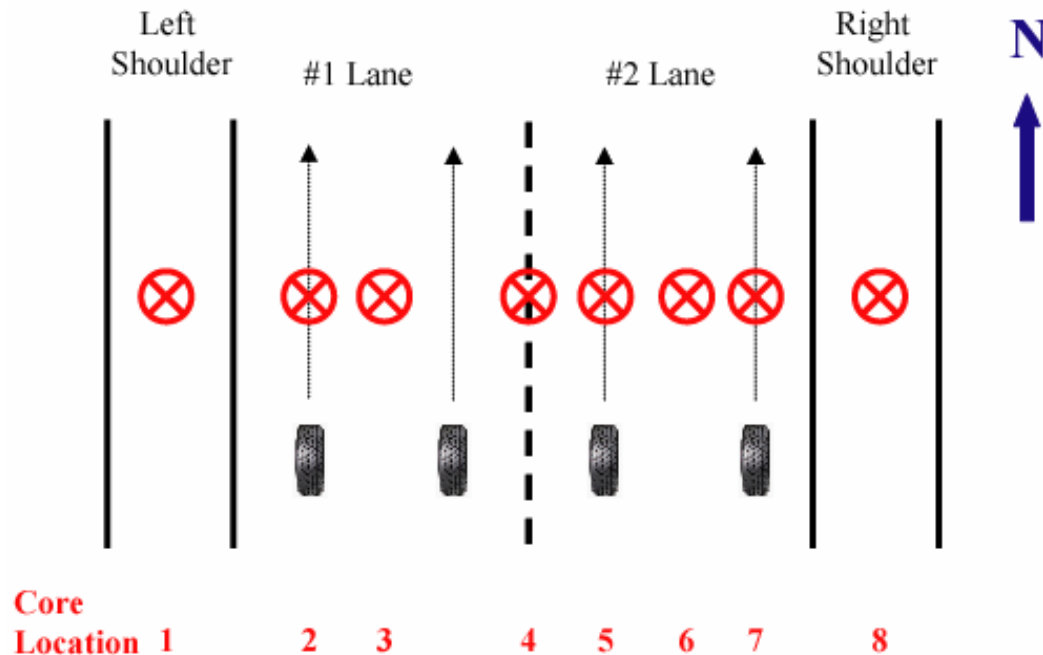
**Figure 11. District 11 coring pattern for SR-86.**

A total of 35 wet cores were collected at 9 different locations. Assessment of cores first involved measurement of chip seal thickness. Rut depths at coring locations also were measured. Digital photos documenting the appearance of all cores were taken and archived for future study. The surface of the cores taken between wheelpaths showed aggregate that appeared competent and well-embedded. The surface of cores from within wheelpaths showed aggregate that appeared abraded.

Chip seal thickness and rut depth measurements are presented in Table 1. Chip seal thickness was reasonably consistent for all coring locations and did not correlate with rut depths. Caltrans collected three of the 35 cores (not shown in Table 1) from Station 696, where no distress was observed and OGAC (no chip seal) had been placed. The chip seal was placed within 0.5 miles of the INS station and another OGAC layer was placed afterward. This is in the 1-mile long section where the Construction Engineer approved a CCO for the contractor to place OGAC to address the bleeding prior to the second post-construction review in September 2004.
