Quieter Pavement Research: Concrete Pavement Tire Noise

Work Conducted as Part of Partnered Pavement Research Center Strategic Plan Element No. 4.22:
Quiet Concrete Pavement Research

DOCUMENT RETRIEVAL PAGE		UCPRC Research Report No.: UCPRC-RR-2010-03			
Title: Quieter Pavement Research: Concrete Pavement Tire Noise					
Author: E. Kohler and J. Harvey					
Prepared for: California Department of Transportation, Division of Research and Innovation, Office of Roadway Research		FHWA No.: CA121200A	Date Work Submitted: August 20, 2010	Date: May 2010	
Strategic Plan Element No.: 4.22		Status: Stage 6, final version		Version No.: 1	
<p>Abstract: This research report presents the results of tire/pavement noise measurements performed on concrete pavements as a part of the California Department of Transportation (Caltrans) Quieter Pavement Research (QPR) study to investigate tire/pavement noise characteristics on concrete pavements and bridge decks.</p> <p>The study included a total of 120 pavement sections at 47 different sites on various state highways throughout California. Most of the sites (36) were divided into three sections each for measurement and evaluation of tire/pavement nois

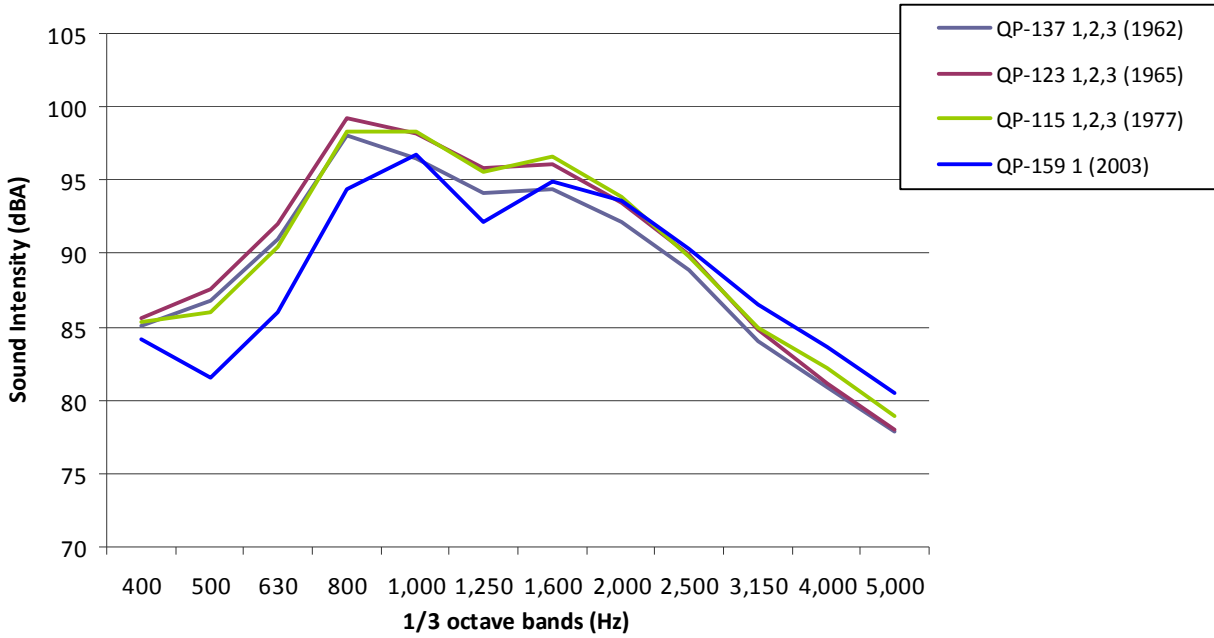
Figure 3.1: OBSI spectral content for burlap drag sections, texture *aged*.

There were no sections with burlap drag texture in the *new* texture category. The texture *aged* and texture *worn out* sections are shown in Figure 3.1 and Figure 3.2 respectively. A comparison of the average spectral content for the conditions is shown in Figure 3.3. For one-third octave band frequencies below 1,600 Hz, the spectra for the sections with the texture *worn out* have greater sound intensity levels than for *aged* texture sections.

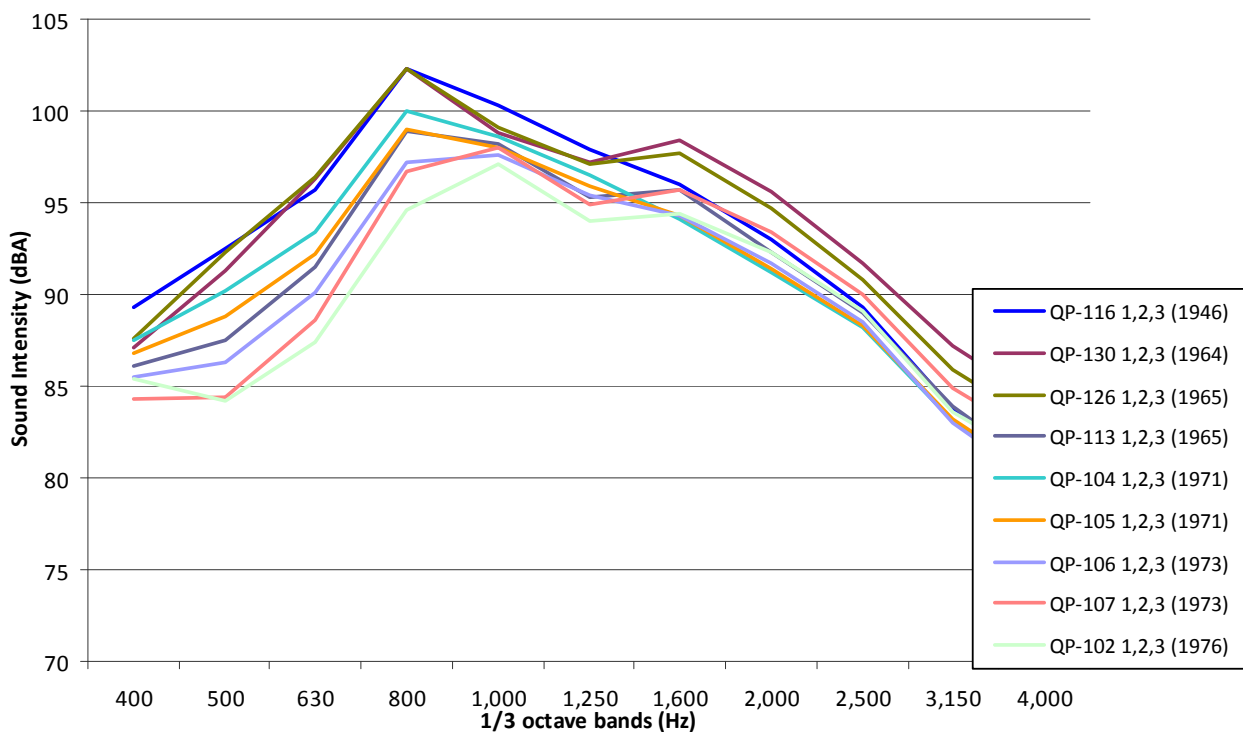
Figure 3.2: OBSI spectral content for burlap drag sections, texture *worn out*.

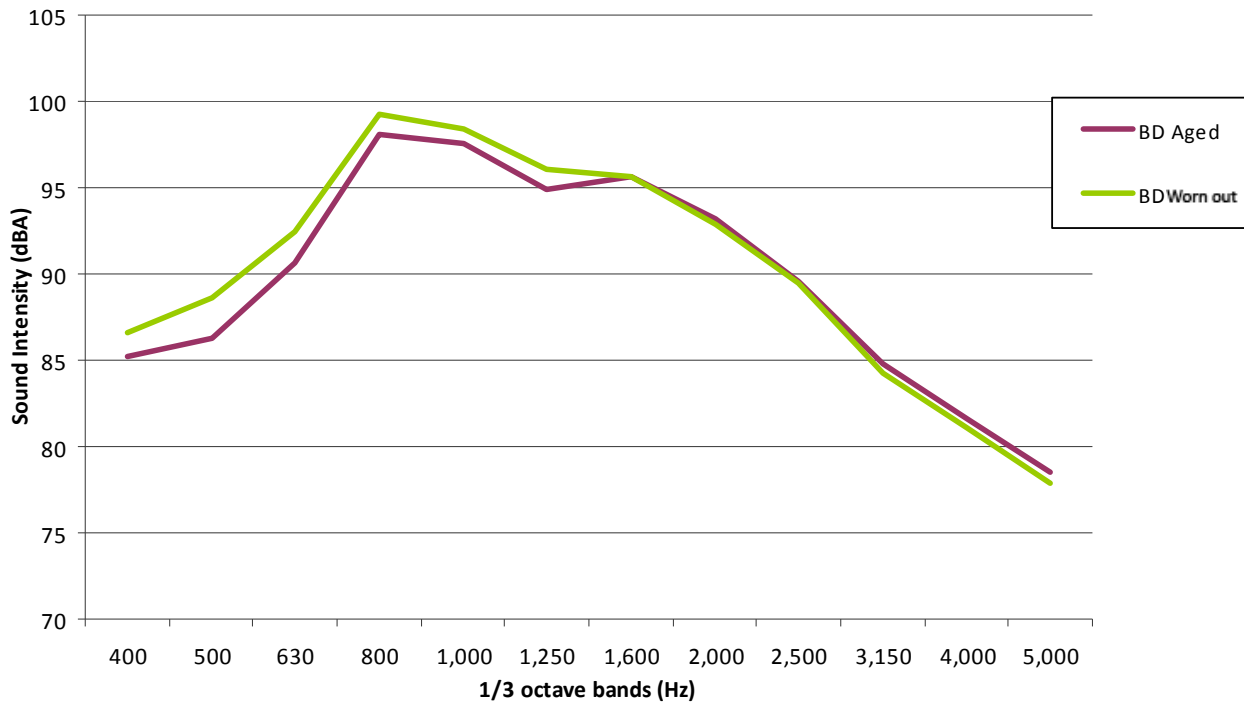
Figure 3.3: Comparison of average OBSI spectral content for burlap drag sections with texture in different conditions.

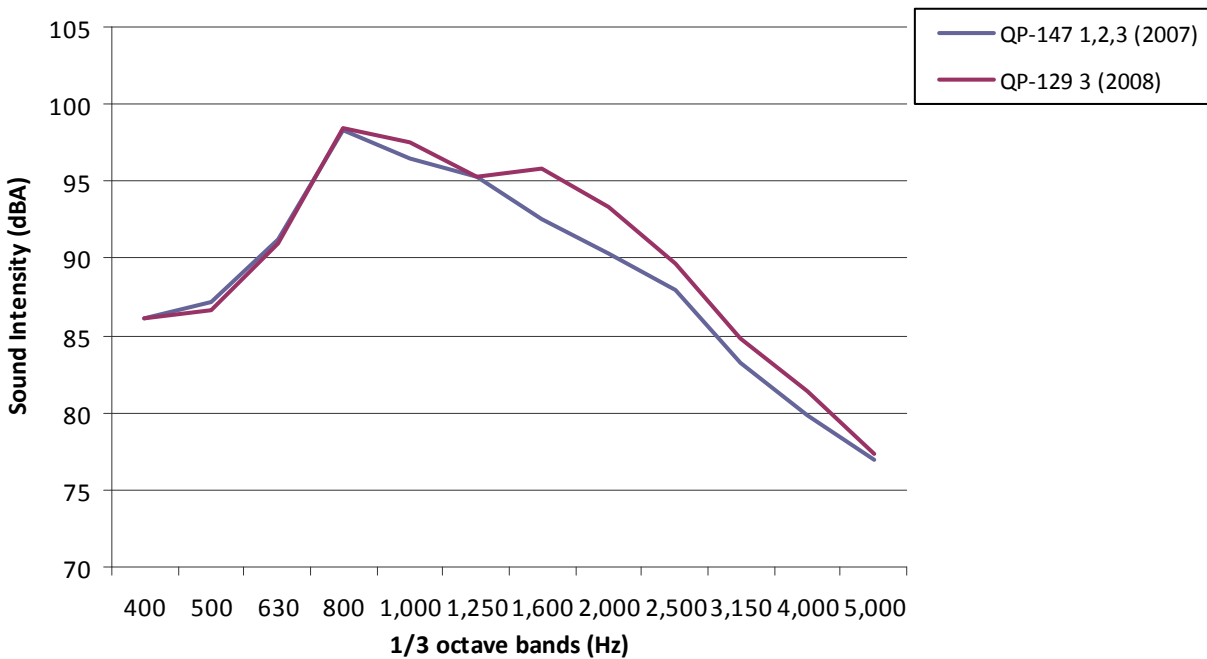
Figure 3.4: OBSI spectral content for diamond ground sections, texture *new*.

There were no diamond ground sections in the texture *worn out* category. The *new* texture and *aged* texture sections are shown in Figure 3.4 and Figure 3.5 respectively. A comparison of the average spectral content for the two texture conditions is shown in Figure 3.6. The comparison shows almost no difference between the *new* and the *aged* textures, on average. Differences within each texture condition category are greater than differences between the average spectra for each category.

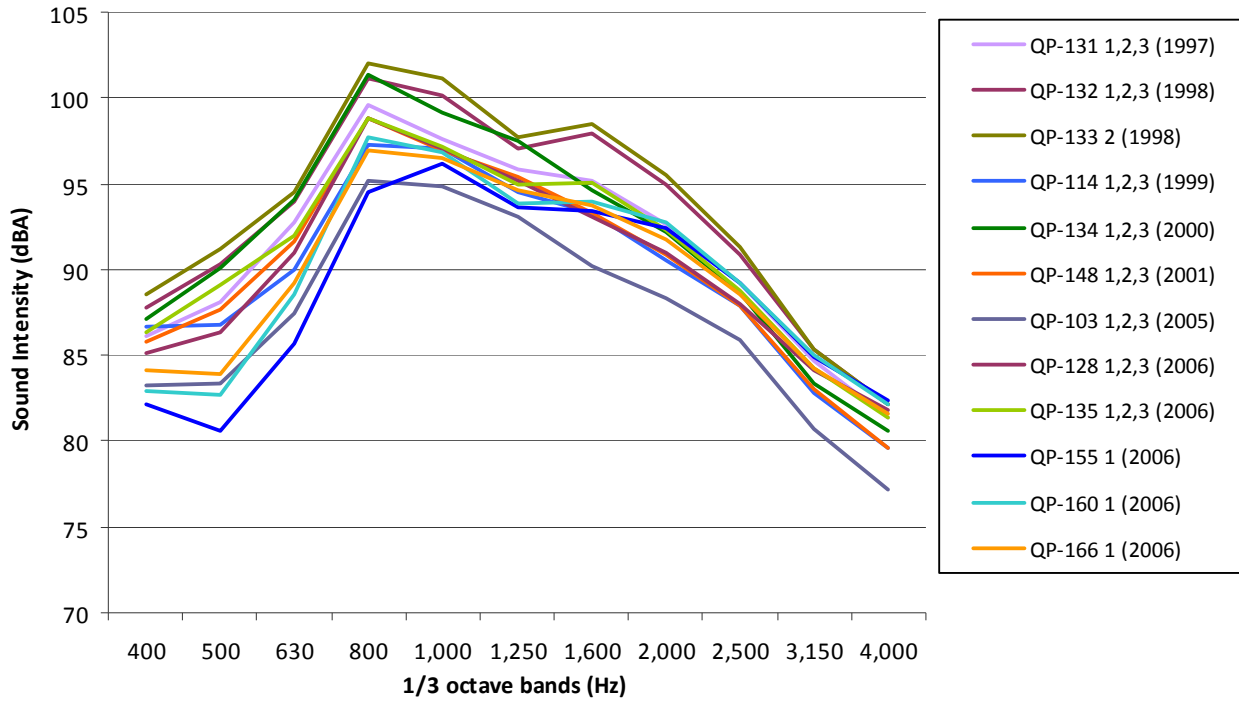
Figure 3.5: OBSI spectral content for diamond ground sections, texture aged.

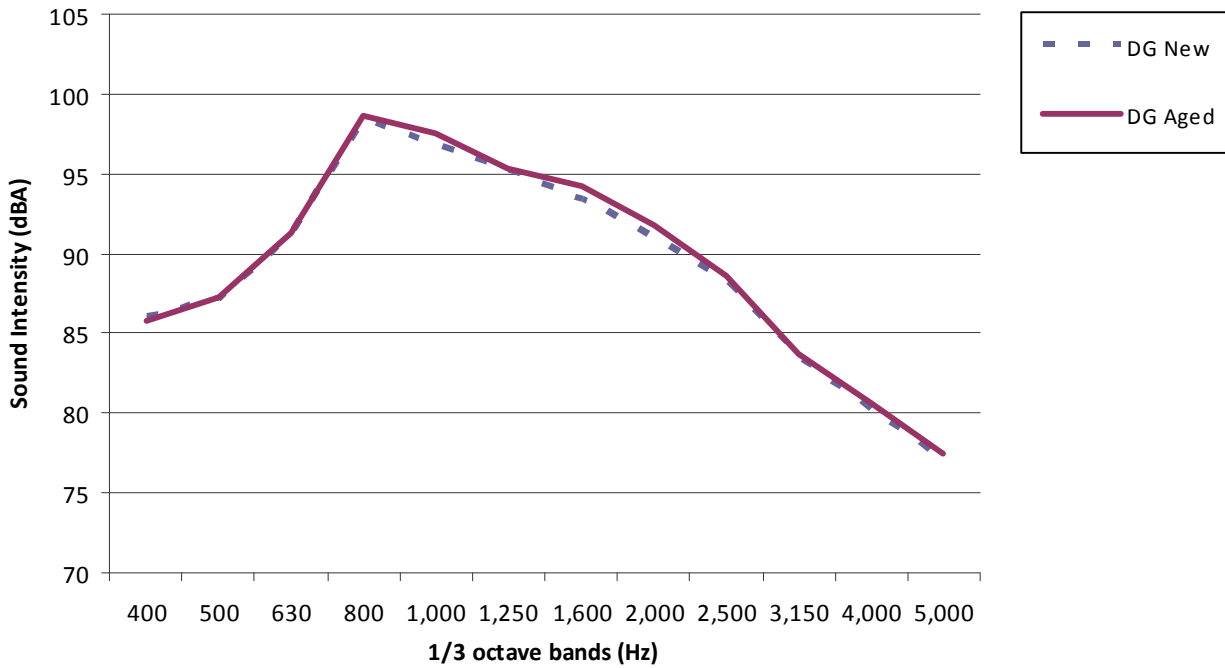
Figure 3.6: Comparison of OBSI spectral content for diamond ground sections with texture in different conditions.

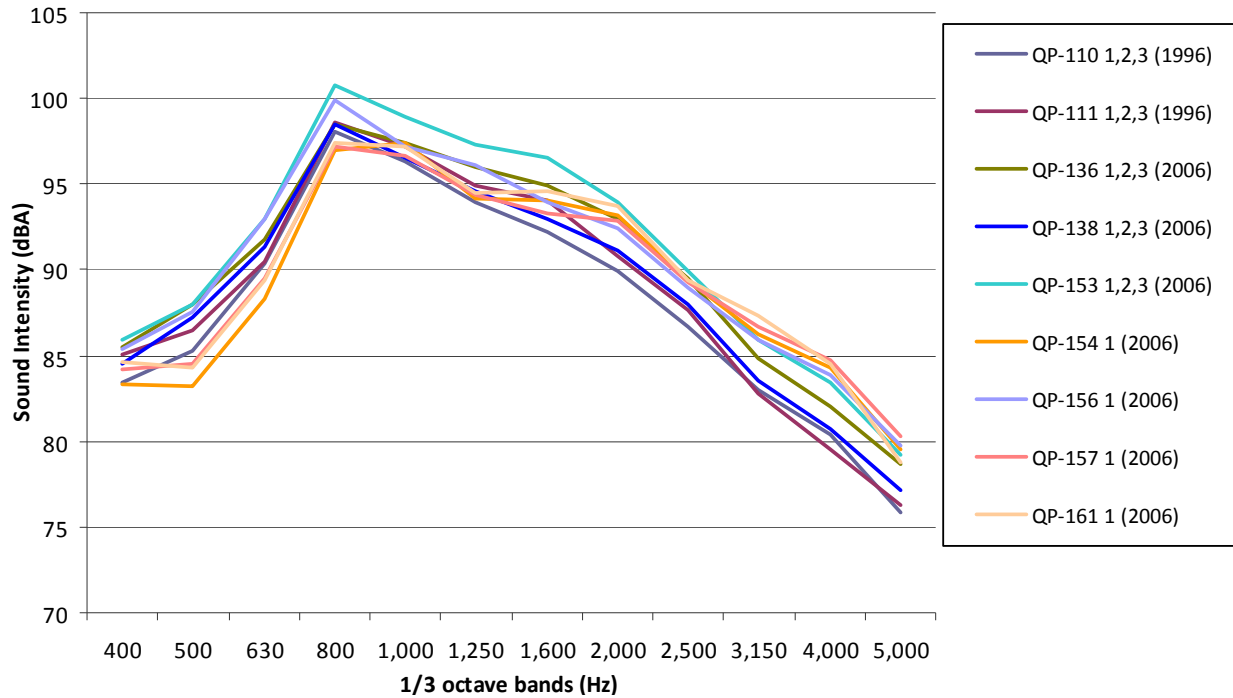
Figure 3.7: OBSI spectral content for diamond grooved sections, texture *aged*.

All diamond grooved sections fall in the *aged* texture category, so comparison against other conditions is not possible. Figure 3.7 shows the results at each site, while Figure 3.8 presents the average of all sites. There is a range of 4 to 5 dB(A) for every frequency within the *aged* texture category. The older sections, built in 1996, appear to have lower OBSI levels for frequencies of 2,000 Hz and higher frequencies, and to have OBSI levels in the middle of the range of the other sections built in 2006 for frequencies below 2,000 Hz.

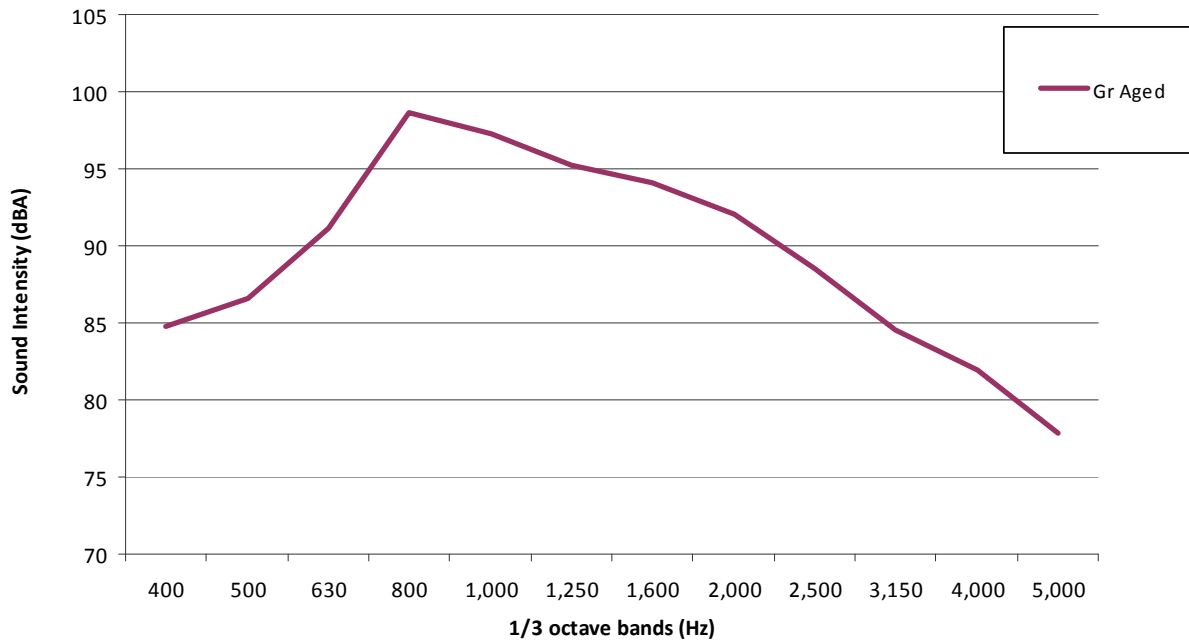
Figure 3.8: Average of OBSI spectral content for diamond grooved sections.

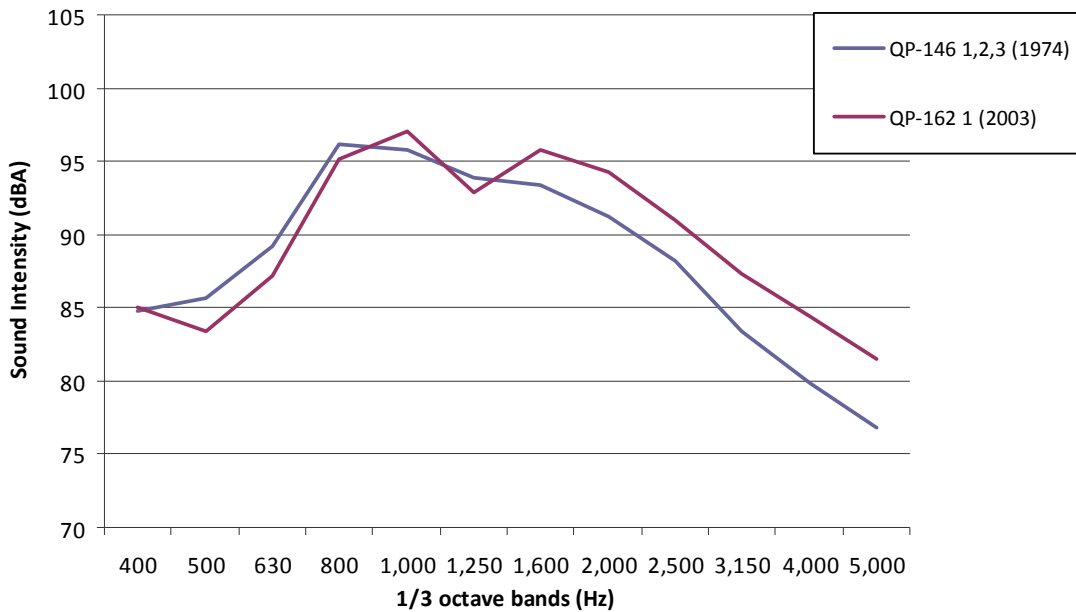
Figure 3.9: OBSI spectral content for longitudinally broomed sections, texture *aged*.

There were no sections with longitudinally broomed texture in the *new* texture category. The texture *aged* and texture *worn out* sections are shown in Figure 3.9 and Figure 3.10 respectively. A comparison of the average spectral content for the two texture conditions is shown in Figure 3.11. It can be seen that there is not much difference between the two texture conditions. Differences within each texture condition category are greater than the differences between the average spectra for each category.

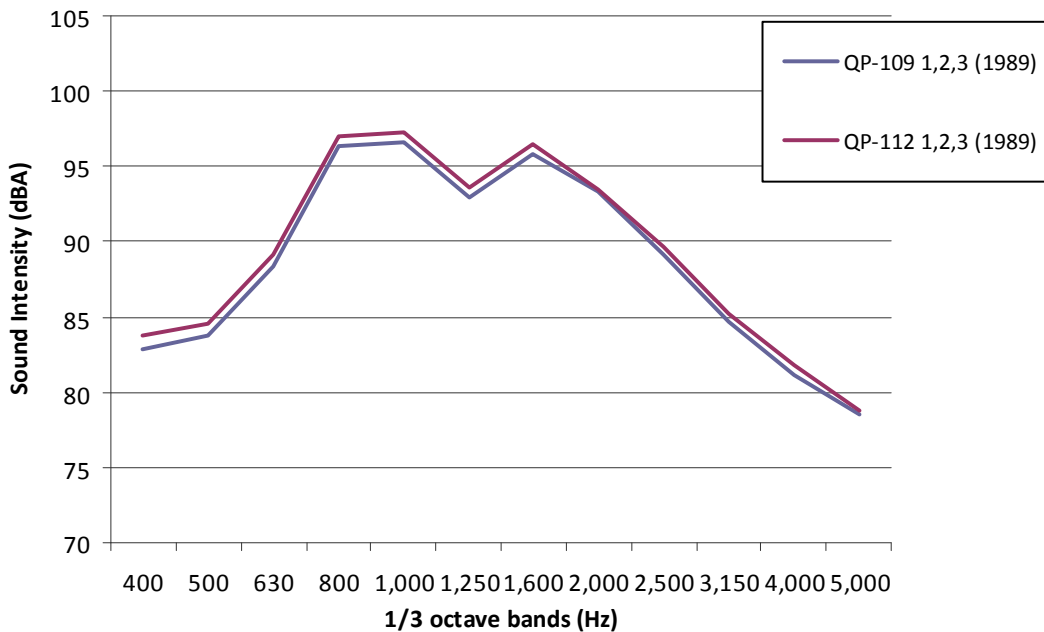
Figure 3.10: OBSI spectral content for longitudinally broomed sections, texture *worn out*.

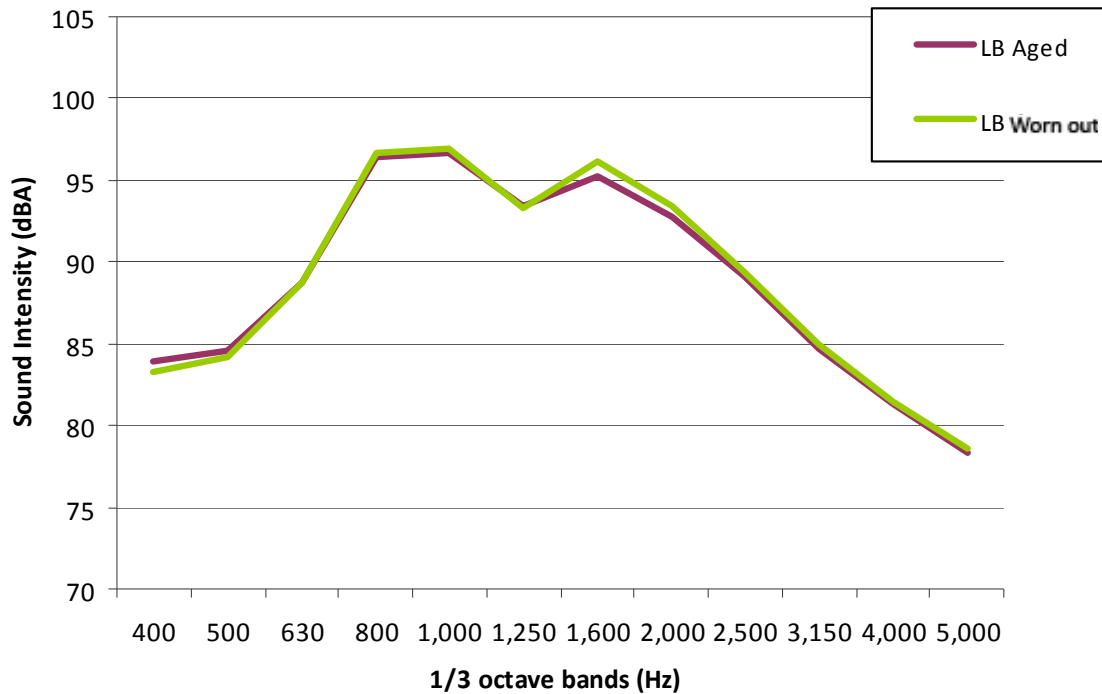
Figure 3.11: Comparison of OBSI spectral content for longitudinally broomed sections with texture in different conditions.

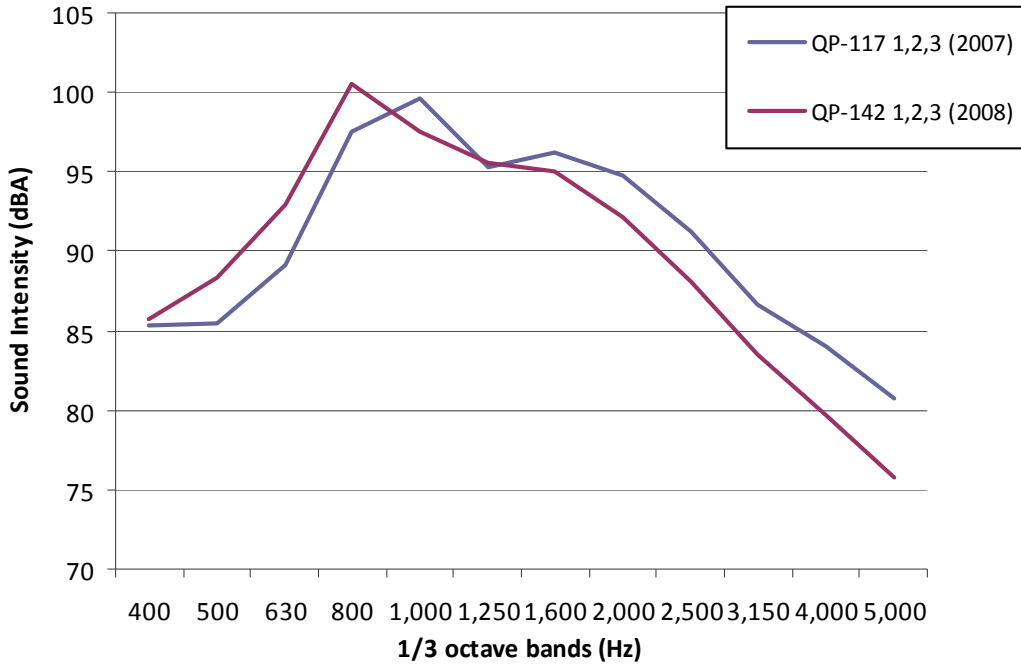
Figure 3.12: OBSI spectral content for longitudinally tined sections, texture *new*.

This is the only texture type with sections found in the three texture conditions. Sections with longitudinally tined texture in the texture *new*, texture *aged*, and texture *worn out* categories are presented in Figure 3.12, Figure 3.13, and Figure 3.14 respectively. The second year results from Section 142 were excluded from the analysis because of extensive damage to the pavement surface caused by truck chain wear. A comparison of the average spectral content for the conditions is shown in Figure 3.15. The average spectra for the three conditions are very similar, with the primary differences being that the OBSI level for the very low frequencies increases after the first year, and that OBSI increases some for the 1,250 Hz frequency as the texture ages. Differences within each texture condition category are greater than differences between the average spectra for each category.

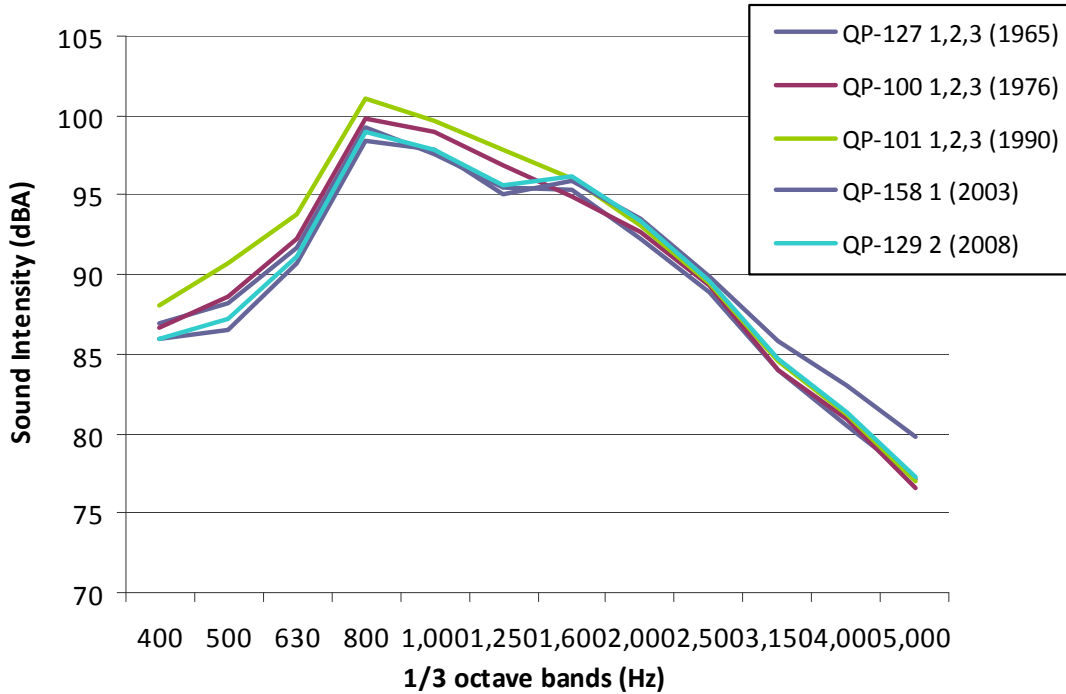
Figure 3.13: OBSI spectral content for longitudinally tined sections, texture *aged*.

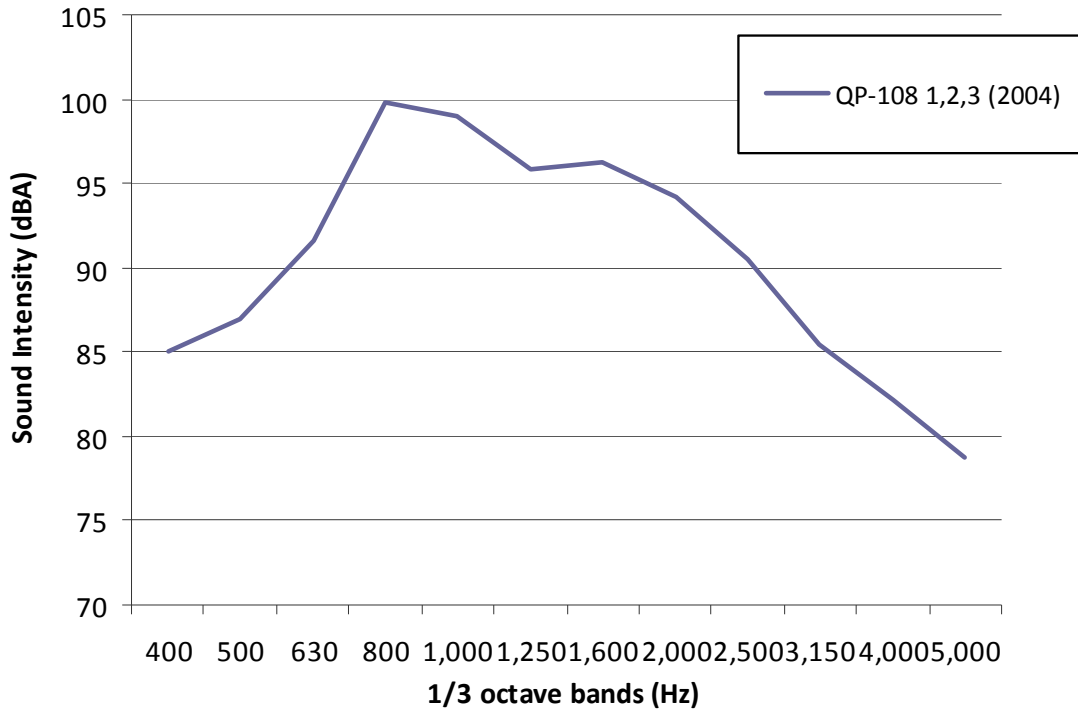
Figure 3.14: OBSI spectral content for longitudinally tined sections, texture *worn out*.

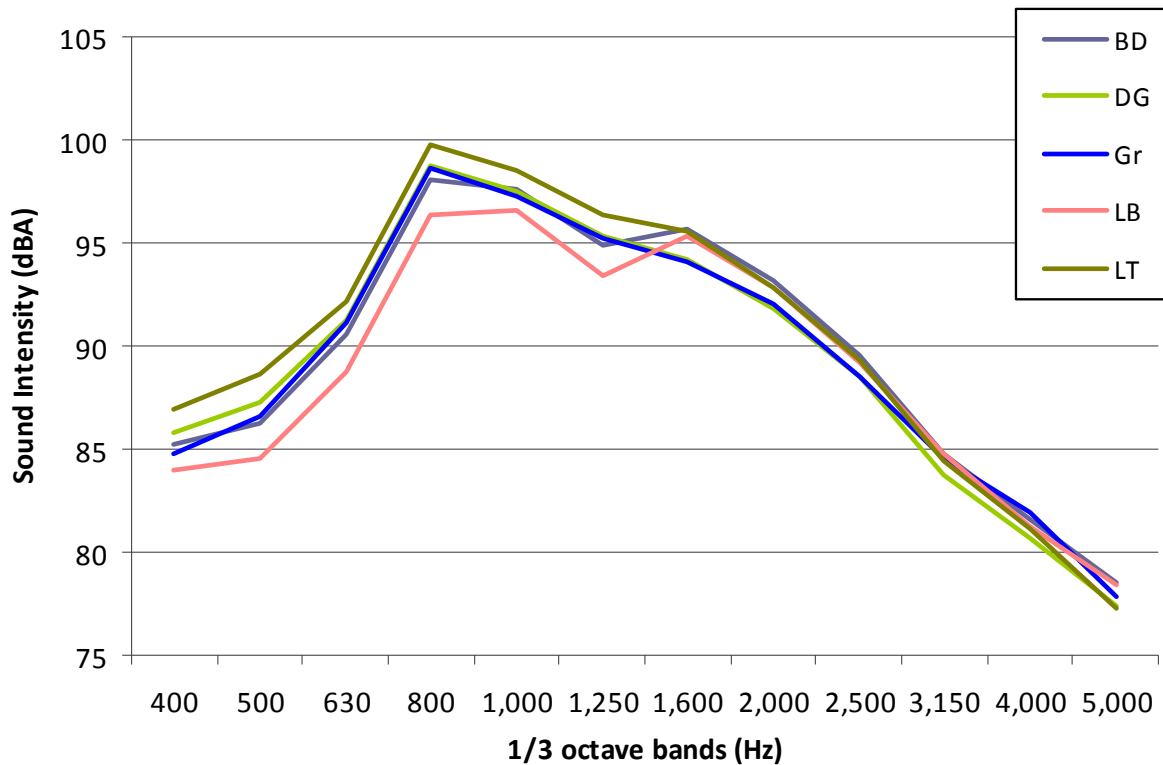
Figure 3.16: Comparison of OBSI spectral content of sections with different texture types, average of all sections of a texture type.

(Note: BD = burlap drag, DG=diamond ground, Gr=diamond grooved, LB=longitudinally broomed, LT=longitudinally tined.)

To begin the examination of the noise characteristics of concrete pavement surface textures in more detail, Figure 3.16 presents the one-third octave sound intensity levels, using the average for each texture type and including textures of all three conditions. The longitudinally broomed texture has markedly lower levels at frequencies below 1,250 Hz. The other surface types are difficult to distinguish from each other in terms of average OBSI spectra. Given that once the texture of a surface has disappeared, it is no longer considered to be designed, and it is more appropriate to consider only those sections with *aged* texture, as presented in Figure 3.17.

The average spectra for all texture types and conditions was shown previously in Figure 3.16. The minimum and maximum spectra values for the one-third octaves are shown for all sections with aged texture in Figure 3.19 and Figure 3.20, respectively.

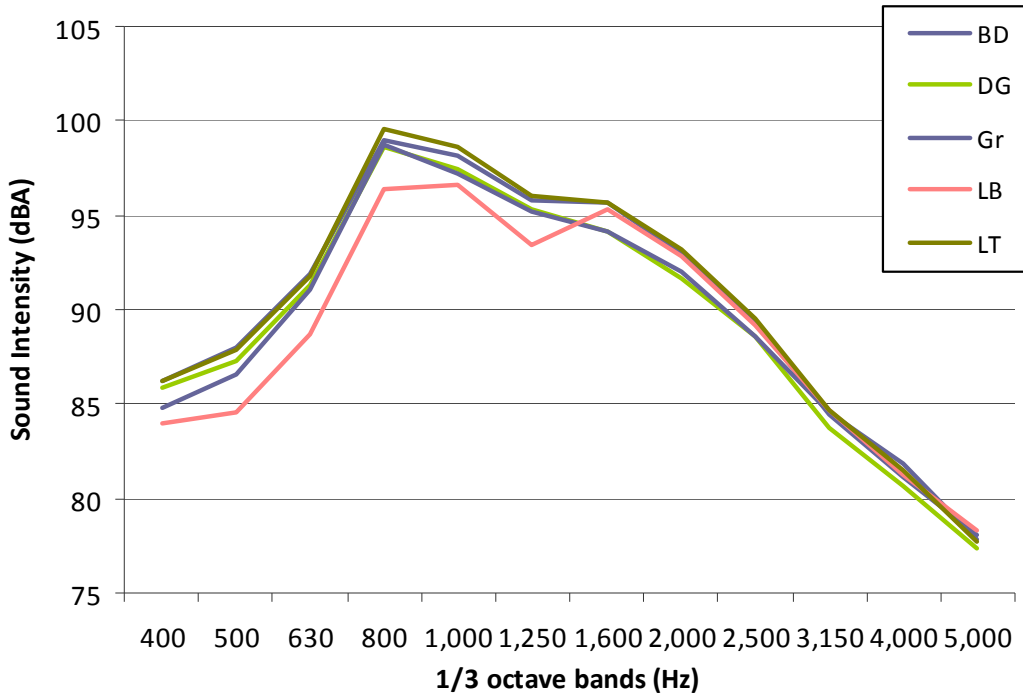
Figure 3.17: Comparison of OBSI spectral content of sections with different texture types, average of sections with texture aged.
 (Note: BD = burlap drag, DG=diamond ground, Gr=diamond grooved, LB=longitudinally broomed, LT=longitudinally tined.)

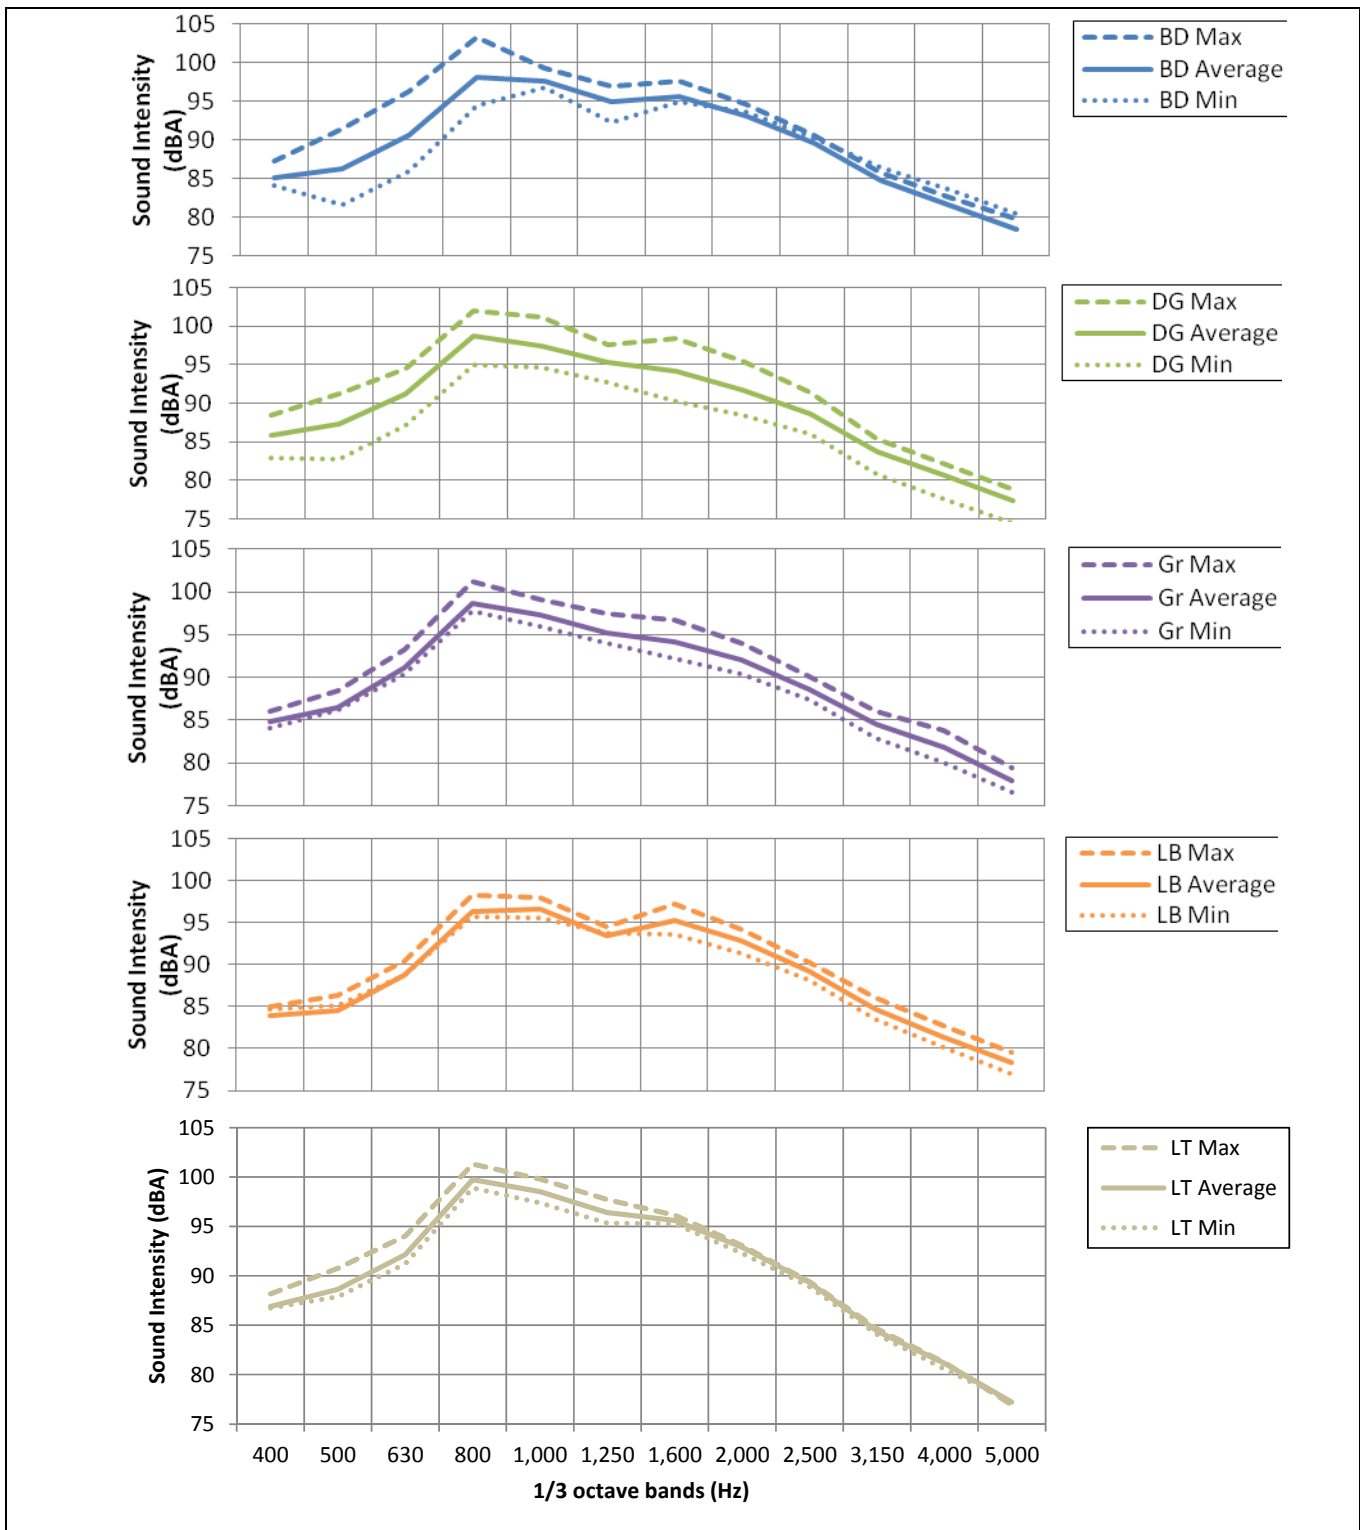
Figure 3.18: Comparison of OBSI spectral content of sections of different texture type (only texture aged).

Because an average spectrum is just a mathematical construction of a fictitious average section, it is convenient to include in the plots the actual spectra for the sections with the highest and lowest OBSI (of the *aged* texture category). This is presented in Figure 3.18.

The results of Figure 3.18 are presented again in Table 3.1, along with the average overall OBSI for the *aged* texture category for each texture type.

Between DG and BD the analysis is as follows: the Max spectra and the Average spectra are similar for the two texture types. At 1,250 Hz, the BD is lower than at the adjacent 1 kHz and 1.6 kHz frequency bands. Below 800 Hz the Min spectra are similar for BD and DG. At 1,000 Hz the BD texture minimum noise level is higher than the DG, but they are similar again at 1,250 Hz. Above 1,600 Hz the BD texture minimum spectrum is similar to the average levels, whereas the Min DG spectrum remains considerably lower than the average spectrum.

The mechanism that increases the loudness of BD texture occurs at low frequencies because above 1,600 Hz the Min, the Average, and the Max spectra are all similar. The mechanism that increases the loudness of DG texture involves the entire spectrum.

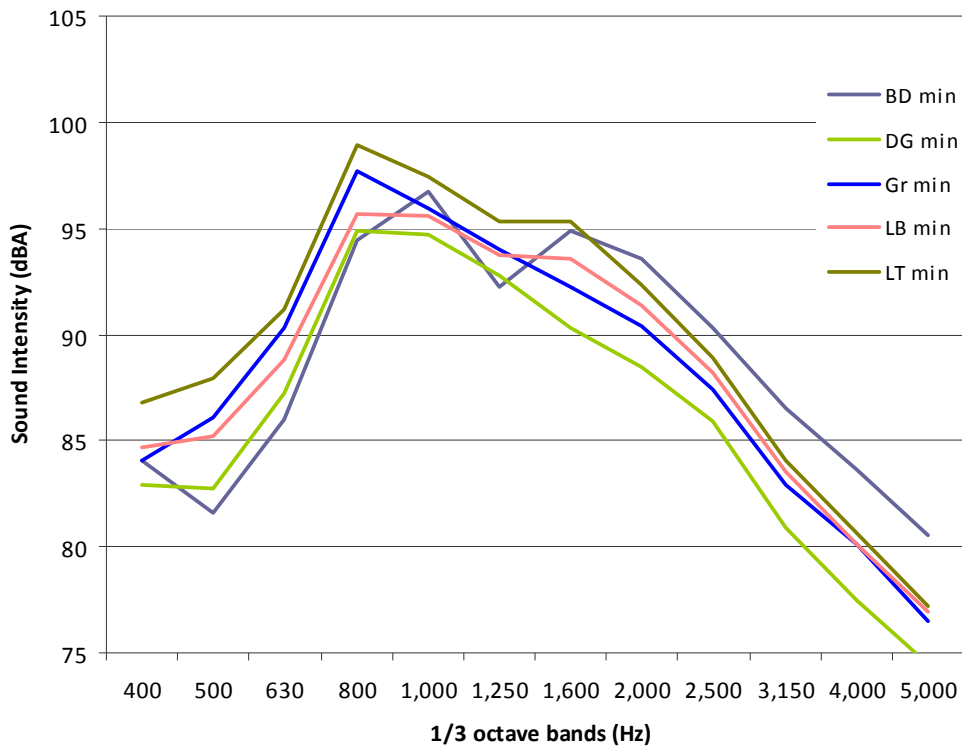
Figure 3.19: Comparison of OBSI spectral content of sections with different texture types, minimum of sections with aged texture.

(Note: BD = burlap drag, DG=diamond ground, Gr=diamond grooved, LB=longitudinally broomed, LT=longitudinally tined.)

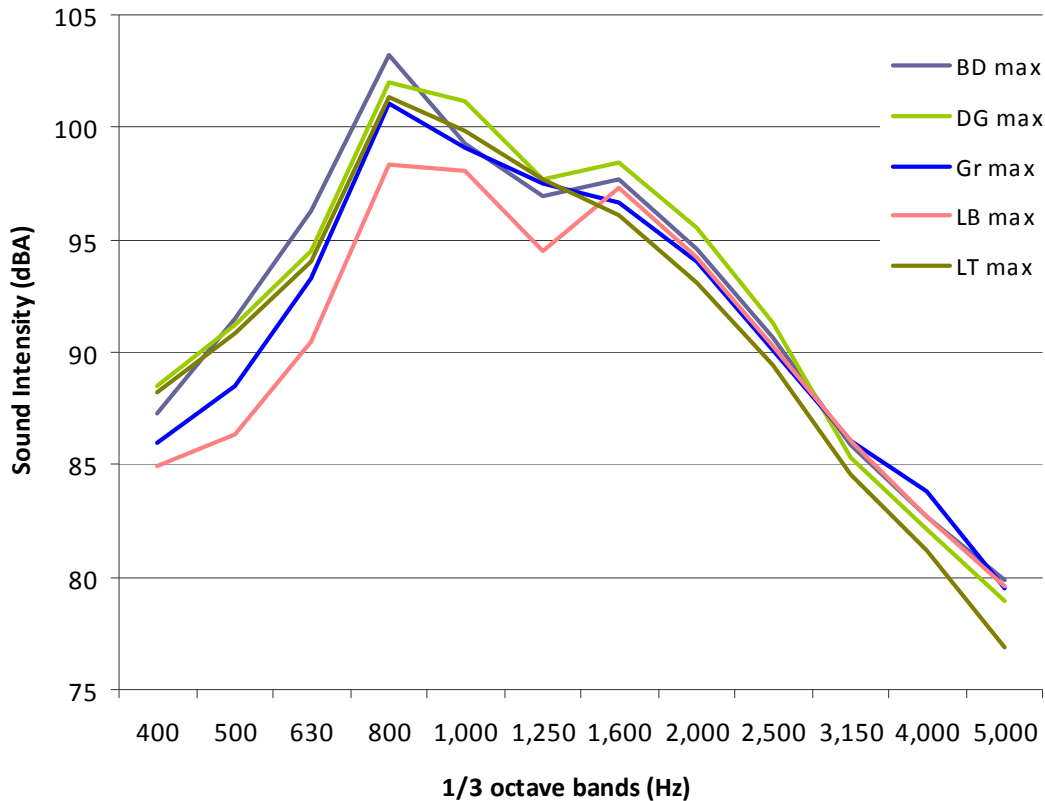
Figure 3.20: Comparison of OBSI spectral content of sections with different texture types, maximum of sections with texture aged.
 (Note: BD = burlap drag, DG=diamond ground, Gr=diamond grooved, LB=longitudinally broomed, LT=longitudinally tined.)

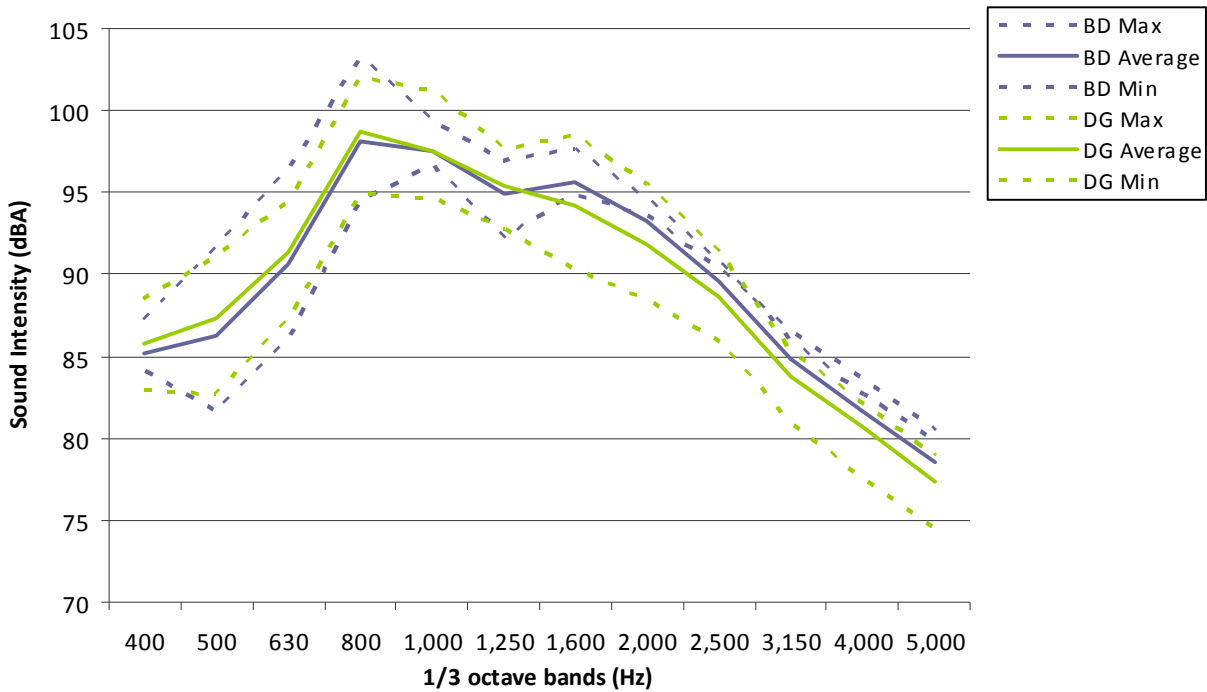
Figure 3.21: Comparison of OBSI spectral content of diamond ground (DG) and burlap drag (BD), texture *aged* sections.

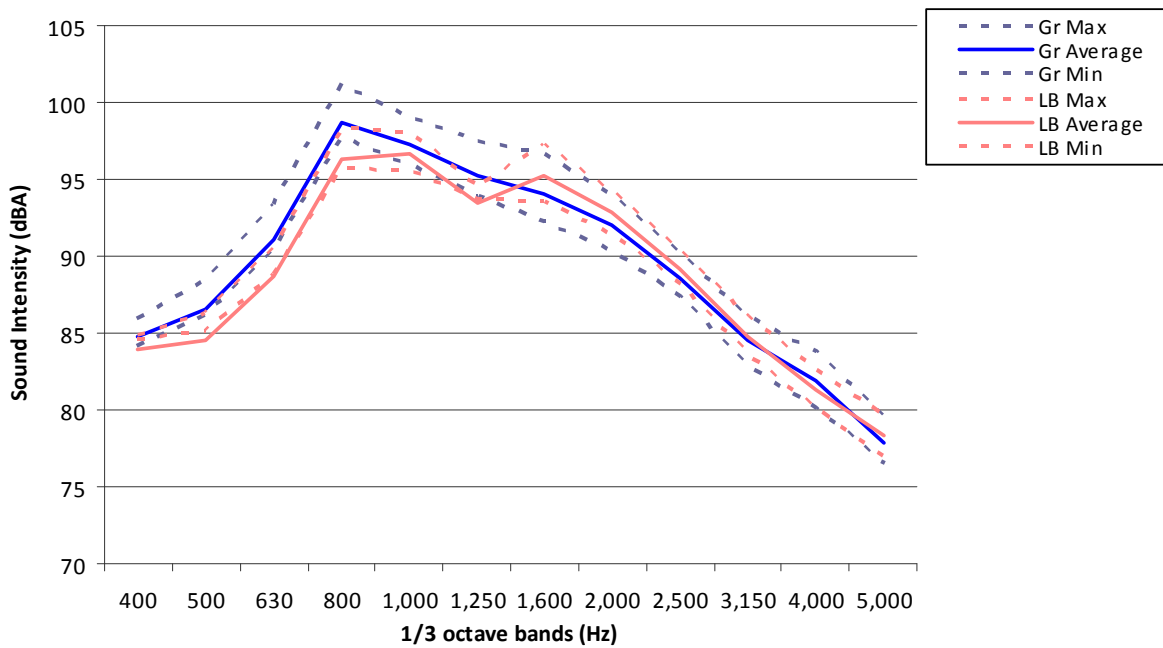
Figure 3.22: Comparison of OBSI spectral content of longitudinally broomed (LB) and diamond grooved (Gr), texture *aged* sections.

Between LB and Gr the analysis is as follows: The Max spectrum is higher for Gr than LB below 1,600 Hz. The Average spectrum is higher for Gr than LB below 1,250 Hz. The LB Average spectrum shows intensities at 800 Hz and 1,000 Hz very similar to those for Gr. The Min LB spectrum is lower than the Average LB spectrum only at the 1,600 and 2,000 Hz bands. The Max and Average LB spectra show markedly lower intensities at 800, 1,000, and 1,250 Hz compared to the Gr spectra, which are the primary contributors to overall sound intensity.

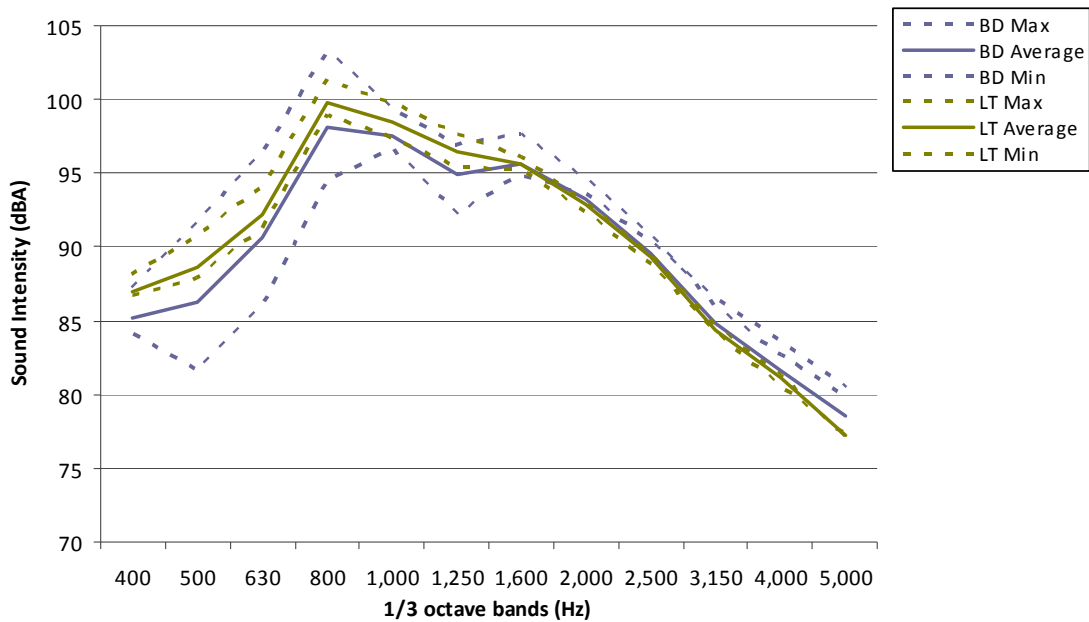
Figure 3.23: Comparison of OBSI spectral content of longitudinally timed (LT) and burlap drag (BD) sections.

Between LT and BD the analysis is as follows: The LT spectrum is very similar for the Max, the Average, and the Min curves for both textures at frequencies higher than 1,600 Hz, with the differences in the low frequencies. In these low frequencies the BD texture is quieter than the LT texture for the Average and the Min curves.

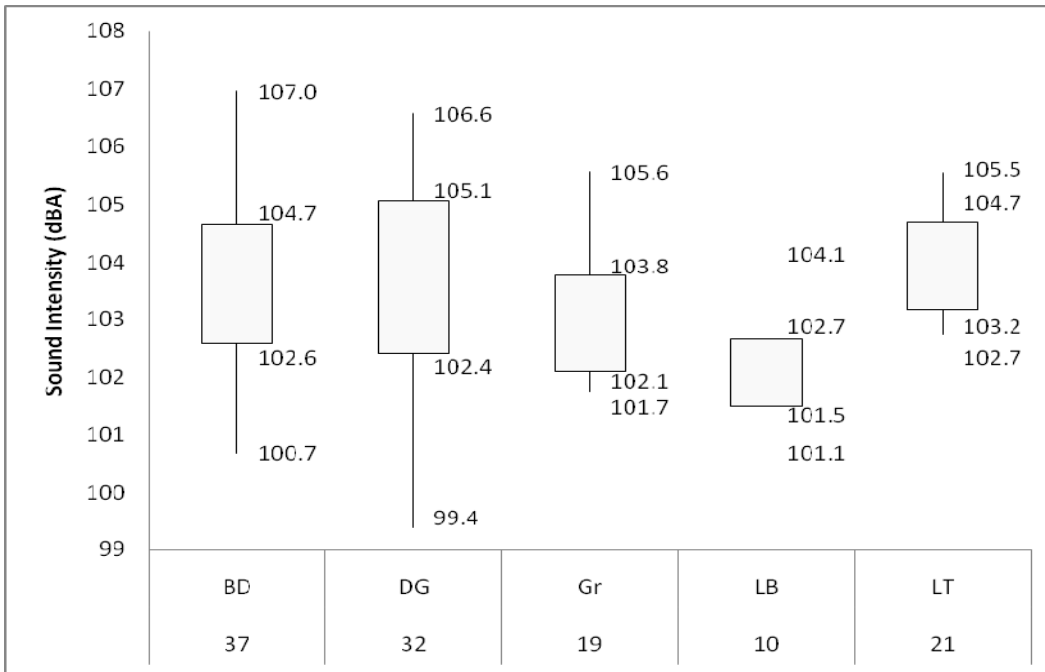
Figure 3.24: Box plots of OBSI results by texture type, Year 1.

(Notes: BD = burlap drag, DG=diamond ground, Gr=diamond grooved, LB=longitudinally broomed, LT=longitudinally tined; number of observations in sample shown below texture type.)

The box plots in Figure 3.24 through Figure 3.26 show the OBSI level by texture type respectively for the data set corresponding to Year 1, Year 2, and the combined Year 1 and Year 2 data. The values shown in the box plots are the minimum and the maximum, and the 1st and 3rd quartiles.

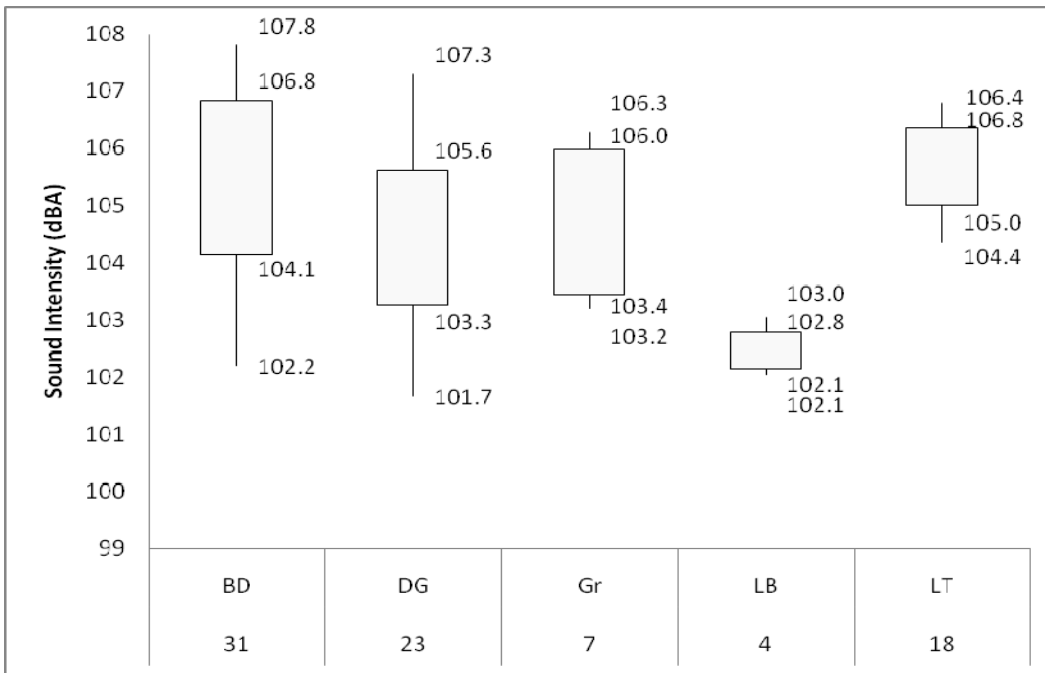
Figure 3.25: Box plots of OBSI results by texture type, Year 2.

(Notes: BD = burlap drag, DG=diamond ground, Gr=diamond grooved, LB=longitudinally broomed, LT=longitudinally tined; number of observations in sample shown below texture type.)
