Quieter Pavement Research: Concrete Pavement Tire Noise

Work Conducted as Part of Partnered Pavement Research Center Strategic Plan Element No. 4.22:
Quiet Concrete Pavement Research

DOCUMENT RETRIEVAL PAGE		UCPRC Research Report No.: UCPRC-RR-2010-03			
Title: Quieter Pavement Research: Concrete Pavement Tire Noise					
Author: E. Kohler and J. Harvey					
Prepared for: California Department of Transportation, Division of Research and Innovation, Office of Roadway Research		FHWA No.: CA121200A	Date Work Submitted: August 20, 2010	Date: May 2010	
Strategic Plan Element No.: 4.22		Status: Stage 6, final version		Version No.: 1	
<p>Abstract: This research report presents the results of tire/pavement noise measurements performed on concrete pavements as a part of the California Department of Transportation (Caltrans) Quieter Pavement Research (QPR) study to investigate tire/pavement noise characteristics on concrete pavements and bridge decks.</p> <p>The study included a total of 120 pavement sections at 47 different sites on various state highways throughout California. Most of the sites (36) were divided into three sections each for measurement and evaluation of tire/pavement nois

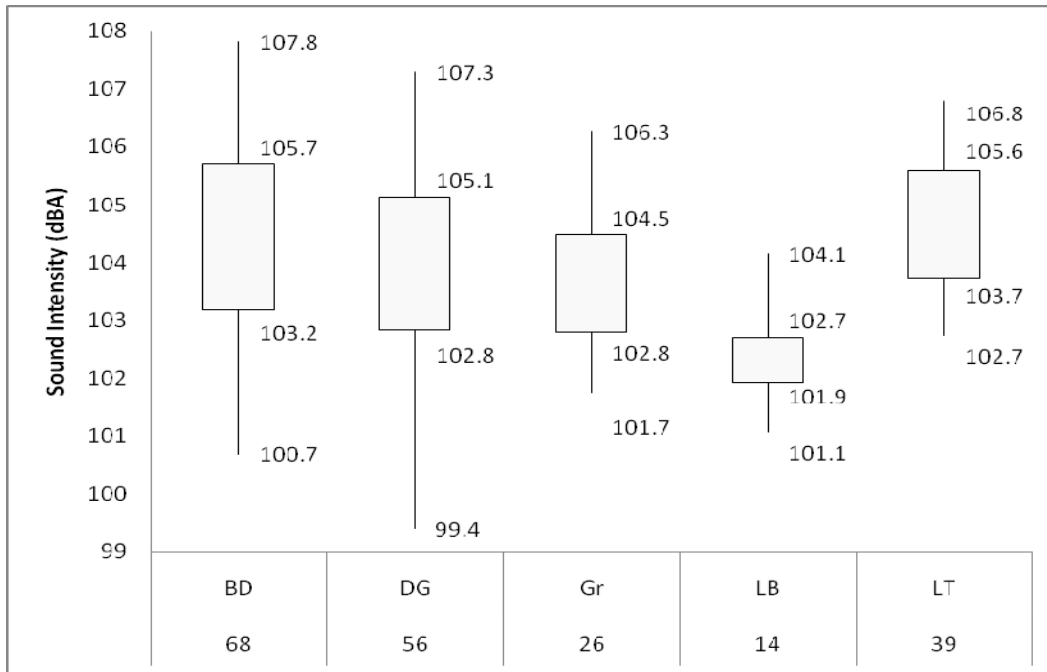
Figure 3.26: Box plots of OBSI results by texture type, Years 1 and 2 combined.
 (Notes: BD = burlap drag, DG=diamond ground, Gr=diamond grooved, LB=longitudinally broomed, LT=longitudinally tined; number of observations in sample shown below texture type.)

The box plots in Figure 3.24 through Figure 3.26 show the OBSI level by texture type respectively for the data set corresponding to Year 1, Year 2, and the combined Year 1 and Year 2 data. The values shown in the box plots are the minimum and the maximum, and the 1st and 3rd quartiles.

The quietest texture type, when considering the mean of the OBSI results of all sections with the same nominal surface type with all texture conditions (*new, aged and worn out*) and combining Year 1 and Year 2 data, was found to be the longitudinally broomed (LB), although this conclusion must be treated with some caution because of the smaller sample size for this texture type. The longitudinally broomed group presented a mean OBSI level of 102.3 dB(A) based on 14 measurements obtained by combining the two years of results on 10 sections located at four different sites (Table 2.5). Next, the diamond grooved and diamond ground texture types showed values similar to each other in terms of mean OBSI level—103.6 and 103.8 dB(A), respectively—and are therefore ranked as the second quietest. The value for diamond ground sections is the result of 56 measurements on 32 sections located at 14 sites, and for diamond grooved it is the result of 26 measurements on 19 sections located at 9 different sites. Burlap drag and longitudinally tined surfaces had mean OBSI levels of 104.5 and 104.8 dB(A), respectively. There were 42 measurements on 21 longitudinally tined sections located at eight different sites, and 68 measurements for burlap drag on 37 sections at 13 sites.

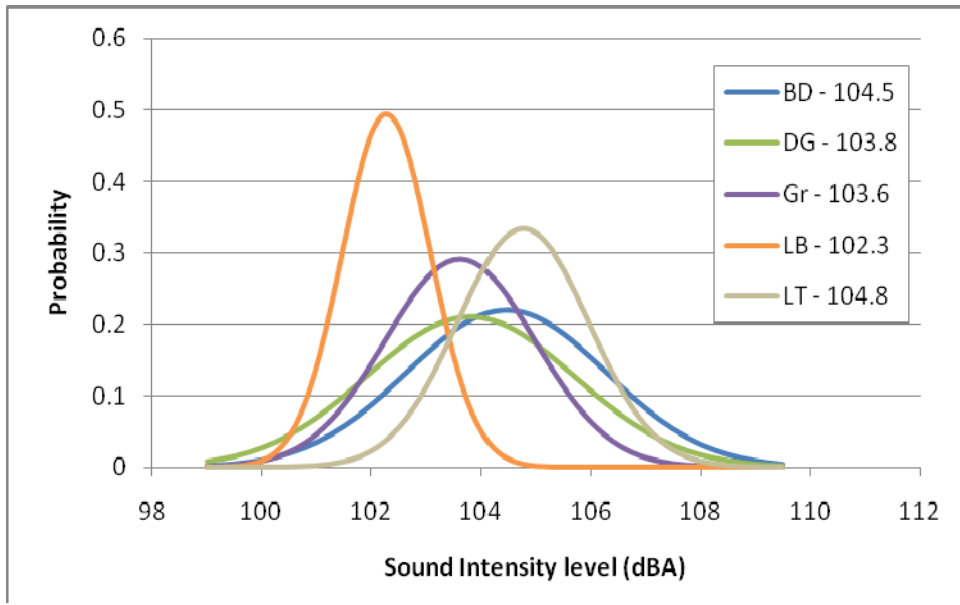
Figure 3.28: Normal distribution curves of OBSI results by texture type, all sections.
 (Notes: BD=burlap drag, DG=diamond ground, Gr=diamond grooved, LB=longitudinally broomed, LT=longitudinally tined; sample sizes for LB and Gr are smaller than for other textures.)

Figure 3.27 shows a box plot of overall OBSI for each texture type for the *new* and *aged* textures, with those sections with *worn out* textures removed. Figure 3.28 shows the normal distribution curves of OBSI results by texture type, all sections. Figure 3.29 shows the normal distribution curves of OBSI results by texture for the *new* and *aged* textures, with the *worn out* textures removed.

Table 3.3 for the combined data from Year 1 and Year 2, and for each texture type. The resulting charts are presented in Figure 3.28 including all sections and in Figure 3.29 excluding sections with the texture *worn out* condition. The legend includes the mean OBSI level in dB(A) next to the texture-type abbreviation.

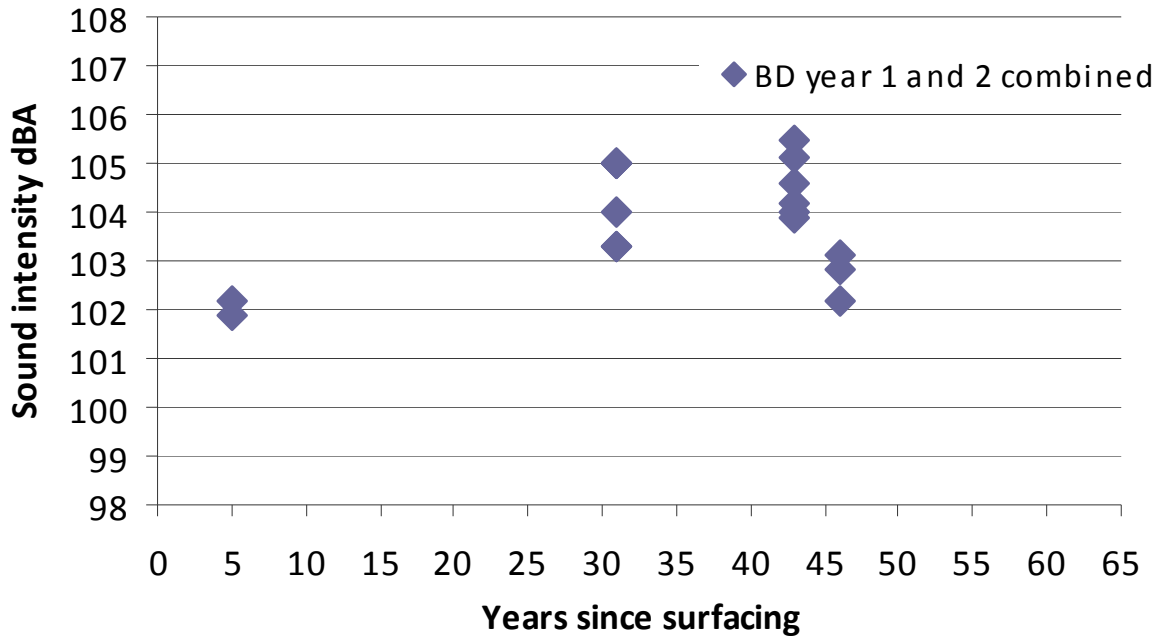
Figure 3.31: Year 1 and Year 2 OBSI values for all burlap drag sections versus years since last surfacing.

Figure 3.30 shows OBSI results for the burlap drag sections. The vast majority of the burlap drag sections were built in the 1960s and 1970s. The only “young” section, which was about six years old at the time of testing, is QP-159.1 at the Mojave Bypass. The oldest sections, which were 62 years old, are on Interstate 80 in Solano County (QP-116.1, QP-116.2, and QP-116.3). Older sections have higher OBSI levels. Figure 3.31 shows all texture conditions for the burlap drag sections plotted versus the number of years since they were last surfaced, including all Year 1 and Year 2 measurements.

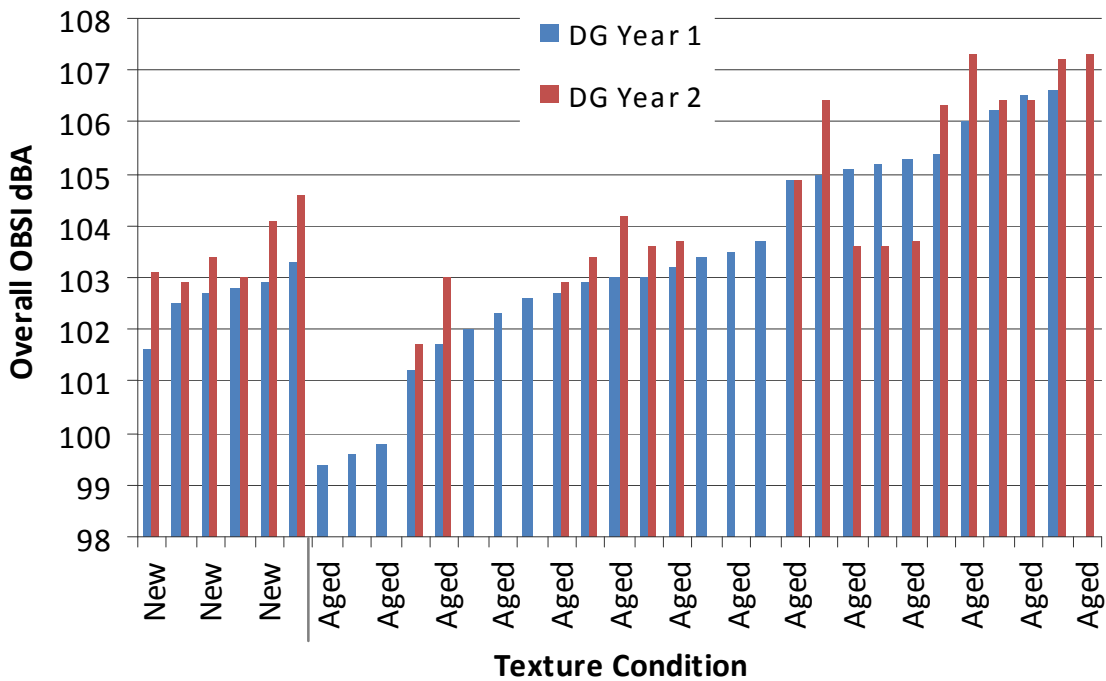
Figure 3.32: Year 1 and Year 2 OBSI values for all diamond ground sections.

Figure 3.32 shows OBSI results for the diamond ground sections. The oldest sections evaluated were 11 years old at the time of testing. It seems again that older sections have higher OBSI levels. Figure 3.33 shows all texture conditions for the diamond ground sections plotted versus the number of years since they were last surfaced, including all Year 1 and Year 2 measurements.

Figure E.5: Compare with Figure 3.32: Diamond ground Year 1 and Year 2 results for all texture conditions (*new, aged, and worn out*).

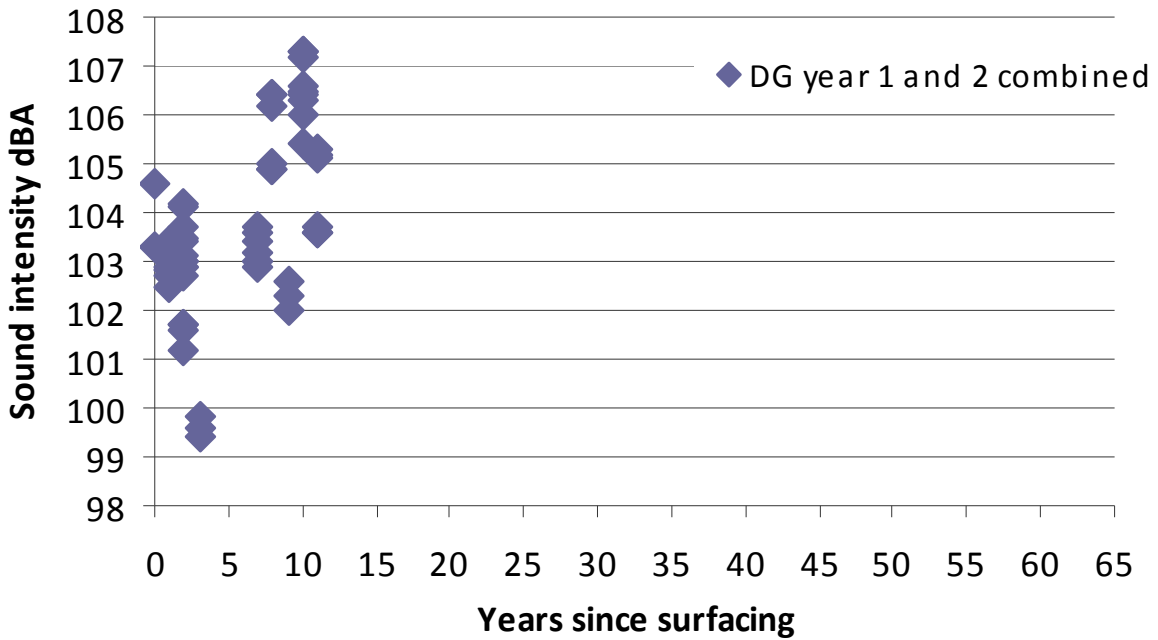
Figure 3.33: Year 1 and Year 2 OBSI values for all diamond ground sections versus years since last surfacing.

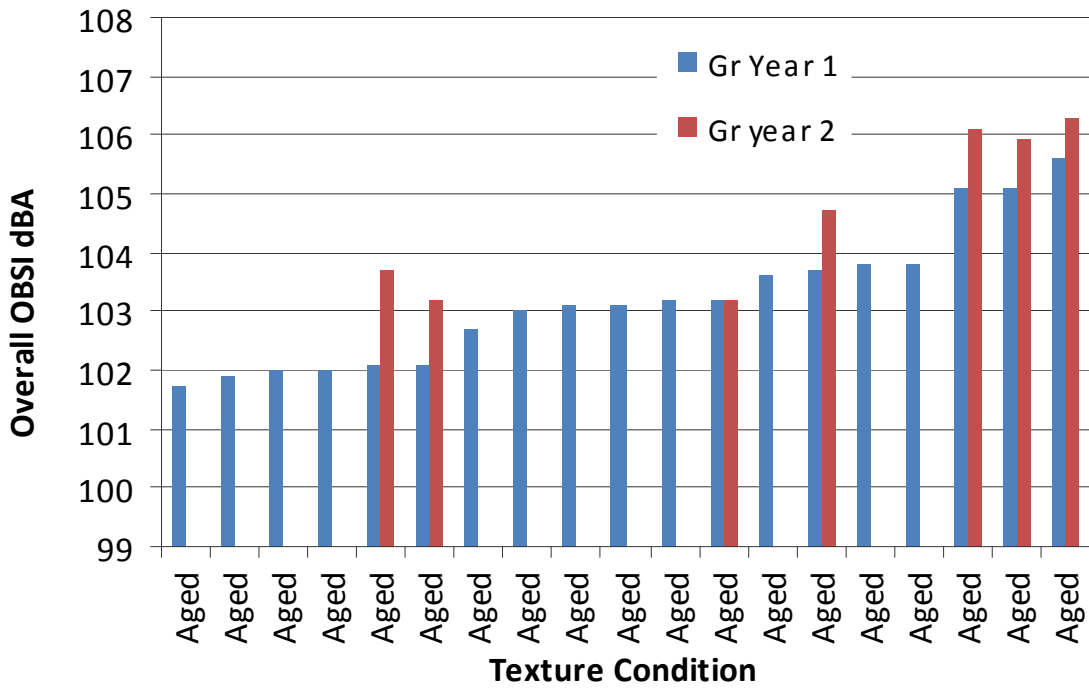
Figure 3.34: Year 1 and Year 2 OBSI values for all diamond grooved sections.

Figure 3.34 shows OBSI results for the diamond grooved sections. Although some of the pavements on US 101 in Sonoma County were built in 1962 (QP-136 and QP-138), records indicate that the sections were diamond grooved in 2006. Older sections were about 12 years old after grooving, and were located on Interstate 80 in Nevada County (QP-110 and QP-111). It is not possible to observe a trend in OBSI level over time with the available data. Figure 3.35 shows all texture conditions for the diamond grooved sections plotted versus the number of years since they were last surfaced, including all Year 1 and Year 2 measurements.

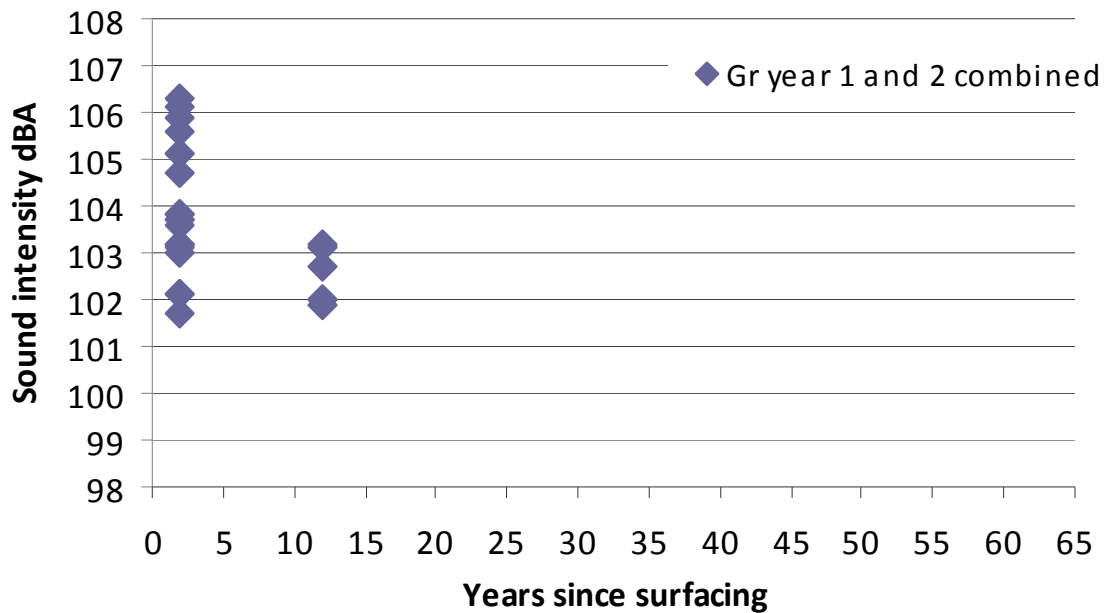
Figure 3.35: Year 1 and Year 2 OBSI values for all diamond grooved sections versus years since last surfacing.

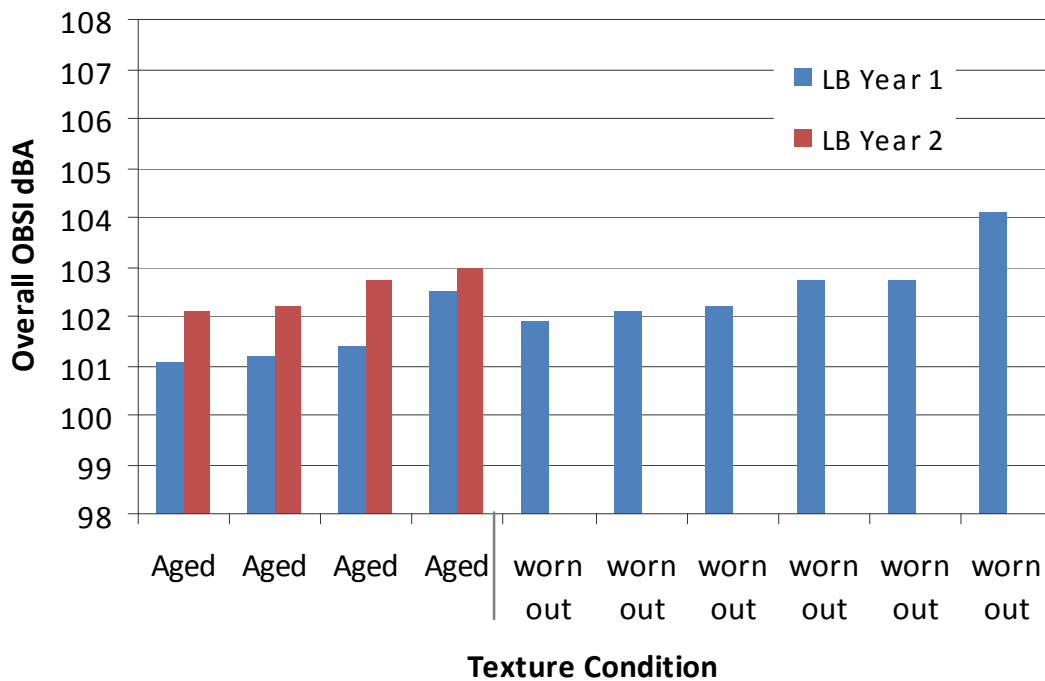
Figure 3.36: Year 1 and Year 2 OBSI values for all longitudinally broomed sections.

Figure 3.36 shows OBSI results for the longitudinally broomed sections. The six-year old section is at the Mojave Bypass on State Route 58. The 19-year old sections are on Interstate 80 in Nevada County (QP-109 and QP-112), but were overlaid with asphalt between Year 1 and Year 2. The 34-year-old sections are on Interstate 280 in San Mateo County (QP-146). From the limited available data, it seems that OBSI levels on this type of surface texture do not increase much over time. Figure 3.37 shows all texture conditions for the longitudinally broomed sections plotted versus the number of years since they were last surfaced, including all Year 1 and Year 2 measurements.

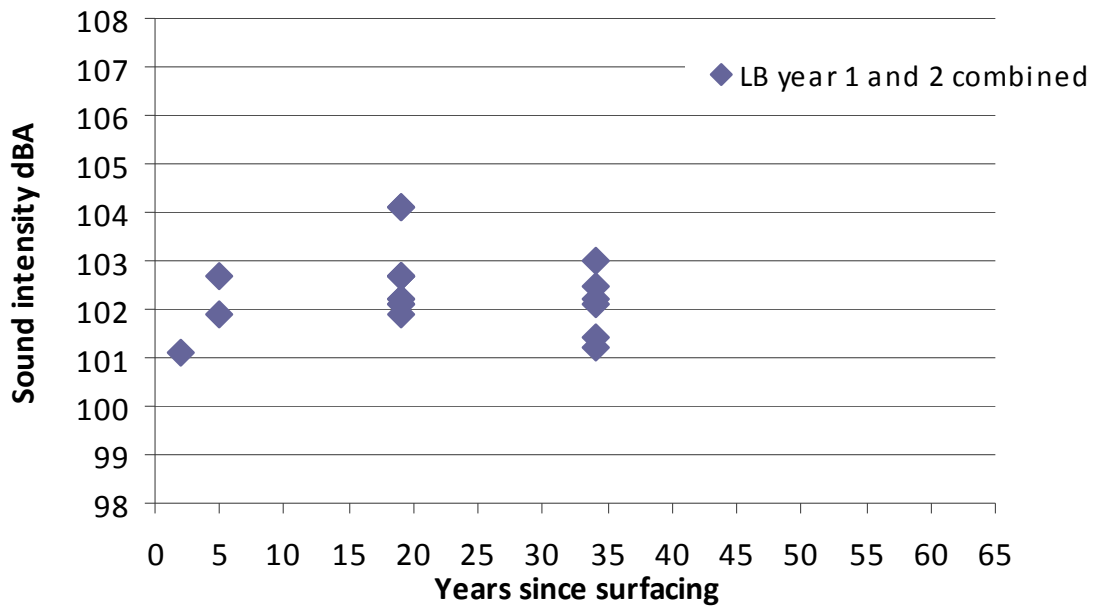
Figure 3.37: Year 1 and Year 2 OBSI values for all longitudinally broomed sections versus years since last surfacing.

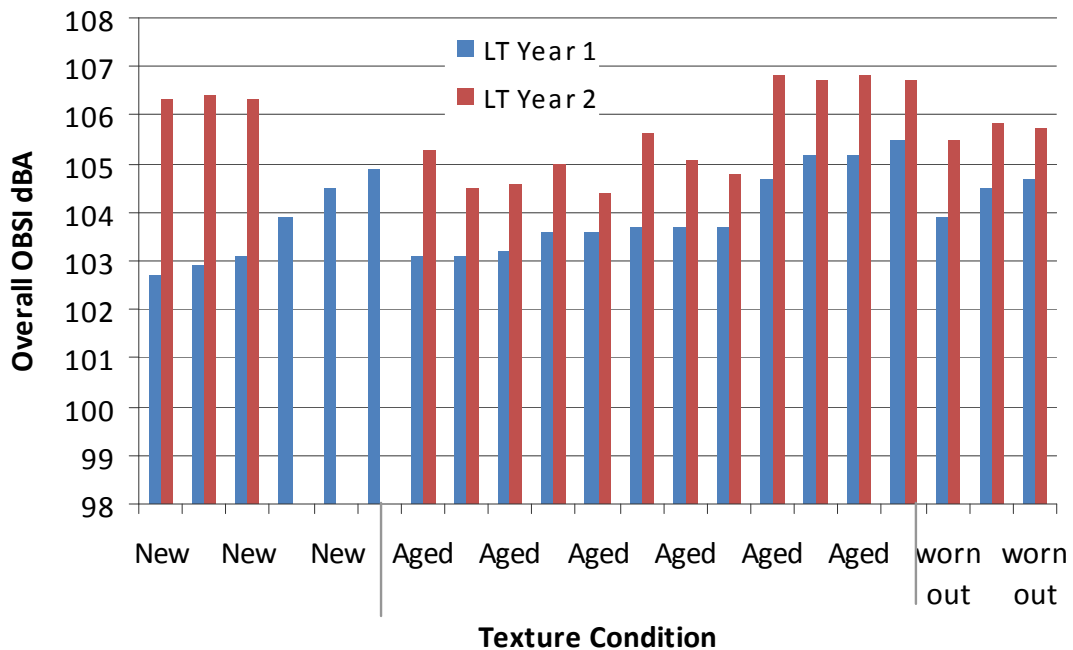
Figure 3.38: Year 1 and Year 2 OBSI values for all longitudinally tined sections.

Figure 3.38 shows OBSI results for the longitudinally tined sections. The OBSI levels remain mostly between 103 and 107 dB(A), even for sections that are over 30 and 40 years old. Figure 3.39 shows all texture conditions for the longitudinally tined sections plotted versus the number of years since they were last surfaced, including all Year 1 and Year 2 measurements.

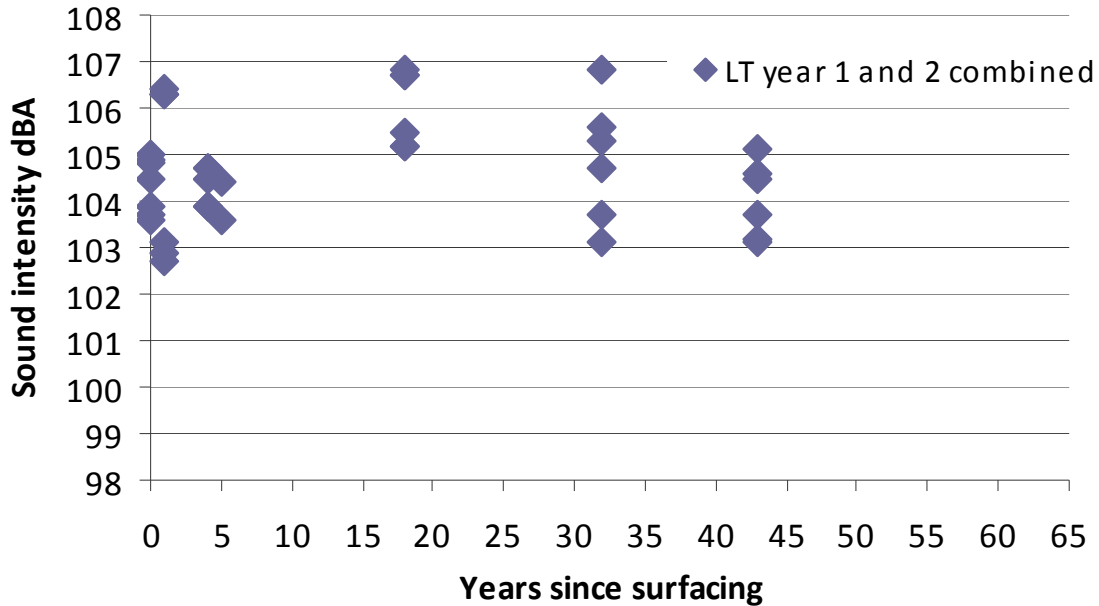
Figure 3.39: Year 1 and Year 2 OBSI values for all longitudinally tined sections versus years since last surfacing.

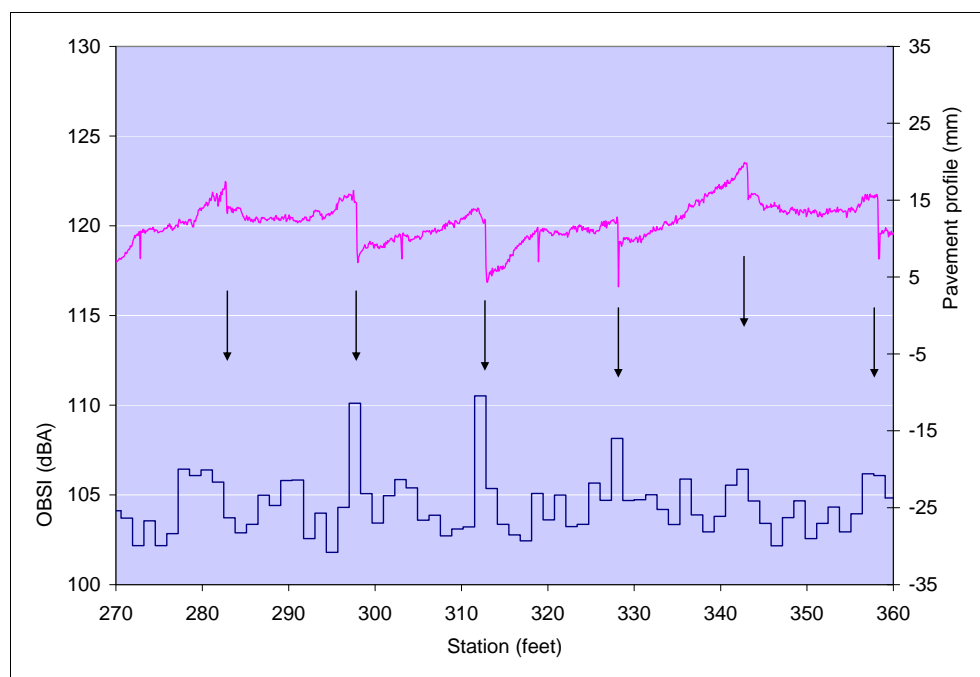
Figure 3.40: Noise level spikes and correspondence to joint faulting.

slap caused by the joint groove, faulting and overbanded sealant. An example of that initial analysis is shown in Figure 3.40 for a faulted jointed concrete pavement on I-80 near Davis, CA, with the pavement profile measured with a high-speed laser in the right wheelpath shown above and OBSI in 15-ms intervals shown below. The example shows a maximum spike of about 8 dB(A) at the third joint from the left (joints indicated by arrows in the figure), where the fault height is approximately 9 mm (0.36 inches). The effects of faulting and joint groove cross-sectional area are not separated at that joint. Analysis of these results was extremely labor-intensive and there was insufficient funding in the project to fully analyze and consider these effects in the results, or to automate the analysis.

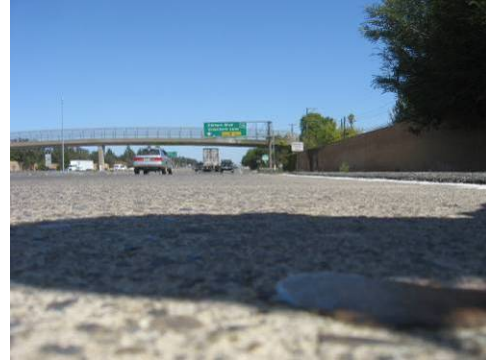
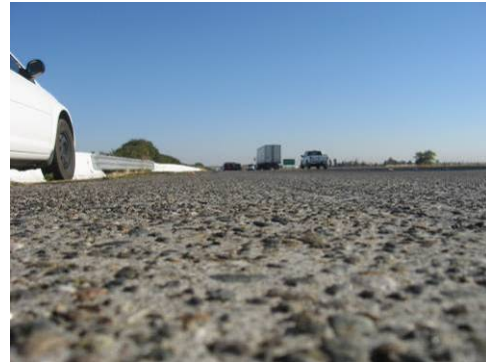
QP-102.2 (103.0 dB[A])

QP-107.3 (103.7 dB[A])

QP-130.1 (107.3 dB[A])

QP-116.1 (107.8 dB[A])

Figure 4.1: Example photographs of burlap drag surfaces and their OBSI levels.

The oldest concrete pavement sections evaluated in this study have burlap drag texture, with sections on Interstate 80 in Solano County having been in service for over 60 years according to the available records (QP-116). Due to their long service life, some of the sections in this category had pavements that showed no signs of applied surface texture, and were then categorized as *worn out* texture. Burlap drag sections are not constructed in California highways any more, which is why no “young” sections, other than one built for a field evaluation experiment, were included in the experiment. This young section, which was about five years old when first tested, yielded an OBSI level of about 102 dB(A). Other than the experimental section, all burlap drag sections were older than 30 years, and had OBSI levels ranging between 101 and 108 dB(A). These values indicate that the actions of traffic, often combined with rainfall, will tend to polish some concrete surfaces and remove positive texture (stones protruding from the surface) without damaging the paste around the stones. The same combination of traffic and environment will tend to ravel asphalt surfaces and cause loss of paste around the aggregates in some concrete surfaces, creating positive texture by leaving the stones protruding from the surface. The quieter sections seem to be, judging from the pictures, those with shallow texture, as shown in Figure 4.1. Therefore, a possible reason for variability of OBSI for the burlap drag sections is variation in the macrotexture caused by the protrusion of aggregates. A summary of the information for burlap drag sections is presented in Table 4.1.

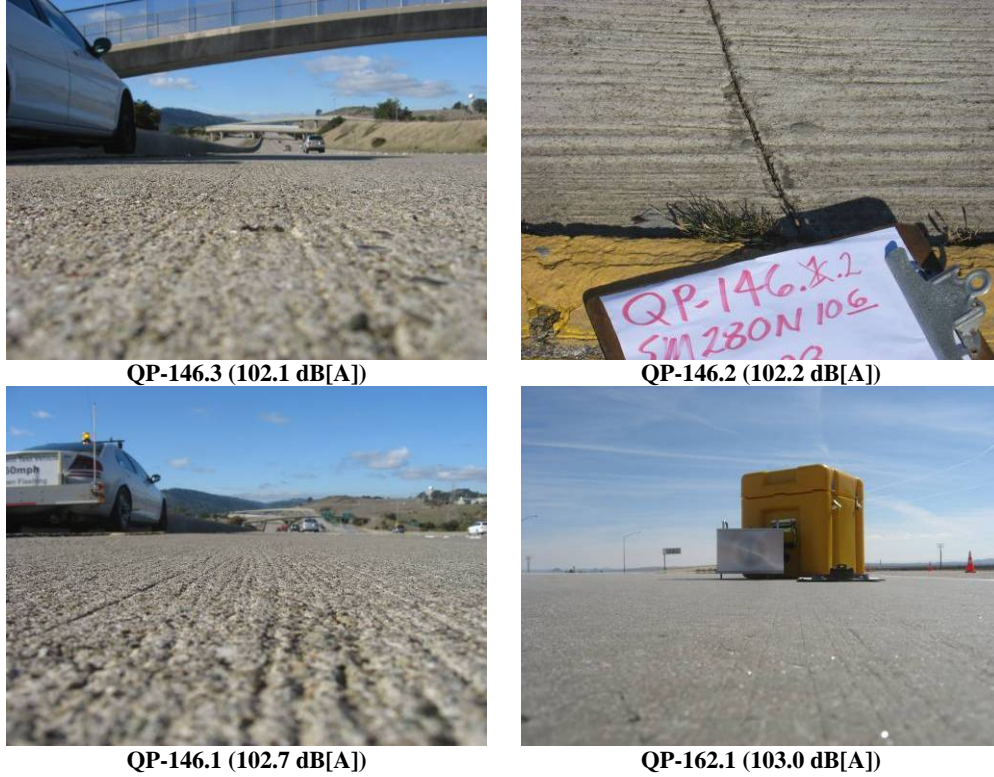
Figure 4.4: Example photographs of longitudinally broomed surfaces and their OBSI levels.

Longitudinally broomed pavement surface texture is uncommon on California highways. The difference between longitudinally broomed and burlap drag surface textures is only clear on surfaces that are not *worn out* (i.e., texture has not been worn off by traffic) and still show the striations caused by the texturing tool. The difference between the two techniques is less apparent in the case of *worn out* surfaces. In this study, the presence of striations of more than 1 or 2 mm depth (as evaluated subjectively from photographs) was considered reason to label a texture as longitudinally broomed. If only shallower striations or none were observed, then the section was labeled as having a burlap drag texture type. This resulted in a low number of longitudinally broomed sections, and affected the balance of the experimental factorial, complicating the interpretation of results. From a practical point of view, longitudinal brooming could be considered equivalent to a “heavy drag” texture. A summary of the information for longitudinally broomed sections is presented in Table 4.4. Photographs of example longitudinally broomed surfaces are shown in Figure 4.4.

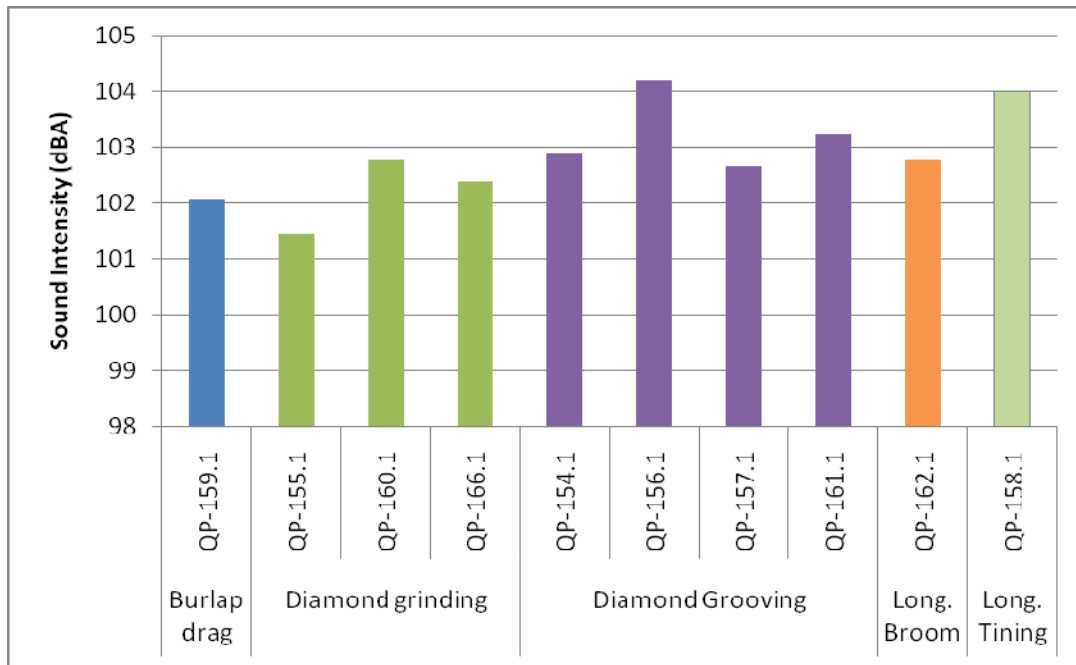
Figure 4.6: Comparison of OBSI noise levels of concrete pavement textures in Mojave sections averaged over the two years of measurement.

Table 4.6, Figure 4.6, and Figure 4.7 present the results of the pavement sections in the Mojave test site (Kern 58). The quietest sections were those with a diamond-ground surface. Figure 4.6 shows the results of the sections averaged across the two years while Figure 4.7 shows each year of measurement individually, ordered by the Year 1 OBSI measured value. The one-year change on the Mojave sections in the reported data for the corrected OBSI values ranges from 0 to 1.6 dB(A), averaging 0.7 db(A), which is greater than expected. It should be noted that the effects of the error term for the tire correction equation discussed in Chapter 2 is accentuated on a small sample such as the Mojave sections. In this case, since there are only two years of data the error term is large relative to the expected annual change (noise to signal ratio), and the error does not get averaged out well on a small sample. Additional years of data will be needed to clarify the rate of change of OBSI on these sections.

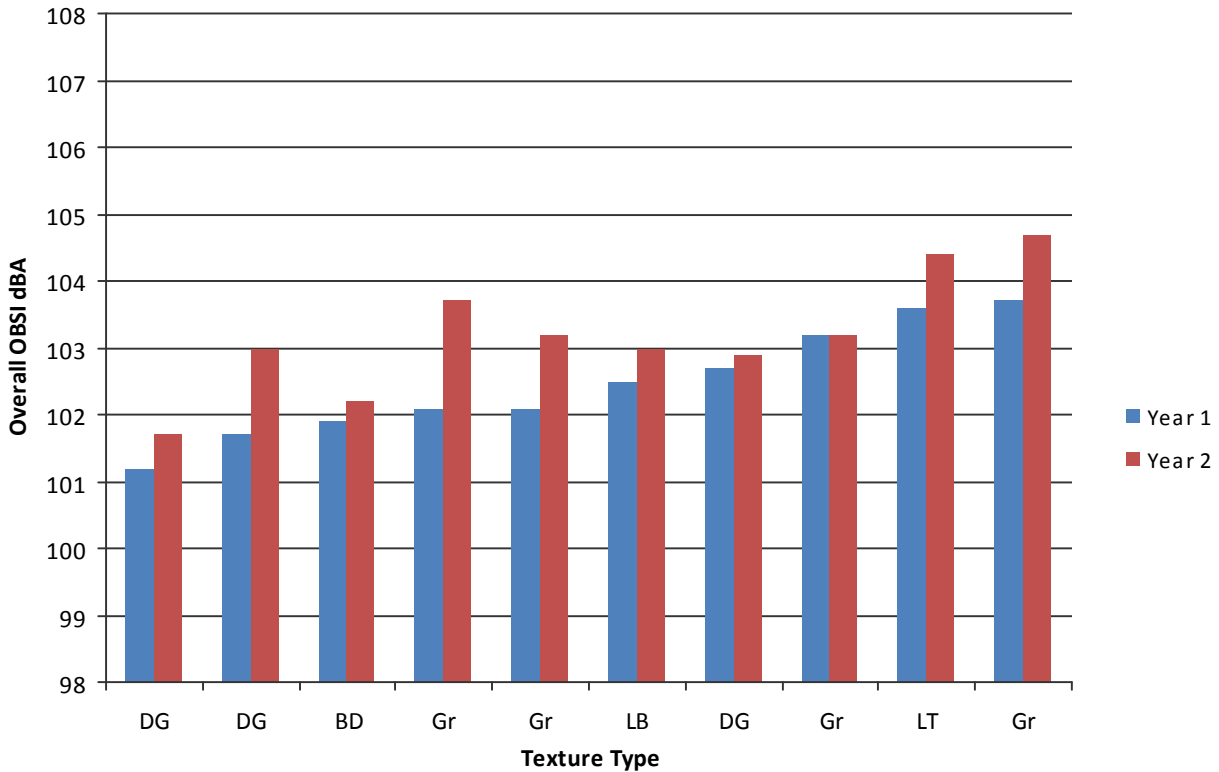
Figure 4.7: Comparison of average OBSI noise levels of concrete pavement textures in Mojave sections ranked from quietest to loudest in Year 1 (Year 1 on the left and Year 2 on the right).

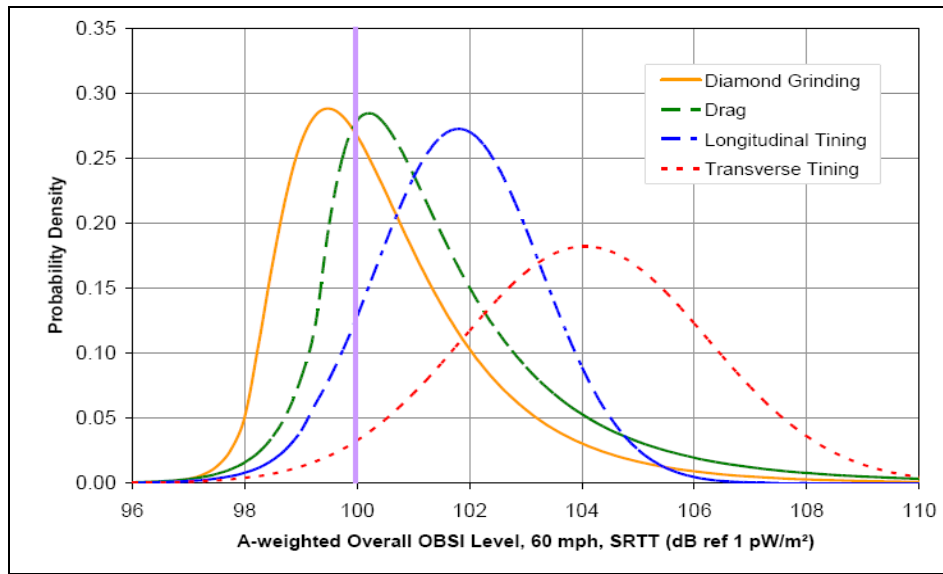
Figure 4.8: Probability distributions of OBSI noise levels for concrete pavement textures as reported by the National Concrete Pavement Technology Center (4).

Although the rankings are similar, the OBSI levels included in the 2008 NCPTC report were consistently lower than those measured in this study, as can be seen in Figure 4.8 and Figure 4.9.

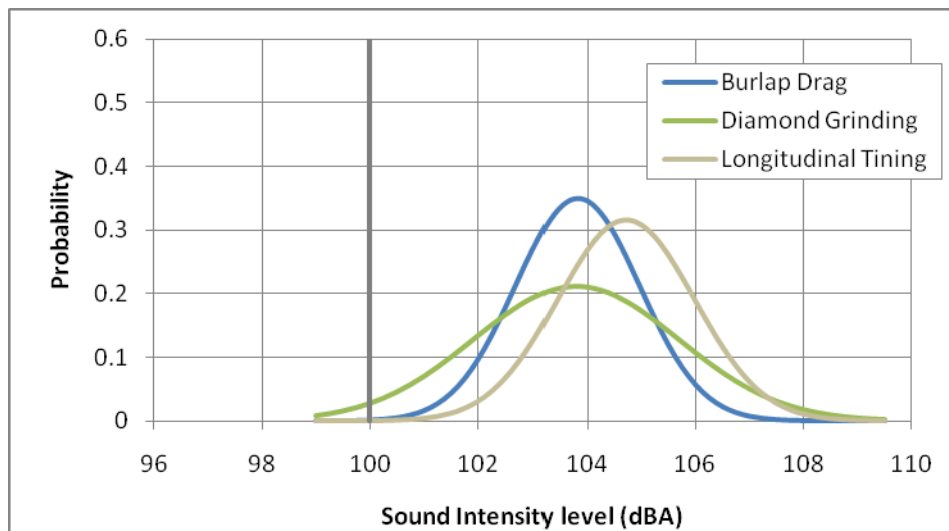
Figure 4.9: Distributions of OBSI noise levels in this study (excluding LB and Gr because of limited amount of data).

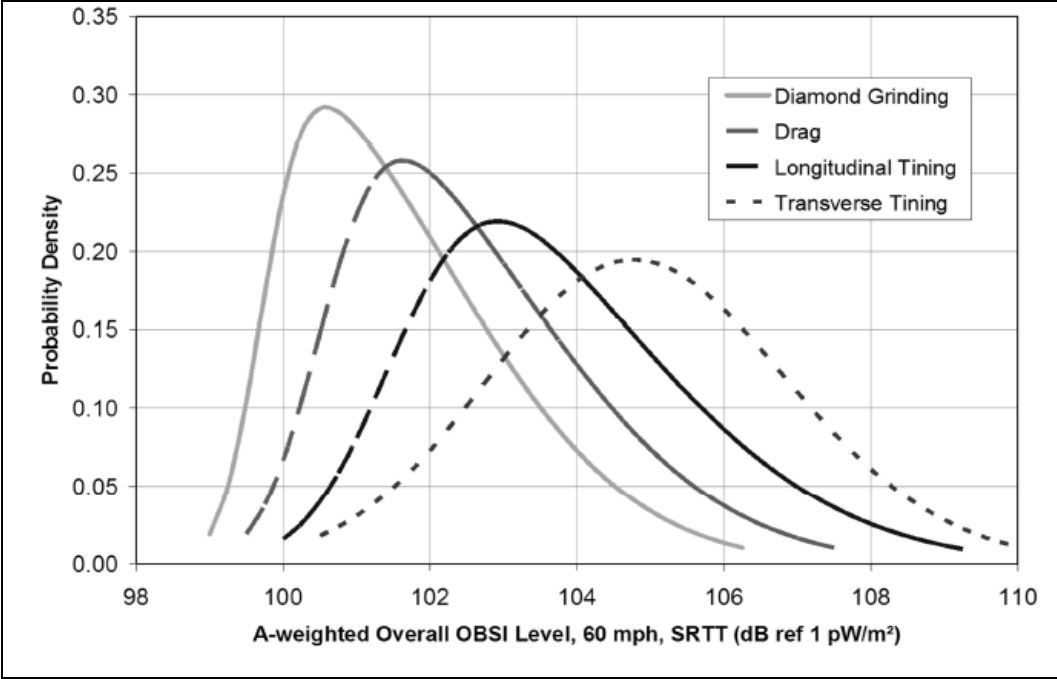
Figure 4.10: Updated probability distributions of OBSI noise levels for concrete pavement textures from NCPTC study.

The NCPTC study has been ongoing, with a very large sample. It can be expected that results will change as more measurements are taken. A more recent conference presentation, titled “Quieter Concrete Pavements: An Update of Pooled Fund TPF-5(139)” in October 2010 at the Pavement Evaluation Conference in Roanoke, Virginia, indicates that the NCPTC data is indicating higher OBSI levels than those shown previously. Continued comparisons of California data and NCPTC data will be worthwhile to identify common conclusions and where California and NCPTC data differ, and comparison will provide better understanding of reasons for variability within surface textures.

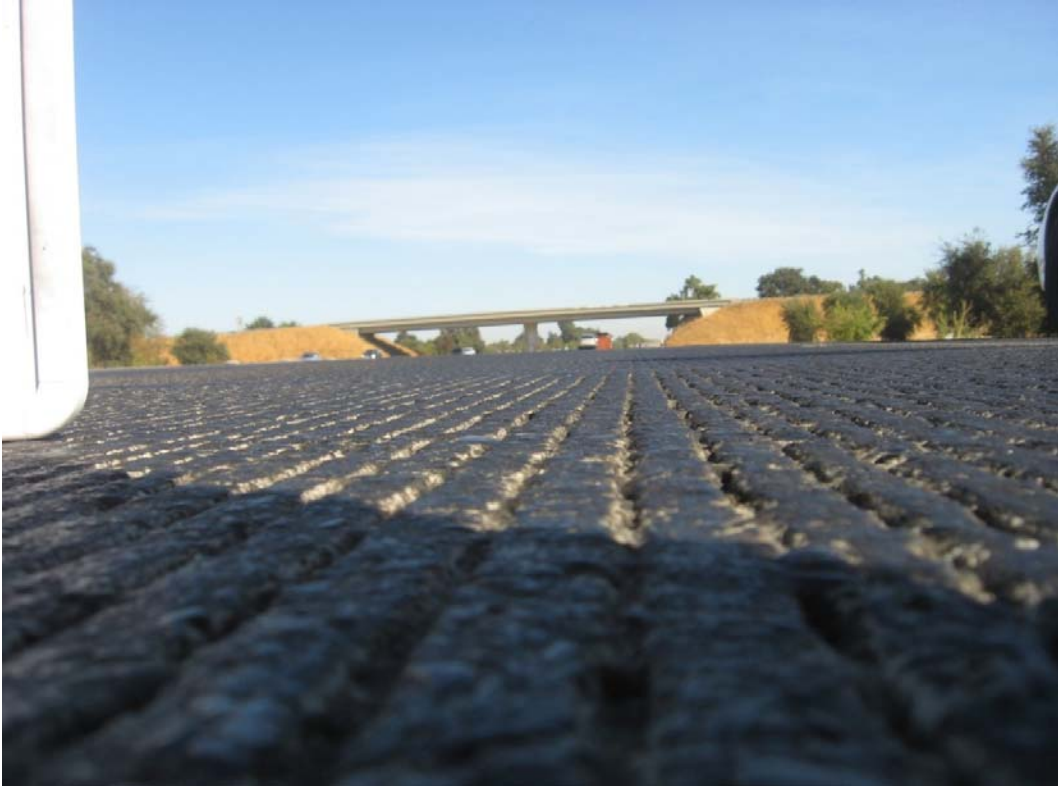
Figure A.10: Longitudinally tined, SI=105.5 dB(A) (Section QP-101.2).

Two photographs of the same texture type are shown on each page, displaying the surface texture as observed with the camera held directly on the pavement surface. The top and bottom photographs show respectively sections with low and high OBSI level. Surface type, section ID, and OBSI level are presented in the caption.

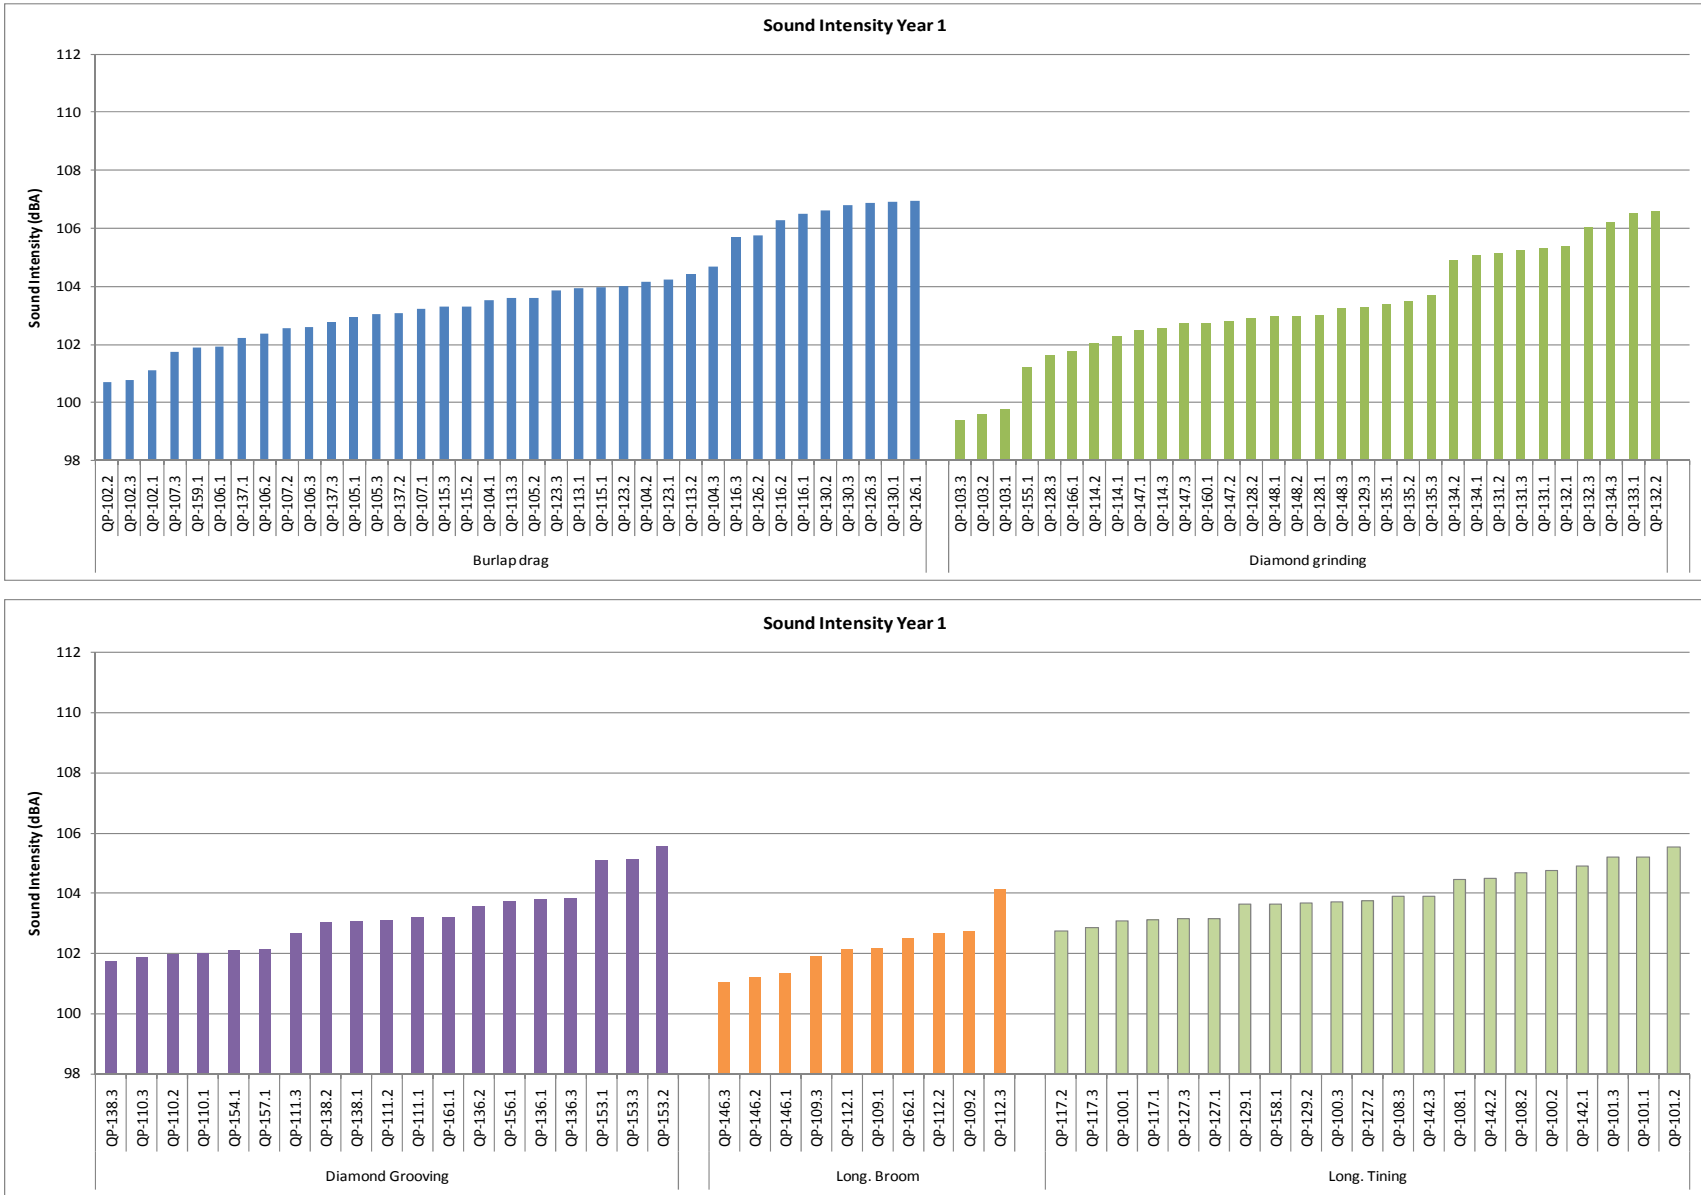
Figure B.1: On-board Sound Intensity levels of all sections as measured in Year 1.

The overall OBSI levels of each section measured in Year 1 and Year 2 are presented here.

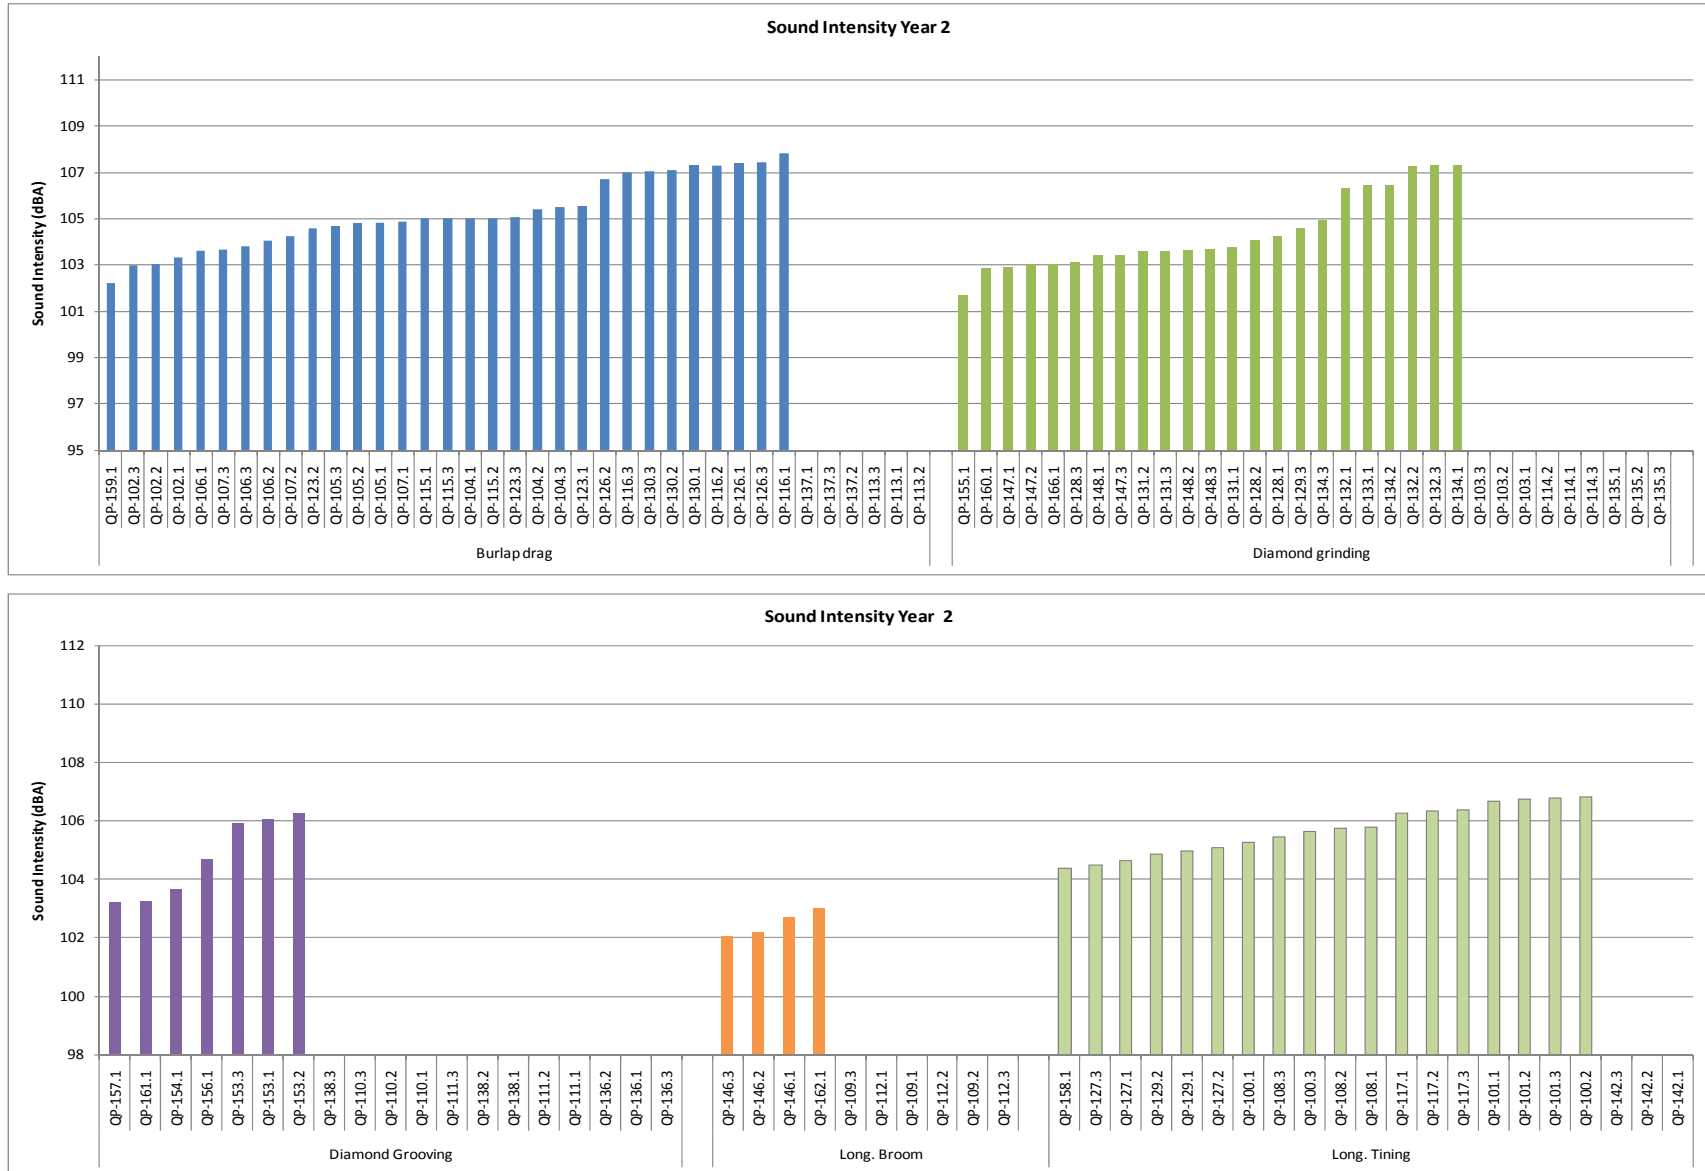
Figure B.2: On-board Sound Intensity levels of all sections as measured in Year 2.

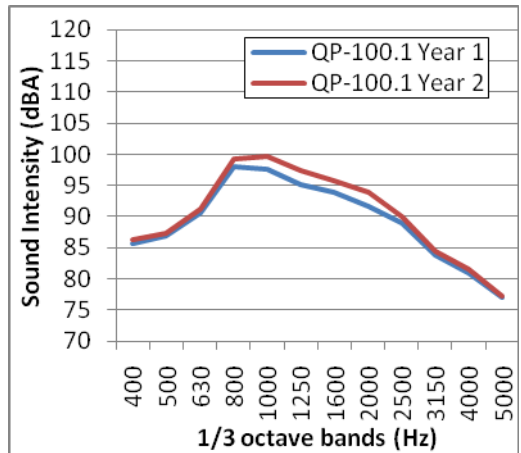
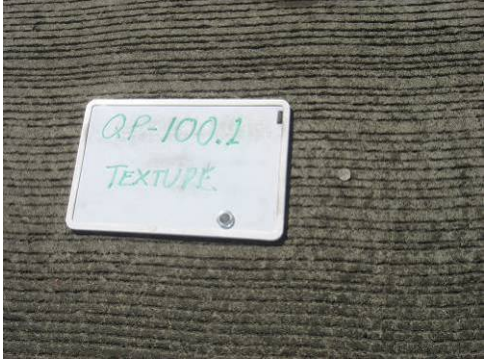
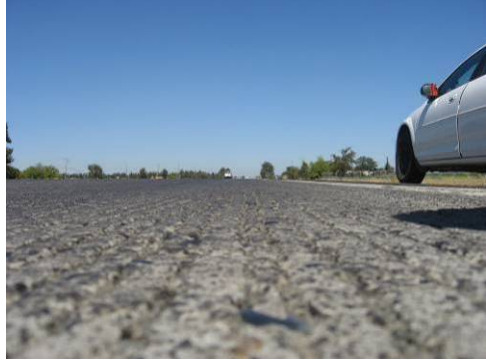
QP-100.1

Type of section: Pavement Field testing Year 1: 9/3/2008 15:09
 Location: 03Yol113N3.0 Field testing Year 2: 9/4/2009 14:07
 Comments: Longitudinally tined. Aggressive texture, sealed joints.
 Surface Year: 1976

<p>Onboard picture Year 1</p>

<p>Texture detail</p>
