Quieter Pavement Research: Concrete Pavement Tire Noise

Work Conducted as Part of Partnered Pavement Research Center Strategic Plan Element No. 4.22:
Quiet Concrete Pavement Research

DOCUMENT RETRIEVAL PAGE		UCPRC Research Report No.: UCPRC-RR-2010-03			
Title: Quieter Pavement Research: Concrete Pavement Tire Noise					
Author: E. Kohler and J. Harvey					
Prepared for: California Department of Transportation, Division of Research and Innovation, Office of Roadway Research		FHWA No.: CA121200A	Date Work Submitted: August 20, 2010	Date: May 2010	
Strategic Plan Element No.: 4.22		Status: Stage 6, final version		Version No.: 1	
<p>Abstract: This research report presents the results of tire/pavement noise measurements performed on concrete pavements as a part of the California Department of Transportation (Caltrans) Quieter Pavement Research (QPR) study to investigate tire/pavement noise characteristics on concrete pavements and bridge decks.</p> <p>The study included a total of 120 pavement sections at 47 different sites on various state highways throughout California. Most of the sites (36) were divided into three sections each for measurement and evaluation of tire/pavement nois

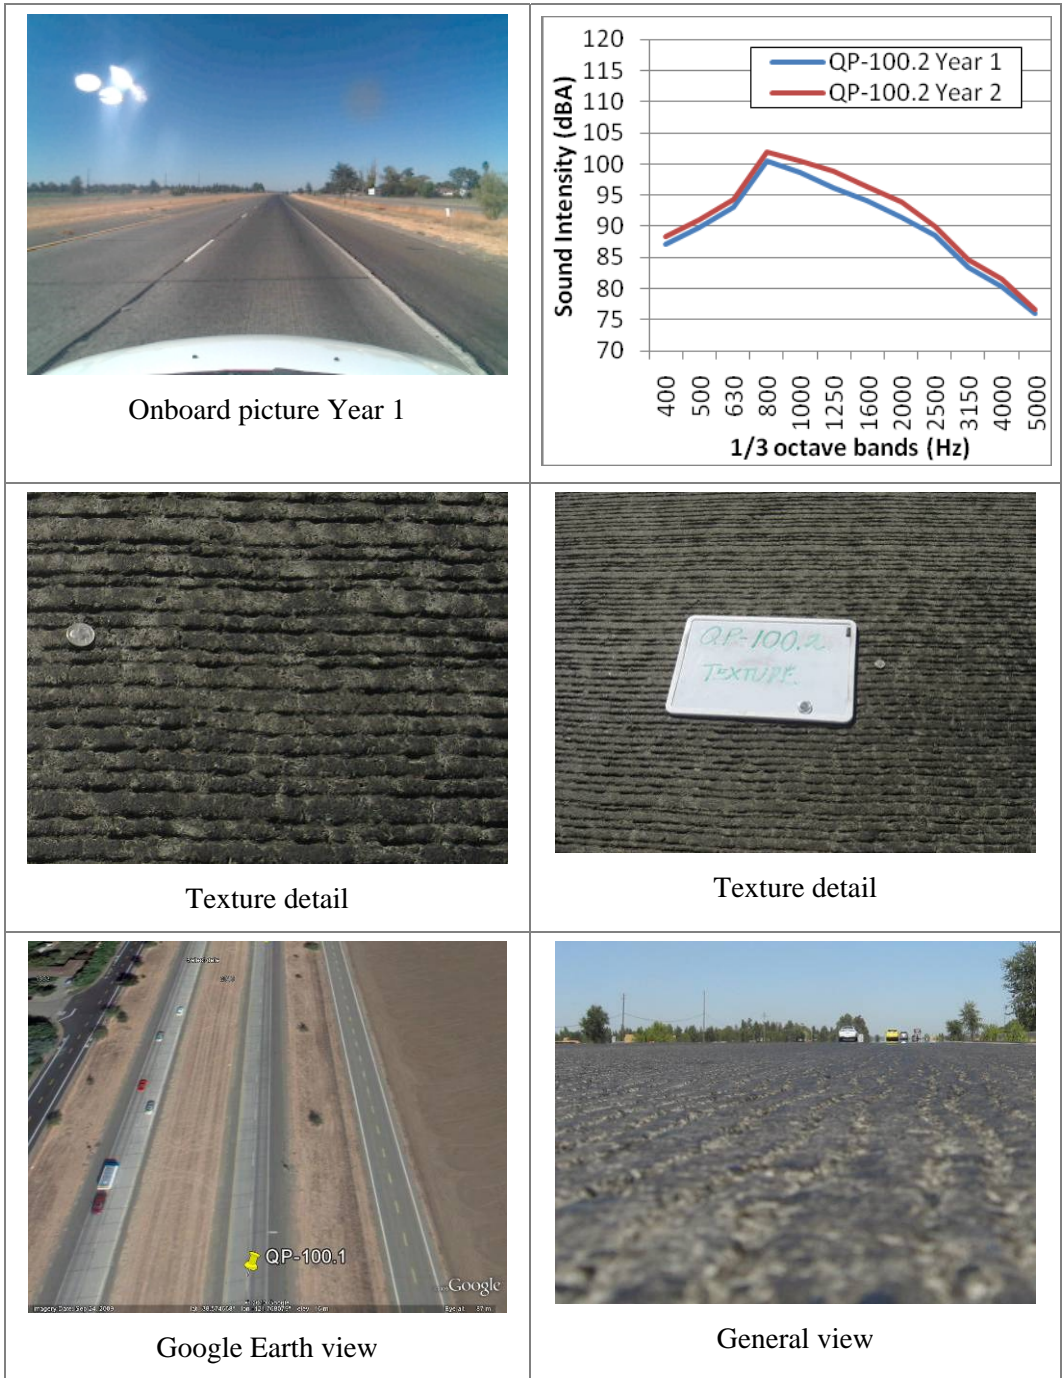
QP-100.2

Type of section: Pavement Field testing Year 1: 9/3/2008 15:59
 Location: 03Yol113N3.1 Field testing Year 2: 9/4/2009 14:24
 Comments: Longitudinally tined. Aggressive texture, sealed joints.
 Surface Year: 1976

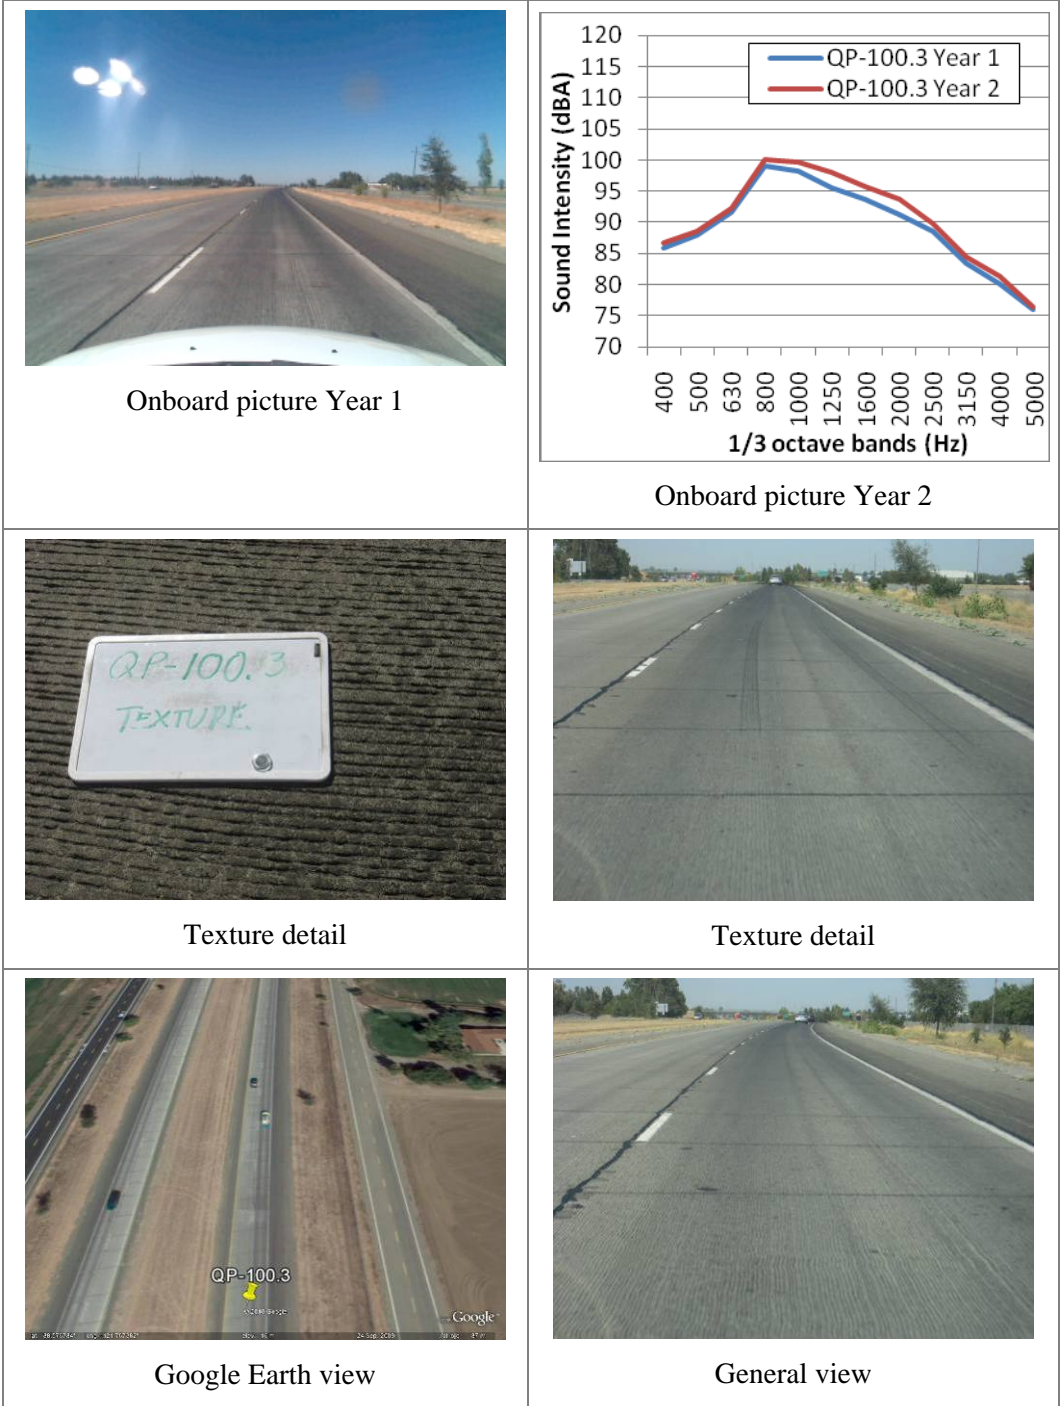
QP-100.3

Type of section: Pavement Field testing Year 1: 9/3/2008 16:10
 Location: 03Yol113N3.2 Field testing Year 2: 9/4/2009 14:40
 Comments: Longitudinally tined. Aggressive texture, sealed joints.
 Surface Year: 1976

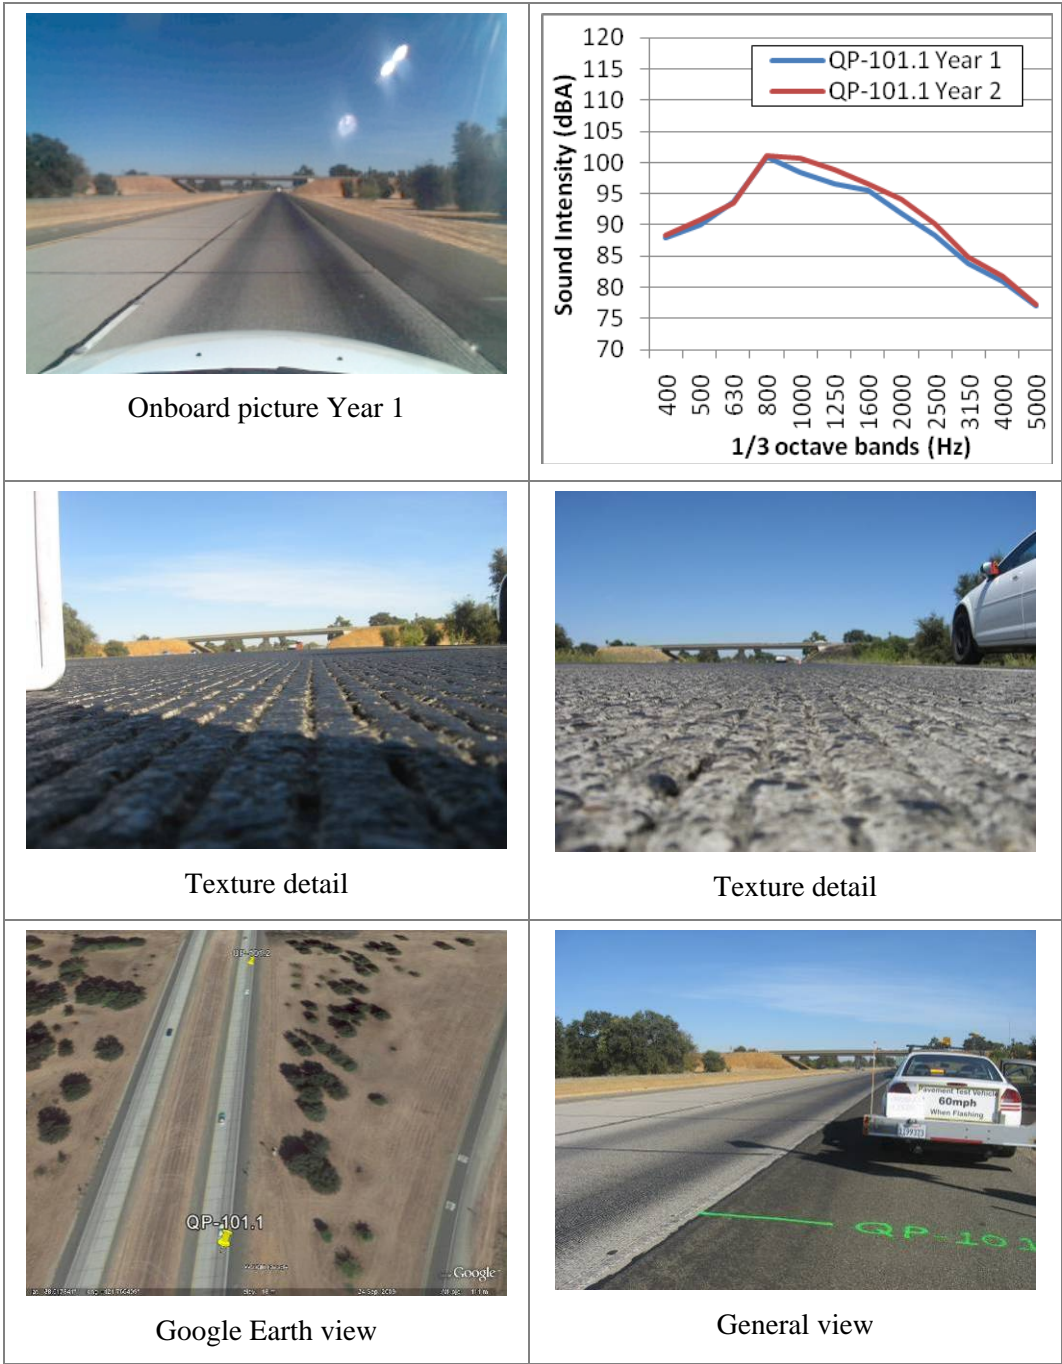
QP-101.1

Type of section: Pavement Field testing Year 1: 9/23/2008 10:42
 Location: 03Yol113N6.0 Field testing Year 2: 9/4/2009 14:16
 Comments: Longitudinally tined. Deep tining. Rubber built-up.
 Surface Year: 1990

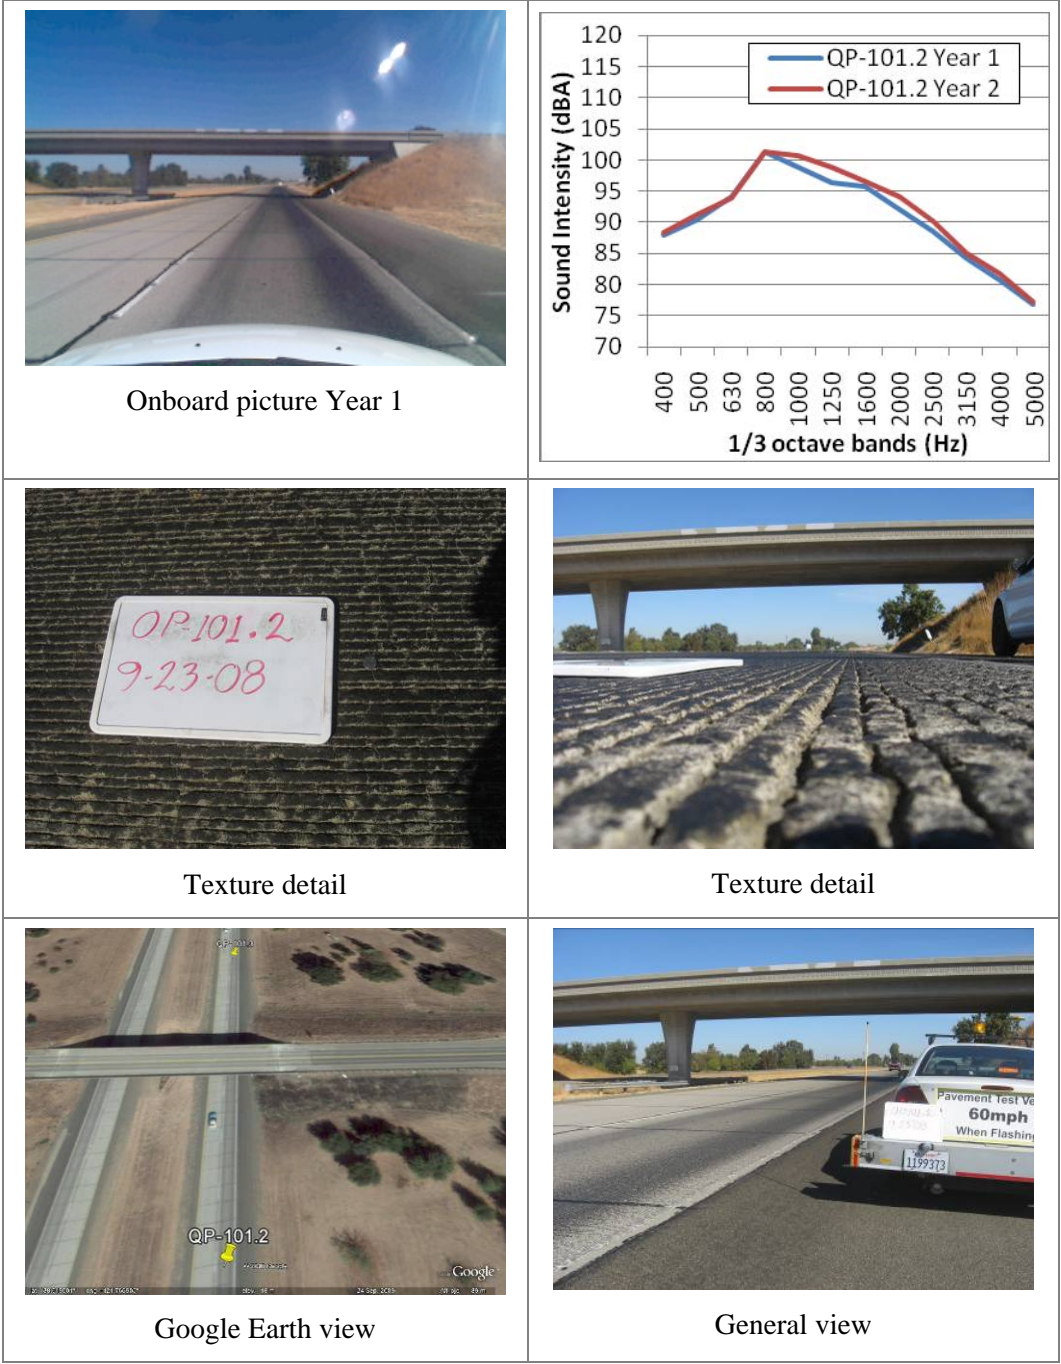
QP-101.2

Type of section: Pavement Field testing Year 1: 9/23/2008 11:00
 Location: 03Yol113N6.1 Field testing Year 2: 9/4/2009 14:29
 Comments: Longitudinally tined. Deep tines. Rubber built-up. Overcross at middle of section.
 Surface Year: 1990

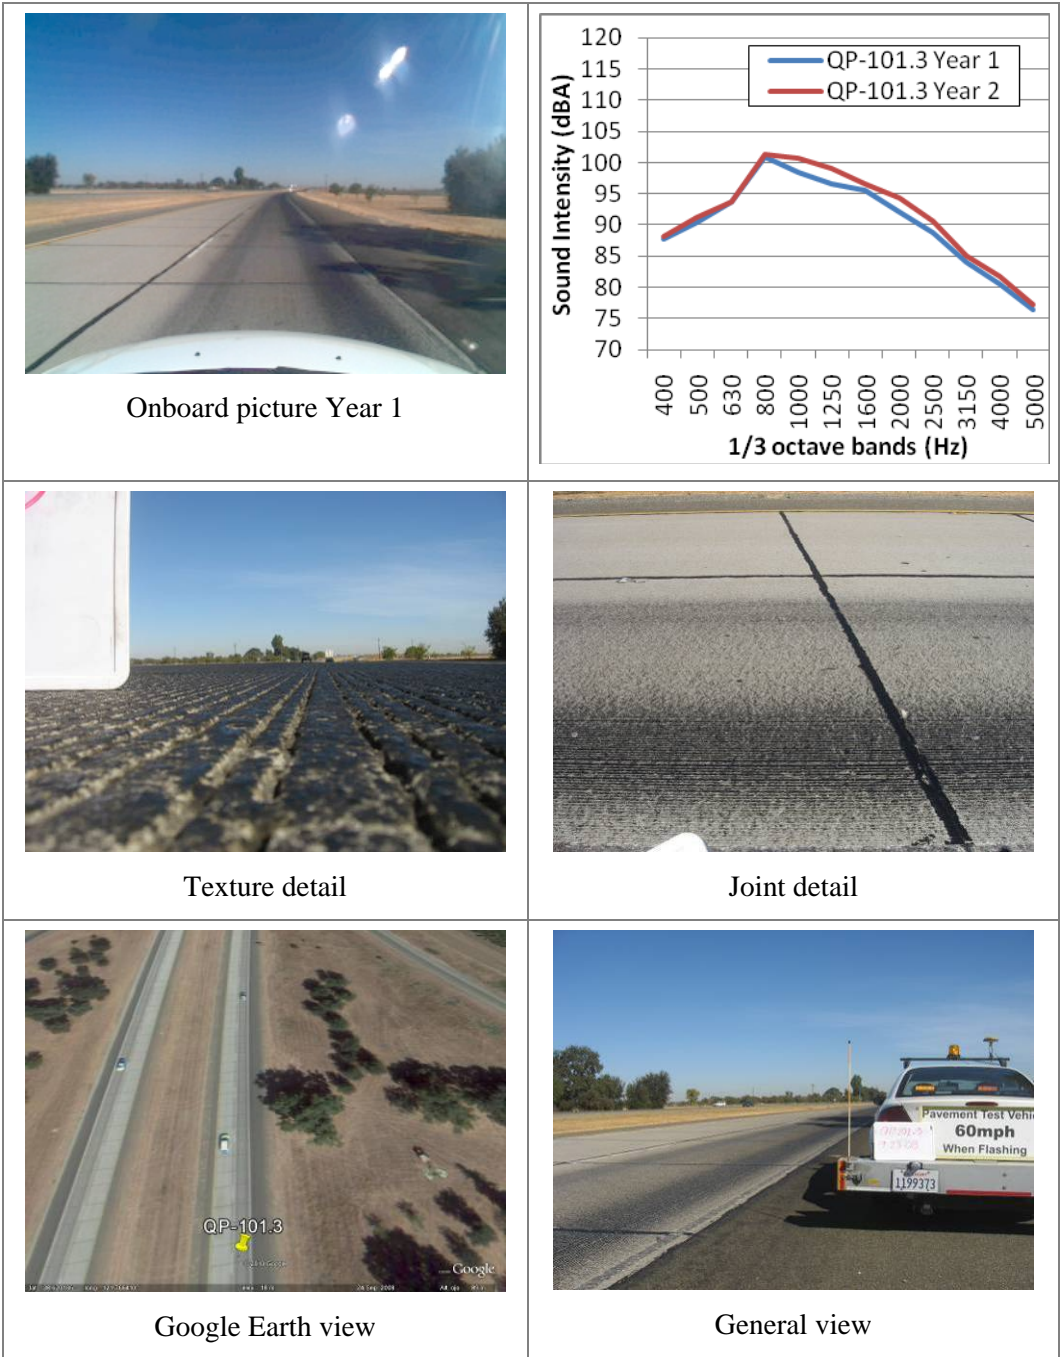
QP-101.3

Type of section: Pavement Field testing Year 1: 9/23/2008 11:09
 Location: 03Yol113N6.2 Field testing Year 2: 9/4/2009 14:46
 Comments: Longitudinally tined. Deep tines. Rubber built-up.
 Surface Year: 1990

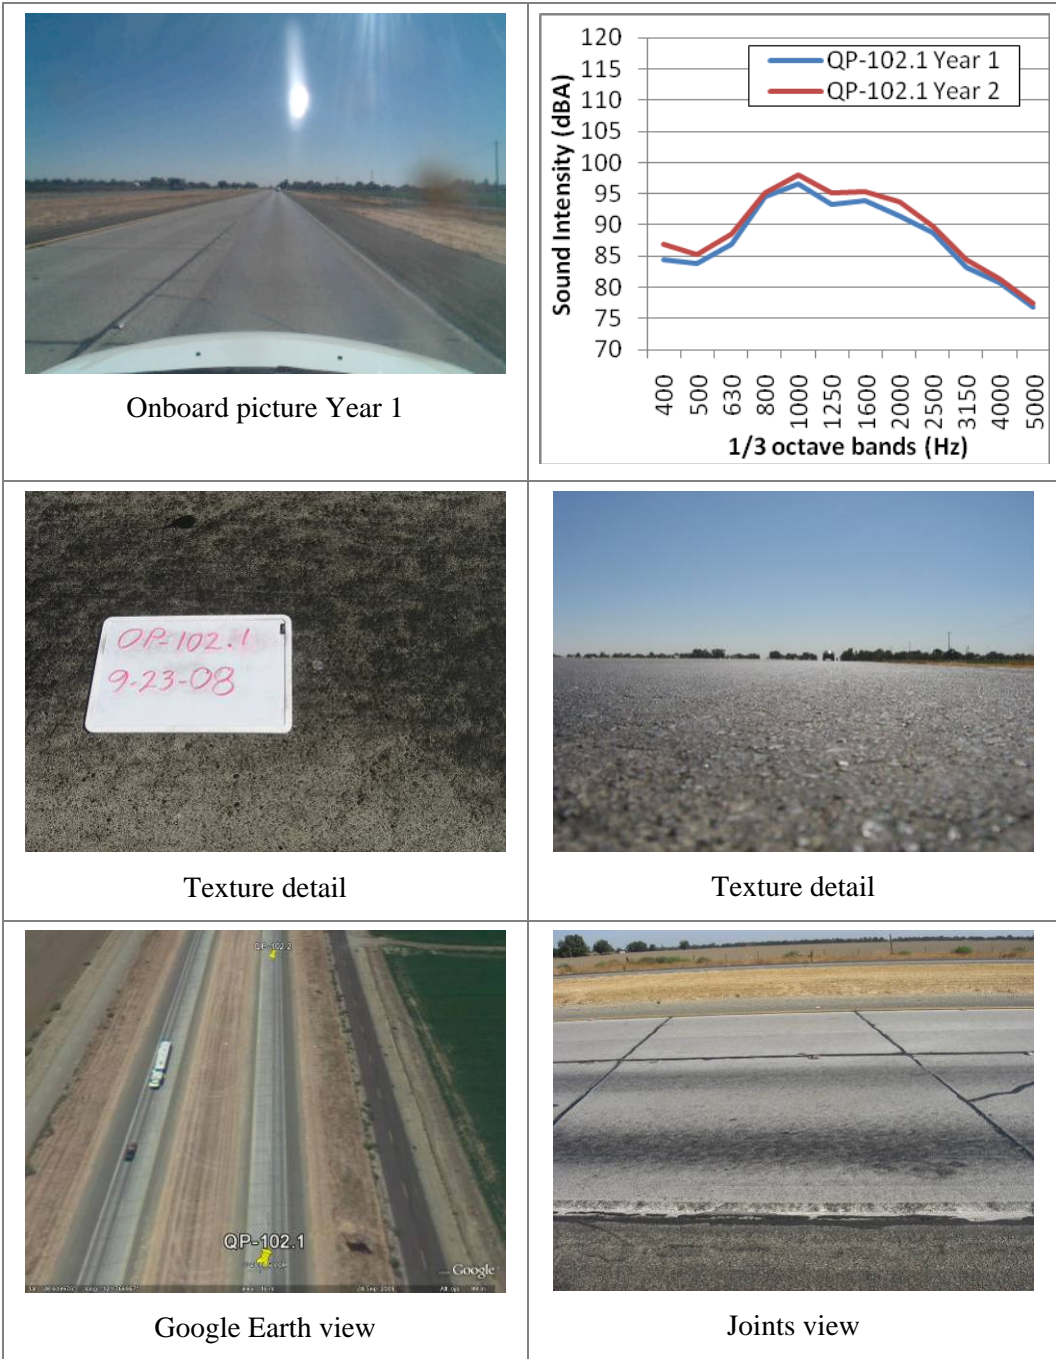
QP-102.1

Type of section: Pavement Field testing Year 1: 9/23/2008 13:12
 Location: 03Yol113S5.5 Field testing Year 2: 9/4/2009 14:20
 Comments: Burlap drag. Rubber built-up, some transverse cracks.
 Surface Year: 1976

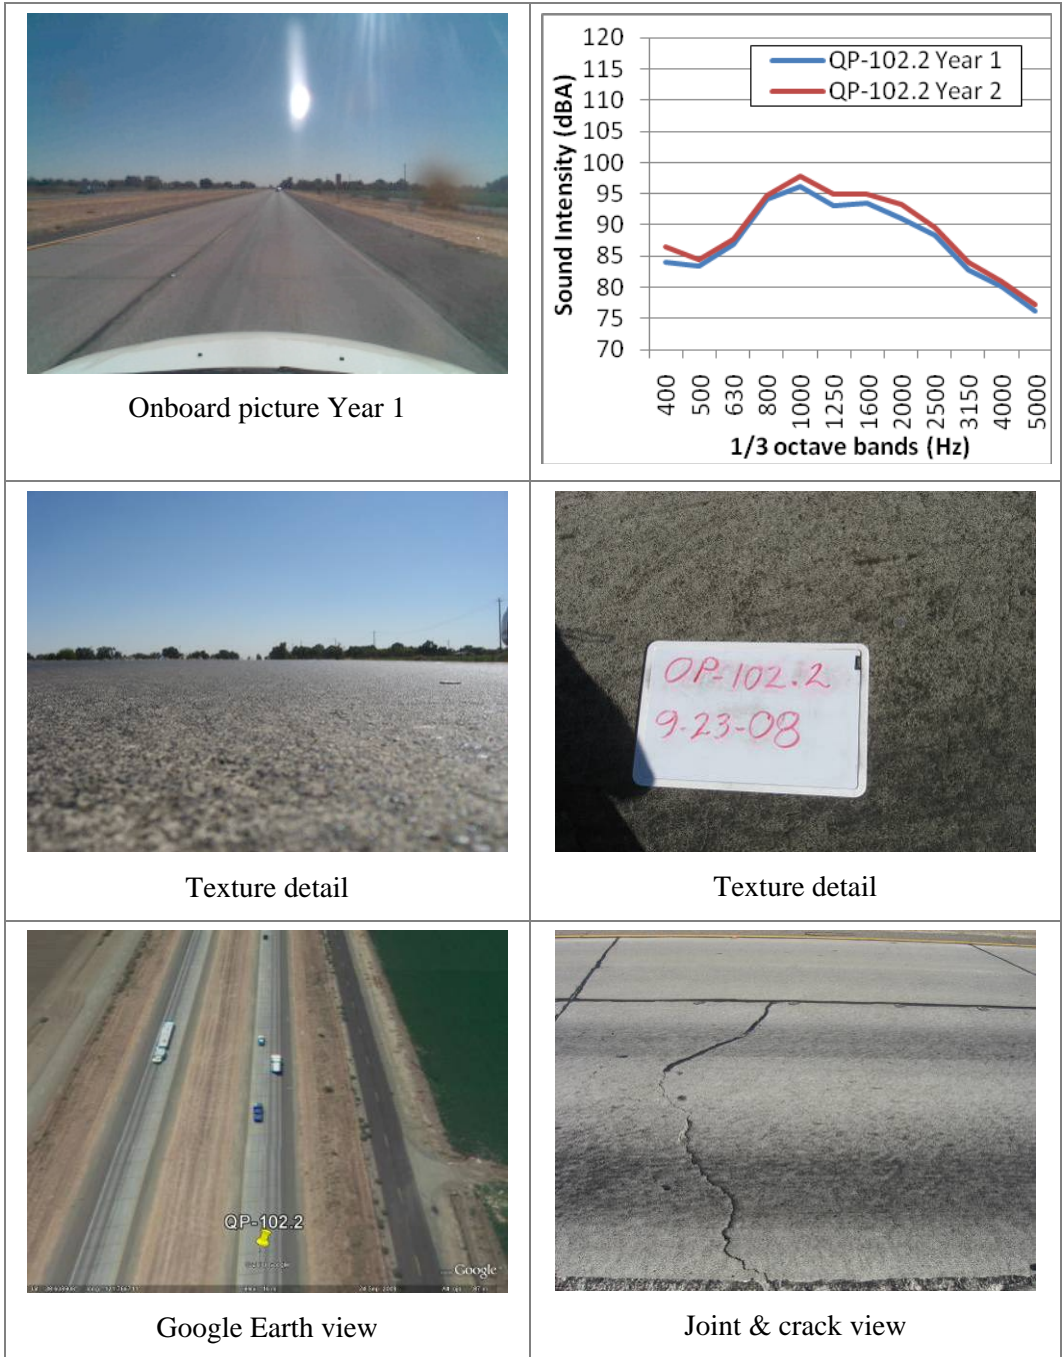
QP-102.2

Type of section: Pavement Field testing Year 1: 9/23/2008 13:46
 Location: 03Yol113S5.4 Field testing Year 2: 9/4/2009 14:49
 Comments: Burlap drag. Rubber built-up, some transverse cracks.
 Surface Year: 1976

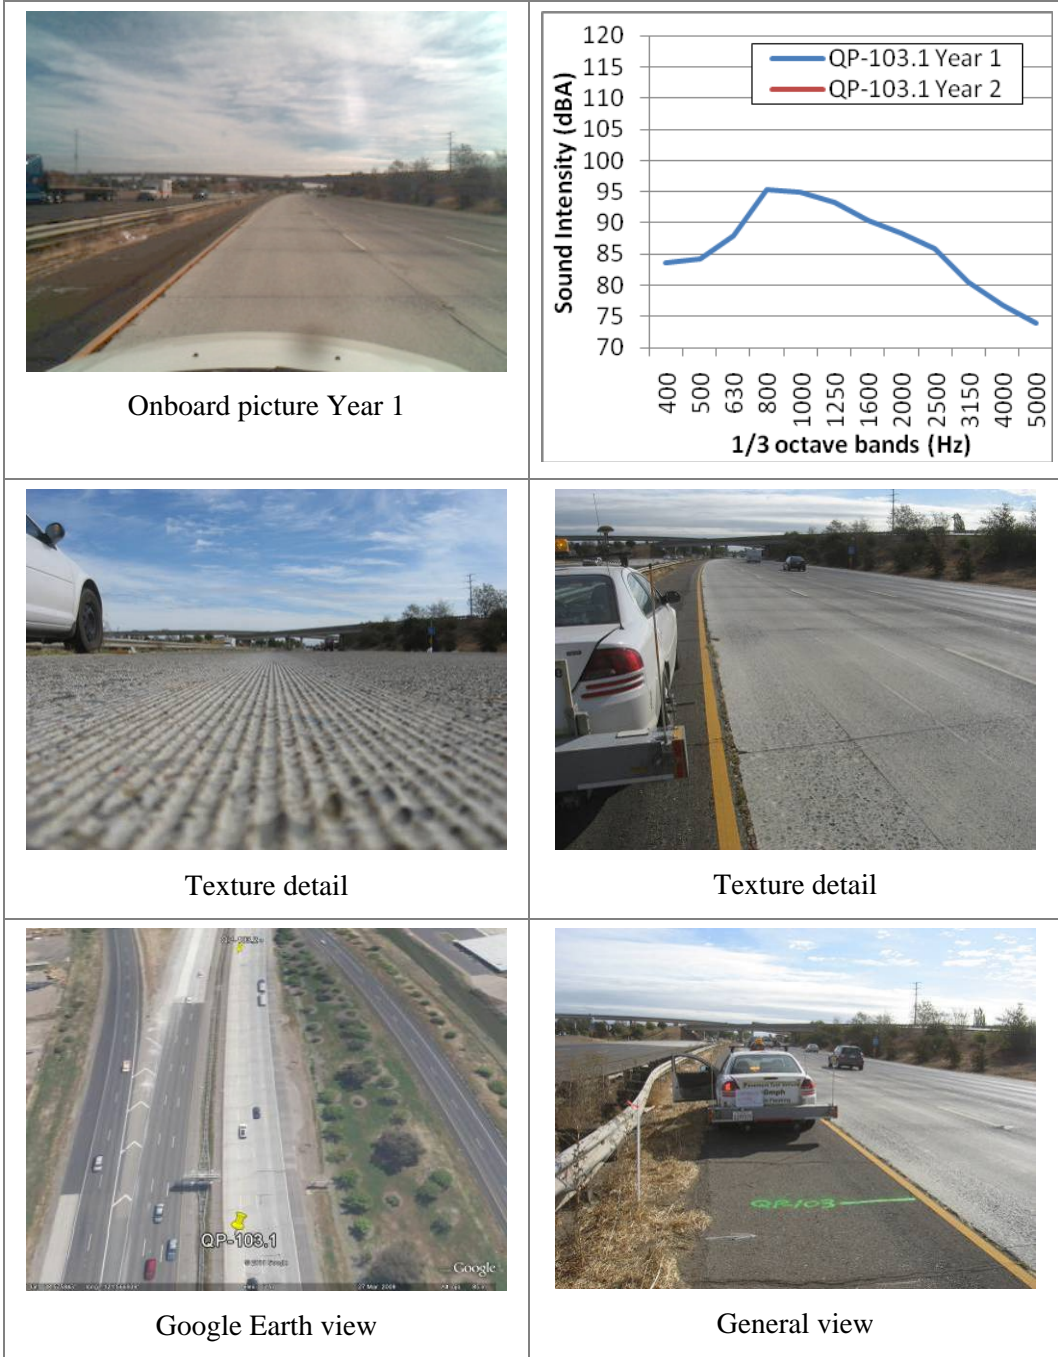
QP-103.1

Type of section: Pavement
 Location: 03Yol50E0.2
 Comments: Diamond ground.
 Surface Year: 2005

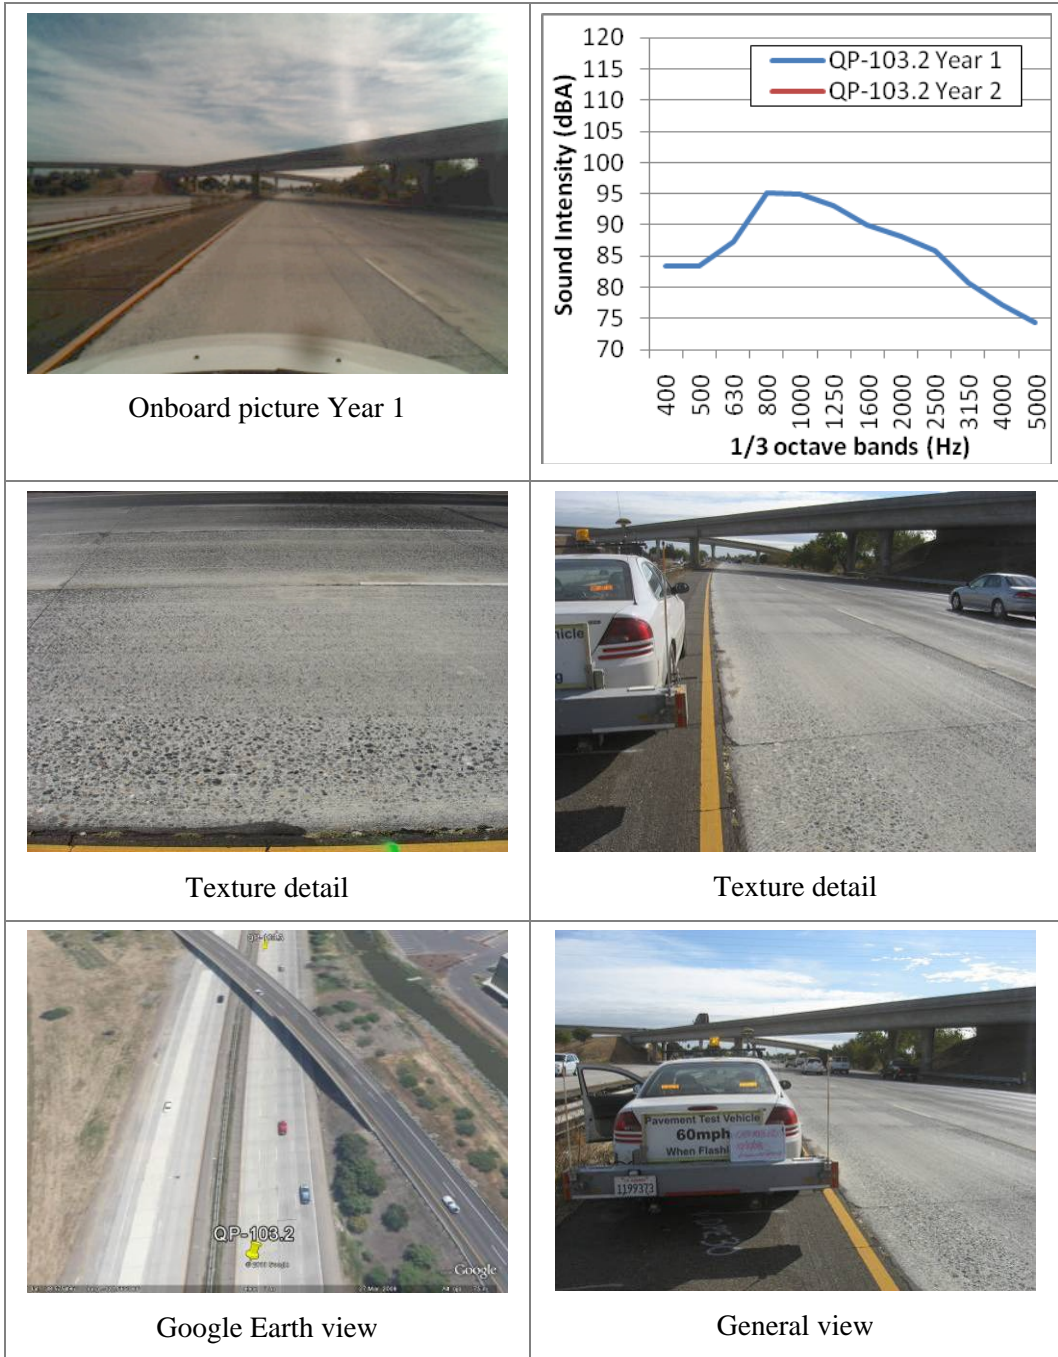
QP-103.2

Type of section: Pavement
 Location: 03Yol50E0.2
 Comments: Diamond ground.
 Surface Year: 2005

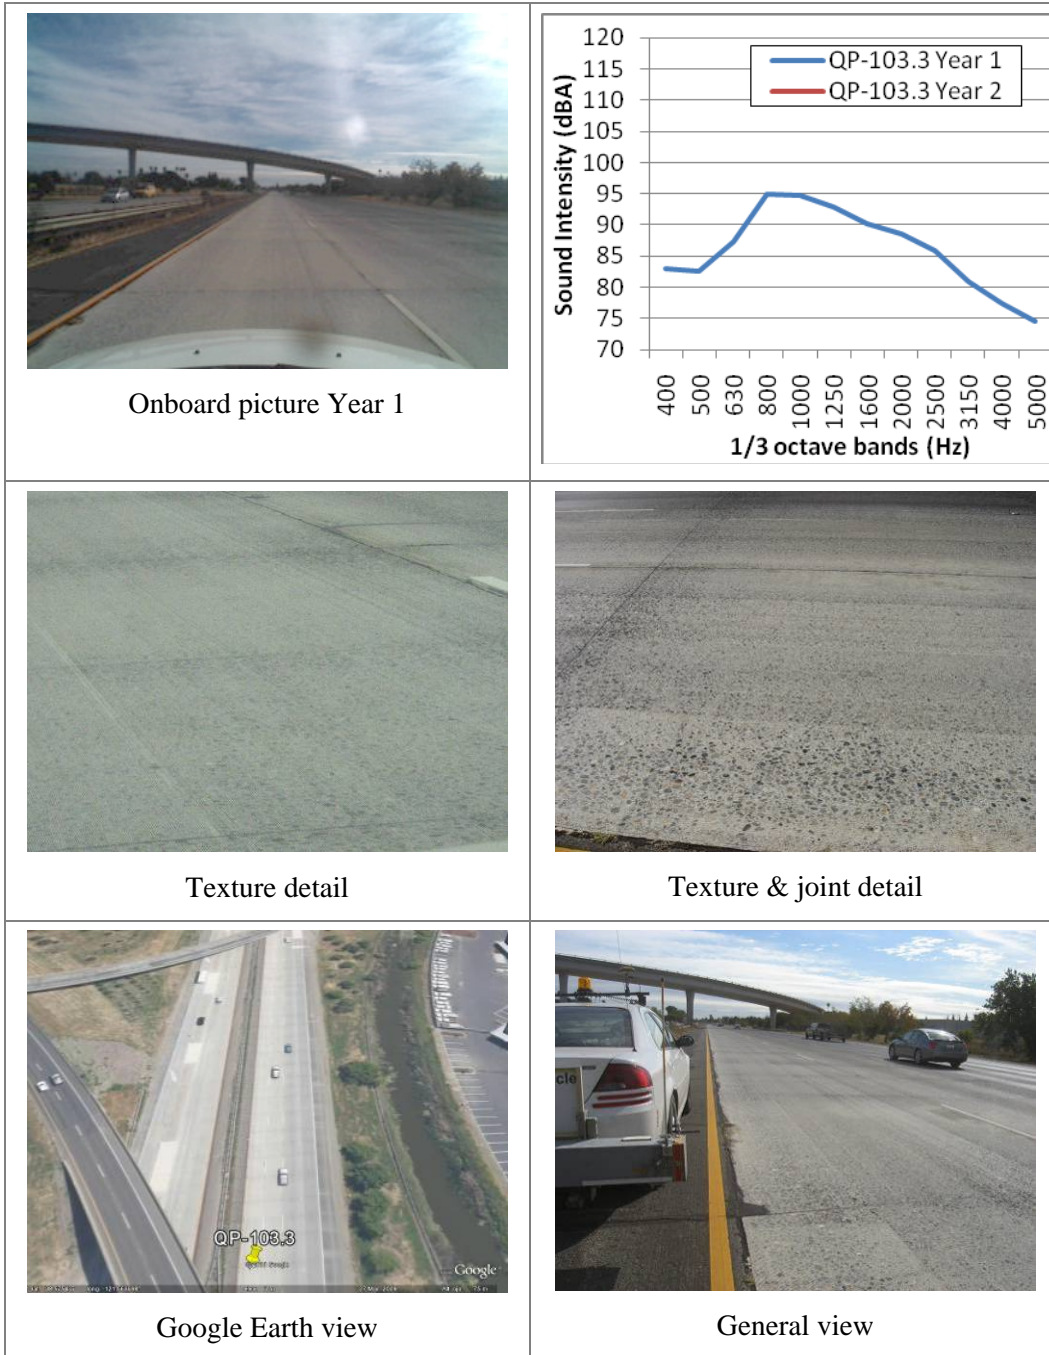
QP-103.3

Type of section: Pavement
Location: 03Yol50E0.3
Comments: Diamond ground.
Surface Year: 2005

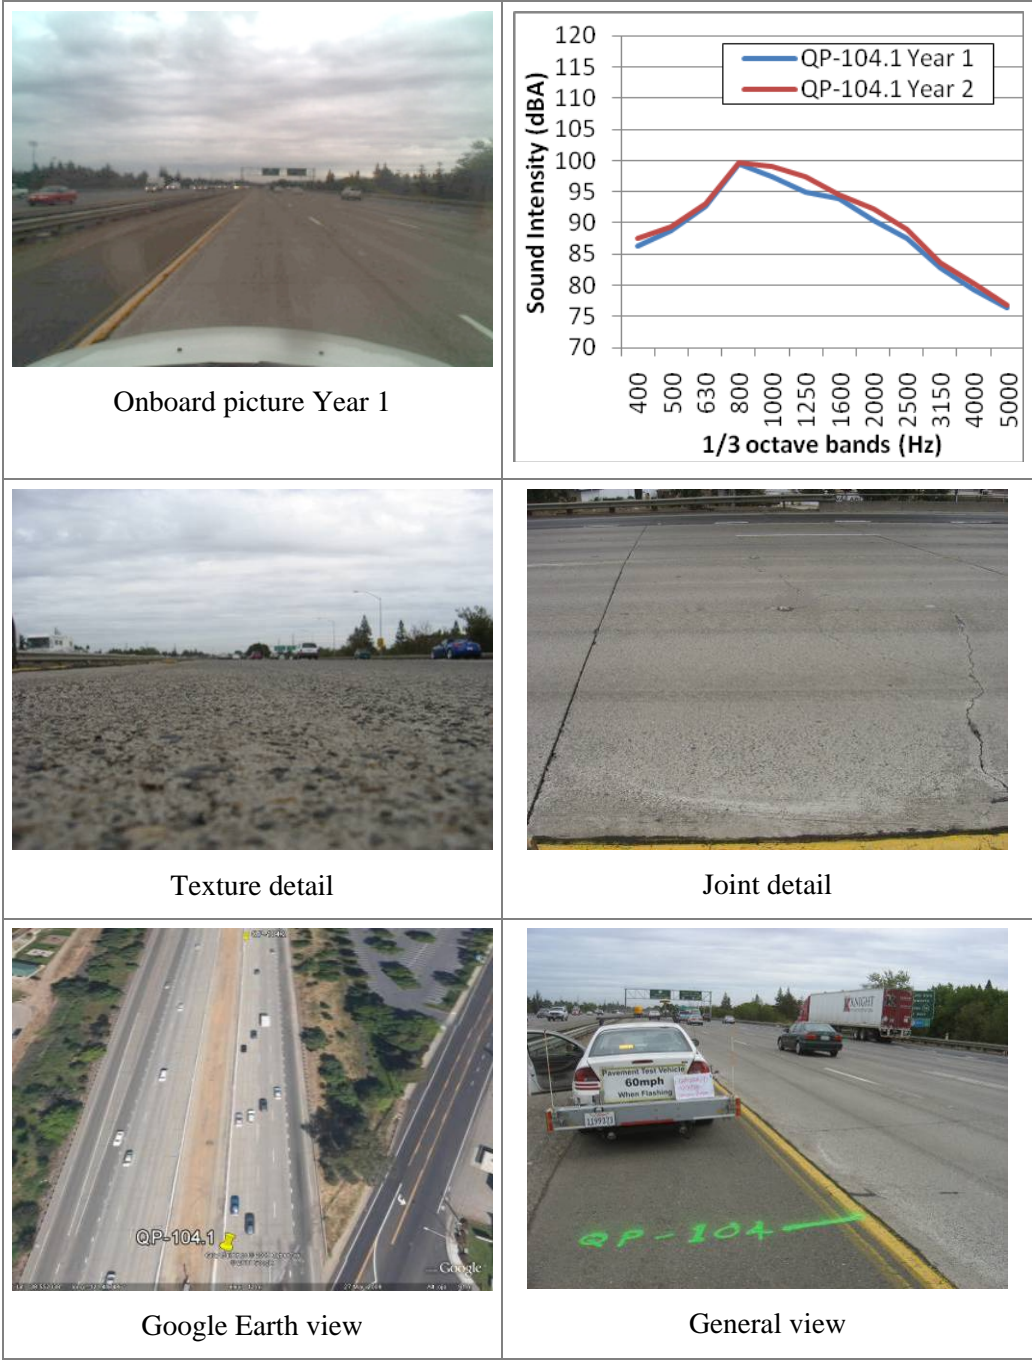
QP-104.1

Comments: Burlap drag. Worn BD.

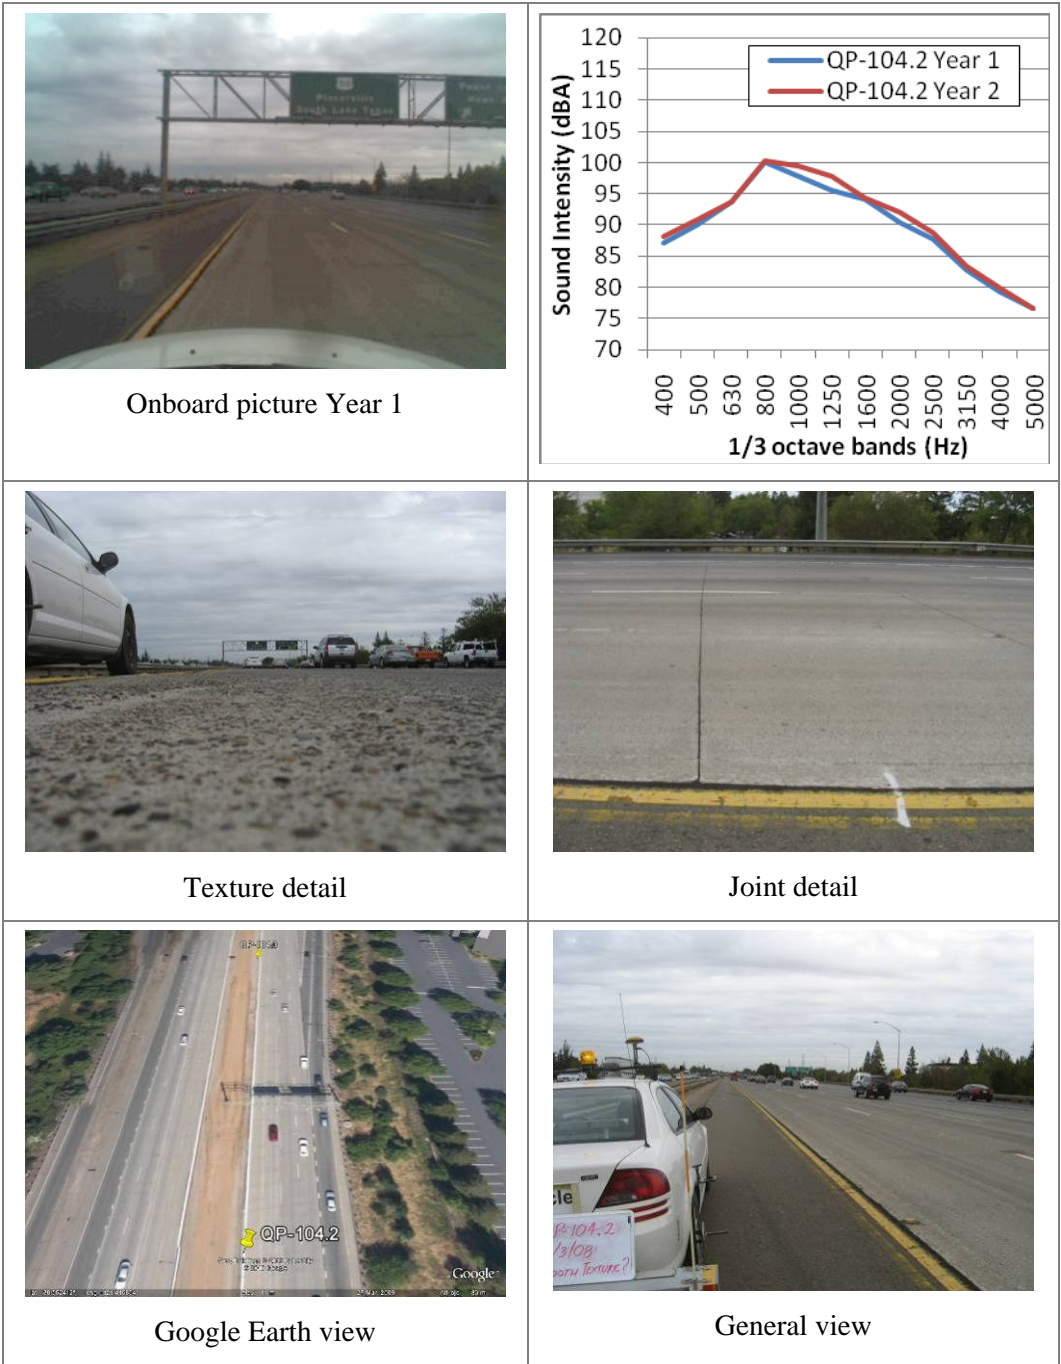
QP-104.2

Type of section: Pavement
 Location: 03Yol50E0.4
 Comments: Burlap drag.
 Surface Year: 1971

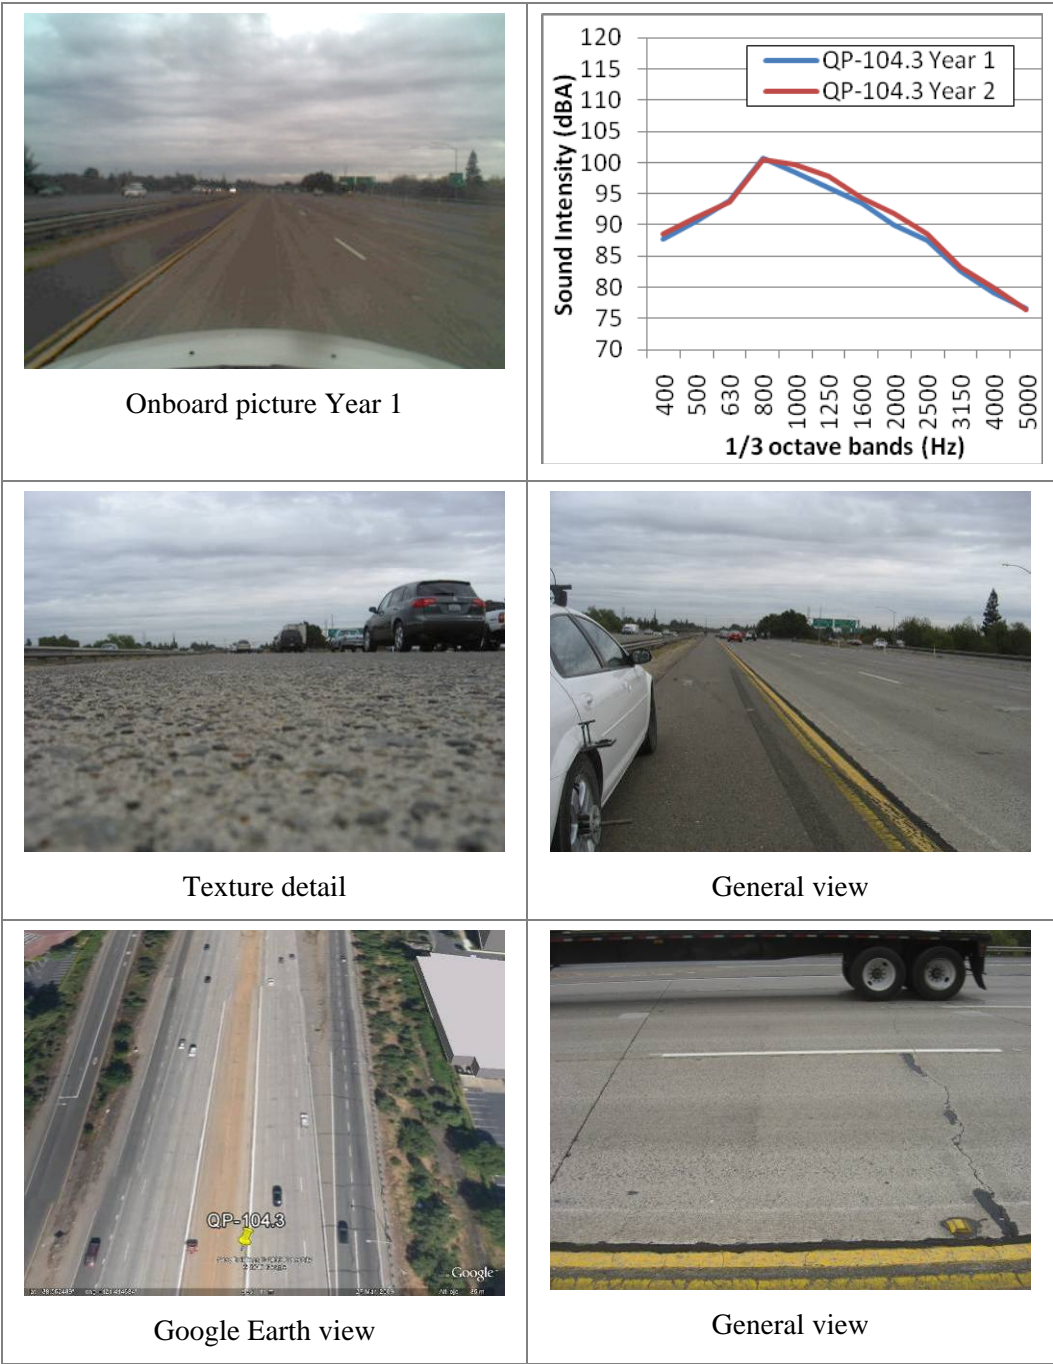
QP-104.3

Type of section: Pavement Field testing Year 1: 10/3/2008 13:56
 Location: 03Sac50E3.2 Field testing Year 2: 9/11/2009 11:12
 Comments: Burlap drag. moderately worn BD.
 Surface Year: 1971

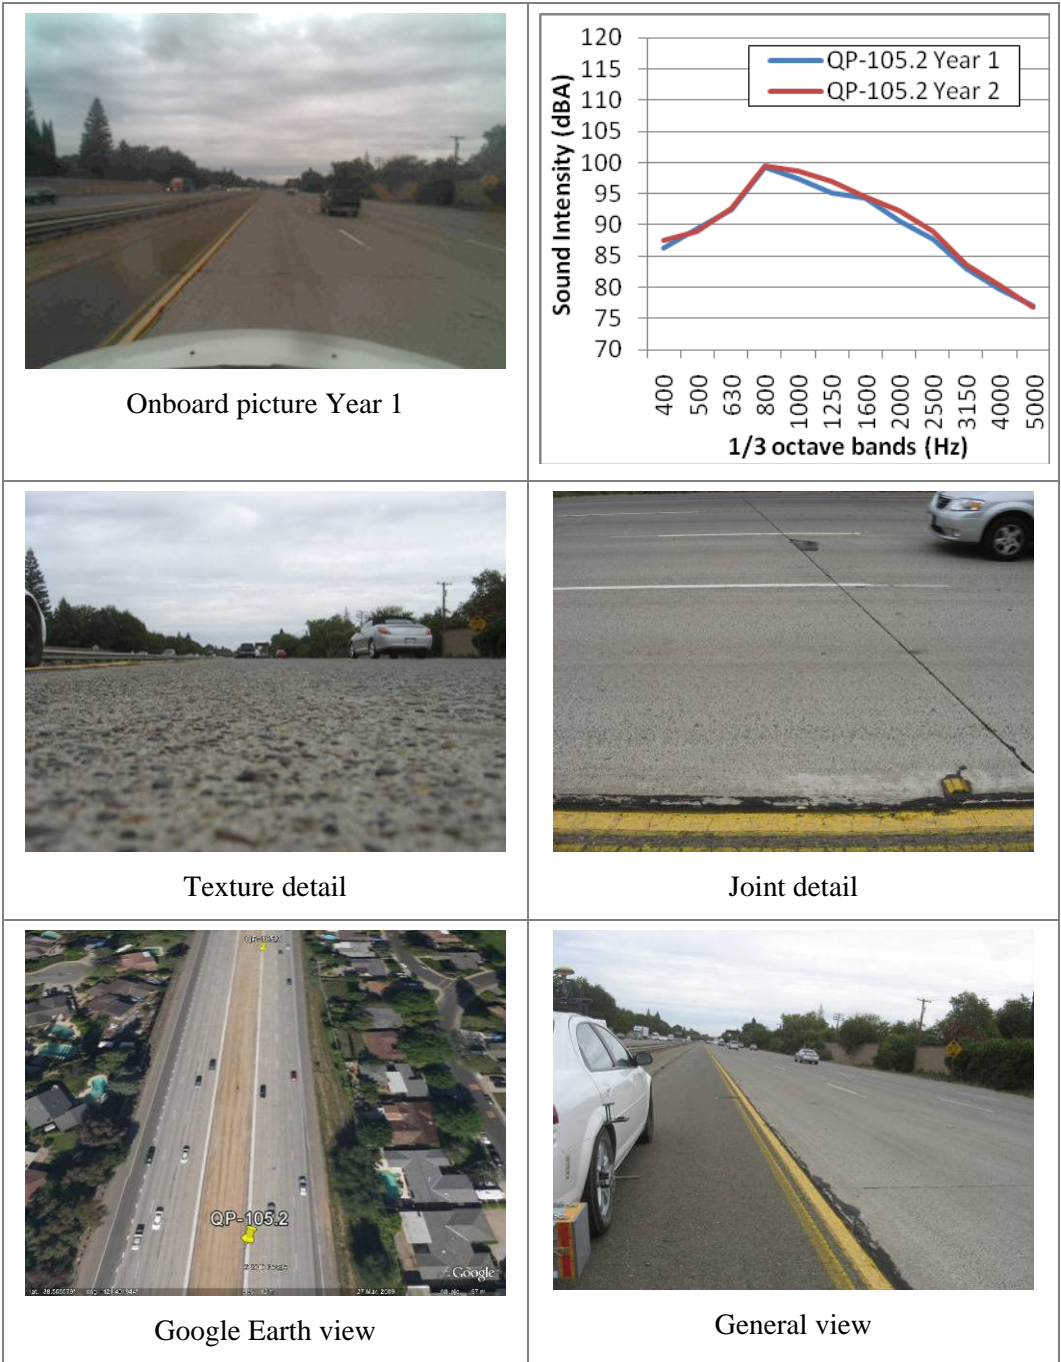
QP-105.2

Type of section: Pavement Field testing Year 1: 10/3/2008 14:11
 Location: 03Sac50E4.1 Field testing Year 2: 9/11/2009 11:55
 Comments: Burlap drag. Worn texture, unsealed joints.
 Surface Year: 1971

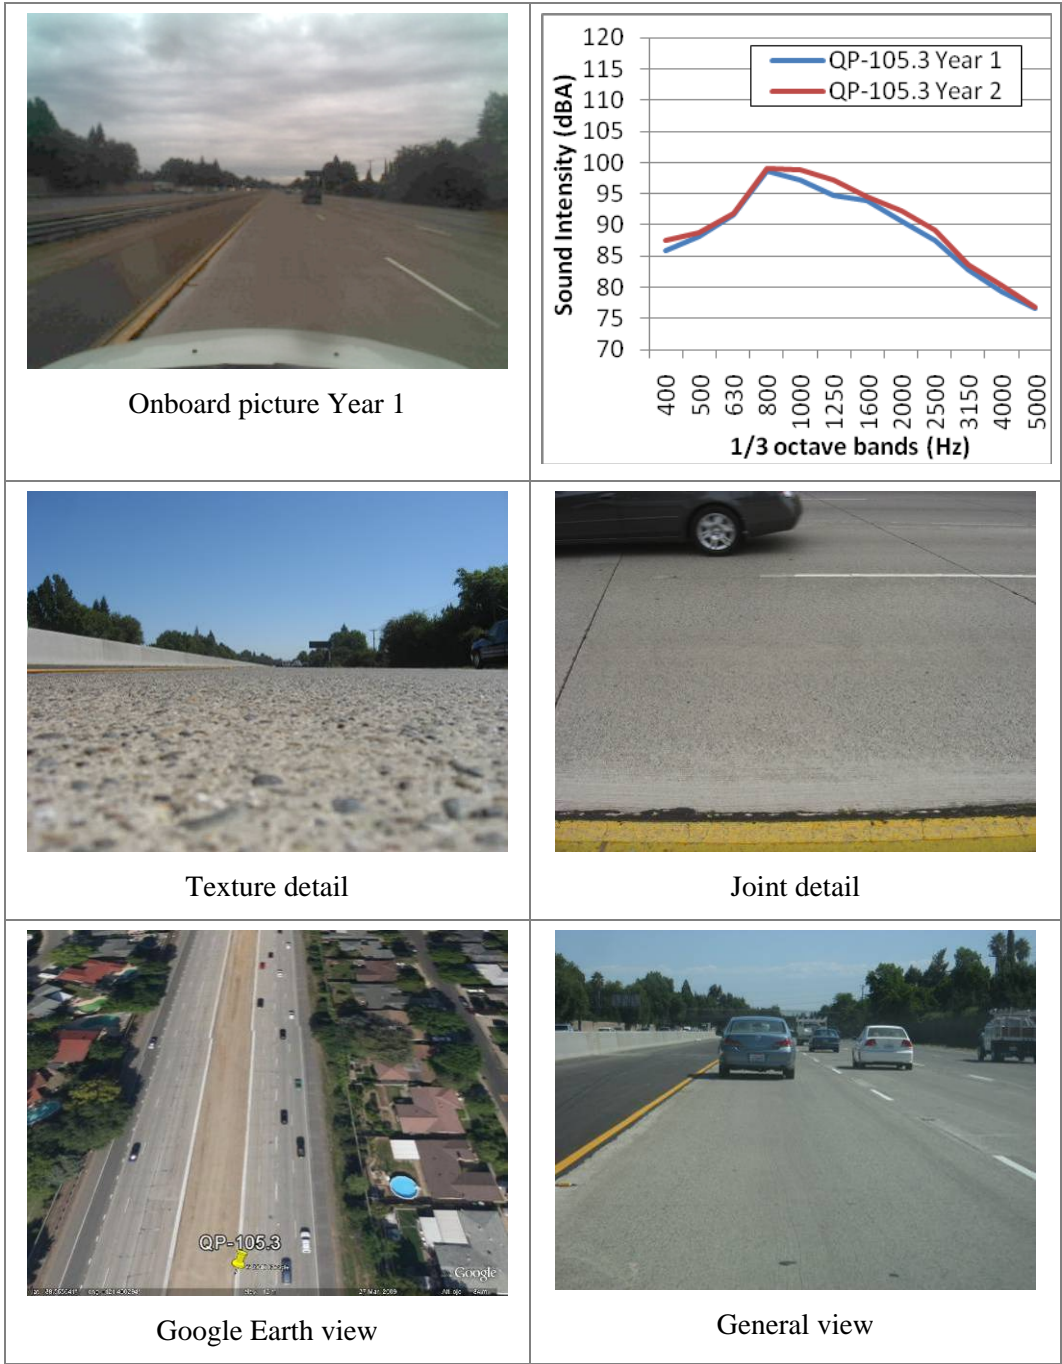
QP-105.3

Type of section: Pavement Field testing Year 1: 10/3/2008 14:46
 Location: 03Sac50E4.2 Field testing Year 2: 9/11/2009 12:06
 Comments: Burlap drag. Worn texture, unsealed joints.
 Surface Year: 1971
