Quieter Pavement Research: Concrete Pavement Tire Noise

Work Conducted as Part of Partnered Pavement Research Center Strategic Plan Element No. 4.22:
Quiet Concrete Pavement Research

DOCUMENT RETRIEVAL PAGE		UCPRC Research Report No.: UCPRC-RR-2010-03			
Title: Quieter Pavement Research: Concrete Pavement Tire Noise					
Author: E. Kohler and J. Harvey					
Prepared for: California Department of Transportation, Division of Research and Innovation, Office of Roadway Research		FHWA No.: CA121200A	Date Work Submitted: August 20, 2010	Date: May 2010	
Strategic Plan Element No.: 4.22		Status: Stage 6, final version		Version No.: 1	
<p>Abstract: This research report presents the results of tire/pavement noise measurements performed on concrete pavements as a part of the California Department of Transportation (Caltrans) Quieter Pavement Research (QPR) study to investigate tire/pavement noise characteristics on concrete pavements and bridge decks.</p> <p>The study included a total of 120 pavement sections at 47 different sites on various state highways throughout California. Most of the sites (36) were divided into three sections each for measurement and evaluation of tire/pavement nois

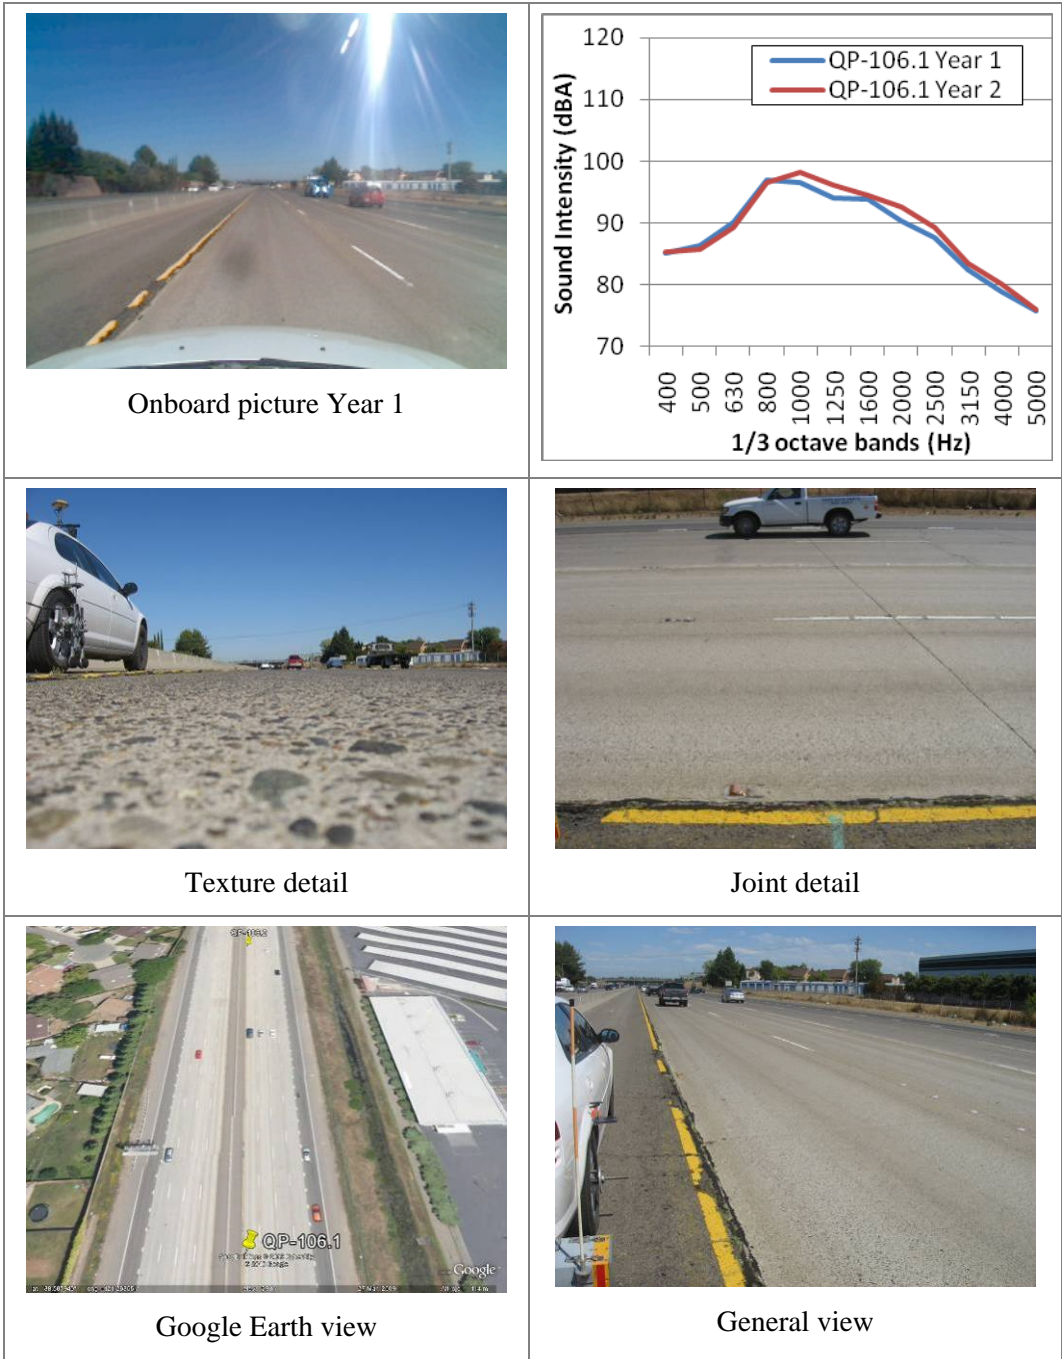
QP-106.1

Type of section: Pavement Field testing Year 1: 10/13/2008 14:48
 Location: 03Sac50E10.5 Field testing Year 2: 9/11/2009 14:11
 Comments: Burlap drag. Worn texture, unsealed joints.
 Surface Year: 1973

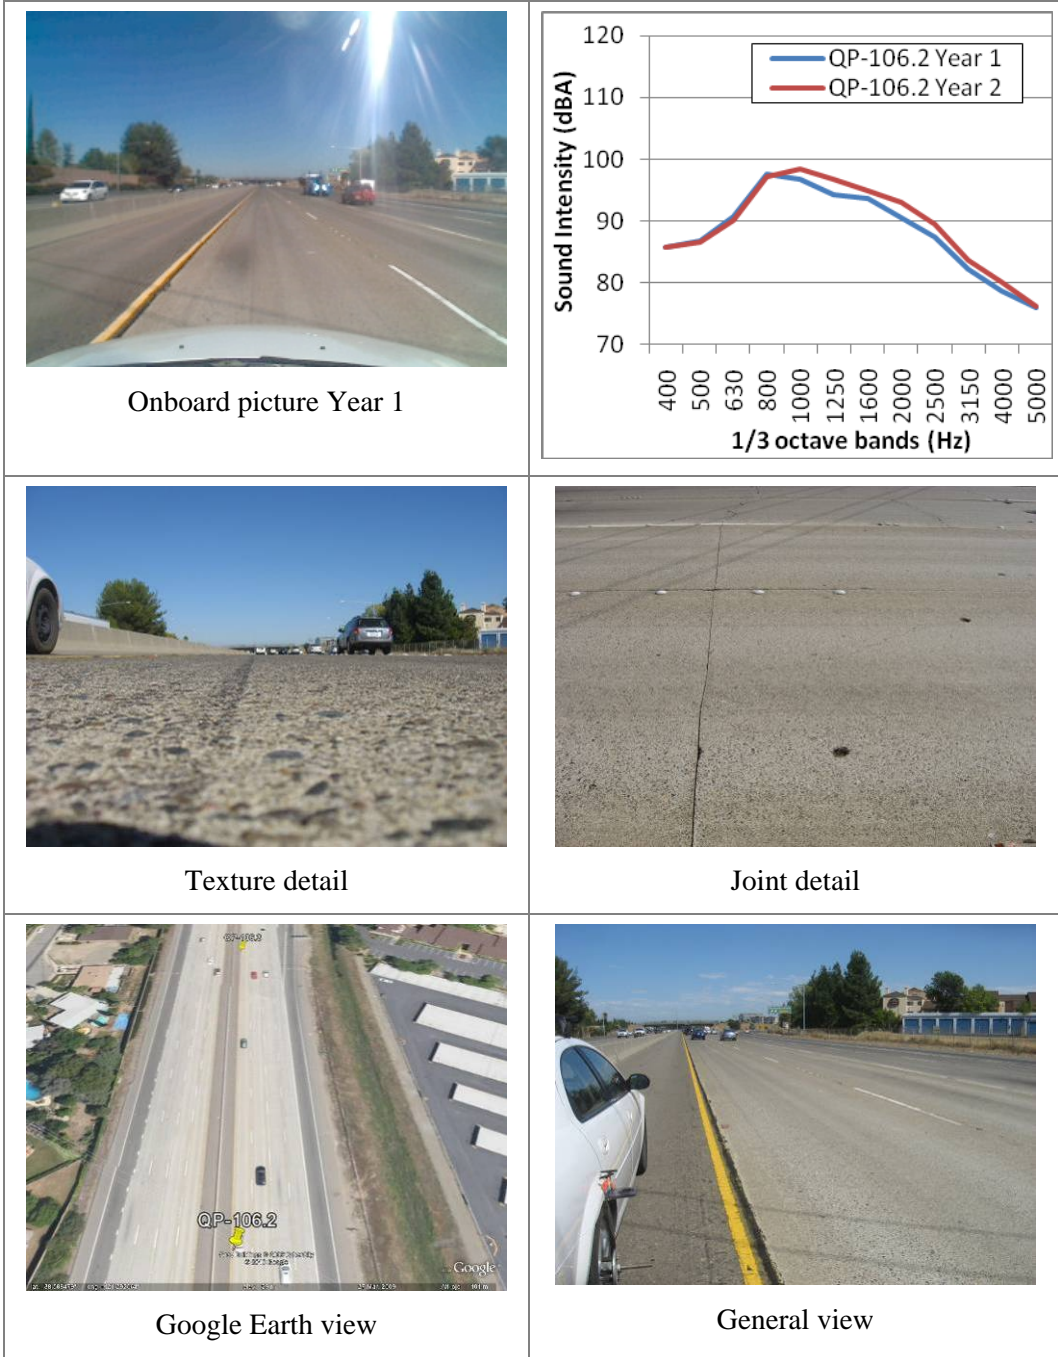
QP-106.2

Type of section: Pavement Field testing Year 1: 10/13/2008 14:55
 Location: 03Sac50E10.6 Field testing Year 2: 9/11/2009 14:36
 Comments: Burlap drag. Worn texture, unsealed joints.
 Surface Year: 1973

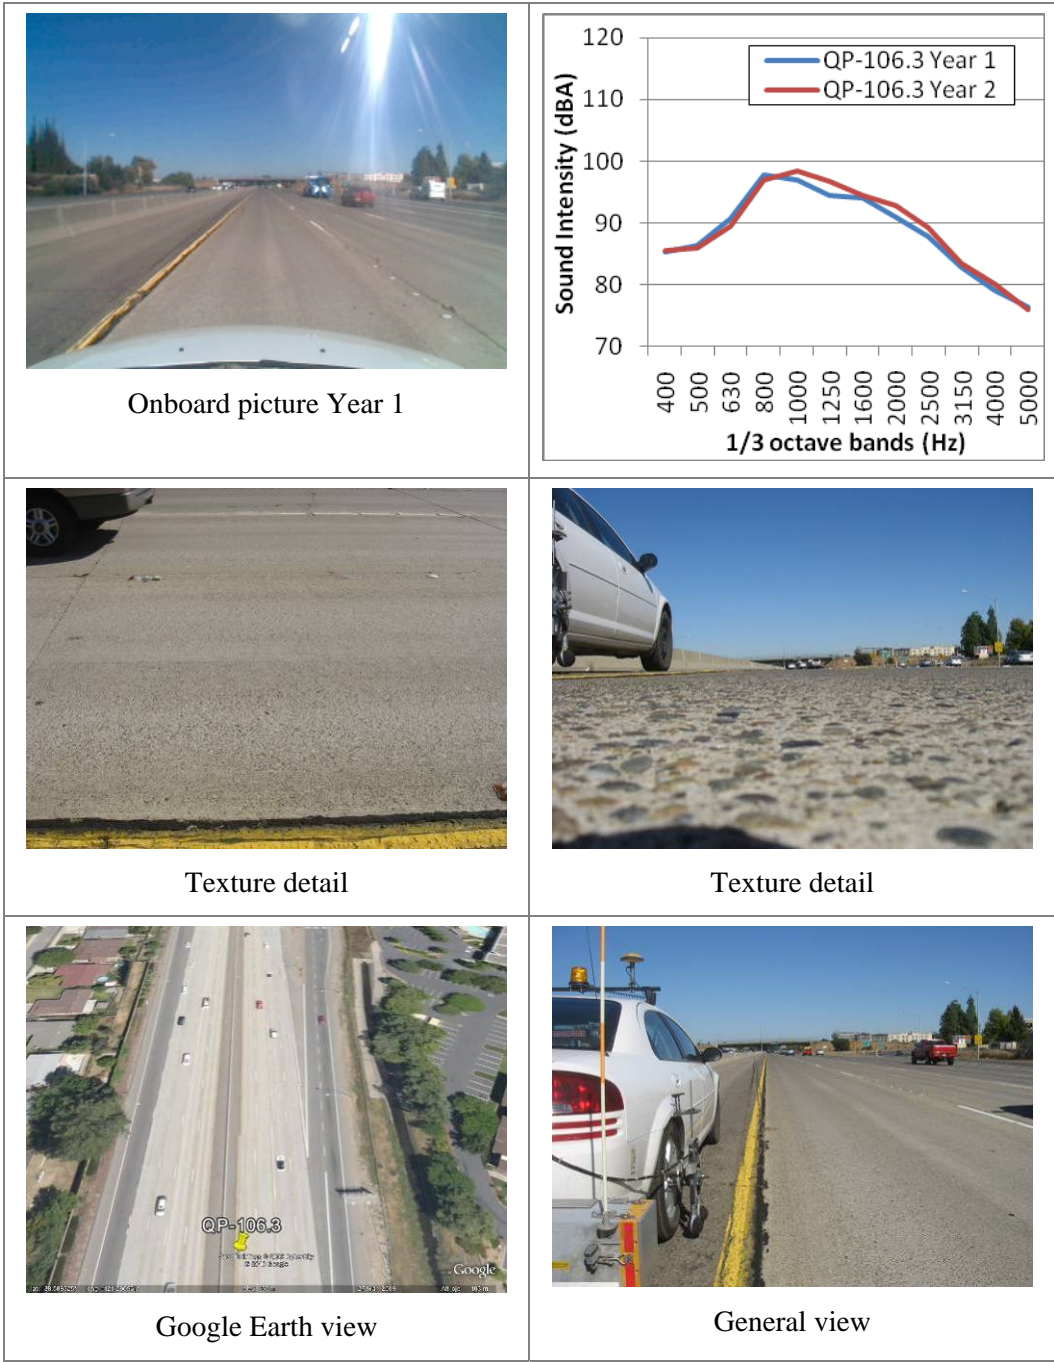
QP-106.3

Type of section: Pavement Field testing Year 1: 10/13/2008 15:14
 Location: 03Sac50E10.7 Field testing Year 2: 9/11/2009 14:42
 Comments: Burlap drag. Worn texture, unsealed joints.
 Surface Year: 1973

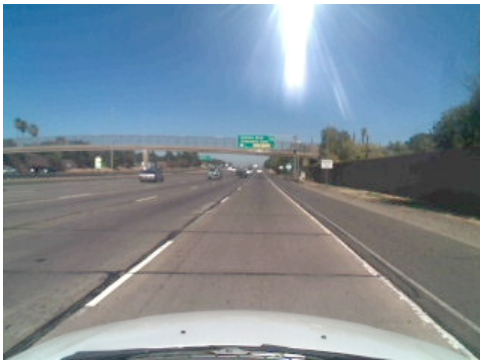
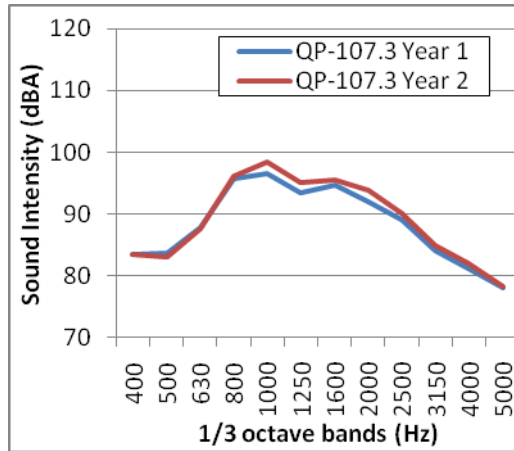
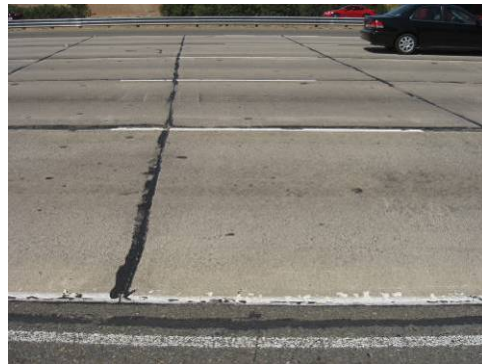
QP-107.3

Type of section: Pavement Field testing Year 1: 10/16/2008 14:36
 Location: 03Sac80E13.8 Field testing Year 2: 9/9/2009 13:18
 Comments: Burlap drag. Shallow texture.
 Surface Year: 1973

Onboard picture Year 1

Texture detail

Joint detail

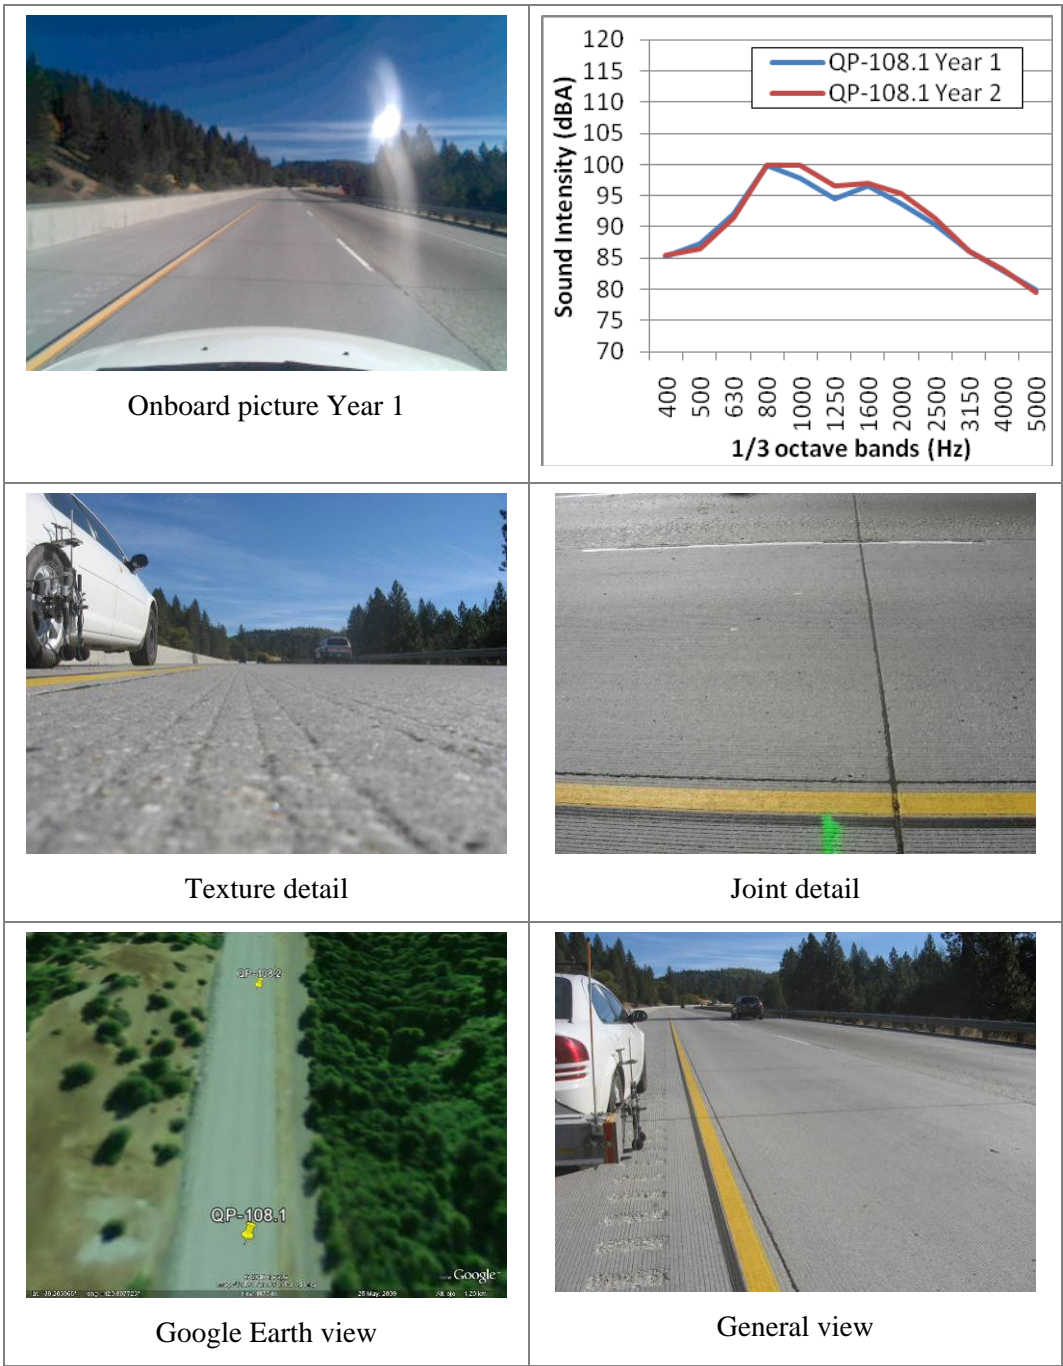
QP-108.1

Type of section: Pavement Field testing Year 1: 10/21/2008 11:24
 Location: 03Pla80E45.0 Field testing Year 2: 9/16/2009 12:26
 Comments: Longitudinally tined. Shallow texture, worn out.
 Surface Year: 2004

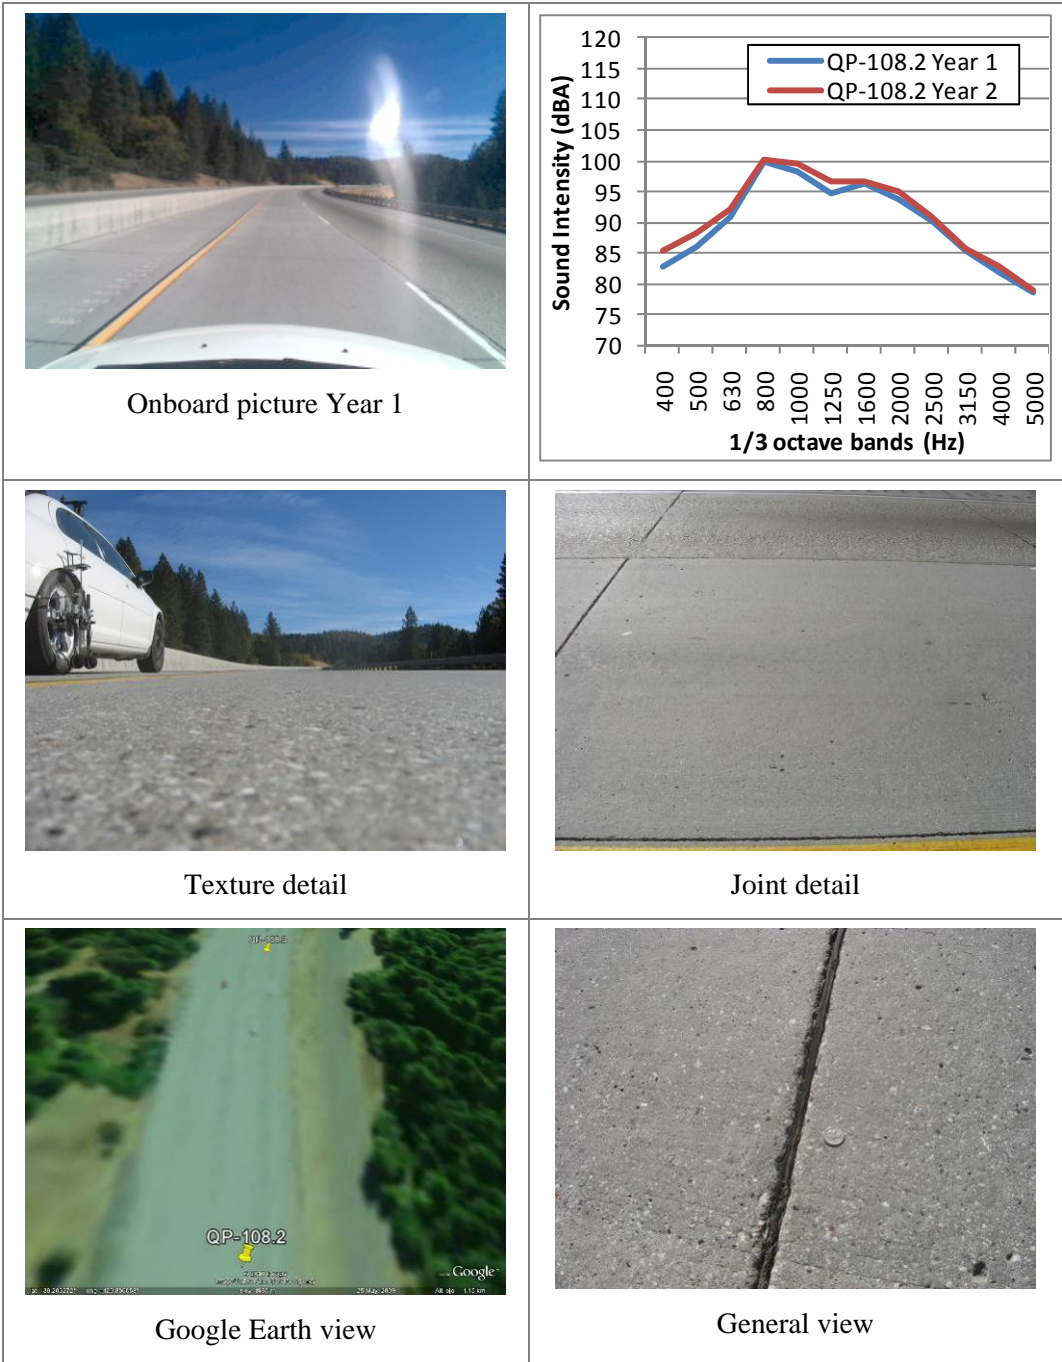
QP-108.2

Type of section: Pavement Field testing Year 1: 10/21/2008 11:42
 Location: 03Pla80E45.1 Field testing Year 2: 9/16/2009 12:35
 Comments: Longitudinally tined. Texture shallower than 108.1.
 Surface Year: 2004

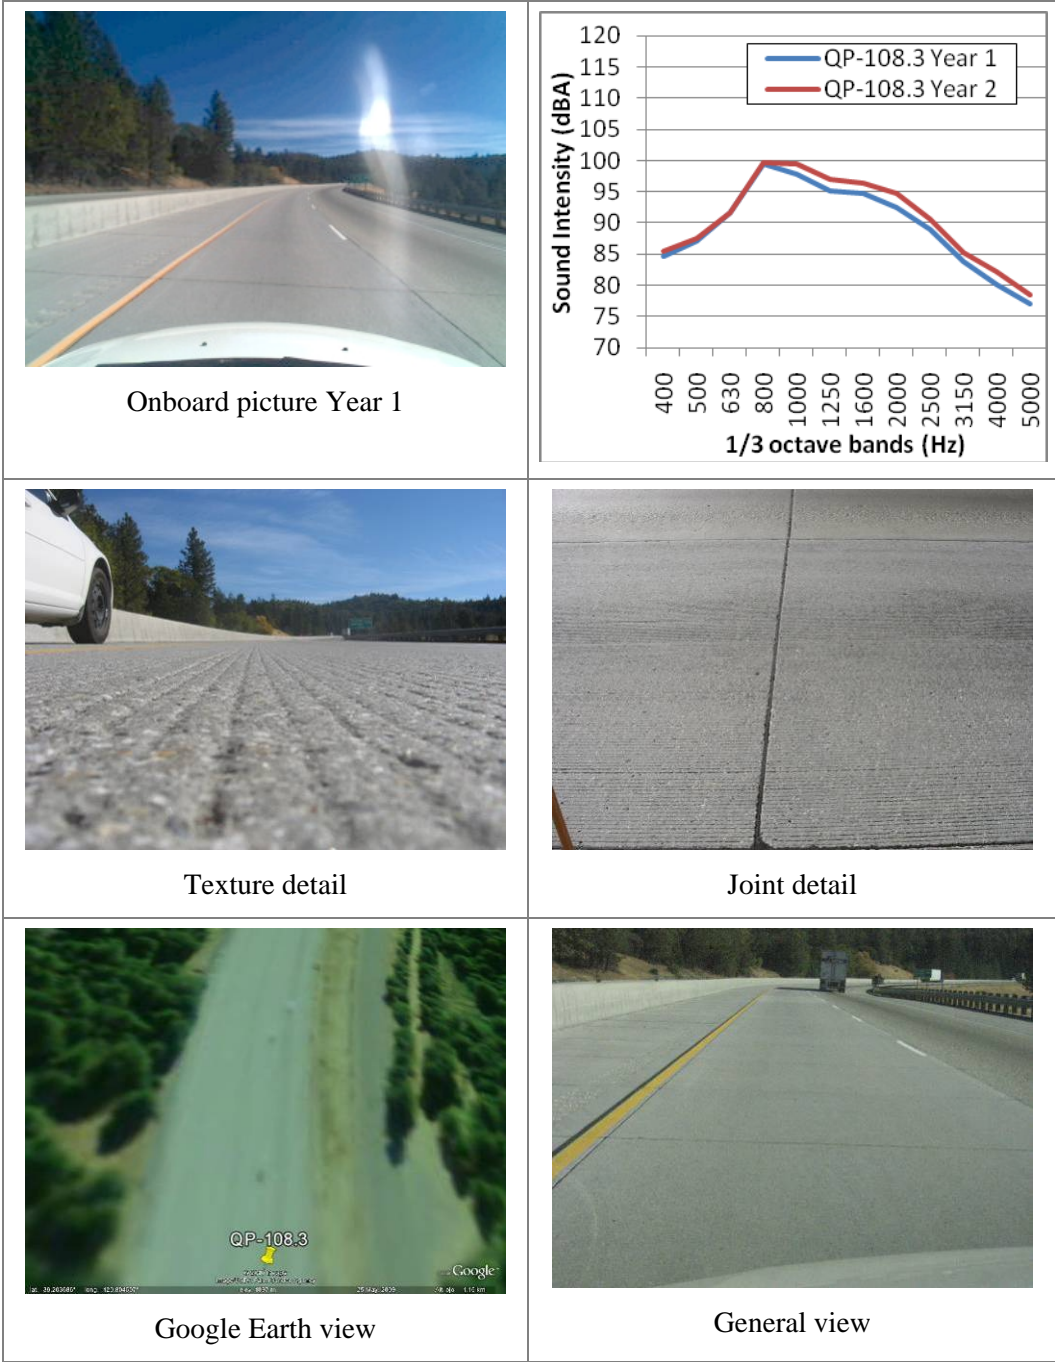
QP-108.3

Type of section: Pavement Field testing Year 1: 10/21/2008 11:48
 Location: 03Pla80E45.2 Field testing Year 2: 9/16/2009 12:45
 Comments: Longitudinally tined. Texture deeper than 108.1.
 Surface Year: 2004

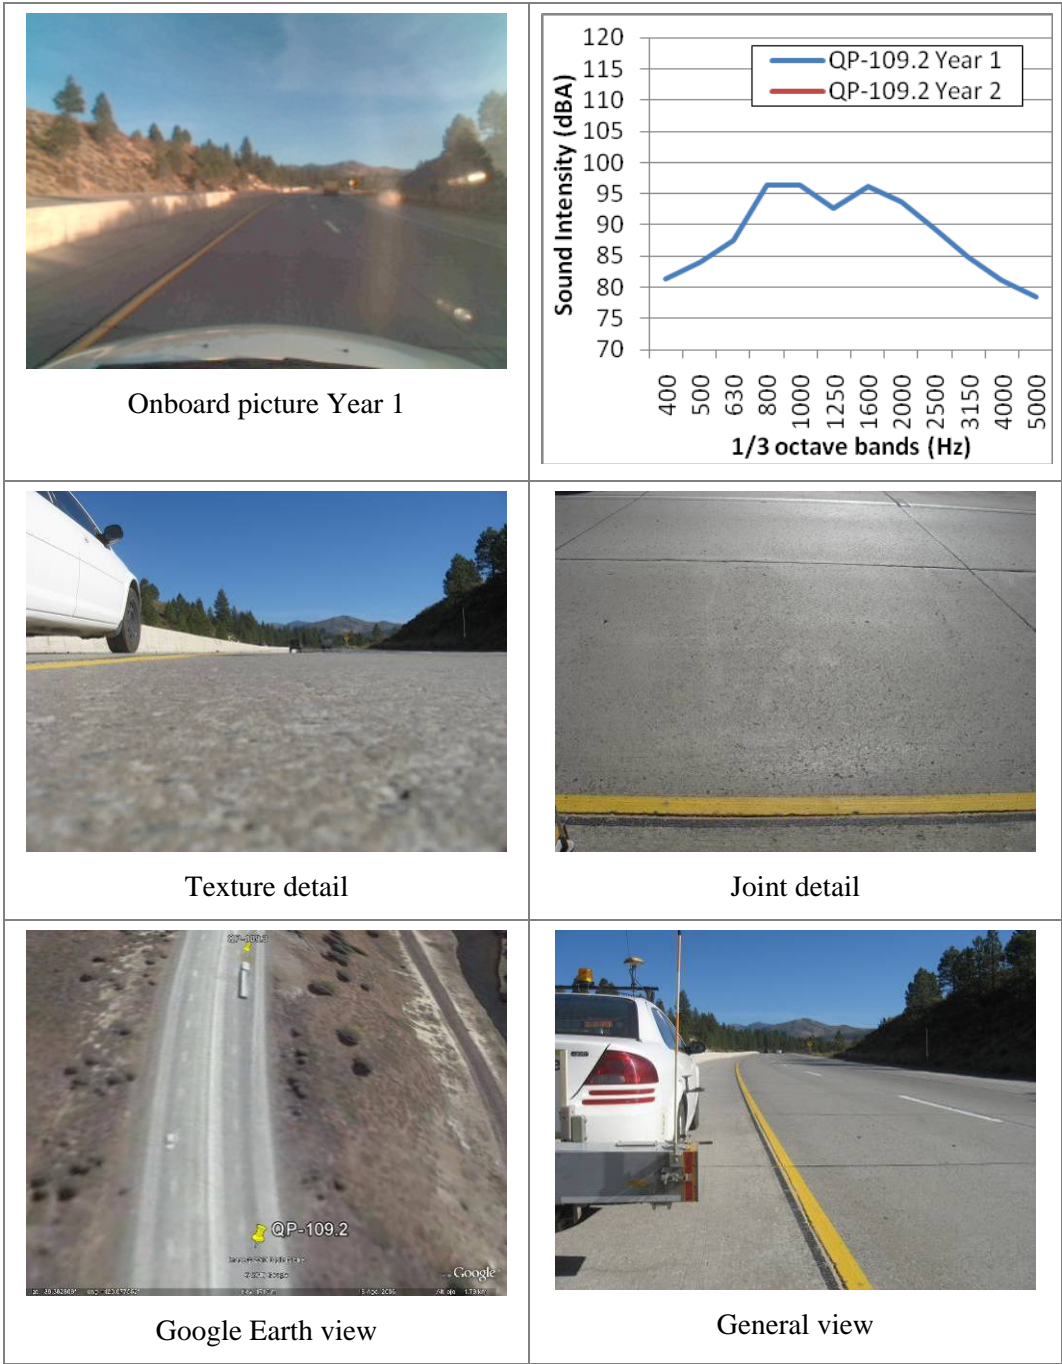
QP-109.2

Type of section: Pavement Field testing Year 1: 10/21/2008 17:24
 Location: 03Nev80E22.6 Field testing Year 2:
 Comments: Longitudinally broomed. Worn out texture.
 Surface Year: 1989

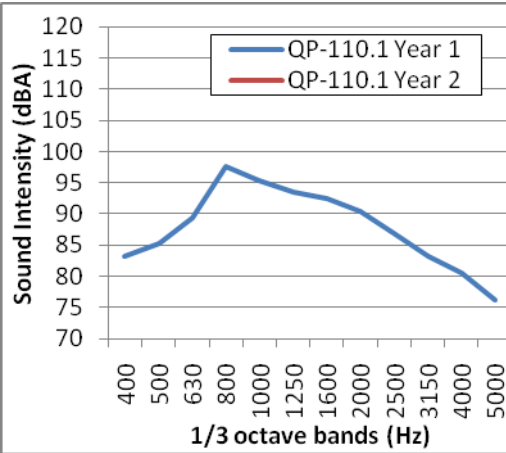
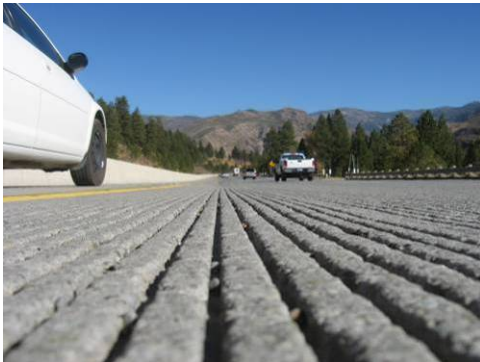
Texture detail

Comments: Diamond grooved.

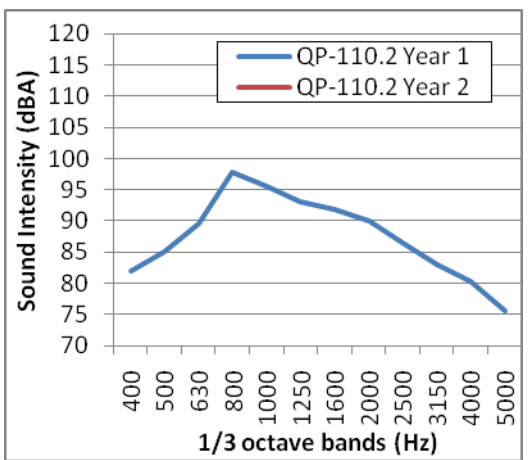
Texture detail

Comments: Diamond grooved.

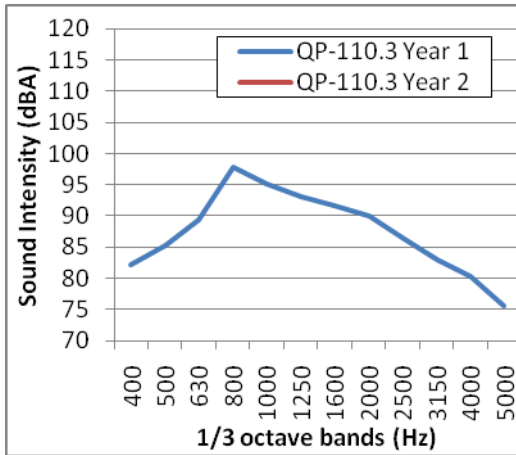
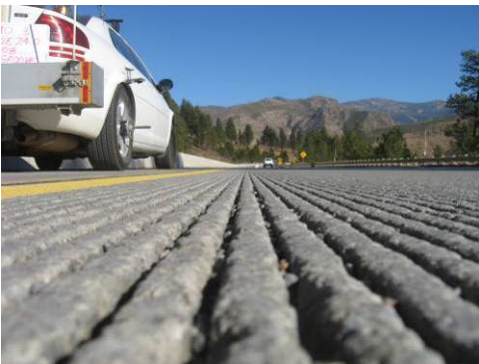
Texture detail

Comments: Diamond grooved.

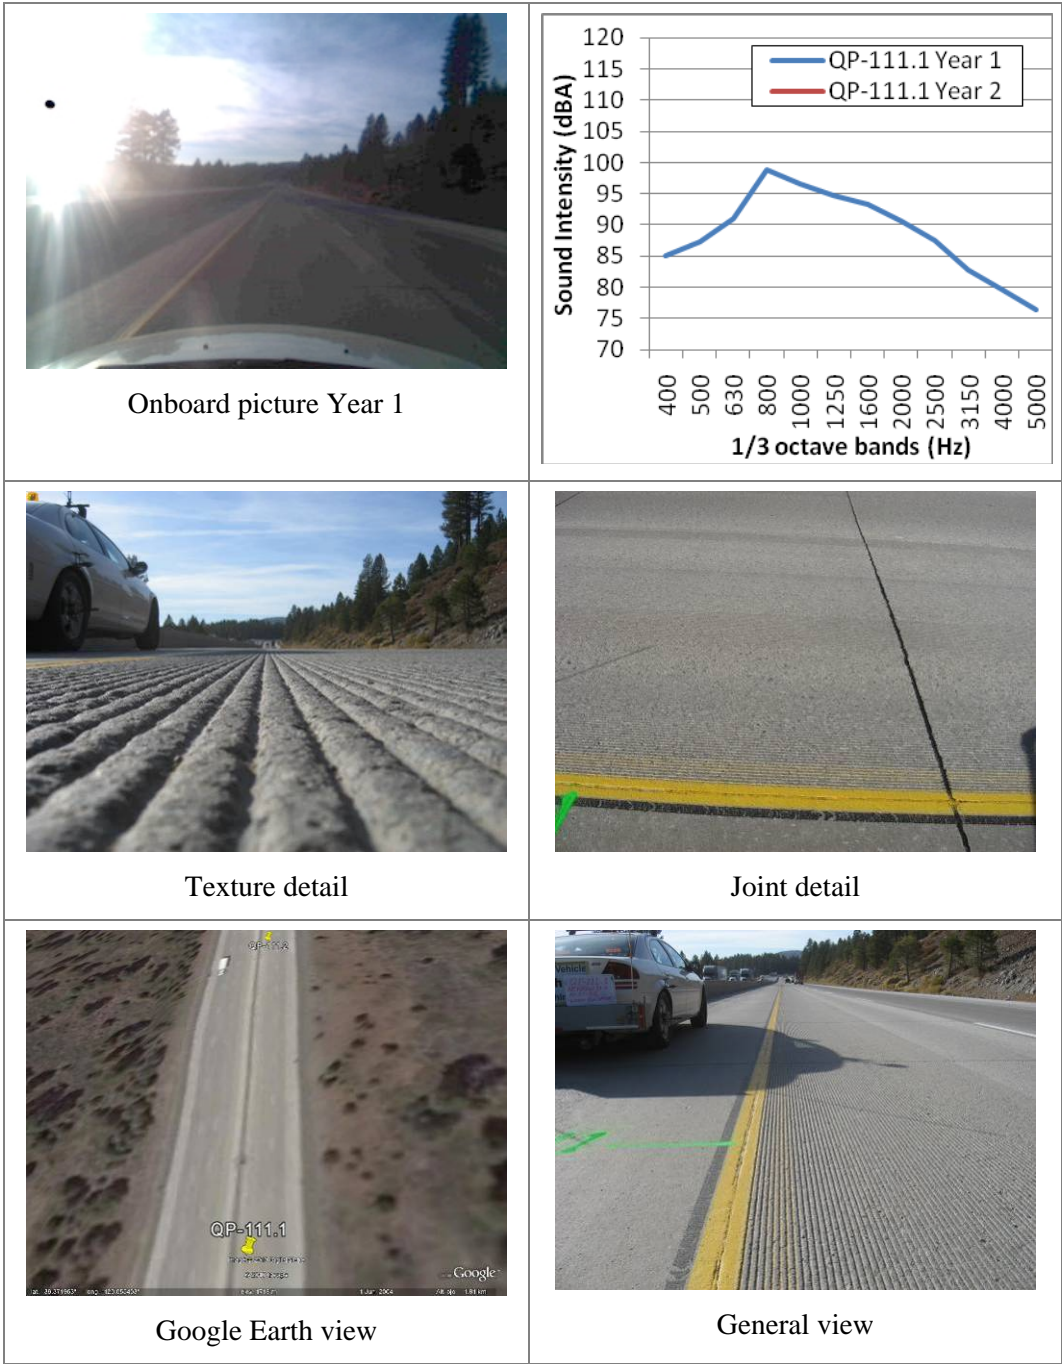
QP-111.1

Comments: Diamond grooved.

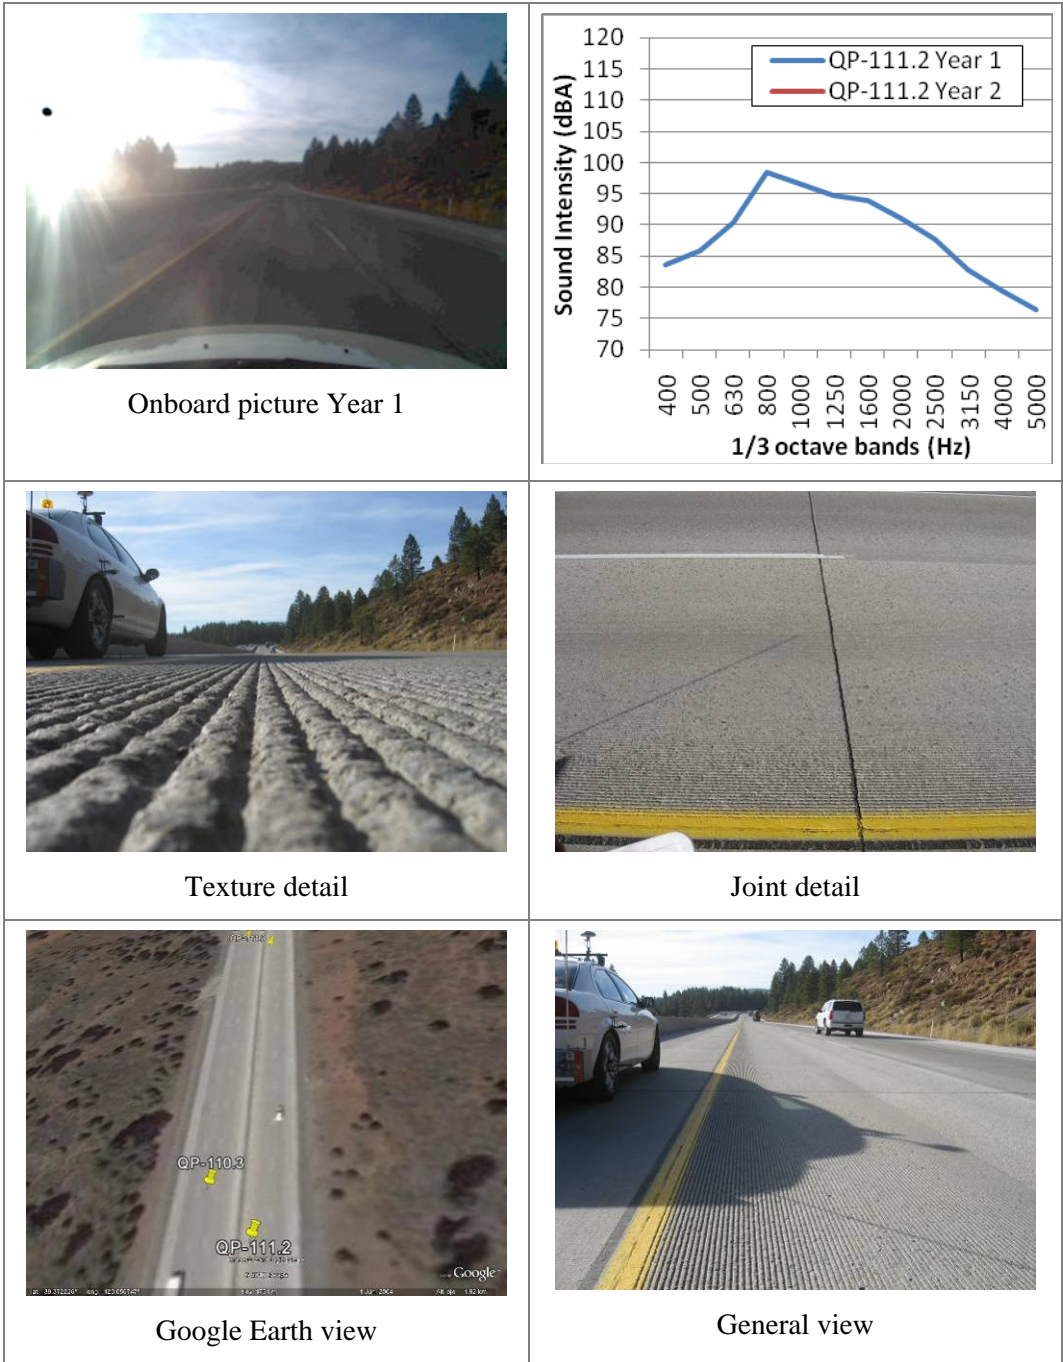
QP-111.2

Comments: Diamond grooved.

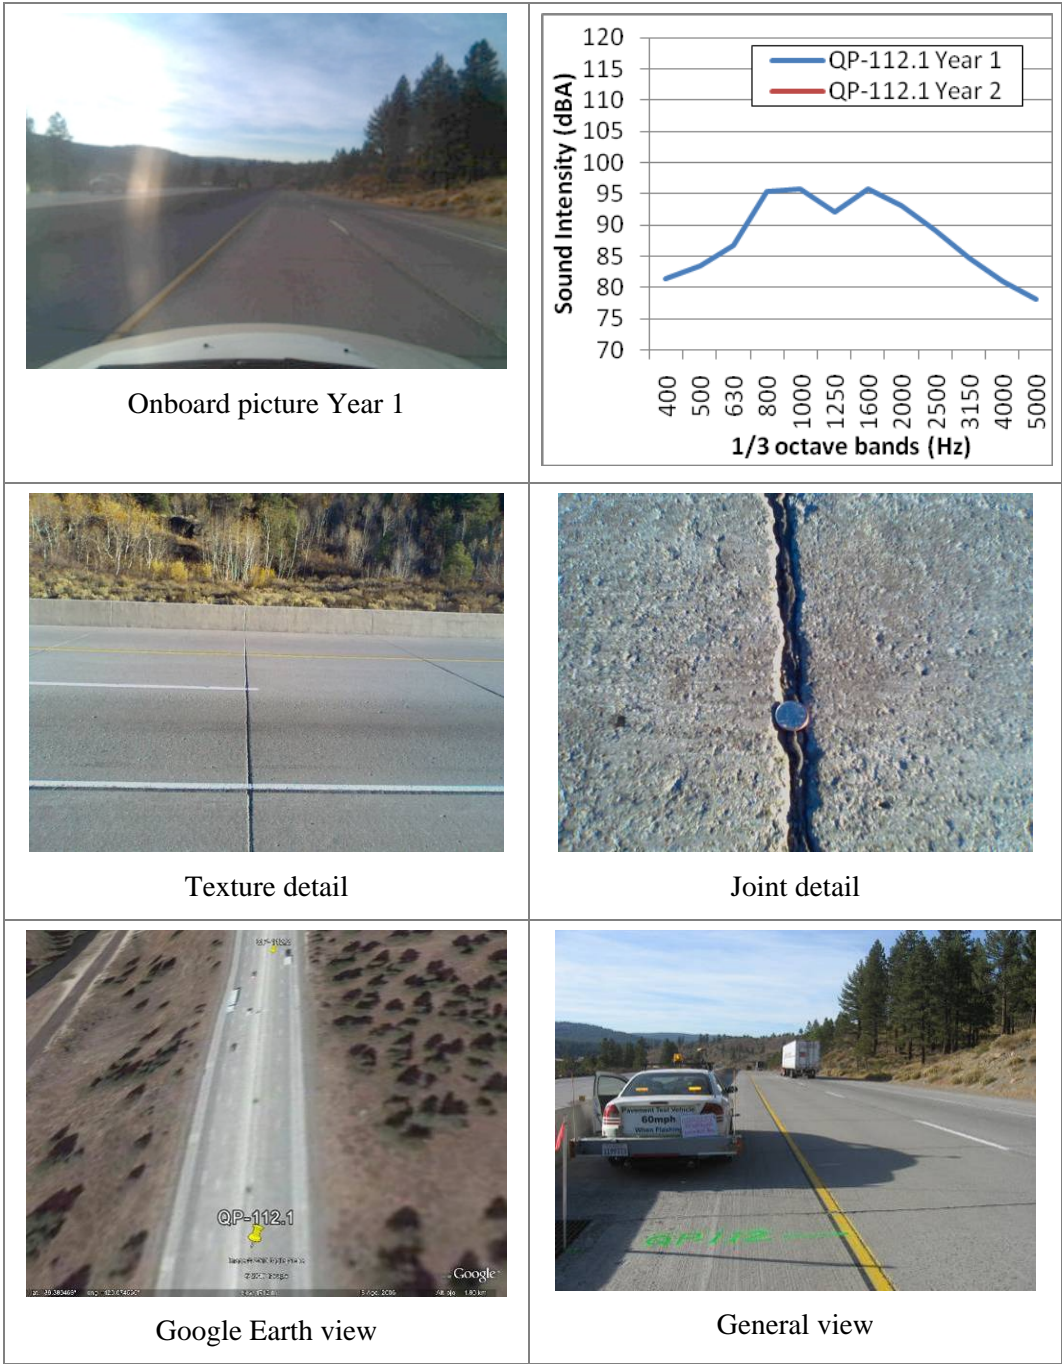
QP-112.1

Type of section: Pavement Field testing Year 1: 10/21/2008 17:21
 Location: 03Nev80W23.0 Field testing Year 2:
 Comments: Longitudinally broomed. Uneven wear along section. Wide joints.
 Surface Year: 1989

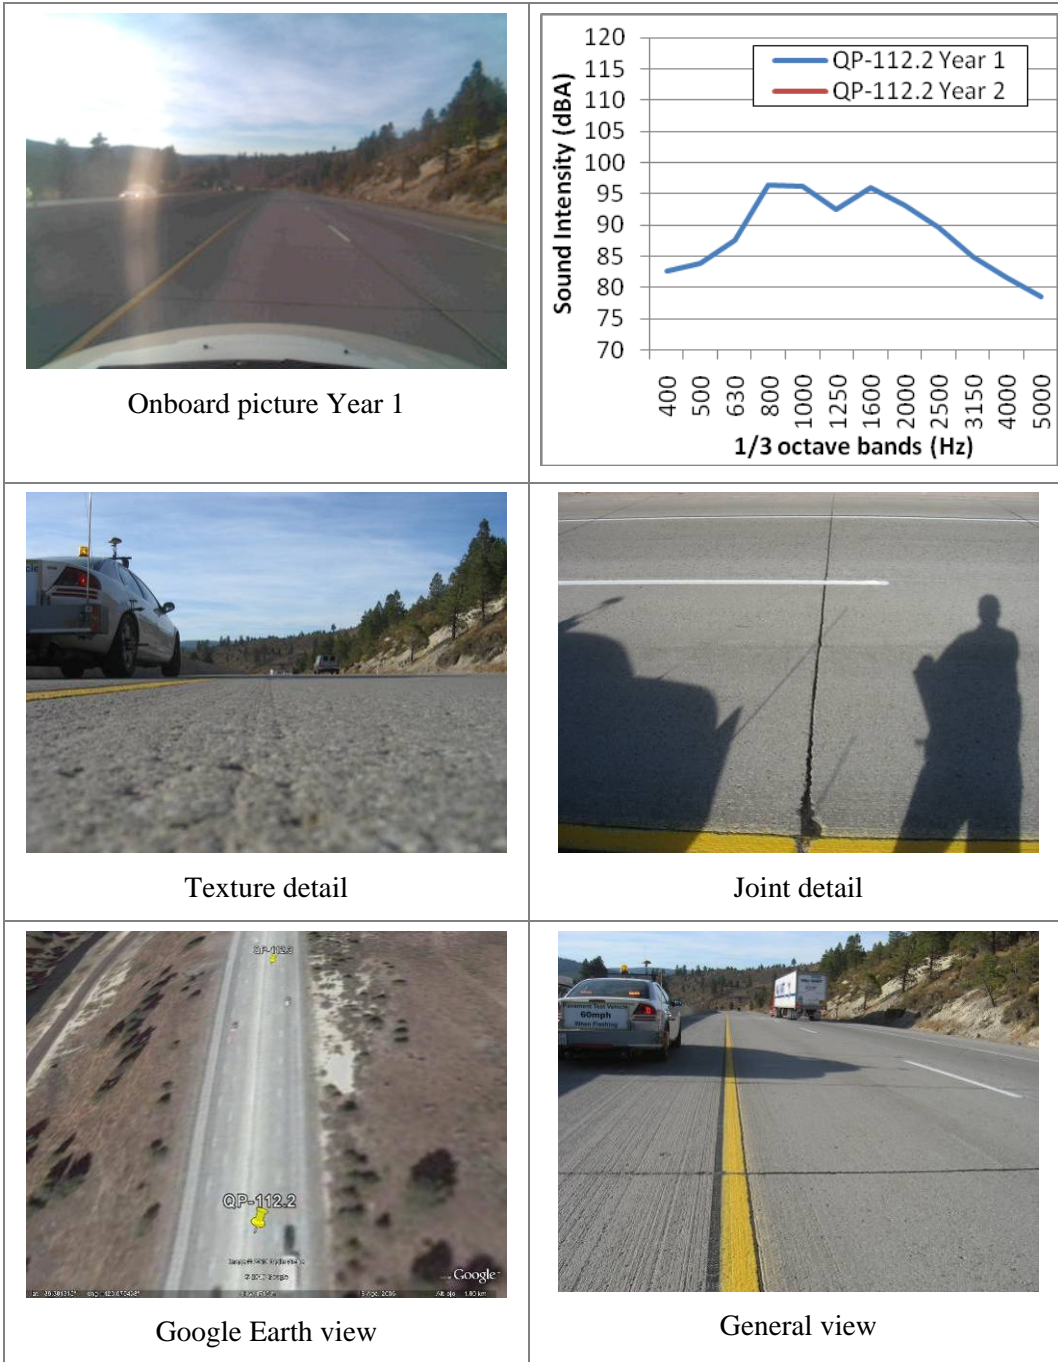
QP-112.2

Comments: Longitudinally broomed. Uneven wear along section. Wide joints.

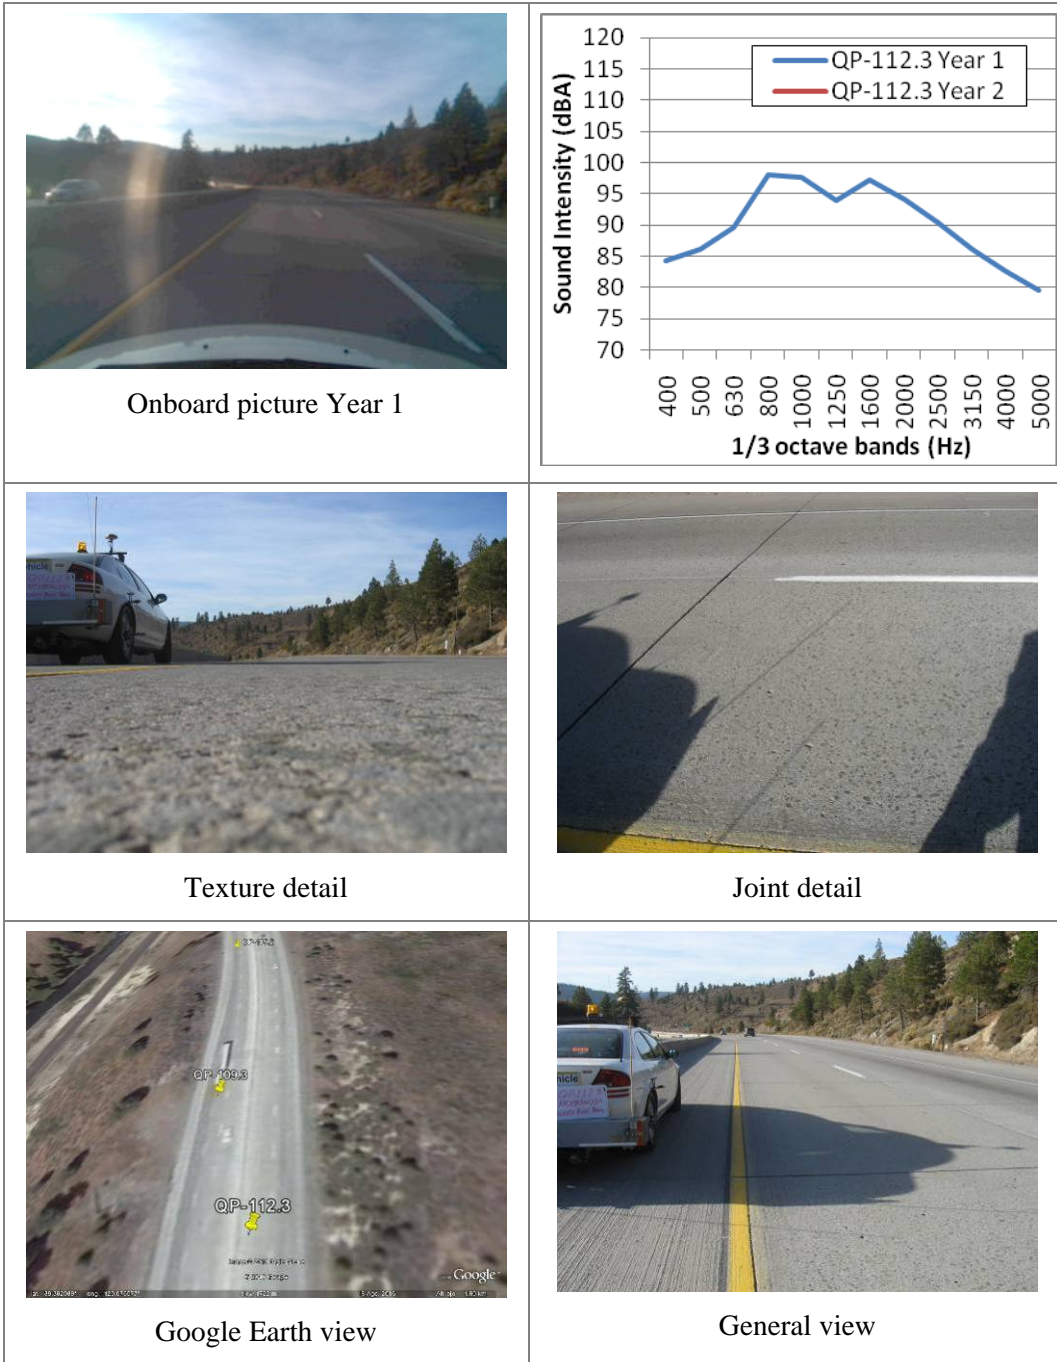
QP-112.3

Type of section: Pavement Field testing Year 1: 10/21/2008 17:45
 Location: 03Nev80W22.8 Field testing Year 2:
 Comments: Longitudinally broomed. Uneven wear along section. Wide joints.
 Surface Year: 1989

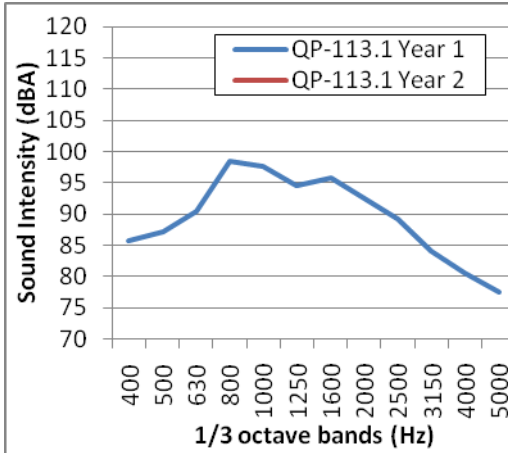
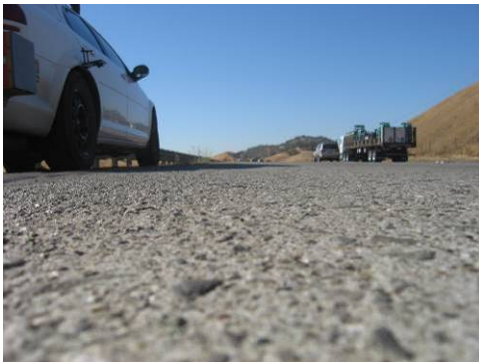
Texture detail

Comments: Burlap drag. Worn out texture.

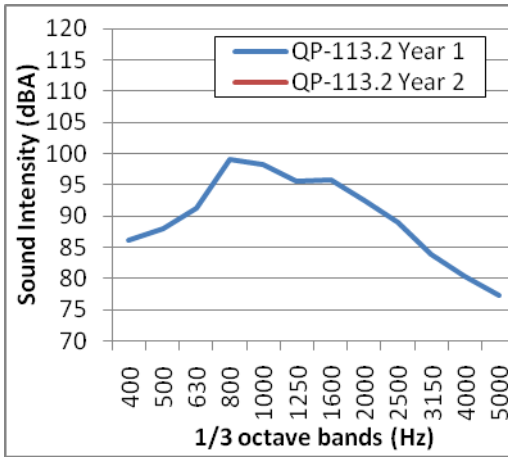
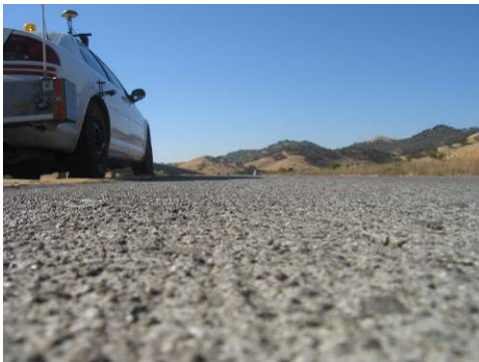
Texture detail

Comments: Burlap drag. Worn out texture.

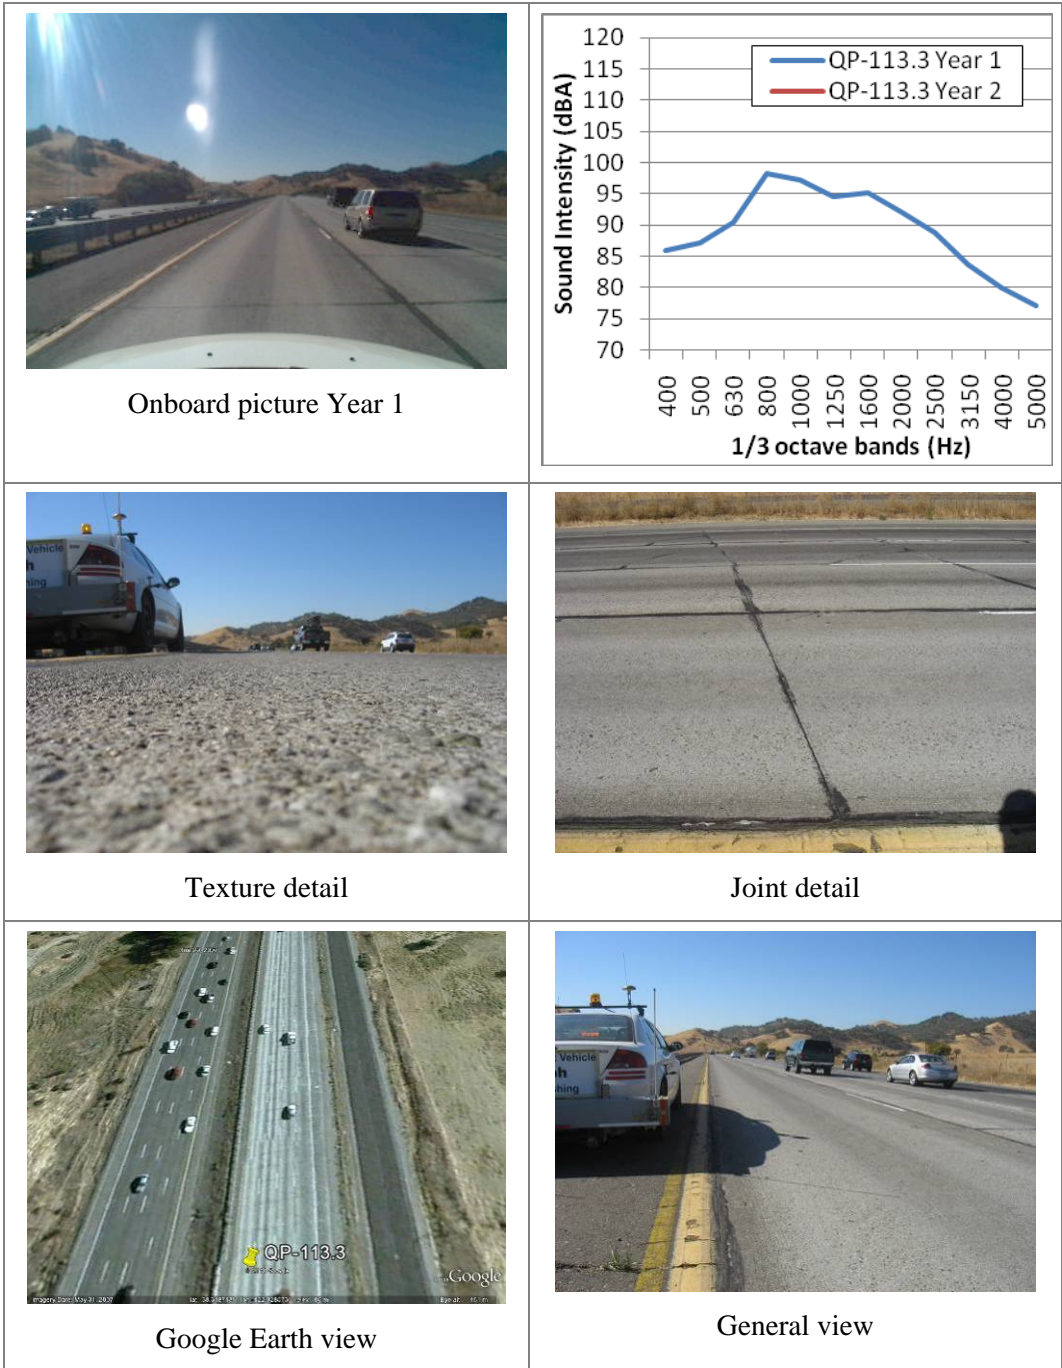
QP-113.3

Type of section: Pavement Field testing Year 1: 10/23/2008 12:54
 Location: 03Yol80W22.7 Field testing Year 2:
 Comments: Burlap drag. Worn out texture.
 Surface Year: 1965

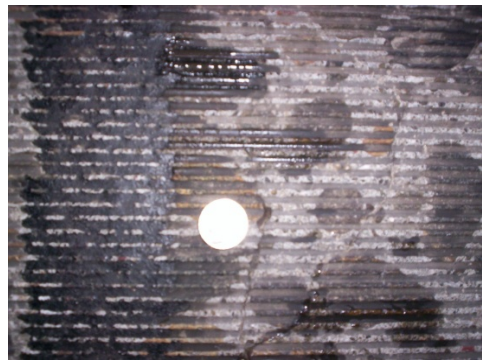
Texture detail

Type of section: Pavement Field testing Year 1: 10/23/2008 15:31
Location: 04Sol80W18.5 Field testing Year 2:
Comments: Diamond ground. Right wheelpath on DG CRCP.
Surface Year: 1999

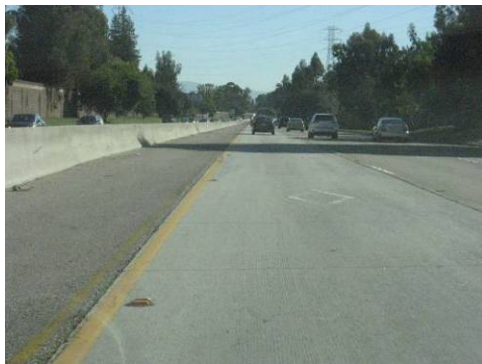
Texture detail

Comments: Longitudinally tined.

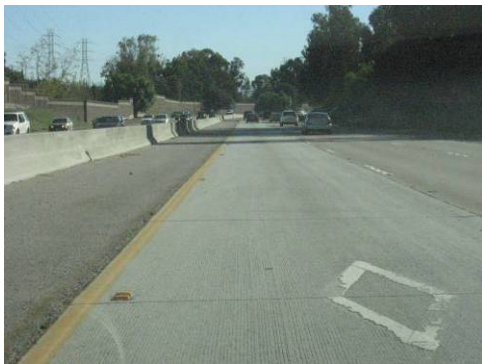
Texture detail

Comments: Diamond ground. Pre-existing longitudinal tining.

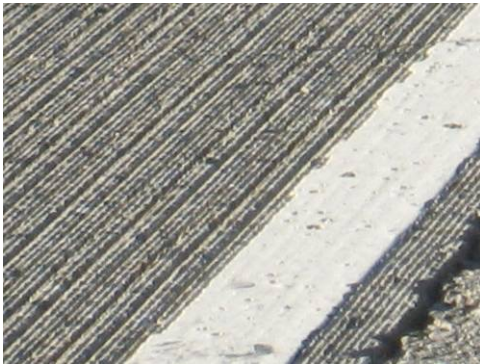
Texture detail

Type of section: Pavement Field testing Year 1: 11/7/2008 15:46
 Location: 04SCL85N14.10 Field testing Year 2: 11/18/2009 15:15
 Comments: Diamond ground. Pre-existing longitudinal tining.
 Surface Year: 2006
