Quieter Pavement Research: Concrete Pavement Tire Noise

Work Conducted as Part of Partnered Pavement Research Center Strategic Plan Element No. 4.22:
Quiet Concrete Pavement Research

DOCUMENT RETRIEVAL PAGE		UCPRC Research Report No.: UCPRC-RR-2010-03			
Title: Quieter Pavement Research: Concrete Pavement Tire Noise					
Author: E. Kohler and J. Harvey					
Prepared for: California Department of Transportation, Division of Research and Innovation, Office of Roadway Research		FHWA No.: CA121200A	Date Work Submitted: August 20, 2010	Date: May 2010	
Strategic Plan Element No.: 4.22		Status: Stage 6, final version		Version No.: 1	
<p>Abstract: This research report presents the results of tire/pavement noise measurements performed on concrete pavements as a part of the California Department of Transportation (Caltrans) Quieter Pavement Research (QPR) study to investigate tire/pavement noise characteristics on concrete pavements and bridge decks.</p> <p>The study included a total of 120 pavement sections at 47 different sites on various state highways throughout California. Most of the sites (36) were divided into three sections each for measurement and evaluation of tire/pavement nois

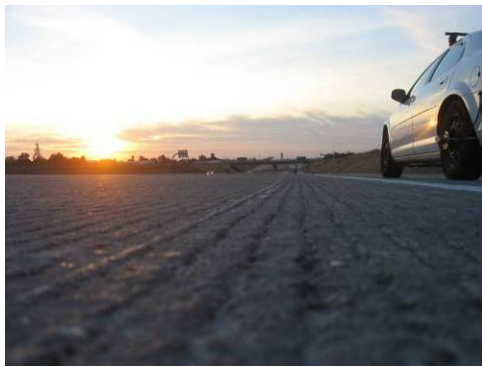
Texture detail

Type of section: Pavement Field testing Year 1: 11/10/2008 17:17
 Location: 06FRE180W55.5 Field testing Year 2: 11/13/2009 15:19
 Comments: Diamond ground. DG on LT.
 Surface Year: 2008

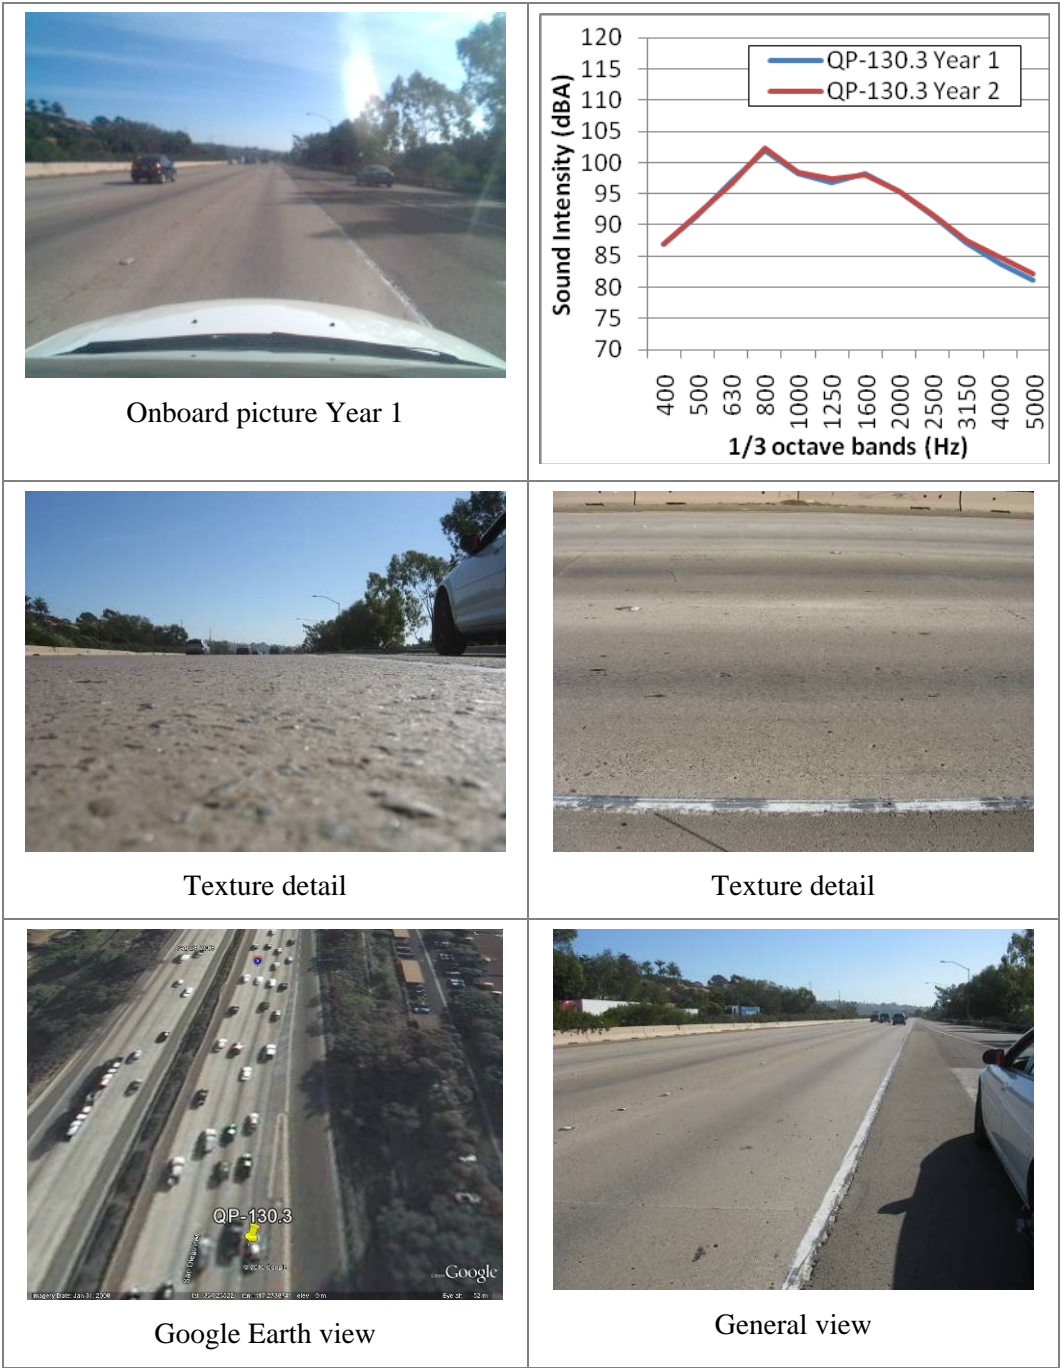
Type of section: Pavement
 Location: 11SD5S39.5
 Comments: Burlap drag.
 Surface Year: 1964

Onboard picture Year 1

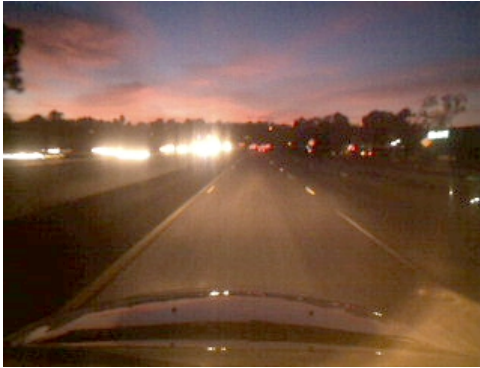
QP-131.1

Type of section: Pavement Field testing Year 1: 11/11/2008 17:01
 Location: 11SD8W15.5 Field testing Year 2: 11/23/2009 9:33
 Comments: Diamond ground. DG on LT.
 Surface Year: 1997

Onboard picture Year 1

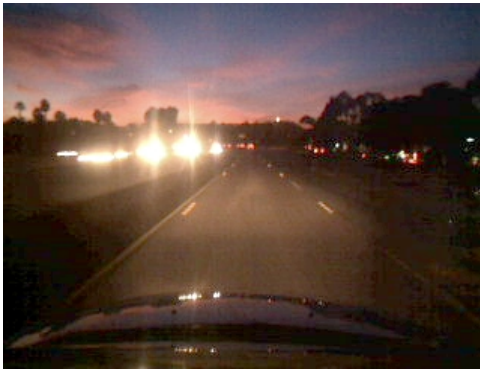
QP-131.2

Type of section: Pavement
 Location: 11SD8W15.6
 Comments: Diamond ground.
 Surface Year: 1997

Onboard picture Year 1

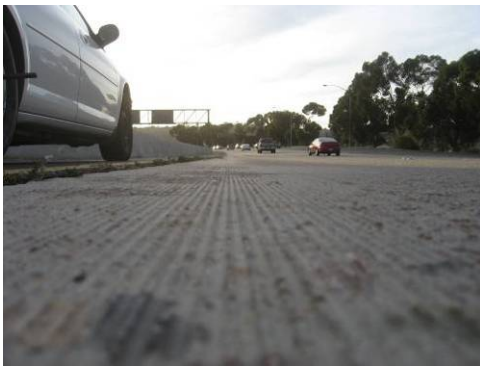
Texture detail

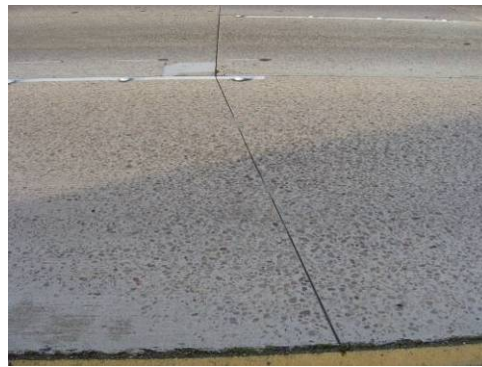
Joint detail

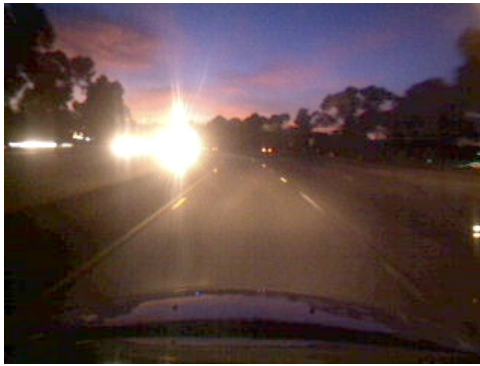
QP-131.3

Type of section: Pavement
Location: 11SD8W15.7
Comments: Diamond ground.
Surface Year: 1997

Onboard picture Year 1

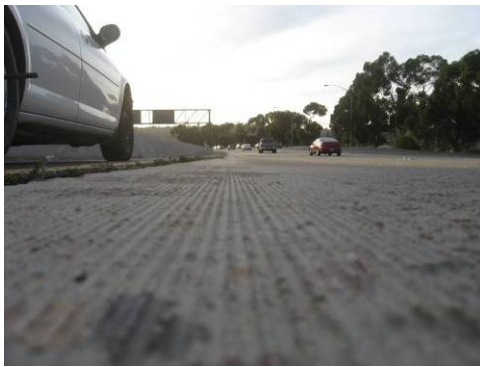
Texture detail

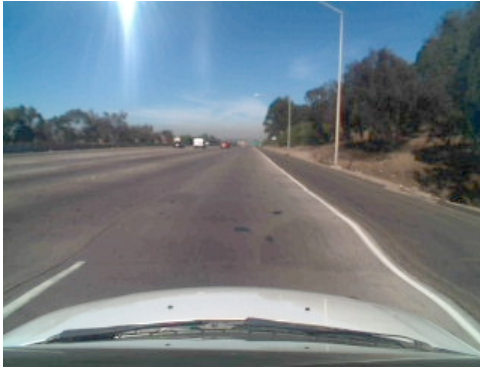
QP-132.1

Type of section: Pavement Field testing Year 1: 11/12/2008 12:39
 Location: 11SD805N2.1 Field testing Year 2: 11/24/2009 11:06
 Comments: Diamond ground. DG on LB.
 Surface Year: 1998

Onboard picture Year 1

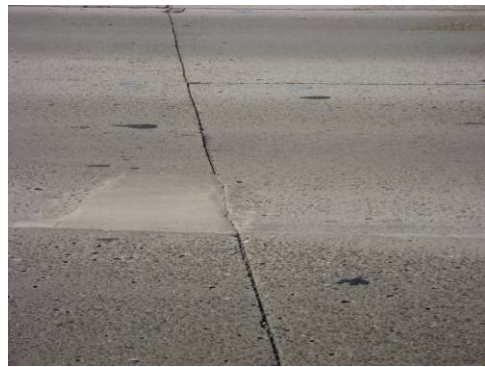
Joint detail

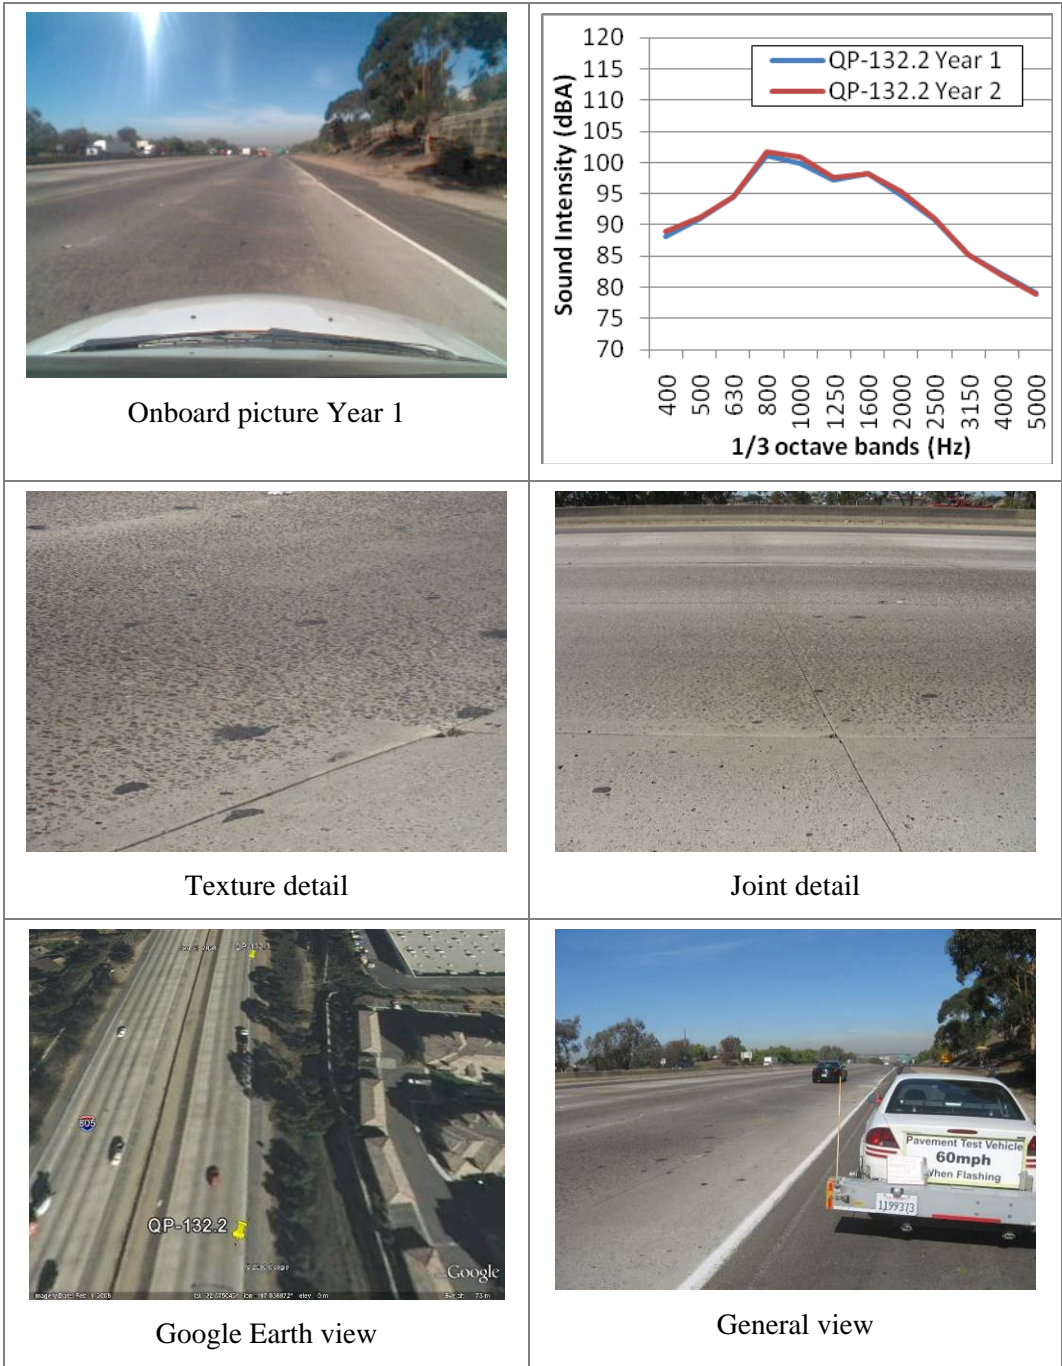
QP-132.2

Type of section: Pavement
 Location: 11SD805N2.2
 Comments: Diamond ground.
 Surface Year: 1998

Onboard picture Year 1

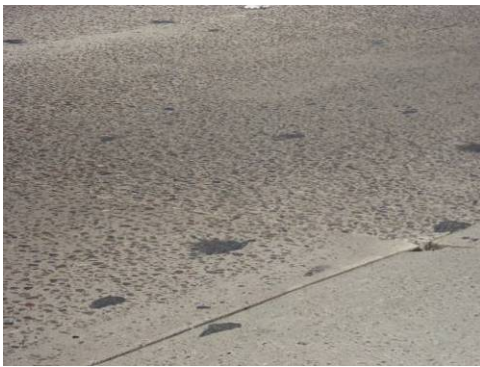
Texture detail

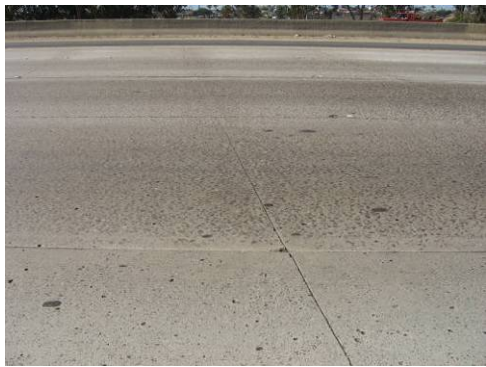
Joint detail

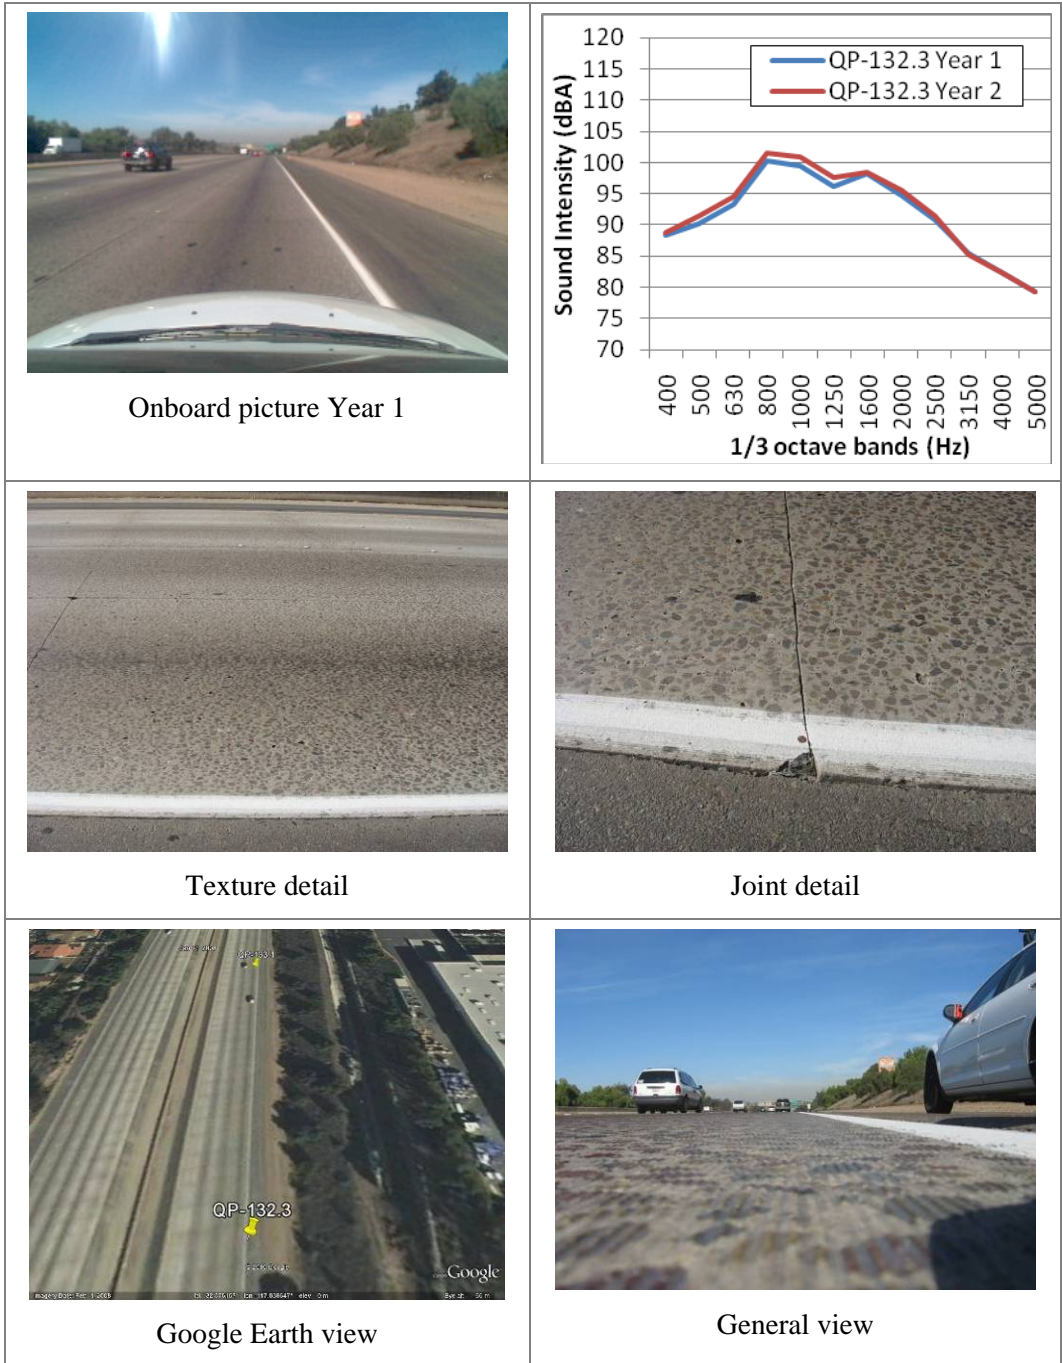
QP-132.3

Type of section: Pavement
 Location: 11SD805N2.3
 Comments: Diamond ground.
 Surface Year: 1998

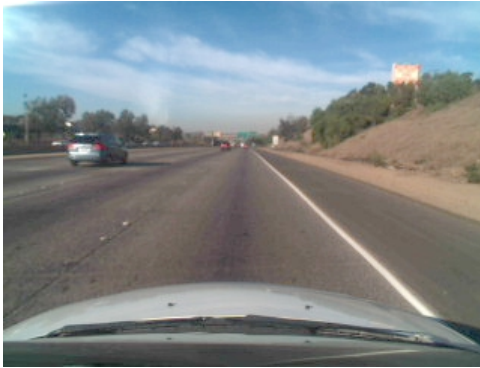
QP-133.1

Type of section: Pavement Field testing Year 1: 11/12/2008 14:36
 Location: 11SD805N2.3 Field testing Year 2: 11/24/2009 11:50
 Comments: Diamond ground. DG on transverse tining.
 Surface Year: 1998

Onboard picture Year 1

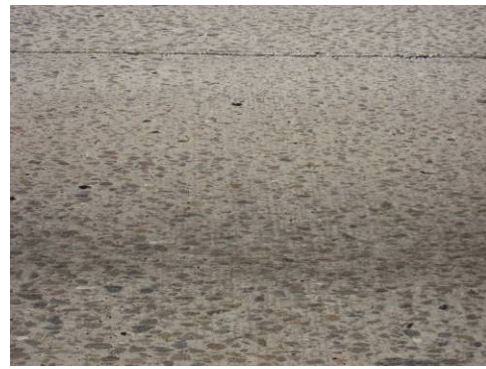
Texture detail

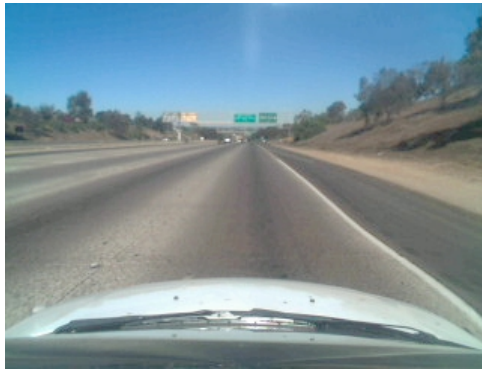
QP-133.2

Type of section: Pavement
 Location: 11SD805N2.4
 Comments: Diamond ground.
 Surface Year: 1998

Onboard picture Year 1

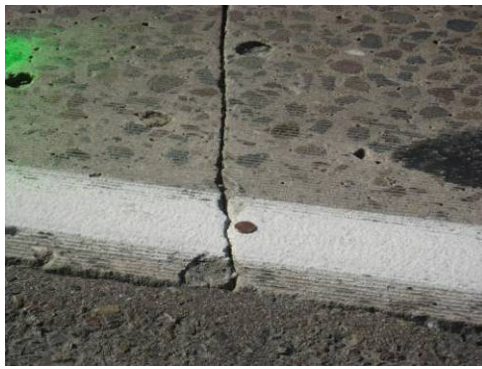
Texture detail

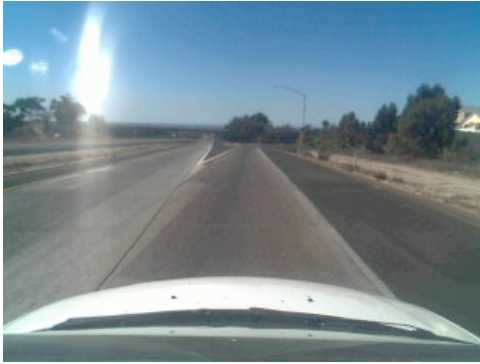
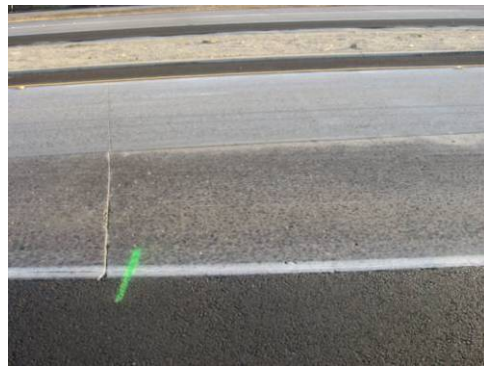
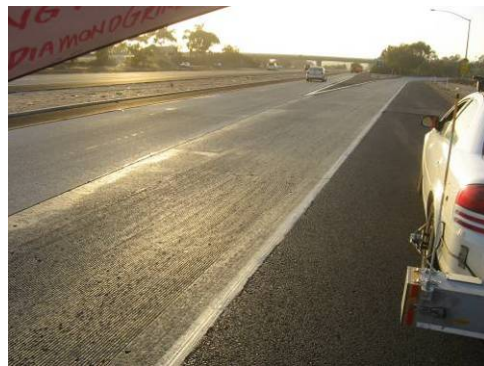
QP-134.2

Type of section: Pavement Field testing Year 1: 11/12/2008 16:35
 Location: 11SD905W5.1 Field testing Year 2: 11/24/2009 12:31
 Comments: Diamond ground. DG on deep longitudinal tining. Off-ramp.
 Surface Year: 2000

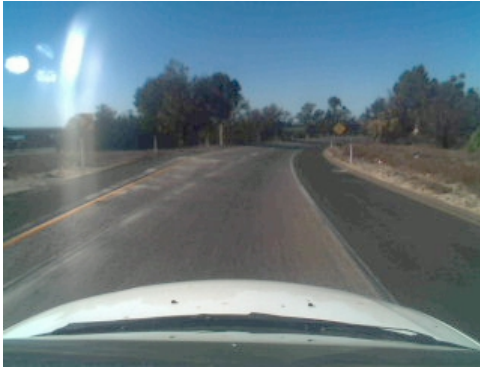
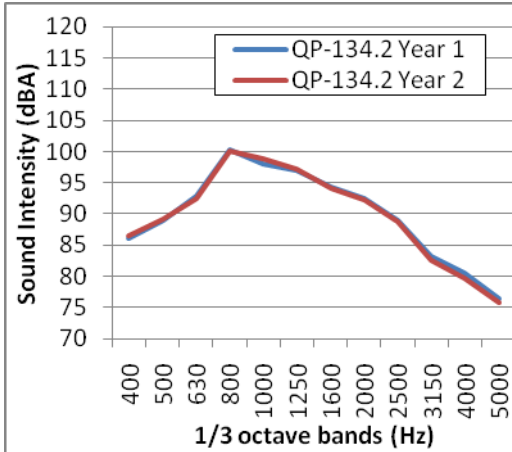
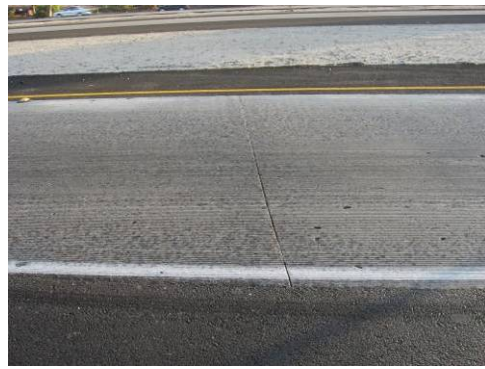
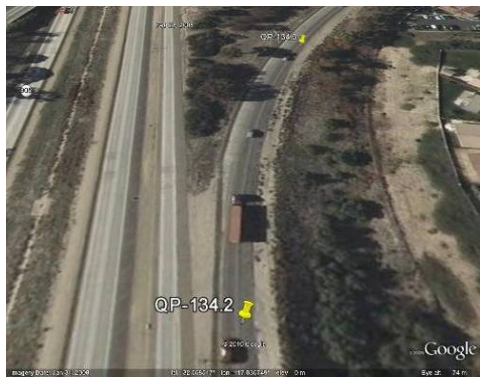
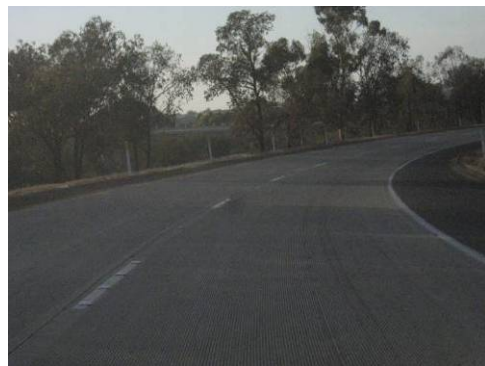
Type of section: Pavement Field testing Year 1: 11/12/2008 16:39
 Location: 11SD905W5.0 Field testing Year 2: 11/24/2009 12:35
 Comments: Diamond ground. DG on deep longitudinal tining. Off-ramp.
 Surface Year: 2000

Section ID	Location:	Lane ¹	Texture Type ²	Const. Year	Surfacing Year	Texture Condition ³	Test Tire Year 1	Uncorrected OBSI Year 1	Test Tire Year 2	Uncorrected OBSI Year 2	Corrected to SRTT #1 OBSI Year 1	Corrected to SRTT #1 OBSI Year 2
	Dist-Cnty-Rte-Dir-PM											
QP-132.1	11SD805N2.1	5 of 5	DG	1975	1998	Aged	SRTT #2	106.8	SRTT #3	106.6	105.4	106.3
QP-132.2	11SD805N2.2	5 of 5	DG	1975	1998	Aged	SRTT #2	107.8	SRTT #3	107.4	106.6	107.2
QP-132.3	11SD805N2.3	5 of 5	DG	1975	1998	Aged	SRTT #2	107.3	SRTT #3	107.4	106	107.3
QP-133.1	11SD805N2.3	4 of 4	DG	1975	1998	Aged	SRTT #2	107.6	SRTT #3	106.6	106.5	106.4
QP-133.2	11SD805N2.4	4 of 4	DG	1975	1998	Aged	SRTT #2	Not Tested	SRTT #3	107.4		107.3
QP-134.1	11SD905W5.2	2 of 2	DG	1975	2000	Aged	SRTT #2	106.3	SRTT #3	106.6	105	106.4
QP-134.2	11SD905W5.1	2 of 2	DG	1975	2000	Aged	SRTT #2	106.2	SRTT #3	105.3	104.9	104.9
QP-134.3	11SD905W5.0	2 of 2	DG	1975	2000	Aged	SRTT #2	107.3	SRTT #3	106.6	106.2	106.4

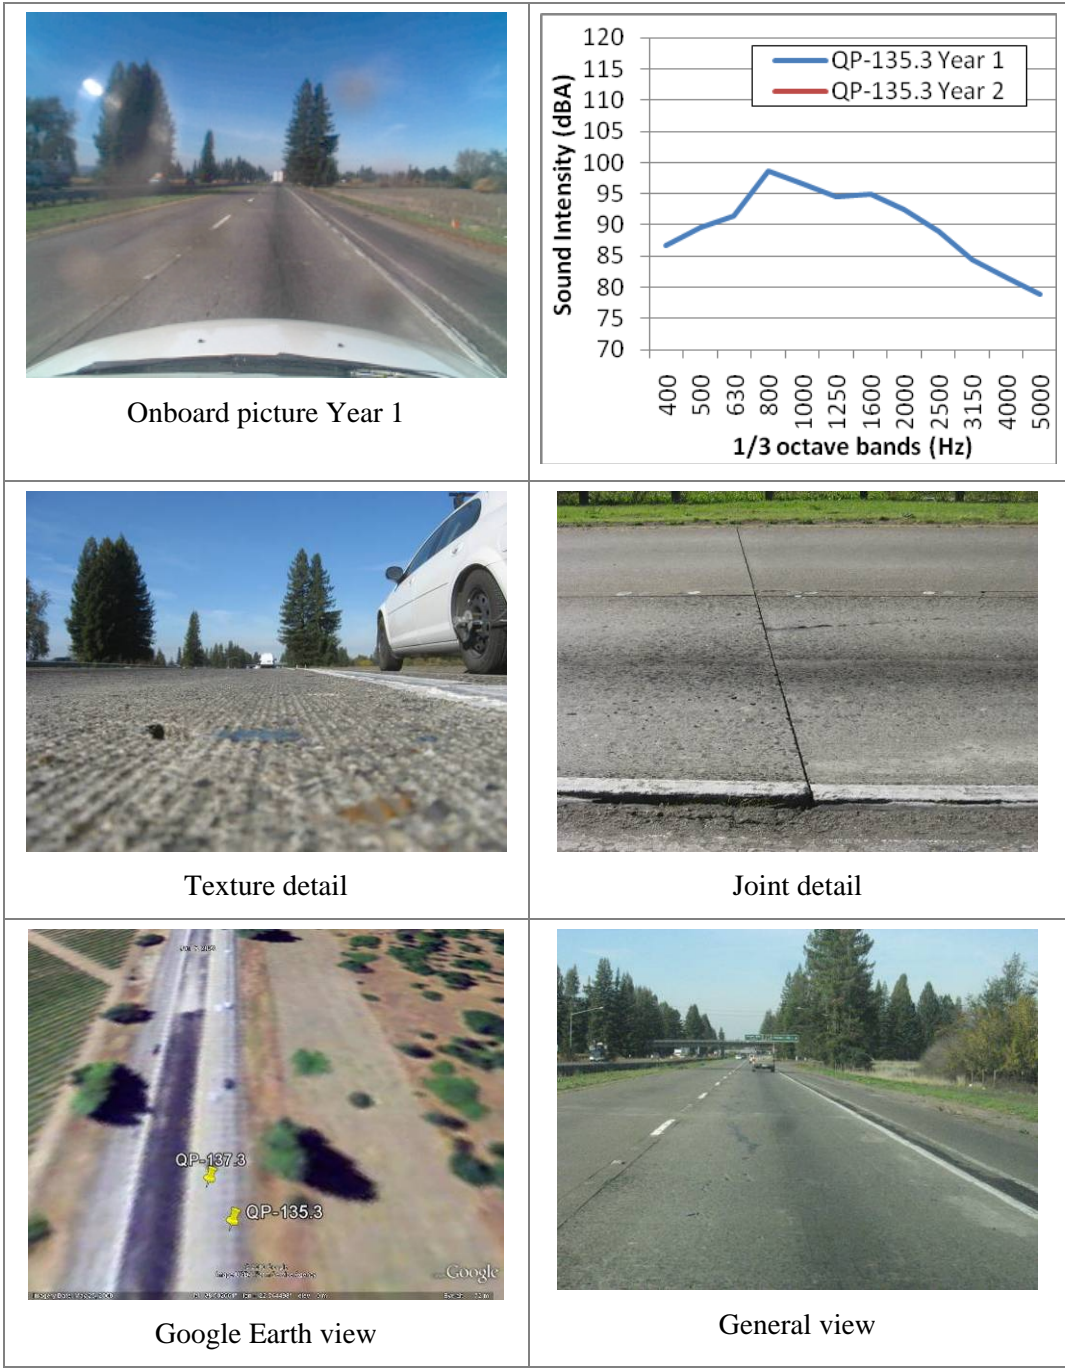
QP-136.1

Comments: Diamond grooved.

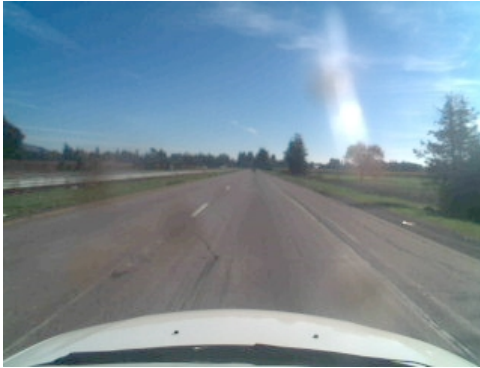
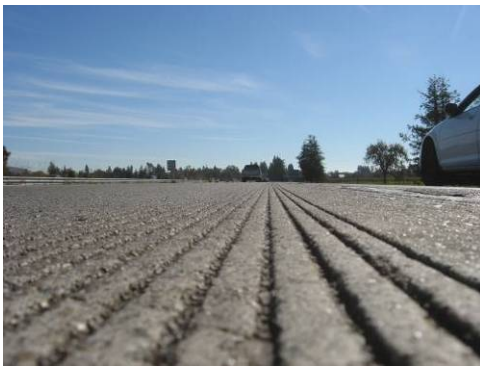
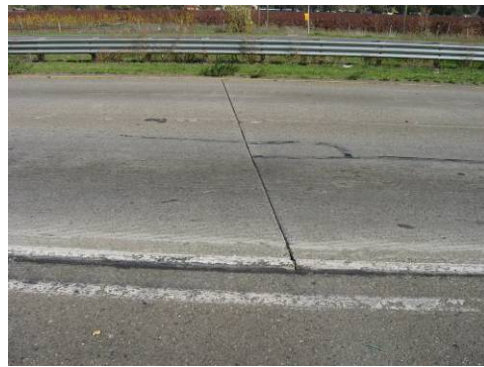
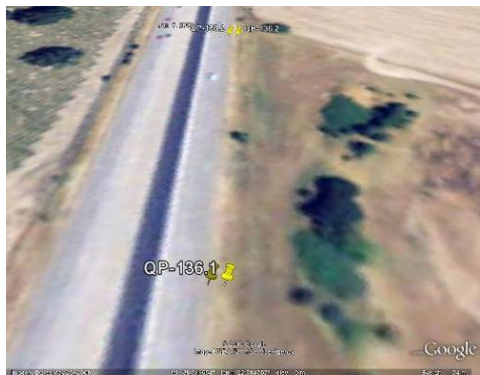
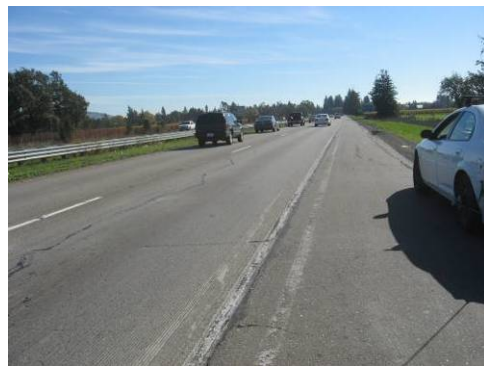
QP-136.2

Comments: Diamond grooved.

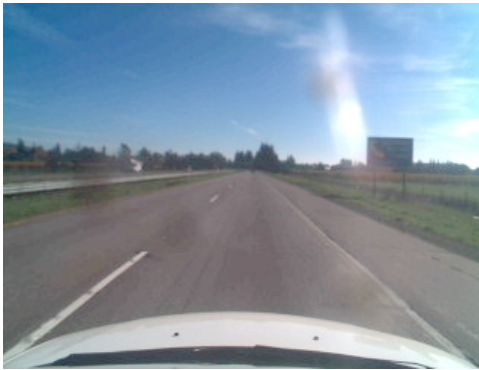
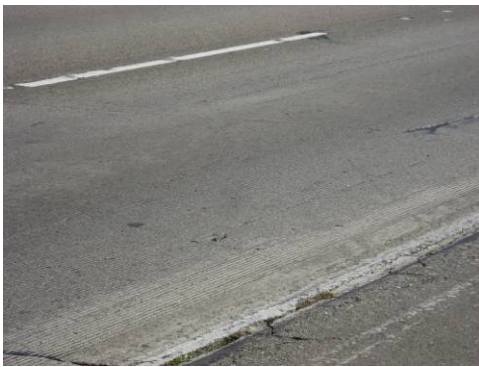
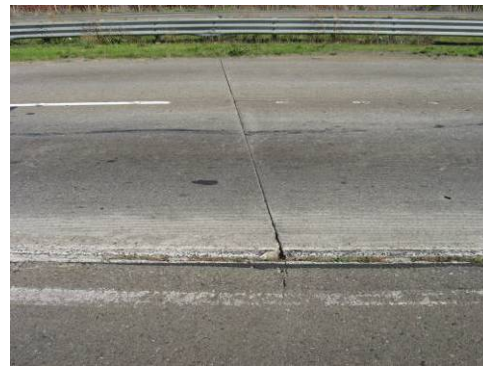
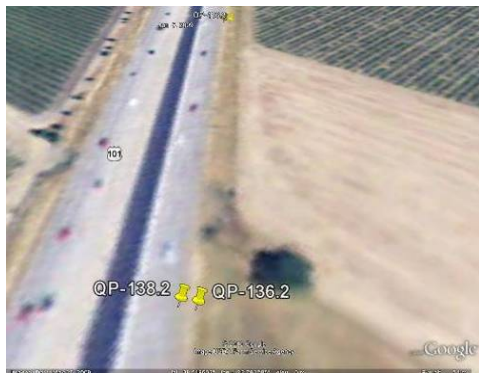
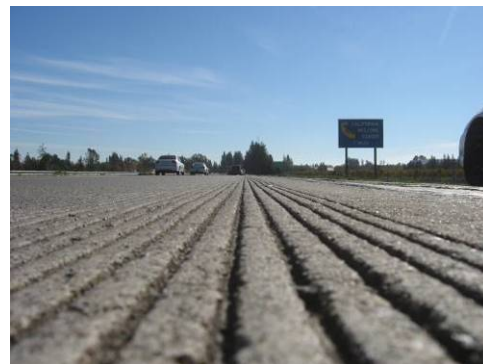
QP-136.3

Comments: Diamond grooved.

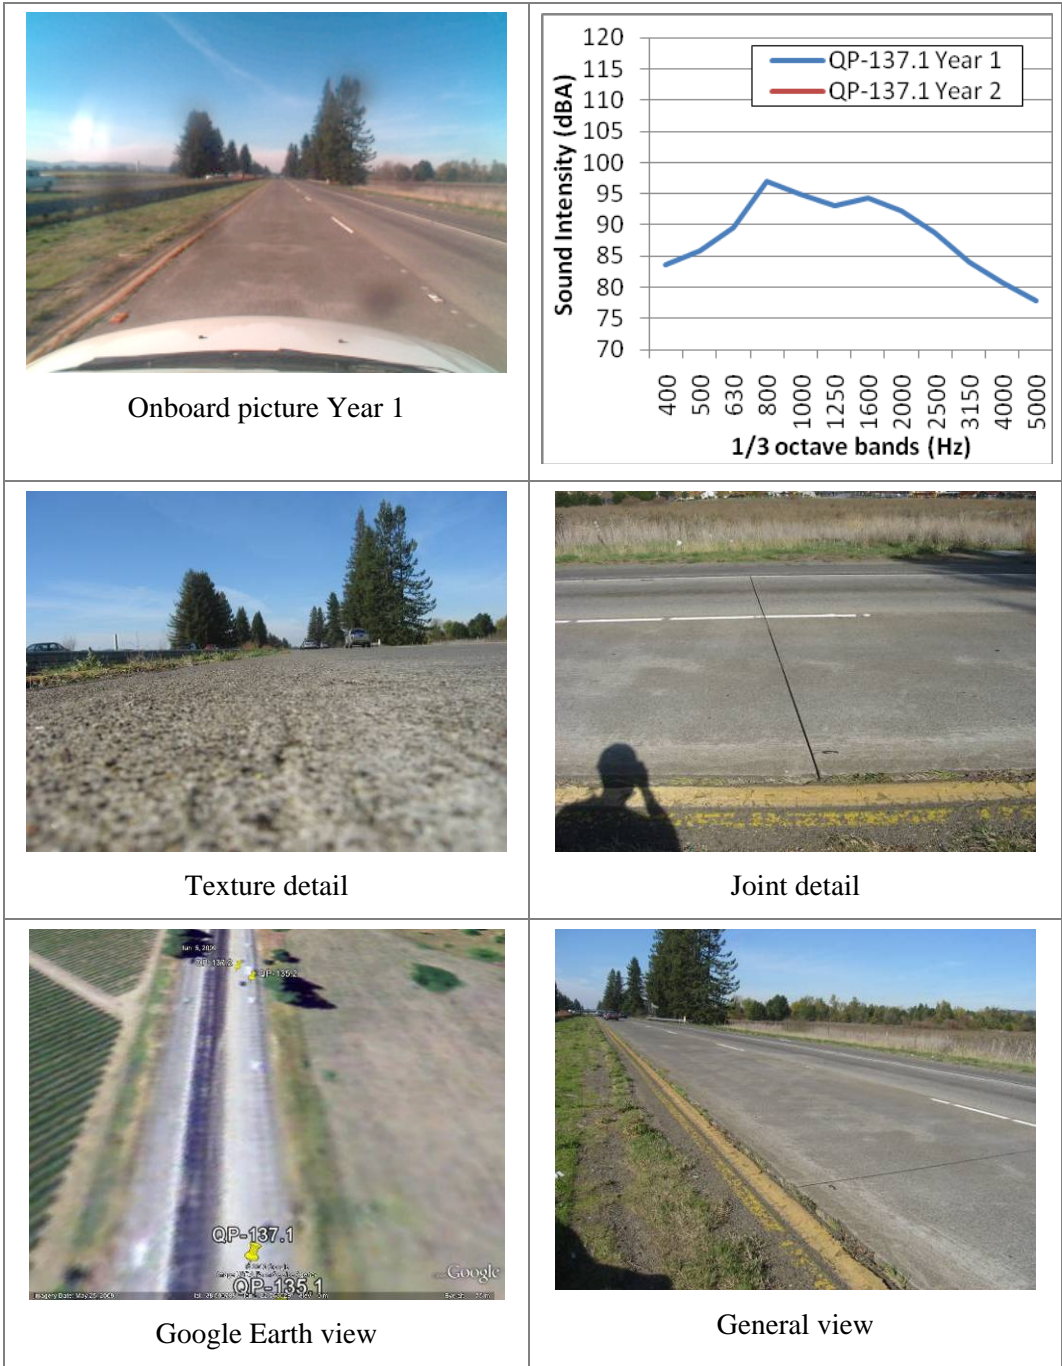
Type of section: Pavement
 Location: 04SON101N25.4L1
 Comments: Burlap drag.
 Surface Year: 1962

Field testing Year 1: 11/17/2008 14:07
 Field testing Year 2:

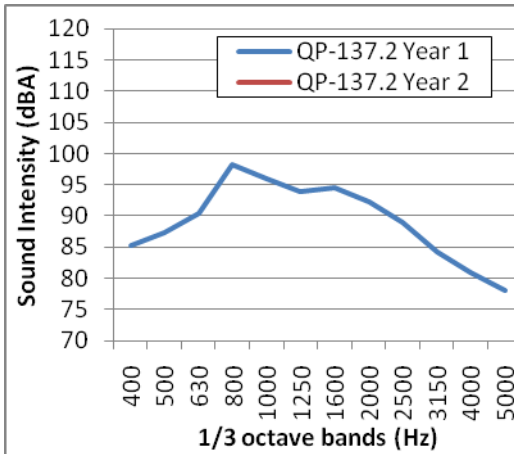
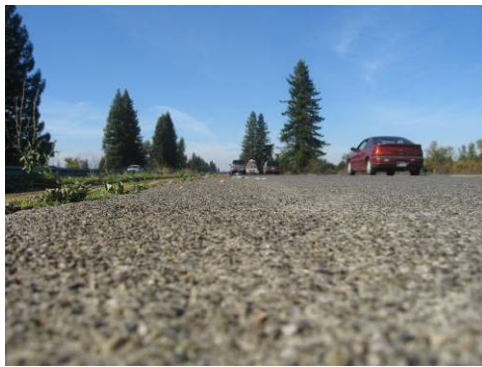
Comments: Burlap drag.

Texture detail

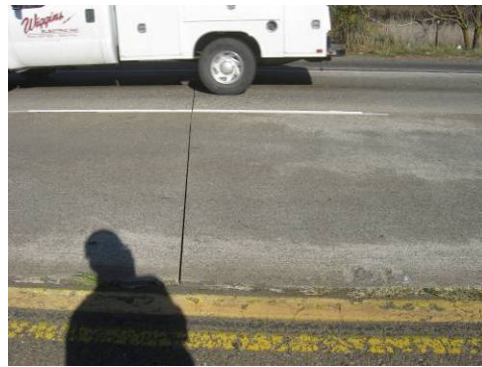
Joint detail

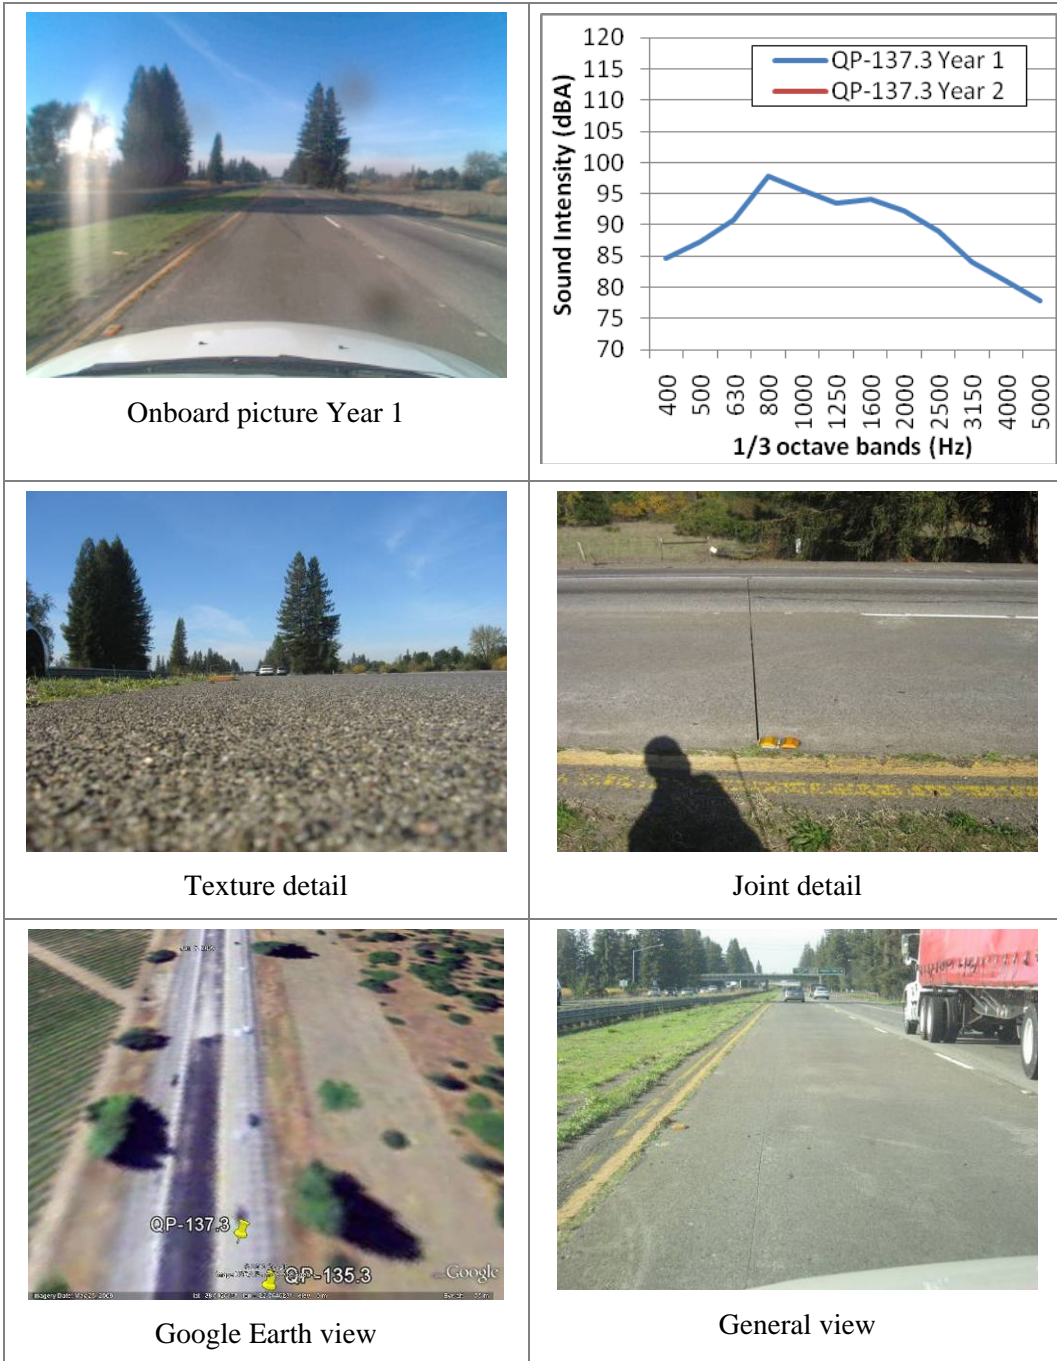
QP-137.3

Type of section: Pavement
 Location: 04SON101N25.4L1
 Comments: Burlap drag.
 Surface Year: 1962

Field testing Year 1: 11/17/2008 14:55
 Field testing Year 2:

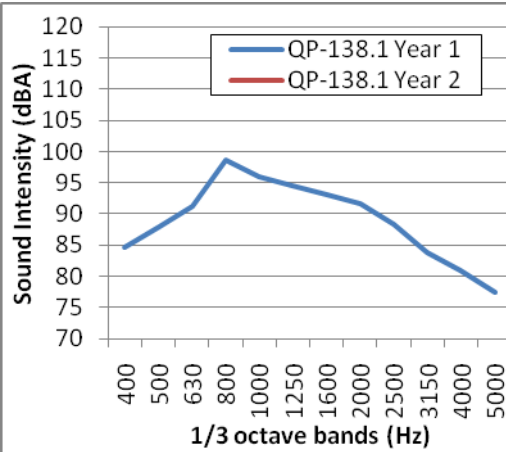
Comments: Diamond grooved.

Texture detail

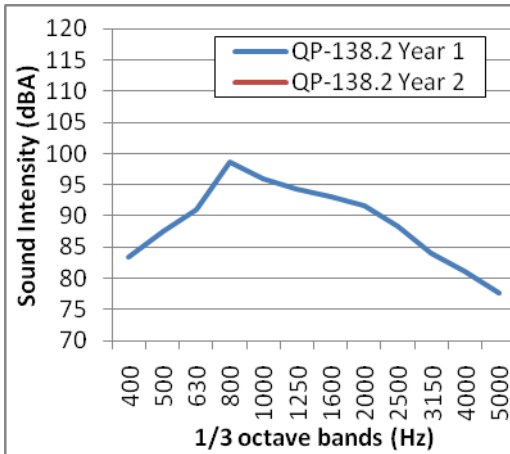
Comments: Diamond grooved.

Texture detail

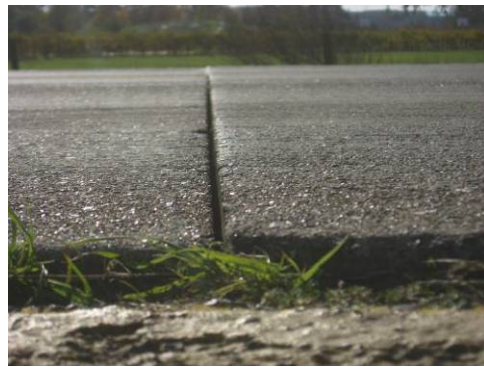
Joint detail

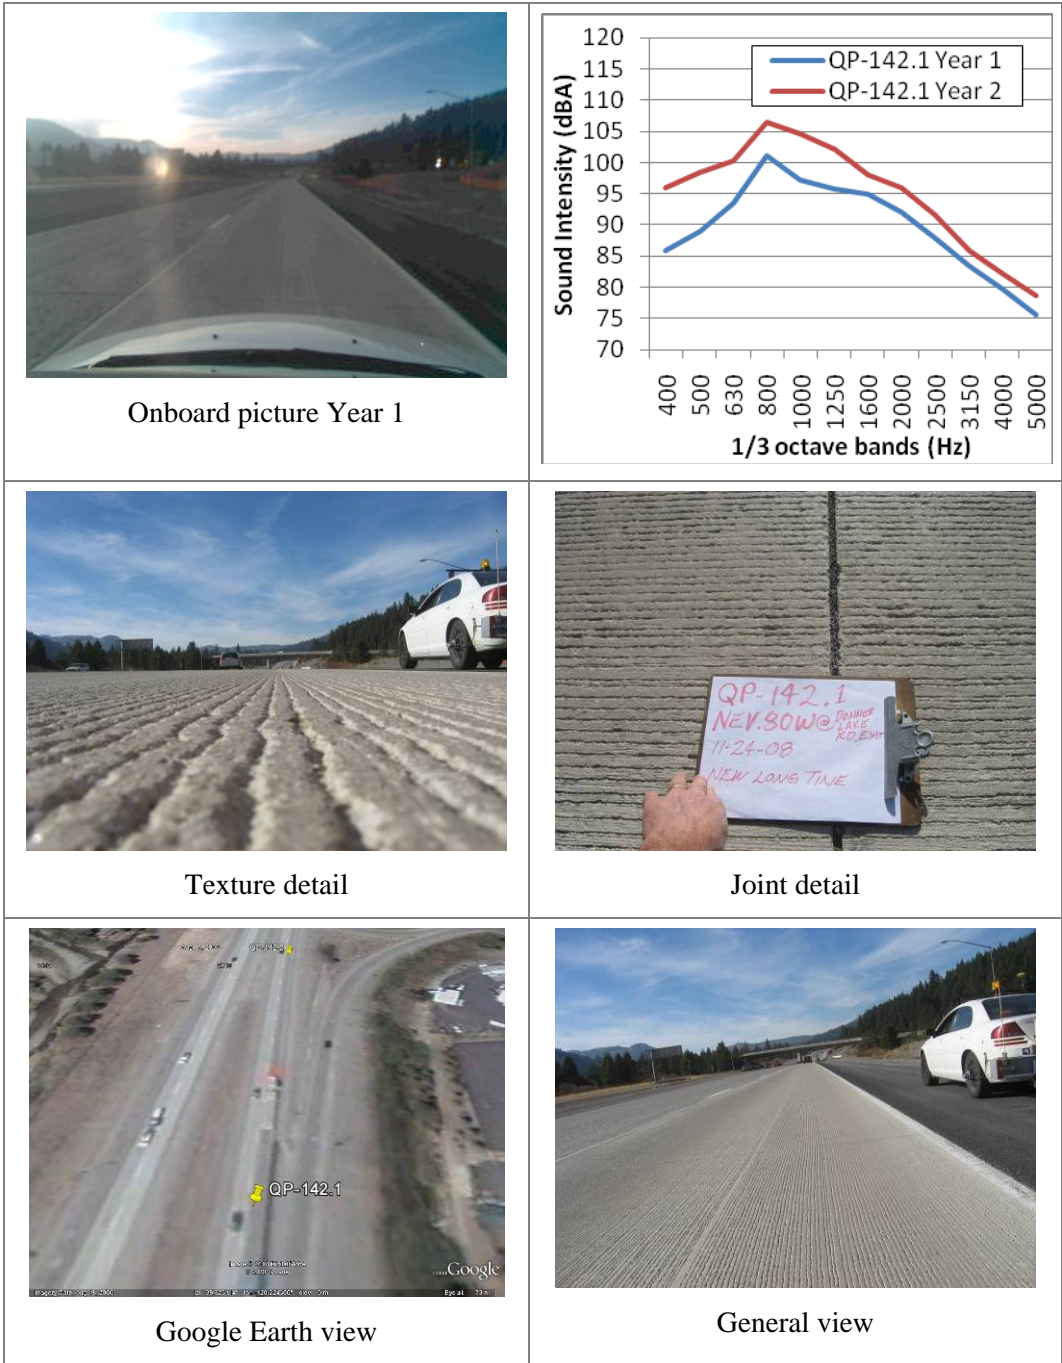
QP-142.1

Type of section: Pavement Field testing Year 1: 11/24/2008 15:10
 Location: 03NEV80W1.0 Field testing Year 2: 9/17/2009 12:31
 Comments: Longitudinally tined. New LT.
 Surface Year: 2008

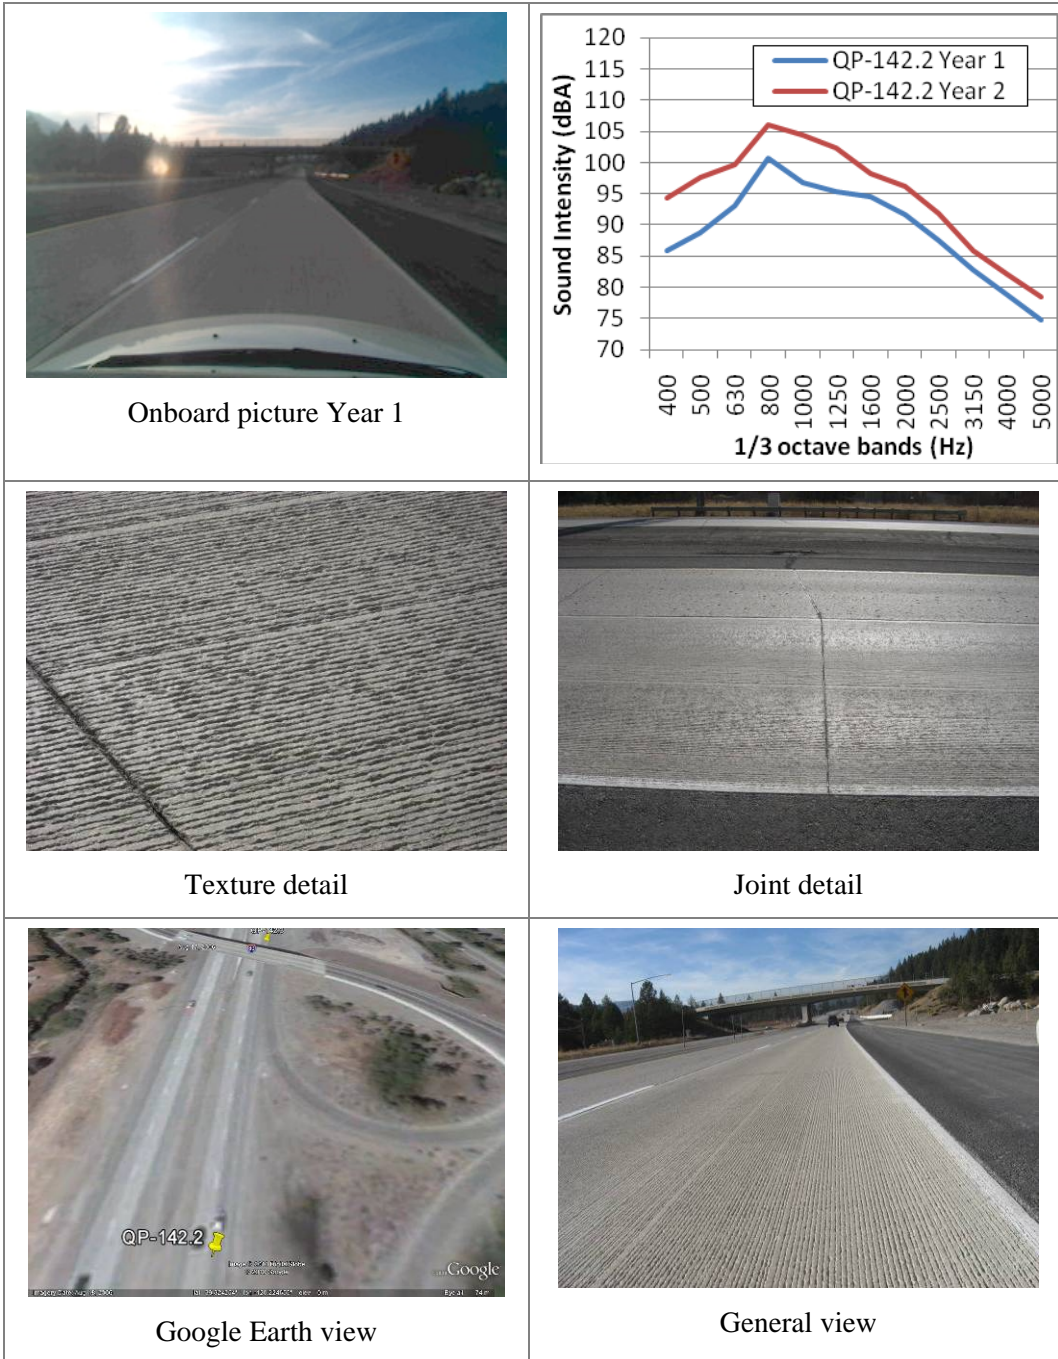
QP-142.2

Type of section: Pavement Field testing Year 1: 11/24/2008 15:16
 Location: 03NEV80W0.9 Field testing Year 2: 9/17/2009 12:49
 Comments: Longitudinally tined. New LT.
 Surface Year: 2008

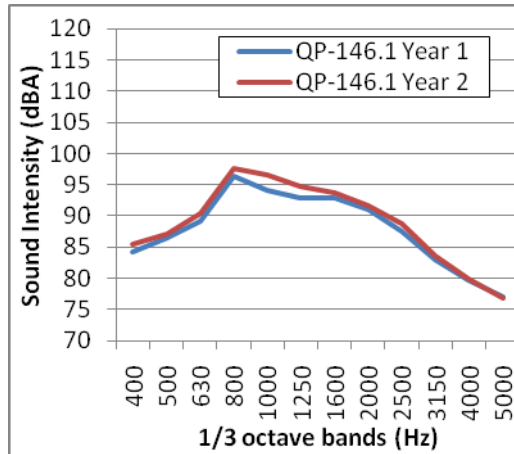
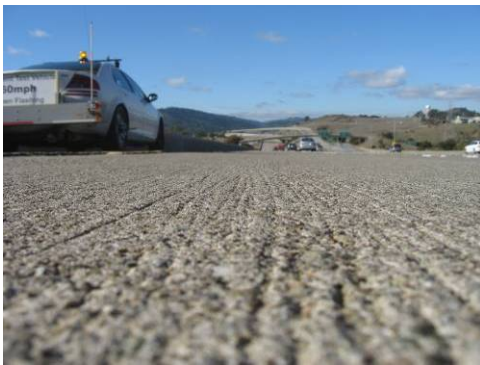
Comments: Longitudinally broomed.

Texture detail

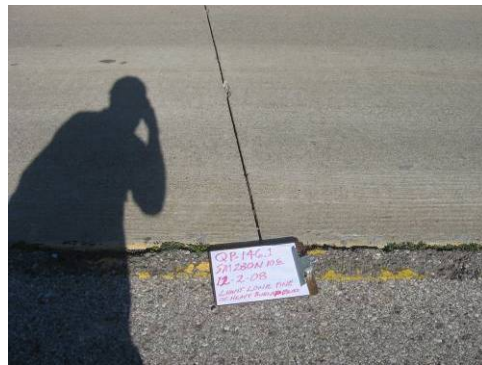
Joint detail

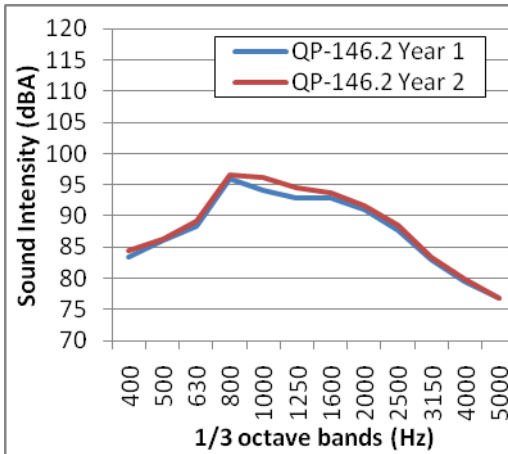
Comments: Longitudinally broomed.

Texture detail

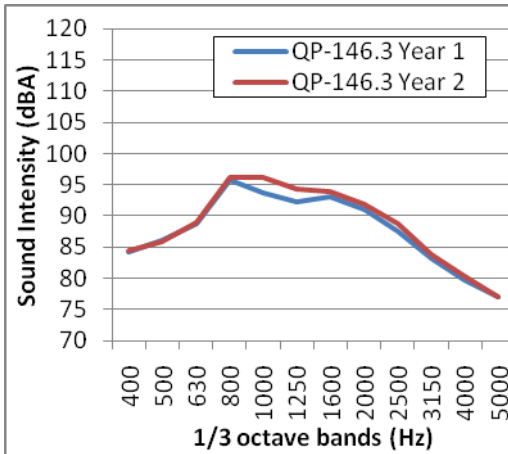
Comments: Longitudinally broomed.

Texture detail

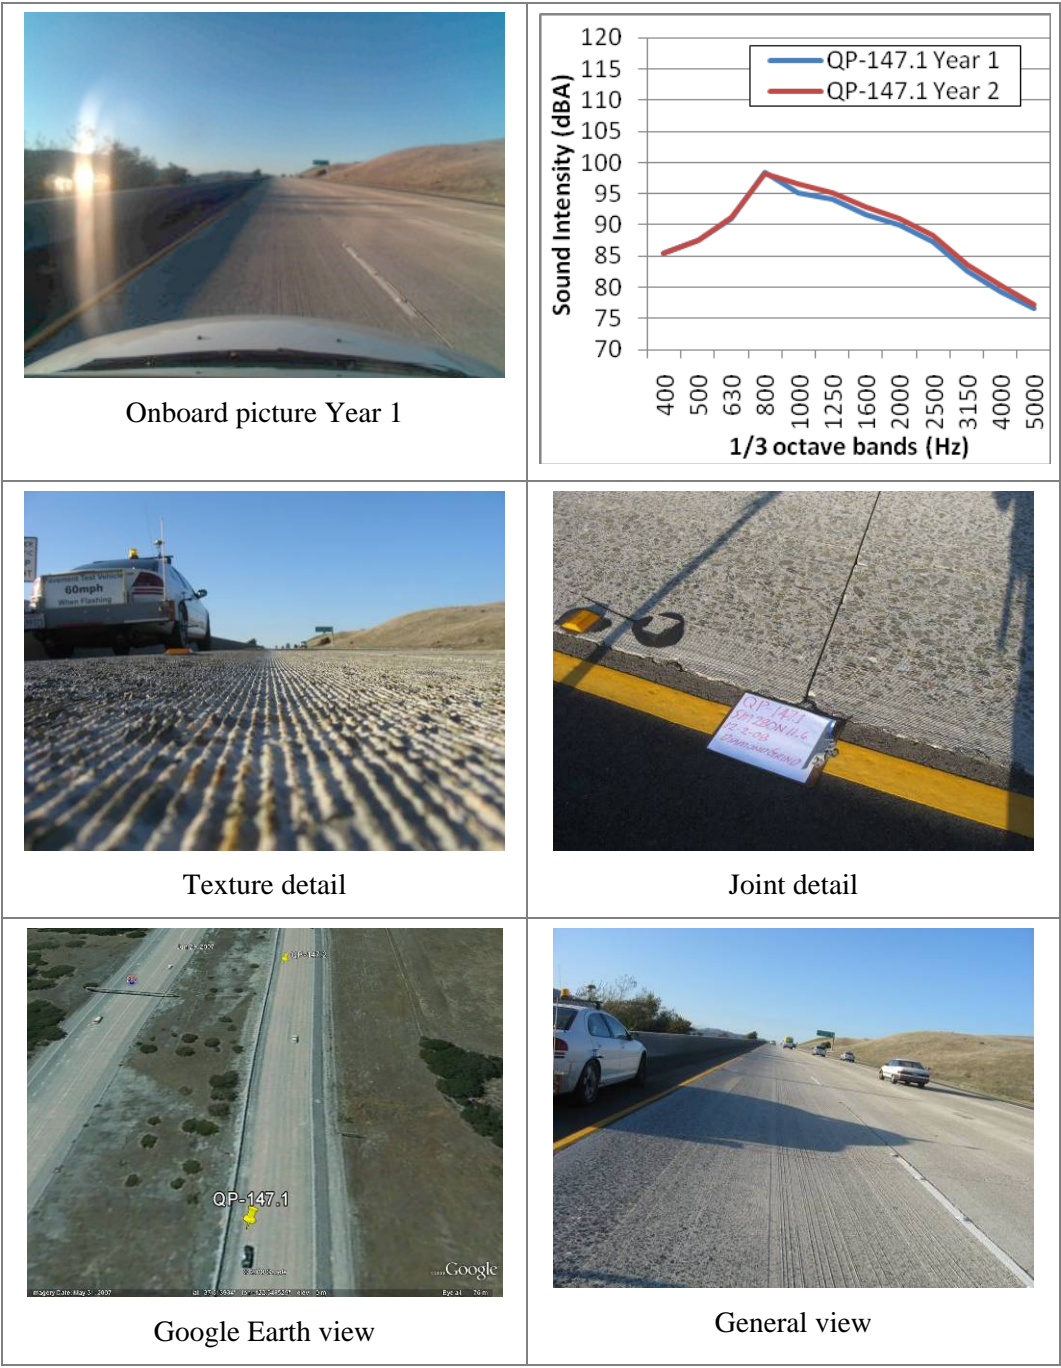
QP-147.1

Type of section: Pavement
 Location: 04SM280N11.6
 Comments: Diamond ground.
 Surface Year: 2007

Field testing Year 1: 12/2/2008 15:46
 Field testing Year 2: 11/16/2009 12:29

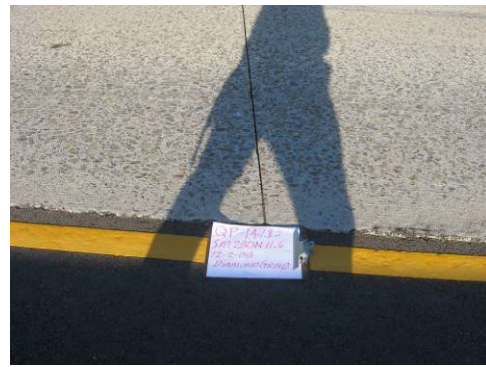
Joint detail
