Quieter Pavement Research: Concrete Pavement Tire Noise

Work Conducted as Part of Partnered Pavement Research Center Strategic Plan Element No. 4.22:
Quiet Concrete Pavement Research

DOCUMENT RETRIEVAL PAGE		UCPRC Research Report No.: UCPRC-RR-2010-03			
Title: Quieter Pavement Research: Concrete Pavement Tire Noise					
Author: E. Kohler and J. Harvey					
Prepared for: California Department of Transportation, Division of Research and Innovation, Office of Roadway Research		FHWA No.: CA121200A	Date Work Submitted: August 20, 2010	Date: May 2010	
Strategic Plan Element No.: 4.22		Status: Stage 6, final version		Version No.: 1	
<p>Abstract: This research report presents the results of tire/pavement noise measurements performed on concrete pavements as a part of the California Department of Transportation (Caltrans) Quieter Pavement Research (QPR) study to investigate tire/pavement noise characteristics on concrete pavements and bridge decks.</p> <p>The study included a total of 120 pavement sections at 47 different sites on various state highways throughout California. Most of the sites (36) were divided into three sections each for measurement and evaluation of tire/pavement nois

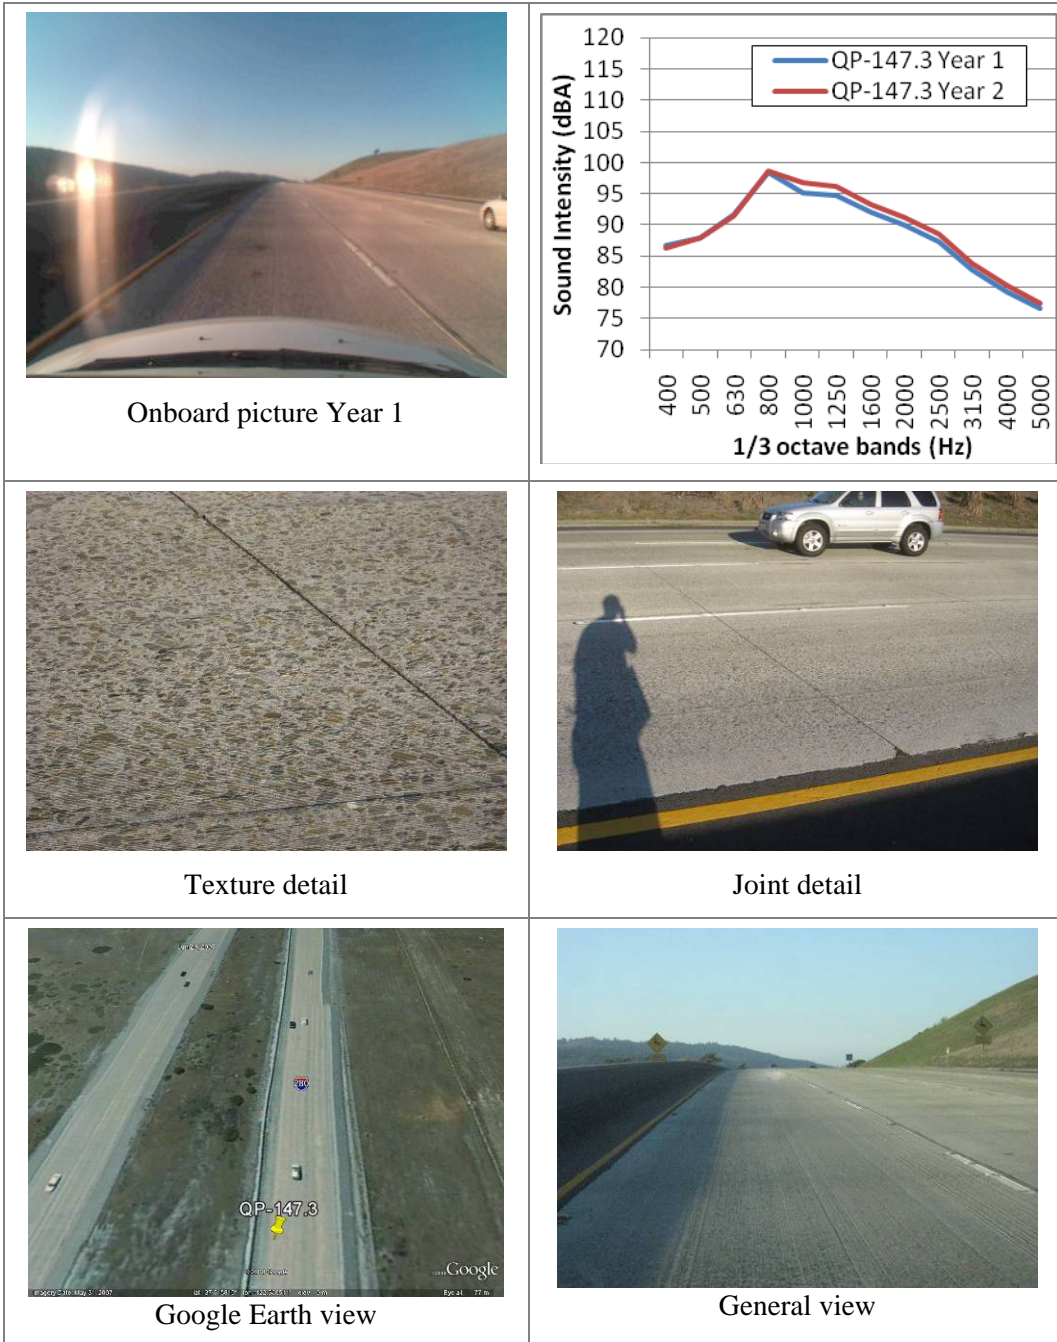
QP-147.3

Type of section: Pavement
 Location: 04SM280N11.8
 Comments: Diamond ground.
 Surface Year: 2007

Field testing Year 1: 12/2/2008 16:09
 Field testing Year 2: 11/16/2009 12:46

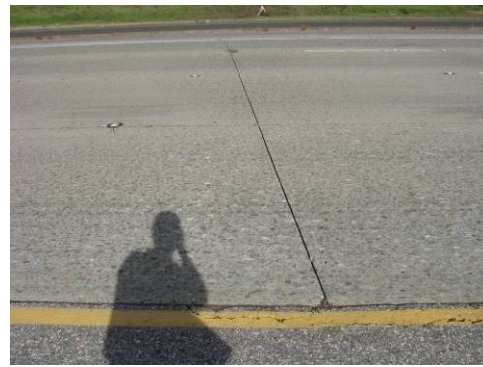
Joint detail

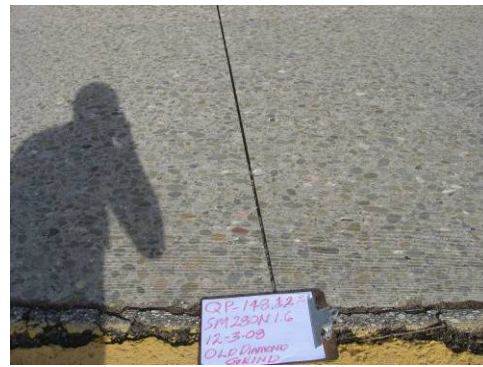
Joint detail

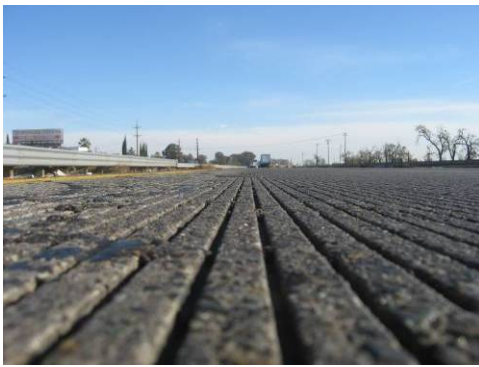
Comments: Diamond grooved.

Texture detail

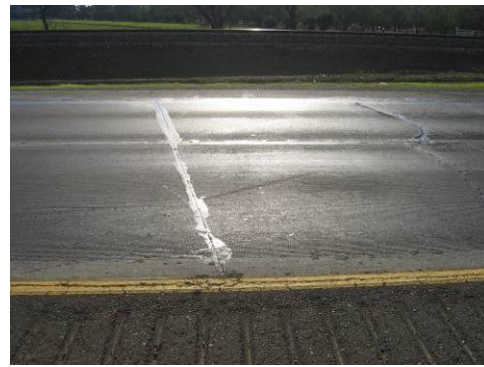
Joint detail

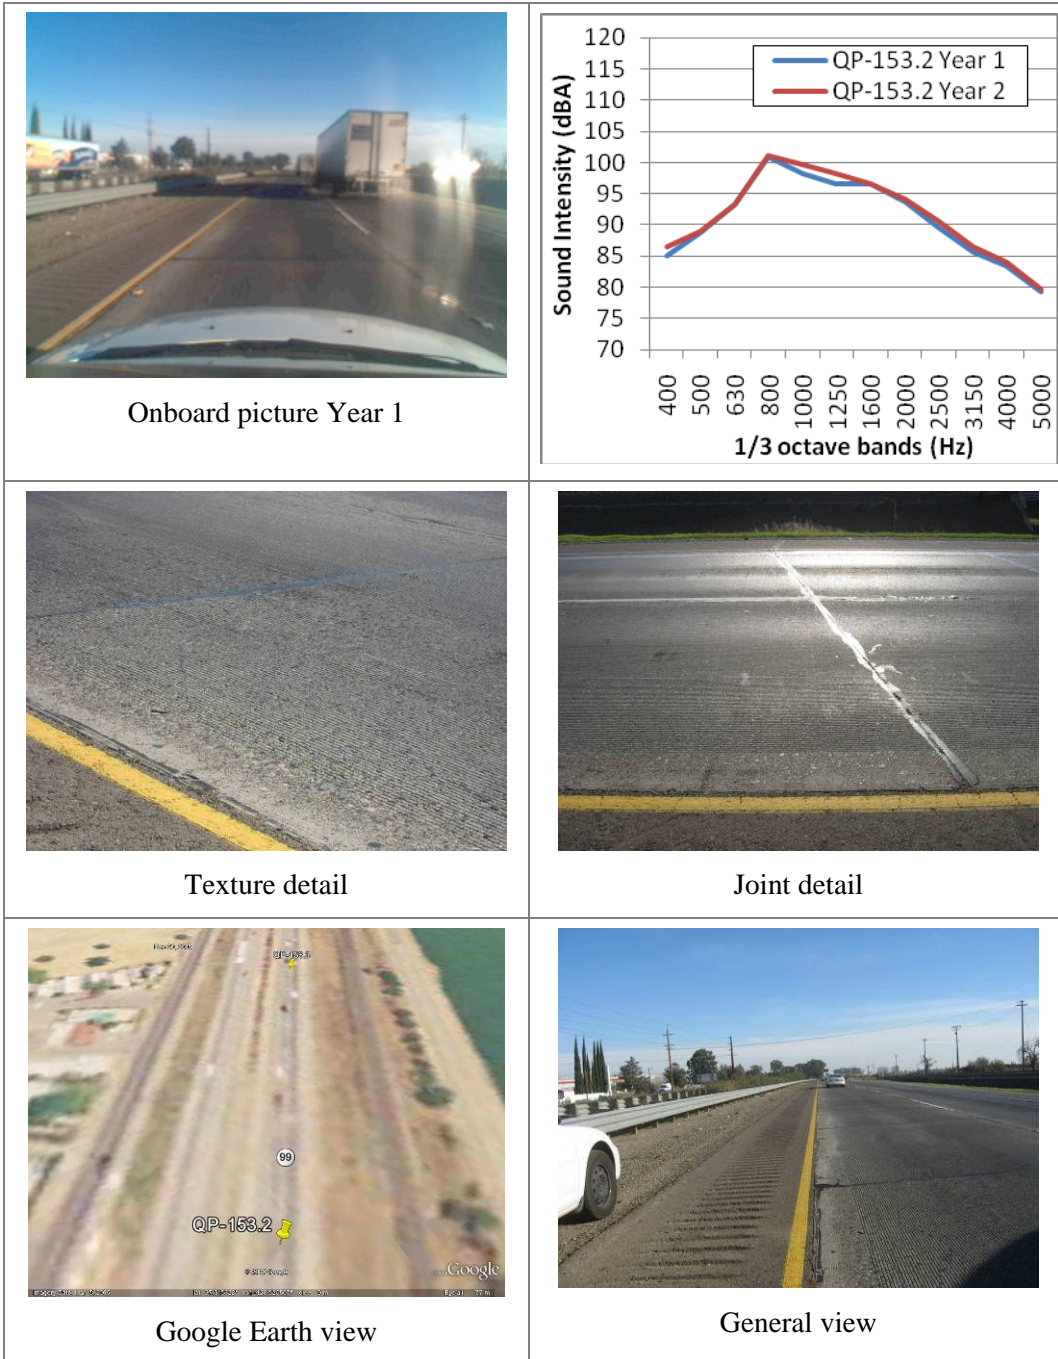
QP-153.2

Type of section: Pavement
 Location: 10Mer99S17.4
 Comments: Diamond grooved.
 Surface Year: 2006

Field testing Year 1: 12/17/2008 15:21
 Field testing Year 2: 11/13/2009 13:16

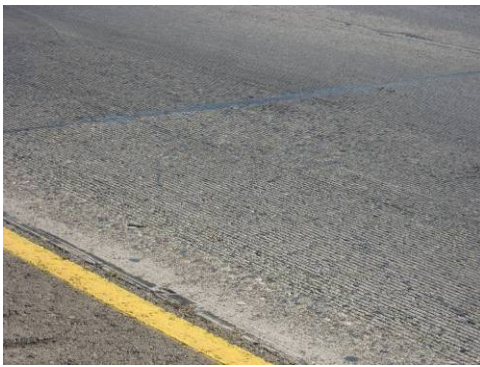
Texture detail

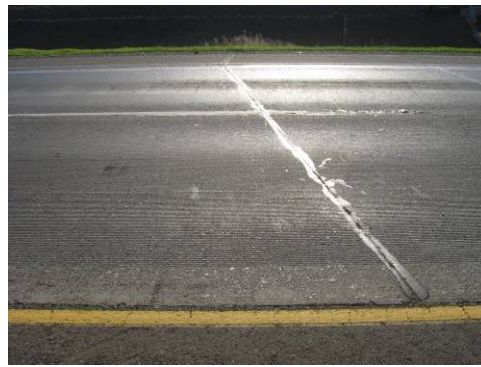
Joint detail

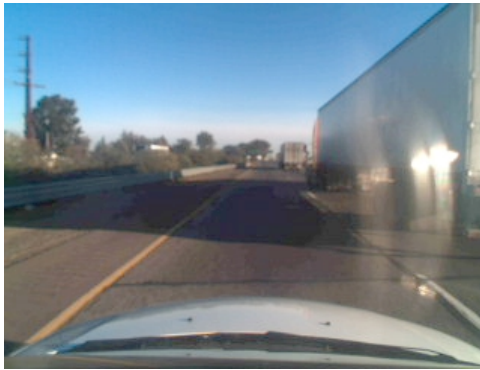
Onboard picture Year 1

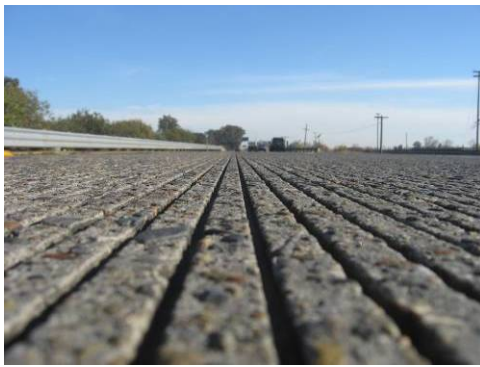
Texture detail

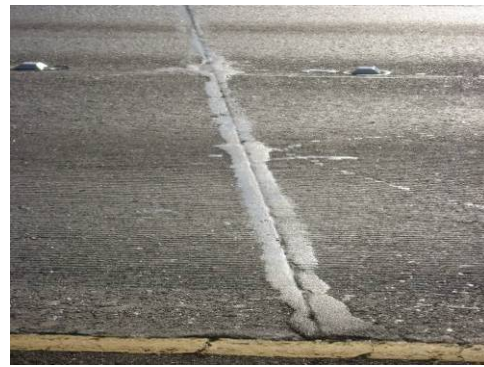
Joint detail

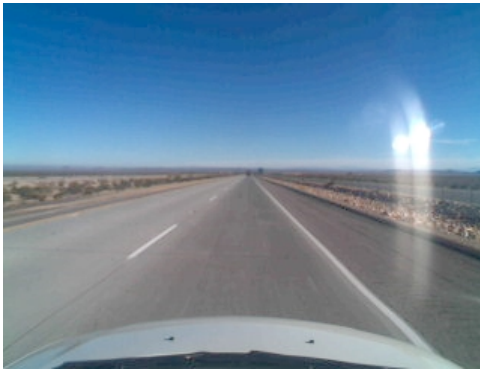
Onboard picture Year 1

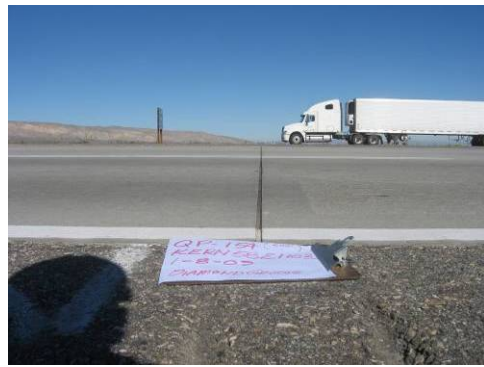
Joint detail

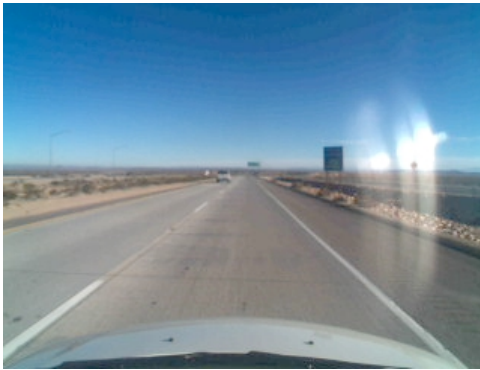
Onboard picture Year 1

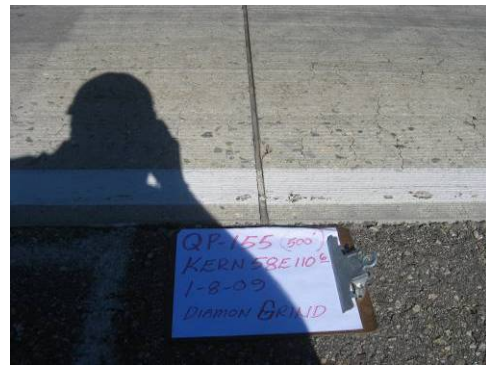
Joint detail

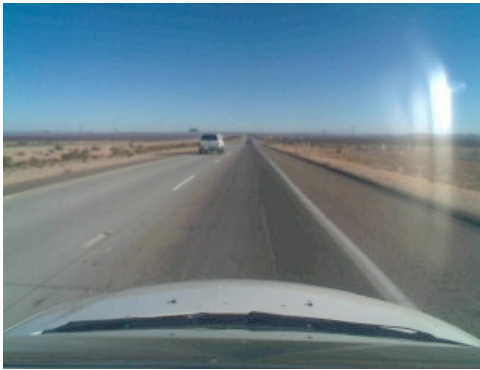
Onboard picture Year 1

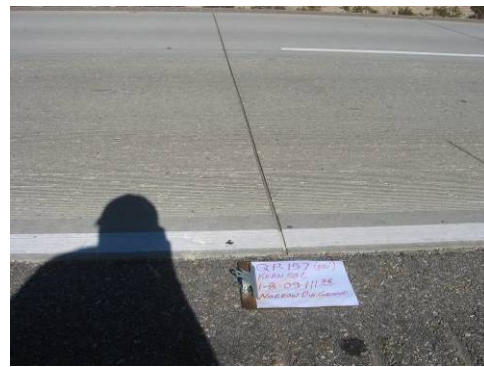
Joint detail

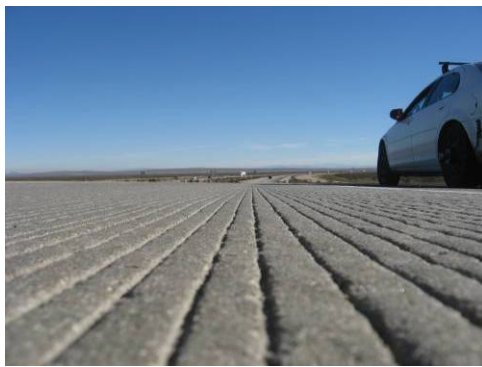
Texture detail

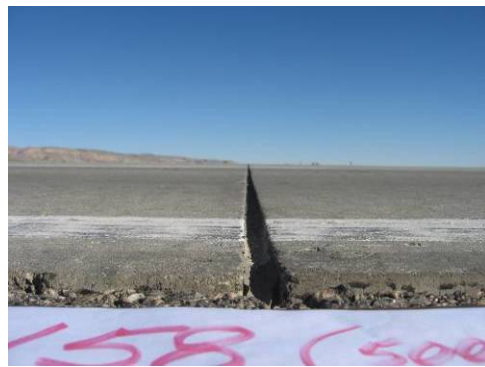
Joint detail

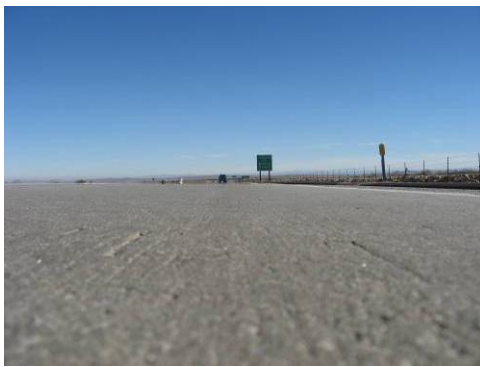
Texture detail

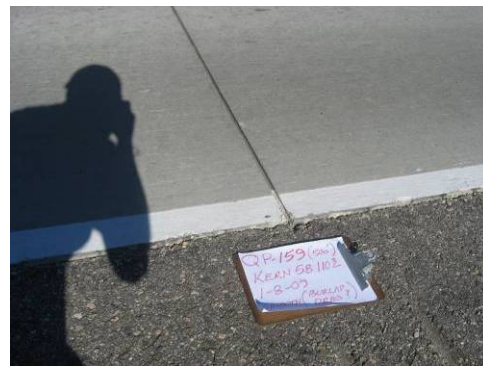
Joint detail

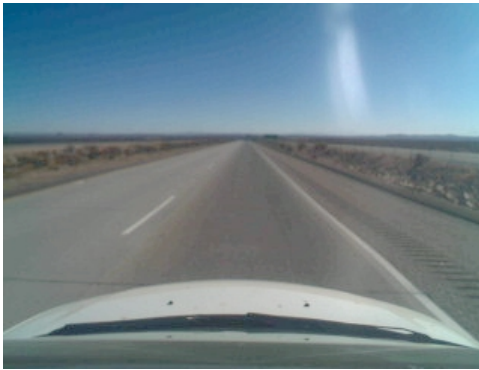
Onboard picture Year 1

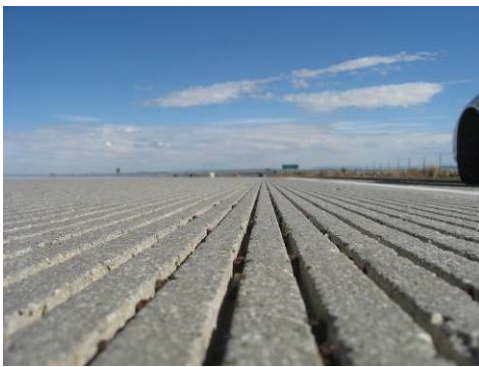
Texture detail

Type of section: Pavement Field testing Year 1: 2/24/2009 16:53
 Location: 06Ker58E111.5 Field testing Year 2: 12/3/2009 10:41
 Comments: Longitudinally broomed. Base texture for other sections in this area.
 Surface Year: 2003

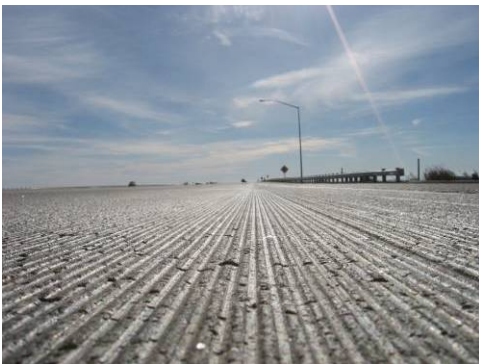
Texture detail

Comments: Diamond ground.

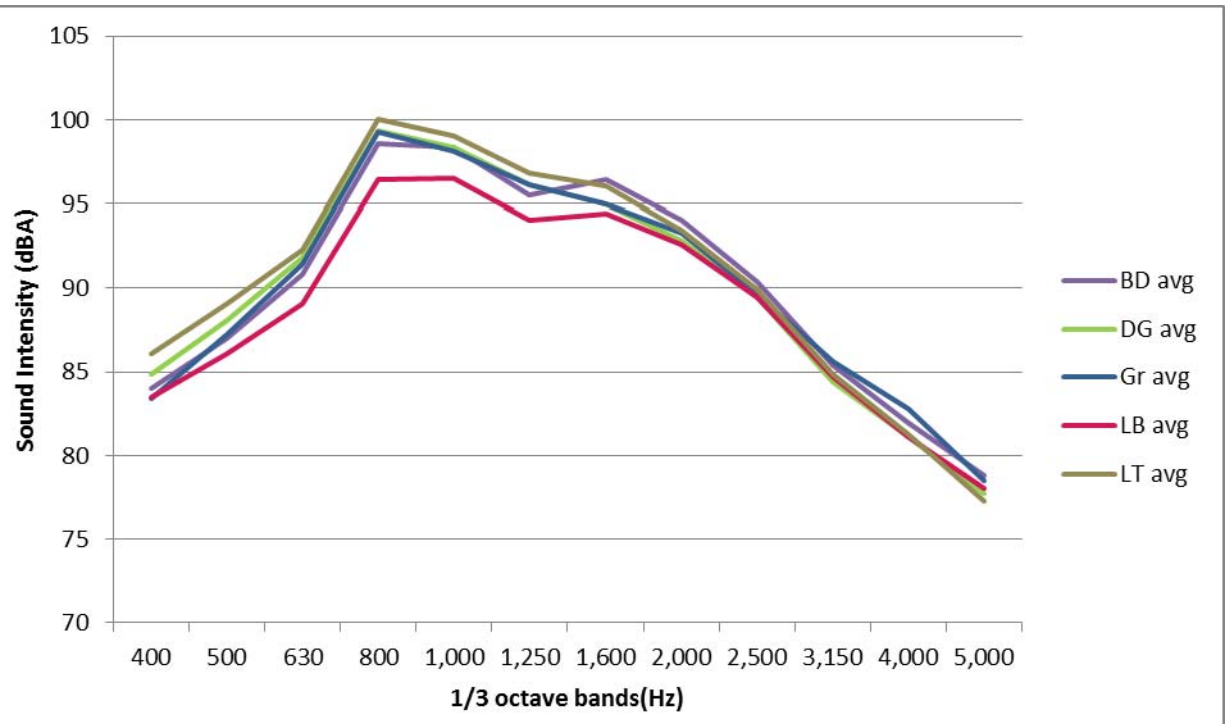
This appendix presents selected tables and figures from the main body of this report that have been remade using data without corrections for tire type and analyzer. The numbering and captions for the tables and figures are the same as those in the main body of the report to facilitate comparison.

Figure E.1: Figure 3.17: Comparison of OBSI spectral content of sections with different texture types, average of sections with texture aged.
(Note: BD = burlap drag, DG=diamond ground, Gr=diamond grooved, LB=longitudinally broomed, LT=longitudinally tined.)

To begin the examination of the noise characteristics of concrete pavement surface textures in more detail, Figure 3.16 presents the one-third octave sound intensity levels, using the average for each texture type and including textures of all three conditions. The longitudinally broomed texture has markedly lower levels at frequencies below 1,250 Hz. The other surface types are difficult to distinguish from each other in terms of average OBSI spectra. Given that once the texture of a surface has disappeared, it is no longer considered to be designed, and it is more appropriate to consider only those sections with *aged* texture, as presented in Figure 3.17.

Figure 3.17: Comparison of OBSI spectral content of sections with different texture types, average of sections with texture aged.
 (Note: BD = burlap drag, DG=diamond ground, Gr=diamond grooved, LB=longitudinally broomed, LT=longitudinally tined.)

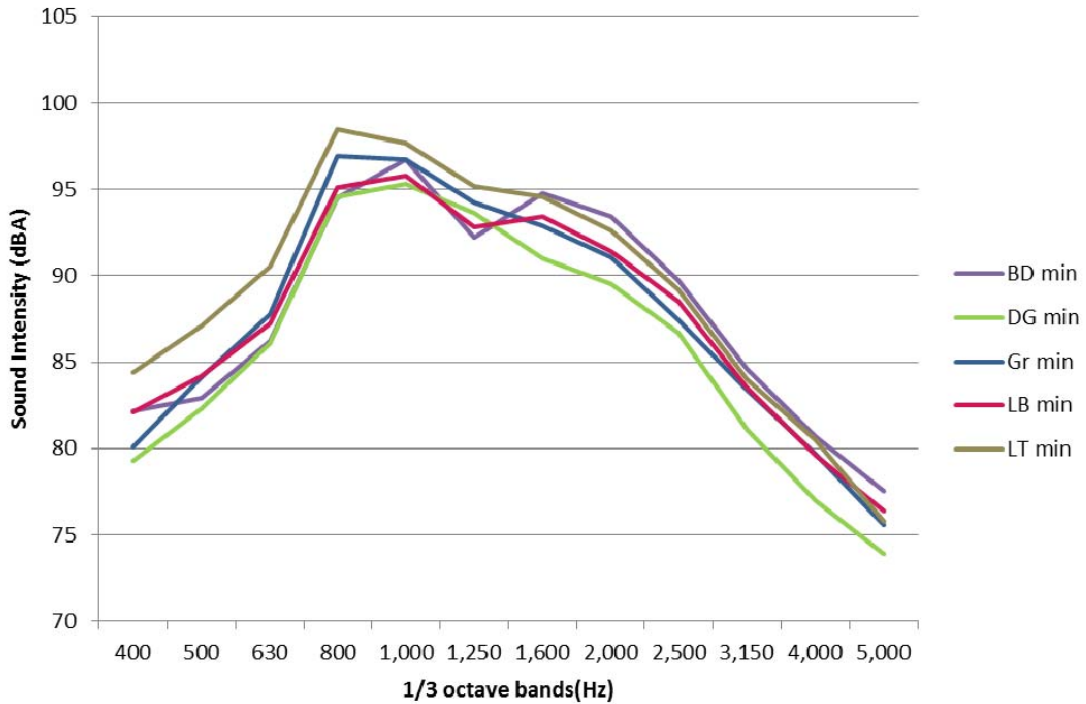
Figure E.2: Compare with Figure 3.19: Comparison of OBSI spectral content of sections with different texture types, minimum of sections with aged texture.
 (Note: BD = burlap drag, DG=diamond ground, Gr=diamond grooved, LB=longitudinally broomed, LT=longitudinally tined.)

The average spectra for all texture types and conditions was shown previously in Figure 3.16. The minimum and maximum spectra values for the one-third octaves are shown for all sections with aged texture in Figure 3.19 and Figure 3.20, respectively.

Figure 3.19: Comparison of OBSI spectral content of sections with different texture types, minimum of sections with aged texture.

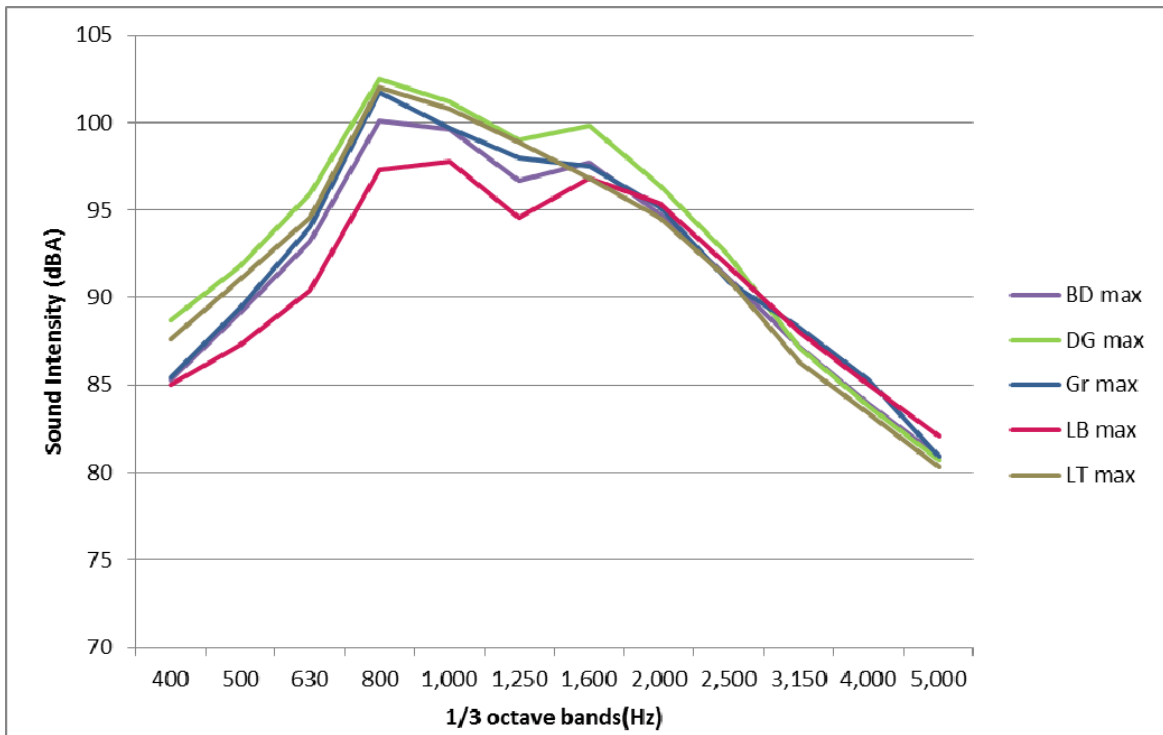
Figure E.3: Compare with Figure 3.20: Comparison of OBSI spectral content of sections with different texture types, maximum of sections with aged texture.
 (Note: BD = burlap drag, DG=diamond ground, Gr=diamond grooved, LB=longitudinally broomed, LT=longitudinally tined.)

Figure 3.20: Comparison of OBSI spectral content of sections with different texture types, maximum of sections with texture aged.
 (Note: BD = burlap drag, DG=diamond ground, Gr=diamond grooved, LB=longitudinally broomed, LT=longitudinally tined.)

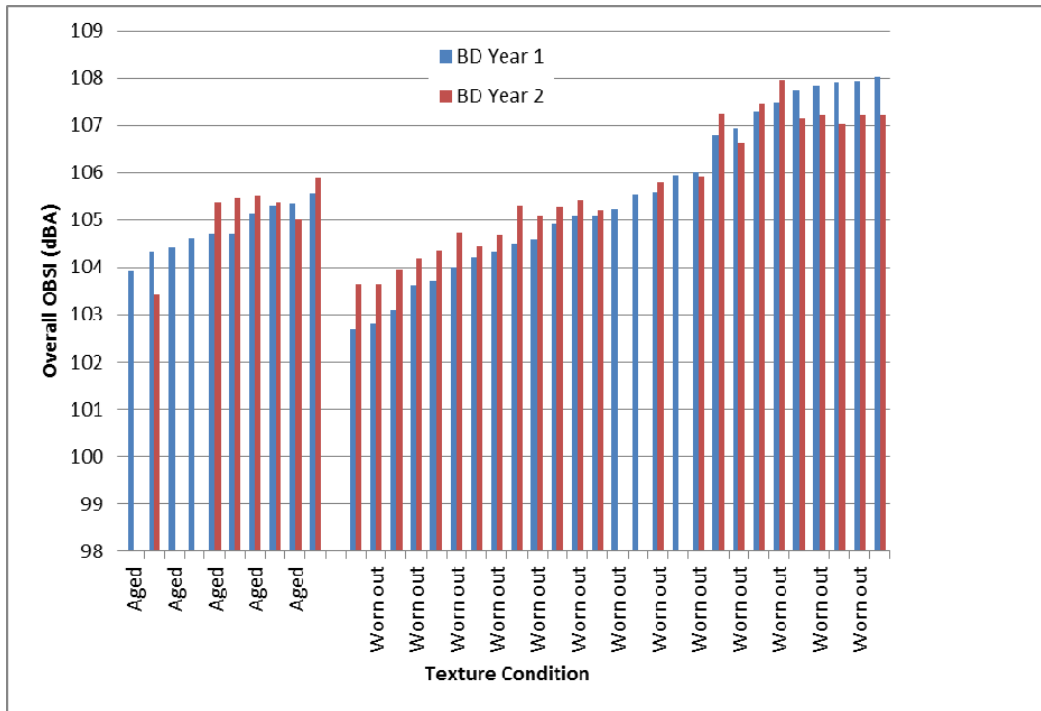
Figure E.4: Compare with Figure 3.30: Burlap drag Year 1 and Year 2 results for all texture conditions (*new, aged, worn out*).

Figure 3.30 shows OBSI results for the burlap drag sections. The vast majority of the burlap drag sections were built in the 1960s and 1970s. The only “young” section, which was about six years old at the time of testing, is QP-159.1 at the Mojave Bypass. The oldest sections, which were 62 years old, are on Interstate 80 in Solano County (QP-116.1, QP-116.2, and QP-116.3). Older sections have higher OBSI levels. Figure 3.31 shows all texture conditions for the burlap drag sections plotted versus the number of years since they were last surfaced, including all Year 1 and Year 2 measurements.

Figure 3.30: Year 1 and Year 2 OBSI values for all burlap drag sections.

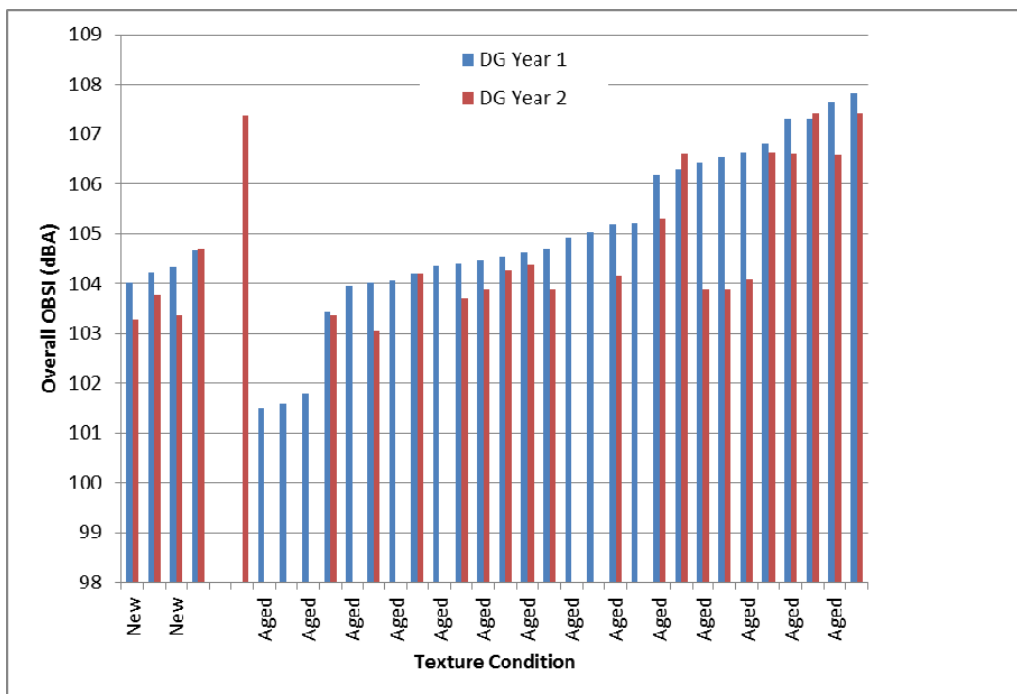
Figure E.5: Compare with Figure 3.32: Diamond ground Year 1 and Year 2 results for all texture conditions (*new, aged, and worn out*).

Figure 3.32 shows OBSI results for the diamond ground sections. The oldest sections evaluated were 11 years old at the time of testing. It seems again that older sections have higher OBSI levels. Figure 3.33 shows all texture conditions for the diamond ground sections plotted versus the number of years since they were last surfaced, including all Year 1 and Year 2 measurements.

Figure 3.32: Year 1 and Year 2 OBSI values for all diamond ground sections.

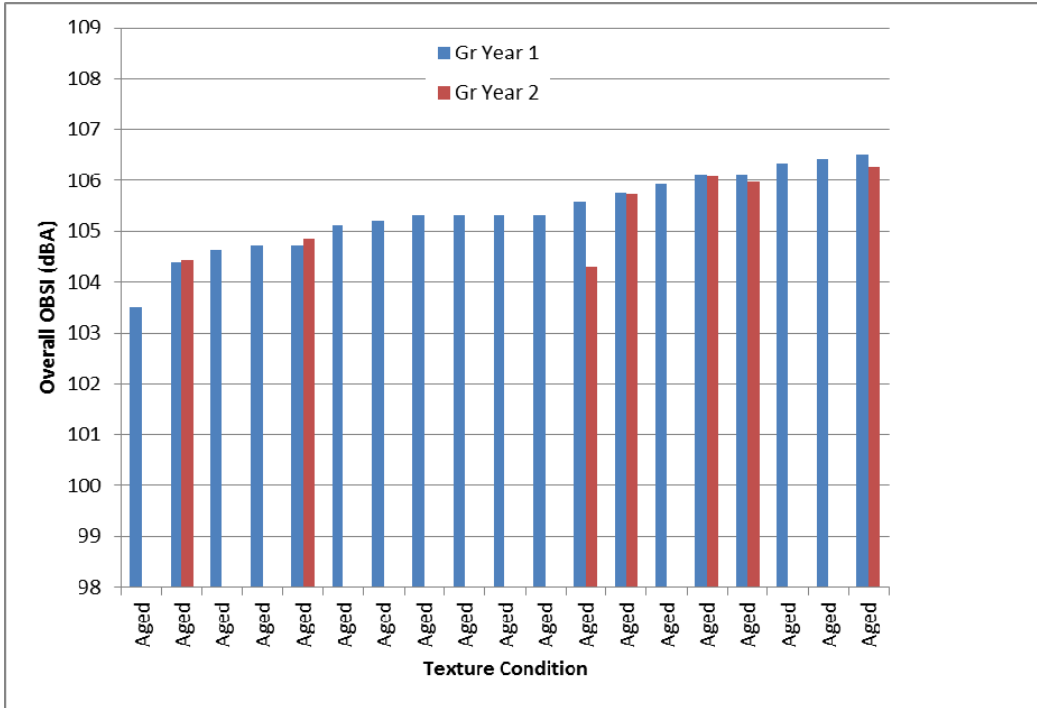
Figure E.6: Compare with Figure 3.34: Diamond grooved Year 1 and Year 2 results for all texture conditions (*new, aged, worn out*).

Figure 3.34 shows OBSI results for the diamond grooved sections. Although some of the pavements on US 101 in Sonoma County were built in 1962 (QP-136 and QP-138), records indicate that the sections were diamond grooved in 2006. Older sections were about 12 years old after grooving, and were located on Interstate 80 in Nevada County (QP-110 and QP-111). It is not possible to observe a trend in OBSI level over time with the available data. Figure 3.35 shows all texture conditions for the diamond grooved sections plotted versus the number of years since they were last surfaced, including all Year 1 and Year 2 measurements.

Figure 3.34: Year 1 and Year 2 OBSI values for all diamond grooved sections.

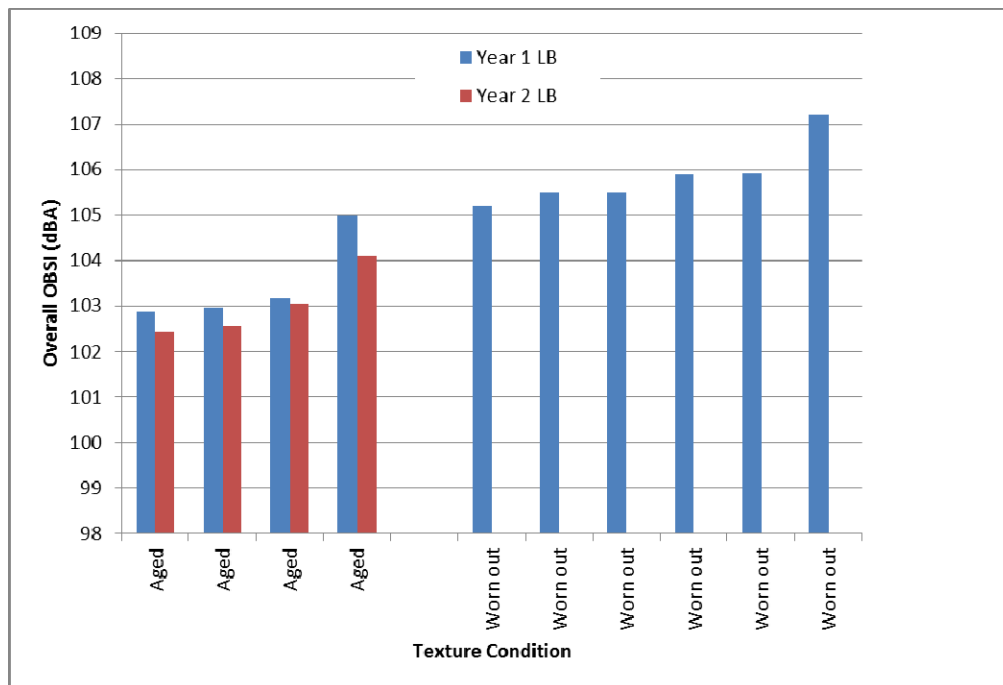
Figure E.7: Compare with Figure 3.36: Longitudinally broomed Year 1 and Year 2 results for all texture conditions (*new, aged, worn out*).

Figure 3.36 shows OBSI results for the longitudinally broomed sections. The six-year old section is at the Mojave Bypass on State Route 58. The 19-year old sections are on Interstate 80 in Nevada County (QP-109 and QP-112), but were overlaid with asphalt between Year 1 and Year 2. The 34-year-old sections are on Interstate 280 in San Mateo County (QP-146). From the limited available data, it seems that OBSI levels on this type of surface texture do not increase much over time. Figure 3.37 shows all texture conditions for the longitudinally broomed sections plotted versus the number of years since they were last surfaced, including all Year 1 and Year 2 measurements.

Figure 3.36: Year 1 and Year 2 OBSI values for all longitudinally broomed sections.

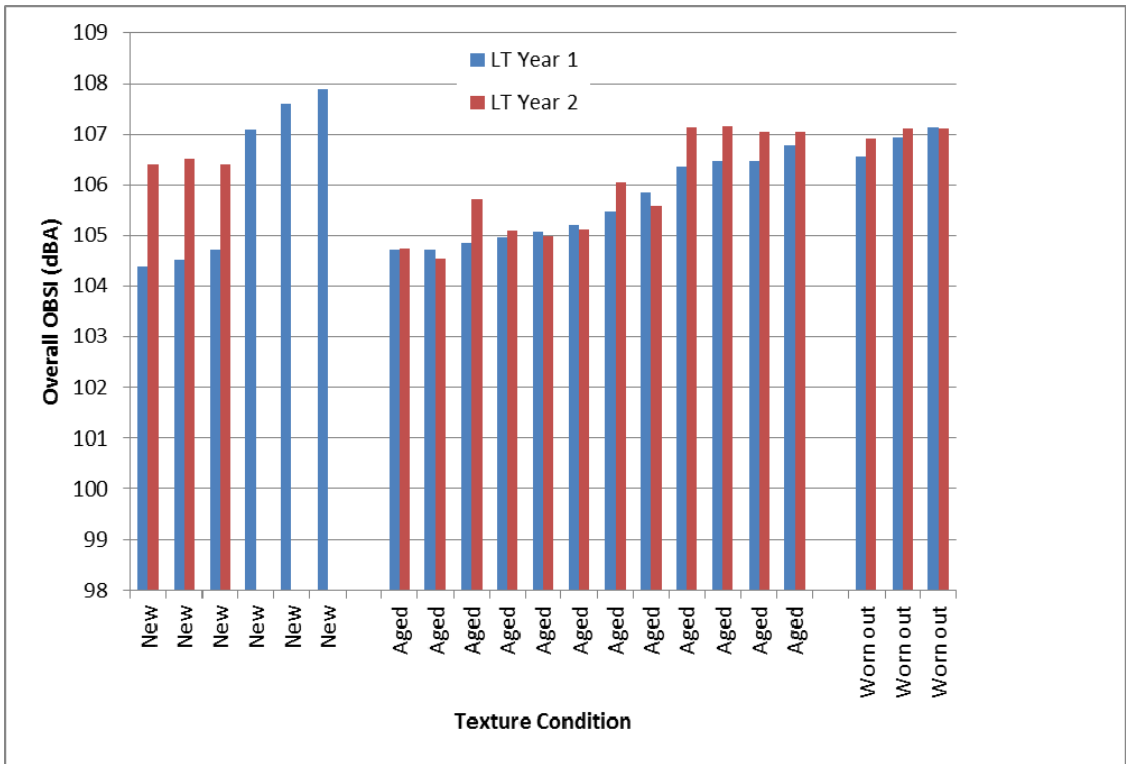
Figure E.8: Compare with Figure 3.38: Longitudinally timed Year 1 and Year 2 results for all texture conditions (new, aged, worn out).

Figure 3.38 shows OBSI results for the longitudinally tined sections. The OBSI levels remain mostly between 103 and 107 dB(A), even for sections that are over 30 and 40 years old. Figure 3.39 shows all texture conditions for the longitudinally tined sections plotted versus the number of years since they were last surfaced, including all Year 1 and Year 2 measurements.

Figure 3.38: Year 1 and Year 2 OBSI values for all longitudinally tined sections.
