**Environmental Influences on the Curling of Concrete Slabs at the
Palmdale HVS Test Site**

Louw du Plessis,
CSIR Transportek

John Harvey,
UC Pavement Research Center

For the California Department of Transportation

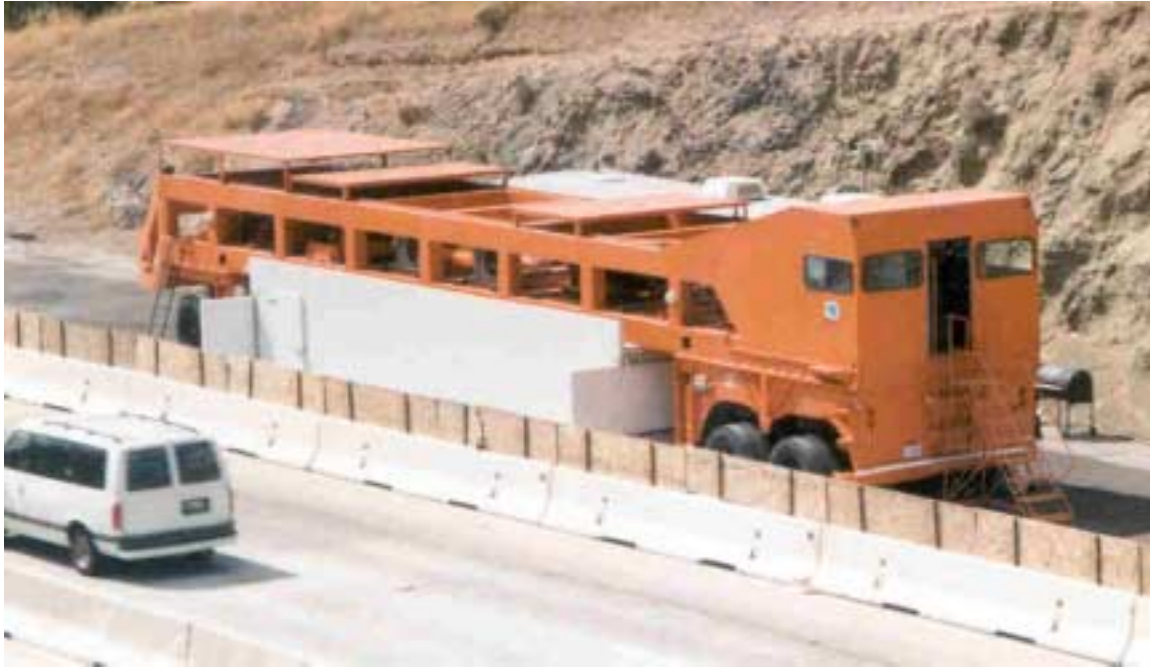
Figure 1.1. HVS with temperature control chamber at the Palmdale test sections.

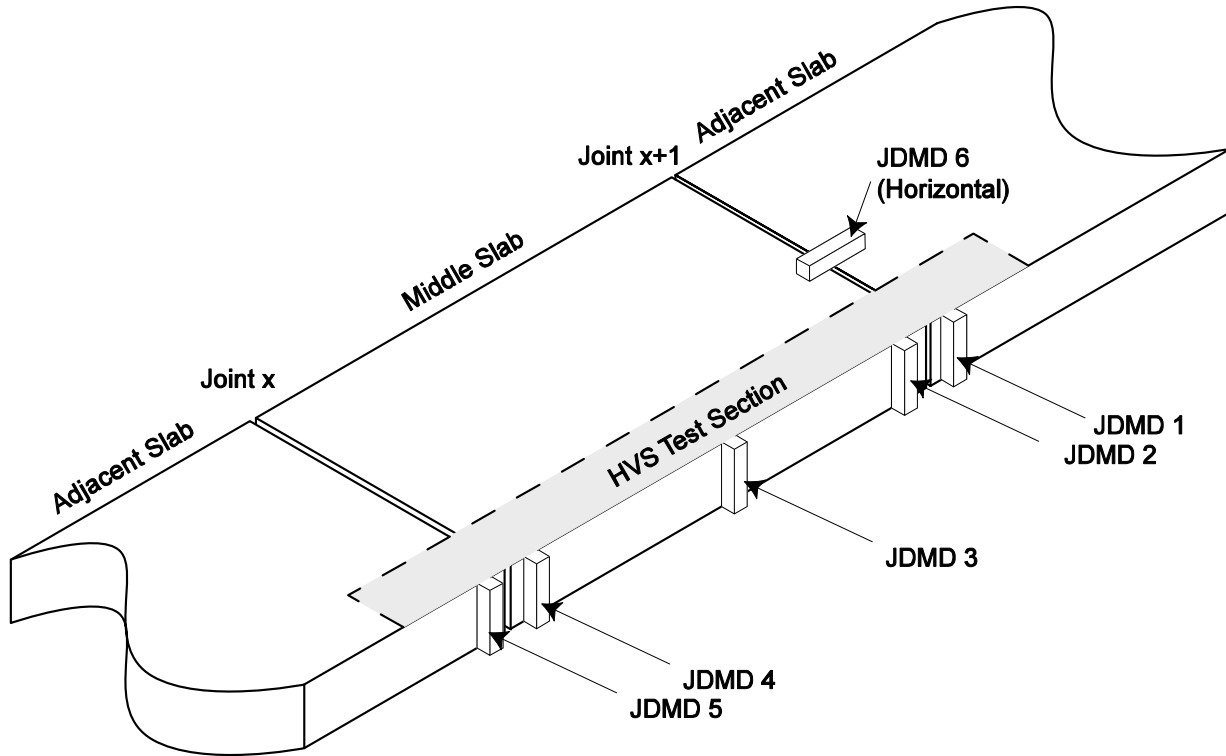
Figure 3.1. Placement of JDMD instruments with respect to the test sections.

MDDs were placed between the two wheel paths of the dual HVS loading wheels, approximately 300 mm from the edge of the concrete slab. All MDDs were fitted with 4 in-depth LVDTs, placed at depths of 100 mm, 300 mm, 450 mm, and 650 mm. However, for this

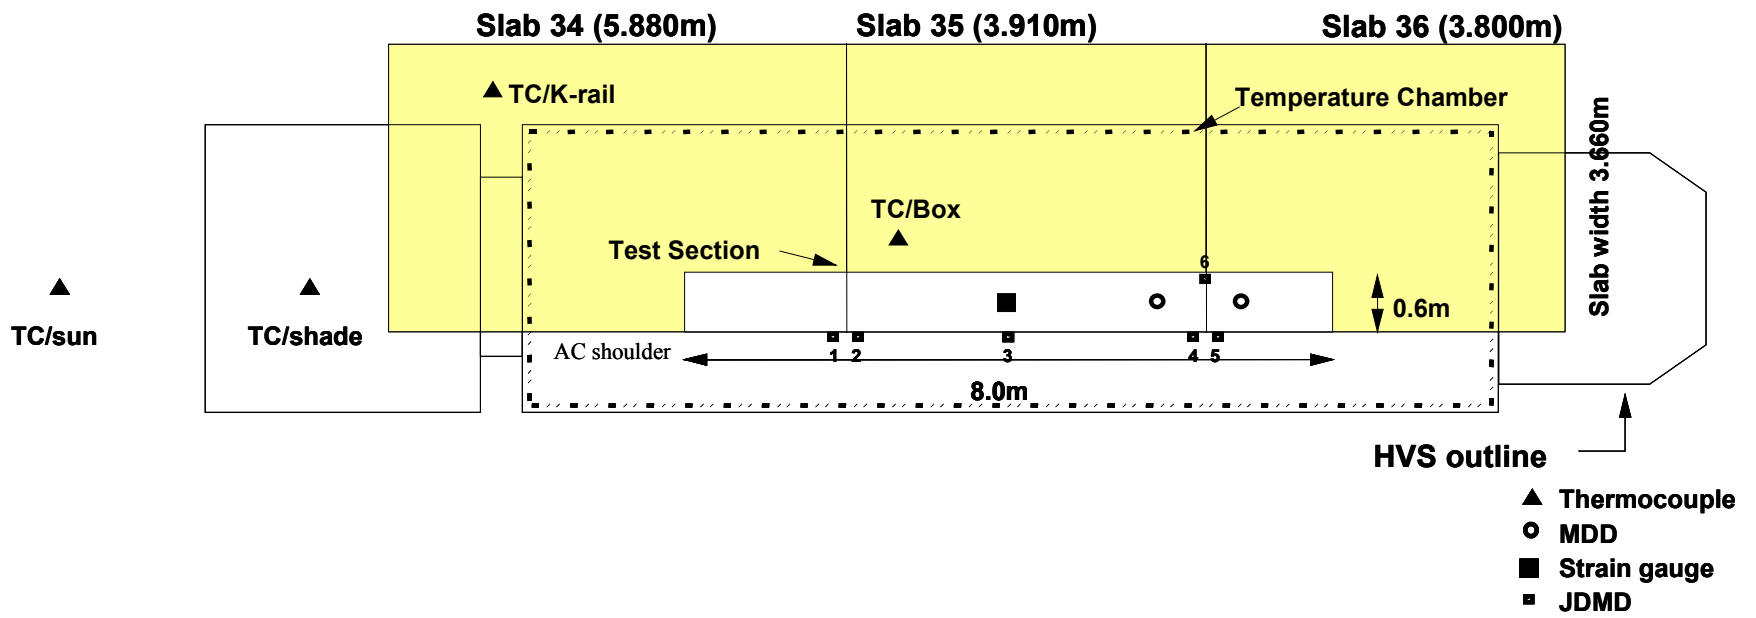
Figure 3.3. Instrumentation layout of Test Section 534FD.

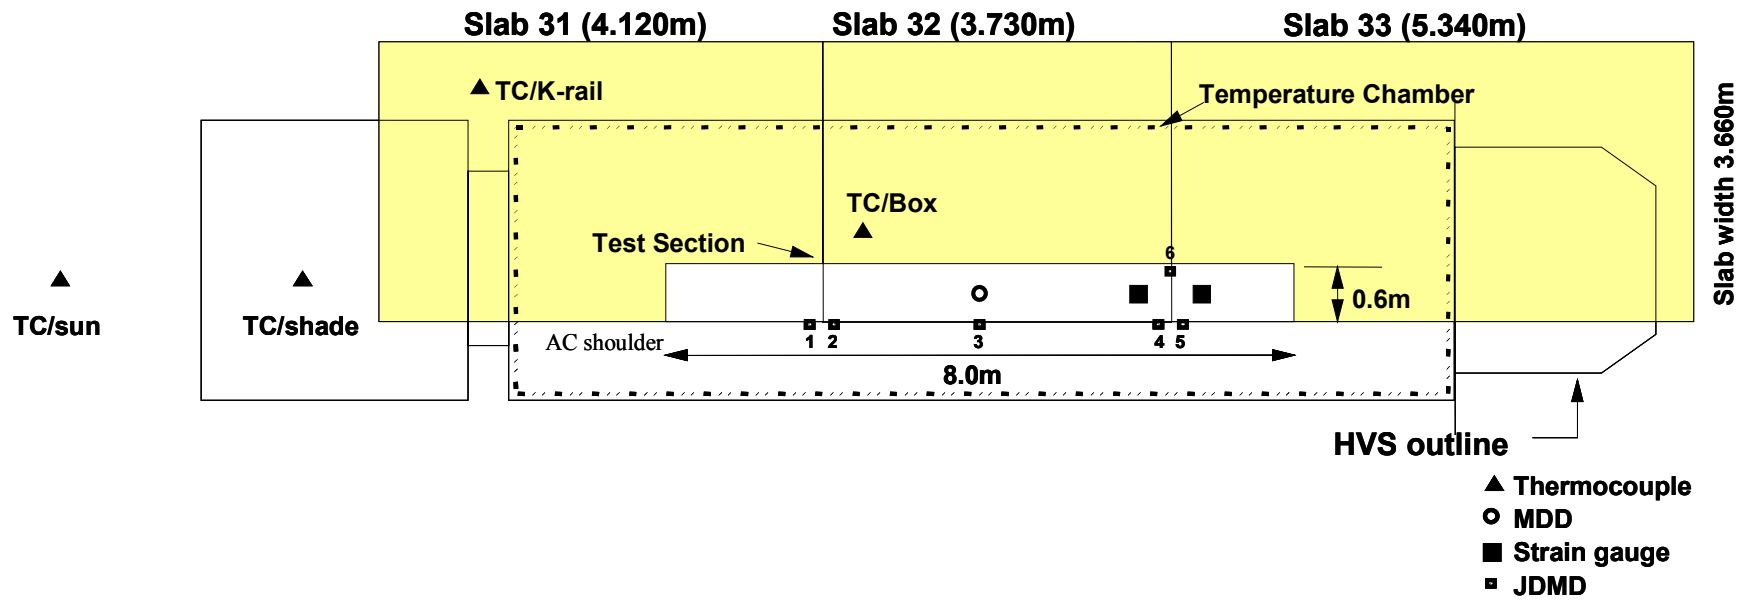
Figure 3.4. Instrumentation layout of Test Section 535FD.

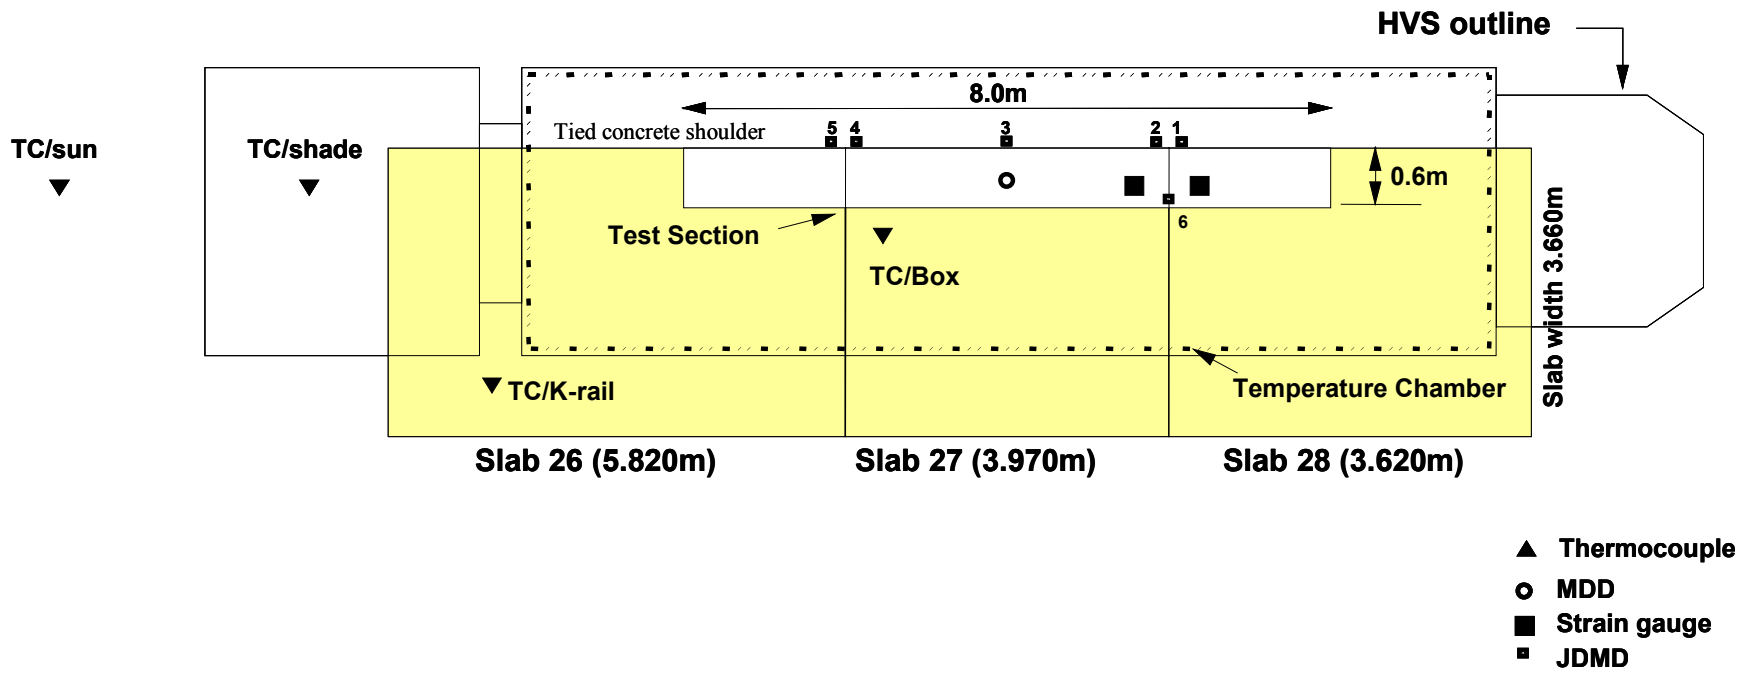
Figure 3.5. Instrumentation layout of Test Section 536FD.

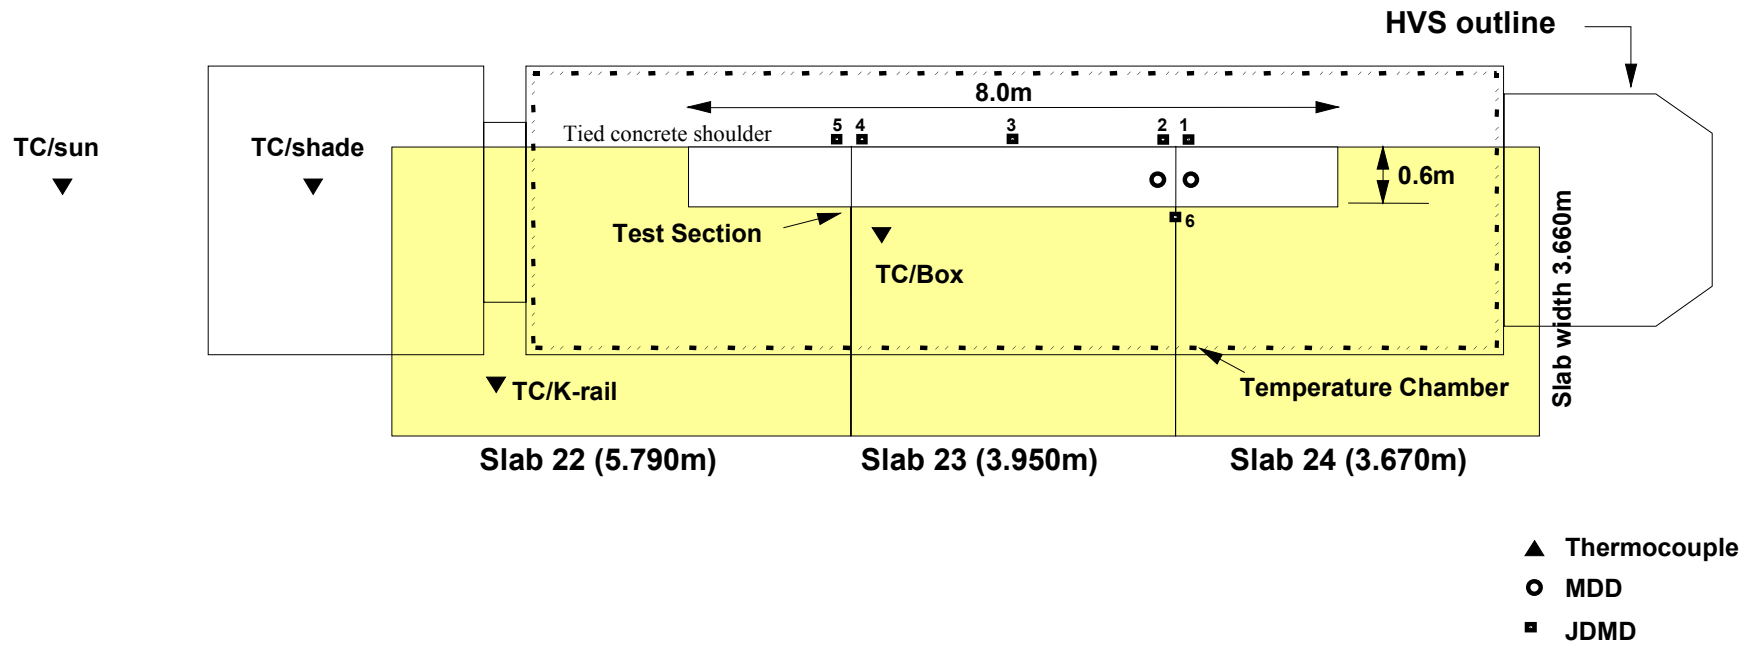
Figure 3.6. Instrumentation layout of Test Section 537FD.

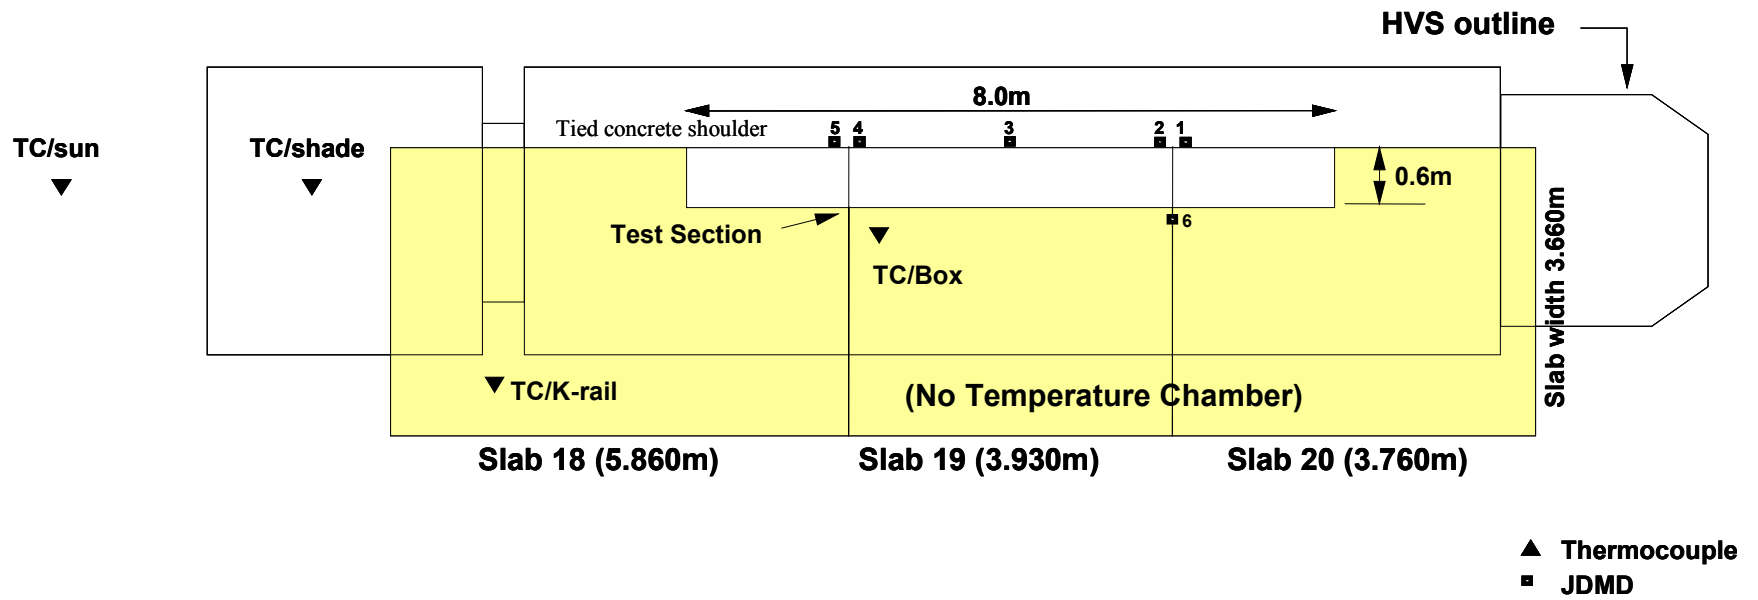
Figure 3.7. Instrumentation layout of Test Section 538FD.

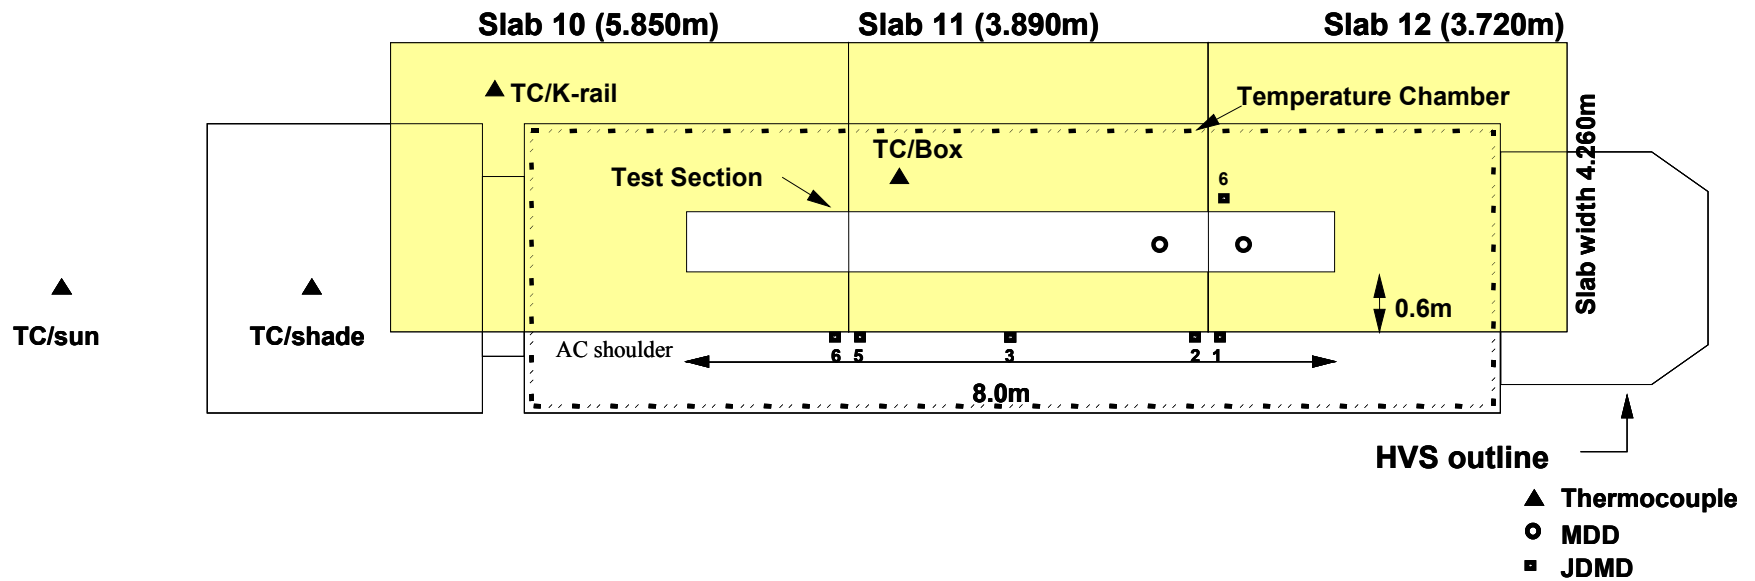
Figure 3.8. Instrumentation layout of Test Section 539FD.

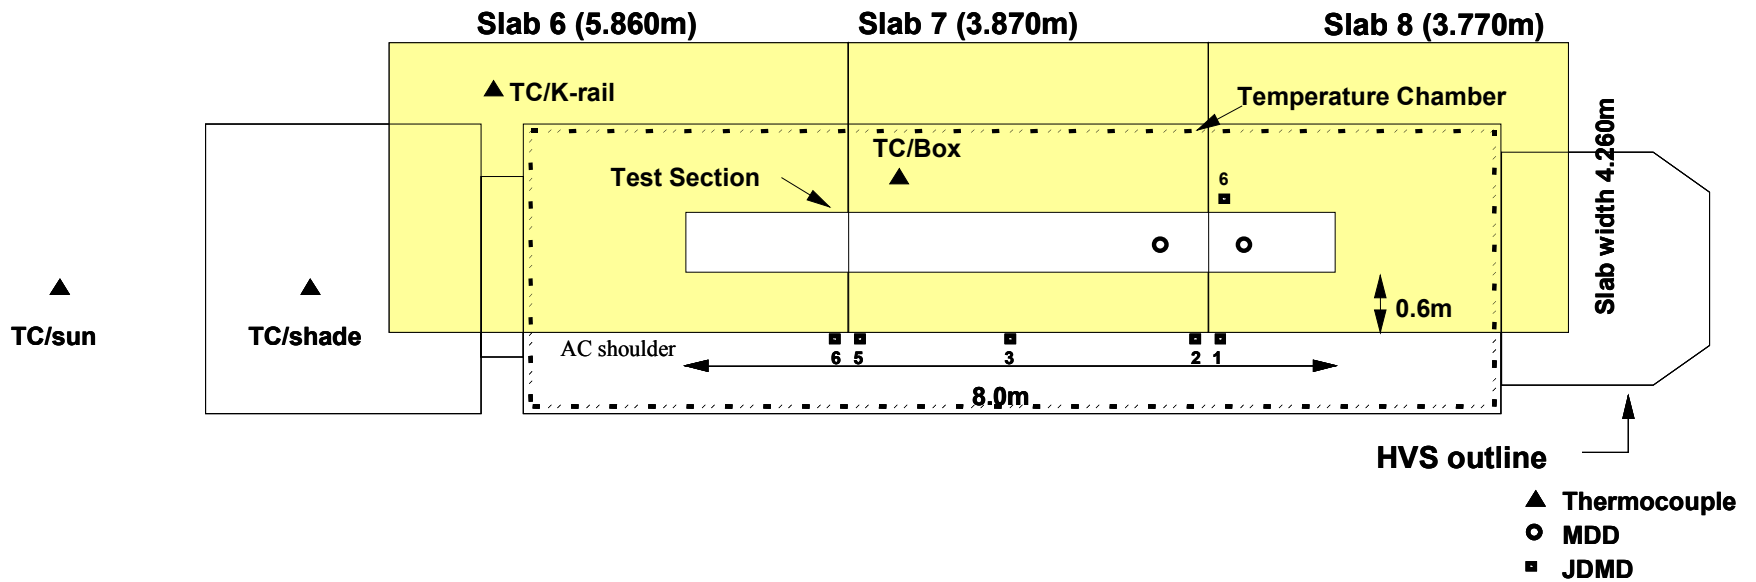
Figure 3.9. Instrumentation layout of Test Section 540FD.

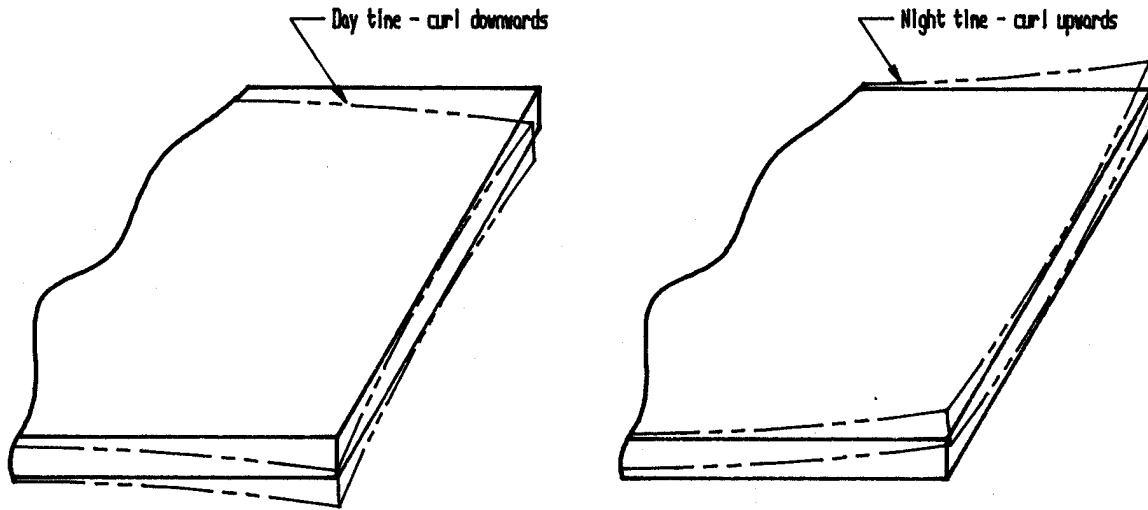
Figure 4.1. Edge and corner curling caused by daily temperature variation.

Slab corner curling is caused by temperature differentials between the top and the bottom of the slab. Concrete contracts as the temperature decreases and expands as the temperature rises. If the top and bottom of the concrete slab are not at the same temperature, the resulting temperature differential causes the slab to curl, with the corners moving either upward or downward.

During the day, the upper surface area (exposed to direct sunlight) heats up and causes the upper surface to expand. The bottom surface (200 mm below the top surface) does not reach the same temperature, as it is not exposed to sunlight. The net effect of this is that the slab corners tend to curl downward, because the bottom of the slab expands less than the top.

During the night, the effect is reversed. The upper surface, exposed to the open air, cools more rapidly than the underside. This causes the top part of the slab to contract more than the bottom part (which is not exposed to the ambient air temperature) and the slab corners to curl upward. This effect is illustrated in Figures 4.1 for edge and corner curling.

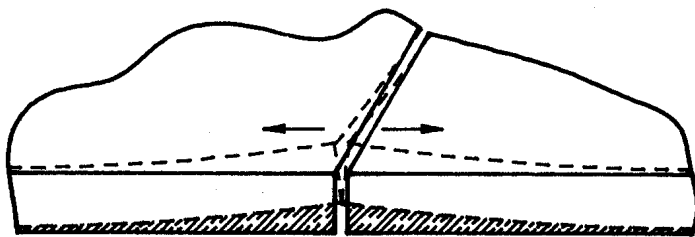
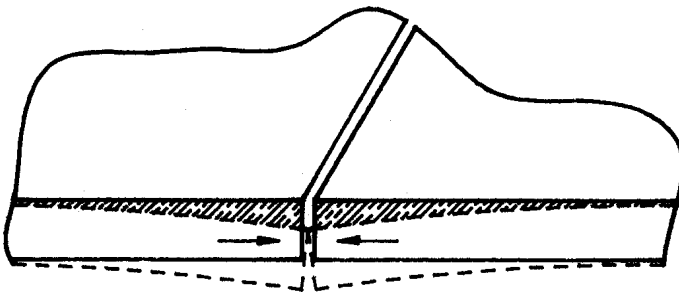
Night time: Slab shrinks and curls upwards - joint gap increases.

Day time: Slab expands and curls downwards - joint gap decreases.

Figure 4.2. Horizontal movement at transverse joints caused by daily temperature variation.

Curling caused by temperature difference between the top and bottom of the slab and total slab expansion is visible at the transverse construction joints. During the night, the concrete contracts and corners curl upward, which causes the gap in the joint at the surface to widen. During the day, the opposite occurs: the slab heats up, expands and the corners curl downward, closing the gap between the slabs at the surface. The effect of this was measured by JDMD 6, which was placed horizontally across the joints, as is illustrated in Figure 4.2. To assist in the

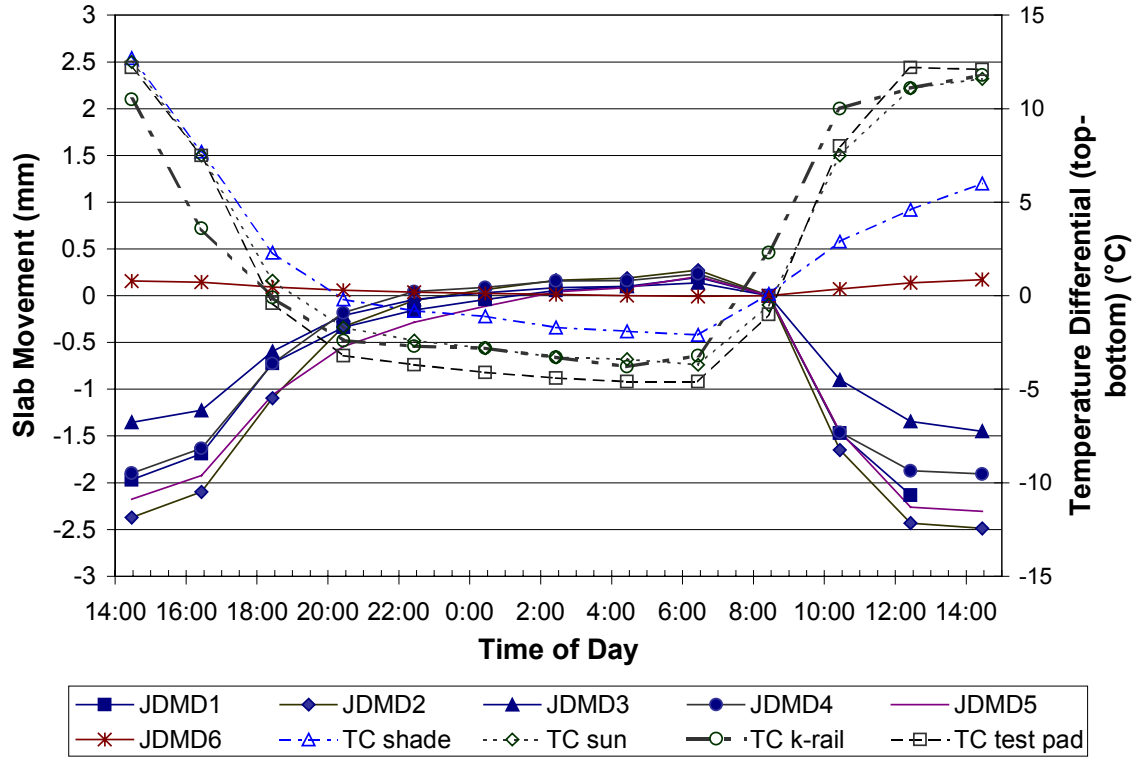
Figure 4.3. Section 534FD JDMD results (no HVS, no temperature control chamber).

The results presented in Table 4.1 and Figure 4.3 make logical sense: during the day, the slab is hotter at the surface than at the bottom. This causes the slab to expand and the corners to

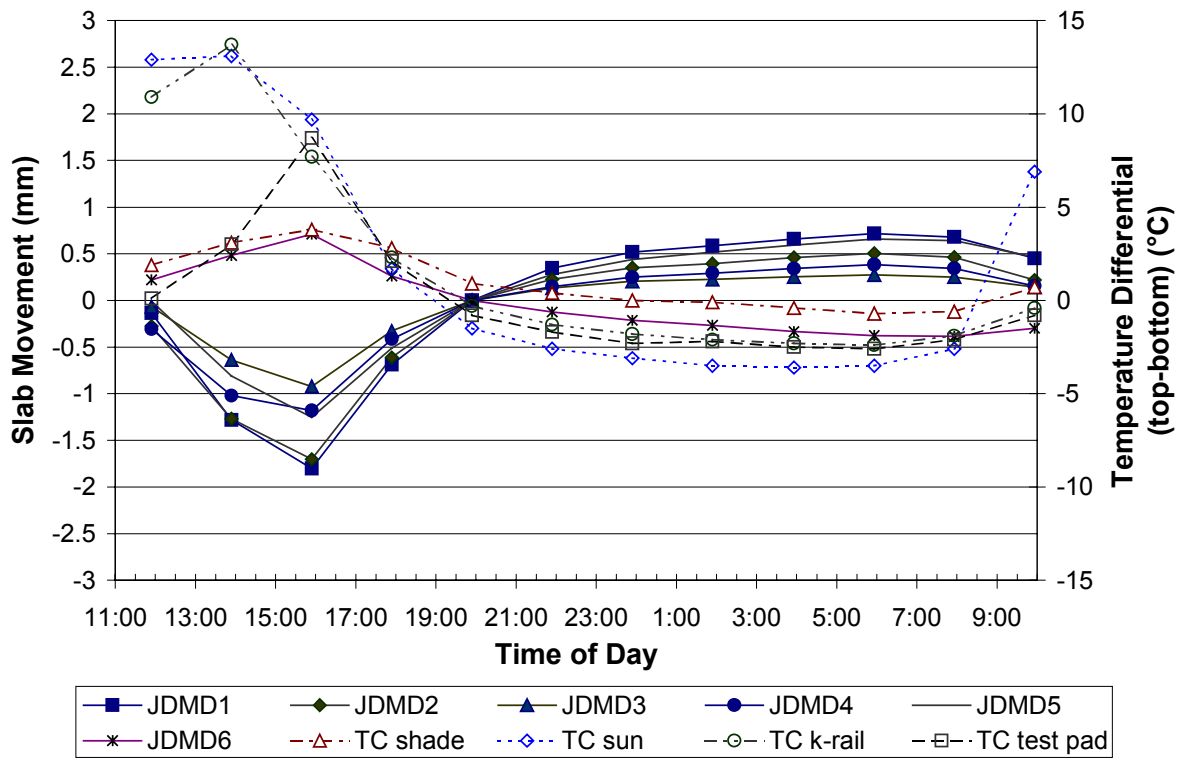
Figure 4.4. Section 534FD JDMD results (with HVS, no temperature control chamber).

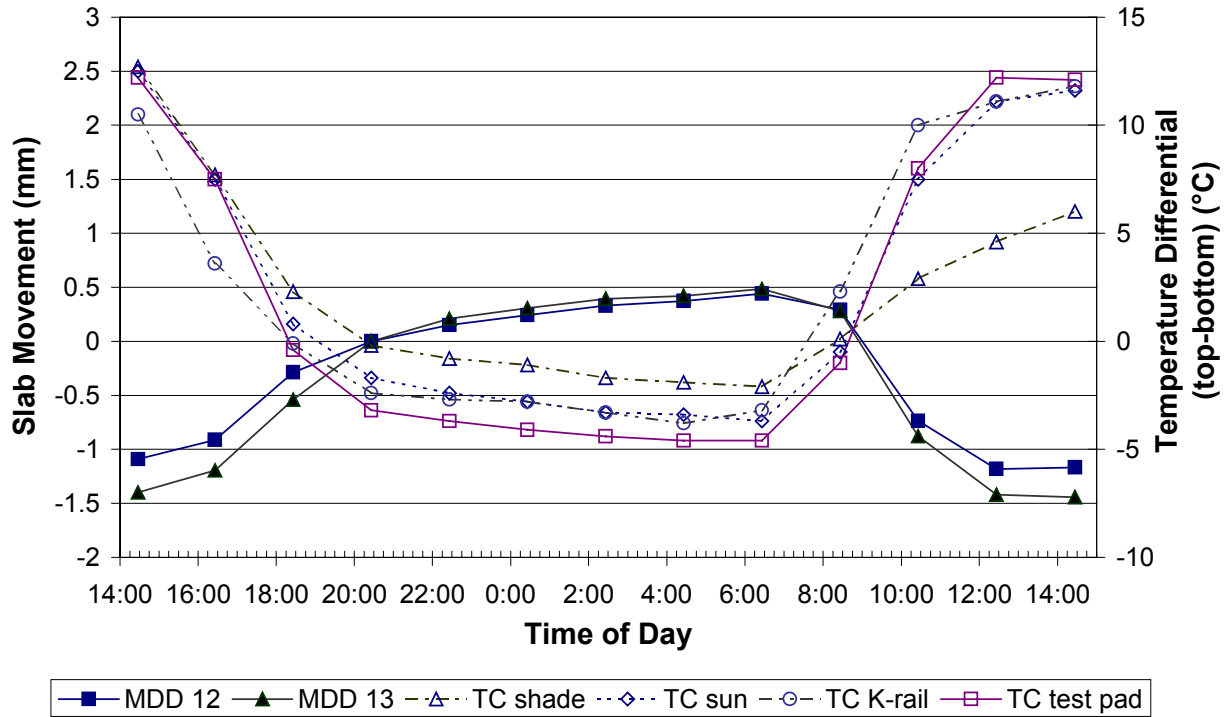
Figure 4.7. Section 534FD MDD results (no HVS, no temperature control chamber).

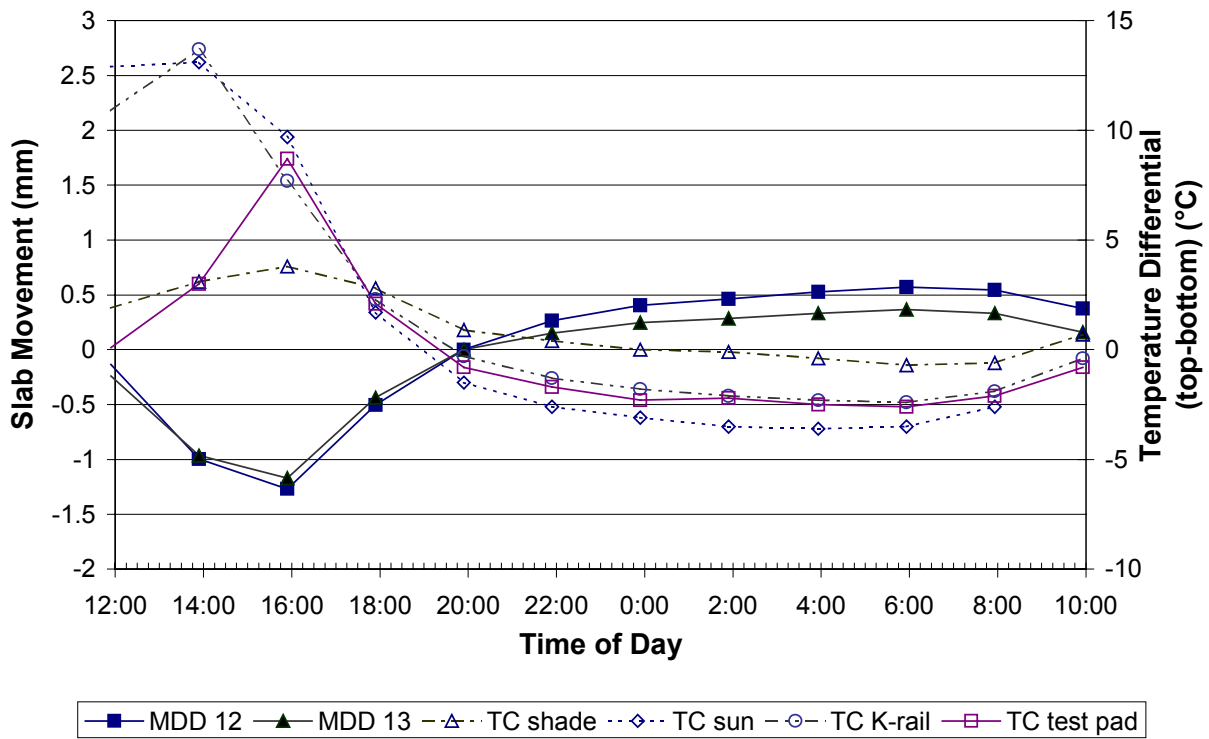
Figure 4.8. Section 534FD MDD results (with HVS, no temperature control chamber)

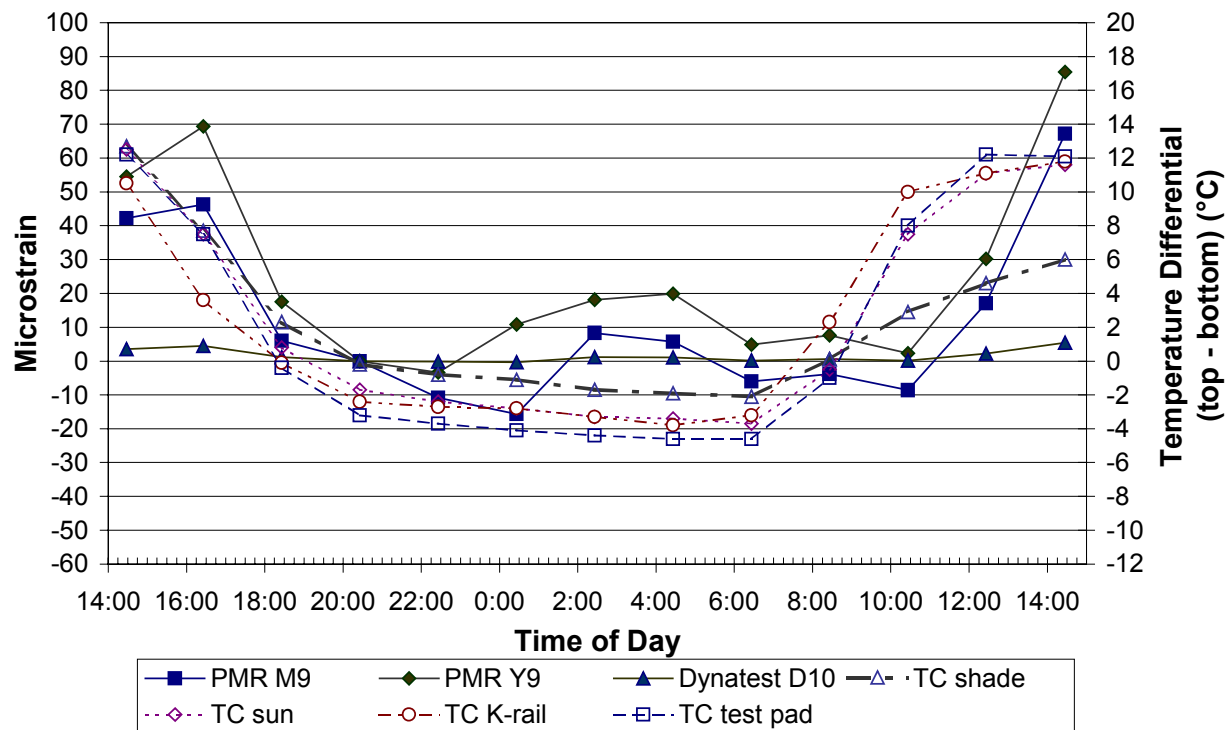
Figure 4.10. Section 534FD strain response (no HVS, no temperature control chamber).

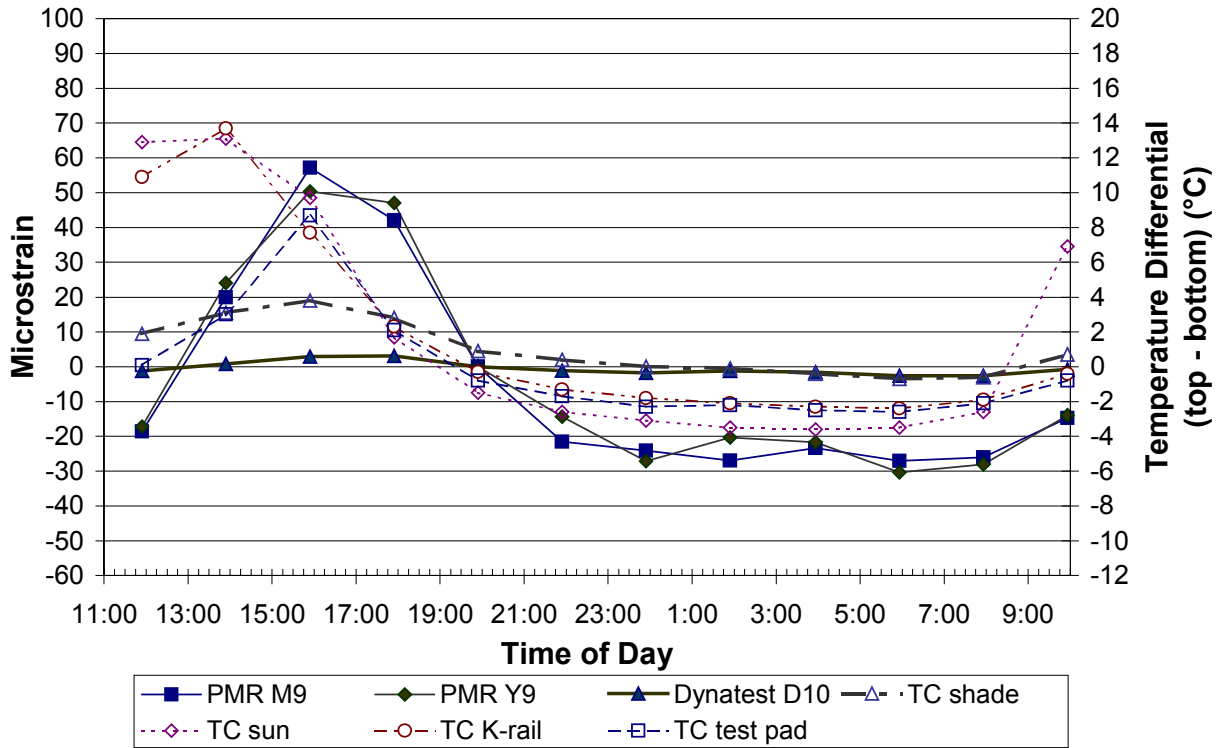
Figure 4.11. Section 534FD strain response (with HVS, no the temperature control chamber).

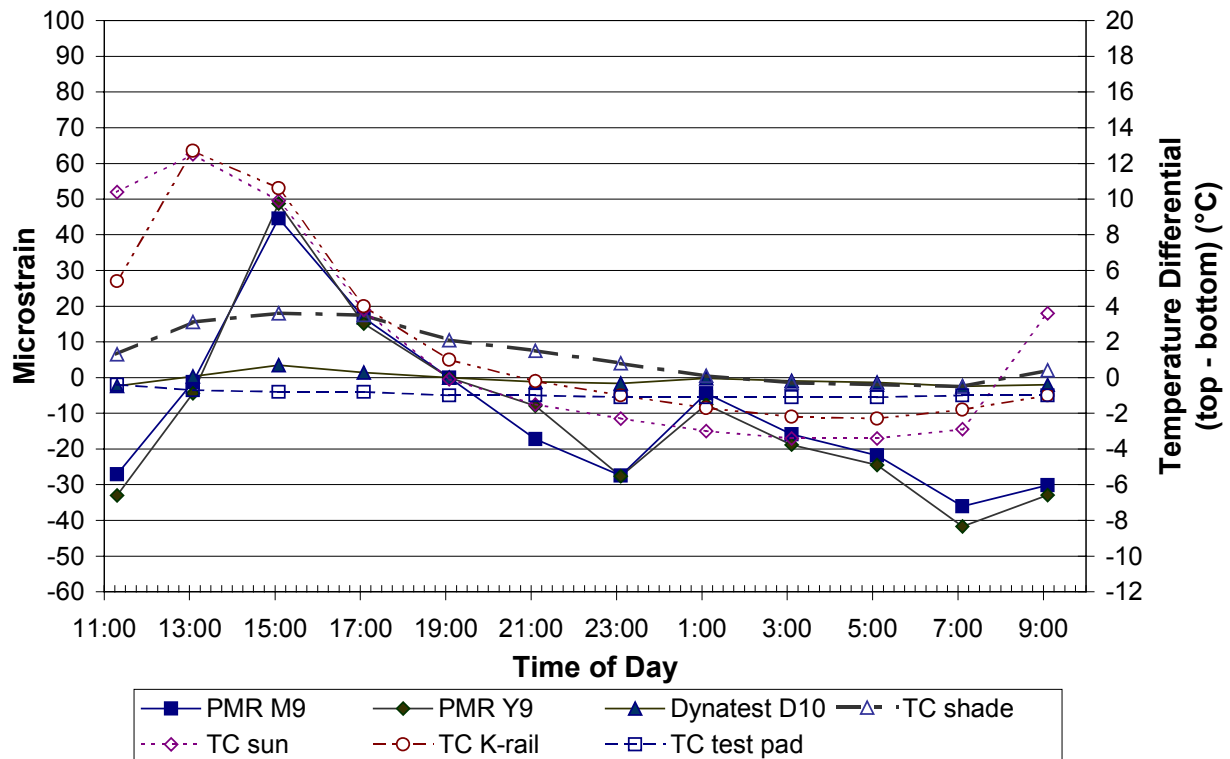
Figure 4.12. Section 534FD strain response (with HVS and temperature control chamber).

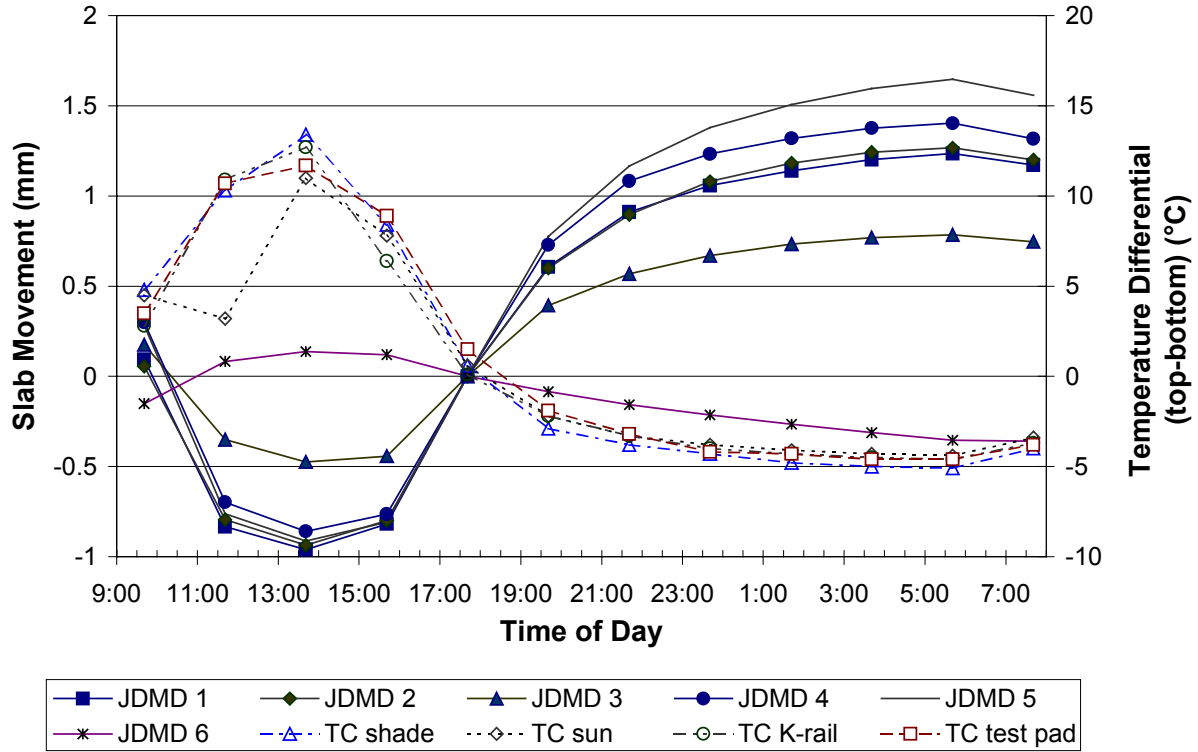
Figure 4.13. Section 535FD JDMD results (no HVS, no temperature control chamber).

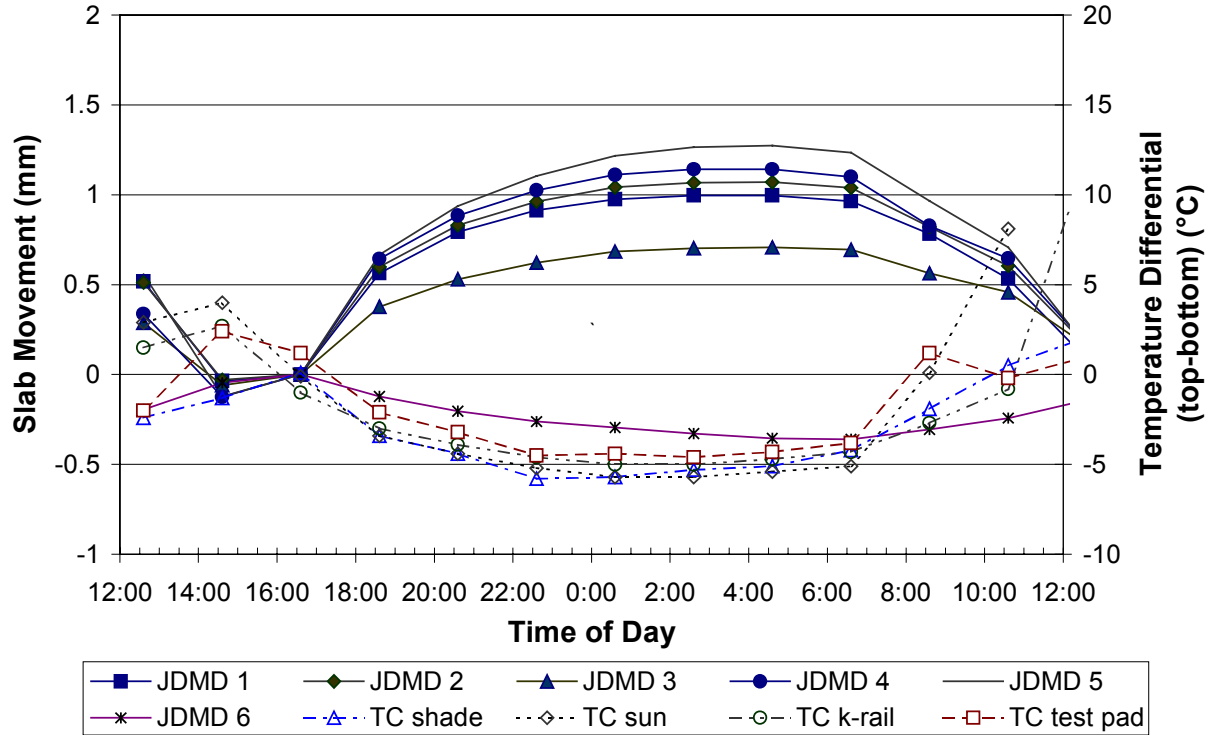
Figure 4.14. Section 535FD JDMD results (with HVS, no temperature control chamber).

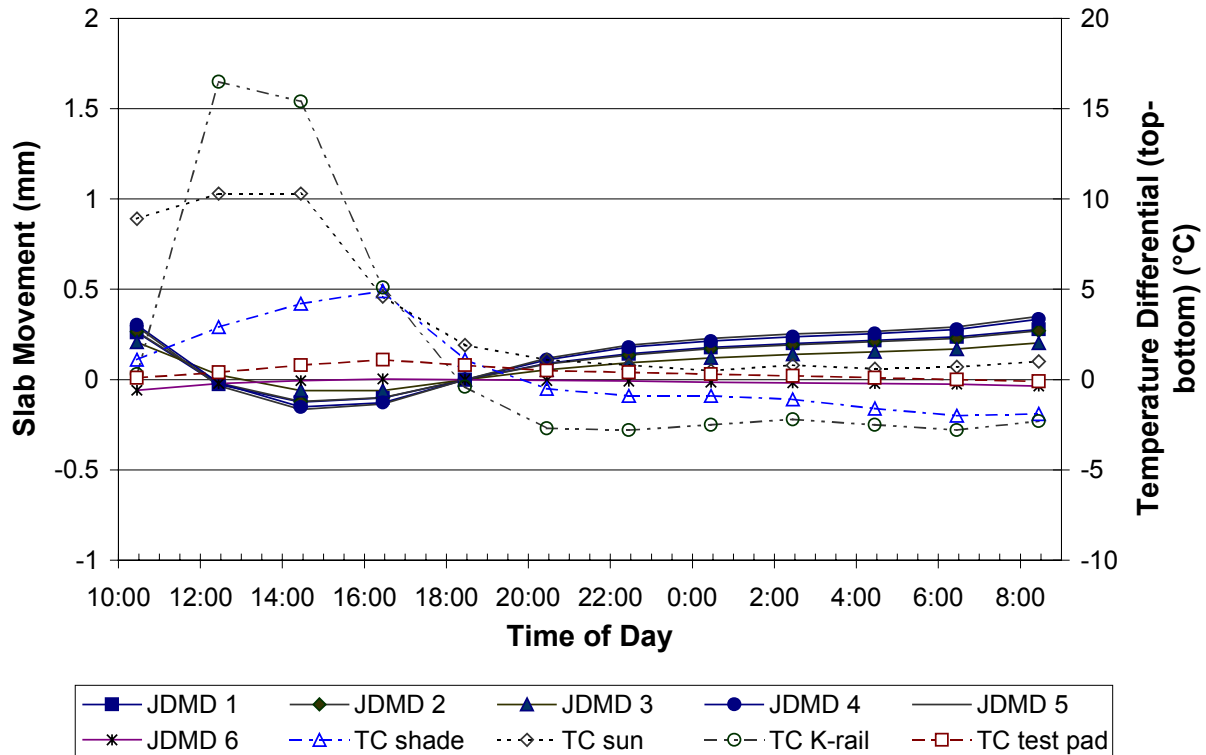
Figure 4.15. Section 535FD JDMD results (with HVS and temperature control chamber).

- In the case of Test 535FD with the HVS and the temperature control chamber (Table 4.9), there was good temperature control inside the chamber, where the maximum surface temperature change was only 0.9°C during the 24 hours, in comparison with the maximum total temperature change of 16.3°C which was recorded when the section was completely exposed to the sun. A maximum movement of 0.516 mm was recorded by JDMD 5 during the 24-hour cycle. These results are very similar to those for Test 534FD under the same conditions (with the HVS and the temperature control chamber). Because the overall slab temperatures were reduced by the temperature control chamber from 31.3°C to 16.5°C (Tables 4.7 and 4.9), the joint did not lock up and the joint opening was fully controlled by the temperatures and base friction.

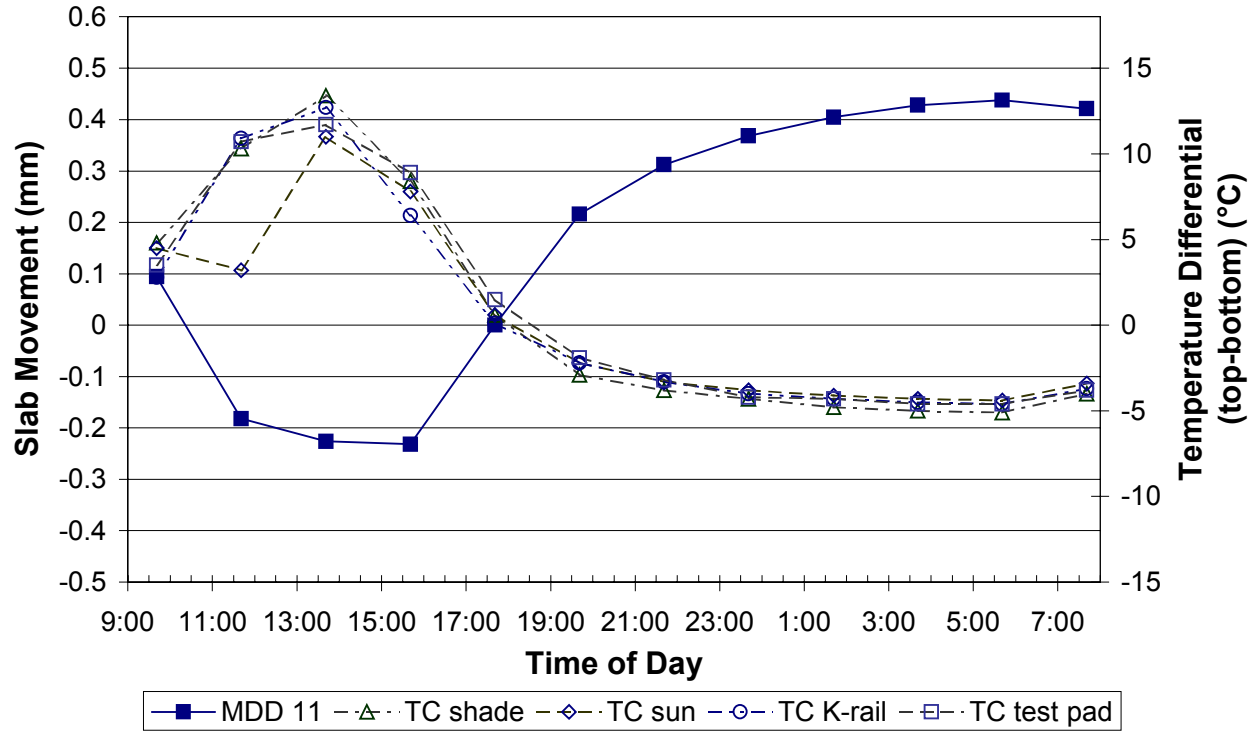
Figure 4.16. Section 535FD MDD results (no HVS, no temperature control chamber).

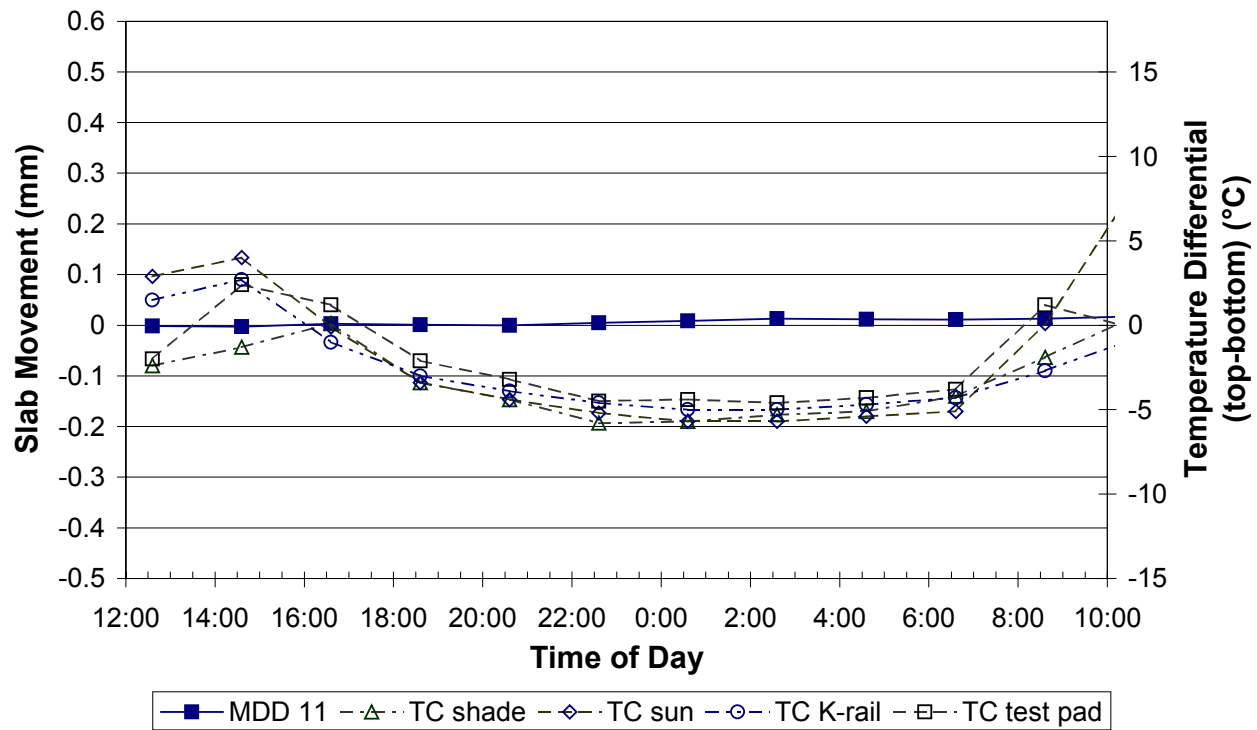
Figure 4.17. Section 535FD MDD results (with HVS, no temperature control chamber).
