**Environmental Influences on the Curling of Concrete Slabs at the
Palmdale HVS Test Site**

Louw du Plessis,
CSIR Transportek

John Harvey,
UC Pavement Research Center

For the California Department of Transportation

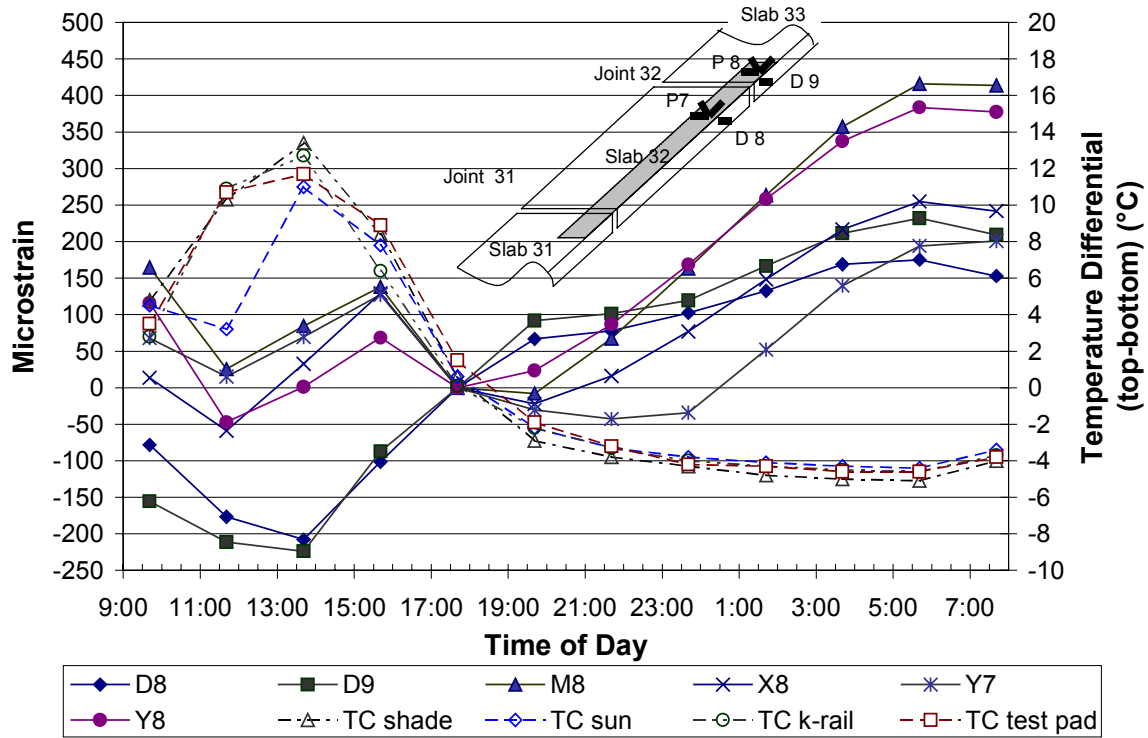
Figure 4.19. Section 535FD strain response (no HVS, no temperature control chamber).

Figure 4.19 presents the strain response for the case in which the whole test section was exposed to direct sunlight. The Dynatest gauges went through a cycle of being in compression during the day (periods of positive temperature gradients) to tension during the night (periods of negative temperature gradients). The maximum compression strain was 223 μ strain, which was caused by a positive temperature differential of 13.2°C. The maximum tensile strain of 255 μ was achieved during a temperature differential of -5.1°C. This behavior is in agreement with

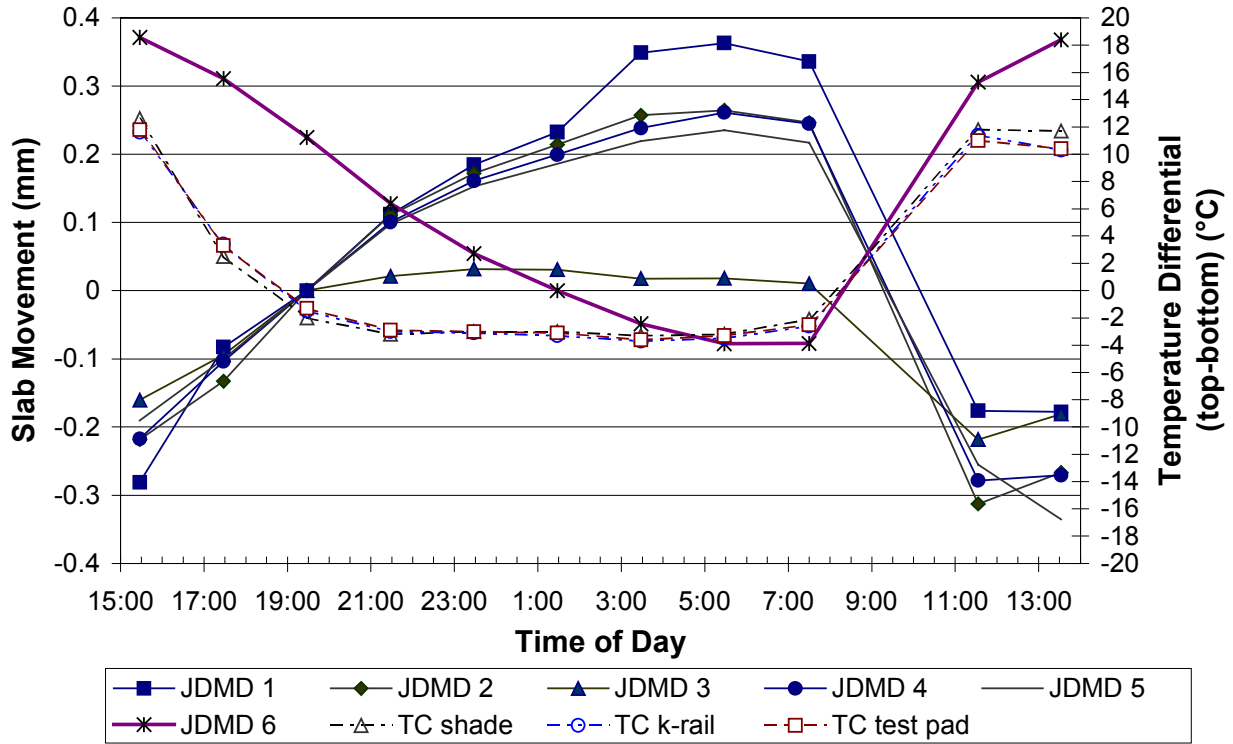
Figure 4.22. Section 536FD JDMD results (no HVS, no temperature control chamber).

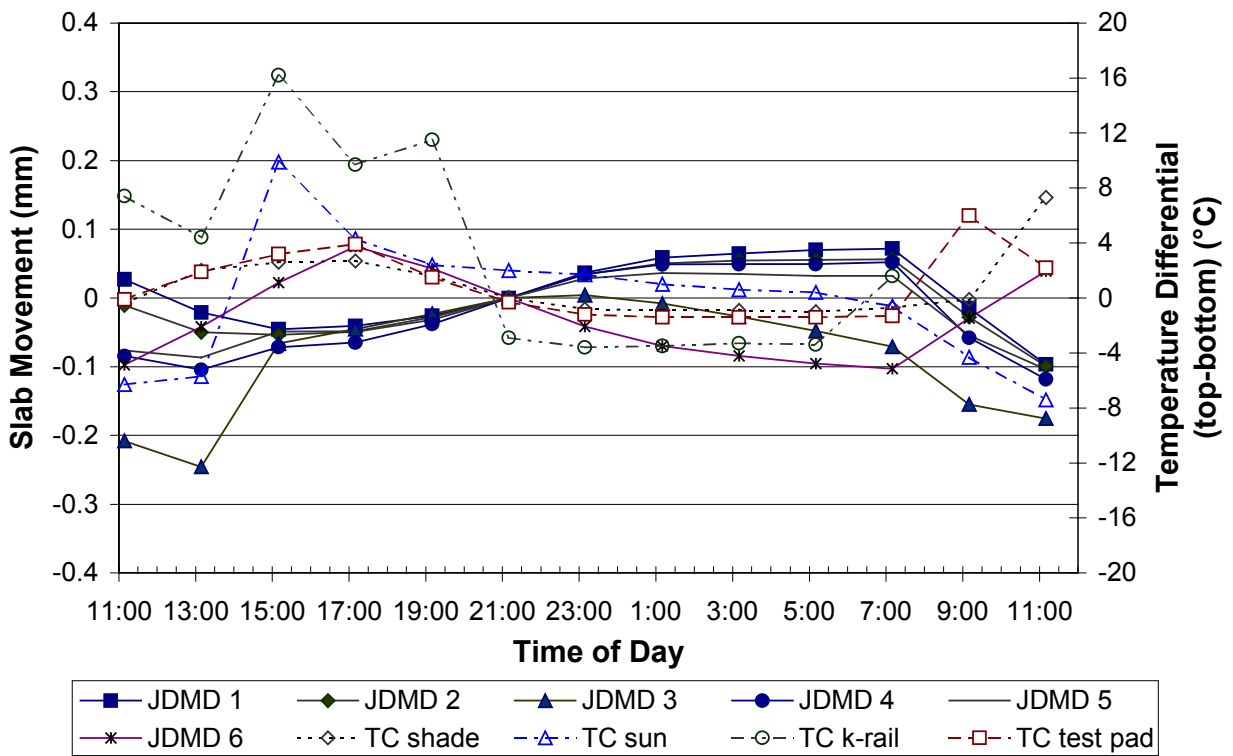
Figure 4.23. Section 536FD JDMD results (with HVS, no temperature control chamber).

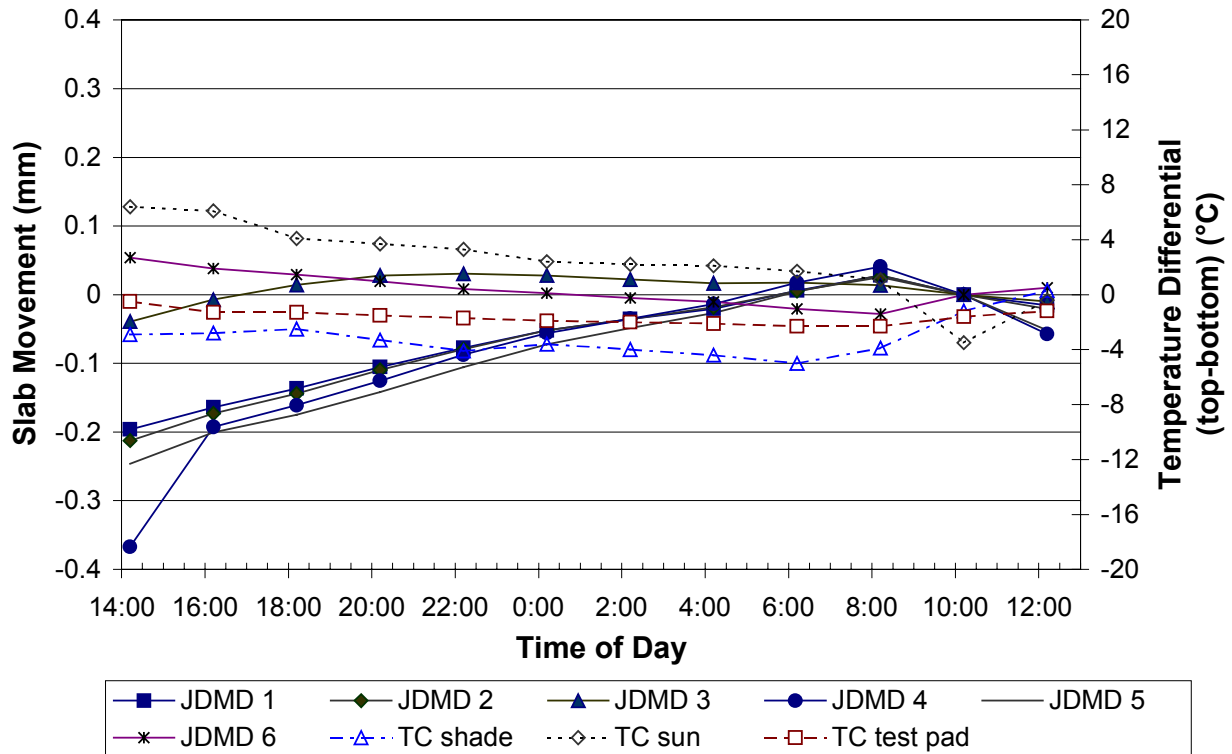
Figure 4.24. Section 536FD JDMD results (with HVS and temperature control chamber).

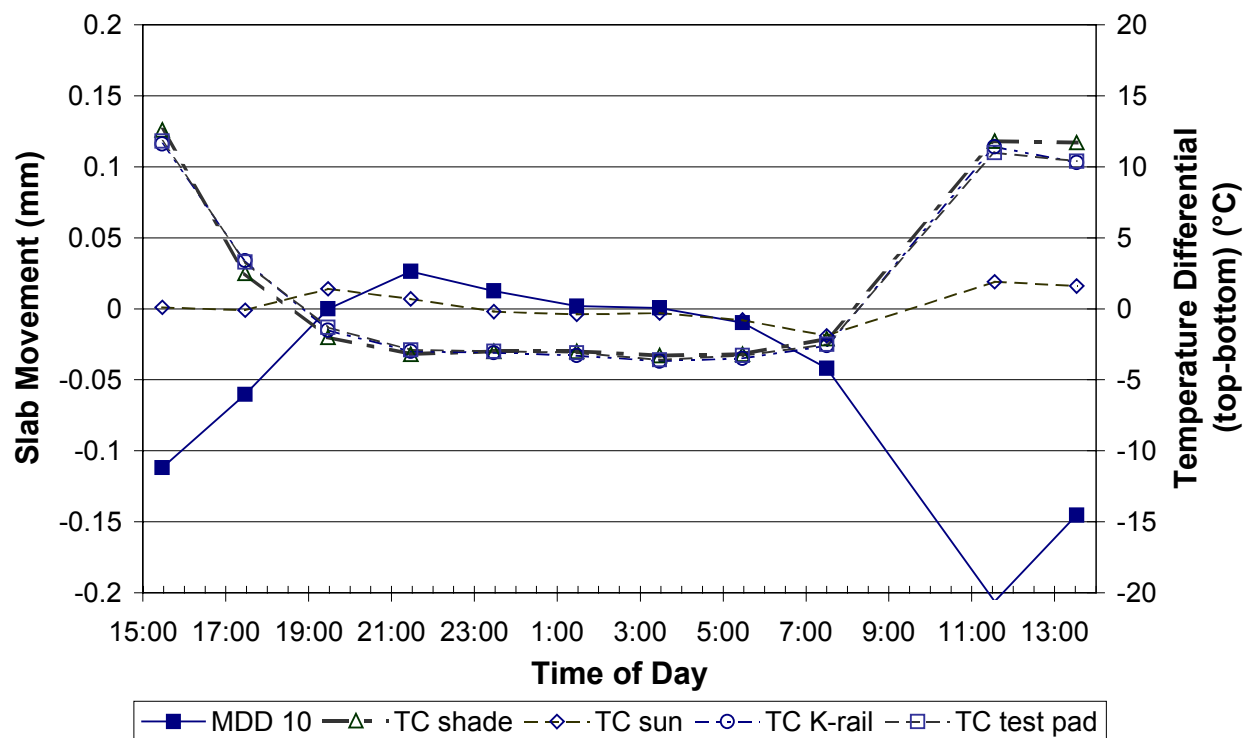
Figure 4.25. Section 536FD MDD results (no HVS, no temperature control chamber).

The MDD data are summarized in Table 4.16 and are represented graphically in Figures 4.25 to 4.27 for the three test conditions. The MDD results followed the same trend as those from the JDMDs except that smaller movements were recorded. When the HVS was parked on the section without the temperature control chamber in place, a time lag was noticed between the time at which the MDD module recorded its peak reading and the time at which the highest temperature differential was recorded (see Figure 4.26).

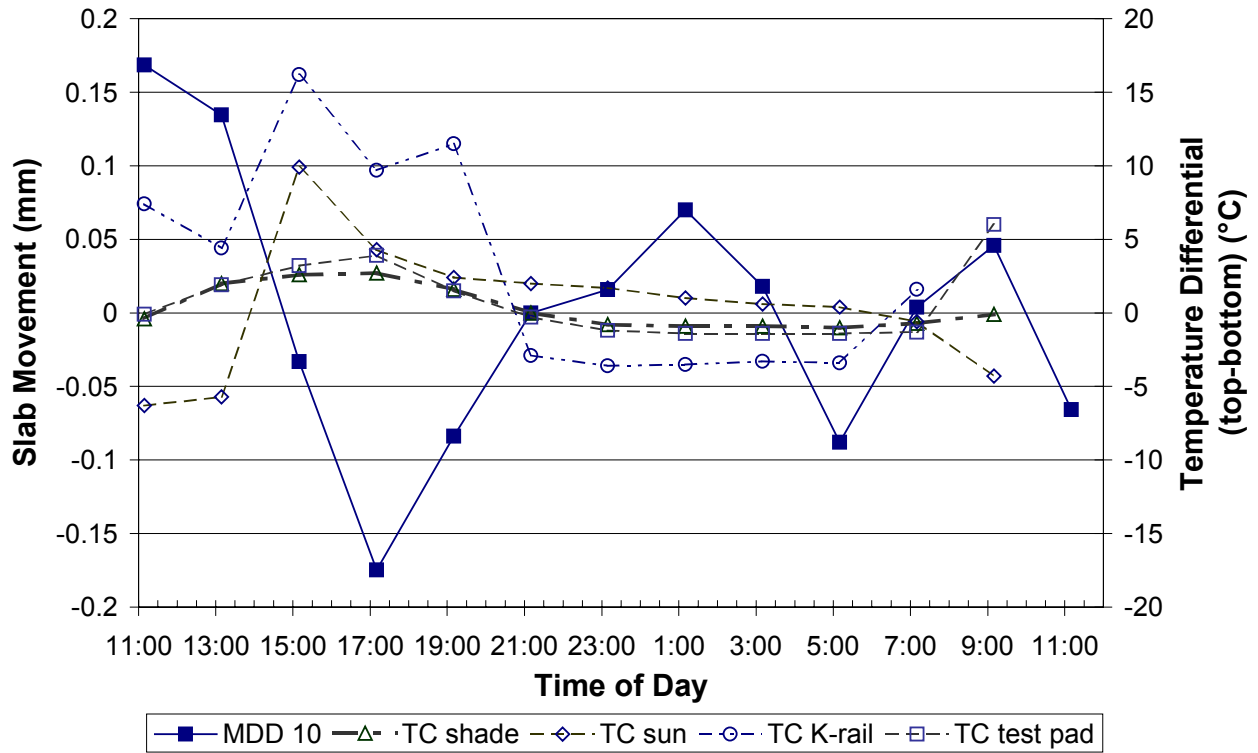
Figure 4.26. Section 536FD MDD results (with HVS, no temperature control chamber).

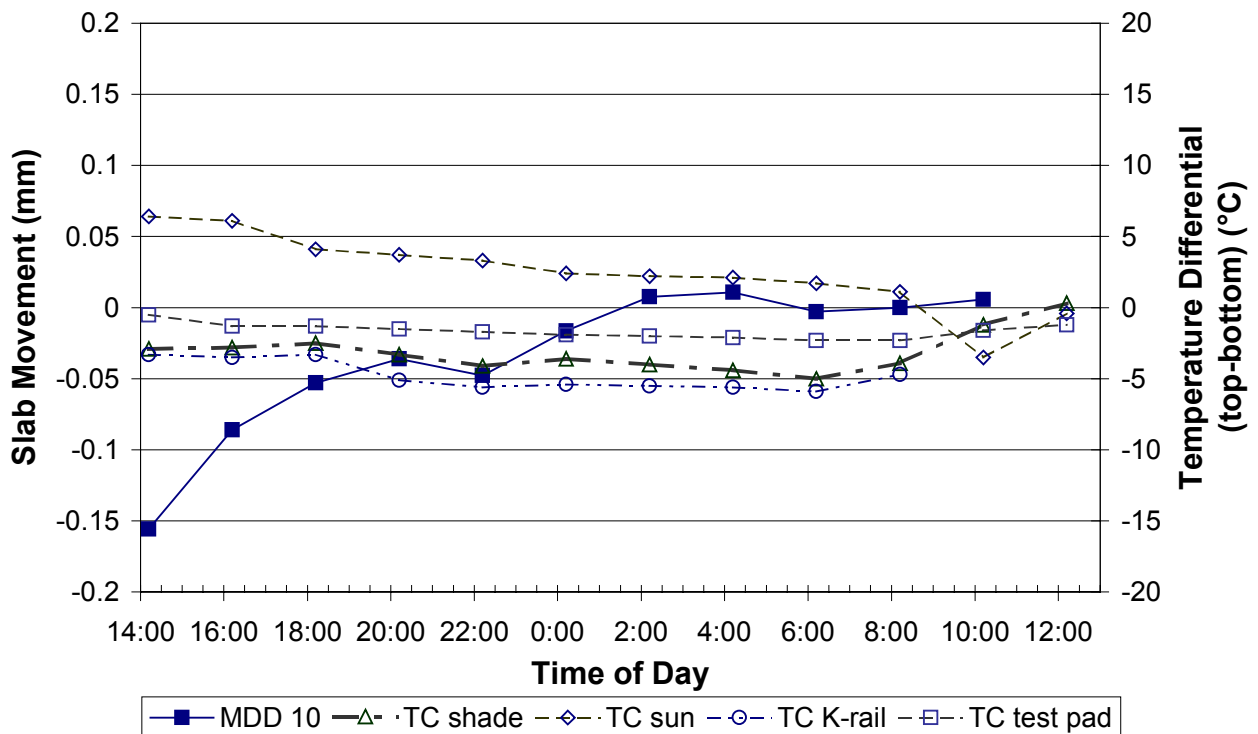
Figure 4.27. Section 536FD MDD results (with HVS and temperature control chamber).

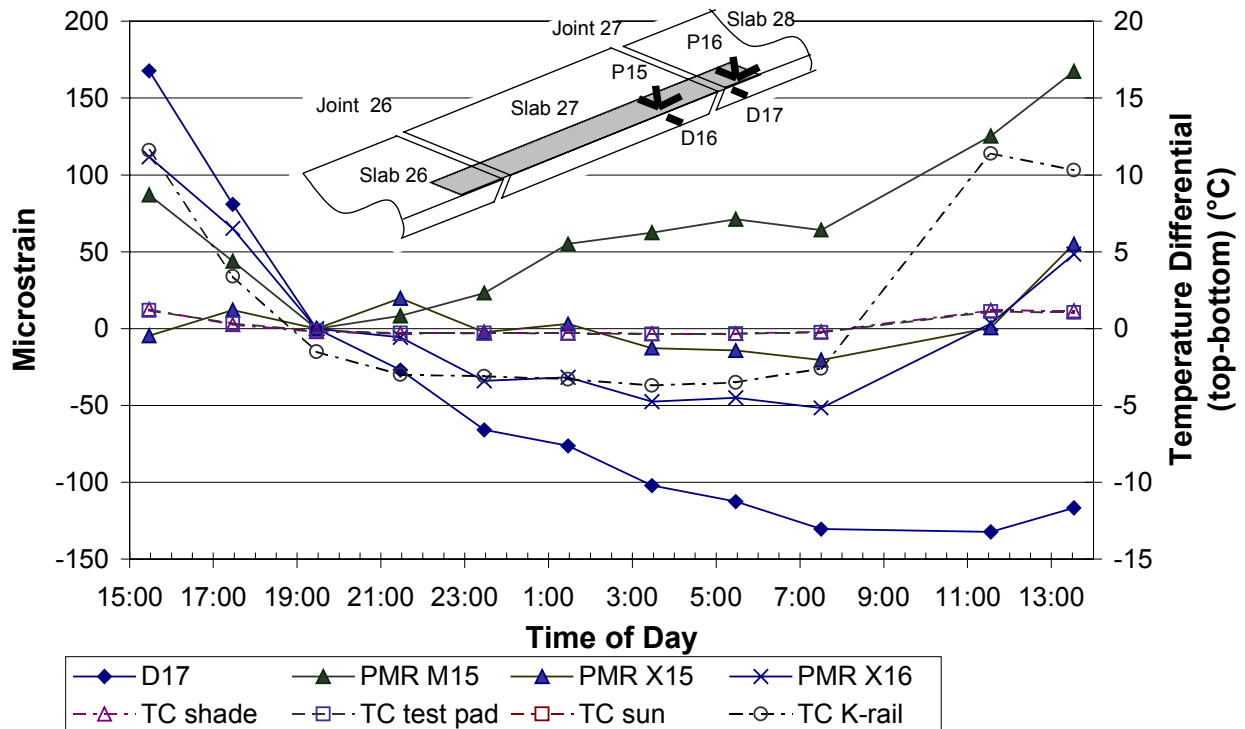
Figure 4.28. Section 536FD strain response (no HVS, no temperature control chamber).

The maximum tensile strains were recorded between 1:30 p.m. and 3:30 p.m., depending on the different gauges (see Figure 4.28). With the exception of the Dynatest D17 gauge, the gauges went through a period of tension (3:30 p.m. – 7:30 p.m.), compression (7:30 p.m. – 7:30 a.m.) and back into tension (7:30 a.m. – 1:30 p.m.). The Dynatest D17 gauge, situated at the bottom of Slab 28, recorded the highest tensile strain (about 167 μ -strain were recorded at 3:30 p.m.) as well as the highest compression strain (132 μ -strain at 11:30 a.m.).

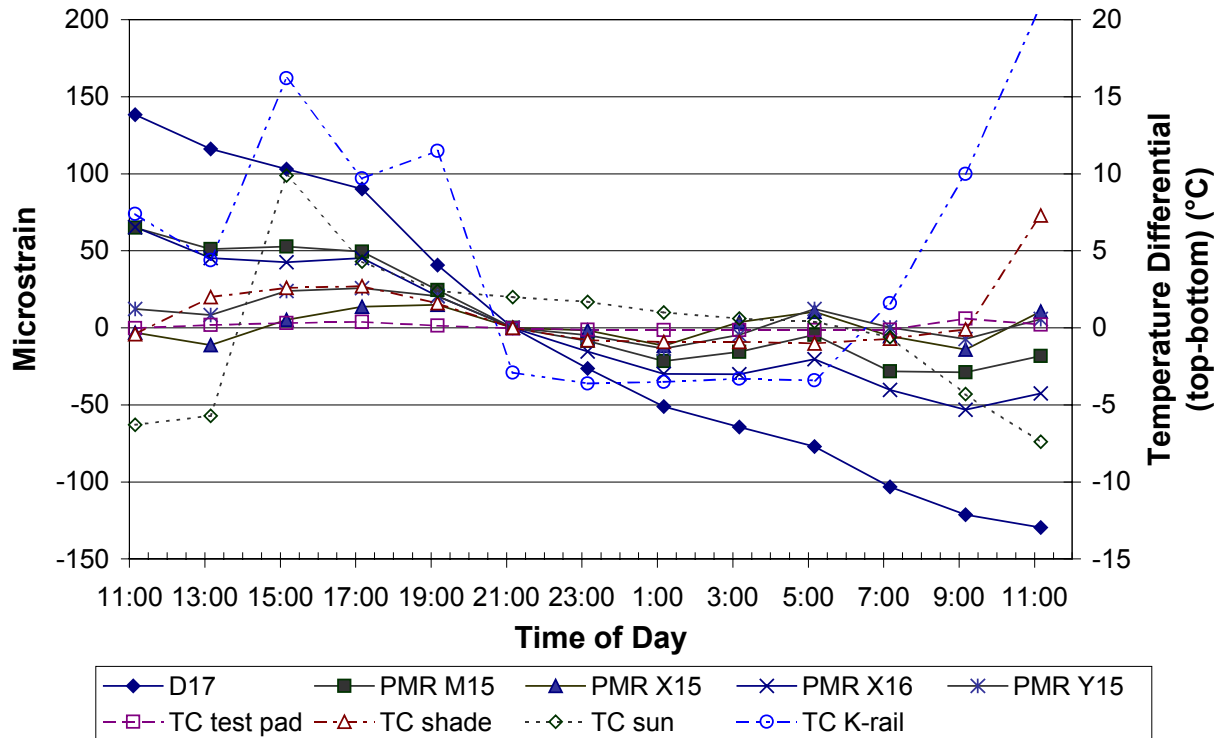
Figure 4.29. Section 536FD strain response (with HVS, no temperature control chamber).

The weight of the HVS parked on the section, together with the shading had an influence on strain development. The strains recorded by the various gauges were more uniform and consistent than those with no HVS on the section (see Figure 4.29).

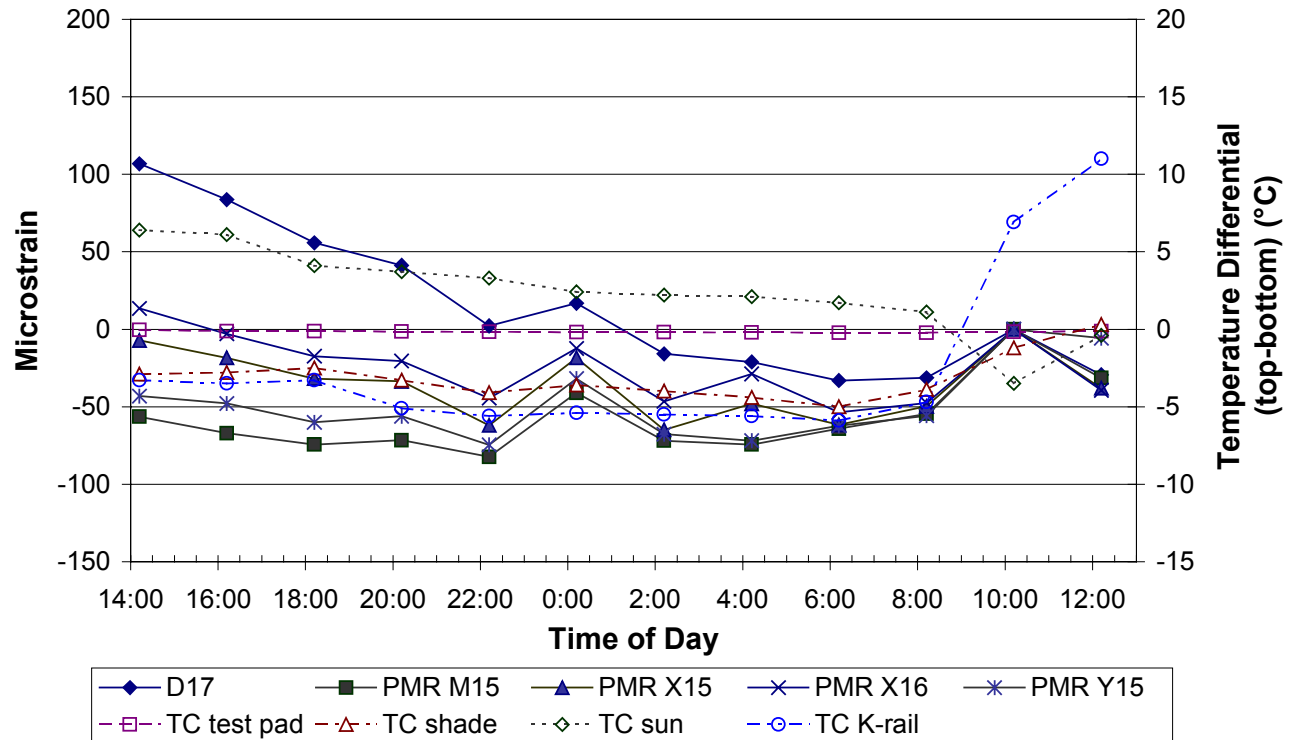
Figure 4.30. Section 536FD strain response (with HVS and temperature control chamber).

The data are shown in Figure 4.30. Apart from an anomalous and unexplained discontinuity at about 12:10 am, the gauges followed the same trend as without the temperature

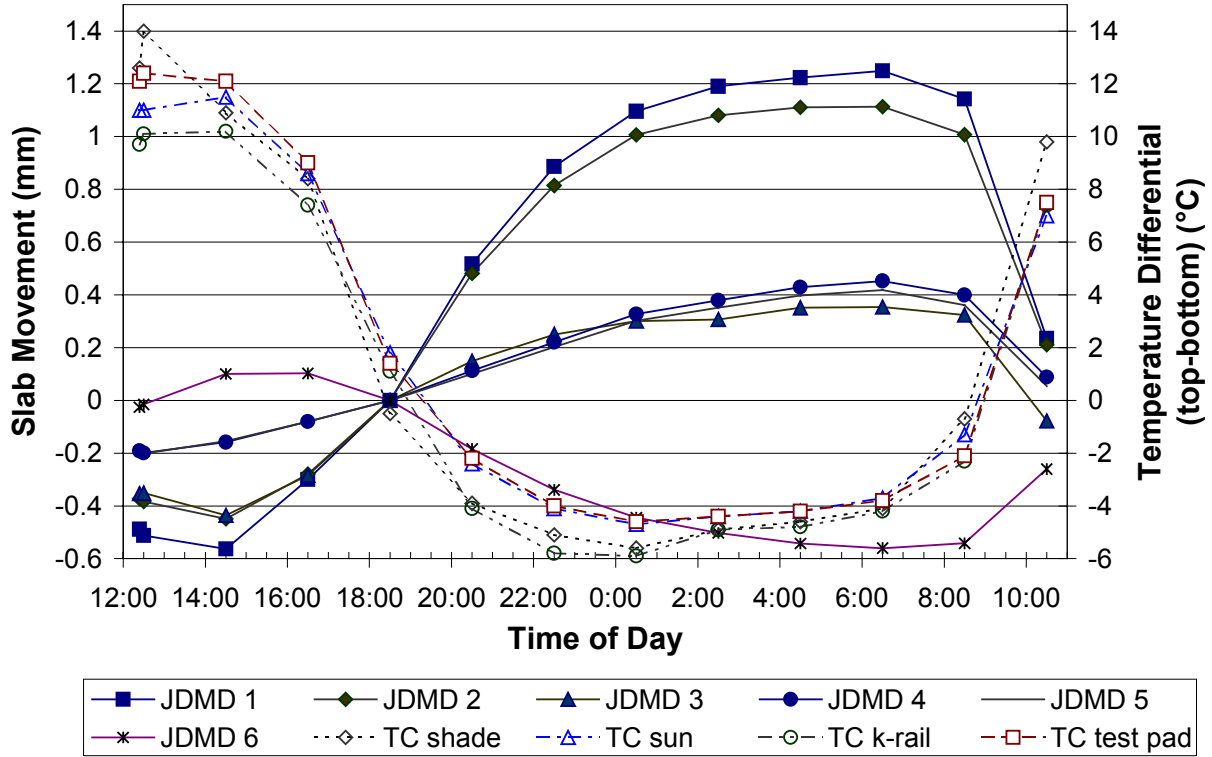
Figure 4.31. Section 537FD JDMD results (no HVS, no temperature control chamber).

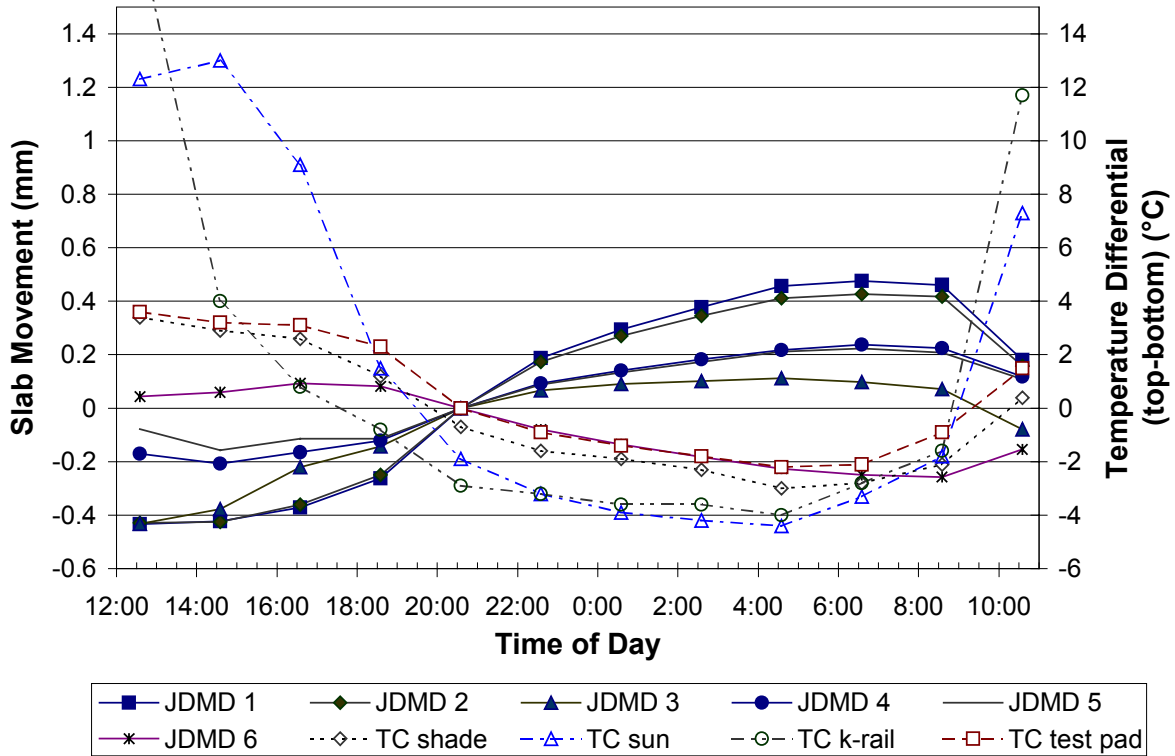
Figure 4.32. Section 537FD JDMD results (with HVS, no temperature control chamber).

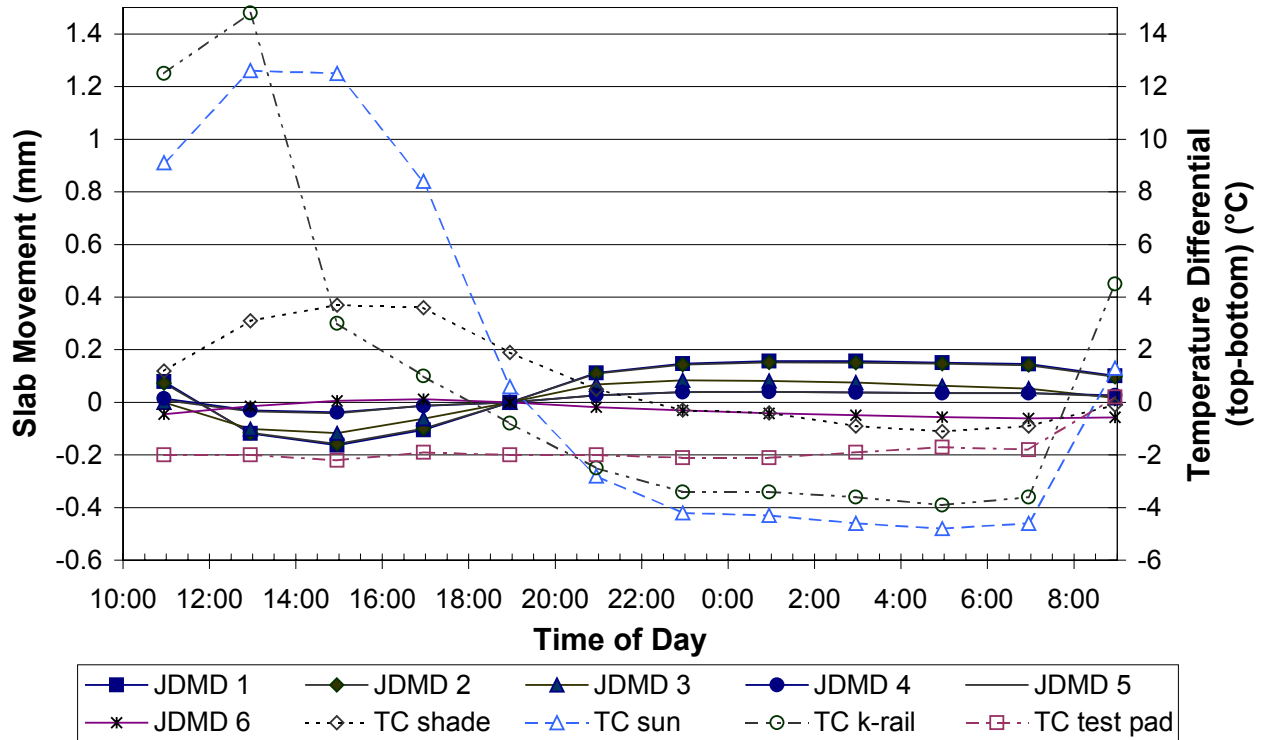
Figure 4.33. Section 537FD JDMD results (with HVS and temperature control chamber).

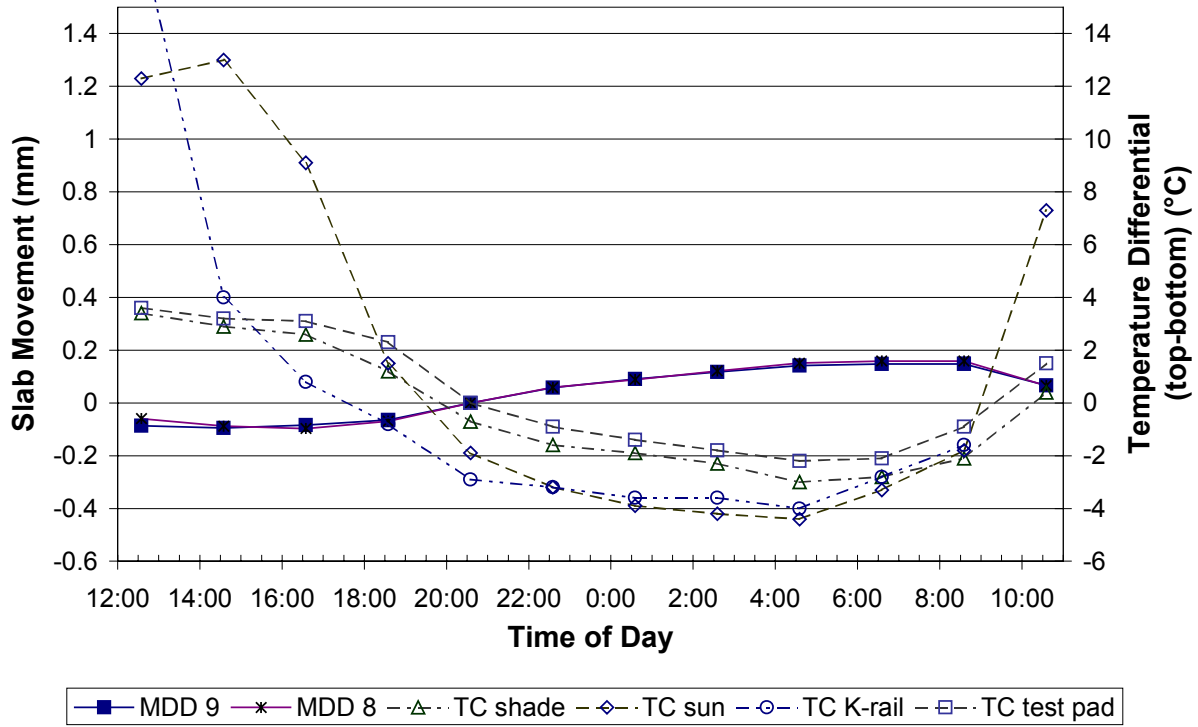
Figure 4.35. Section 537FD MDD results (with HVS, no temperature control chamber).

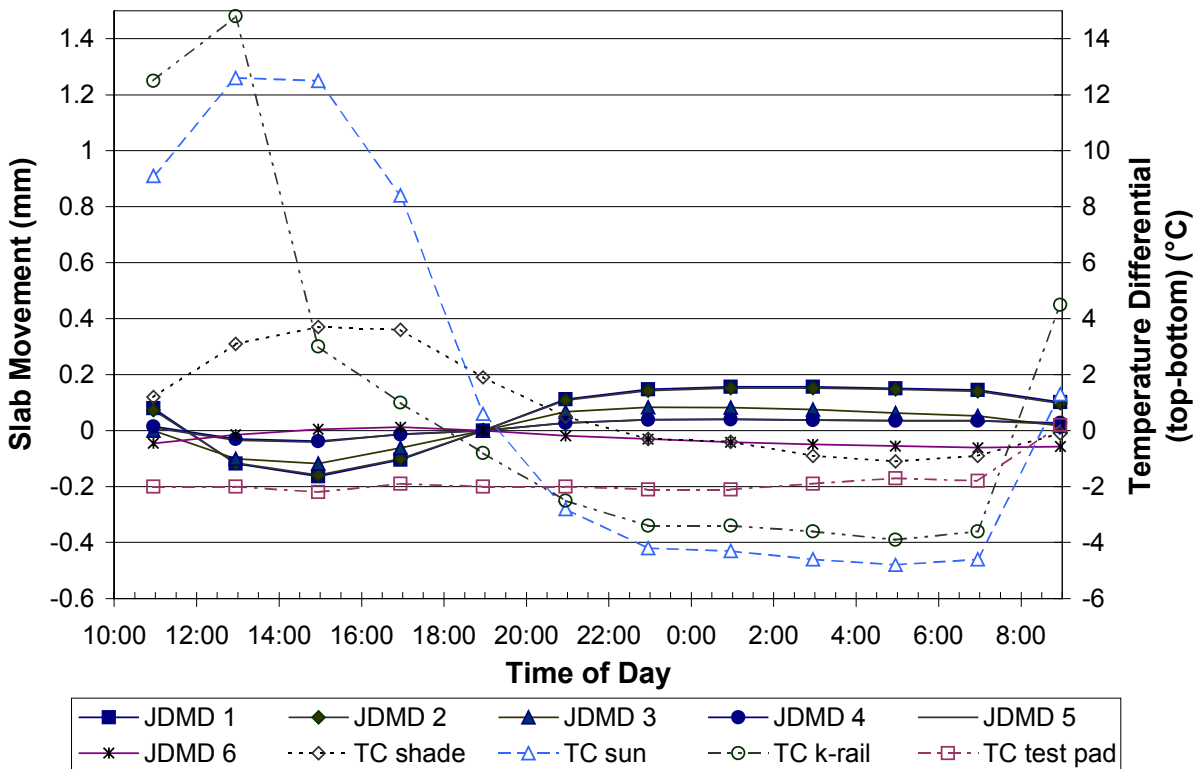
Figure 4.36. Section 537FD MDD results (with HVS and temperature control chamber).

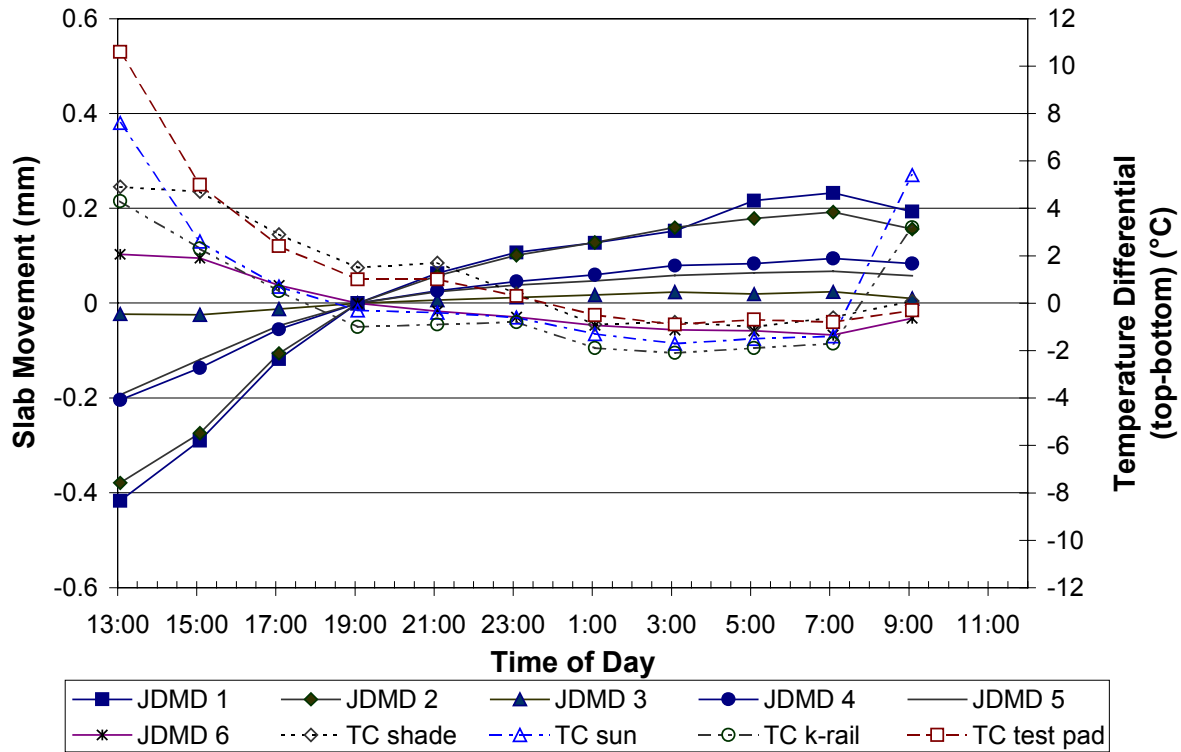
Figure 4.38. Section 538FD JDMD data (with HVS, no temperature control chamber).

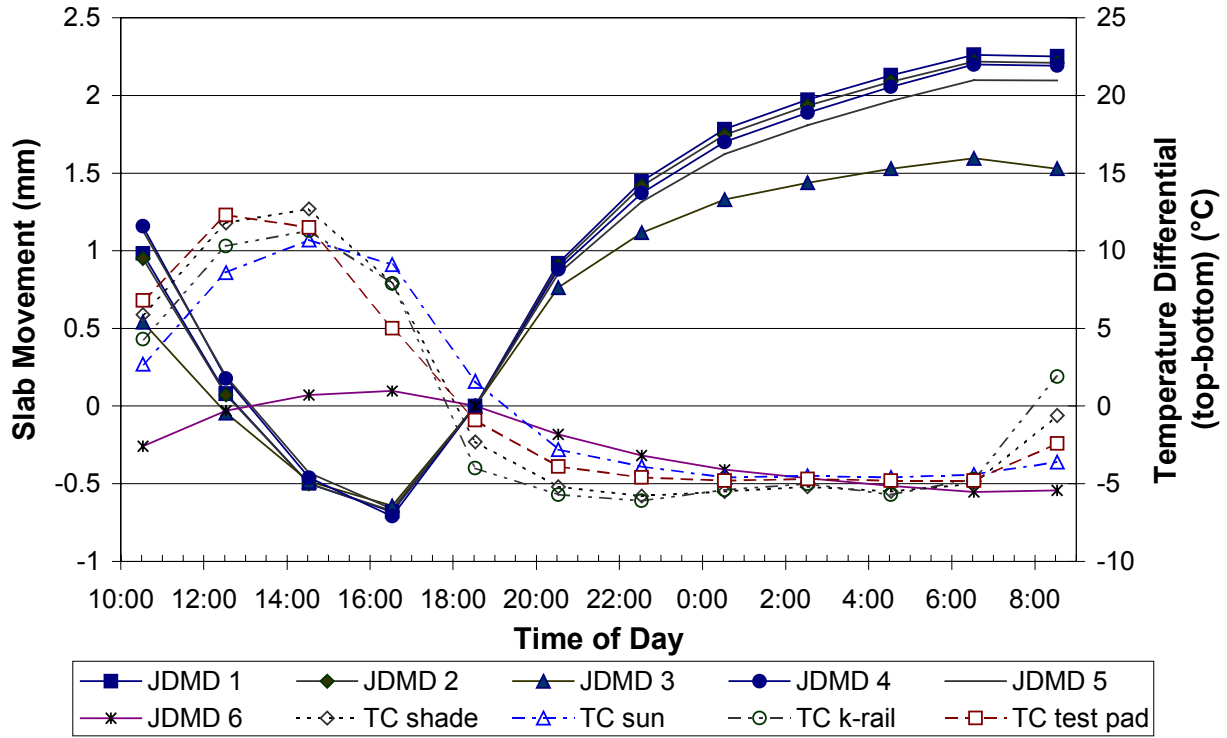
Figure 4.39. Section 539FD JDMD results (no HVS, no temperature control chamber).

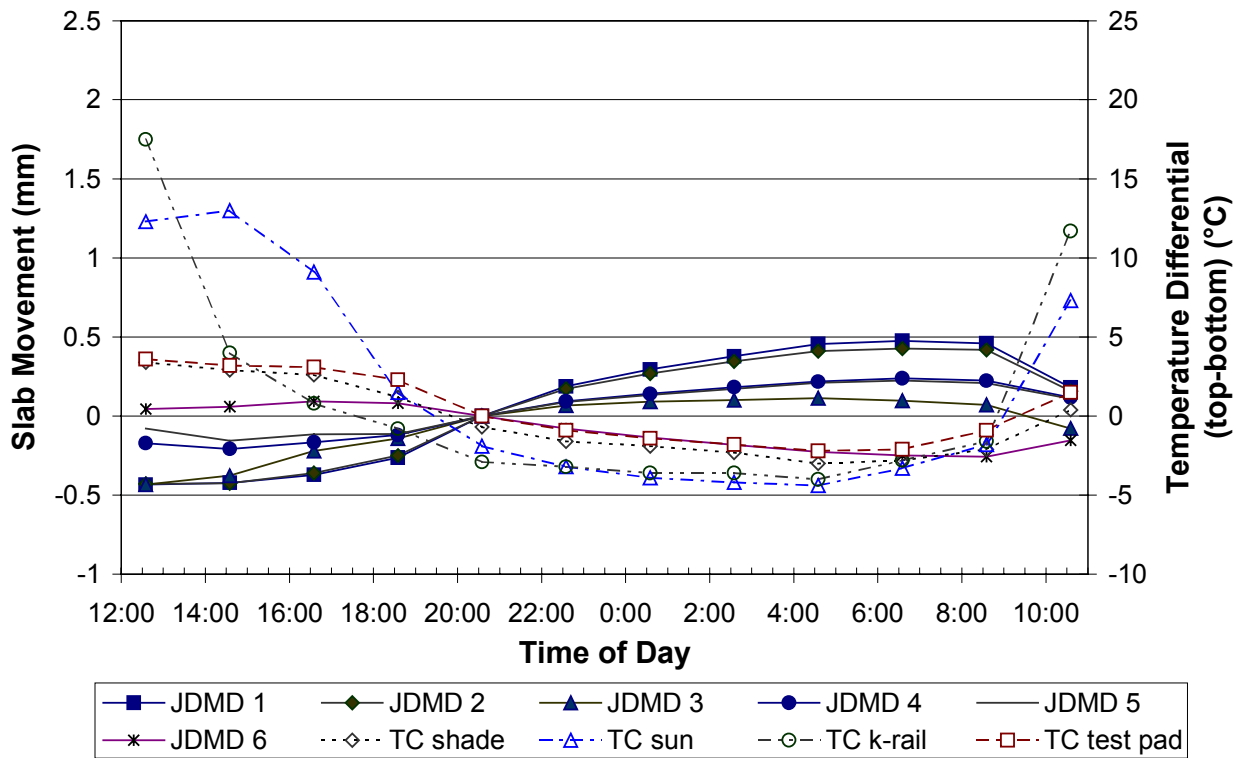
Figure 4.40. Section 539FD JDMD results (with HVS, no temperature control chamber).

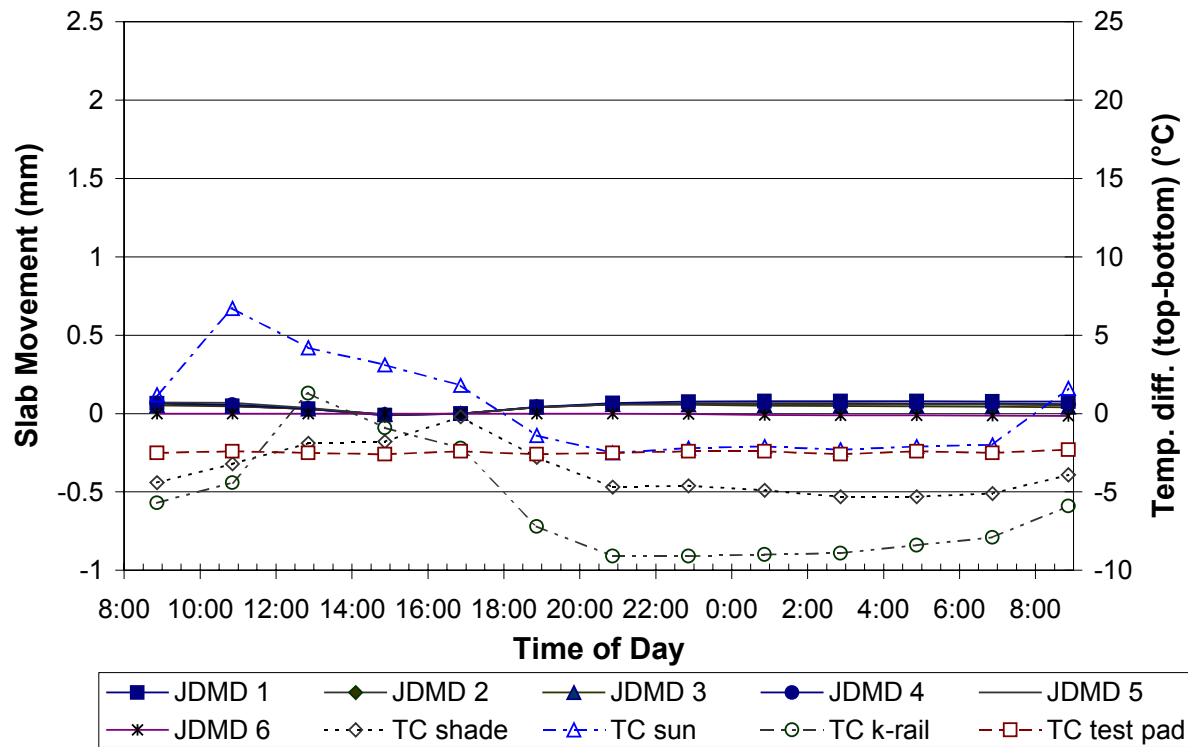
Figure 4.41. Section 539FD JDMD results (with HVS and temperature control chamber).

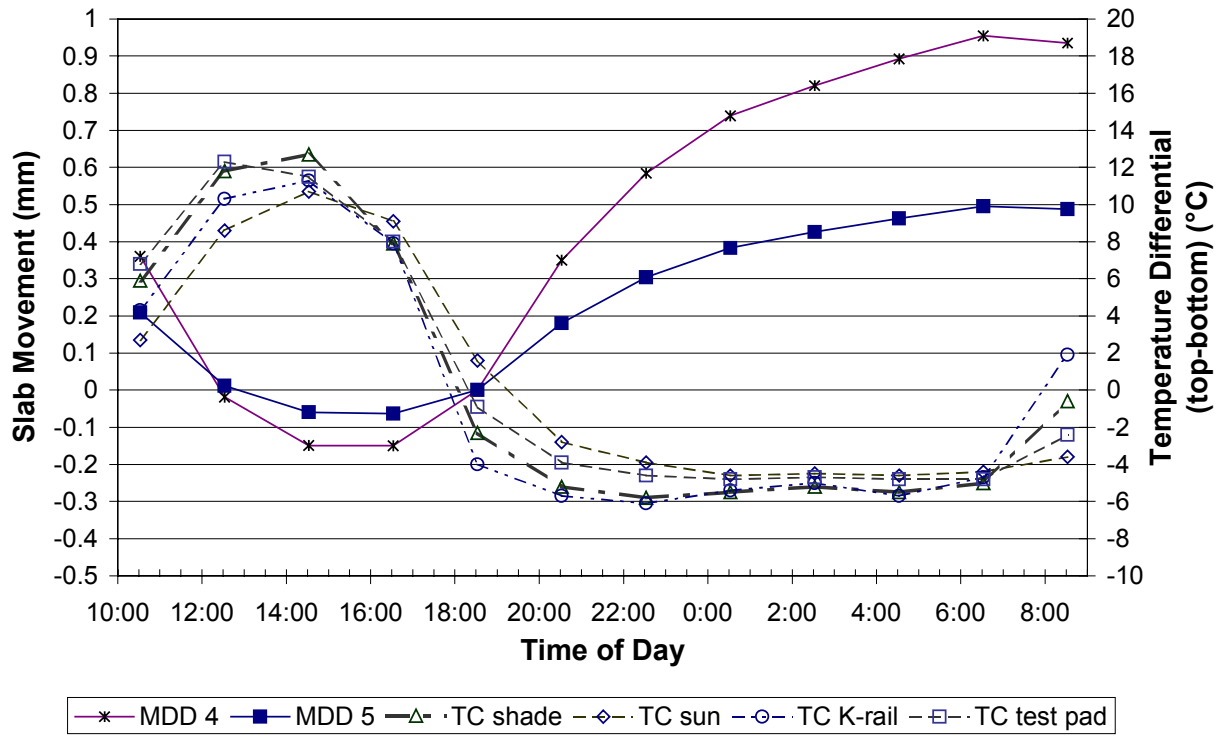
Figure 4.42. Section 539FD MDD results (no HVS, no temperature control chamber).

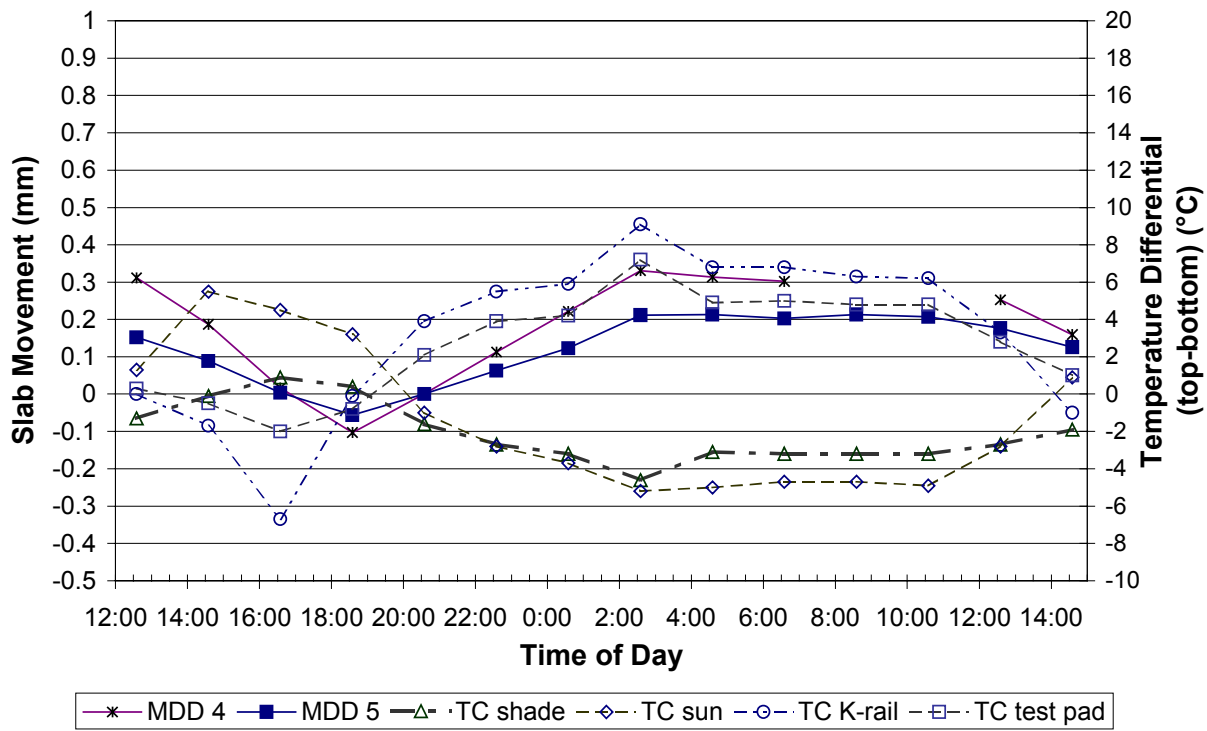
Figure 4.43. Section 539FD MDD results (with HVS, no temperature control chamber).

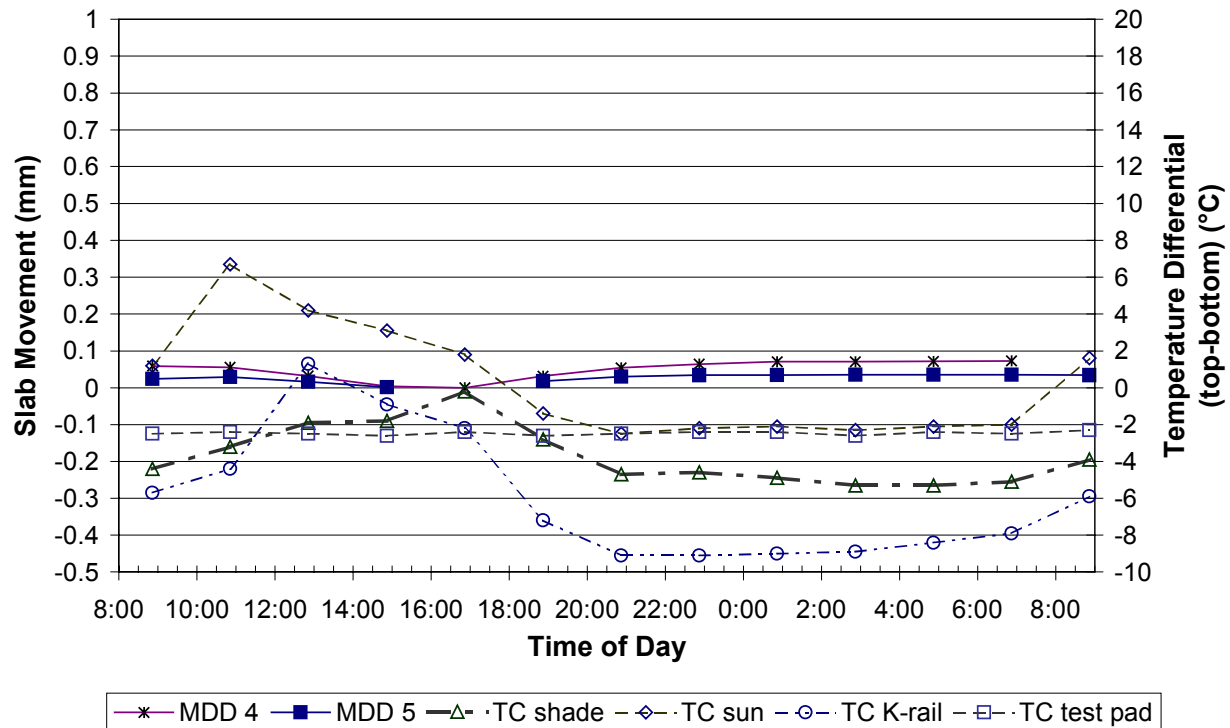
Figure 4.44. Section 539FD MDD results (with HVS and temperature control chamber).

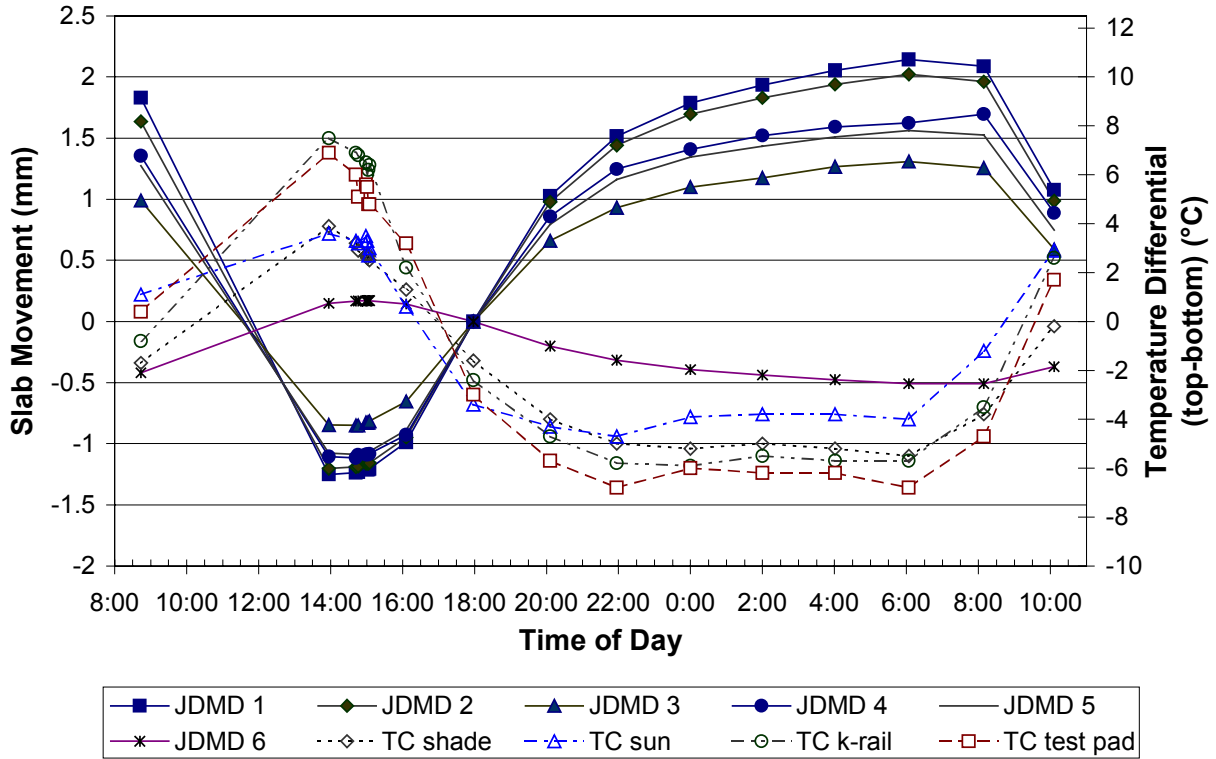
Figure 4.45. Section 540FD JDMD results (no HVS, no temperature control chamber).

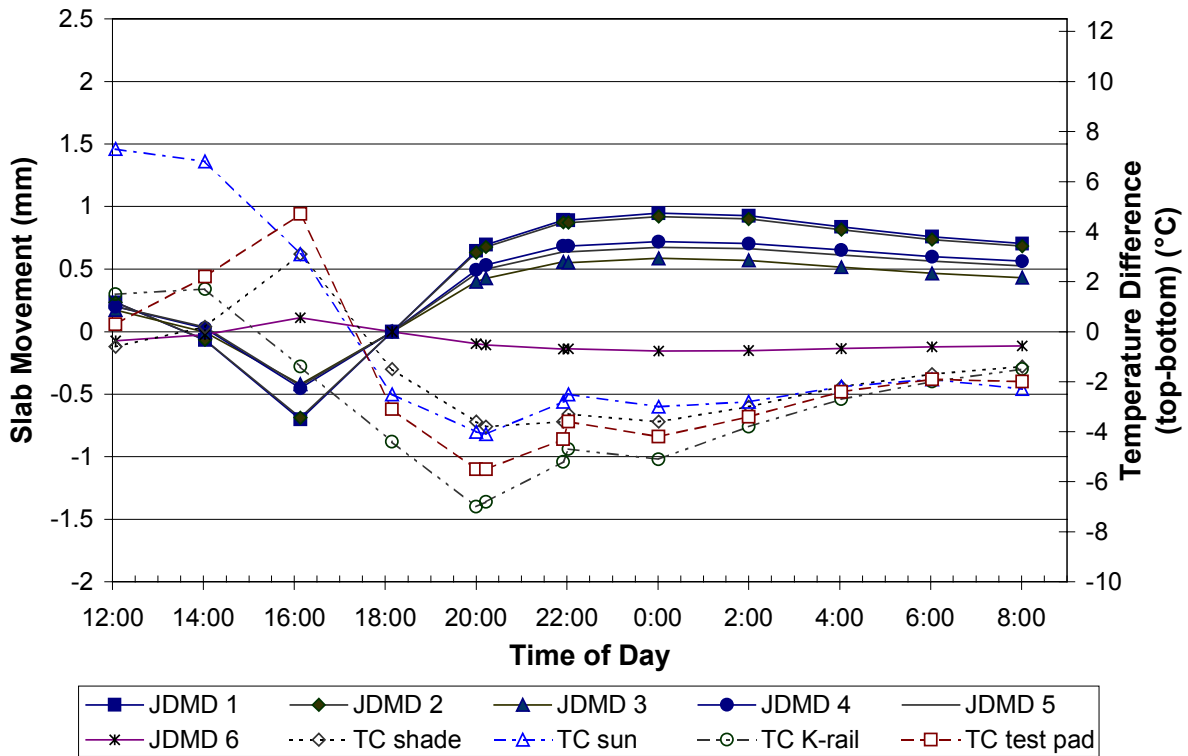
Figure 4.46. Section 540FD JDMD results (with HVS, no temperature control chamber).
