**Environmental Influences on the Curling of Concrete Slabs at the
Palmdale HVS Test Site**

Louw du Plessis,
CSIR Transportek

John Harvey,
UC Pavement Research Center

For the California Department of Transportation

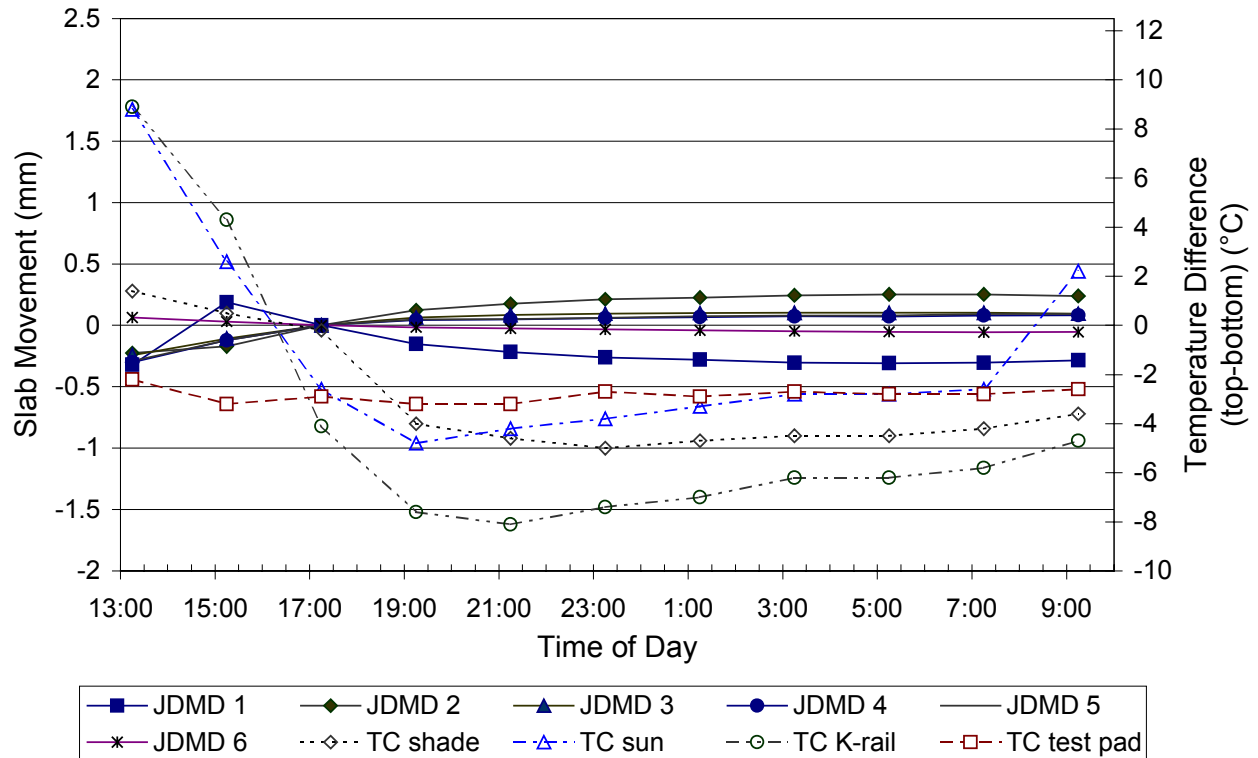
Figure 4.47. Section 540FD JDMD results (with HVS and temperature control chamber).

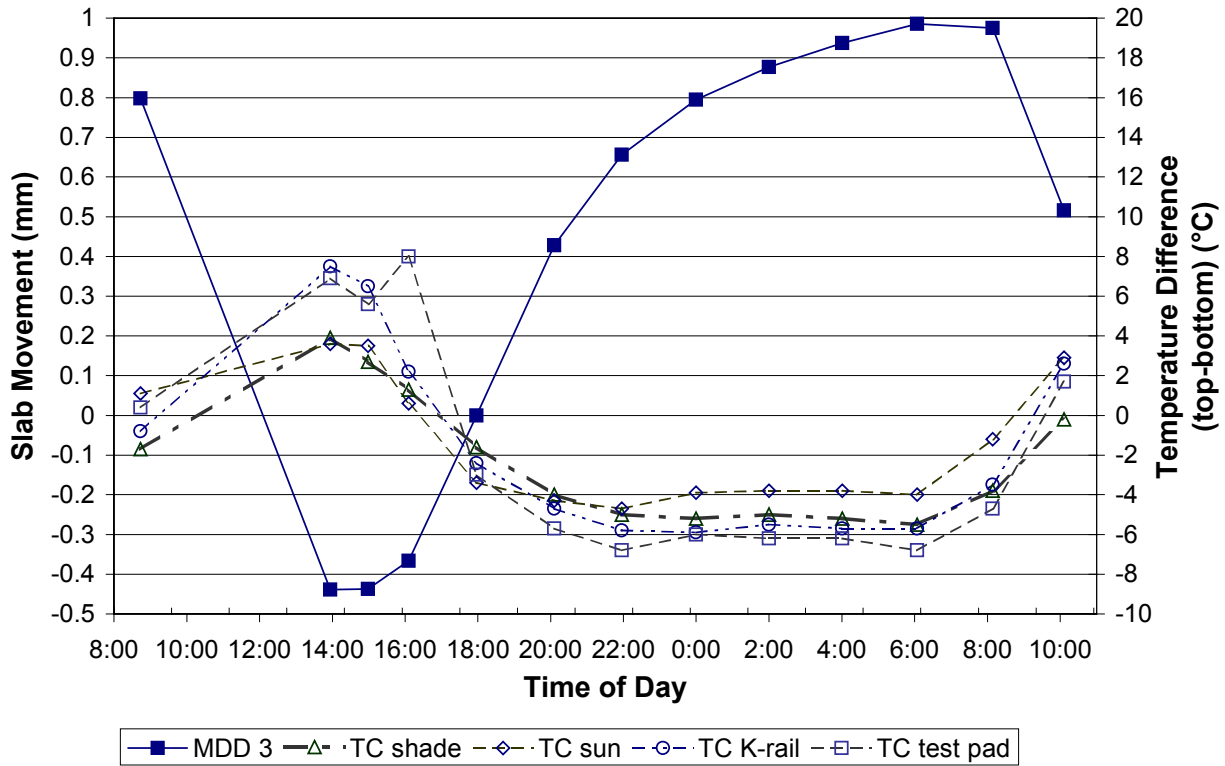
Figure 4.48. Section 540FD MDD results (no HVS, no temperature control chamber).

The maximum movement was recorded with MDD 3 (1.425 mm) when the section was completely exposed to direct sunlight and experienced a temperature differential of 13.7°C. The corresponding movement of MDD 2 was 0.142 mm. In all cases, MDD 2 consistently showed very low movements in comparison with MDD 3, while both instruments were subjected to the same environmental loading conditions. It was therefore concluded that MDD 2 was not working properly. Consequently, MDD 2 results are not presented in this report. The data for MDD 3 for all three cases is summarized in Table 4.35 and shown in Figures 4.48–4.50.

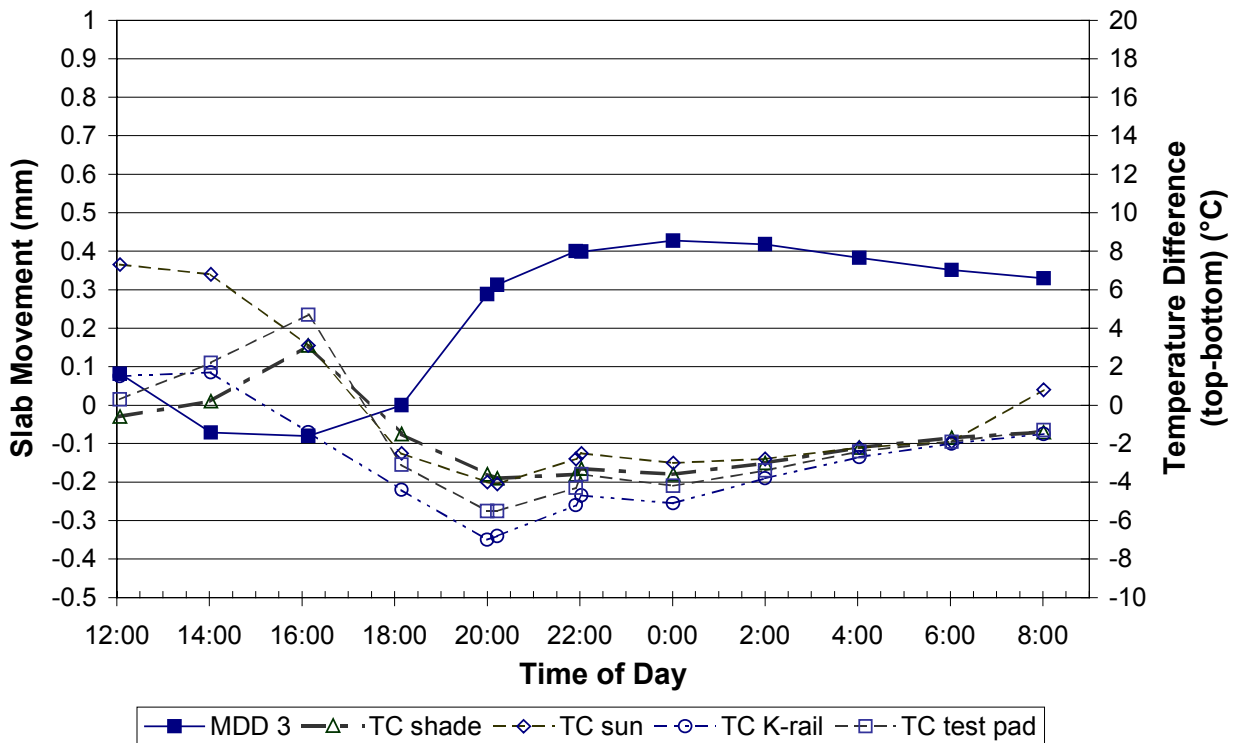
Figure 4.49. Section 540FD MDD results (with HVS, no temperature control chamber).

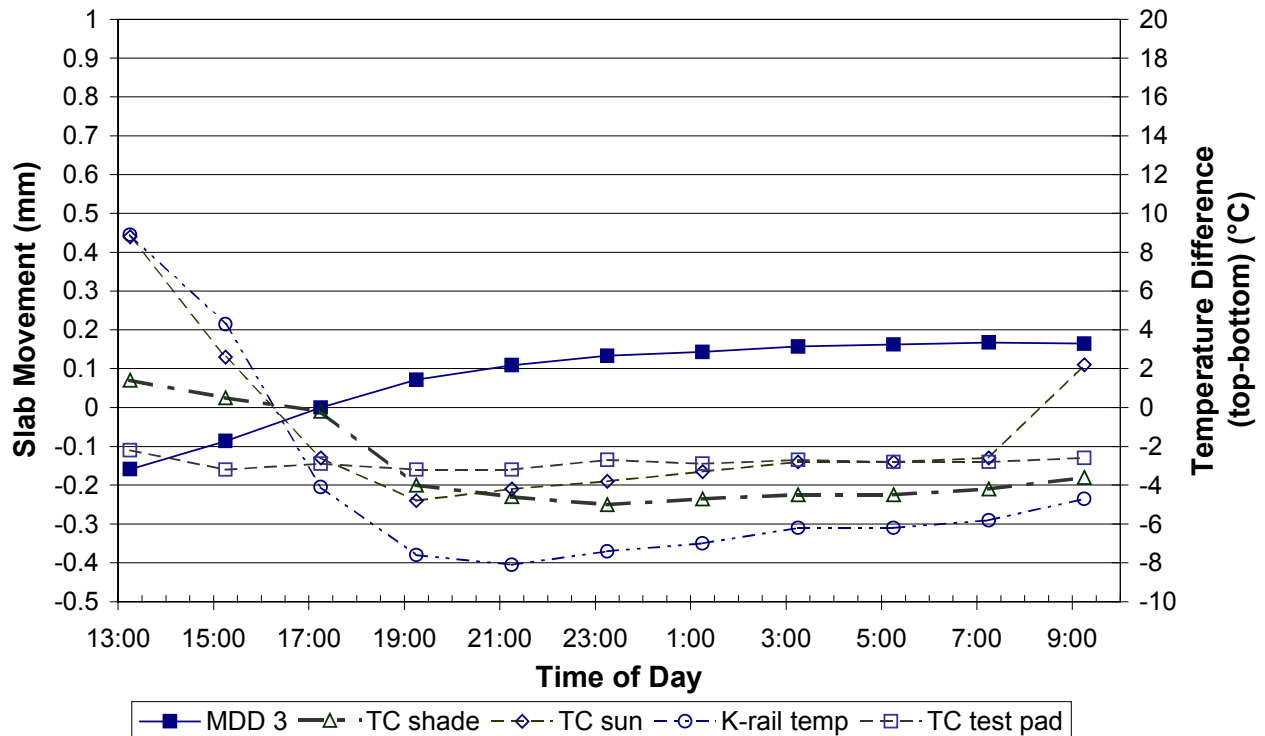
Figure 4.50. Section 540FD MDD results (with HVS and temperature control chamber).

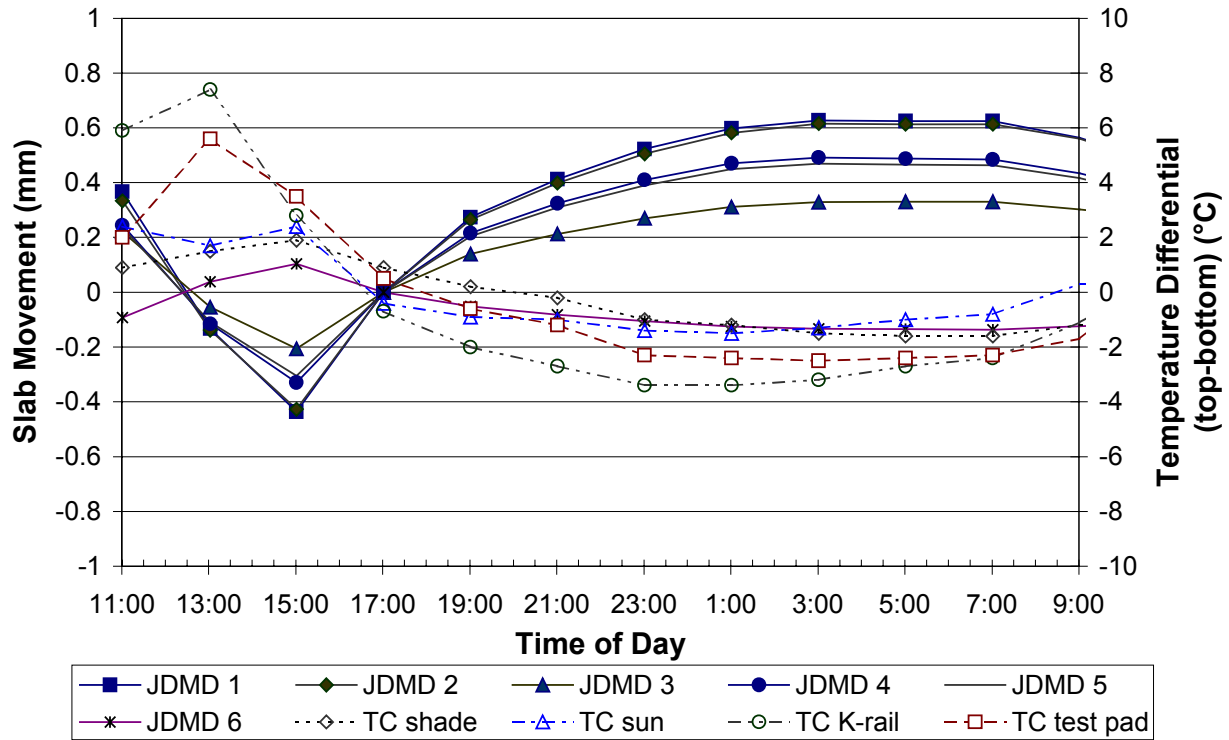
Figure 4.51. Section 541FD JDMD results (no HVS, no temperature control chamber).

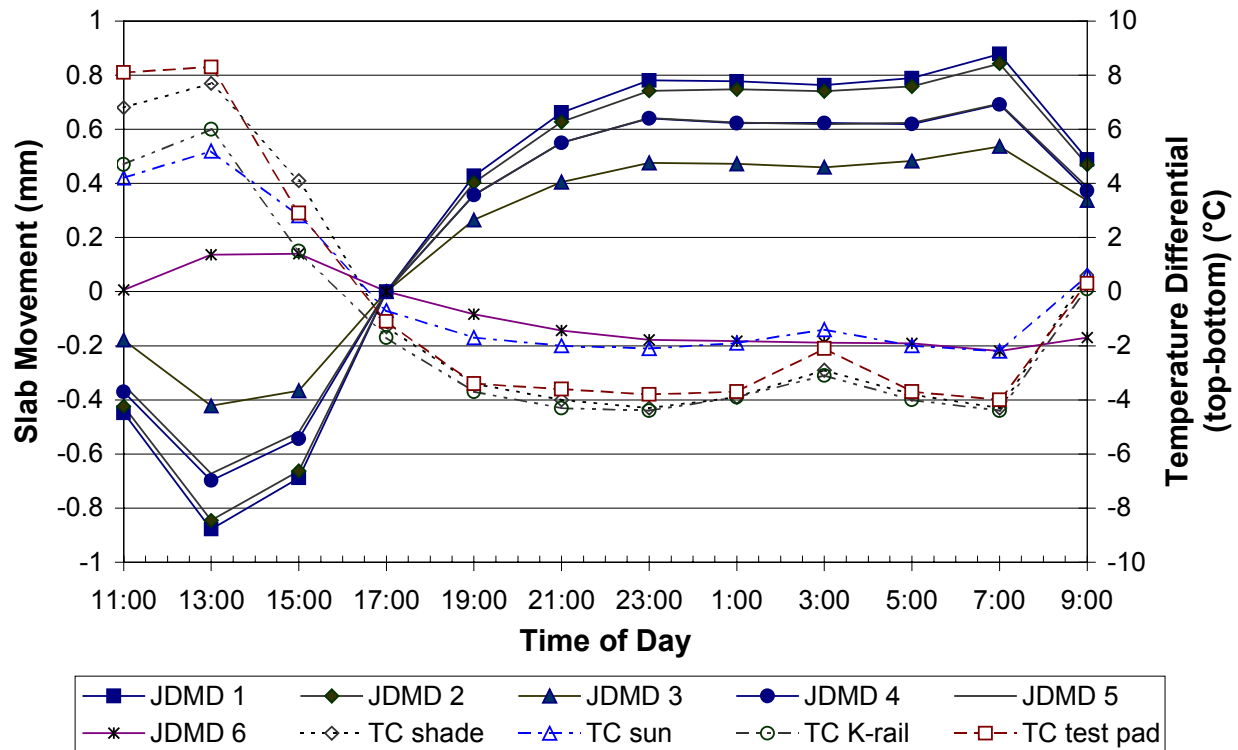
Figure 4.52. Section 541FD JDMD results (with HVS, no temperature control chamber).

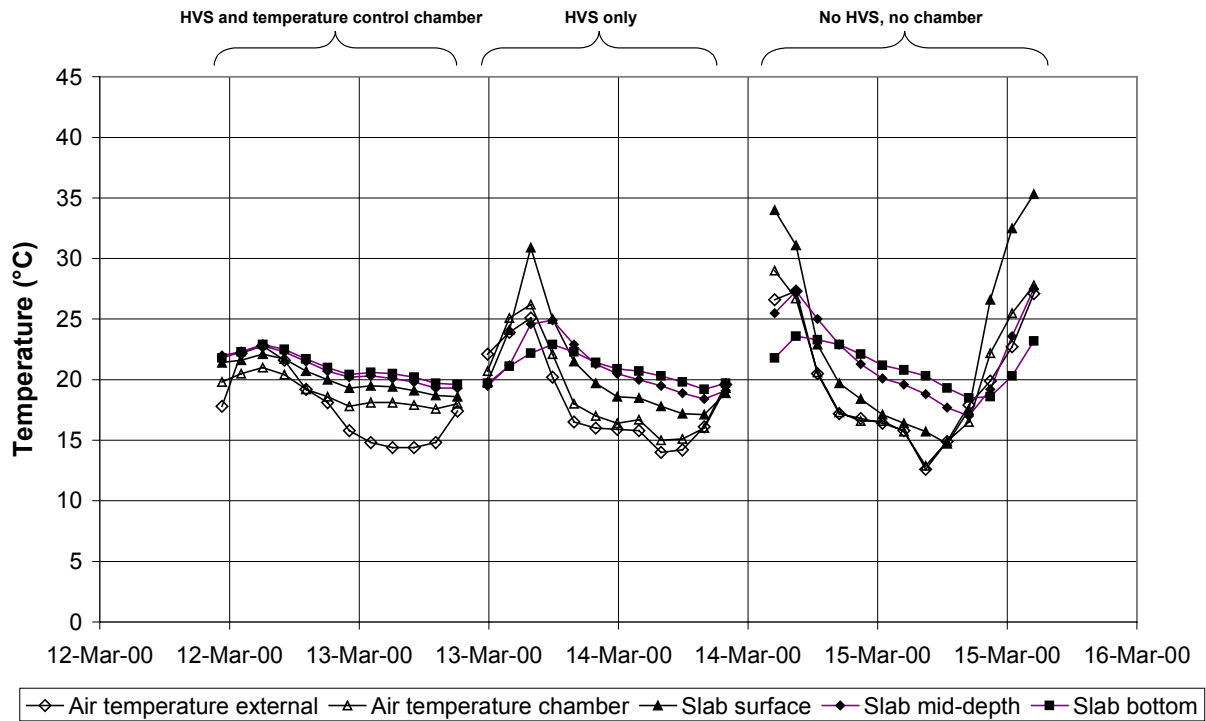
Figure 5.1b. Section 534FD selected temperature measurements.

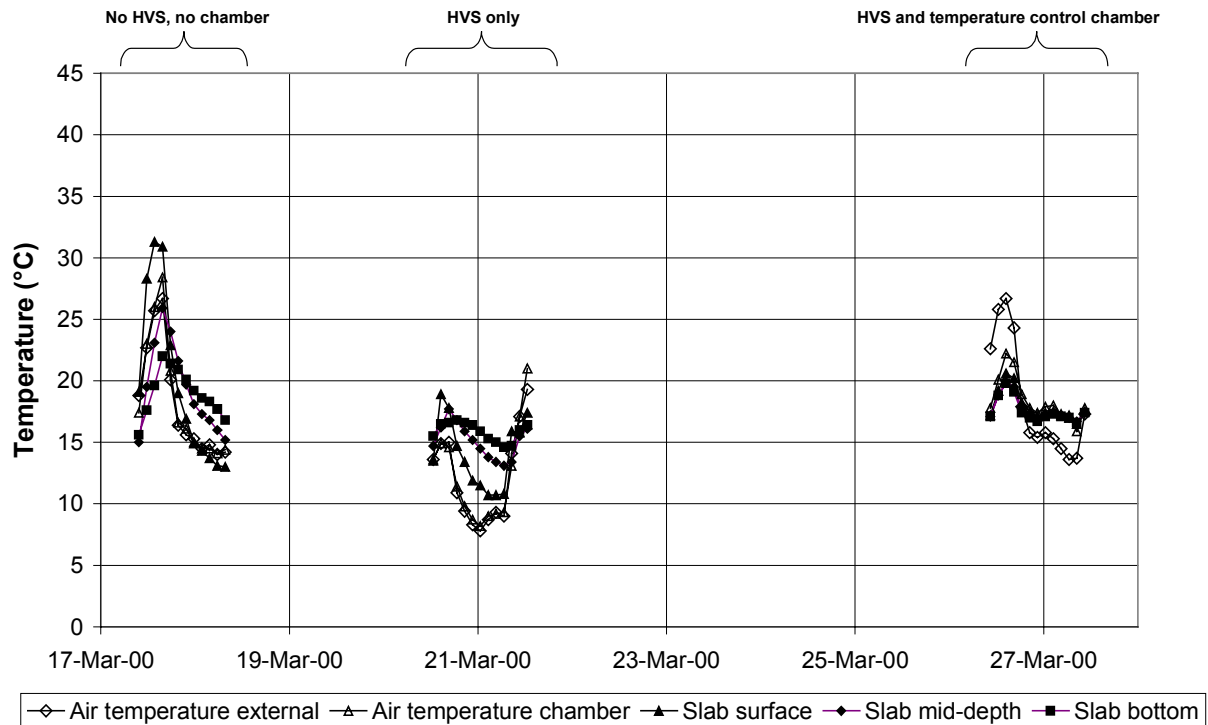
Figure 5.2b. Section 535FD selected temperature measurements.

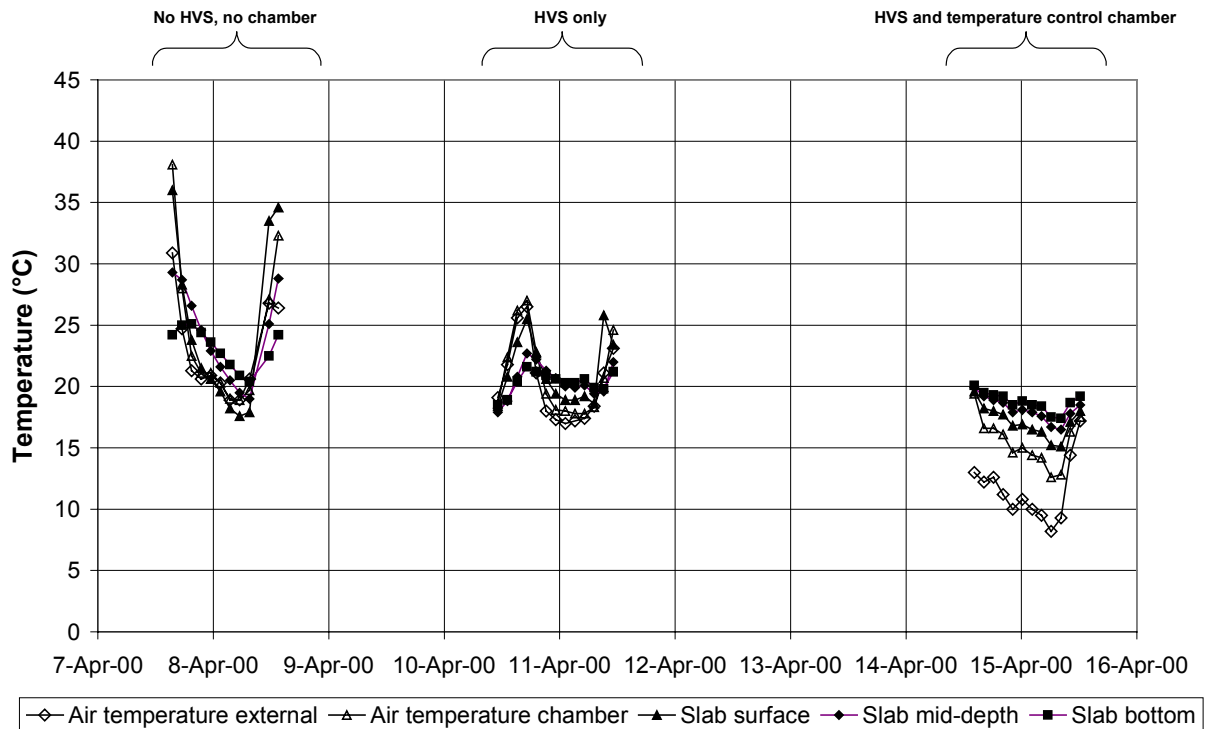
Figure 5.3b. Section 536FD selected temperature measurements.

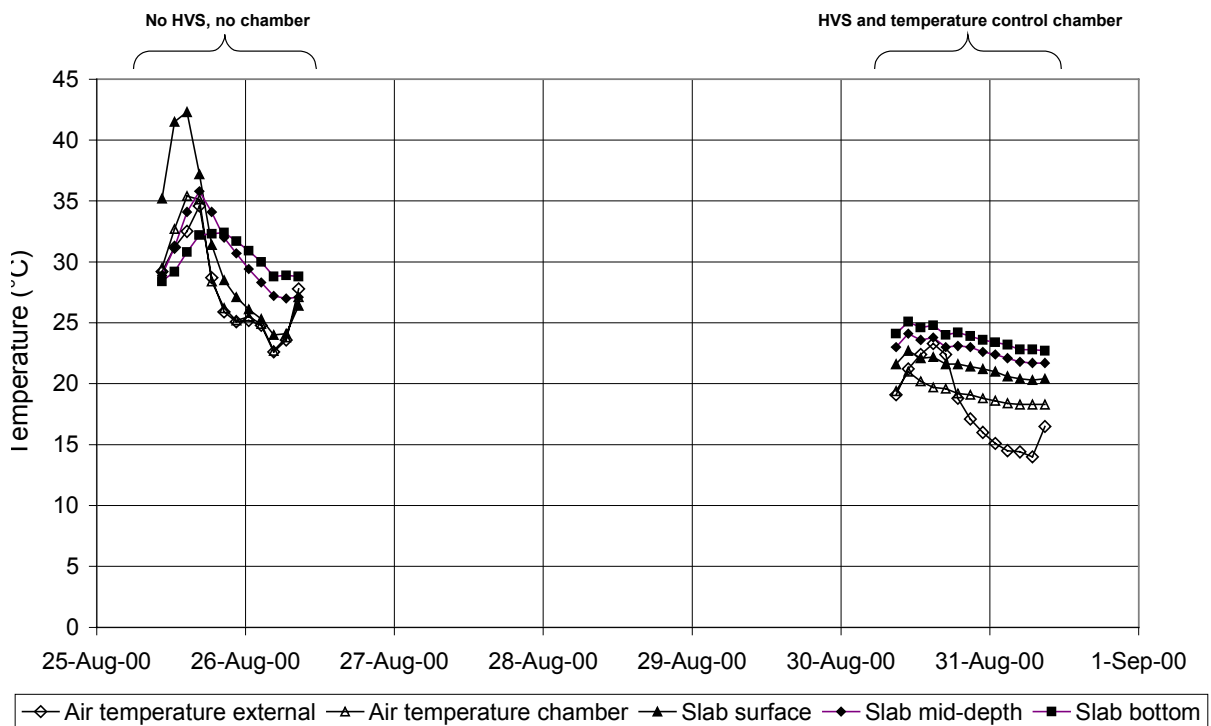
Figure 5.7b. Section 539FD selected temperature measurements.

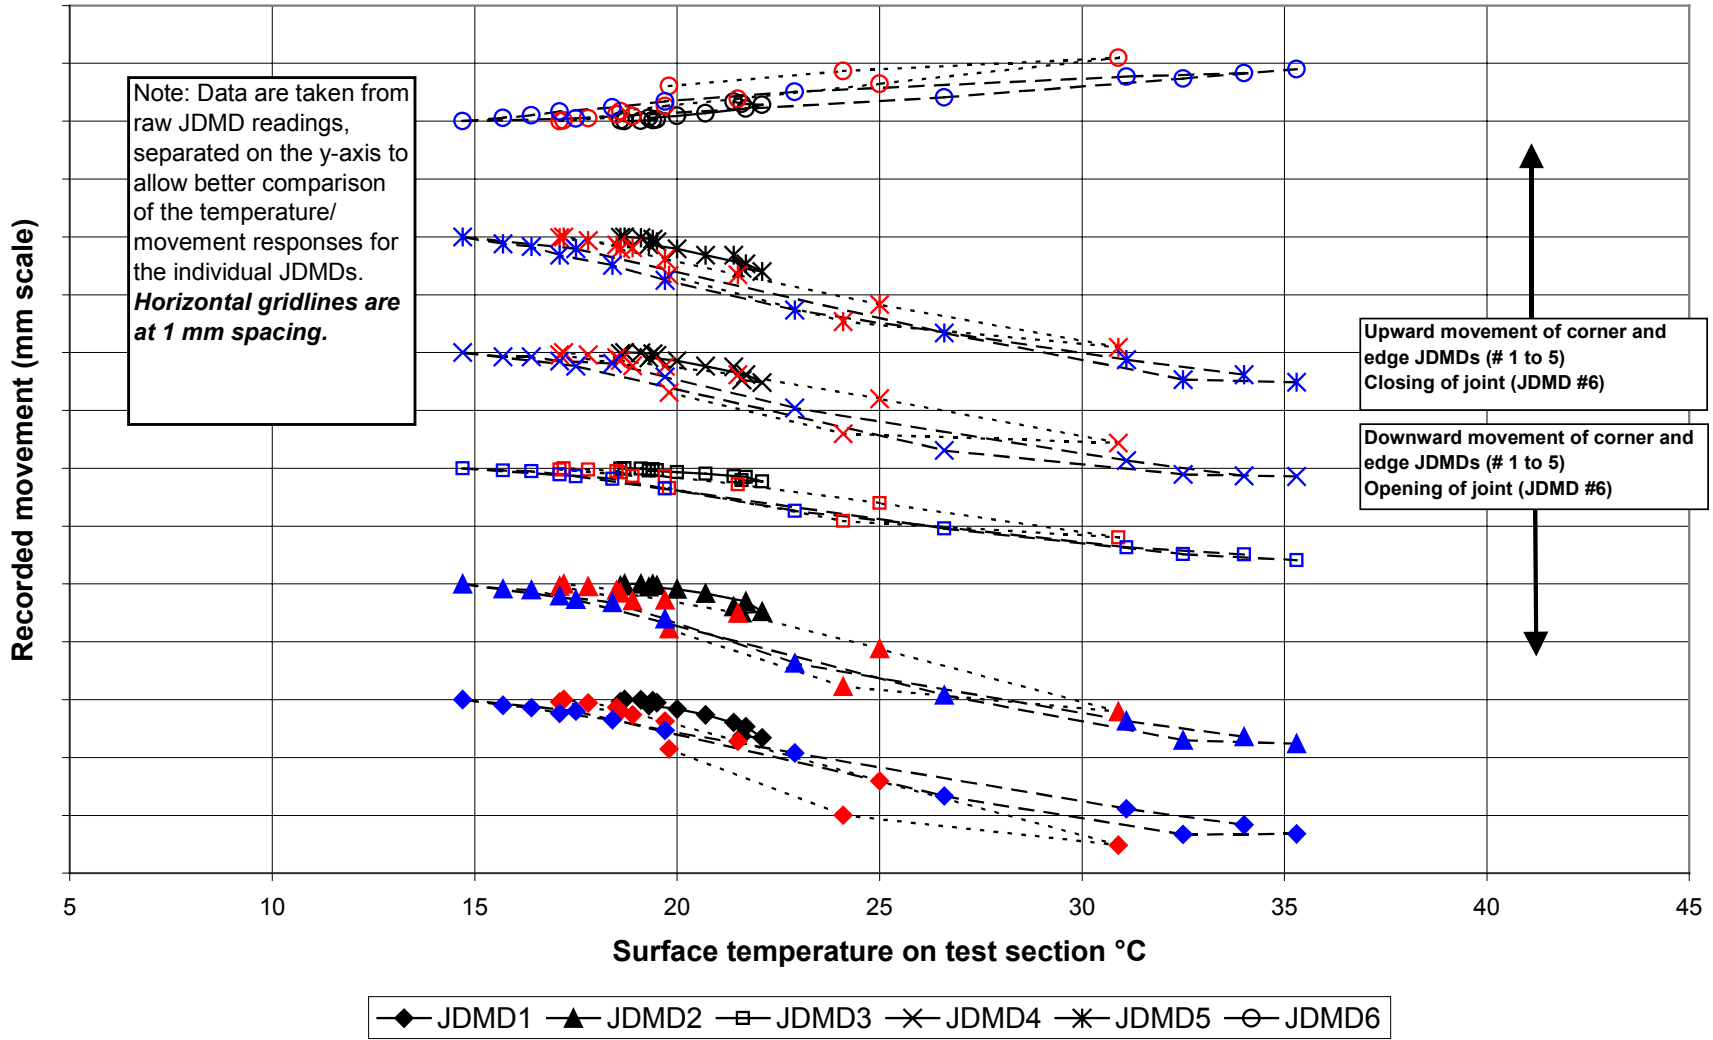
Figure 5.10. Section 534FD JDMD responses to surface temperature (Section 7: no dowels, asphalt shoulder).

The results of the tests on Design Section 7 are presented in Figures 5.10 and 5.11. The range of pavement surface temperatures during these tests was from just over 10°C to just over

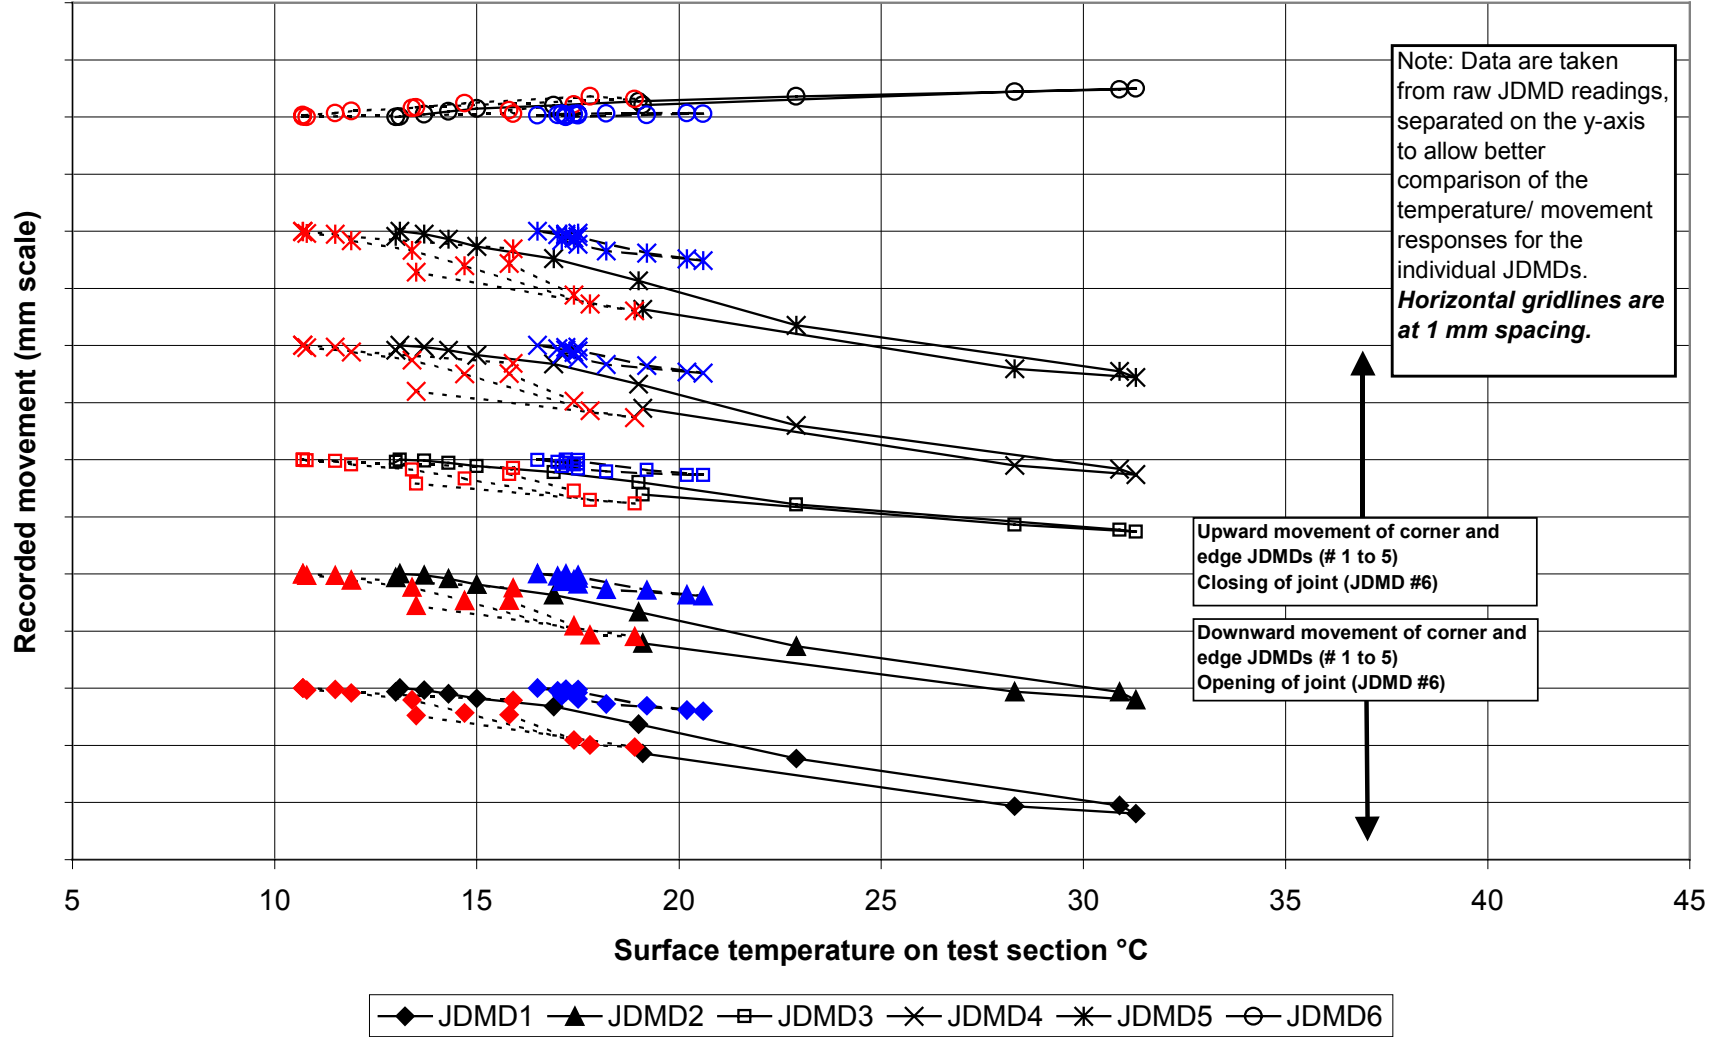
Figure 5.11. Section 535FD JDMD responses to surface temperature (Section 7: no dowels, asphalt shoulder).

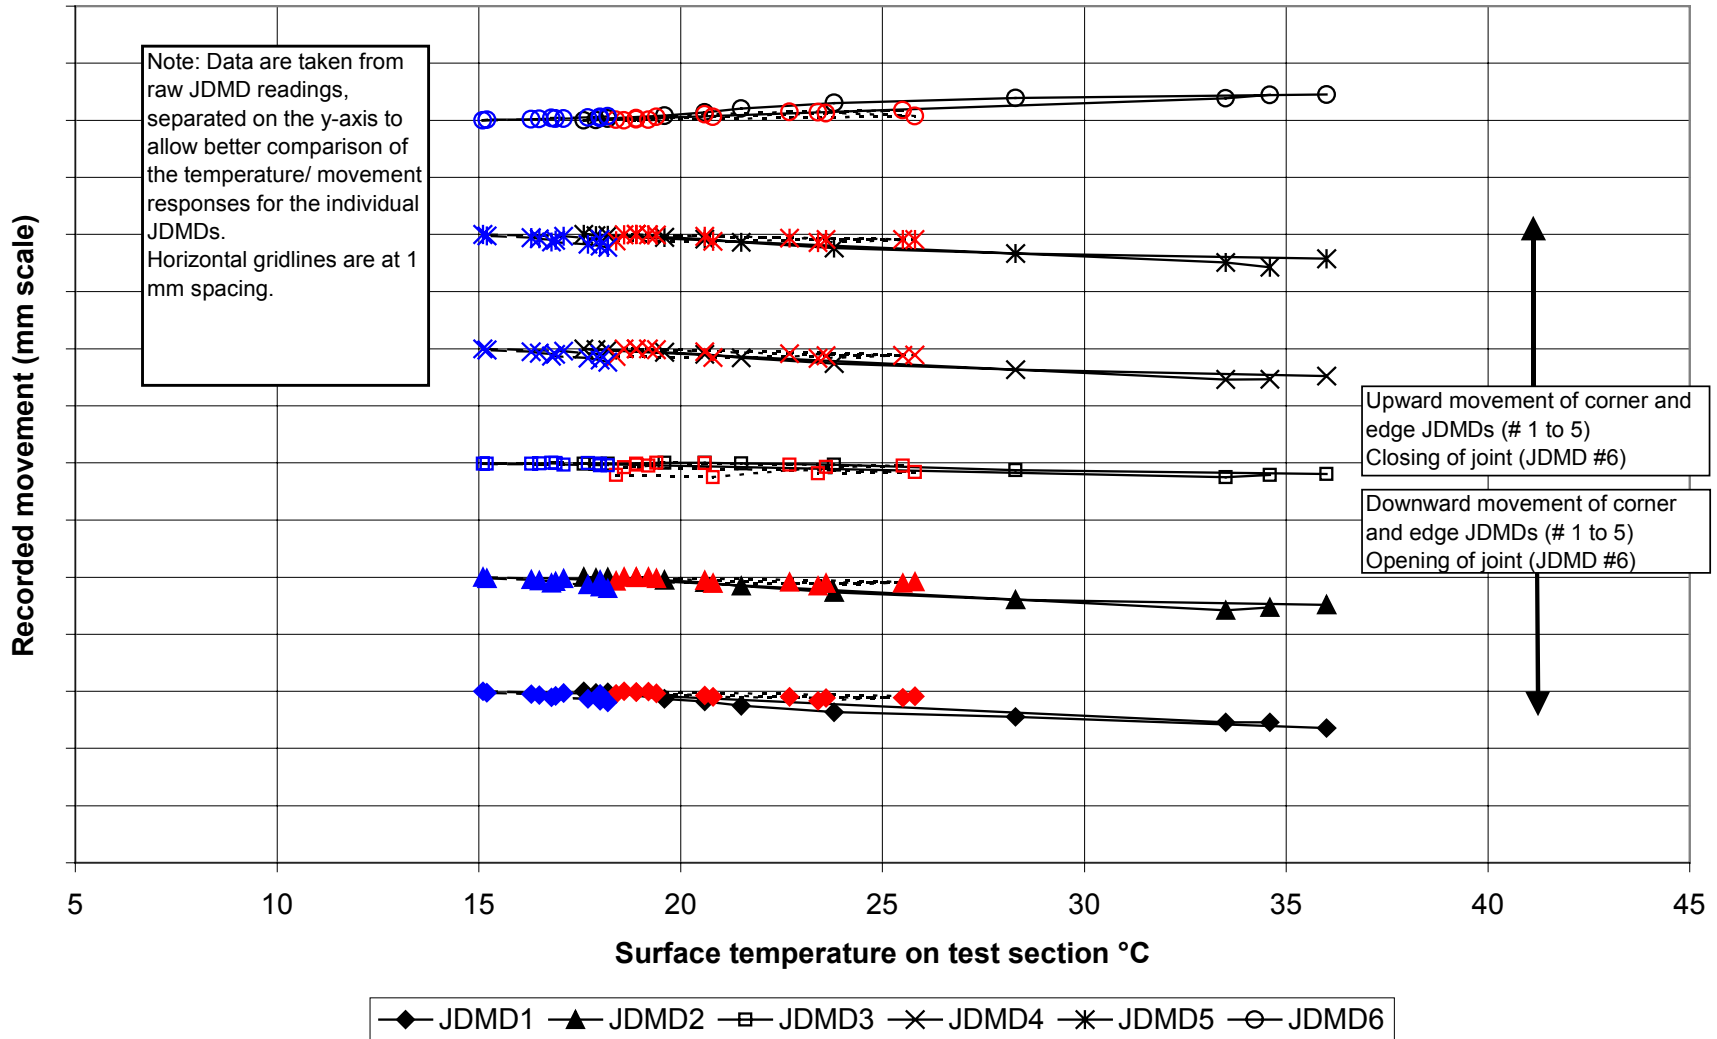
Figure 5.12. Section 536FD JDMD responses to surface temperature (Section 9: dowels, tied concrete shoulder).

The results from the tests on Design Section 9 are presented in Figures 5.12 to 5.14. Compared with the other tests, Section 9 showed much less scattered response overall. The range of pavement surface temperatures during these tests was from approximately 7°C to just over 40°C, with a range of about 15 to 20°C for each test. The vertical responses (corners and edge: JDMDs 1 to 5) show a distinctly lower rate of movement than those of the previous section, presumably mainly attributable to the restraining effects of the tied concrete shoulder and also the inclusion of dowels. Overall, the responses are linear for practical purposes

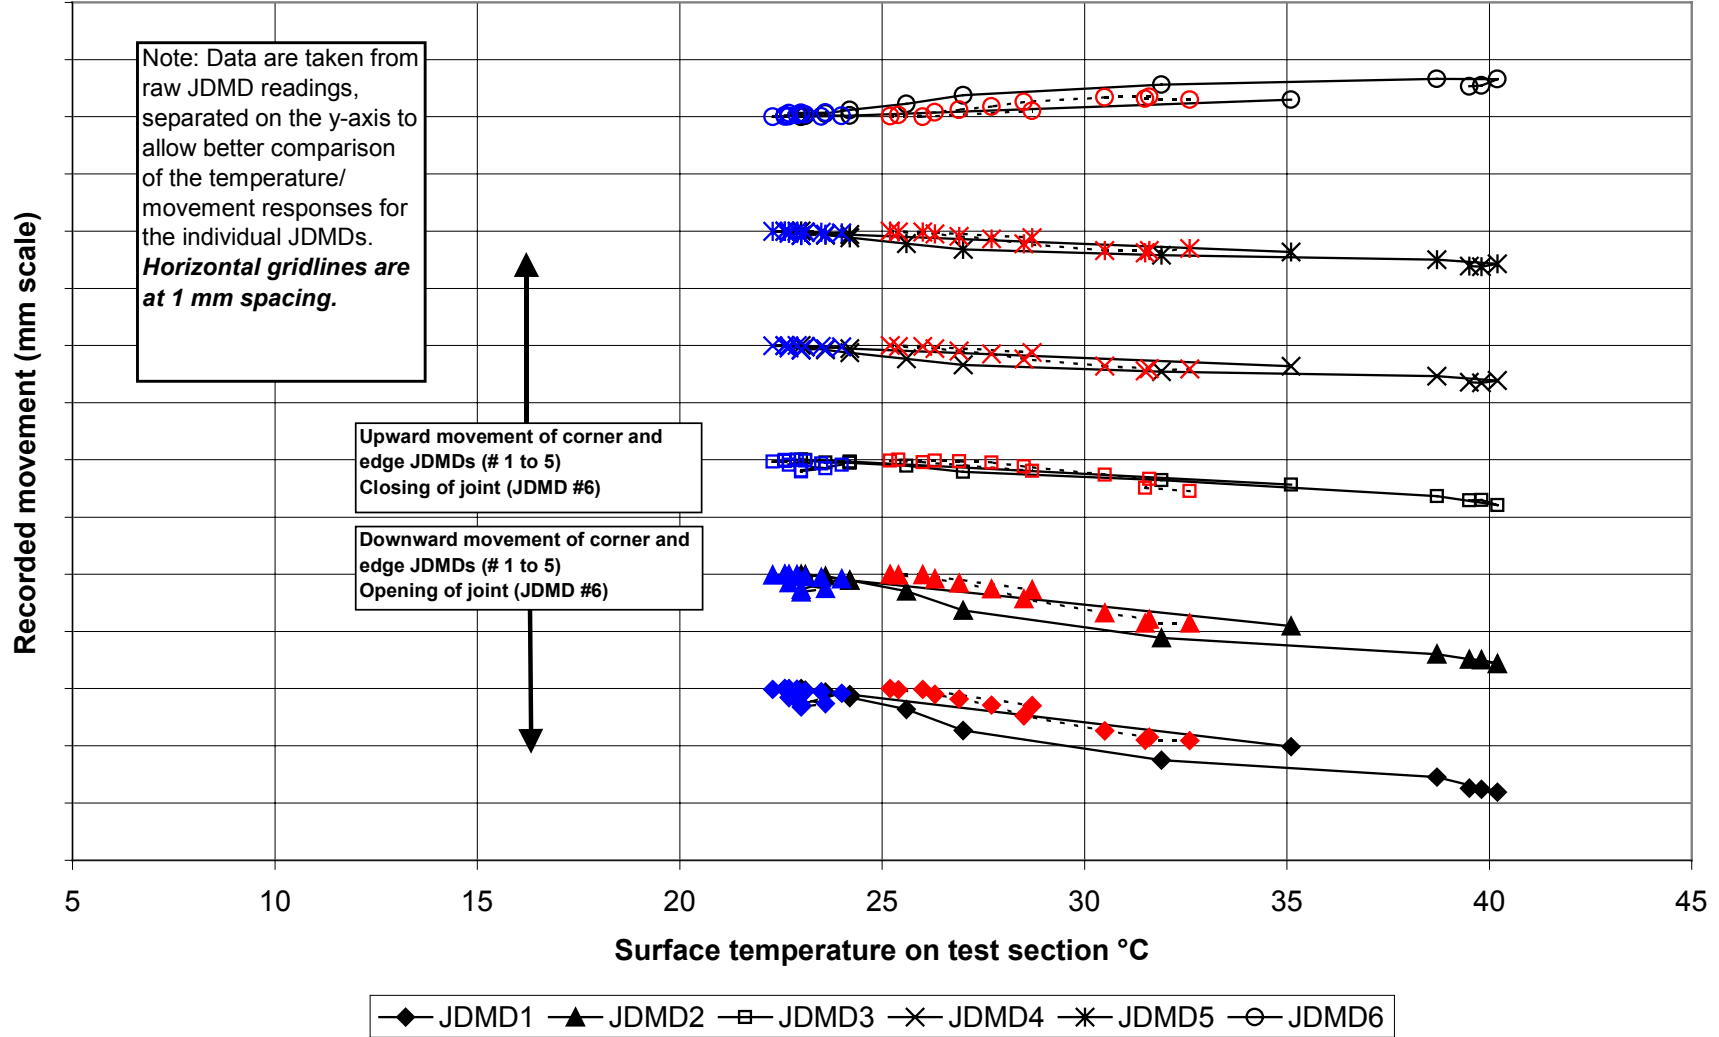
Figure 5.13. Section 537FD JDMD responses to surface temperature (Section 9: dowels, tied concrete shoulder).

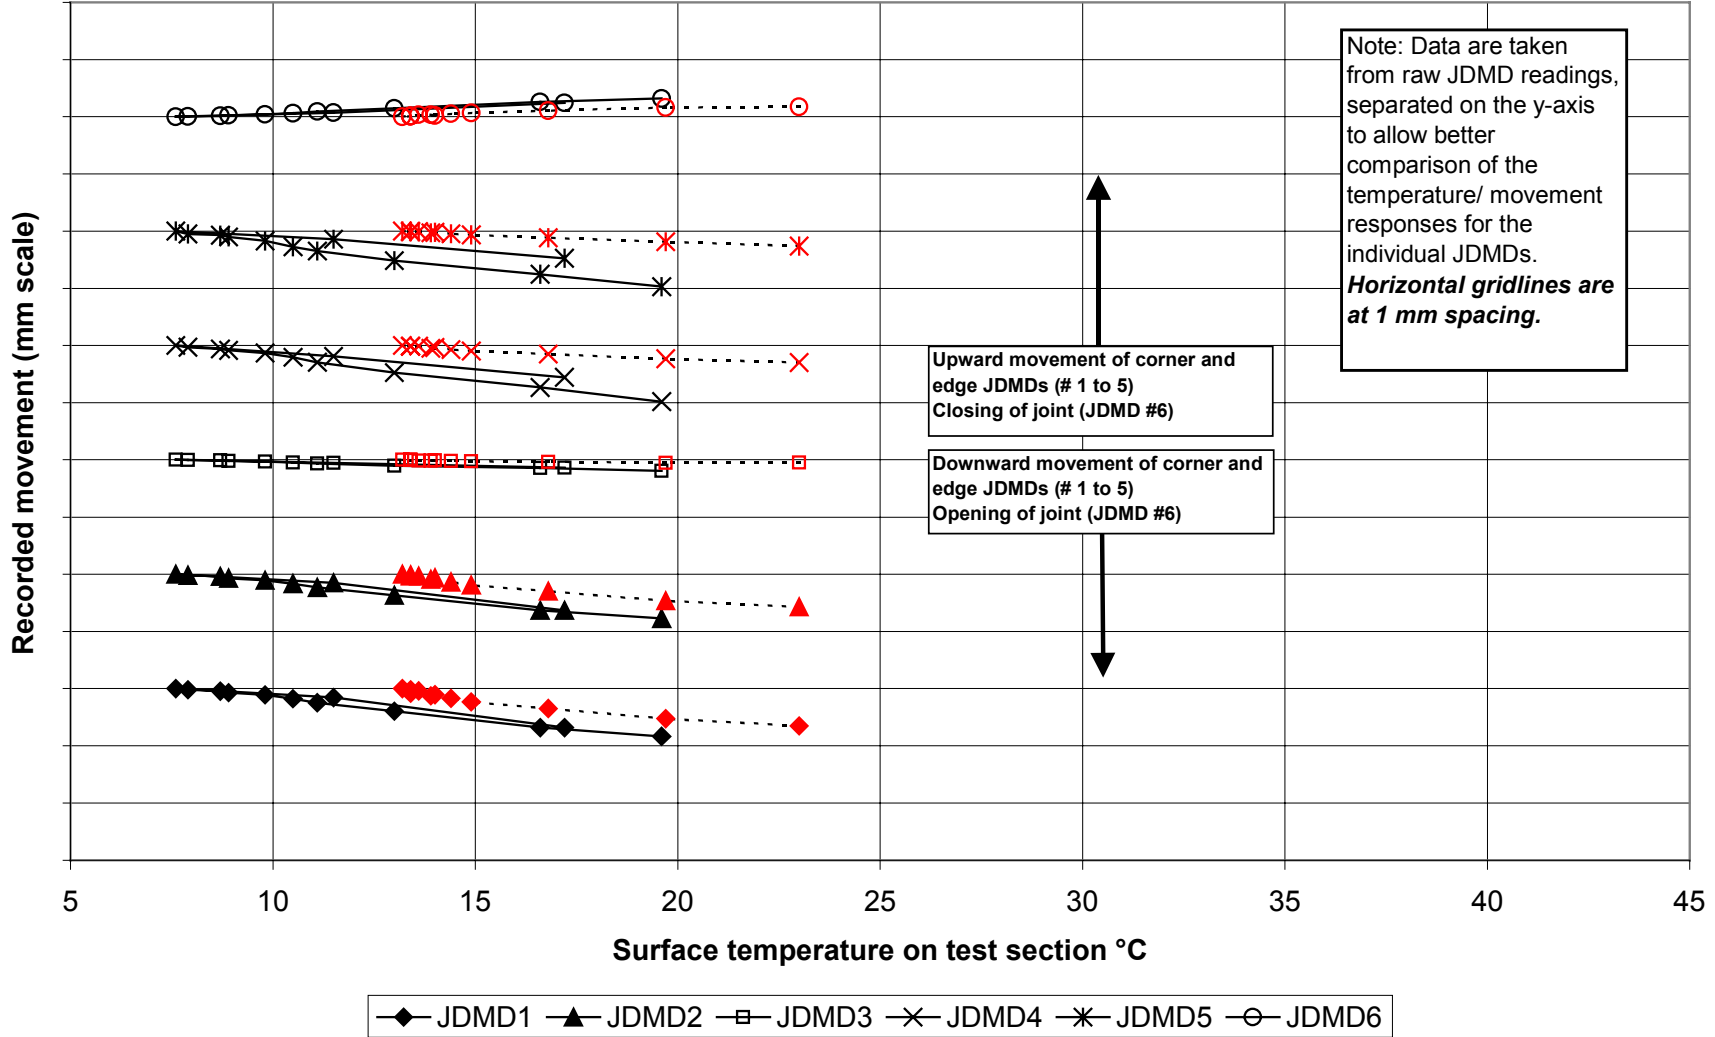
Figure 5.14. Section 538FD JDMD responses to surface temperature (Section 9: dowels, tied concrete shoulder).

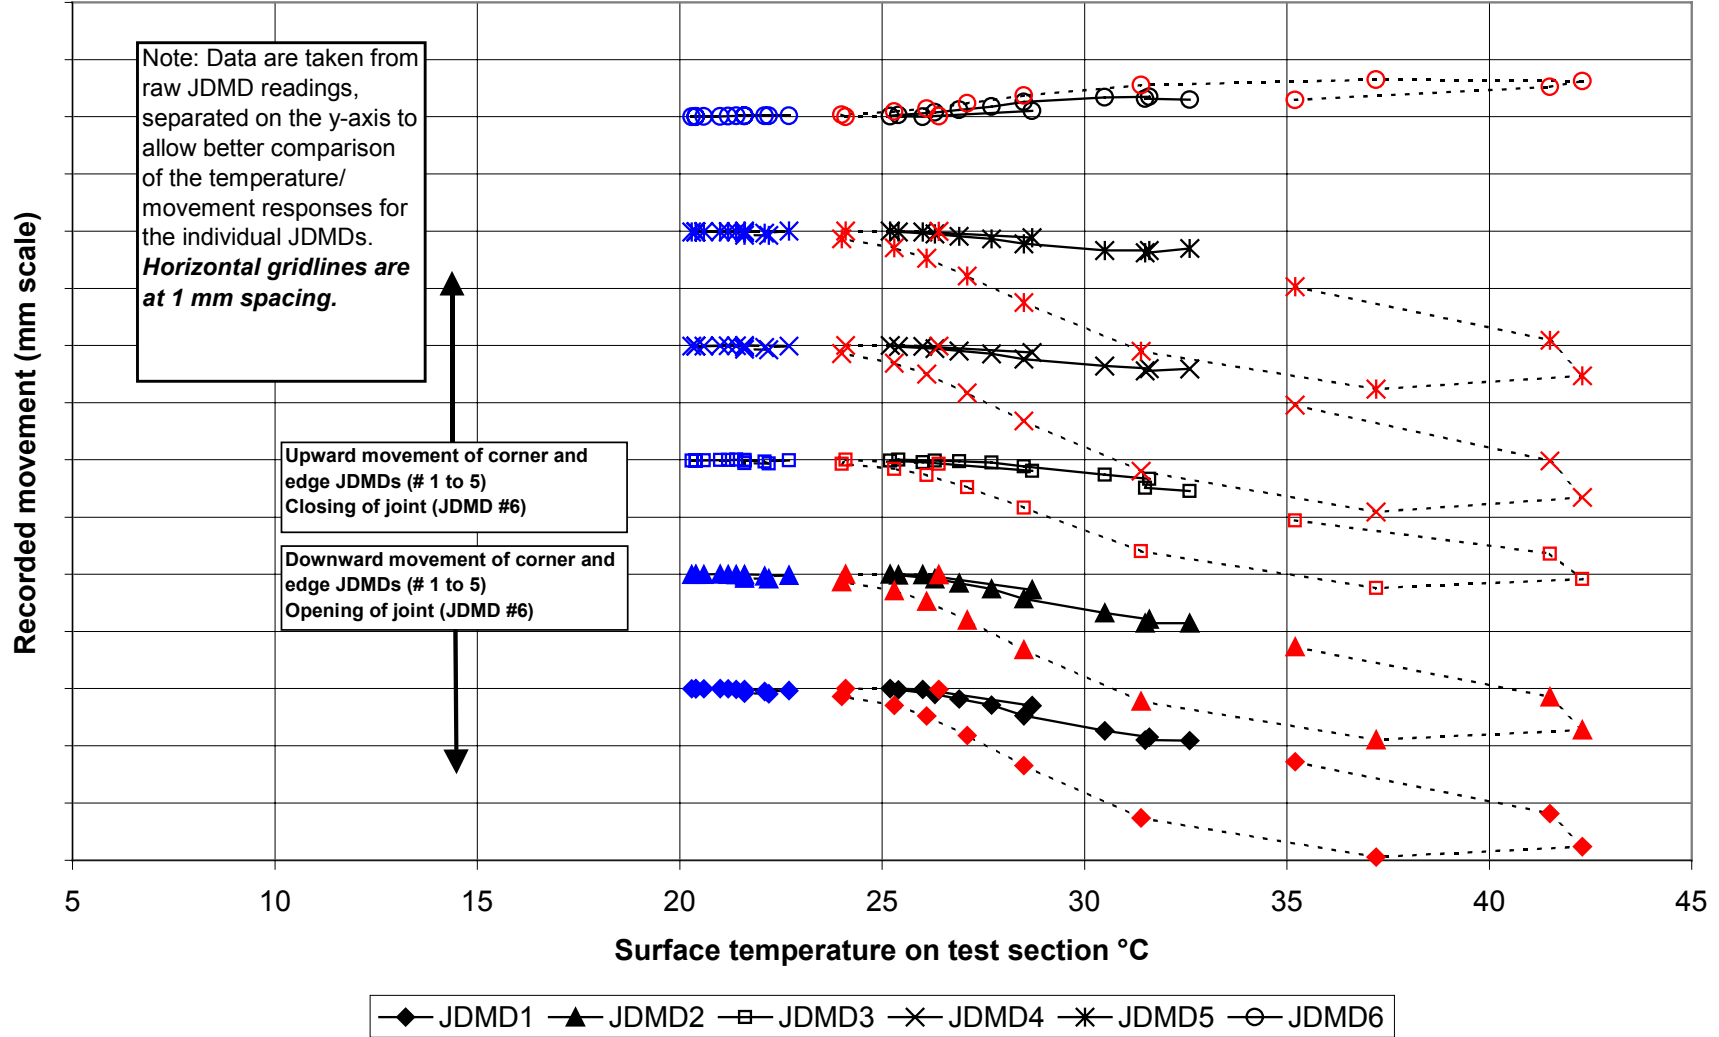
Figure 5.15. Section 539FD JDMD responses to surface temperature (Section 11: dowels, asphalt shoulder, 4.3-m wide lane).

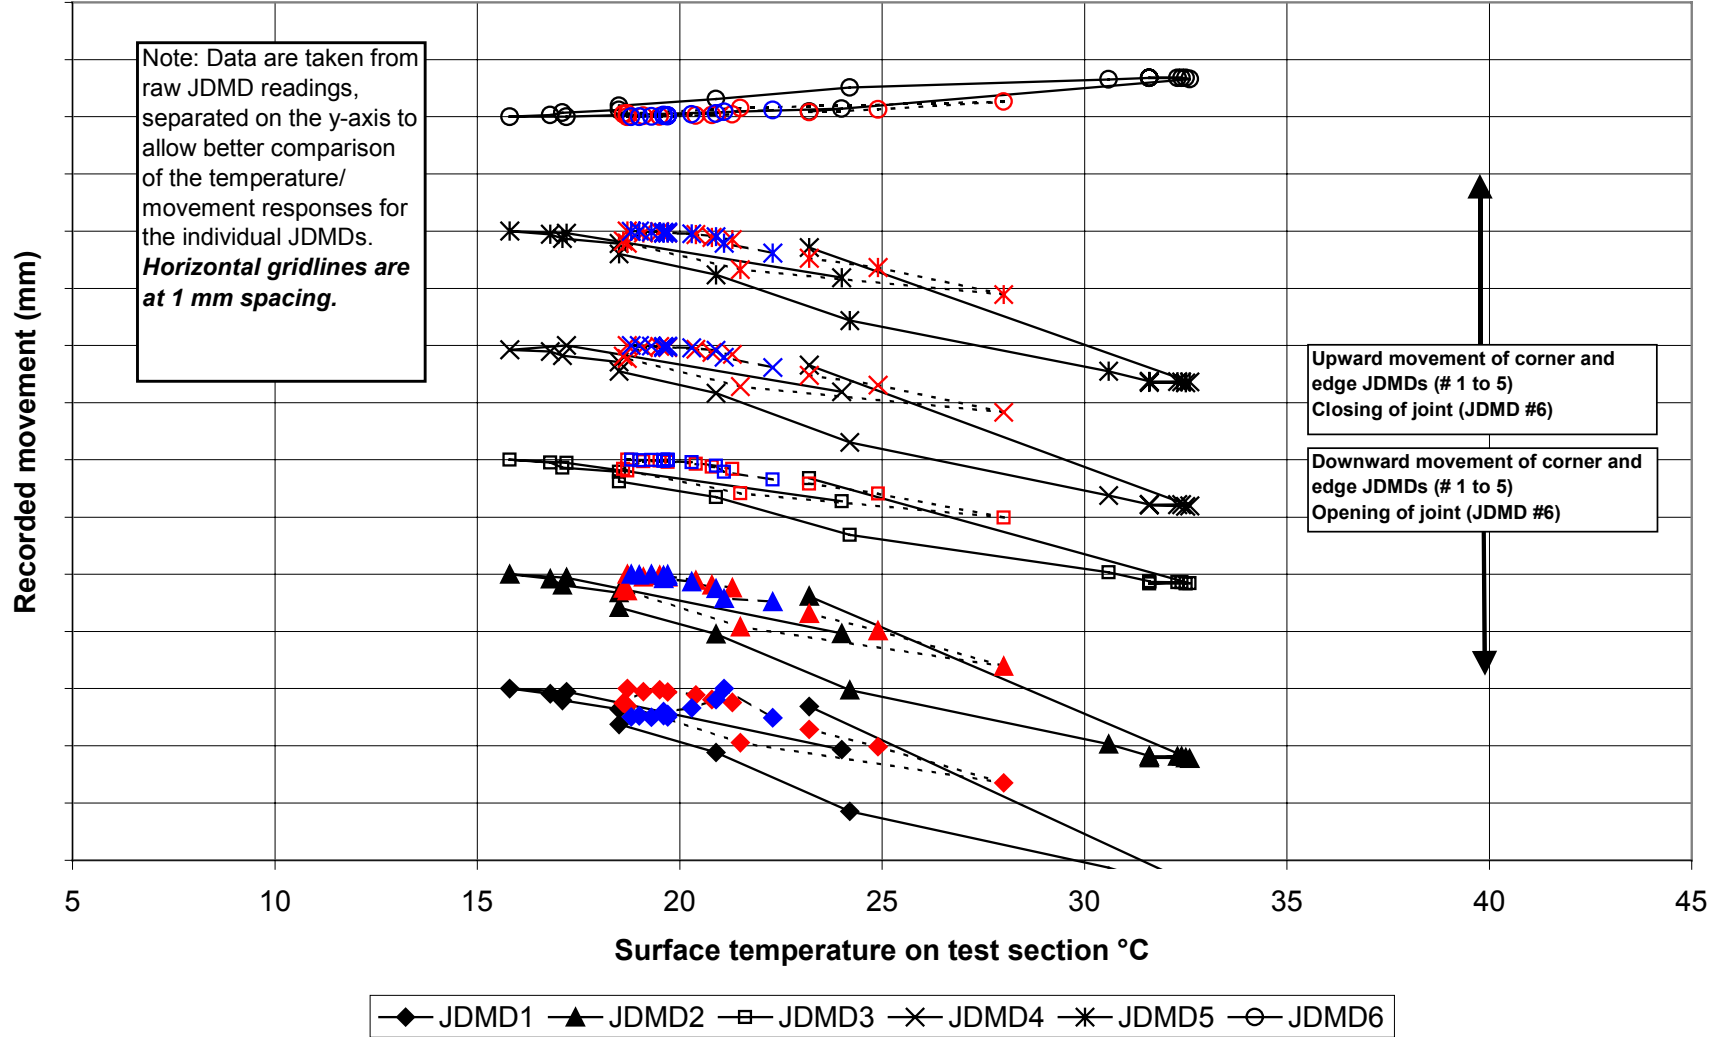
Figure 5.16: Section 540FD JDMD responses to surface temperature (Section 11: dowels, asphalt shoulder, 4.3-m wide lane).
