**Environmental Influences on the Curling of Concrete Slabs at the
Palmdale HVS Test Site**

Louw du Plessis,
CSIR Transportek

John Harvey,
UC Pavement Research Center

For the California Department of Transportation

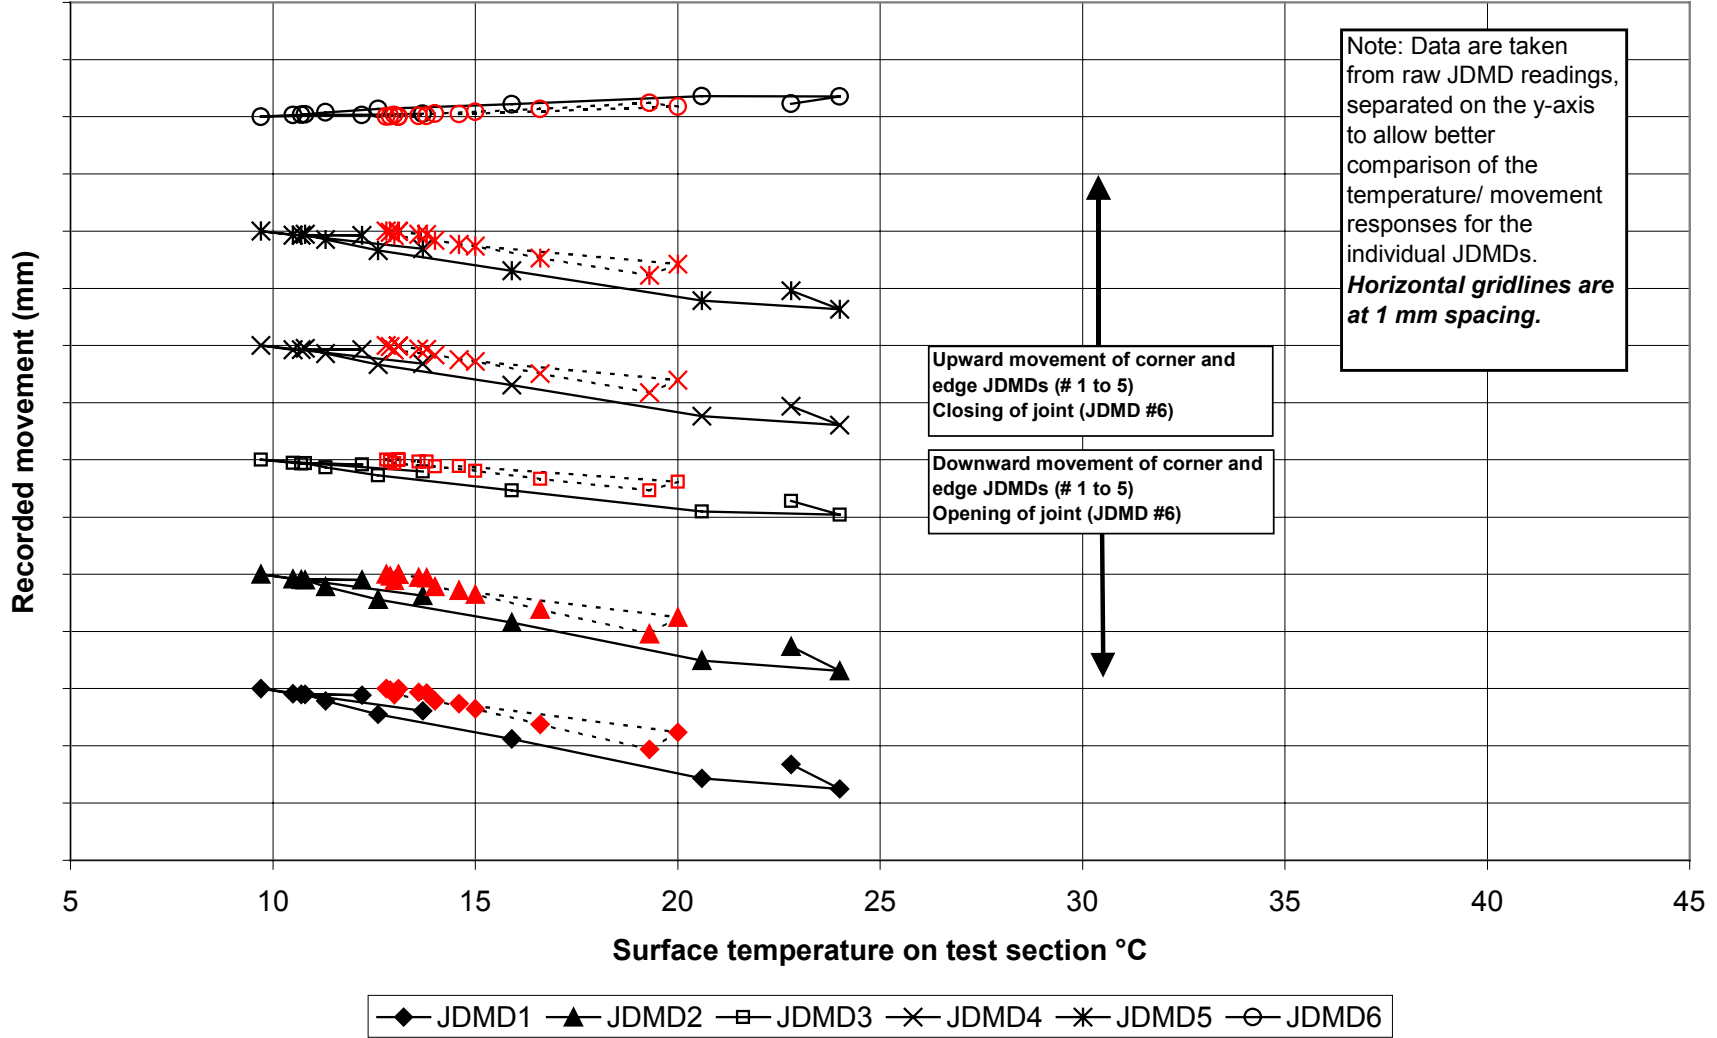
Figure 5.17. Section 541FD JDMD responses to surface temperature (Section 11: dowels, asphalt shoulder, 4.3-m wide lane).

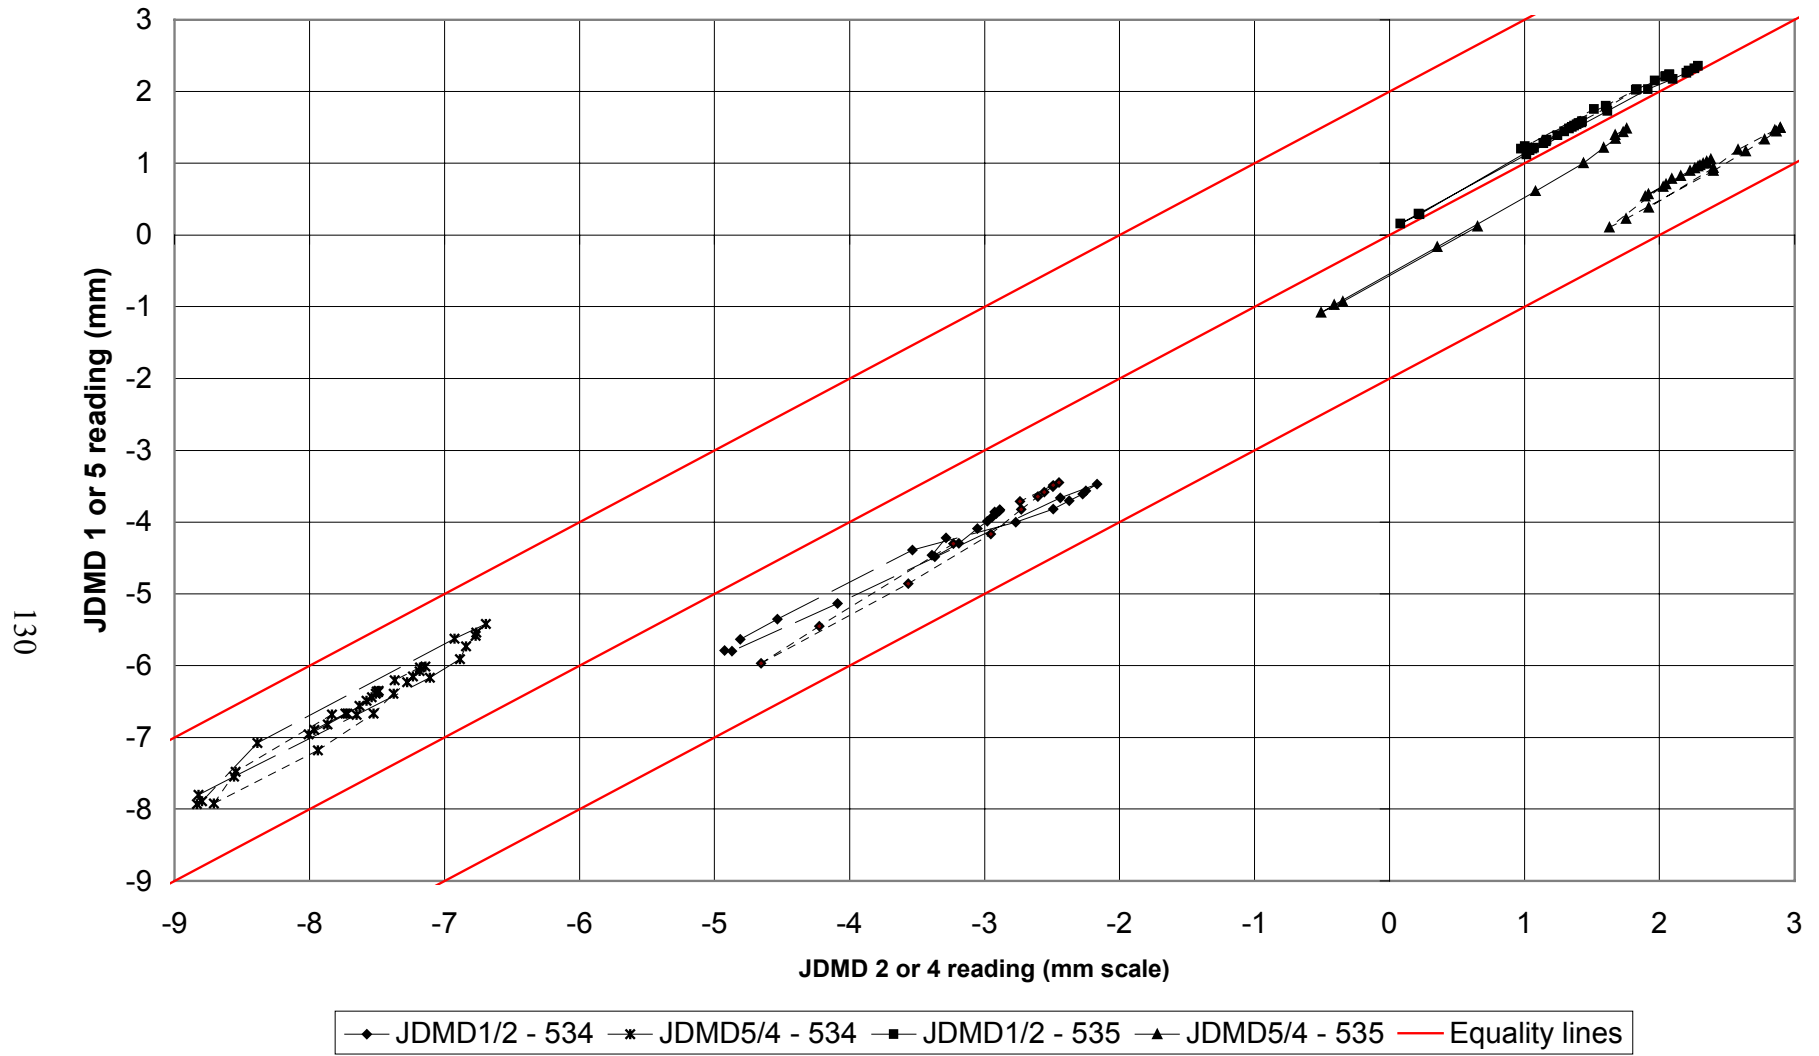
Figure 5.18. Relative movements across the joints for Design Section 7

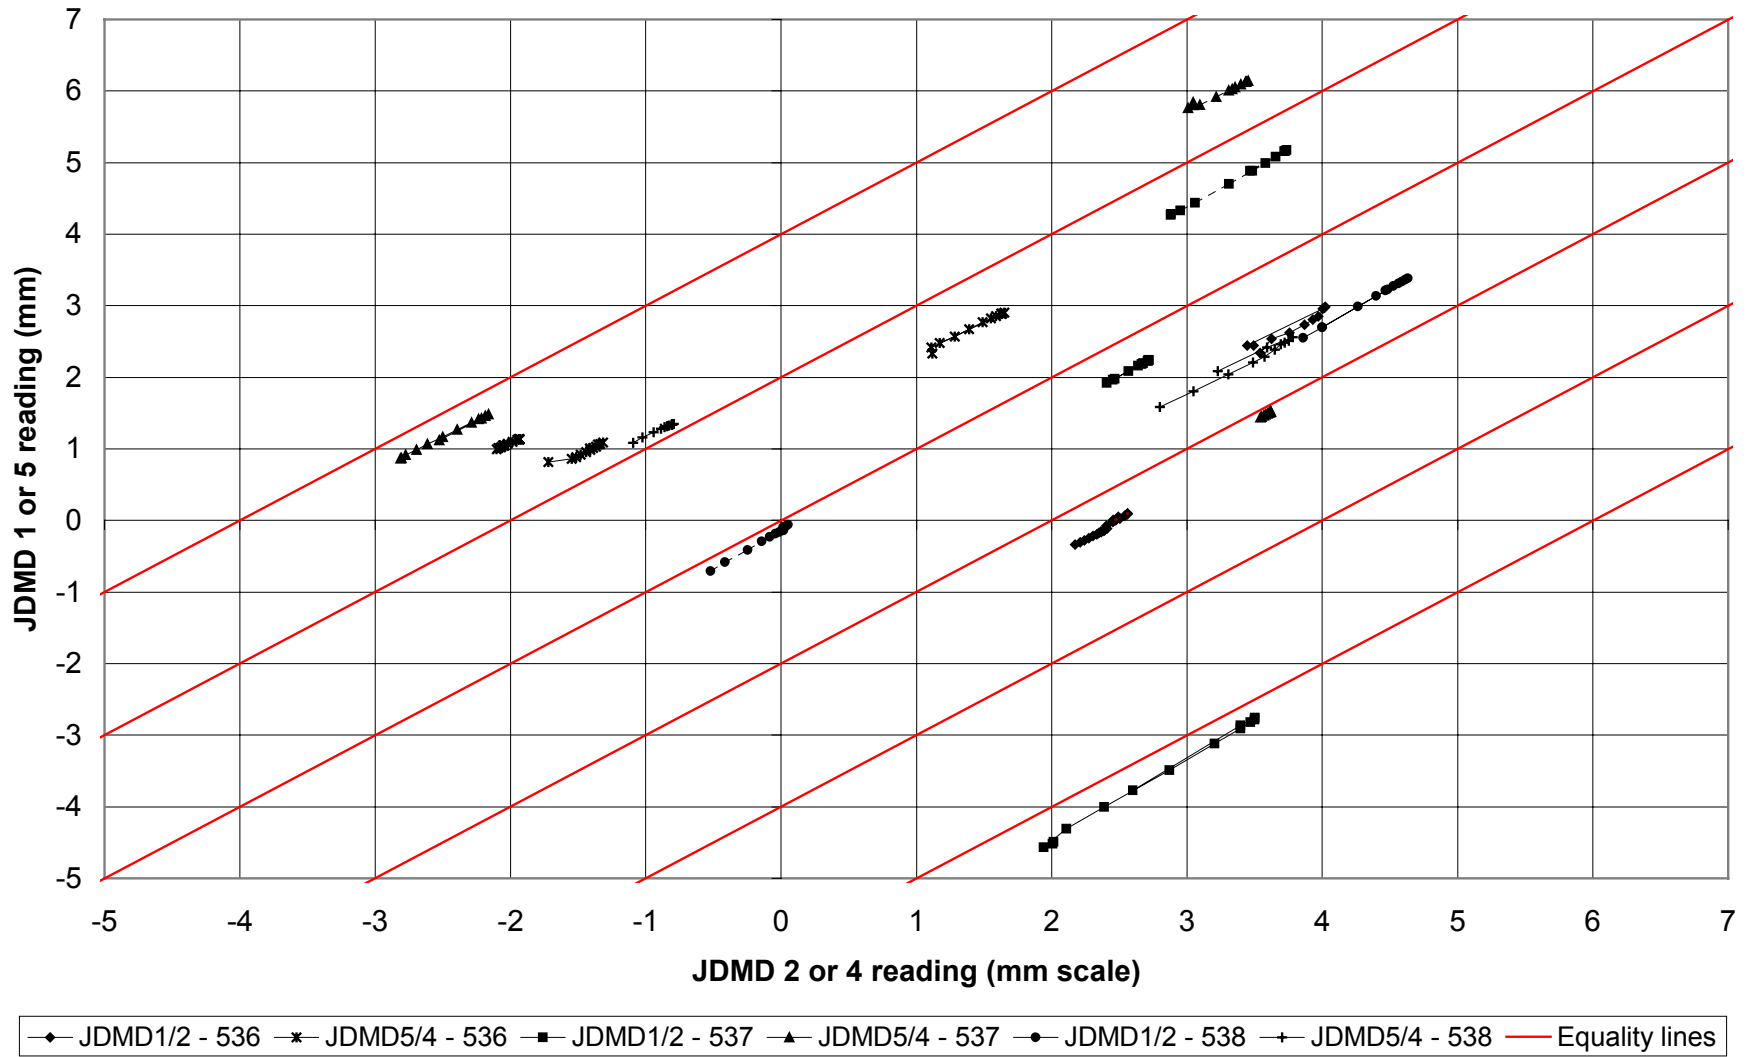
Figure 5.19. Relative movements across the joints for Design Section 9.

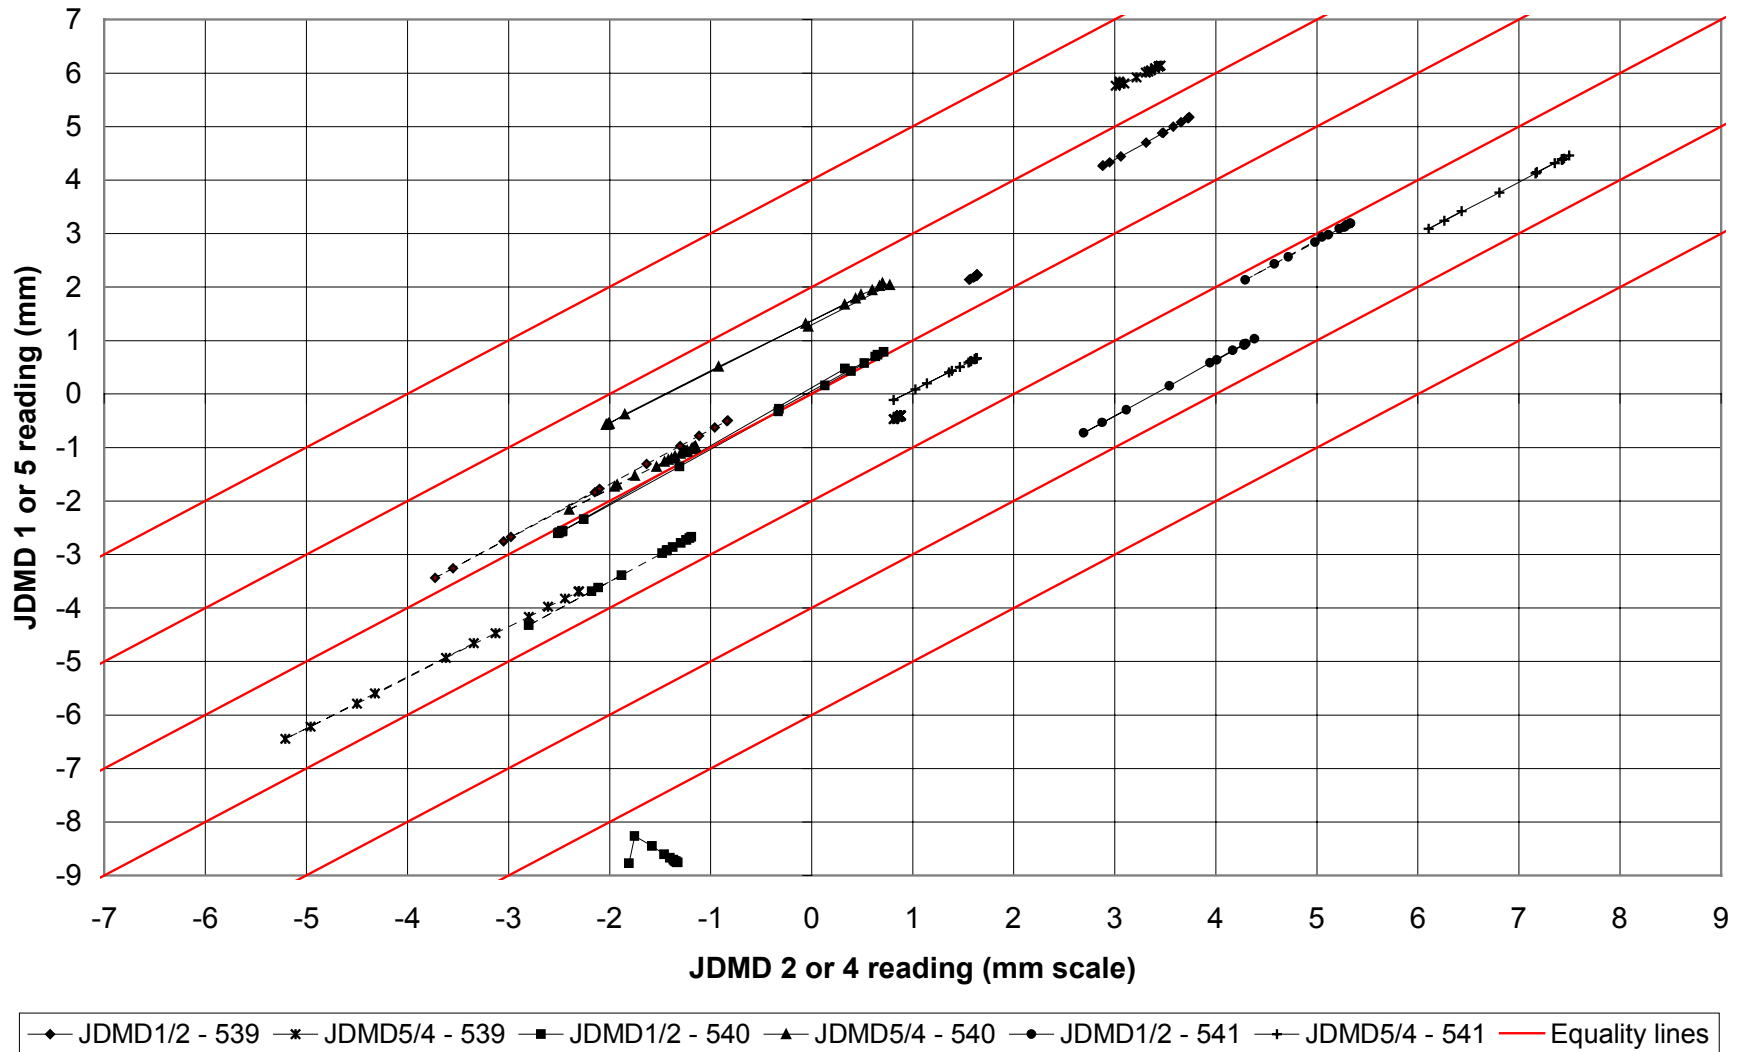
Figure 5.20. Relative movements across the joints for Design Section 11.

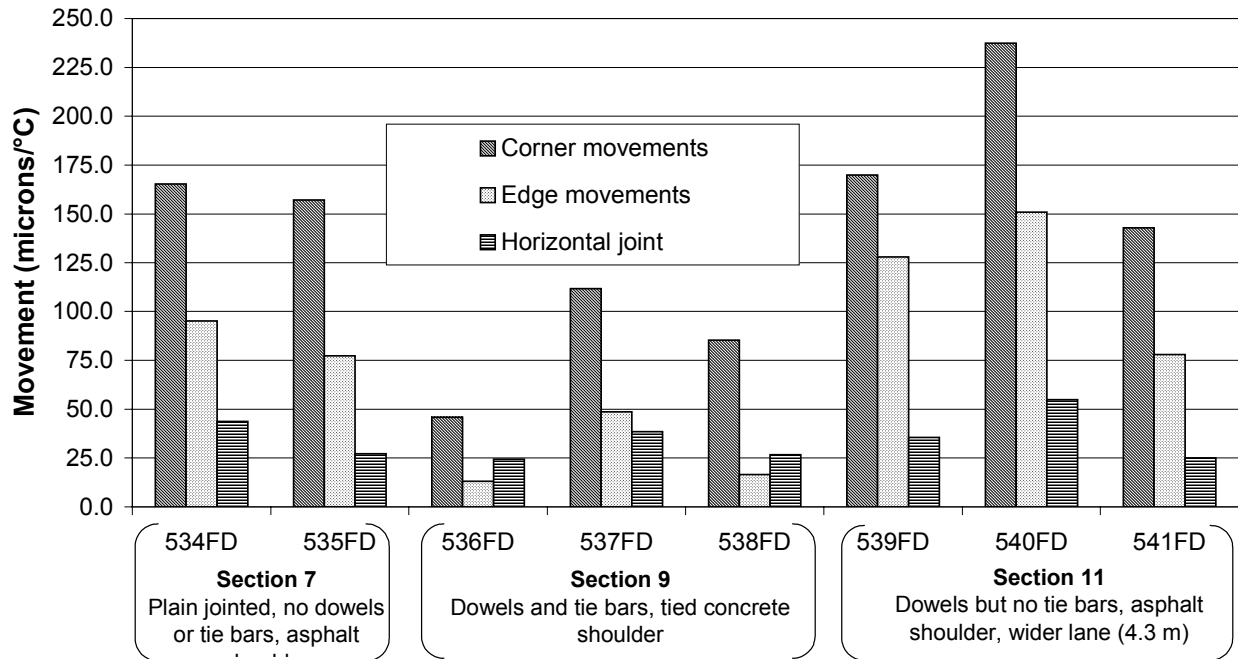
Figure 5.21. Summary of vertical and horizontal movements for all sections.
