# Concrete Pavement Tire Noise: Third-Year Results

**Authors:**  
A. Rezaei and J. Harvey

Version 1  
Work Conducted as Part of Partnered Pavement Research Center Strategic Plan Element No. 4.29:  
Quiet Concrete Pavement Research

University of California  
Pavement Research Center  
Davis and Berkeley

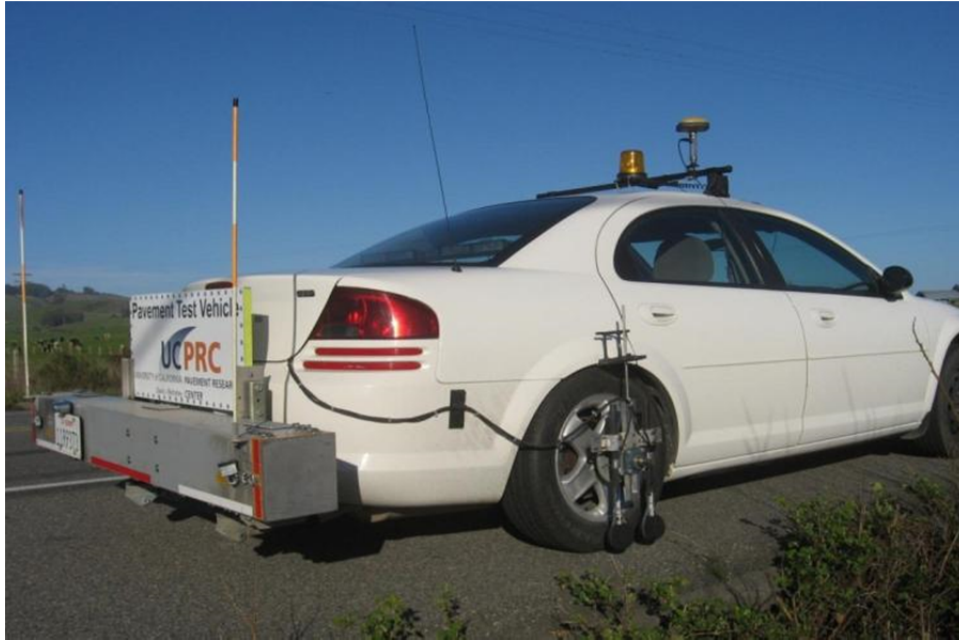
**Figure 2.1: Instrumented vehicle with on-board sound intensity probes and an inertial profilometer.**

In addition to the use of the OBSI method to measure tire/pavement noise, an inertial profilometer was used to measure International Roughness Index (IRI) and Mean Profile Depth (MPD), and visual observations were made of the surface texture type and condition of each test section. The measured IRI values and texture observations were collected at the same fixed short intervals used for OBSI measurement. The instrumented vehicle used in this project is shown in Figure 2.1.

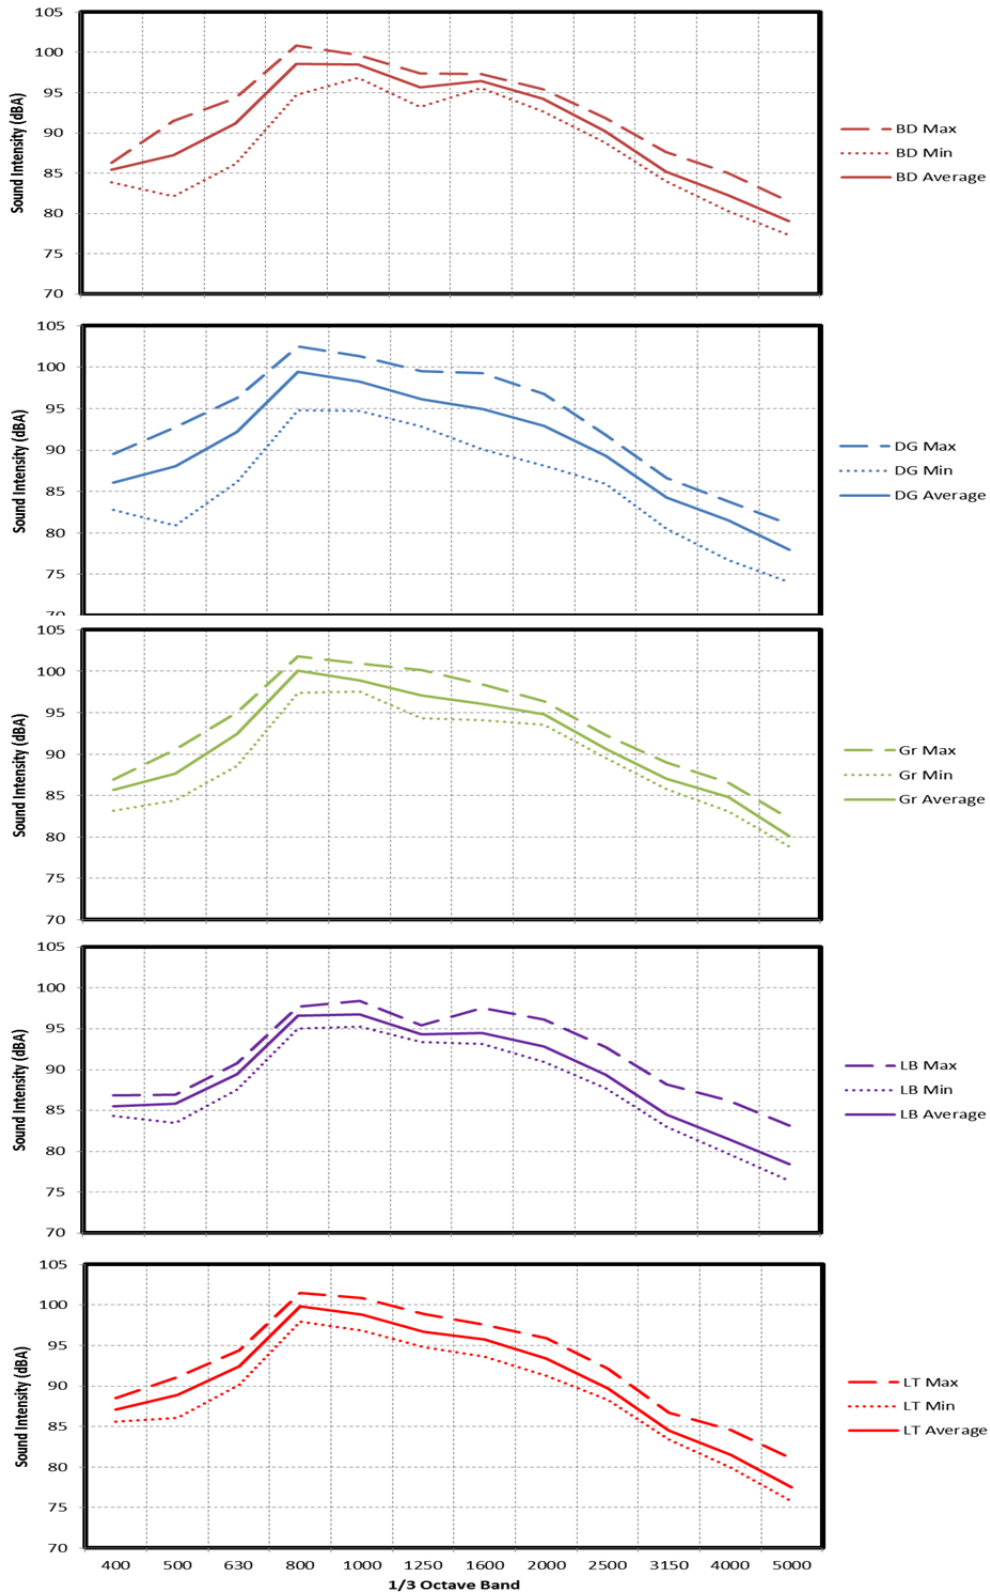
Figure 3.12: Comparison of OBSI spectral content of sections of different texture types (only texture aged).

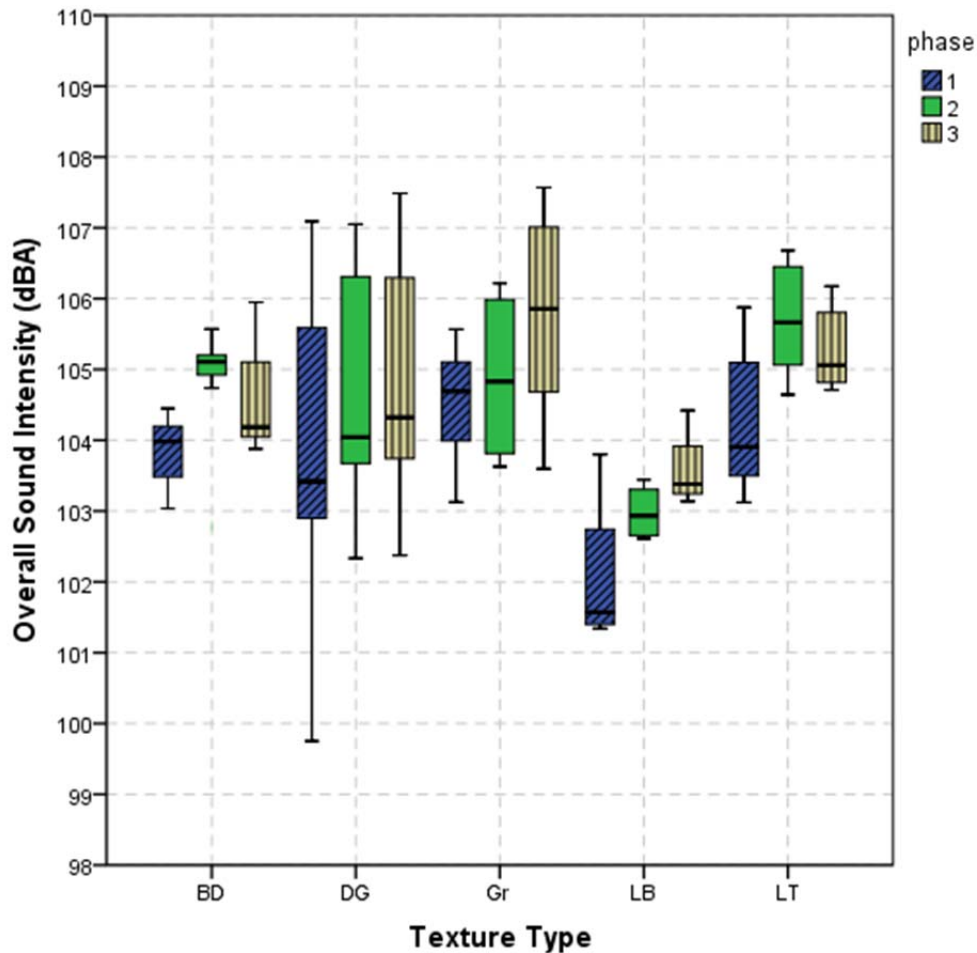
**Figure 3.17: Box plots of OBSI results by texture type, all measurements from Years 1, 2, and 3, with *new* and *aged* conditions.**  
 (Notes: BD = burlap drag, DG = diamond ground, Gr = diamond grooved, LB = longitudinally broomed, and LT = longitudinally tined.)

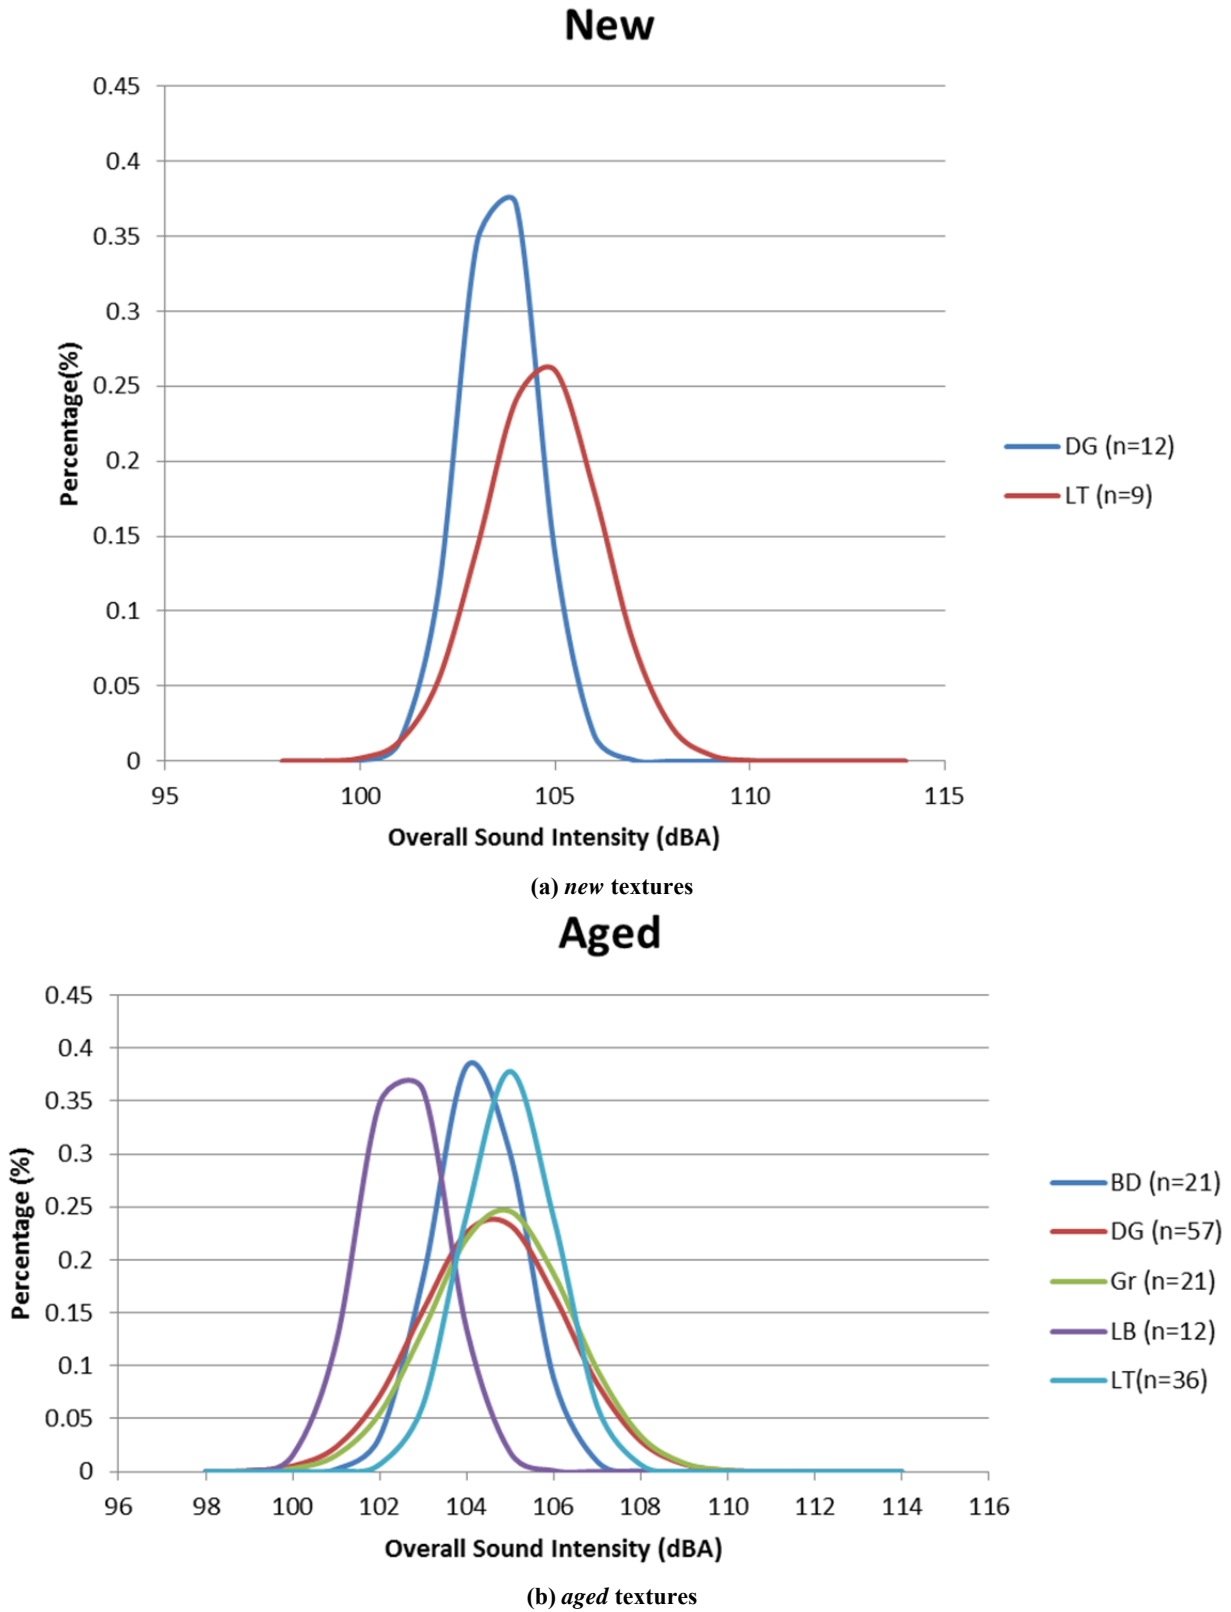
Figure 3.22: Normal distribution curves of OBSI results by texture type, (a) *new* and (b) *aged* texture conditions.

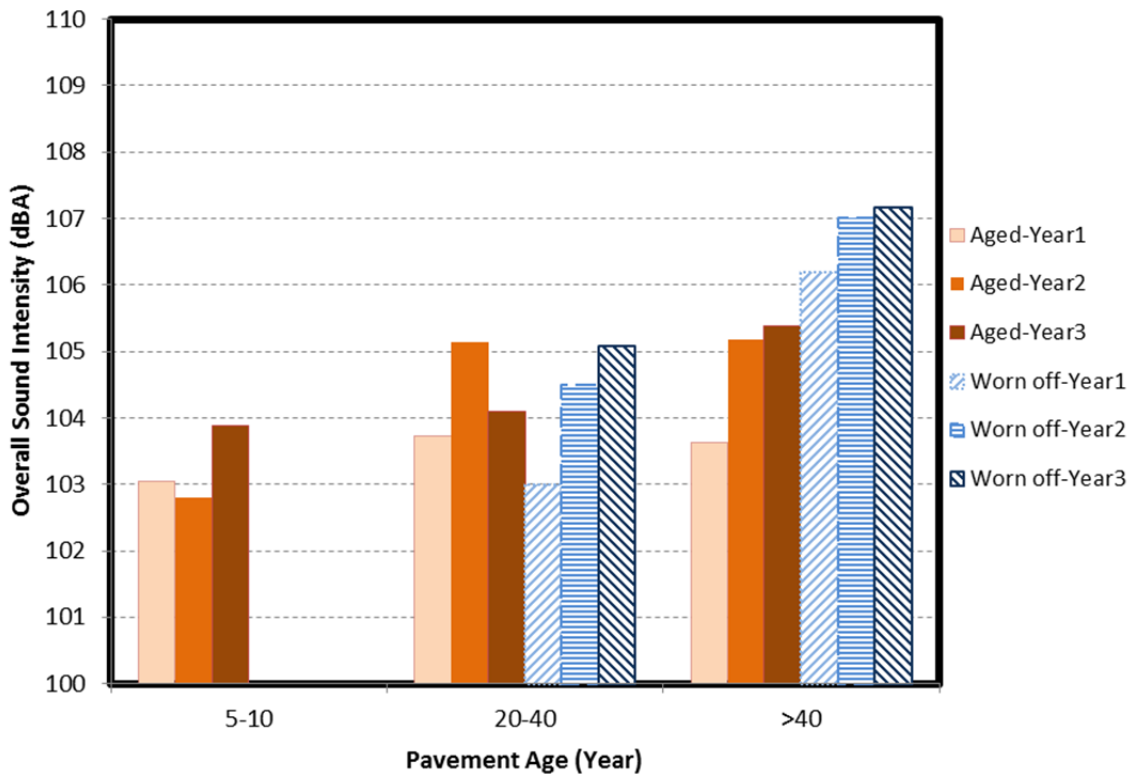
Figure 3.25: Average burlap drag Year 1, 2, and 3 OBSI results for *aged* and *worn out* texture sections (no *new* condition sections measured) by different age categories.

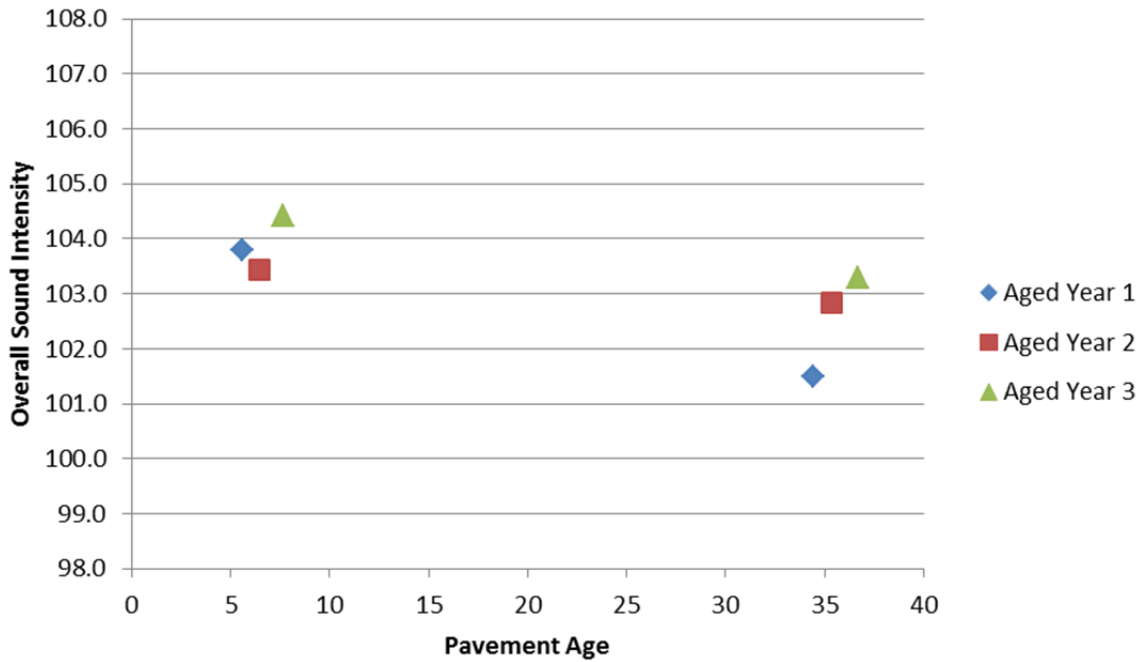
Figure 3.32: Longitudinally broomed Year 1, 2, and 3 OBSI results for *aged* texture sections (no *new* or *worn out* condition sections measured) versus years since last surfacing.

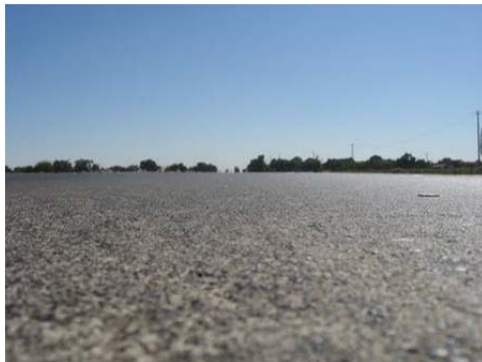
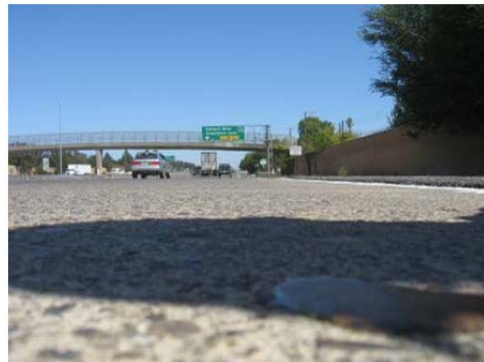
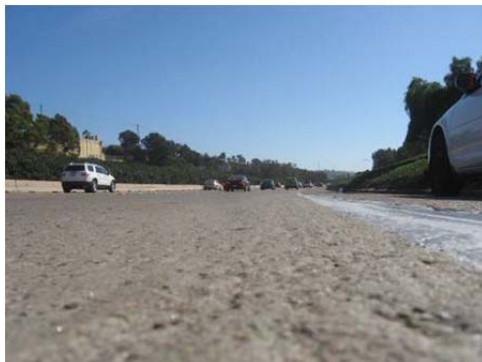
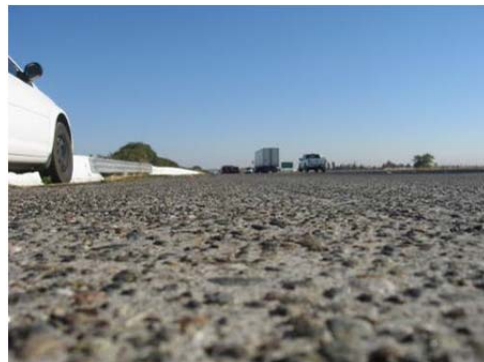
**Figure 4.1: Example photographs of burlap drag surfaces and their OBSI levels.**

**QP-102.2 (102.5 dBA)**

**QP-107.3 (103.8 dBA)**

**QP-130.1 (107.3 dBA)**

**QP-116.1 (107.2 dBA)**

The oldest concrete pavement sections evaluated in this study have burlap drag texture, including sections on Interstate 80 in Solano County that have been in service for over 60 years (QP-116). Due to their long service life, some of the sections for this texture type have surfaces that show no signs of the initial surface texture, and were therefore categorized as *worn out* texture condition. Burlap drag sections are not constructed in California highways any more, which is why no “young” sections, other than the one built for the field evaluation experiment in Mojave (results shown in Section 4.2 of this report), were included in the experiment. This young section, which was about five years old when first tested, yielded an average OBSI level of about 102.7 dBA over three years of measurement. Other than this experimental section, however, all the burlap drag sections were older than 30 years and had OBSI levels ranging between 100.7 and 107.8 dBA in year-to-year measurements. These values indicate that the actions of traffic, often combined with rainfall, will tend to polish some concrete surfaces and to remove positive texture (stones protruding from the surface) without damaging the paste around the stones. The quieter sections appear to be those with shallow texture (based on observation of photos of the textures), as shown in Figure 4.1. Therefore, a possible reason for the variability of OBSI for the burlap drag sections is the variation in macrotexture caused by aggregates creating positive texture on the surface. Comparison of the photographed textures from the five-year old Mojave section and the quietest burlap drag section measured in this study (Figure 4.2) indicates that the slightly noisier Mojave section (QP-159) may

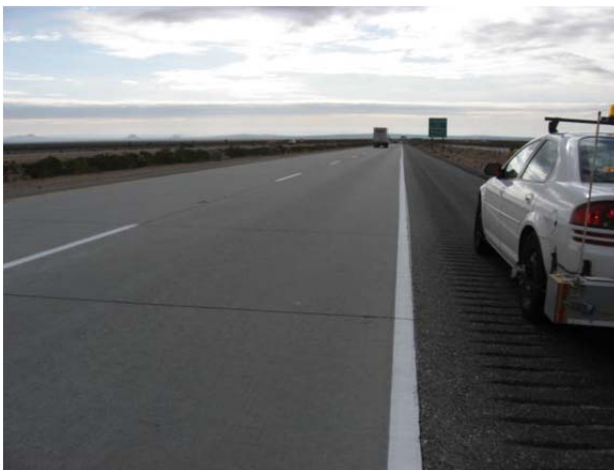
(b) Mojave burlap drag section (QP-159, 102.7 dBA)

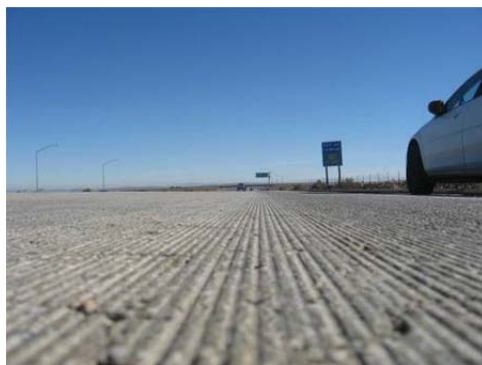
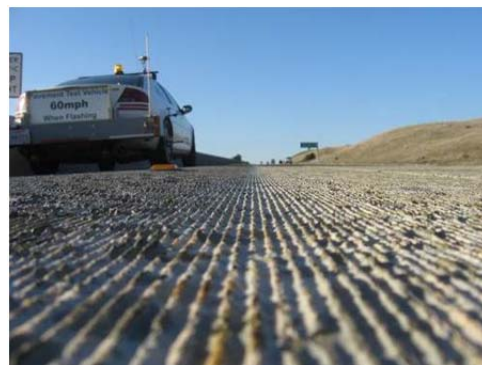
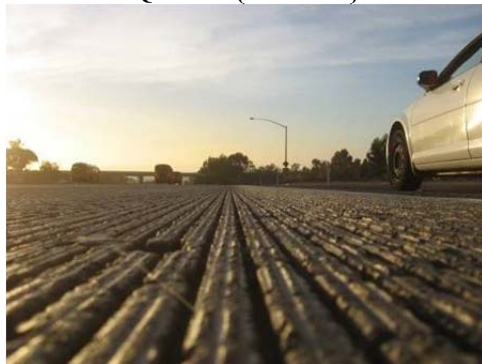
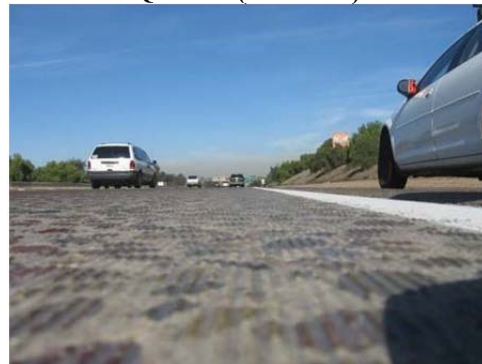
**Figure 4.3: Example photographs of diamond-ground surfaces and their OBSI levels.**

**QP-155.1 (102.8 dBA)**

**QP-147.1 (103.1 dBA)**

**QP-134.1 (106.5 dBA)**

**QP-132.3 (107.0 dBA)**

A summary of the information for the diamond-ground surfaces is presented in Table 4.2. Highly variable texture depth (macrotexture) and the shape of the texture (sharp, rounded, wide versus narrow plateaus) is thought to be a likely reason for the variability in OBSI levels. Photographs of example diamond-ground surfaces are shown in Figure 4.3.

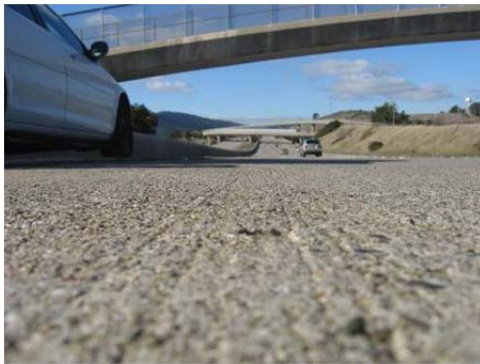
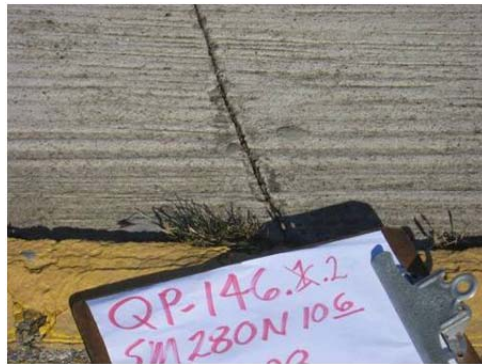
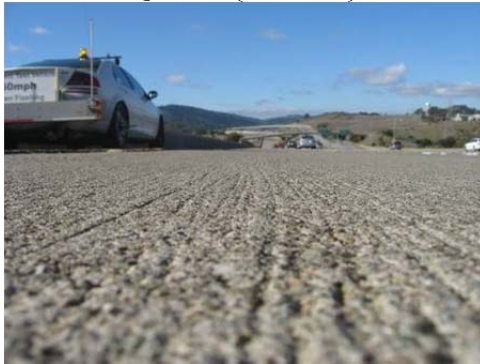
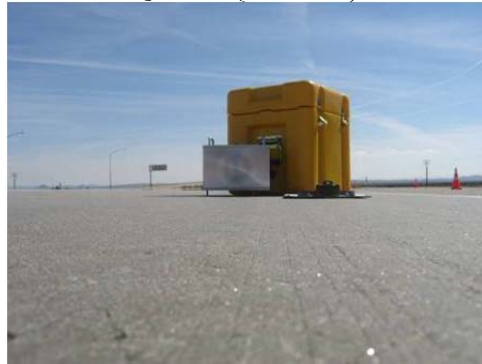
**Figure 4.5: Example photographs of longitudinally broomed surfaces and their OBSI levels.**

**QP-146.3 (102.4 dBA)**

**QP-146.2 (102.5 dBA)**

**QP-146.1 (102.7 dBA)**

**QP-162.1 (103.9 dBA)**

A summary of the information for longitudinally broomed sections is presented in Table 4.4. Photographs of examples of longitudinally broomed surfaces are shown in Figure 4.5.

The longitudinally broomed sections have a narrow range of overall OBSI values compared with the other textures, in large part due to the very small sample size. There is no readily apparent explanation for the differences between OBSI values for different sections based on the photographs of the texture conditions.

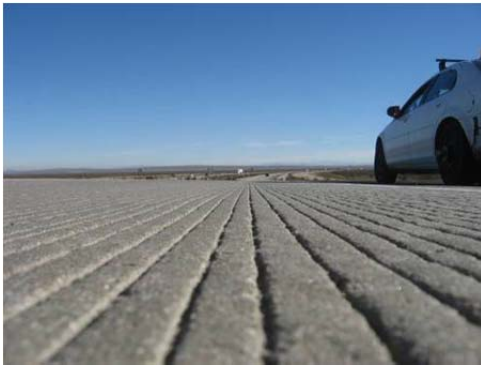
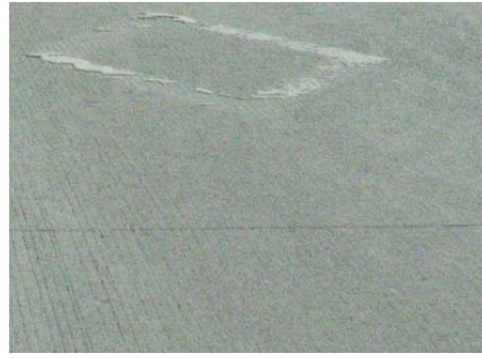
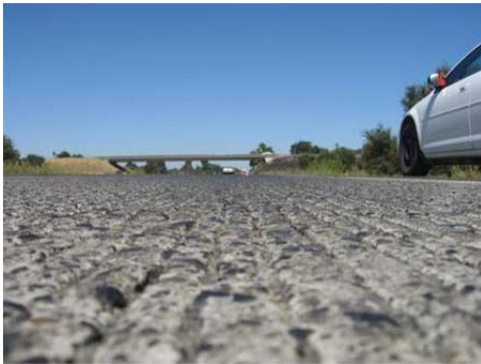
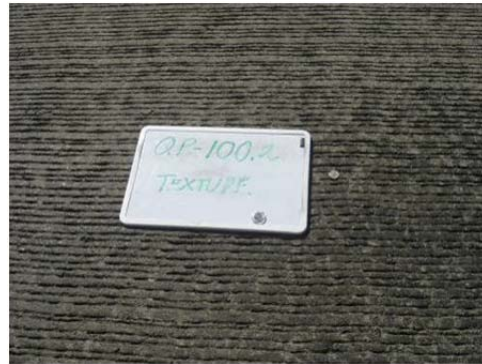
Figure 4.6: Example photographs of longitudinally tined surfaces and their OBSI levels.

QP-158.1 (105.0 dBA)

QP-127.3 (104.3 dBA)

QP-101.1 (106.1 dBA)

QP-100.2 (106.0 dBA)

A summary of the information for the longitudinally tined sections is presented in Table 4.5. The interquartile range reveals that the noise level of 50 percent of the sections of this texture type are expected to fall between 104.7 and 106.1 dBA. This narrow range is unexpected given that the tining process used to create the longitudinal grooves introduces wide variations in some of the grooves' characteristics, among them differences in depth, spacing, the amount of displaced material that protrudes from the surface, and shape (the grooves often appear to be "waves" of different wavelengths, but in other cases they are perfectly straight). This measured OBSI range therefore indicates that the different techniques used in longitudinally tining concrete pavement may result in pavements with similar noise characteristics. Four examples of longitudinally tined sections are shown in Figure 4.6. From the photographs it is interesting to note that Section QP-158.1, which has relatively smooth surfaces on the plateaus between the tine grooves and wide plateaus, and Section QP-100.2, which has narrower plateaus with rougher edges, have nearly the same OBSI value. Looking at the photograph of QP-127.3 (Figure 4.6, upper right), which is the quietest LT section when measurements over three years are averaged, does not provide a visual indication of why it should be quieter than the other LT sections.

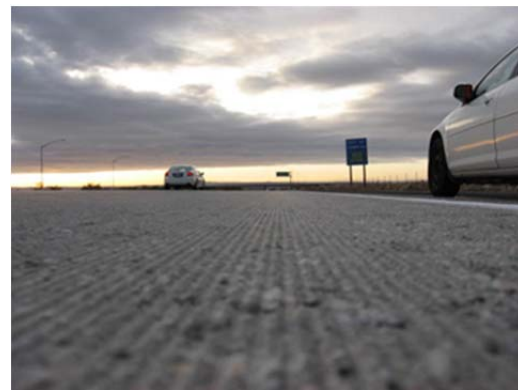
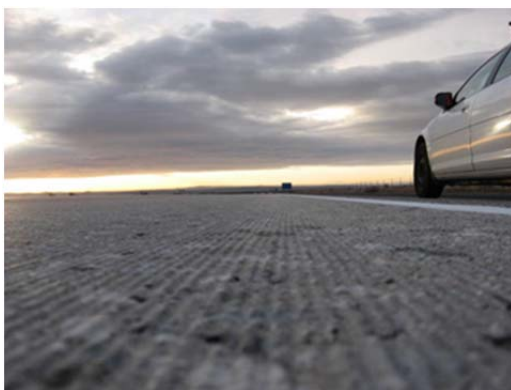
**Example photographs of surface textures and their OBSI levels for the Mojave test sections**  
(continued on next page)

**QP-155 (DG,  $Y_{1,2,3} = 101.2, 101.7, 103.4$  dBA)**

**QP-160 (DG,  $Y_{1,2,3} = 102.7, 102.9, 104.5$  dBA)**

Table 4.6 presents the results of the pavement sections in the Mojave test site (Kern 58). Figure 4.7 shows photographs of the surface textures on each of these sections. The Mojave sections—which are all of the same concrete mix and ages (with some textured in 2003 and others in 2006)—have been exposed to the same traffic and climate conditions. The quietest sections were those with a diamond-ground surface, and the loudest section had a longitudinally tined texture.

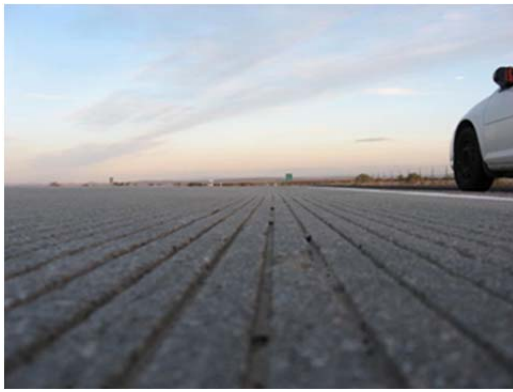
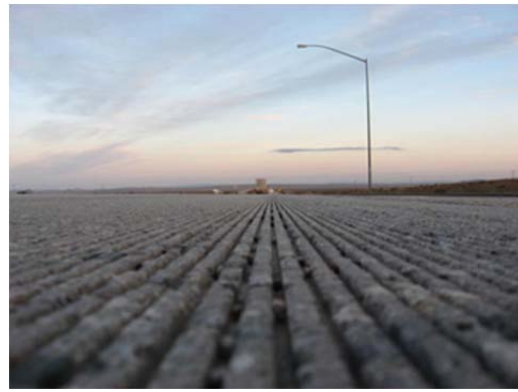
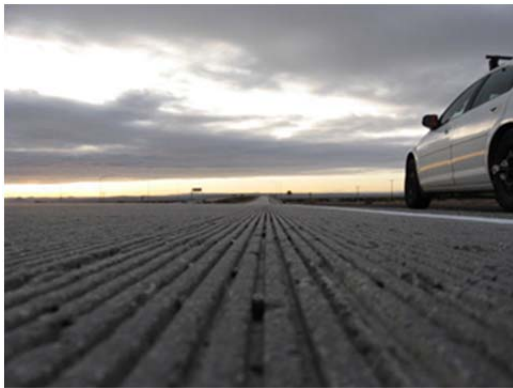
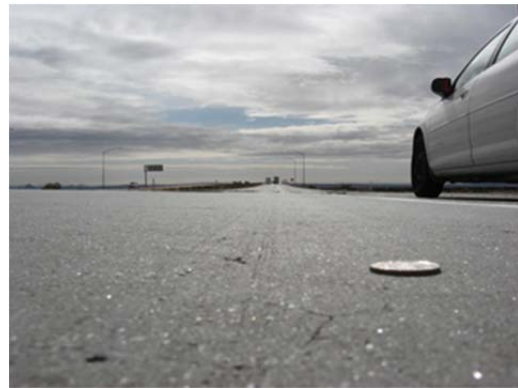
QP-154 (Gr,  $Y_{1,2,3} = 102.1, 103.7, 103.6$  dBA)

QP-156 (Gr,  $Y_{1,2,3} = 103.7, 104.7, 105.9$  dBA)

QP-157 (Gr,  $Y_{1,2,3} = 102.1, 103.2, 105.1$  dBA)

QP-162 (LB,  $Y_{1,2,3} = 102.5, 103.0, 104.4$  dBA)

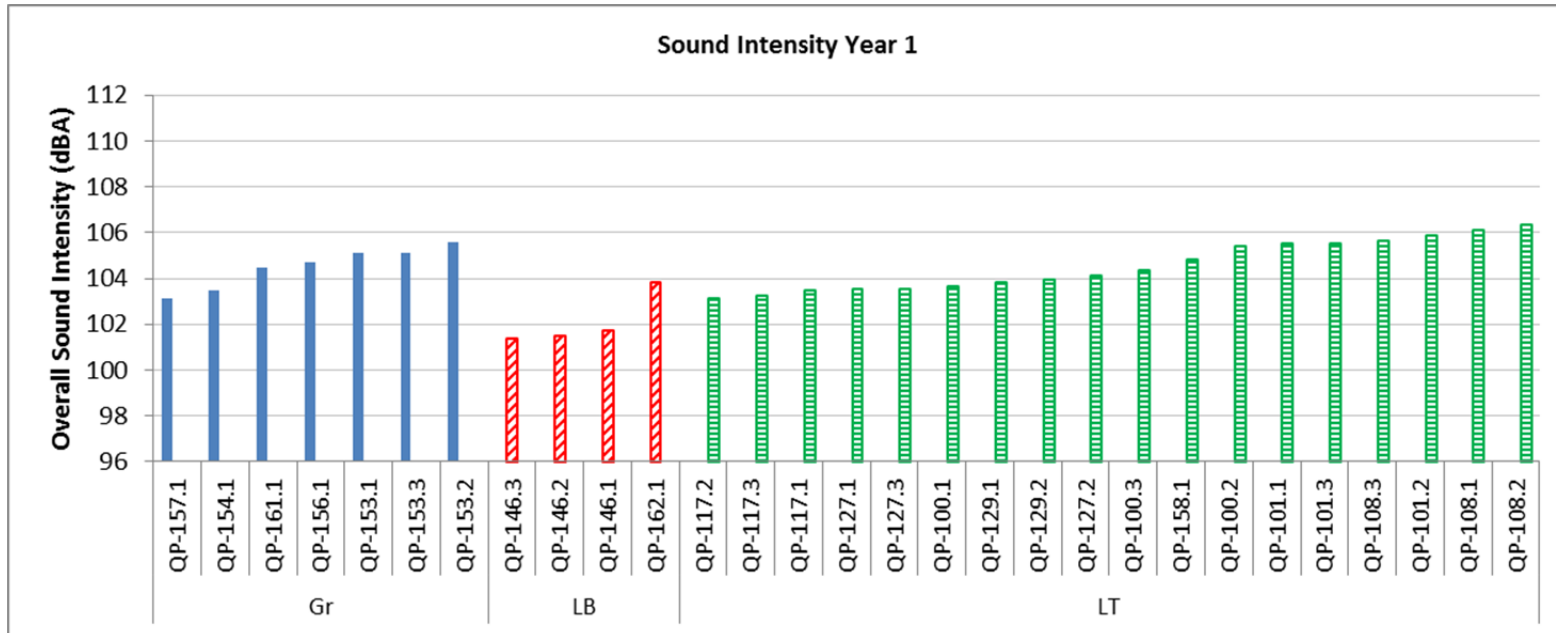
**Figure A.1: On-board Sound Intensity levels of all sections as measured in Year 1.**

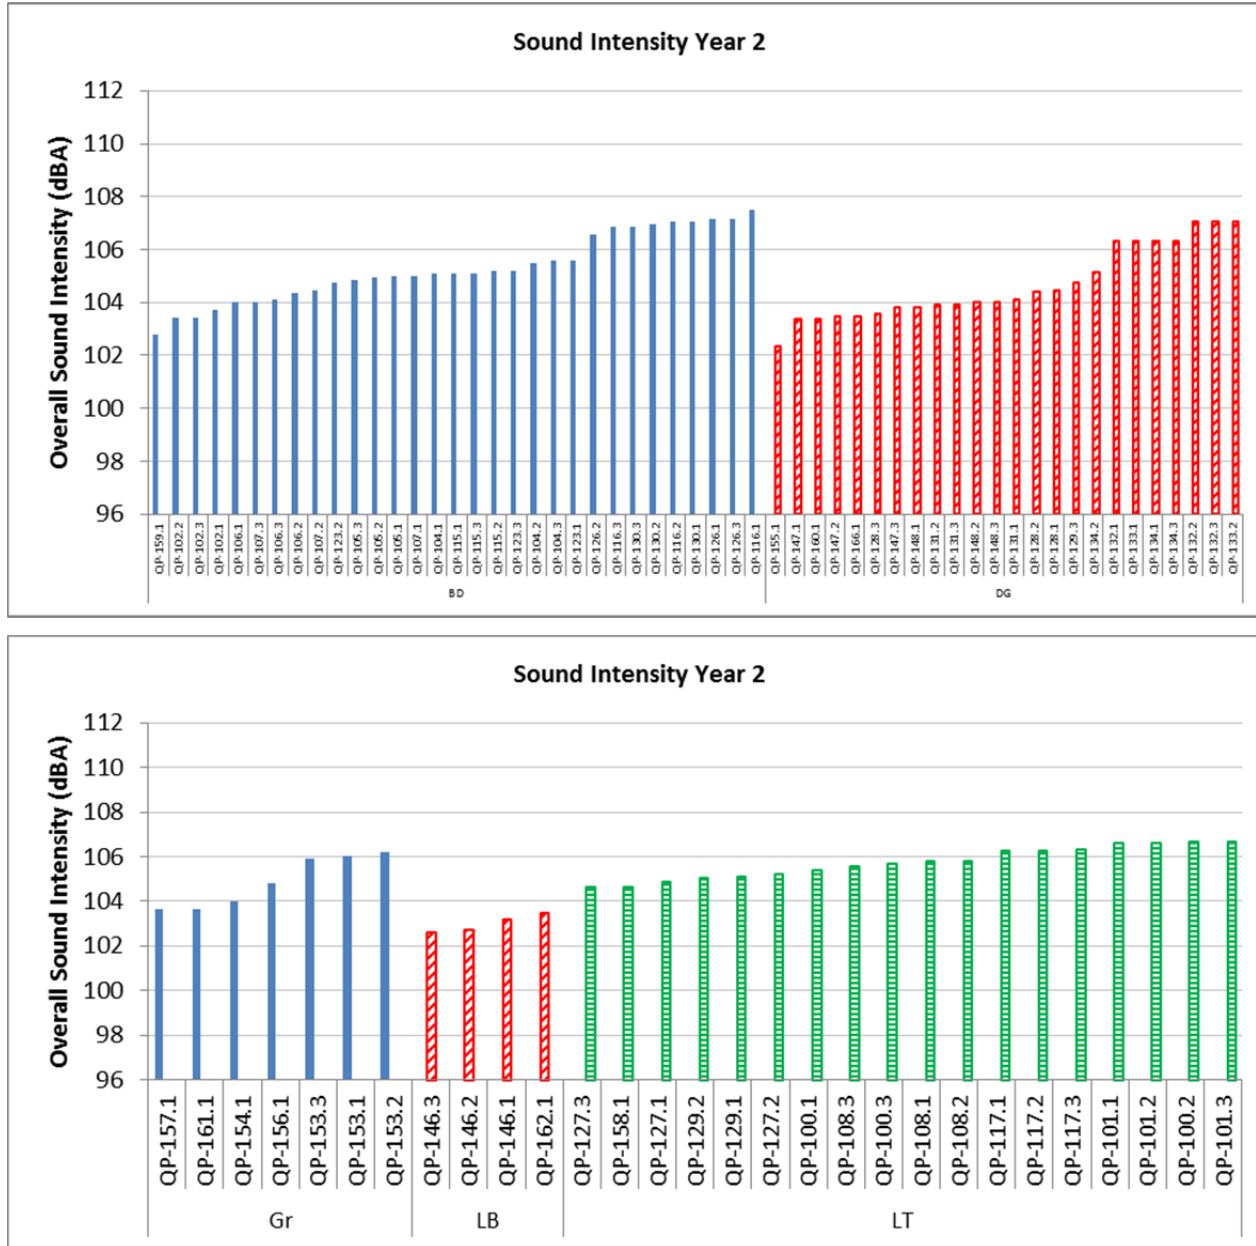
Figure A.2: On-board Sound Intensity levels of all sections as measured in Year 2.

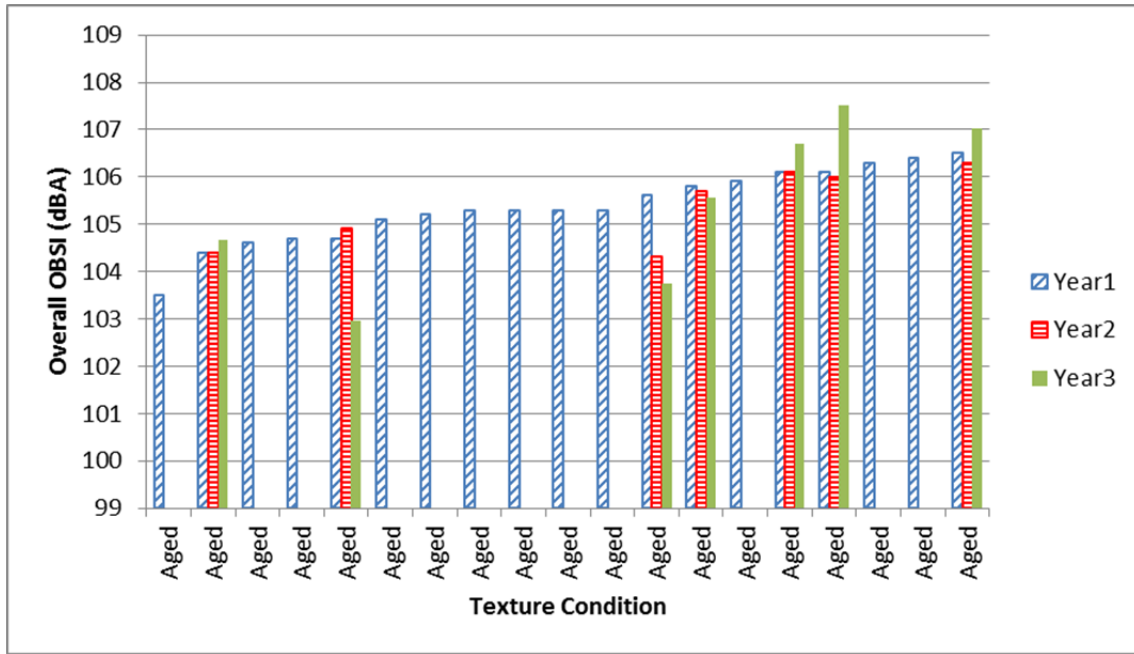
Figure C.3: Compare with Figure 3.29: Diamond-grooved Year 1, 2, and 3 OBSI results for *aged* texture sections (no *new* or *worn out* condition sections measured).

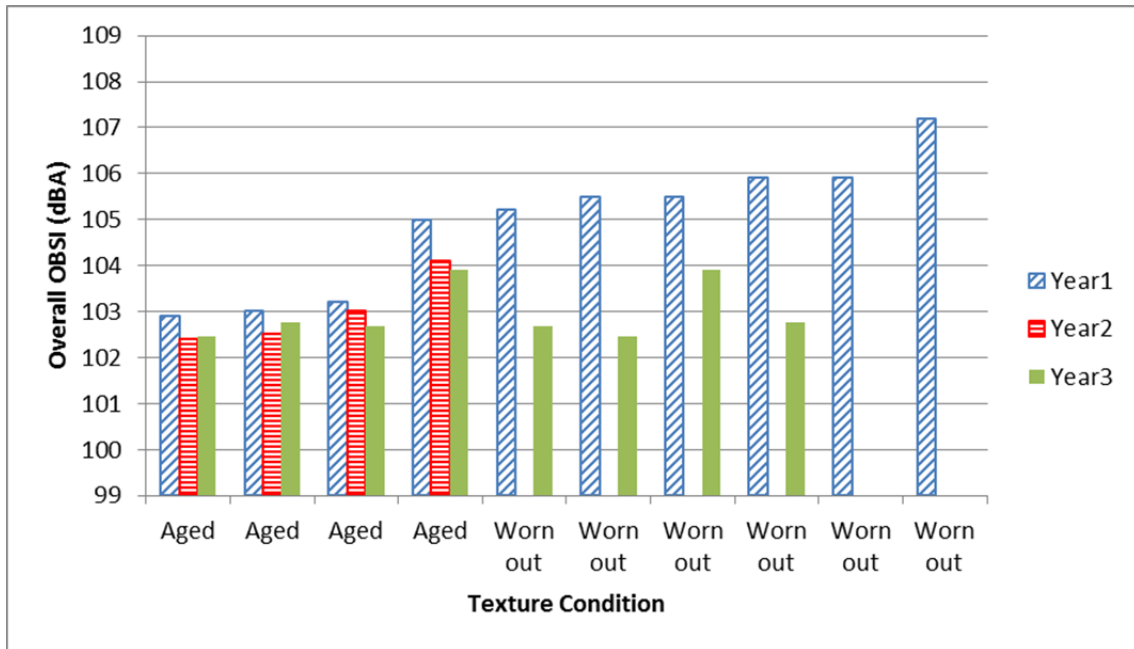
Figure C.4: Compare with Figure 3.31: Longitudinally broomed Year 1, 2 and 3 OBSI results *aged* texture sections (no *new* or *worn out* condition sections measured).
