Investigation of Tire/Pavement Noise for Concrete Pavement Surfaces: Summary of Four Years of Measurements

Authors:
A. Rezaei and J. Harvey

Work Conducted as Part of Partnered Pavement Research Center Strategic Plan Element No. 4.39:
Field and HVS Evaluation of Noise Benefits of Open-Graded and Other Quieter Surfaces

University of California
Pavement Research Center
Davis and Berkeley

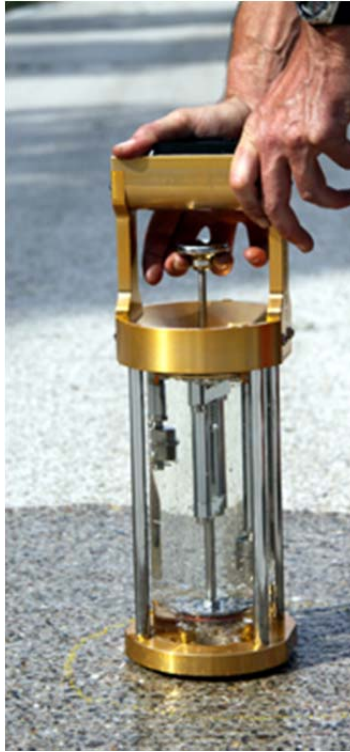
Figure 3.3: Outflow meter.
(Courtesy of KLARUW Systems)

The outflow meter (OFM) (Figure 3.3) is a device that measures the rate at which a known quantity of water, under gravitational pull, escapes through voids in the pavement texture of the structure being tested. The time required for the water to run out is referred to as *outflow time*. Use of the OFM provides a measure of a pavement's ability to relieve pressure from under vehicle tires, which provides an indication of the potential for hydroplaning under wet conditions. The reciprocal of the outflow time is highly correlated with MPD except when a surface is highly porous. The OFM can also be used to detect surface wear and predict correction measures.
