Rehabilitation Design for 01-LAK-53, PM 3.1/6.9 Using Caltrans ME Design Tools: Findings and Recommendations

Partnered Pavement Research Program (PPRC) Contract Strategic Plan Element 3.4:
Development of Improved Rehabilitation Designs for Reflection Cracking

DOCUMENT RETRIEVAL PAGE		Research Report: UCPRC-TM-2008-02		
Title: Rehabilitation Design for 01-LAK-53, PM 3.1/6.9 Using Caltrans ME Design Tools: Findings and Recommendations				
Authors: L. Popescu, J. Signore, J. Harvey, R. Wu, I. Guada, and B. Steven				
Prepared for: California Department of Transportation Division of Research and Innovation Office of Roadway Research and Division of Pavement Engineering Office of Pavement Design	FHWA No.: CA101201B	Date Work Submitted: February 3, 2010	Date: September 2009	
Strategic Plan No.: 3.4	Status: Stage 6, final version		Version No.: 1	
Abstract: This technical memorandum presents the results of pavement evaluation and rehabilitation design for 01-LAK-53, PM 3.1/7.0. The pavement evaluation consisted of deflection testing, coring, and material sampling; backcalculation of stiffnesses using the <i>CalBack</i> program; and condition assessment. Designs were prepared using curren

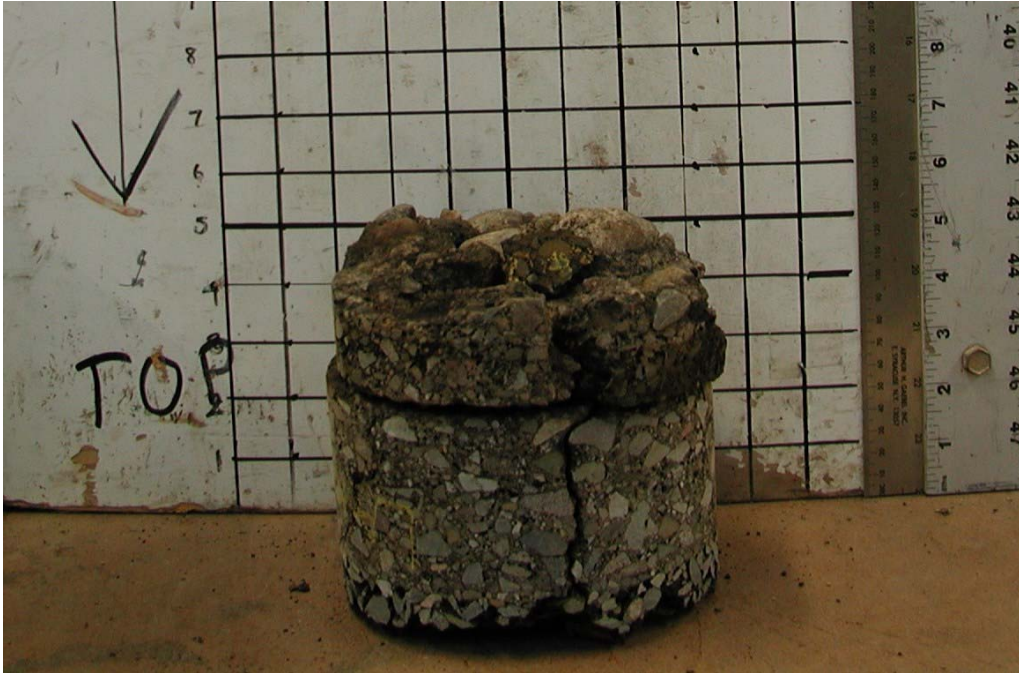
**Figure 3: Core taken at Lake 53, PM 3.3 NB.
(Note that core is upside down in photograph.)**

Pavement Condition. The pavement surface had fatigue cracking over approximately 8 percent of the wheelpath length in the selected test sections, with about 5 percent Alligator A and 3 percent Alligator B. There was transverse cracking typical of low-temperature cracking (uniformly spaced, extending transversely across the entire paved area with relatively straight cracks perpendicular to the direction of travel) over approximately 35 percent of the project area with typical crack width of 1/3 in. (8 mm) and typical crack spacing of 100 ft (30 m). Five out of nine cores debonded at the interface between layers three and four (at the interface between overlays placed in 1960 and 1978). Two cores were extracted from the top of the cracked areas (PM 3.3 North and PM 4 South). The core extracted at PM 3.3 North debonded and was cracked through, as seen in Figure 3. The core at PM 4 South debonded and was cracked through the top lift as seen in Figure 4.

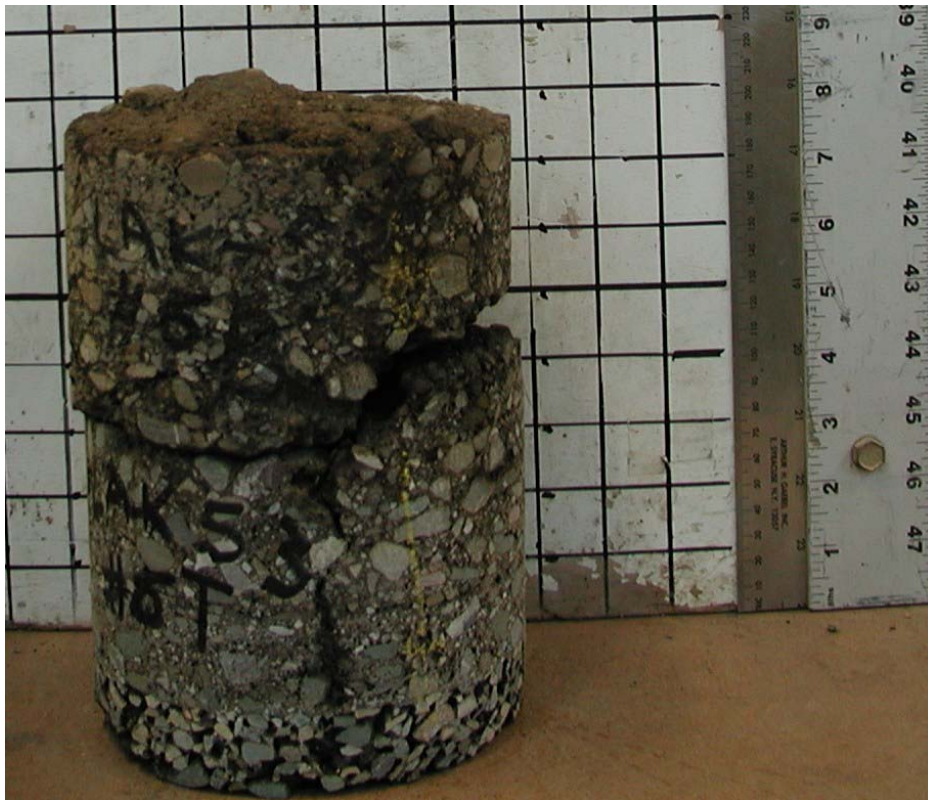
**Figure 4: Core taken at Lake 53, PM 4.0 SB.
(Note that core is shown upside down.)**

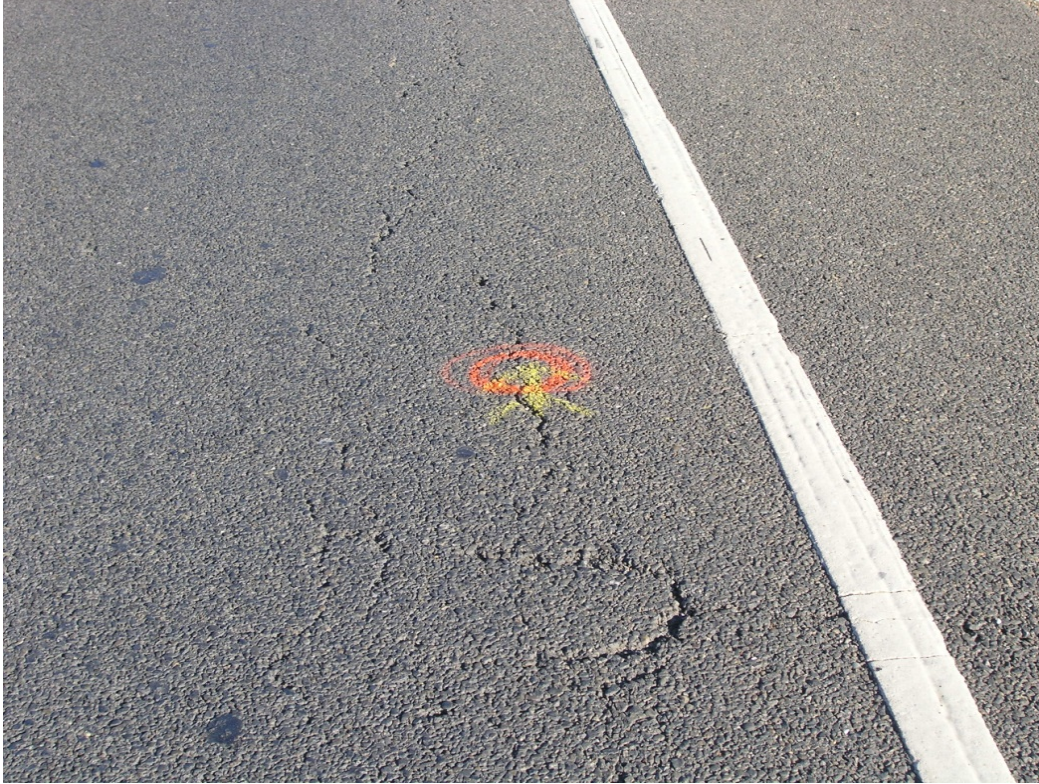
Figure 5: Lake 53 Alligator B crack in the wheelpath (PM 3.3 NB, north of Davis Ave.).

It could be concluded that the predominant distress mechanism was either top-down low-temperature cracking or reflection of existing low-temperature transverse cracks up through the thin overlays. The average (2004 to 2008) annual lowest temperature at this site is 17.5°F (-8.1°C), and there are an average of 78 days each year where the daily low temperature is below freezing. At the same time, it is apparent that there is a second distress mechanism of load-related cracking in the wheelpaths, referred to as alligator cracking. Several representative photographs of the pavement are shown in Figure 5, Figure 6, and Figure 7.

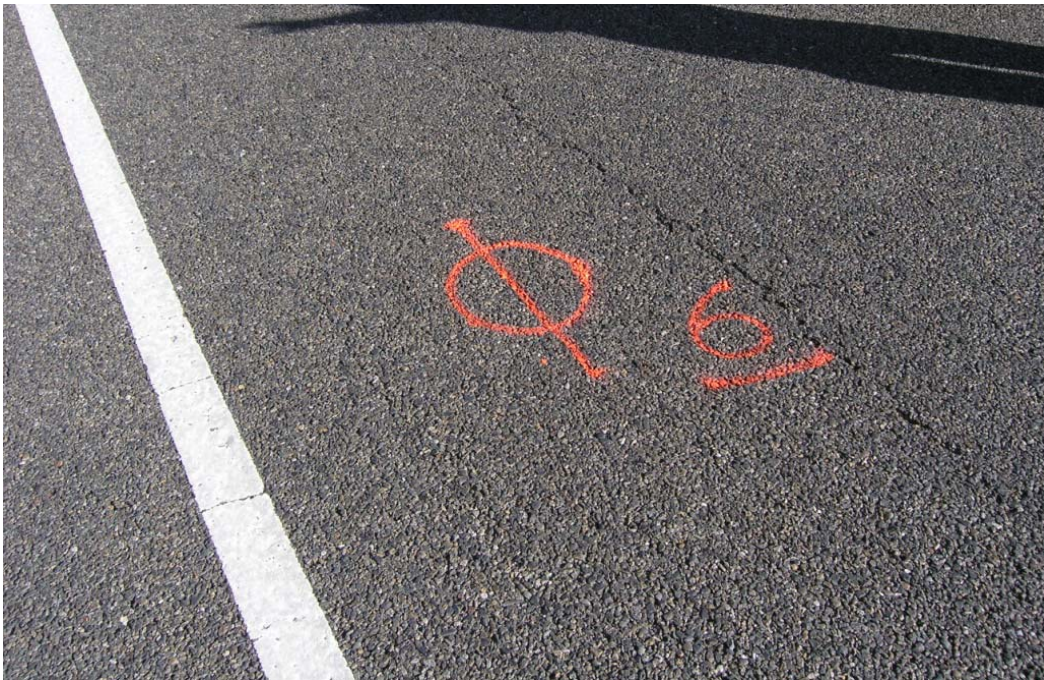
Figure 6: Lake 53 longitudinal crack in the wheelpath (PM 4.0 SB, near Olympic Dr.).

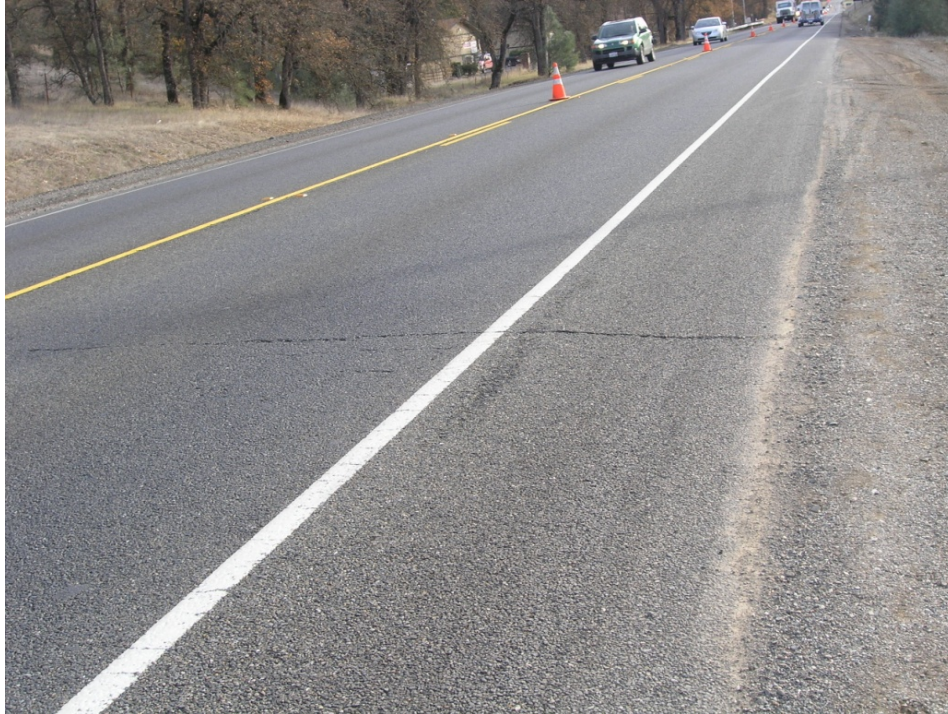
Figure 7: Lake 53 transverse crack (near PM 5.25 NB).

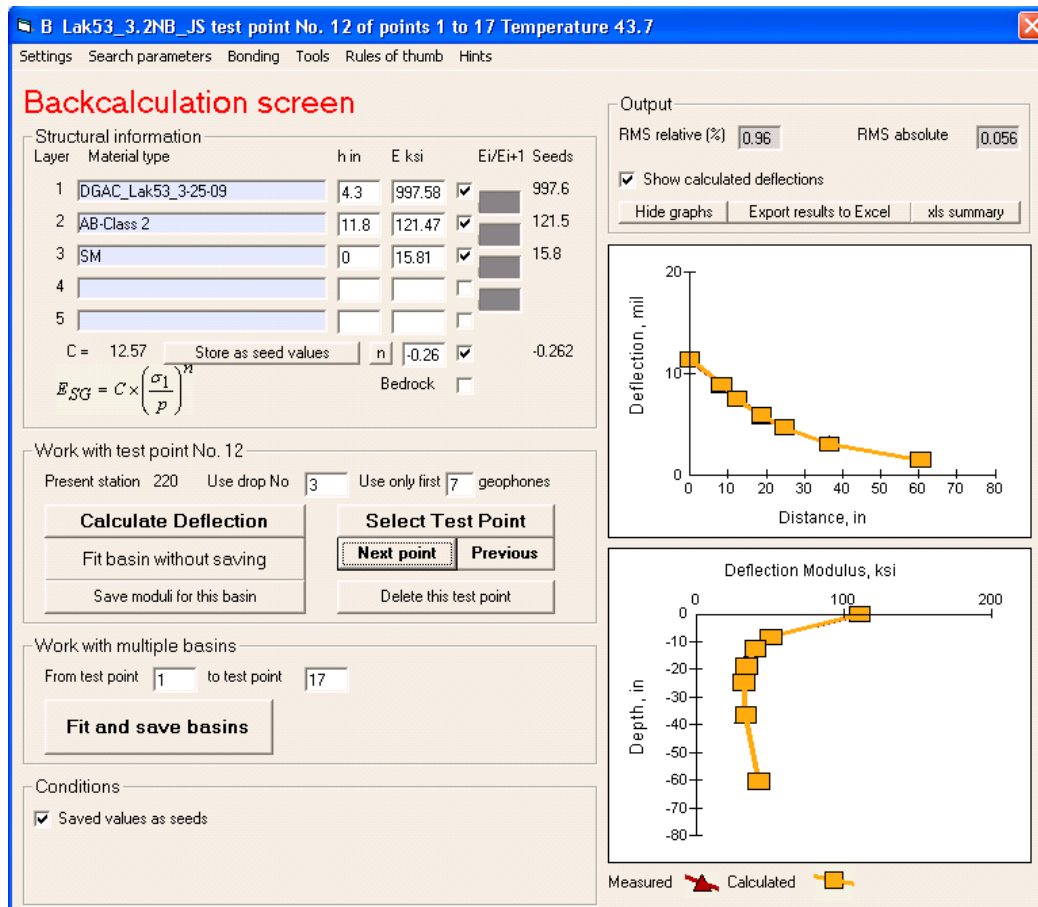
Figure 9: CalBack screen shot of the deflection bowl and corresponding deflection modulus at Test Point 12, Lake 53, PM 3.2 NB.

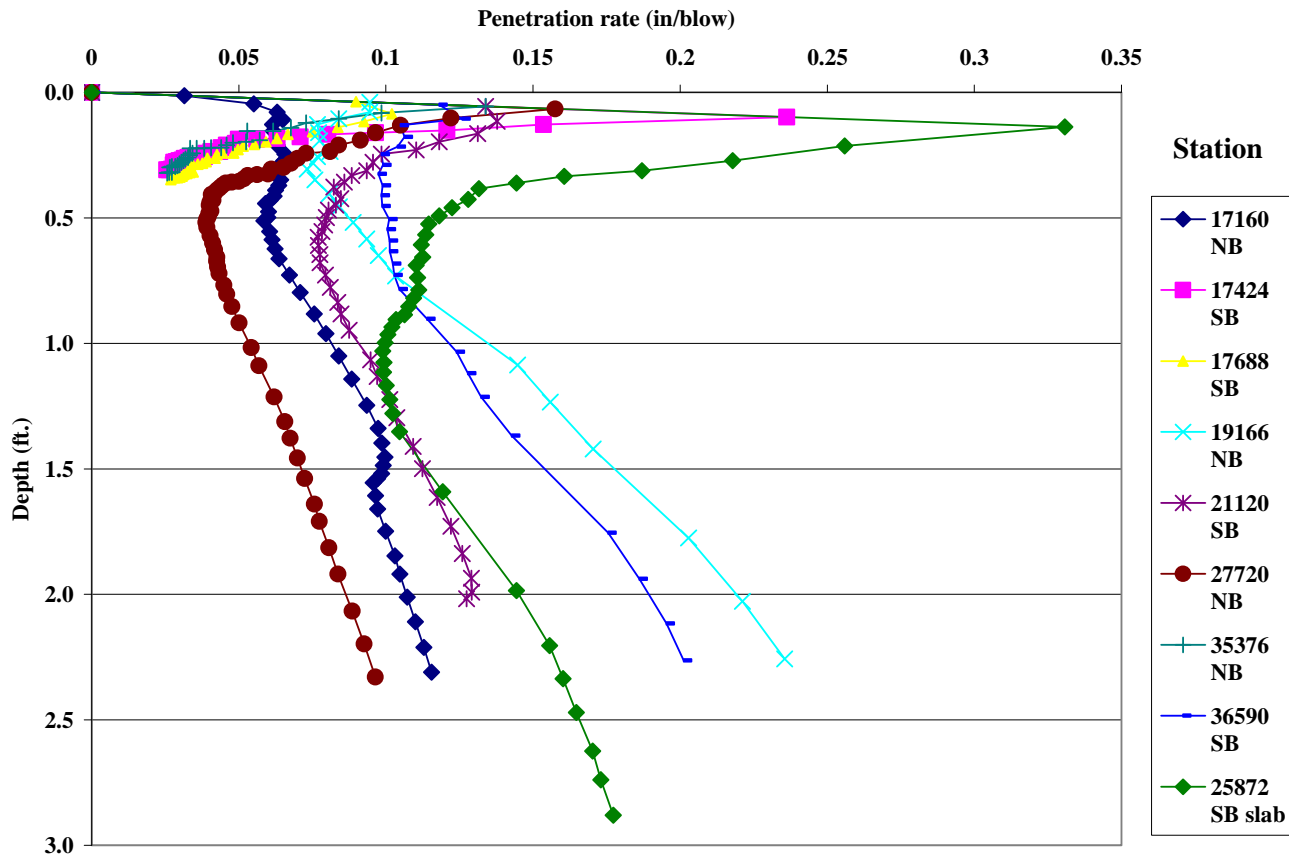
Figure 10: DCP locations and results.
(Depth is depth below top of AB layer.)

(Section B) it was suspected that the DCP tip hit the top of a culvert. At STA 17424 (Section B) and STA 35376 (Section F North) it appeared that a stiff base material and/or large rocks impeded the DCP tip. The DCP results from the six locations were in general consistent, showing uniform stiffness with depth. The weakest location was found at STA 19166 (Section C North). DCP readings at STA 25872 (Section D South) were taken in a trench after removal of the HMA top layer. The top few inches were very weak due to moisture resulting from the wet saw cut method.

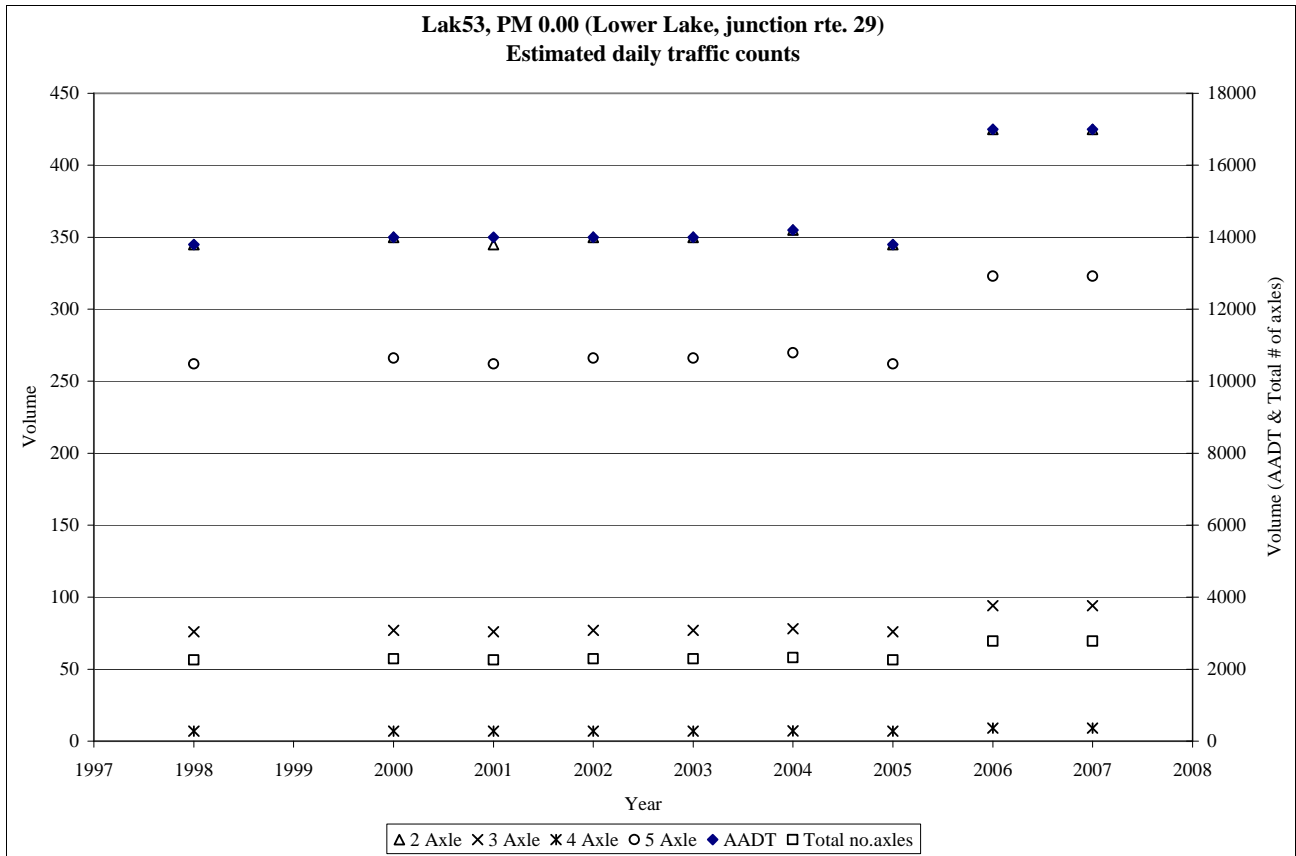
Figure A.1: Plot of traffic data for 01-LAK-53.

The Solver function in Microsoft *Excel* was used to determine ln(1+r) for which the sum of the root mean square error between the measured and calculated truck traffic was minimum. From this analysis ln(1+r) = 0.013644 and r = 0.013737 or r(%) = 1.37 roundup to r = 1.4%.

3. Estimated trucks in 2009 both directions = exp(ln(690)+(2009-1998*ln(1+r))) = exp(6.53669 + 11*0.013644) = 802
4. Estimated no. of axles in 2009 design direction = (802/2)*3.27*365 = 478,456

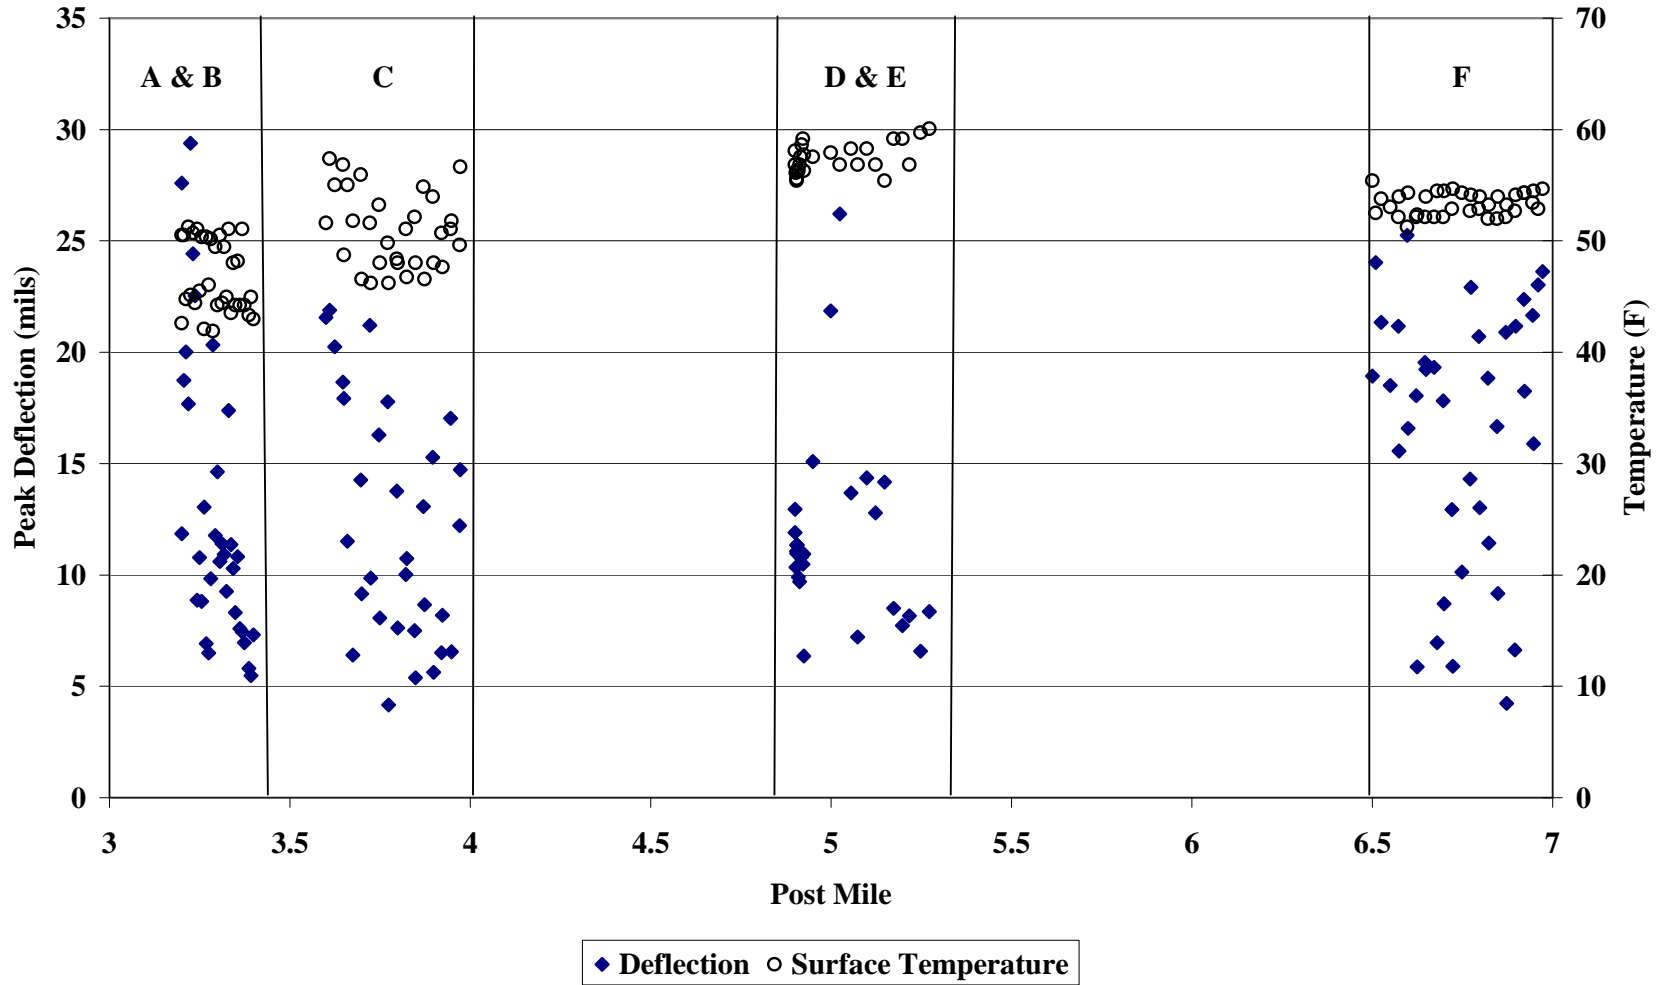
Figure A.3: FWD inner sensor (D1) peak deflection and surface temperature versus post mile.

Figure A.3 shows the Falling Weight Deflectometer deflection data for the inner sensor (D1) and HMA surface temperature versus post mile. Figure A.4 shows the Falling Weight Deflectometer deflection data for the outer sensor (D8) and HMA surface temperature versus post mile. Deflection testing started in the morning at Section A North, and proceeded generally to the adjacent section as indicated by increasing surface temperatures with post mile. Figure A.5 shows the temperature-adjusted layer moduli from *CalBack* for the entire project.
