Technical Memorandum: UCPRC-TM-2008-03

Rehabilitation Design for 06-KIN-198, PM 9.2/17.9 Using Caltrans ME Design Tools: Findings and Recommendations

Partnered Pavement Research Program (PPRC) Contract Strategic Plan Element 3.4:
Development of Improved Rehabilitation Design for Reflective Cracking

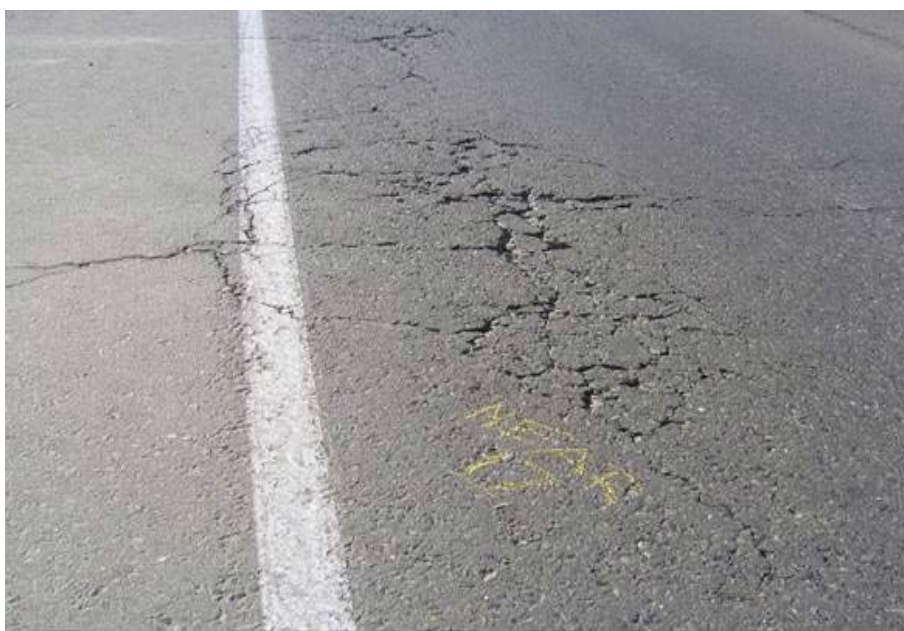
Figure 3: Alligator cracking in the wheelpath with transverse cracking, Section 3 near PM 15.2 EB.

The pavement surface had longitudinal and transverse cracking throughout the project and severe fatigue cracking at isolated locations. Longitudinal cracking was primarily in the wheelpath, indicating that it was related to traffic loading. The source of the transverse cracking—whether it was due to reflection of existing transverse cracks through thin overlays or top-down transverse cracking related to aging and temperature changes—could not be determined.

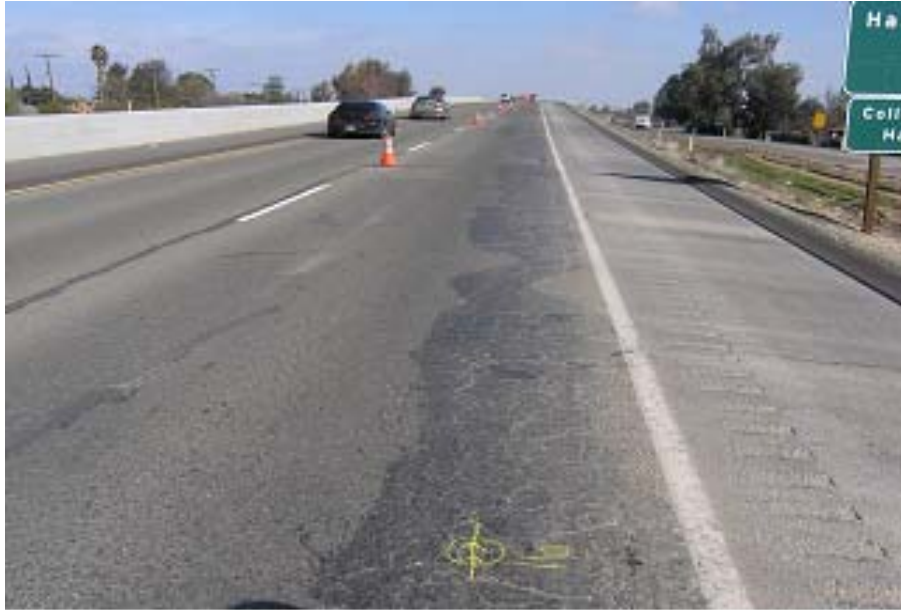
Figure 4: Photo shows sealant over Alligator B cracking on an embankment, Section 2 near PM 14.7 EB.

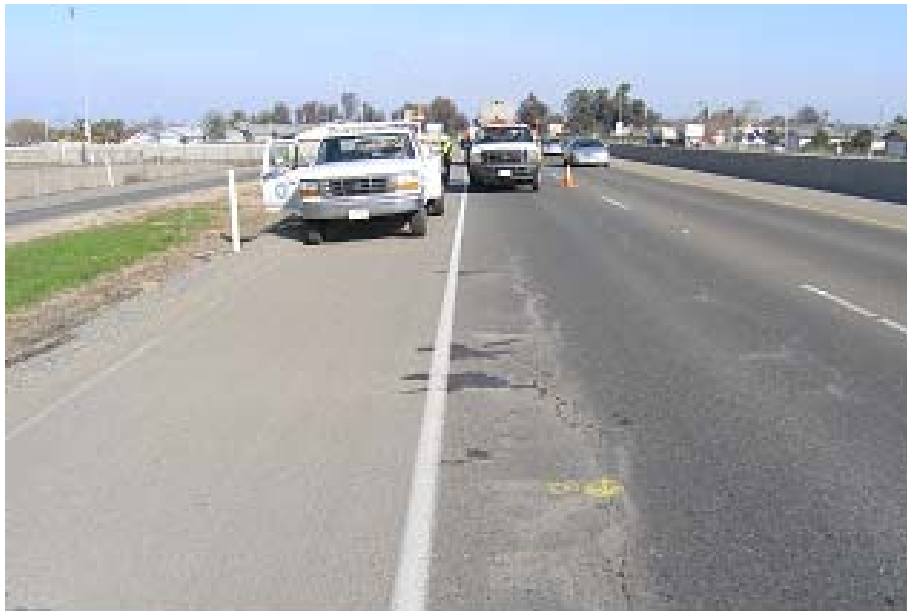
Figure 5: Fines pumped through longitudinal cracking are visible, Section 3 near PM 15.1 WB.

The fine dust observed at some cracked locations suggests drainage-related pumping of the unbound base layers. This pavement has minimal drainage because it is predominantly at grade, has grass and other vegetation growing along its edge, and has been constructed above a native soil with low permeability. It is therefore suspected that after heavy rains the pavement base layers remain saturated at many locations, and this accelerates the mixing of fines into the base layers and pumping through to the surface.

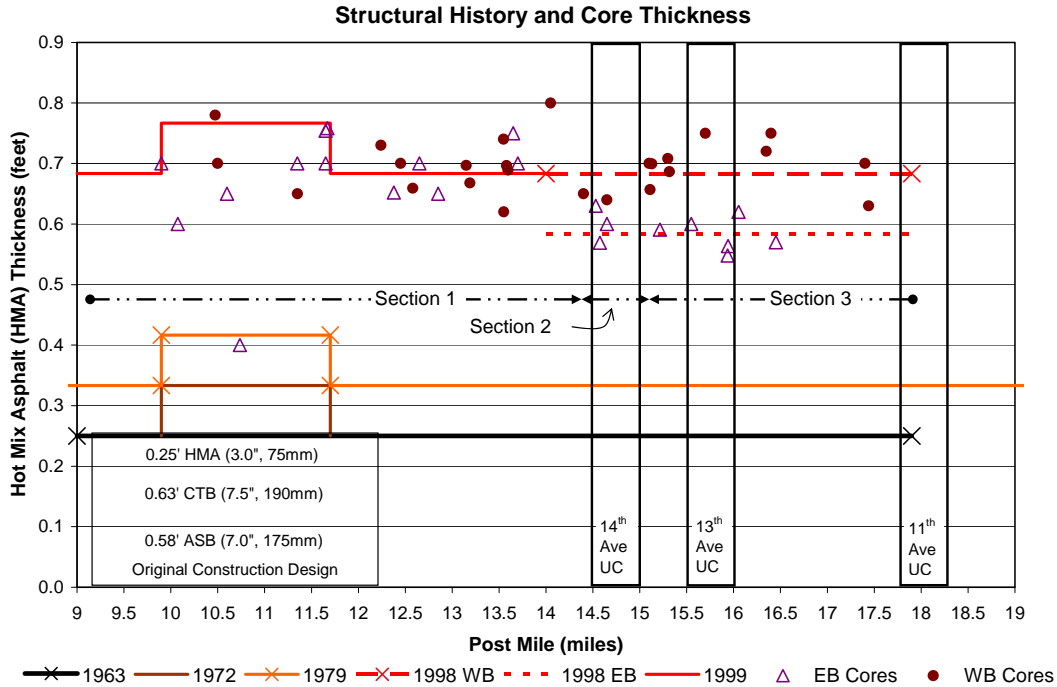
Figure 6: HMA core thicknesses by section and post mile (see Figure 2).

The as-builts from the 1999 construction (EA 06-364804) indicate that the eastbound section between PMs 14.2 and 17.9 has a thinner HMA overlay (0.2 to 0.25 ft [60 to 75 mm]) than the westbound section (0.34 ft [105 mm]). The coring results show that between PMs 14.5 and 16.5, the average difference in HMA thickness between the two directions is 0.11 ft (33 mm). A diagram of the core thicknesses along the project is shown in Figure 6.

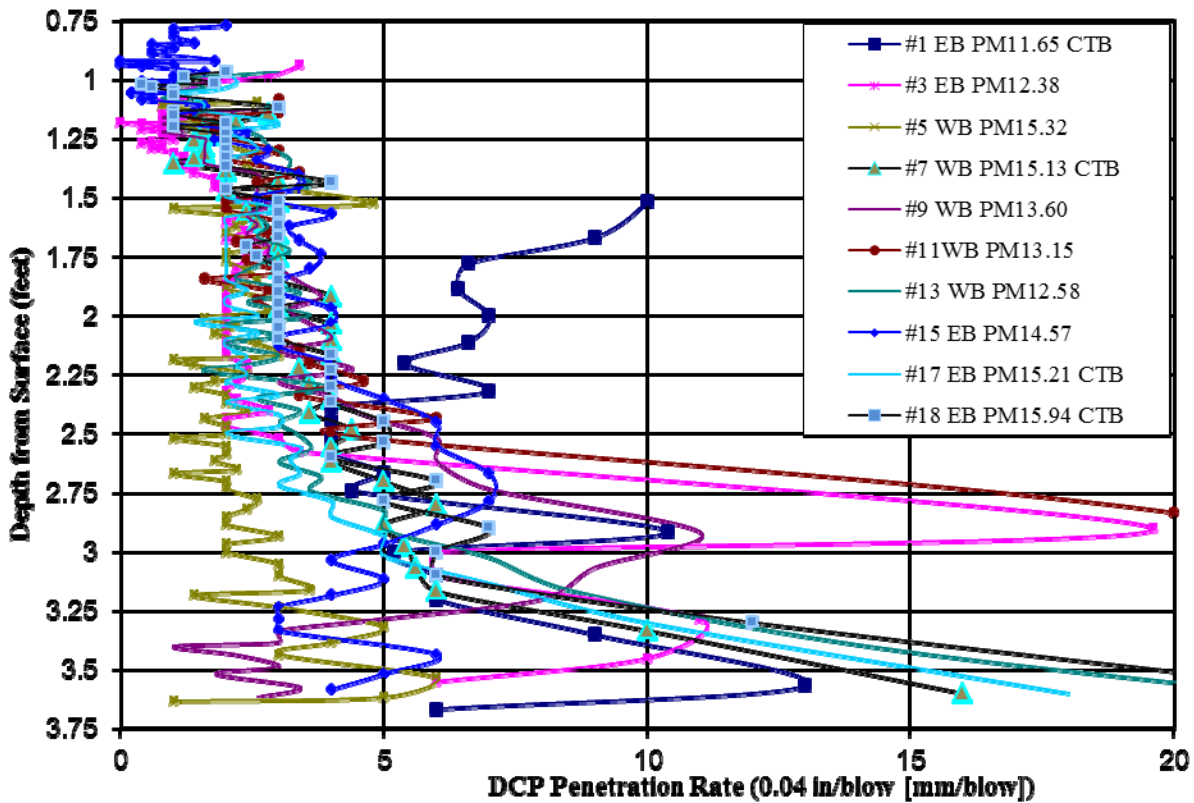
Figure 7: DCP locations and results.

The Dynamic Cone Penetrometer (DCP) was used to estimate base and subbase thickness, with the result based on the *penetration rate*, which is determined by measuring the depth of penetration every five blows. A high penetration rate indicates the presence of softer, weaker materials, while a lower penetration rate indicates that there are stiffer, stronger materials. Figure 7 shows the test results. Areas that had low penetration rates (less than 2 mm/blow) were assumed to be disintegrated CTB. Penetration rates between 2 and 3.5 were considered to be the design aggregate subbase (ASB), and rates greater than 3.5 were considered to represent subgrade, which was encountered between 2.5 and 2.8 ft (760 and 850 mm) below the road surface.

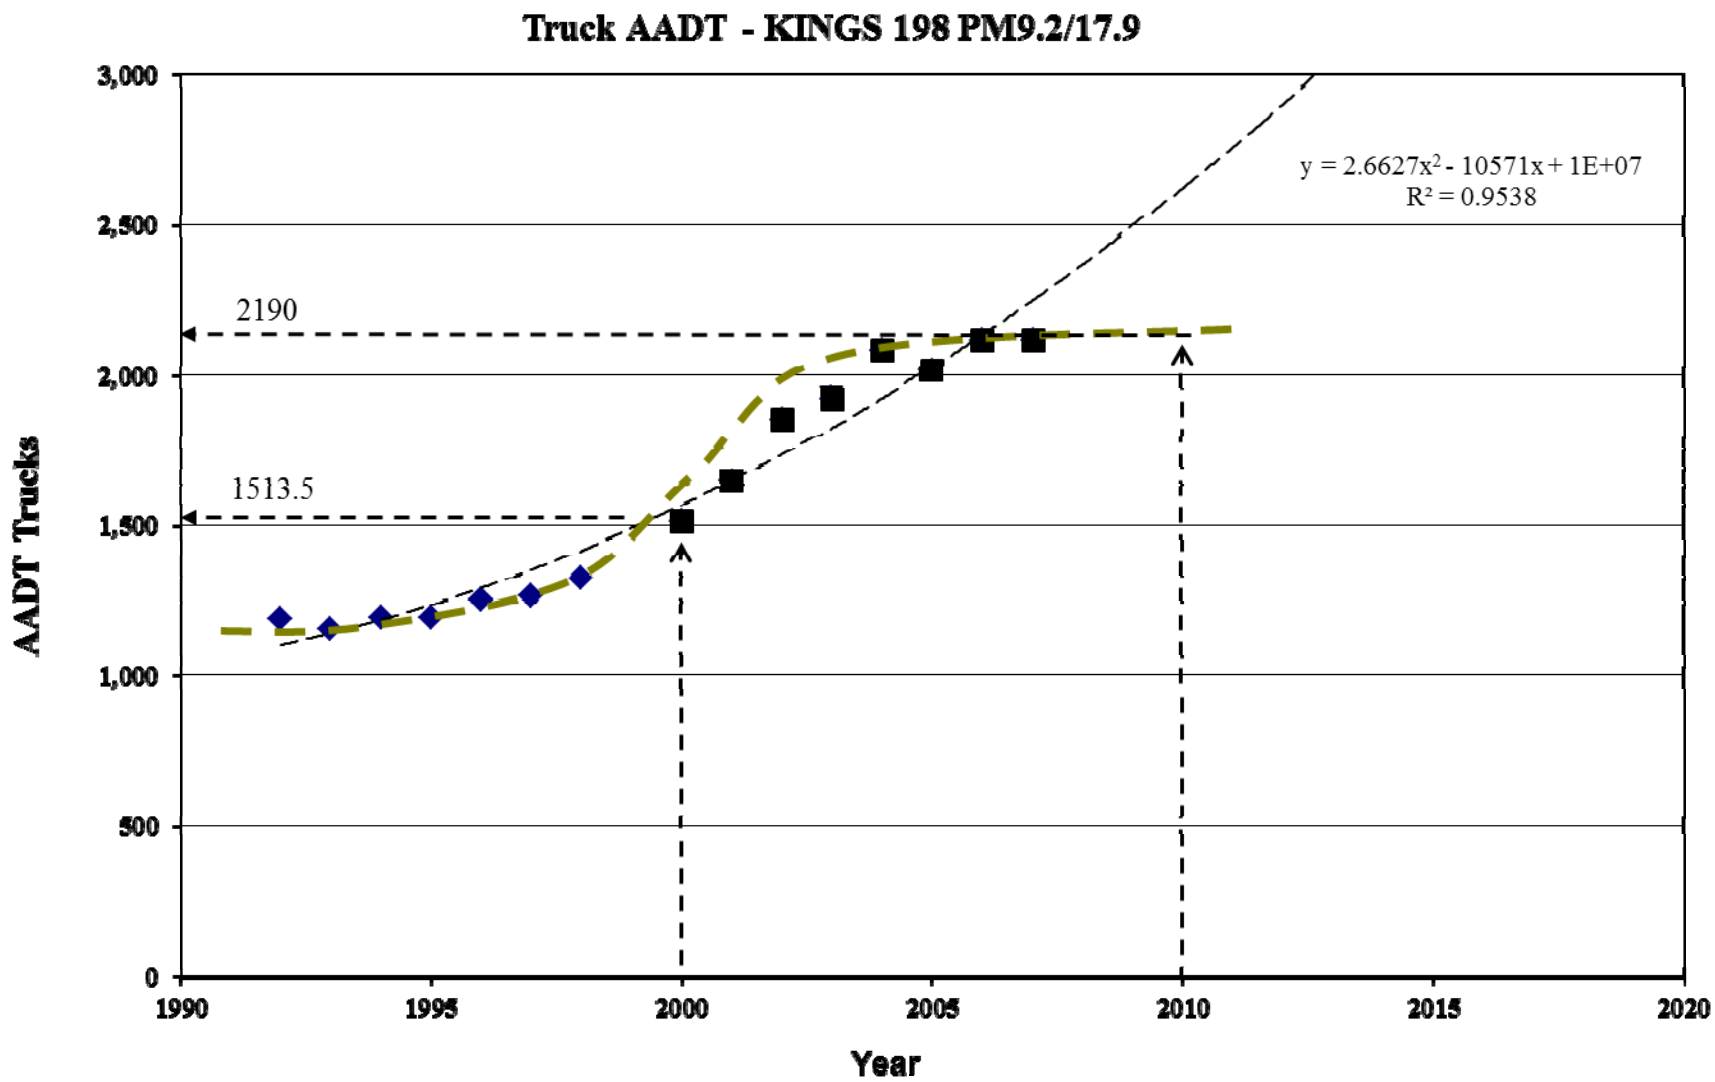
Figure A.1: Plot of truck traffic data for 06-KIN-198, showing AADT estimates for backcasting (1,513.5) and forecasting (2,190).

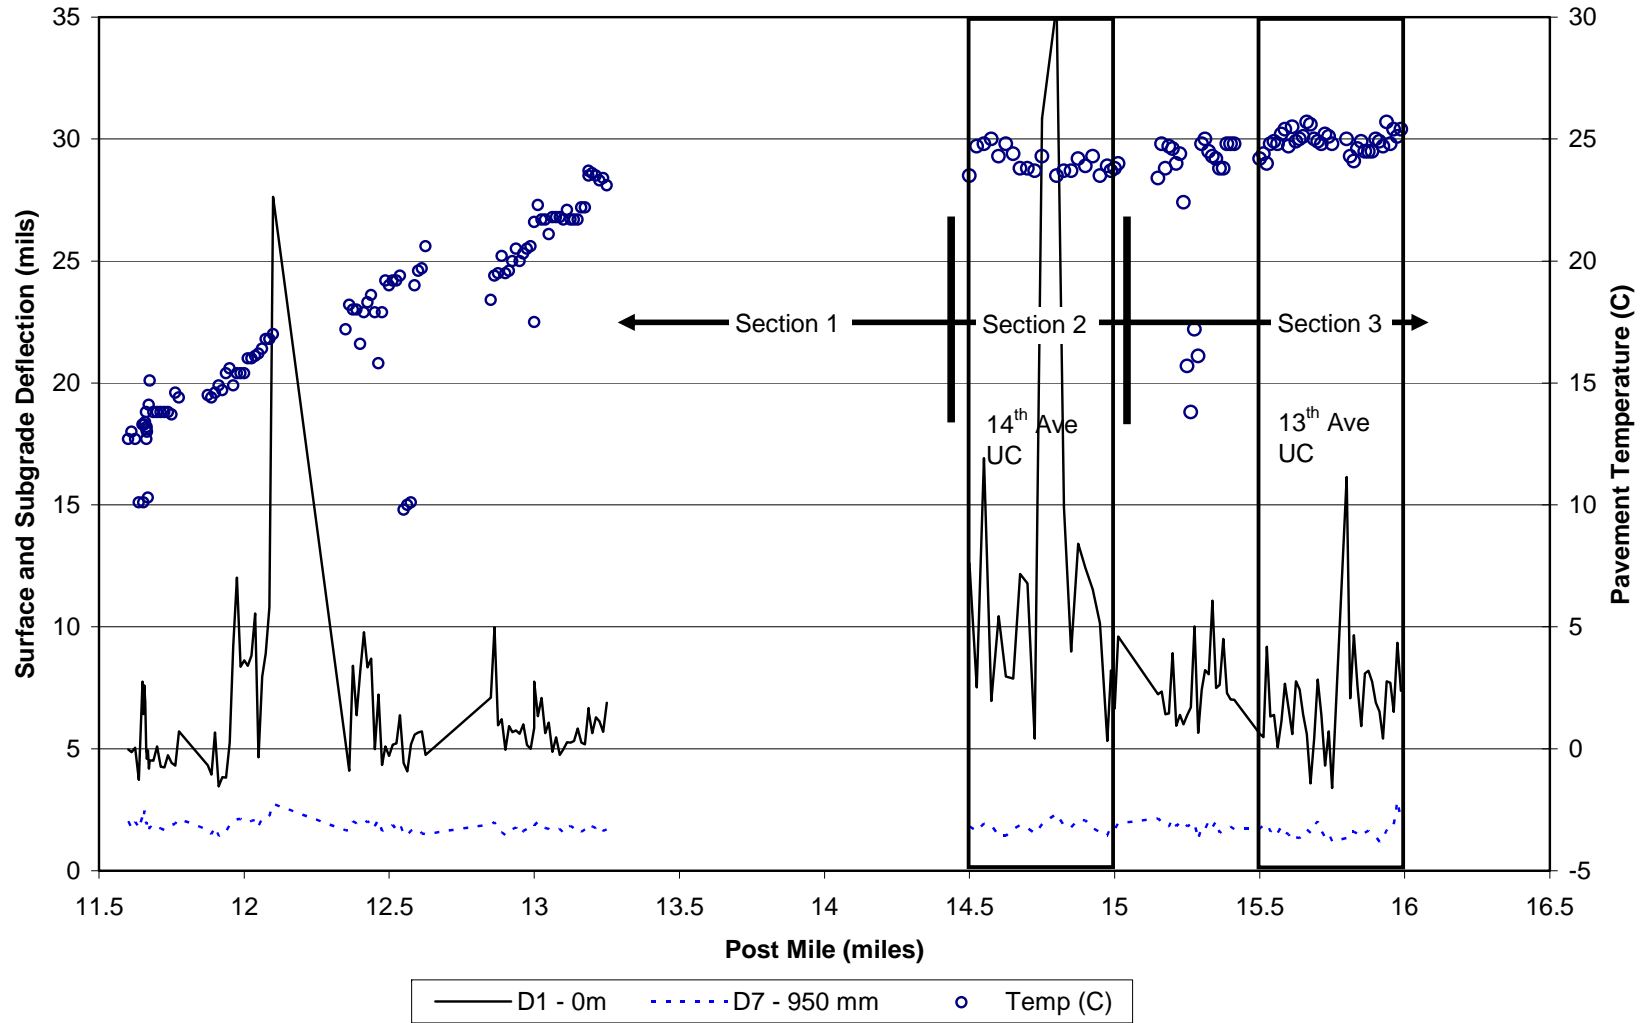
Figure A.3: FWD surface (D1) and subgrade (D7) deflections and surface temperature versus post mile, eastbound.

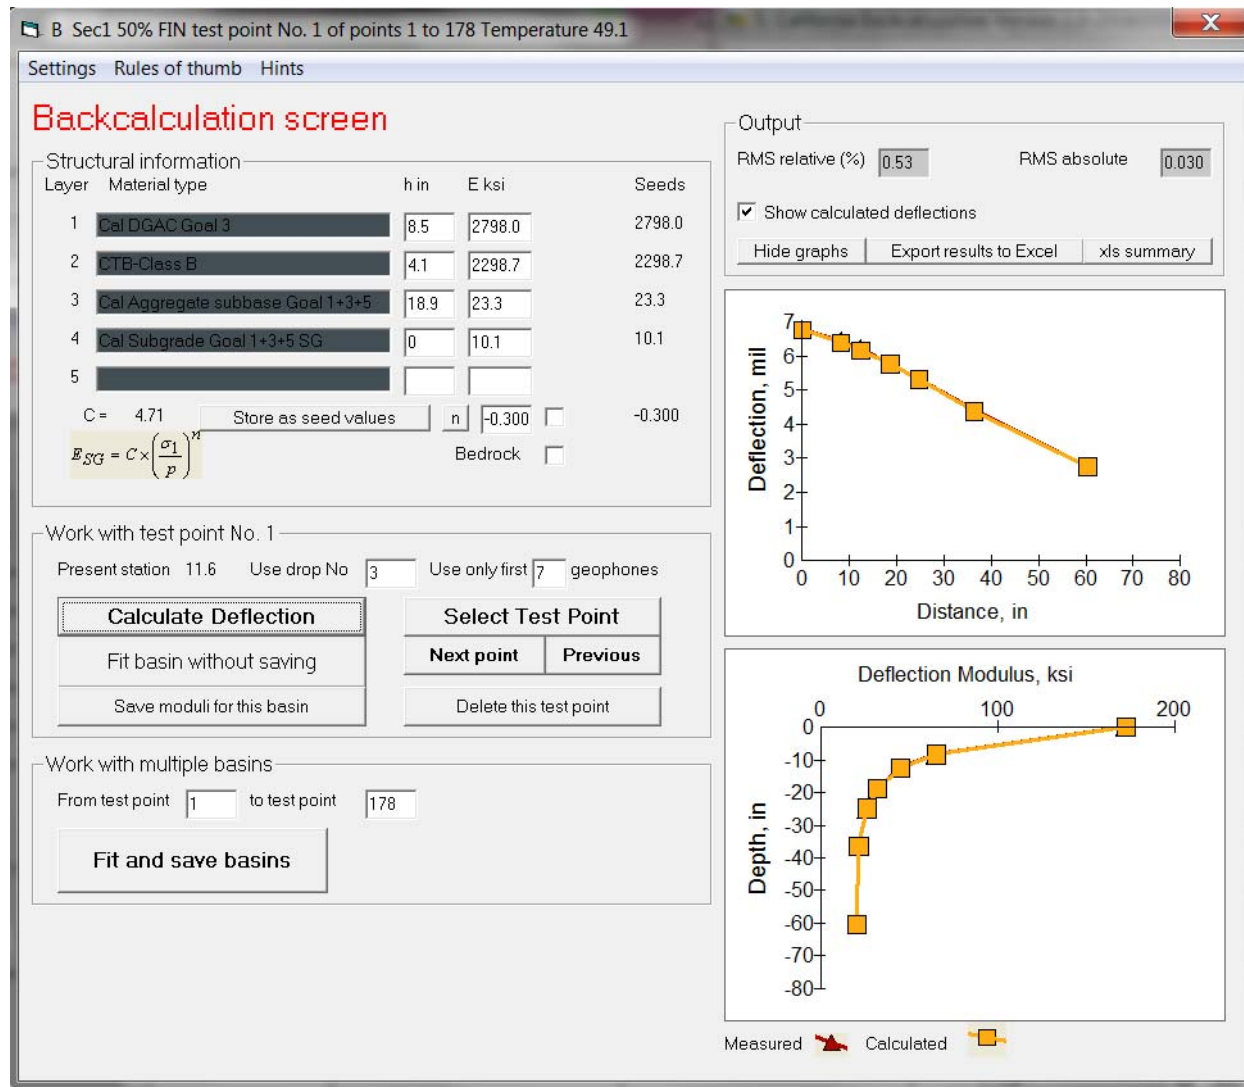
Figure A.5: Screen shot of *CalBack* backcalculation screen for Point 1 of Section 1.

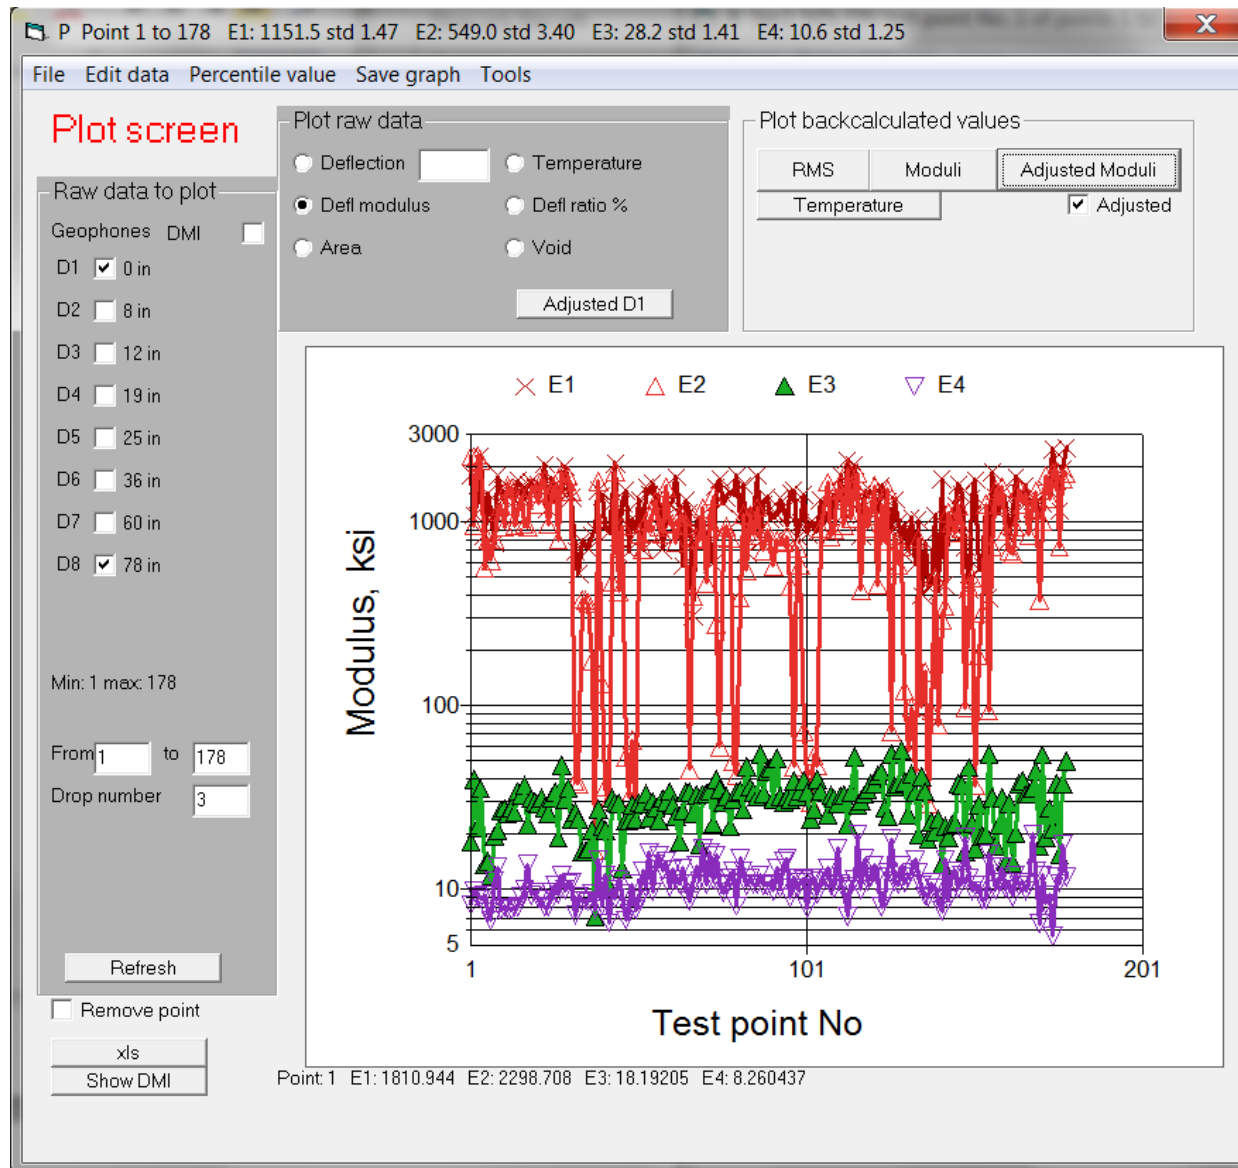
Figure A.6: Screen shot of Section 1 CalBack plot screen of temperature-adjusted moduli.

Figure A.6 shows a screen shot of the Section 1 *CalBack* plot screen of temperature-adjusted moduli, a summary of the calculated moduli along a section. The title bar of the window in the screen shot shows the average moduli (in ksi) among the 178 points tested in Section 1 reported for the different layers; these match the ones reported in Table 2 (in psi) and those used in the *CalME*. Figure A.7 shows the temperature-adjusted layer moduli from *CalBack* for the entire project. Table A.3 contains the raw FWD data from the third drop in the sequence.

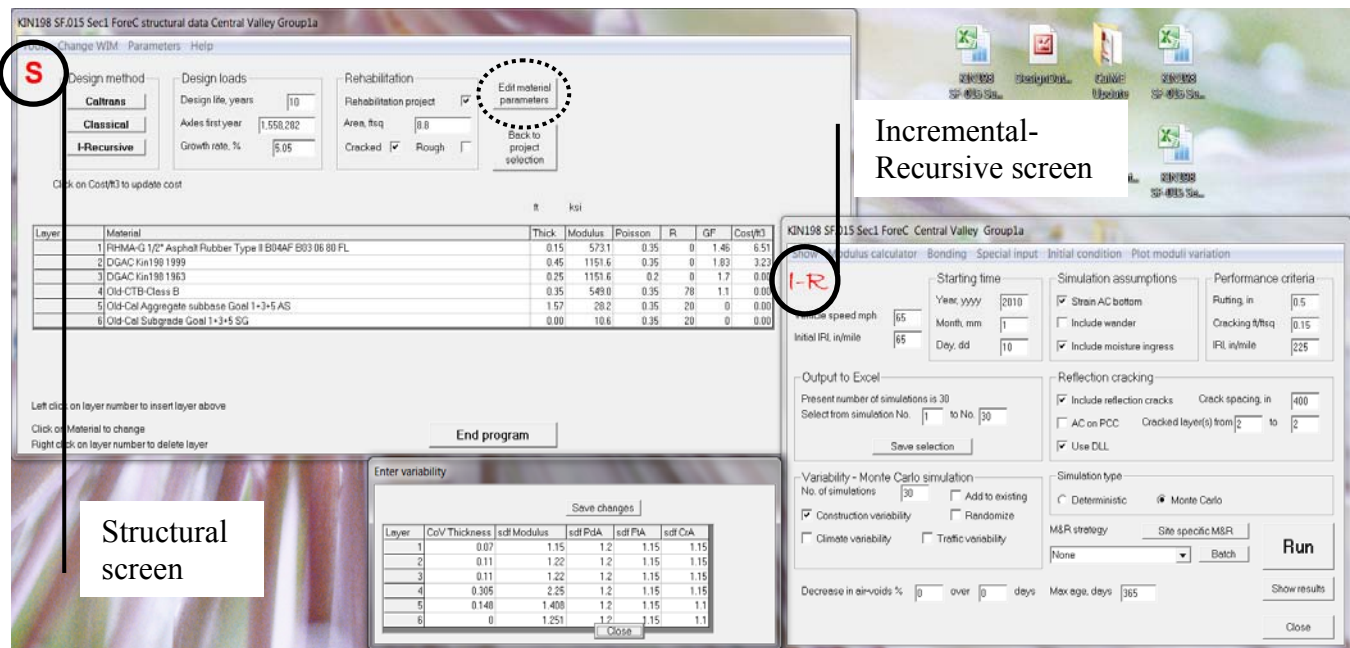
Figure A.8: Screen shot of Section 1 incremental-recursive design inputs for Monte Carlo variability simulation with 0.15 ft (45 mm) RHMA-G overlay.

The *CalME* structure screen has an “Edit Material Parameters” button (the dotted circle in Figure A.8), that allows users to specifically tailor a given material behavior in the program. These parameters are preset but can be adjusted. Figures A.12 through A.15 show the recursive material parameters for the existing materials used in this project: the existing 1963 DGAC, 1999 DGAC, cement-treated base, and aggregate subbase. Figures A.16 through A.19 show the modulus and recursive parameters for the HMA with PG 64-10 binder and RHMA-G from the Materials Library. These parameters were unchanged throughout the analysis.

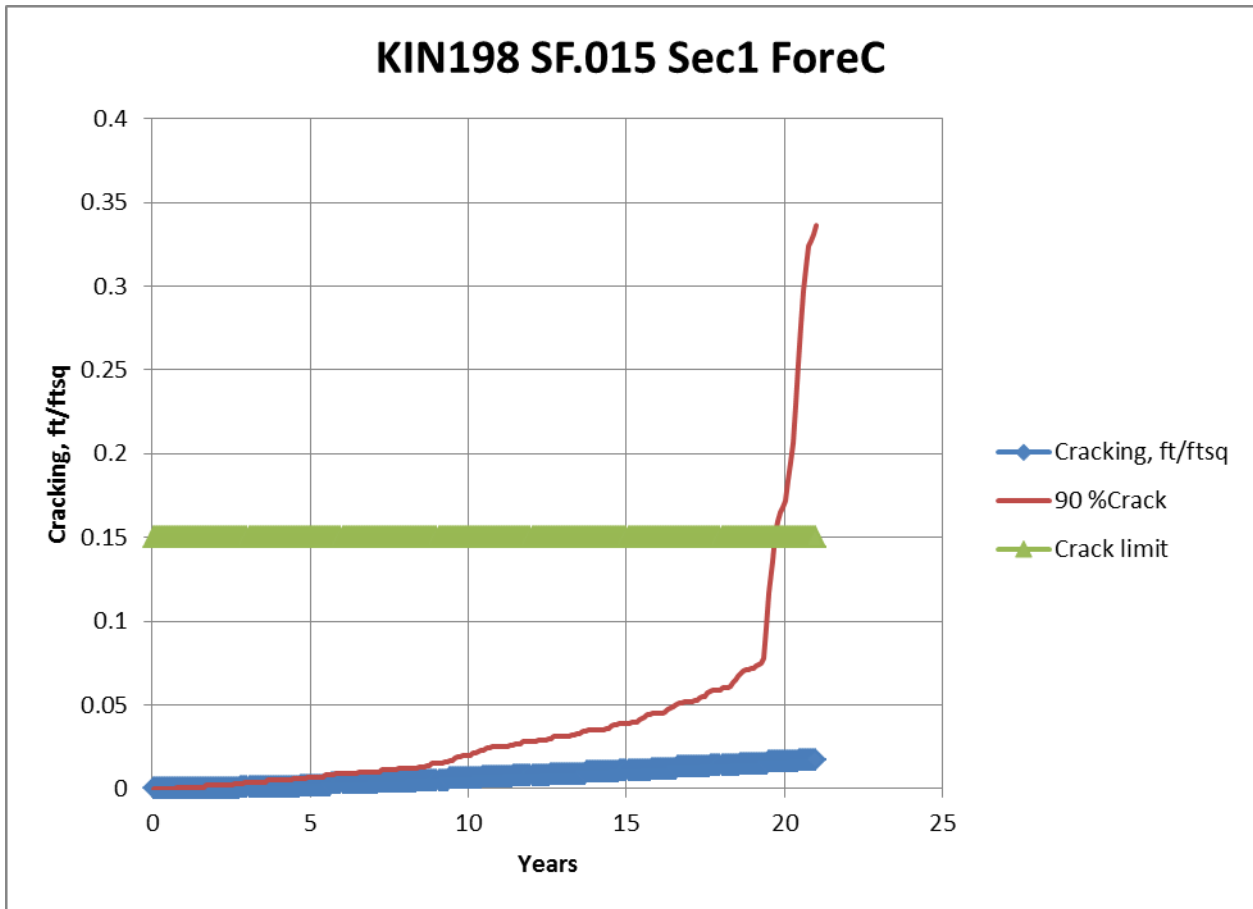
Figure A.9: Cracking-versus-time plot from *CalME* for a 0.10 ft (30 mm) RHMA-G overlay on Section 1.
Note: The mean estimate of cracking after 20 years, with 50% reliability (0.02 ft/ft²), is well below the failure criteria of 0.15 ft/ft². After 18 years, there is a 90% reliability of cracking not exceeding 0.08 ft/ft². But after 20 years, cracking exceeding 0.15 ft/ft² can be expected.

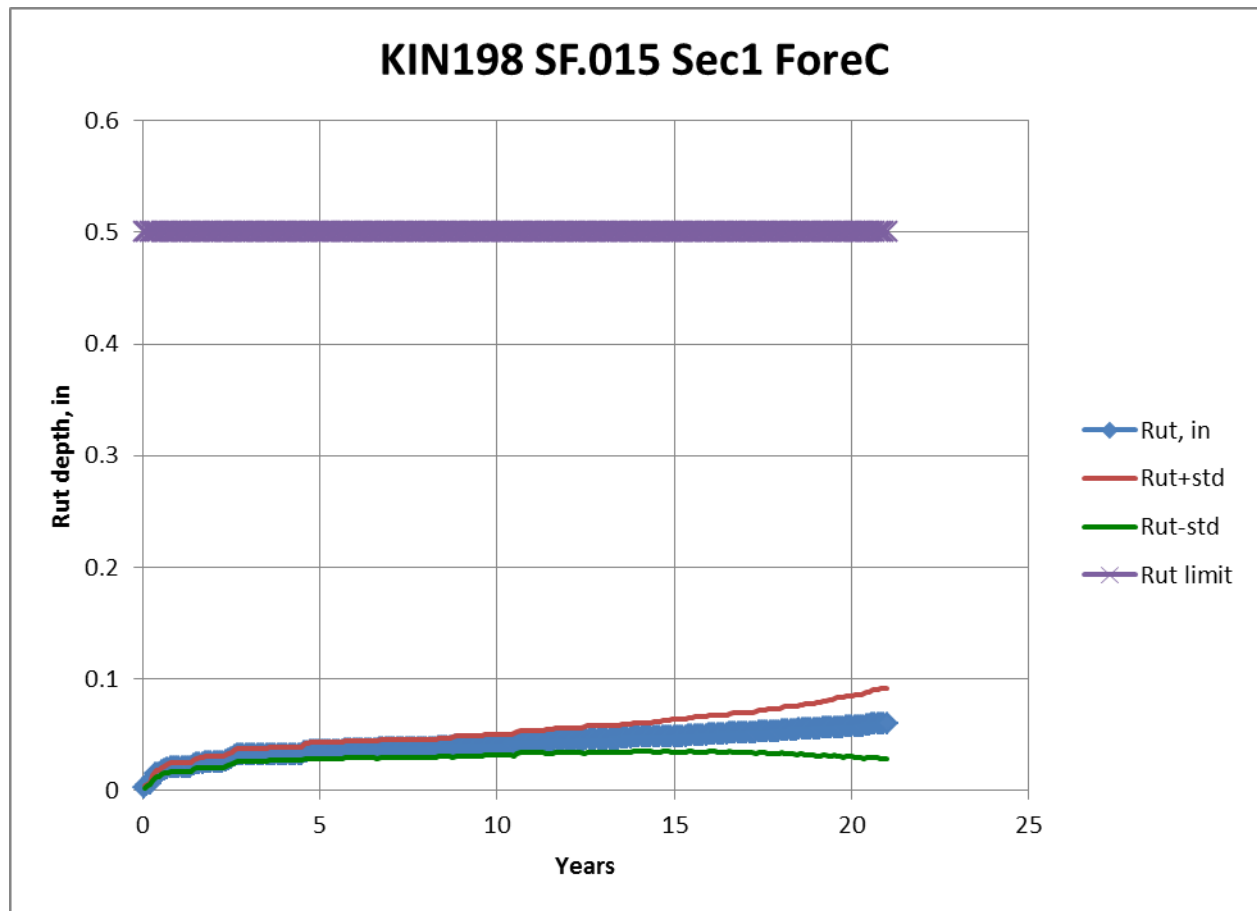
Figure A.11: Rutting-versus-time plot from *CaIME* for a 0.15 ft (45 mm) RHMA-G overlay on Section 1.
Note: The mean estimate of rutting after 20 years, with 50% reliability (0.06 in.), is well below the failure criteria of 0.5 in. The mean plus one standard deviation shows no more than 0.09 in. of rutting after 20 years with 68% reliability, and no more than 0.1 in. with 90% reliability.

Figure A.11 shows the rutting-versus-time plot for the same 0.15 ft (45 mm) RHMA-G overlay on Section 1. Note the progression in rut depth (the thick blue line at about 0.05 in.) and the established limiting criteria (the straight line at 0.5 in.). This pavement reaches the desired 20-year life for rutting.
